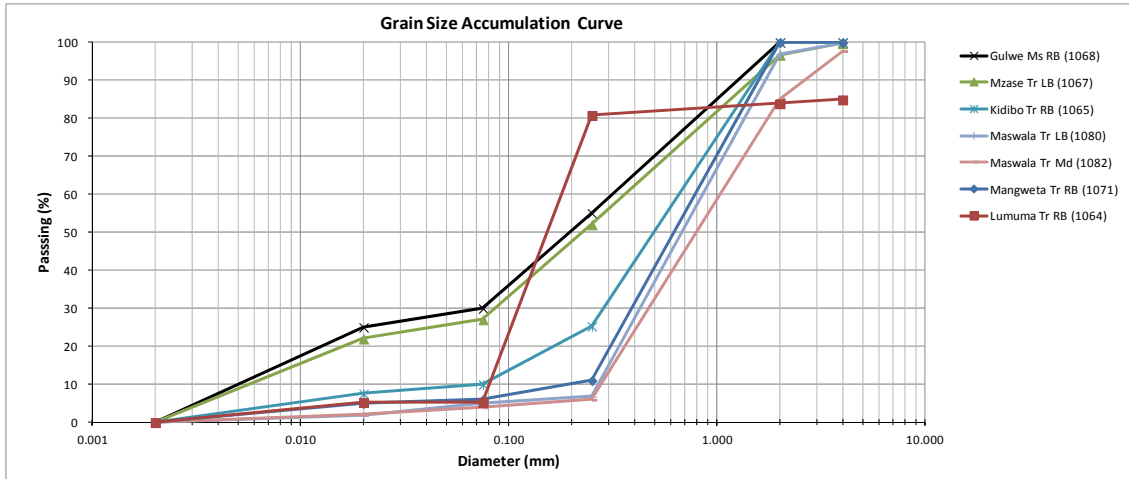
- Material of riverbed deposition in Mzase and Gulwe which consists of materials from Mzase River is almost the same composition. And these materials mainly consist of silt, medium sand and granule. The ratio accounts for about 50%.
- Materials in Kidibo, Maswala, Mangweta River almost consist of granule.
- Material in Lumuma River mainly consists of medium sand.

Figure O.16: Grain Size Accumulation Curve

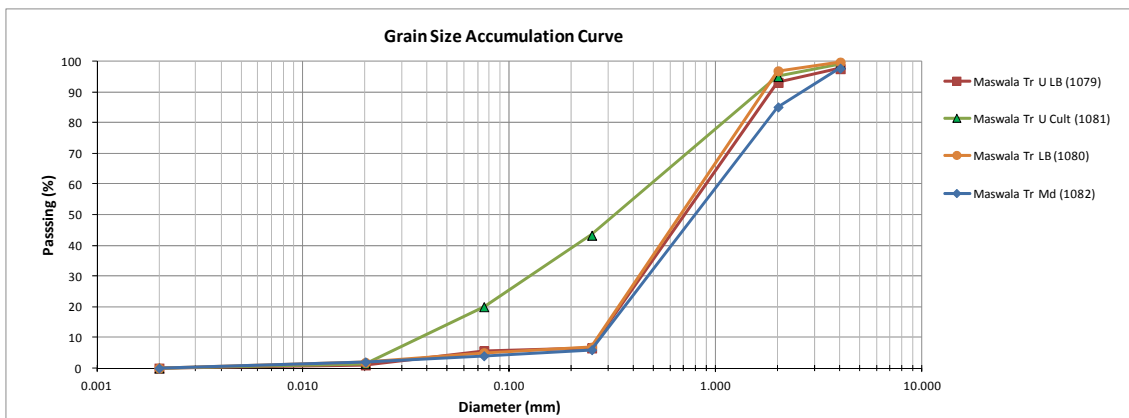
Figure O.17 shows the grain size accumulation curve of riverbed deposition in the Maswala River and that of the cultivated land along the river.

On the other hand, that of the cultivated area shows that the composition ration of very find sand and medium sand accounts for a high ratio compared with the riverbed one. The ratio account for about 40%.

Figure O.17: Grain Size Accumulation Curve

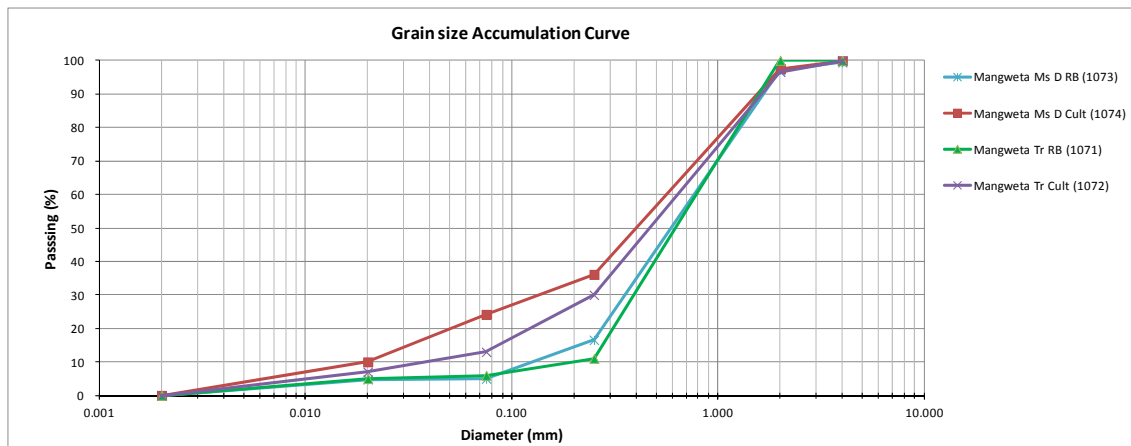
Figure O.18 shows the grain size accumulation curve of riverbed deposition and cultivated area at downstream of confluence of the Mangweta River and that of riverbed deposition and cultivated area in the Mangweta River.

- On the other hand, that of cultivated land shows that the composition ratio of very fine sand and medium sand accounts for a high ratio compared with the riverbed. The ratio accounts for about 30%.

Figure O.18: Grain Size Accumulation Curve

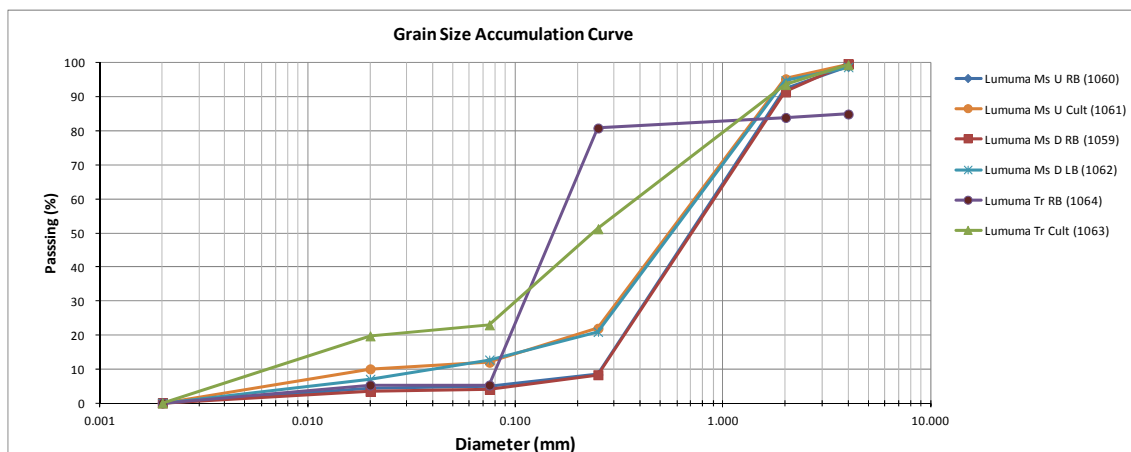
- Material of riverbed deposition in the Kinyasungwe River mainly consists of granule.
- On the other hand, that of riverbed deposition in the Lumuma River shows that the composition ratio of medium sand accounts for a high ratio compared with the riverbed one. The ratio accounts for about 75%.
- And that of cultivated land in the Lumuma River shows a high ratio of very fine sand and medium sand.

Figure O.19: Grain Size Accumulation Curve

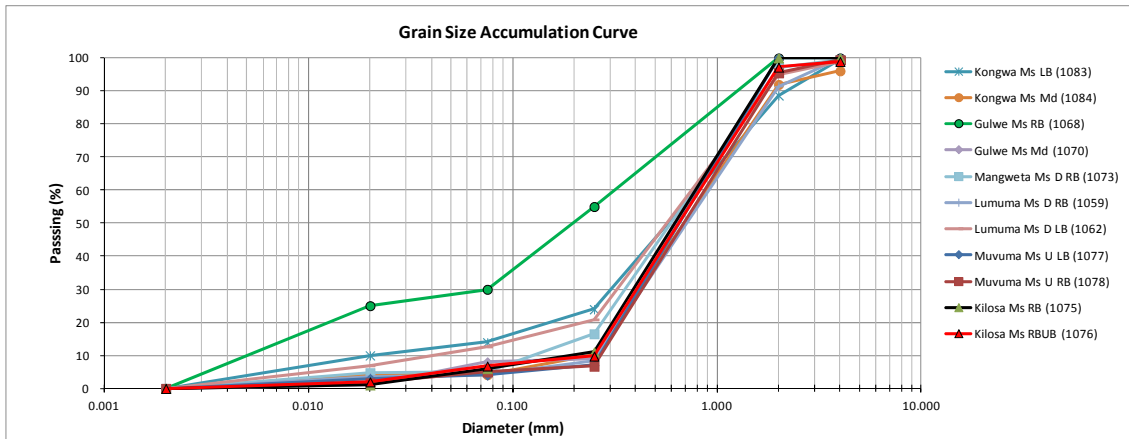
- Material of riverbed deposition in the Kinyasungwe River mainly consists of granule. The ratio accounts for about 70%–90%.
- But, that of Gulwe site consists of silt, medium sand and granule. Because this is presumed that the material of Gulwe site consists of the discharge materials from the Mzase River as mentioned above. The ratio below medium sand accounts for about 55%.

Figure O.20: Grain Size Accumulation Curve

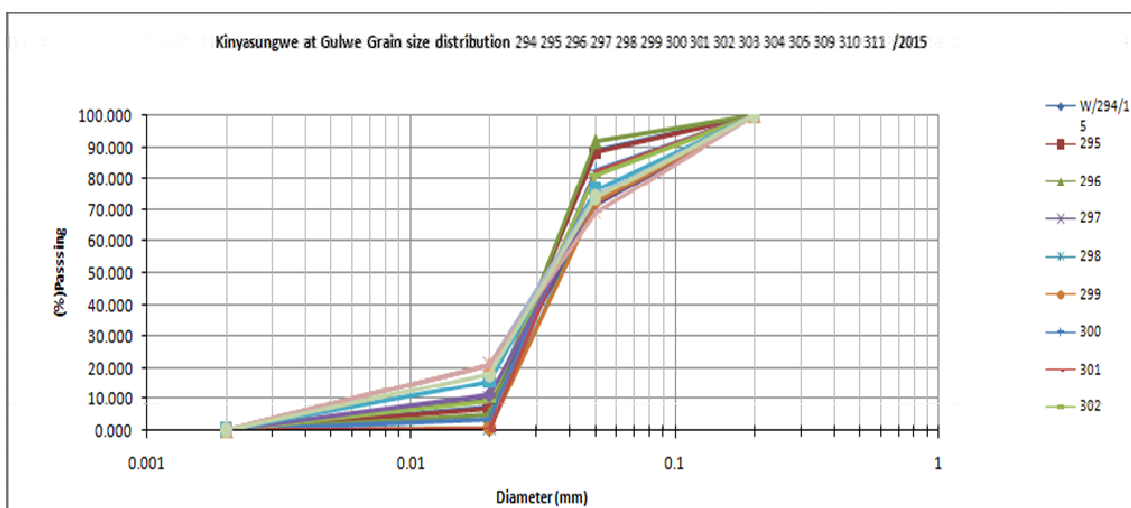
Figure P.36: Grain Size Distribution Analysis Graphs (Kinyasungwe/Gulwe)

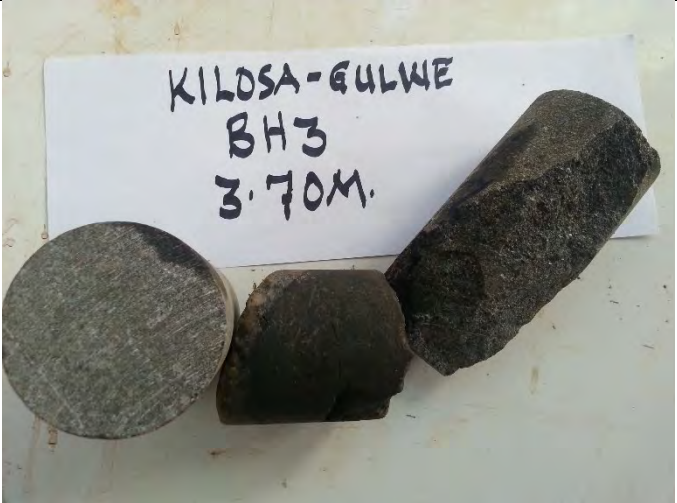
3.0 – 4.4	<ul style="list-style-type: none"> • Dark grey, fine to medium grained • No foliation apparent. Metamorphosed igneous rock. Hornfels. • Some mica

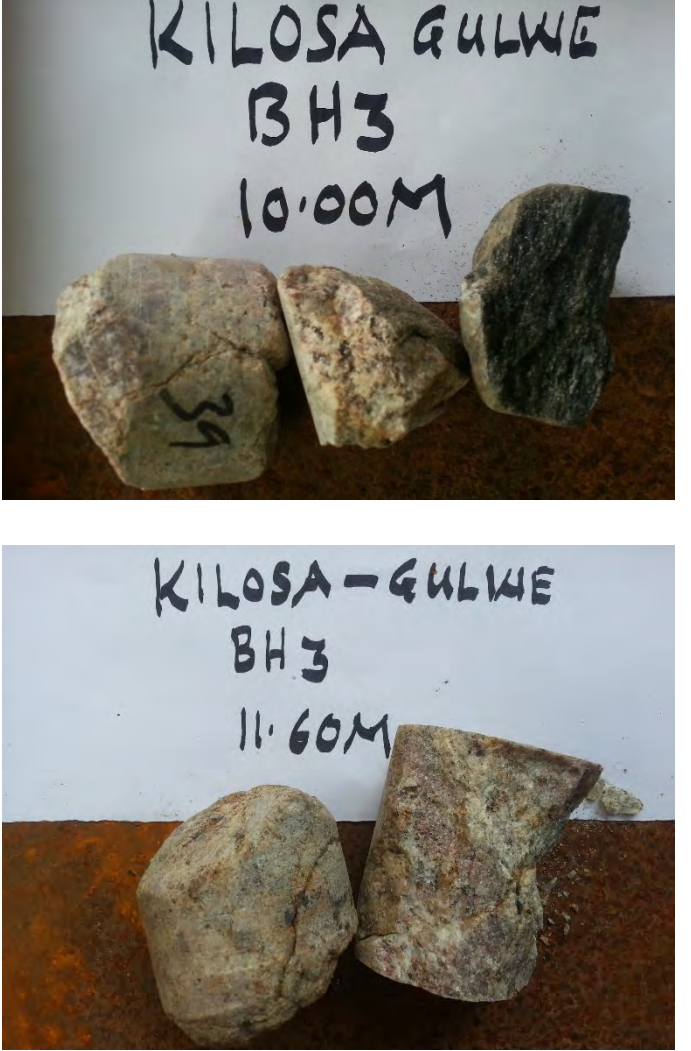
Depth	Observations	Picture
9.4 – 12.1	<ul style="list-style-type: none">• Contact discontinuity at about 9.8m between fine dark grey rock and white quartzitic rock.• Pink rock with some brown discoloration.• Crystals not distinct. Feldspar and Quartz

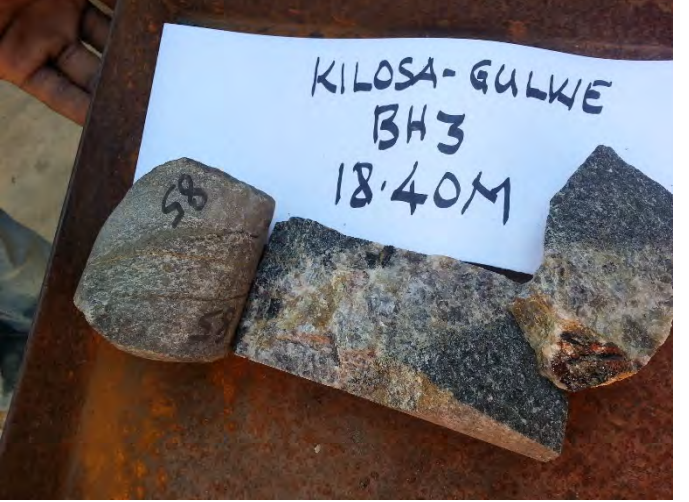
Depth	Observations	Picture
17.1 – 18.9	<ul style="list-style-type: none"> • High concentration of mica • Dark and light grey • Pink siliceous intrusion about 50mm thick dipping about 60deg

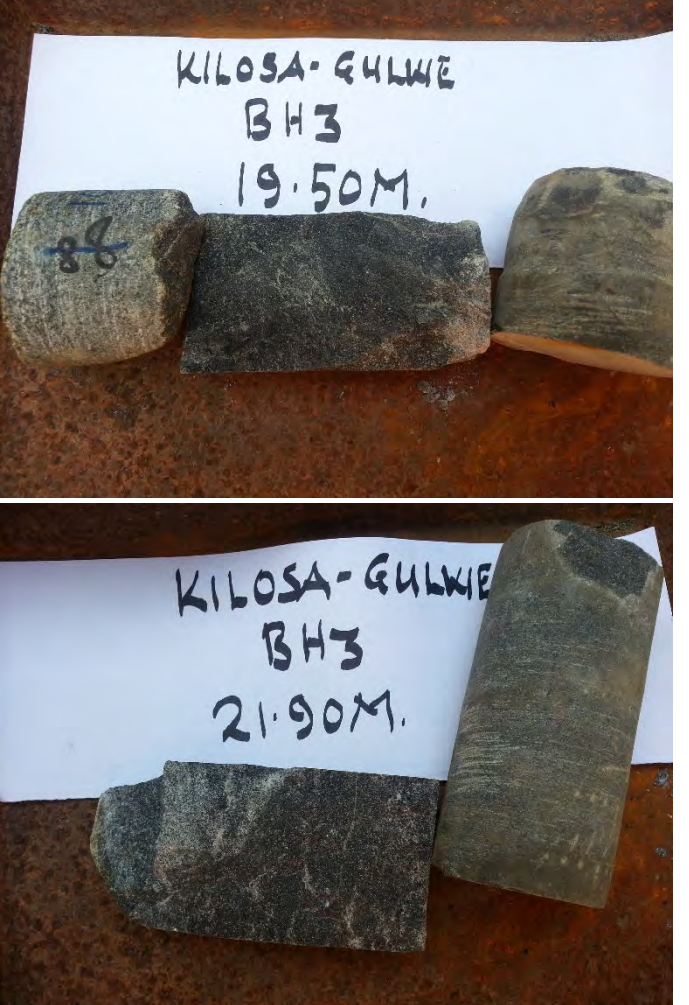
19.2 22.1	<ul style="list-style-type: none"> • Dark grey fine rock. Mafic. Hard but slaty • Foliations not distinct. • Similar to rock found in between 2 and 9m • Mica present
