**PROJECT:** Kilosa-Gulwe Central Railway. JICA Study A3 / 1 of 13

**CLIENT:** PADECO Co. Ltd

**PROJECT NO:** S0820

- 1.0 TERMS OF REFERENCE and CONDITIONS ON SITE
  - 2.0 SITE LOCATION
  - 3.0 GEOLOGY
  - 4.0 INVESTIGATION METHODOLOGY
  - 5.0 SOIL TEST RESULTS
  - 6.0 TEST RESULTS ON ROCK CORES
  - 7.0 GENERAL LITHOLOGY
  - 8.0 CHEMICAL TESTS ON GROUND WATER
  - APPENDICES
-

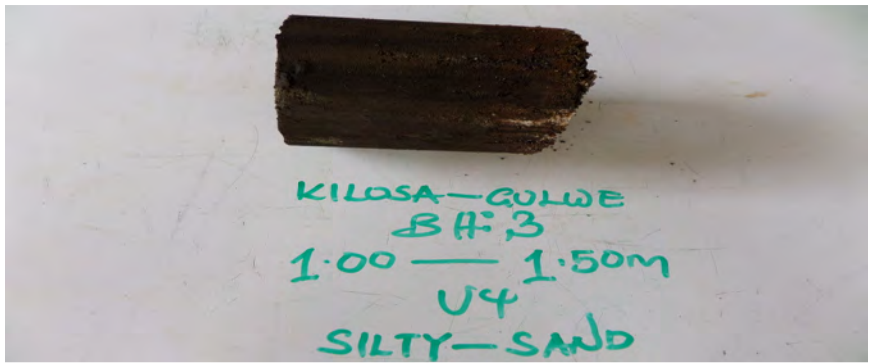
0.00m-1.50m

<p>KILOSA-GULWE BH: 3 1.00 — 1.50m U4 SILTY-SAND</p>
1.50m-2.60m

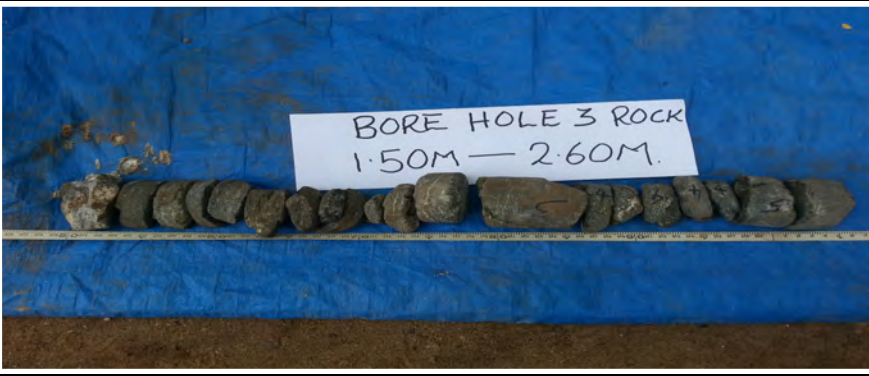
<p>BORE HOLE 3 ROCK 1.50M — 2.60M.</p>
3.00m-4.40m

Depth	Observations	Picture
1.5 - 2.6	<ul style="list-style-type: none"> <li>• Dark grey, fine to medium grained</li> <li>• No foliation apparent. Metamorphosed igneous rock. Hornfels</li> <li>• Intrusive Silica band about 30-40mm</li> <li>• Some mica</li> <li>• Shiny lustre</li> </ul>

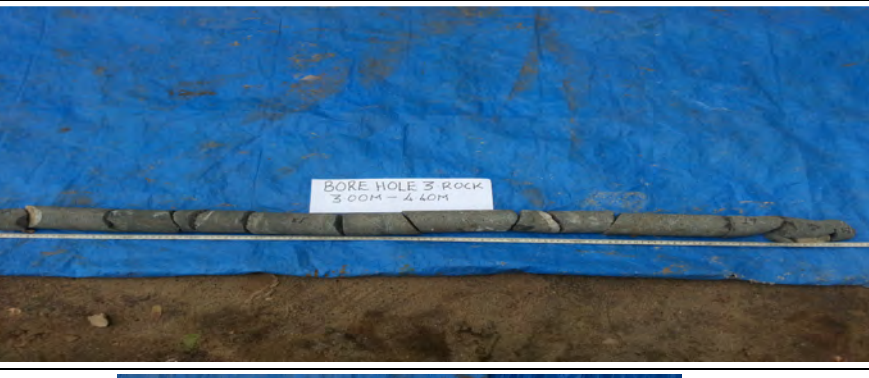
<p>BORE HOLE 3 ROCK 3.00M — 4.40M</p>
5.50m-6.50m

3.0 - 4.4	<ul style="list-style-type: none"> <li>• Dark grey, fine to medium grained</li> <li>• No foliation apparent. Metamorphosed igneous rock. Hornfels.</li> <li>• Some mica</li> </ul>

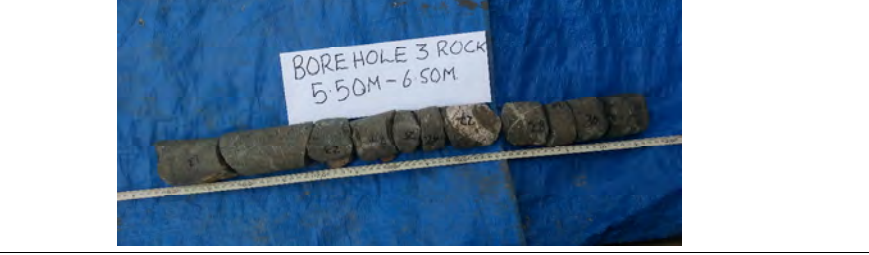
<p>BORE HOLE 3 ROCK 5.50M — 6.50M</p>

5.5 - 6.5	<ul style="list-style-type: none"> <li>• Dark grey, fine to medium grained</li> <li>• No foliation apparent. Metamorphosed igneous rock</li> <li>• Fracture 10mm wide, filled with cemented sand and weak white to pink silica band about 20mm</li> </ul>

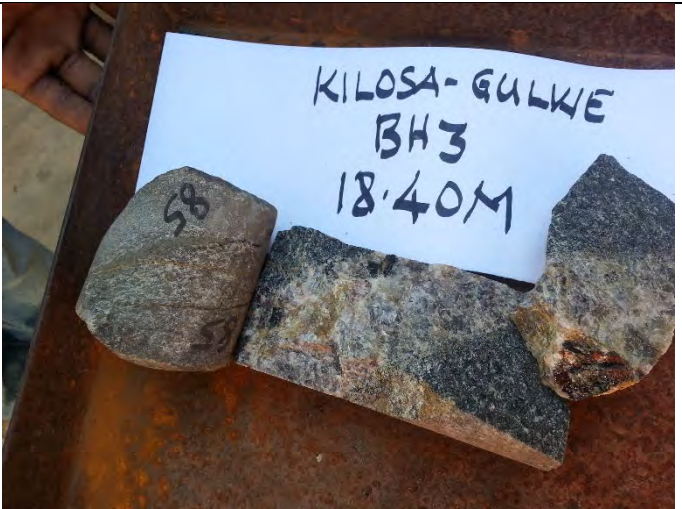
Depth	Observations	Picture
17.1 – 18.9	<ul style="list-style-type: none"> <li>• High concentration of mica</li> <li>• Dark and light grey</li> <li>• Pink siliceous intrusion about 50mm thick dipping about 60deg</li> </ul>

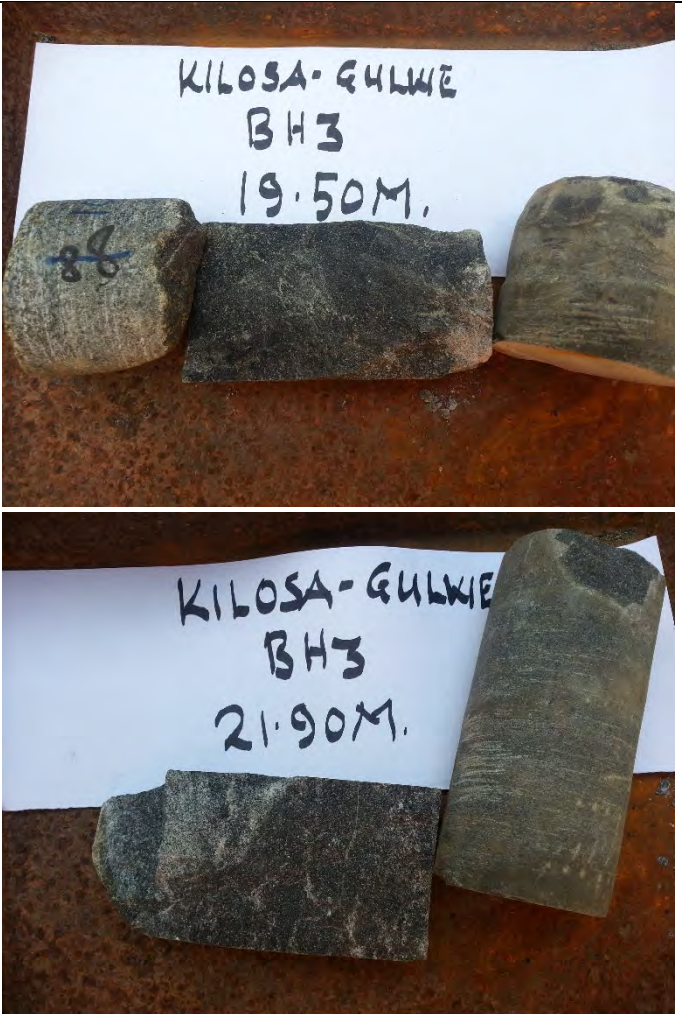
19.2 22.1	<ul style="list-style-type: none"> <li>• Dark grey fine rock. Mafic. Hard but slaty</li> <li>• Foliations not distinct.</li> <li>• Similar to rock found in between 2 and 9m</li> <li>• Mica present</li> </ul>

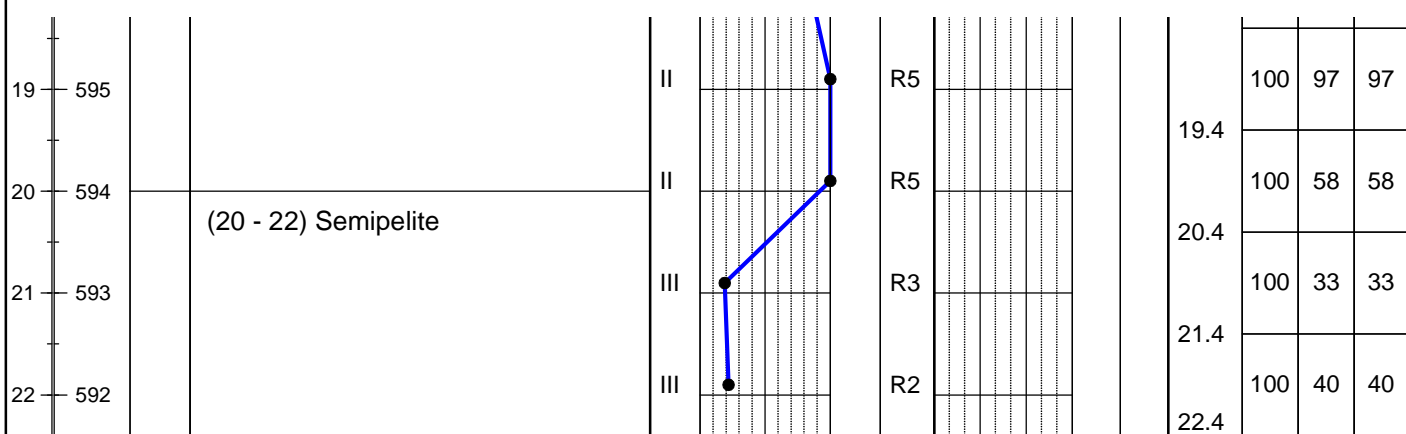
Down Hole Depth (m)	Elevation	Lithology	LITHOLOGIC DESCRIPTION	Degree of Weathering	Strength Data			Discontinuity Data			Core Run depth, m	TCR %	SCR %	RQD %
					UCS MPa	Is (50)	Hardness	Dip Angles		Type				
					50			30	60

Hardness: R0 = Extremely weak, R1 = Very weak, R2 = Weak, R3 = Medium Strong, R4 = Strong, R5 = Very Strong, R6 = Extremely Strong  
 Weathering: I = Fresh, II = Slightly, III = Moderately, IV = Highly, V = Completely, VI = Residual  
 TCR = Total Core Recovery, SCR = Solid core recovery, RQD = Rock Quality Designation,  
 UCS = Unconfined compressive Strength, Is(50) = Adjusted Point Load Strength

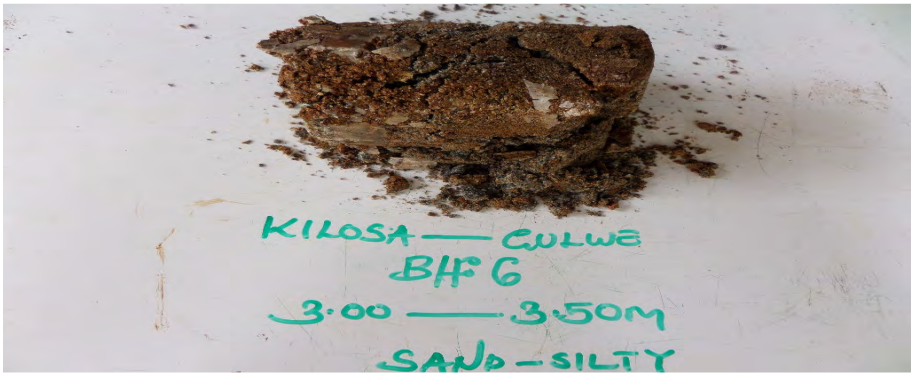
<p>KILOSA — GULWE BH:6 3.00 — 3.50m SAND — SILTY</p>
3.95m-4.90m

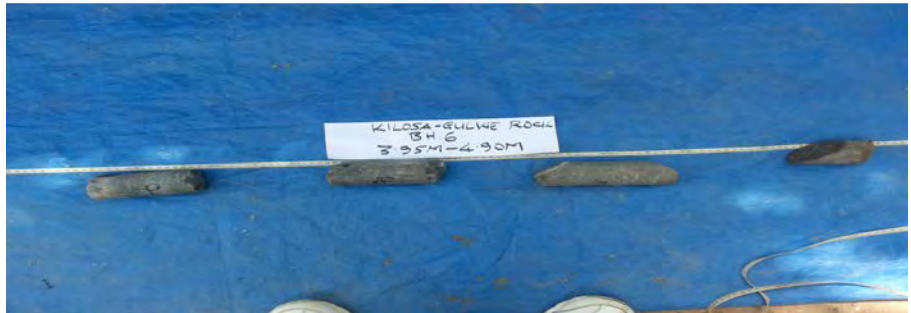
<p>KILOSA — GULWE ROAD BH:6 3.95m — 4.90m</p>
4.90m-6.70m

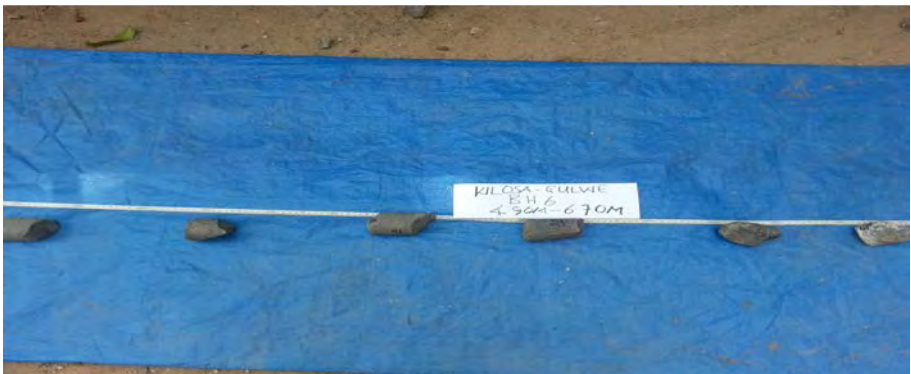
<p>KILOSA — GULWE BH:6 4.90m — 6.70m</p>

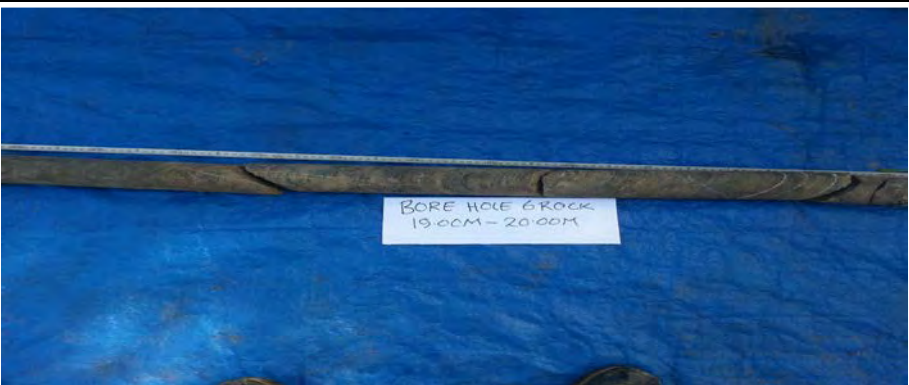
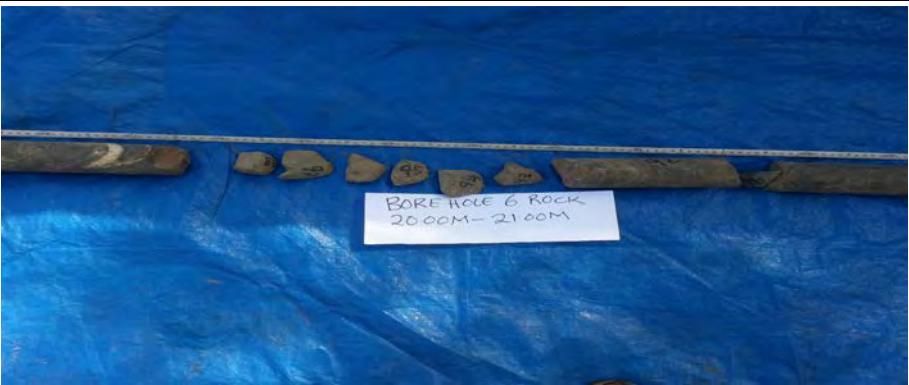
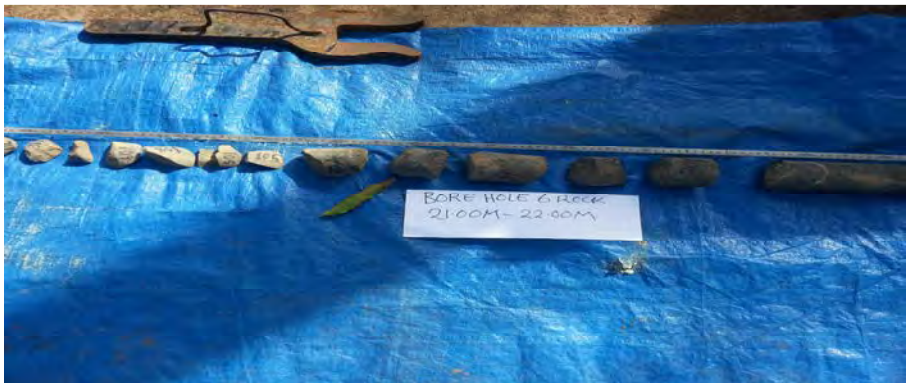
Depth	Observations	Picture
14.7 – 22.0m	<ul style="list-style-type: none"> <li>• Similar to rock formation 8-12.7m deep.</li> <li>• Dark grey banded and lineated rock steeply dipping upto 70 deg.</li> <li>• Fine to medium grained.</li> <li>• <b>Mylonitic</b> tendency.</li> <li>• <b>Amphibolite</b> facies</li> <li>• Occasional Quartz lenses 20 to 40mm thick</li> <li>• High mica concentration.</li> <li>• Some widely spaced filled joints crossing the foliation.</li> </ul>

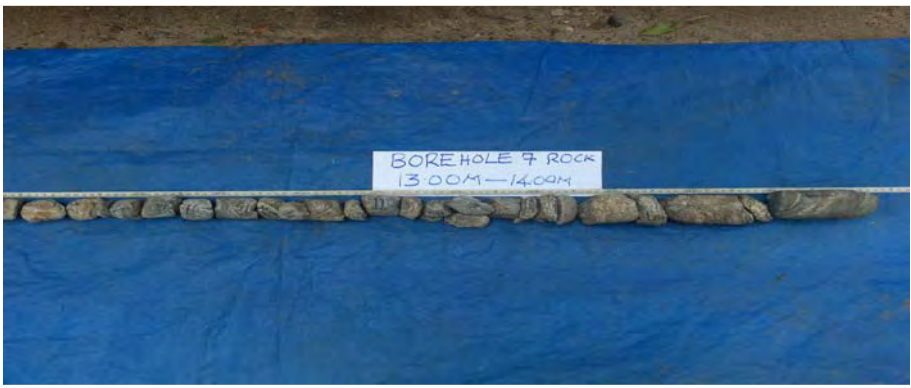
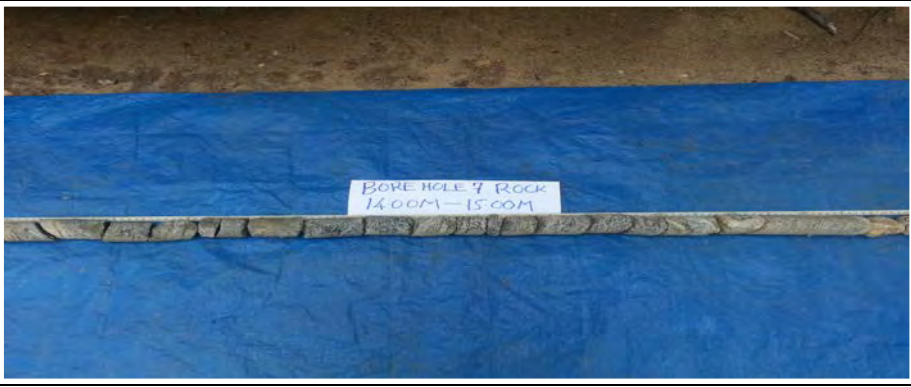
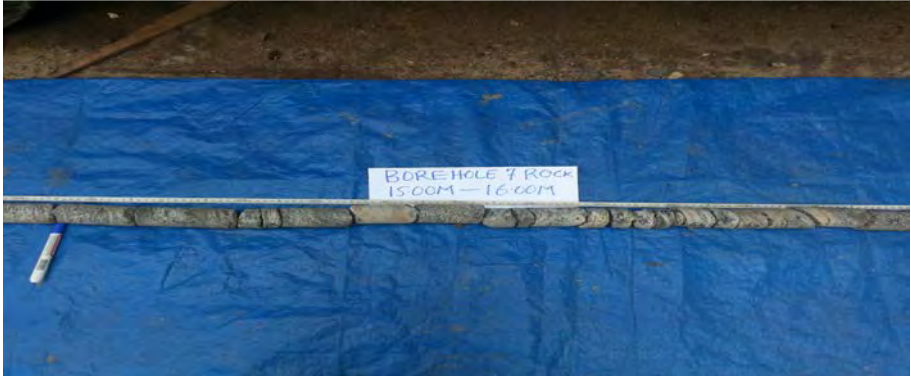
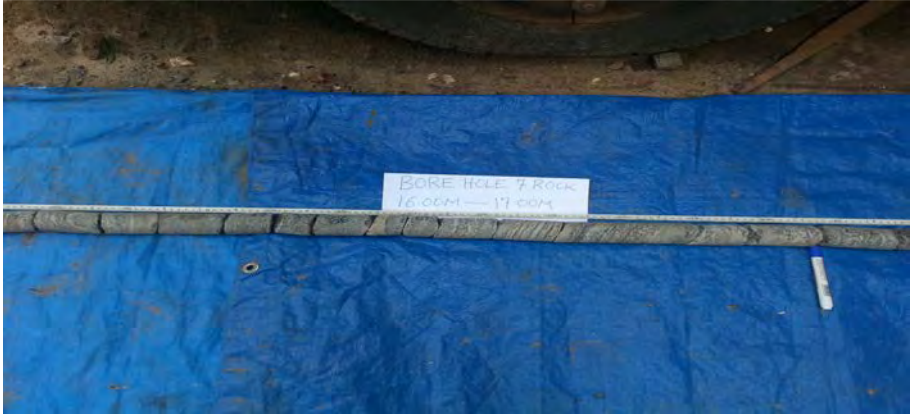
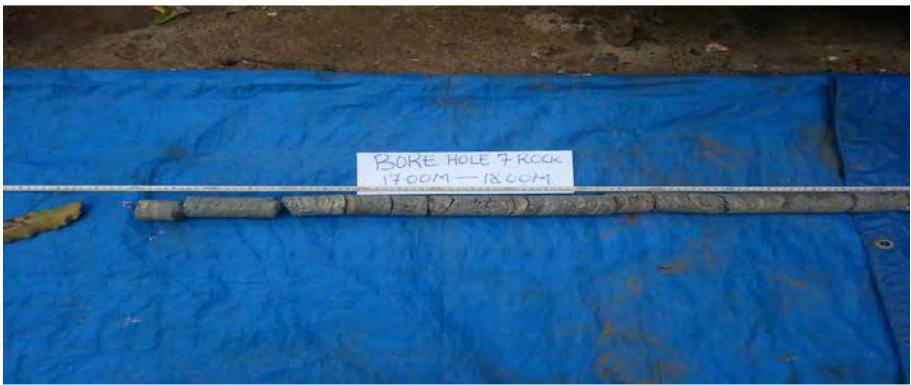
Depth	Observations	Picture
13.0 – 15.0m	<ul style="list-style-type: none"> <li>• Distinctly banded <b>gneiss</b> predominantly dark grey or black. Orthogneiss, granulite.</li> <li>• Medium to coarse grained</li> <li>• Foliations dipping more than 20 to 60 deg.</li> <li>• Mica present</li> <li>• Some Quartzite intrusions.</li> </ul>	 
15.0 – 18.0m	<ul style="list-style-type: none"> <li>• As above</li> </ul>

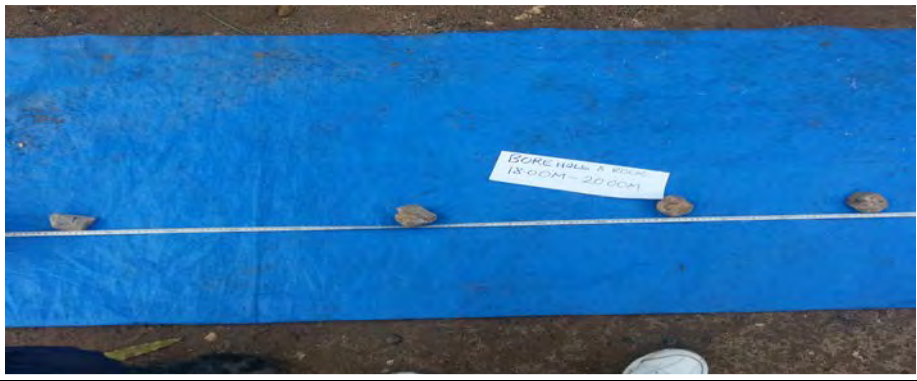
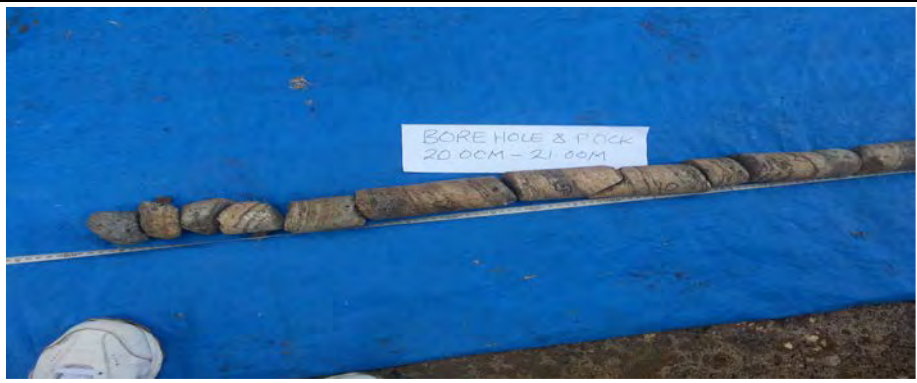
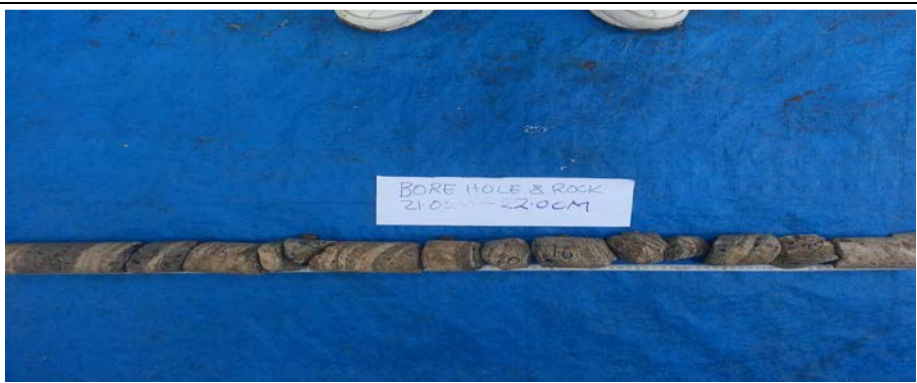
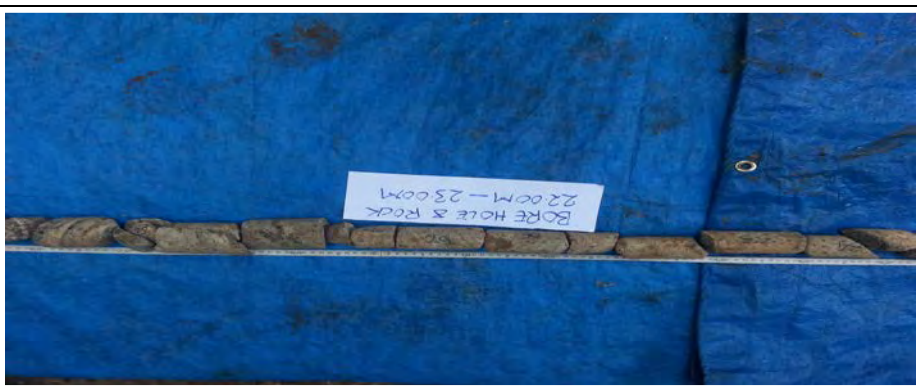
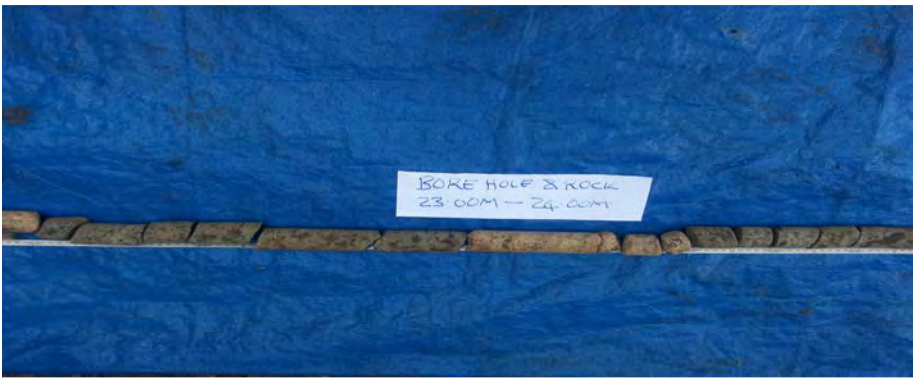
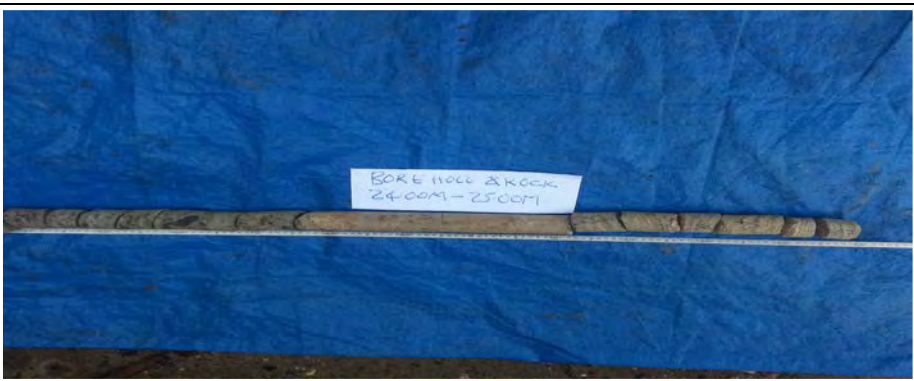
Depth	Observations	Picture
18.0 – 20.0m	<ul style="list-style-type: none"> <li>• Quartzite layers + some pink metamorphosed sandstone.</li> <li>• Light grey layers</li> <li>• Fine to medium grained</li> <li>• Rocks are initially relatively porous</li> </ul>

20.0 – 23.0m	<ul style="list-style-type: none"> <li>• Wide bands/layers (20 to 50mm) of very dark grey / black rock and white rock upto about 22 m depth</li> <li>• Appears as layers of dolerite and microgranite.</li> <li>• <b>Ortho Gneiss</b></li> <li>• Medium to coarse grains</li> </ul>

23.0 – 25.0m	<ul style="list-style-type: none"> <li>• As above but less obviously foliated.</li> <li>• Dark bands predominate. Looks like Dolerite interbedded with light grey rocks similar to microgranite.</li> <li>• Black and white mica visible</li> <li>• Medium to coarse grained.</li> </ul>

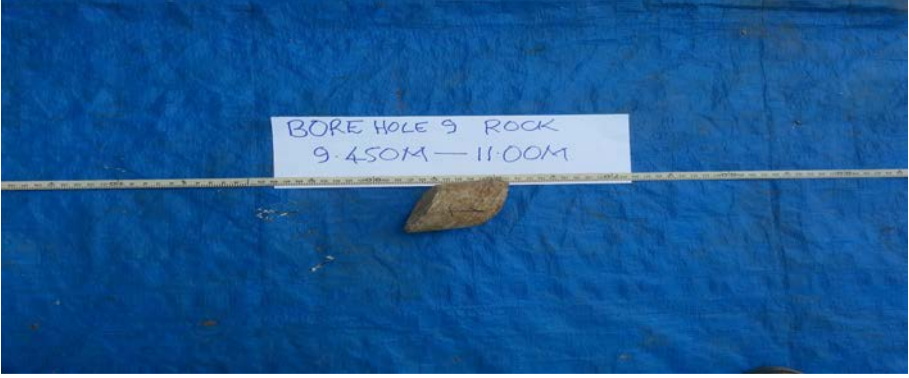
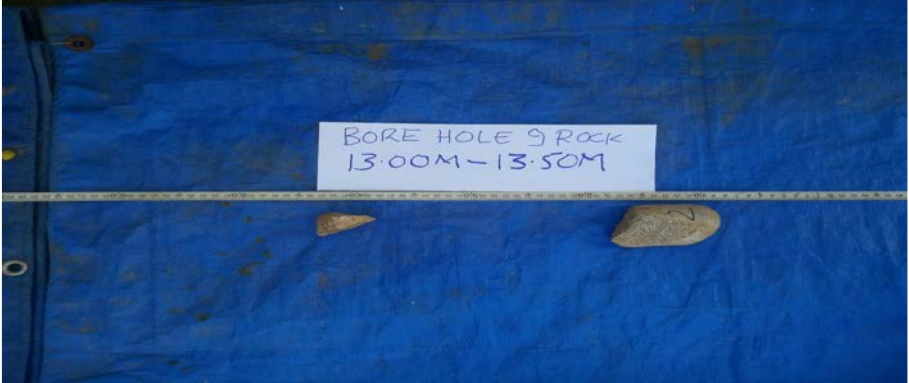
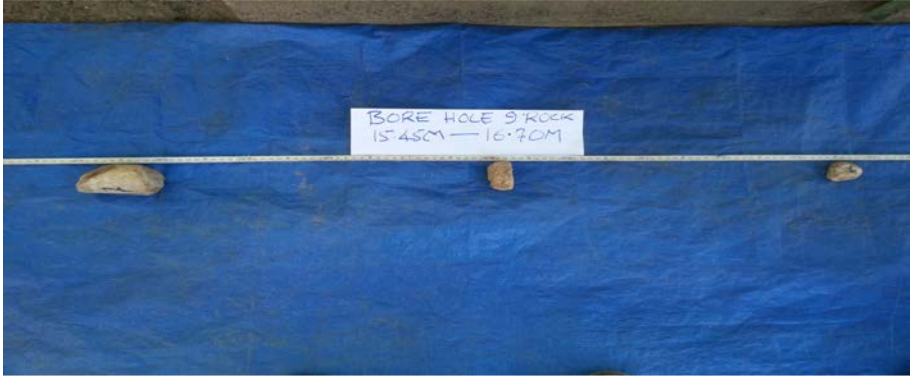
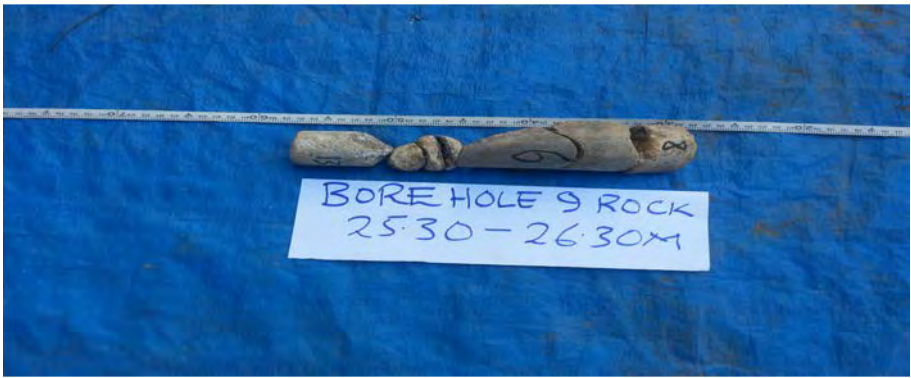
Depth	Observations	Picture
9.45 – 26.3m	<ul style="list-style-type: none"> <li>• Light Grey and pink and brown minerals.</li> <li>• No foliation</li> <li>• Medium to coarse grained</li> <li>• Weathering in the joints.</li> <li>• <b>Paragneiss.</b> Quartzite and other Metasediments</li> <li>• <b>Sandstone</b></li> <li>• Mica present</li> </ul>	
27.0 – 28.0m	<ul style="list-style-type: none"> <li>• Light grey</li> <li>• Layered</li> <li>• Distinct weathering in the joints</li> <li>• Light colored mica present</li> <li>• <b>Paragneiss.</b></li> </ul>	
28.0 – 32.4	<ul style="list-style-type: none"> <li>• Predominantly dark grey rock with fine lineation 2-5mm thick.</li> <li>• Finer elongated minerals. Mylonitic tendency at some depths</li> <li>• <b>Gneiss</b></li> <li>• Fine to medium grained</li> <li>• With quartzite intrusions</li> </ul>

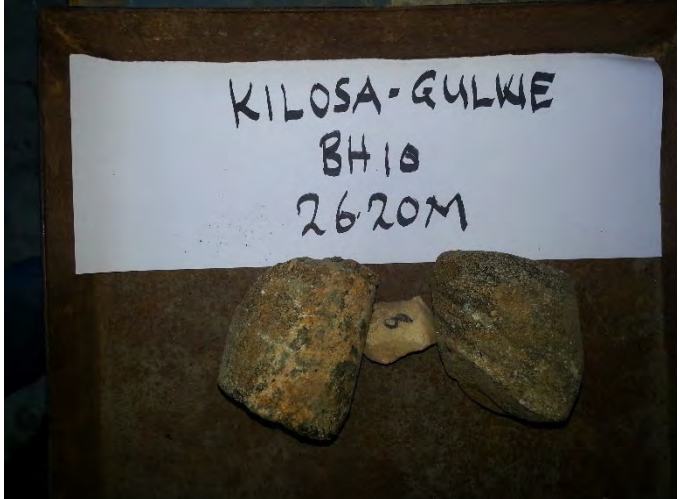
Depth	Observations	Picture
25.8 – 26.8m	<ul style="list-style-type: none"> <li>• Very dark rock</li> <li>• Medium grained</li> <li>• Some quartzite bands</li> <li>• Banded 10-20mm</li> <li>• <b>Gneiss</b></li> </ul>

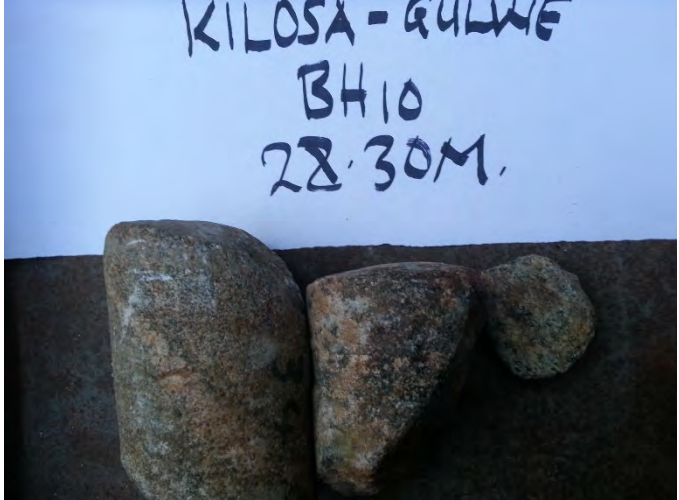
26.8 – 28.8	<ul style="list-style-type: none"> <li>• Dark grey and pink bands</li> <li>• Bands 5-10mm</li> <li>• Mica present and white spots. speckled</li> </ul>

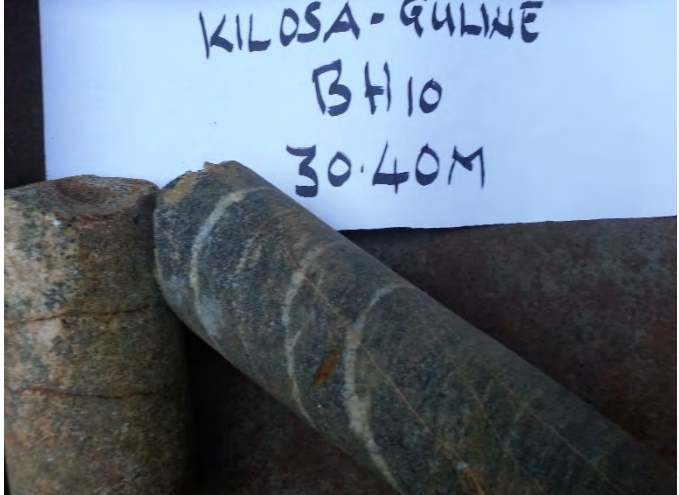
28.0 – 32.4	<ul style="list-style-type: none"> <li>• Thin light colored bands or veins &lt; 5mm vs wider dark bands dipped 0 – 15 degrees.</li> <li>• Some of the dark bands are lineated, mylonitic at some depths. while others are not.</li> <li>• Medium grained.</li> <li>• <b>Gneiss</b></li> <li>• High concentration of mica.</li> </ul>

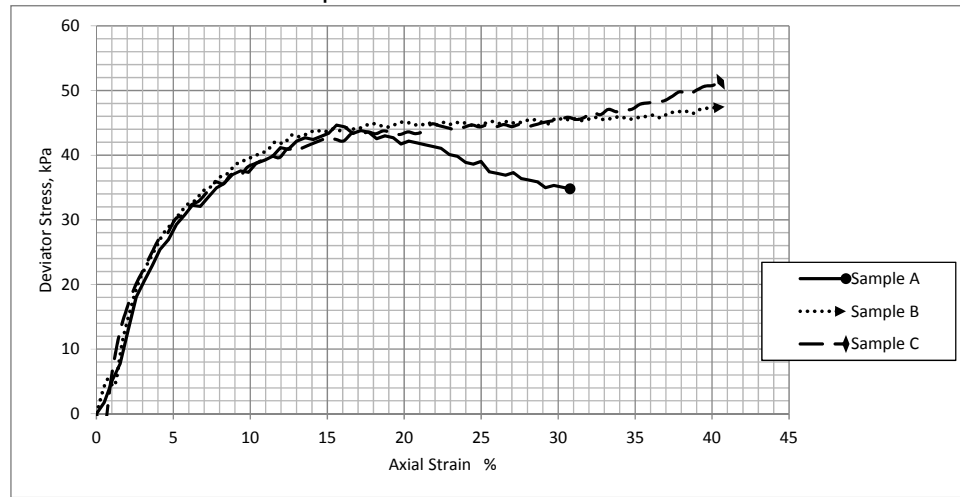
**Stress Strain Graphs**

Mode of Failure:		Maximum Deviator Stress		
Rate of strain	mm/min	0.8	0.8	0.8
Cell Pressure, P1	kPa	150	300	450
Max Deviator Stress	kPa	44.4	45.1	44.7
Major Principal Stress P3,	kPa	194.4	345.1	494.7
Axial Strain at failure	%	16.1%	23.6%	25.4%
Undrained Strength, Su	kPa	22.2	22.6	22.4
<b>Av. Undrained Strength,</b>	<b>kPa</b>	<b>22.4</b>		
E <sub>50</sub> secant modulus,	kPa	729	891	912
E <sub>50</sub> strain	%	3.6	3.3	3.5
<b>E<sub>50</sub> Av. secant modulus</b>	<b>kPa</b>	<b>844</b>		
Cohesion , C	kPa	23.0		
Angle of internal Friction,	φ	0.0

**Undrained Shear Strength**      **22.4 kPa at 22% strain**  
**E<sub>50</sub> secant modulus**            **0.8 Mpa at 3.5% strain**

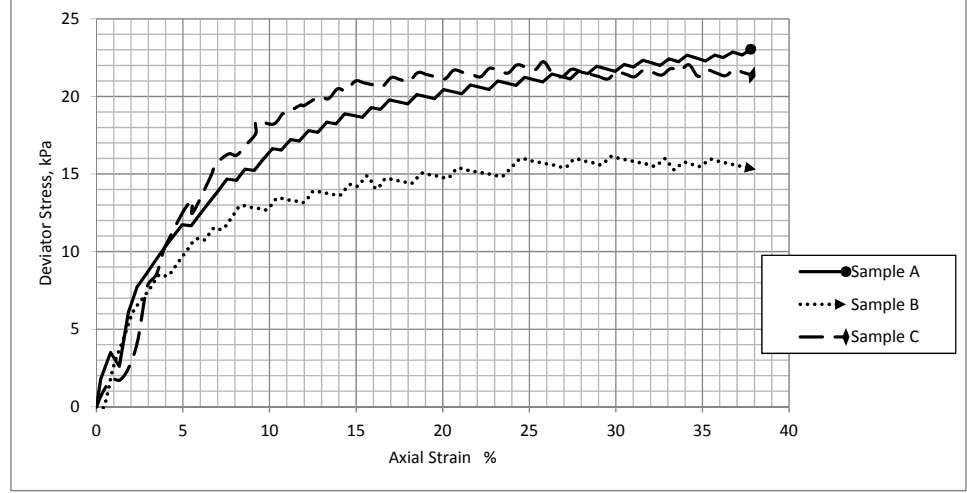
**Stress Strain Graphs**

<b>Mode of Failure:</b>		Maximum Deviator Stress		
Rate of strain	mm/min	0.8	0.8	0.8
Cell Pressure, P1	kPa	150	300	450
Max Deviator Stress	kPa	22.1	16.0	22.2
Major Principal Stress P3,	kPa	172.1	316.0	472.2
Axial Strain at failure	%	30.5%	30.2%	25.8%
Undrained Strength, Su	kPa	11.0	8.0	11.1
<b>Av. Undrained Strength,</b>	<b>kPa</b>	<b>10.0</b>		
E <sub>50</sub> secant modulus,	kPa	251	266	321
E <sub>50</sub> strain	%	5.0	3.6	5.0
<b>E<sub>50</sub> Av. secant modulus</b>	<b>kPa</b>	<b>279</b>		
Cohesion , C	kPa	11.0		
Angle of internal Friction,	φ	0.0

**Undrained Shear Strength**      10 kPa at 29% strain  
**E<sub>50</sub> secant modulus**              0.3 Mpa at 4.5% strain

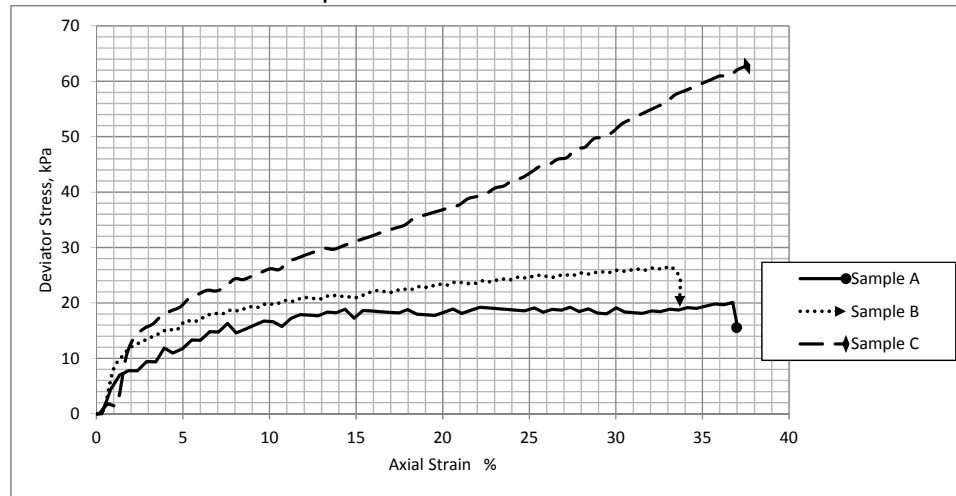
**Stress Strain Graphs**

Mode of Failure:		Maximum Deviator Stress		
Rate of strain	mm/min	0.8	0.8	0.8
Cell Pressure, P1	kPa	150	300	450
Max Deviator Stress	kPa	19.0	25.9	52.2
Major Principal Stress P3,	kPa	169.0	325.9	502.2
Axial Strain at failure	%	23.2%	30.1%	30.3%
Undrained Strength, Su	kPa	9.5	12.9	26.1
<b>Av. Undrained Strength,</b>	<b>kPa</b>	<b>16.2</b>		
E <sub>50</sub> secant modulus,	kPa	329	488	275
E <sub>50</sub> strain	%	3.9	3.1	10.1
<b>E<sub>50</sub> Av. secant modulus</b>	<b>kPa</b>	<b>364</b>		
Cohesion , C	kPa	11.0		
Angle of internal Friction,	φ	0.0

**Undrained Shear Strength**      11.2 kPa at 27% strain  
**E<sub>50</sub> secant modulus**              0.4 Mpa at 3.5% strain

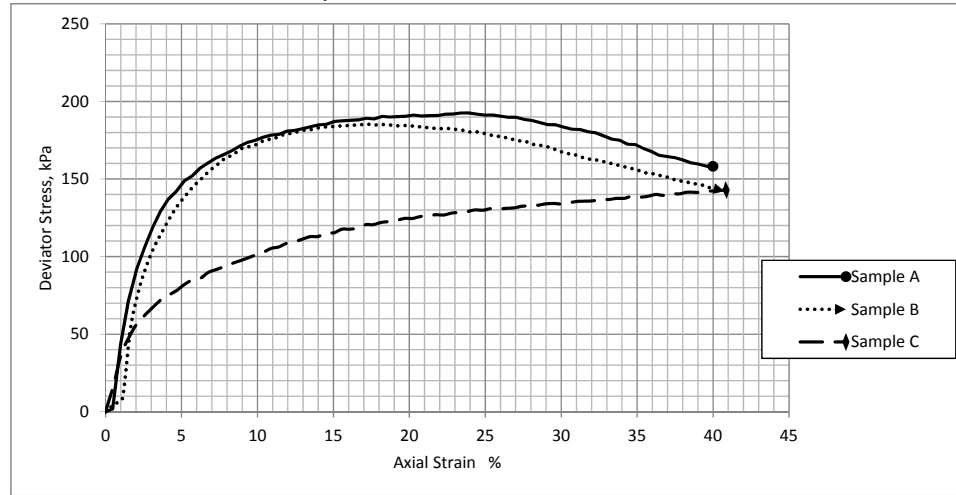
**Stress Strain Graphs**

Mode of Failure:		Maximum Deviator Stress		
Rate of strain	mm/min	0.8	0.8	0.8
Cell Pressure, P1	kPa	150	300	450
Max Deviator Stress	kPa	191.9	185.1	138.3
Major Principal Stress P3,	kPa	341.9	485.1	588.3
Axial Strain at failure	%	24.4%	18.3%	35.2%
Undrained Strength, Su	kPa	95.9	92.6	69.2
<b>Av. Undrained Strength,</b>	<b>kPa</b>	<b>85.9</b>		
E <sub>50</sub> secant modulus,	kPa	4926	5494	1979
E <sub>50</sub> strain	%	2.6	2.6	3.6
<b>E<sub>50</sub> Av. secant modulus</b>	<b>kPa</b>	<b>4133</b>		
Cohesion , C	kPa	94.0		
Angle of internal Friction,	φ	0.0

**Undrained Shear Strength**      **94.3 kPa at 21% strain**  
**E<sub>50</sub> secant modulus**              **5.2 Mpa at 2.6% strain**

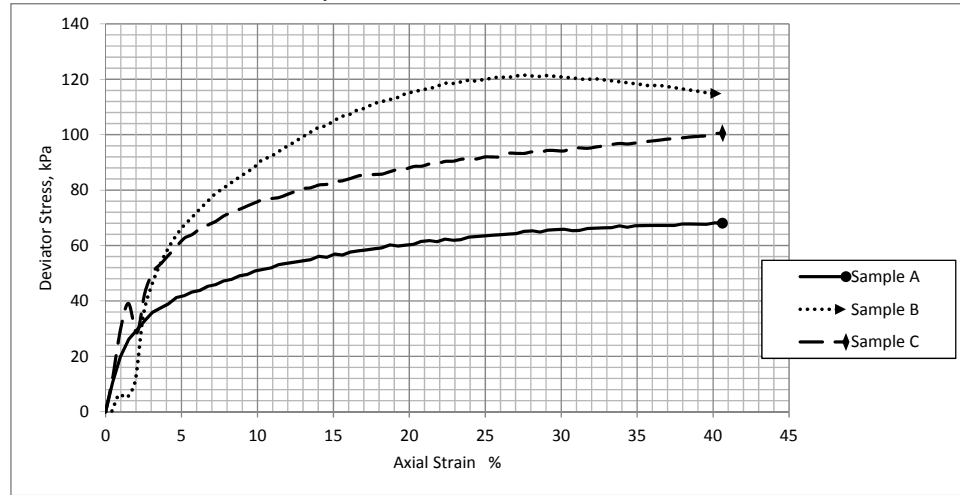
**Stress Strain Graphs**

Mode of Failure:		Maximum Deviator Stress		
Rate of strain	mm/min	0.8	0.8	0.8
Cell Pressure, P1	kPa	150	300	450
Max Deviator Stress	kPa	67.2	121.2	100.4
Major Principal Stress P3,	kPa	217.2	421.2	550.4
Axial Strain at failure	%	35.4%	28.0%	40.1%
Undrained Strength, Su	kPa	33.6	60.6	50.2
<b>Av. Undrained Strength,</b>	<b>kPa</b>	<b>48.1</b>		
E <sub>50</sub> secant modulus,	kPa	1164	1975	2055
E <sub>50</sub> strain	%	3.1	4.6	3.1
<b>E<sub>50</sub> Av. secant modulus</b>	<b>kPa</b>	<b>1731</b>		
Cohesion , C	kPa	55.4		
Angle of internal Friction,	φ	0.0

**Undrained Shear Strength 55.4 kPa at 34% strain**  
**E<sub>50</sub> secant modulus 2 Mpa at 3.9% strain**

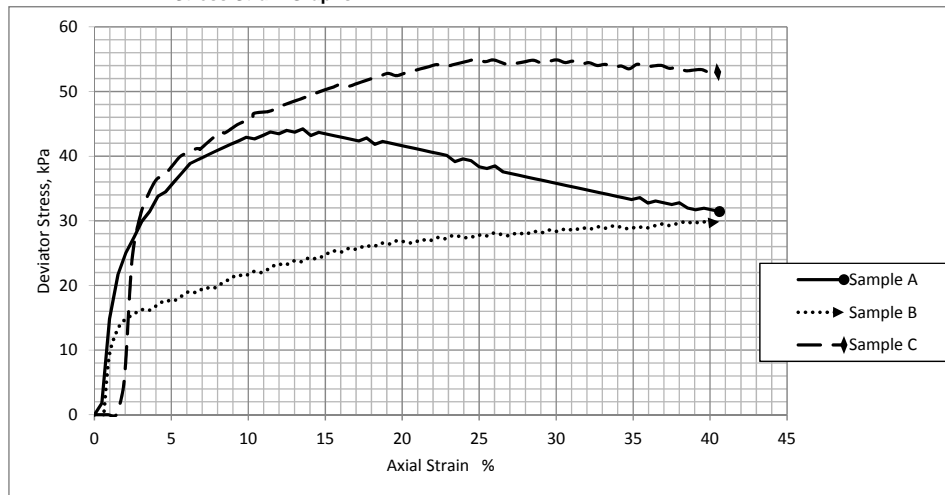
**Stress Strain Graphs**

Mode of Failure:		Maximum Deviator Stress		
Rate of strain	mm/min	0.8	0.8	0.8
Cell Pressure, P1	kPa	150	300	450
Max Deviator Stress	kPa	44.2	29.2	54.9
Major Principal Stress P3,	kPa	194.2	329.2	504.9
Axial Strain at failure	%	13.5%	33.7%	25.9%
Undrained Strength, Su	kPa	22.1	14.6	27.4
<b>Av. Undrained Strength,</b>	<b>kPa</b>	<b>21.4</b>		
E <sub>50</sub> secant modulus,	kPa	1490	1222	2439
E <sub>50</sub> strain	%	2.0	2.0	3.0
<b>E<sub>50</sub> Av. secant modulus</b>	<b>kPa</b>	<b>1717</b>		
Cohesion , C	kPa	25.0		
Angle of internal Friction,	φ	0.0

**Undrained Shear Strength 24.8 kPa at 20% strain**  
**E<sub>50</sub> secant modulus 2 Mpa at 2.5% strain**

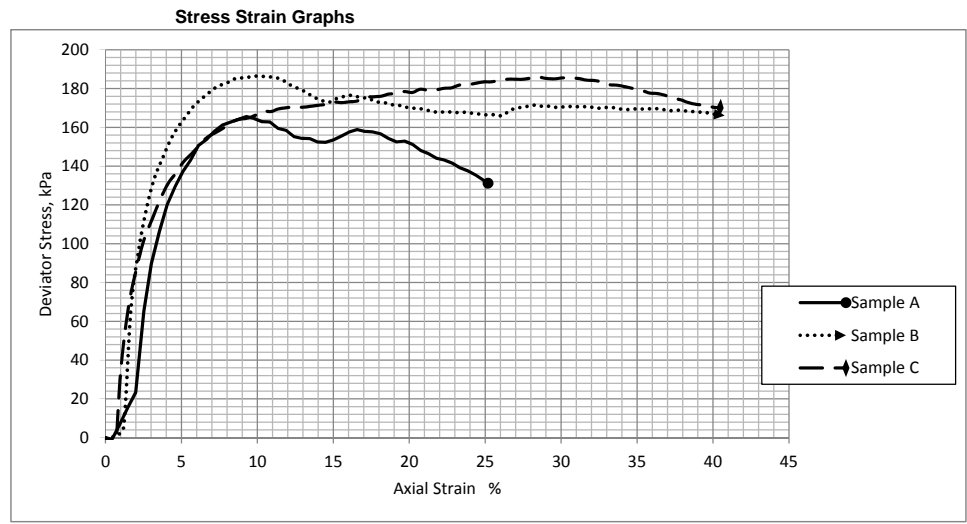
<b>Mode of Failure:</b>		Maximum Deviator Stress		
Rate of strain	mm/min	0.8	0.8	0.8
Cell Pressure, P1	kPa	150	300	450
Max Deviator Stress	kPa	164.7	186.2	185.2
Major Principal Stress P3,	kPa	314.7	486.2	635.2
Axial Strain at failure	%	9.8%	10.5%	29.0%
Undrained Strength, Su	kPa	82.4	93.1	92.6
<b>Av. Undrained Strength,</b>	<b>kPa</b>	<b>89.4</b>		
E <sub>50</sub> secant modulus,	kPa	6467	9045	6140
E <sub>50</sub> strain	%	3.0	2.2	2.5
<b>E<sub>50</sub> Av. secant modulus</b>	<b>kPa</b>	<b>7217</b>		
Cohesion , C	kPa	93.0		
Angle of internal Friction,	φ	0.0

**Undrained Shear Strength      89.4 kPa at 16% strain**  
**E<sub>50</sub> secant modulus              7.2 Mpa at 2.6% strain**

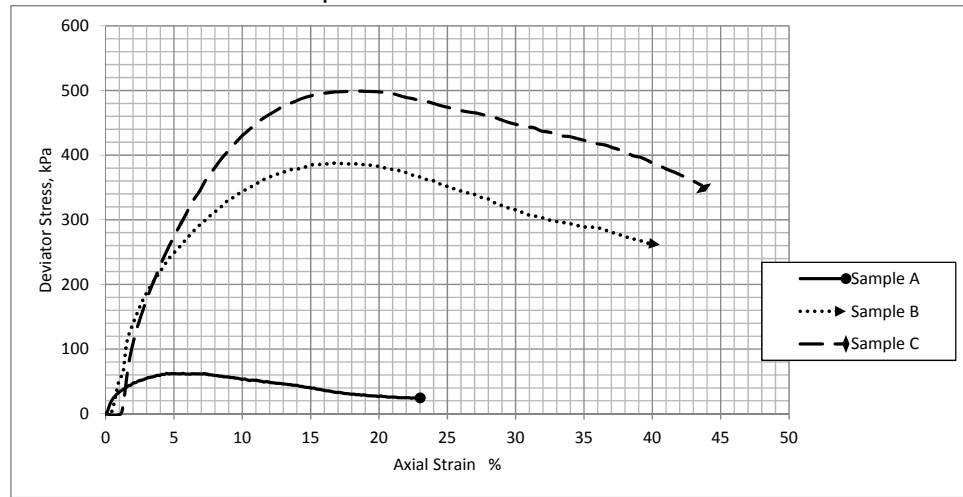
**Stress Strain Graphs**

Mode of Failure:		Maximum Deviator Stress		
Rate of strain	mm/min	0.8	0.8	0.8
Cell Pressure, P1	kPa	150	300	450
Max Deviator Stress	kPa	61.9	386.4	498.8
Major Principal Stress P3,	kPa	211.9	686.4	948.8
Axial Strain at failure	%	5.2%	17.6%	18.8%
Undrained Strength, Su	kPa	30.9	193.2	249.4
<b>Av. Undrained Strength,</b>	<b>kPa</b>	<b>157.8</b>		
E <sub>50</sub> secant modulus,	kPa	3570	6431	7268
E <sub>50</sub> strain	%	1.0	3.7	4.8
<b>E<sub>50</sub> Av. secant modulus</b>	<b>kPa</b>	<b>5756</b>		
App Cohesion , C	kPa	0.0		
App Angle of internal Fricti	φ	21.1

**Undrained Shear Strength**      **221.3 kPa at 18% strain**  
**E<sub>50</sub> secant modulus**              **6.8 Mpa at 4.2% strain**

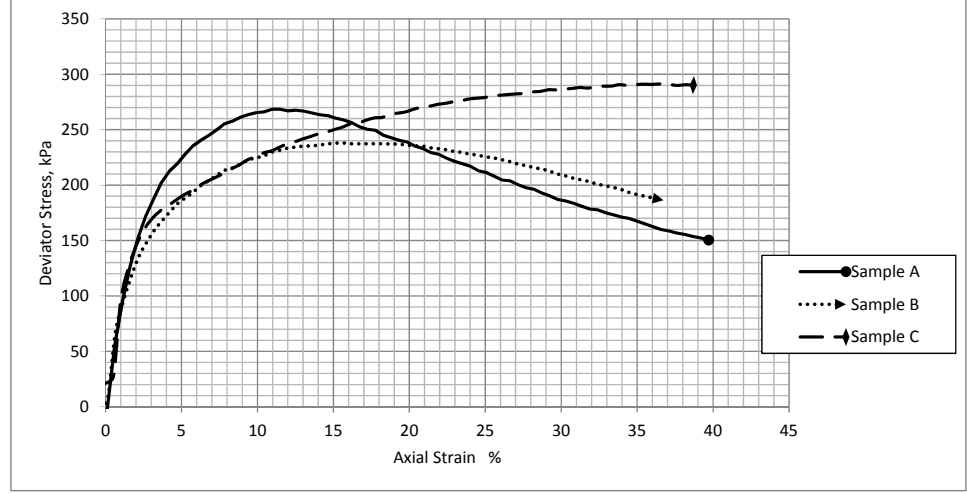
**Stress Strain Graphs**

<b>Mode of Failure:</b>		Maximum Deviator Stress		
Rate of strain	mm/min	0.8	0.8	0.8
Cell Pressure, P1	kPa	150	300	450
Max Deviator Stress	kPa	266.9	237.3	291.2
Major Principal Stress P3,	kPa	416.9	537.3	741.2
Axial Strain at failure	%	12.3%	18.3%	39.6%
Undrained Strength, Su	kPa	133.5	118.6	145.6
<b>Av. Undrained Strength,</b>	<b>kPa</b>	<b>132.6</b>		
E <sub>50</sub> secant modulus,	kPa	7734	6277	6030
E <sub>50</sub> strain	%	2.1	2.2	2.0
<b>E<sub>50</sub> Av. secant modulus</b>	<b>kPa</b>	<b>6680</b>		
Cohesion , C	kPa	133.0		
Angle of internal Friction,	φ	0.0

**Undrained Shear Strength**      132.6 kPa at 23% strain  
**E<sub>50</sub> secant modulus**            6.7 Mpa at 2.1% strain

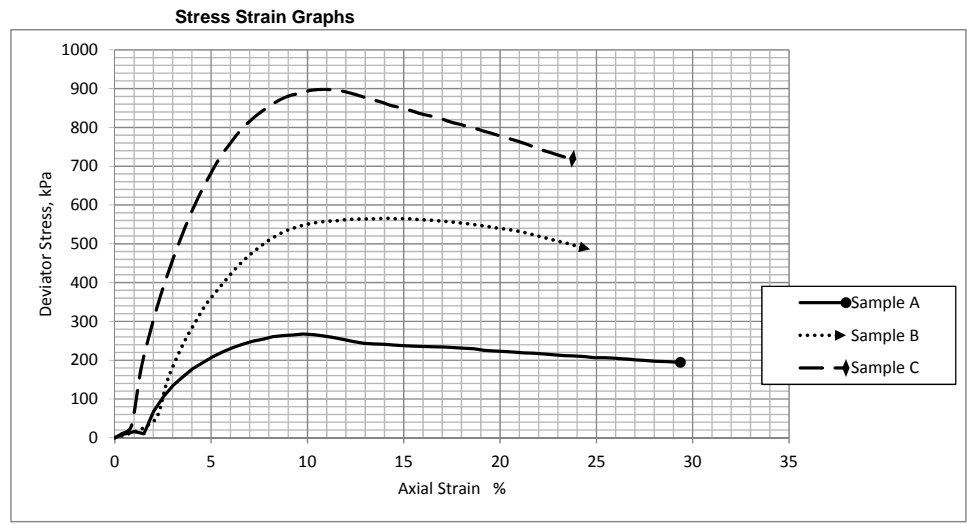
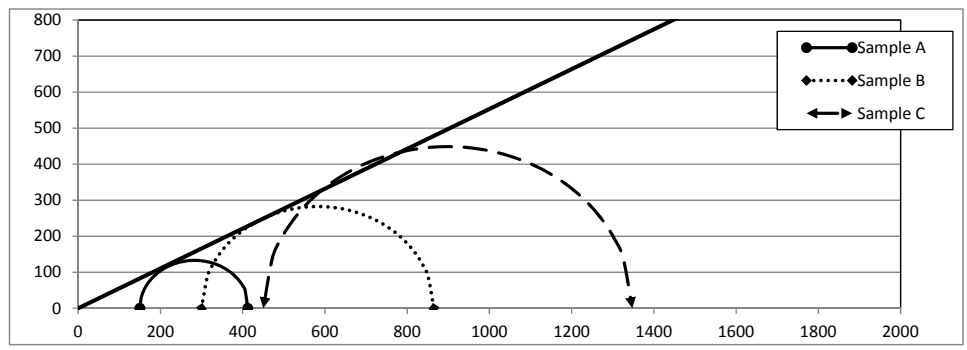
Mode of Failure:	Maximum Deviator Stress		
Rate of strain	mm/min	0.8	0.8
Cell Pressure, P1	kPa	150	300
Max Deviator Stress	kPa	265.7	564.9
Major Principal Stress P3,	kPa	415.7	864.9
Axial Strain at failure	%	10.3%	15.1%
Undrained Strength, Su	kPa	132.9	282.5
<b>Av. Undrained Strength,</b>	<b>kPa</b>	<b>288.0</b>	
E <sub>50</sub> secant modulus,	kPa	8210	12190
E <sub>50</sub> strain	%	3.0	4.2
<b>E<sub>50</sub> Av. secant modulus</b>	<b>kPa</b>	<b>13097</b>	
Cohesion , C	kPa	0.0	
Angle of internal Friction,	φ	29.0

Sample not saturated. Undrained test behaving as a total stress test with c and phi

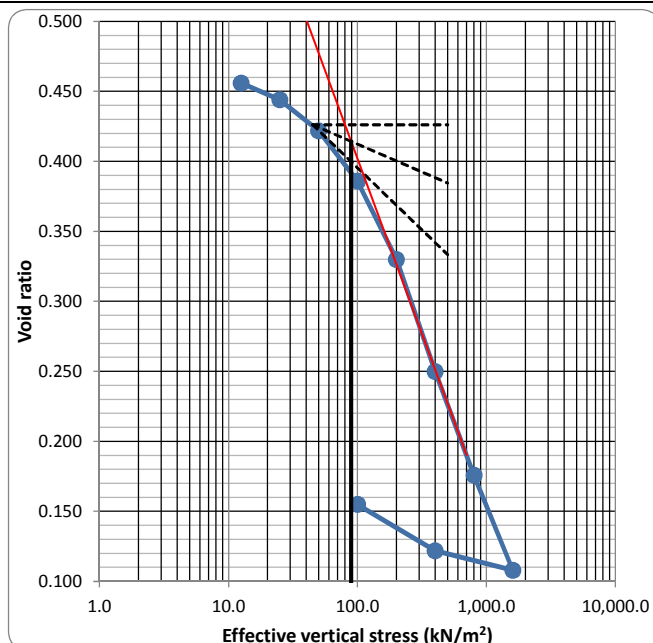
**GRAPHS**

Compression Index (Loading)	0.250	OCR > 1 , Over Consolidated OCR <=1, Normal Consolidation Eoed at 100kN = 2.12mN/m2
Compression Index (Unloading)	0.039	
Preconsolidation Pressure (kN/m <sup>2</sup> )	89.3	
Overburden Pressure (kN/m <sup>2</sup> ) - approx	85.3	
Swelling Pressure (kPa)	--	
OverConsolidation Ratio, OCR - approx	1.0	
Signed by (Materials Engineer/Manager)		Received by;

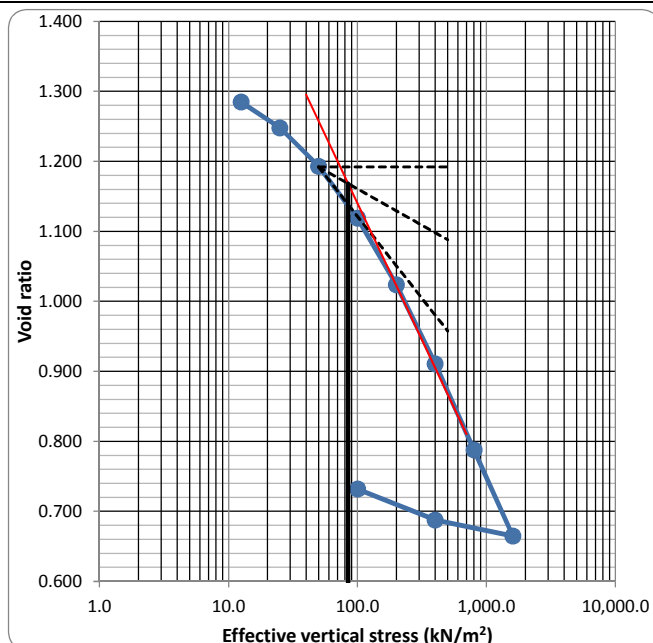
**GRAPHS**

Compression Index (Loading)	0.390	OCR > 1, Over Consolidated OCR <=1, Normal Consolidation Eoed at 120kN = 1.86mN/m2
Compression Index (Unloading)	0.056	
Preconsolidation Pressure (kN/m <sup>2</sup> )	84.7	
Overburden Pressure (kN/m <sup>2</sup> ) - approx	116.8	
Swelling Pressure (kPa)	--	
OverConsolidation Ratio, OCR - approx	0.7	
Signed by (Materials Engineer/Manager)		Received by;

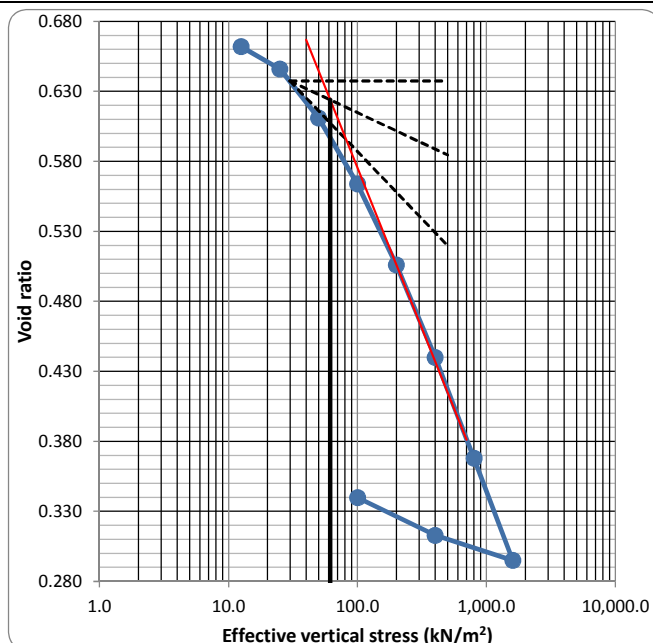
#### GRAPHS

Compression Index (Loading)	0.230	OCR > 1, Over Consolidated OCR <=1, Normal Consolidation Eoed at 200kN = 3.12mN/m2
Compression Index (Unloading)	0.037	
Preconsolidation Pressure (kN/m <sup>2</sup> )	61.5	
Overburden Pressure (kN/m <sup>2</sup> ) - approx	199.1	
Swelling Pressure (kPa)	--	
OverConsolidation Ratio, OCR - approx	0.3	
Signed by (Materials Engineer/Manager)		Received by;

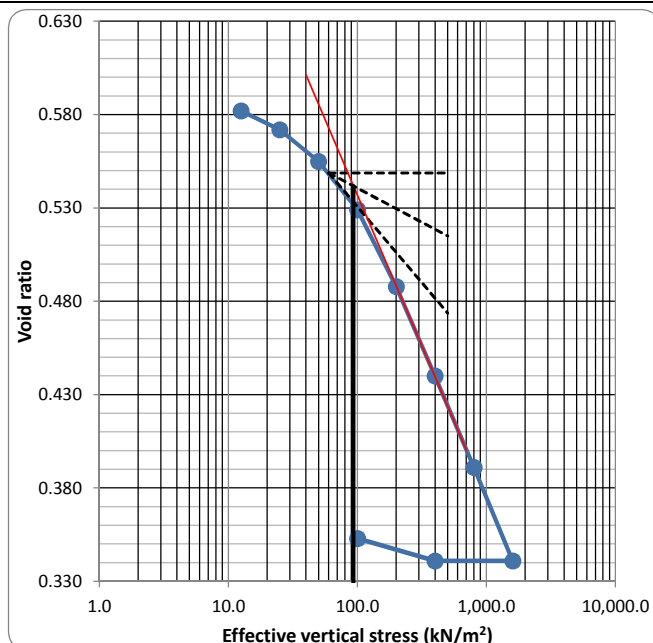
#### GRAPHS

Compression Index (Loading)	0.162	OCR > 1, Over Consolidated OCR <=1, Normal Consolidation Eoed at 305kN = 6.25mN/m2
Compression Index (Unloading)	0.010	
Preconsolidation Pressure (kN/m <sup>2</sup> )	93.3	
Overburden Pressure (kN/m <sup>2</sup> ) - approx	304.0	
Swelling Pressure (kPa)	--	
OverConsolidation Ratio, OCR - approx	0.3	
Signed by (Materials Engineer/Manager)		Received by;

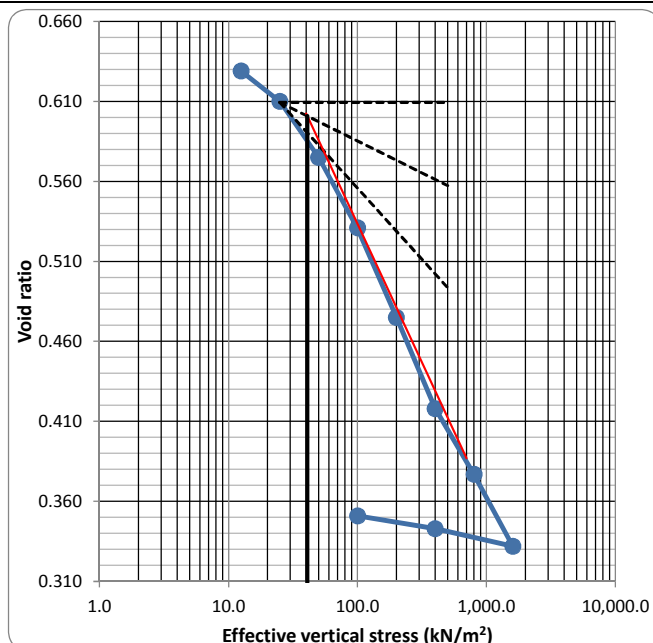
**GRAPHS**

Compression Index (Loading)	0.173	OCR > 1, Over Consolidated OCR <=1, Normal Consolidation Eoed at 355kN = 5.85mN/m2
Compression Index (Unloading)	0.016	
Preconsolidation Pressure (kN/m <sup>2</sup> )	40.8	
Overburden Pressure (kN/m <sup>2</sup> ) - approx	352.2	
Swelling Pressure (kPa)	--	
OverConsolidation Ratio, OCR - approx	0.1	
Signed by (Materials Engineer/Manager)		Received by;
