**PROJECT:** Kilosa-Gulwe Central Railway. JICA Study A3 / 1 of 13

**CLIENT:** PADECO Co. Ltd

**PROJECT NO:** S0820

- 1.0 TERMS OF REFERENCE and CONDITIONS ON SITE
  - 2.0 SITE LOCATION
  - 3.0 GEOLOGY
  - 4.0 INVESTIGATION METHODOLOGY
  - 5.0 SOIL TEST RESULTS
  - 6.0 TEST RESULTS ON ROCK CORES
  - 7.0 GENERAL LITHOLOGY
  - 8.0 CHEMICAL TESTS ON GROUND WATER
  - APPENDICES
-

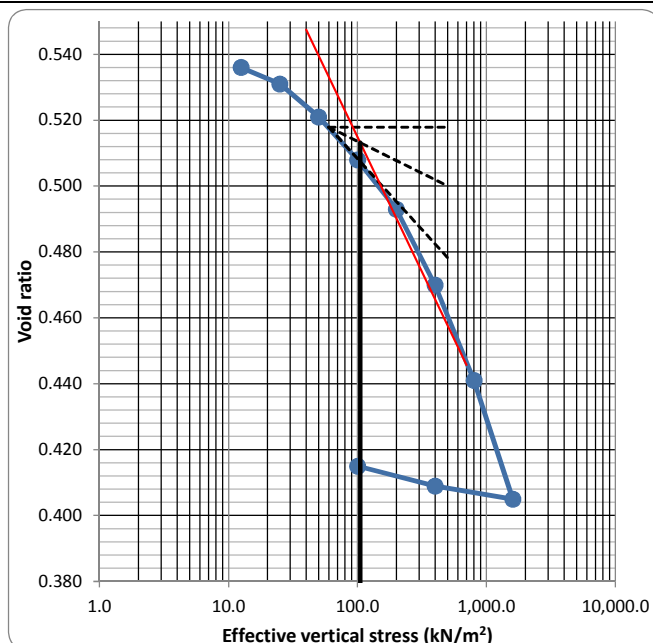
**GRAPHS**

Compression Index (Loading)	0.082	OCR > 1, Over Consolidated OCR <=1, Normal Consolidation Eoed at 455kN = 15.94mN/m <sup>2</sup>
Compression Index (Unloading)	0.008	
Preconsolidation Pressure (kN/m <sup>2</sup> )	105	
Overburden Pressure (kN/m <sup>2</sup> ) - approx	454.7	
Swelling Pressure (kPa)	--	
OverConsolidation Ratio, OCR - approx	0.2	
Signed by (Materials Engineer/Manager)		Received by;

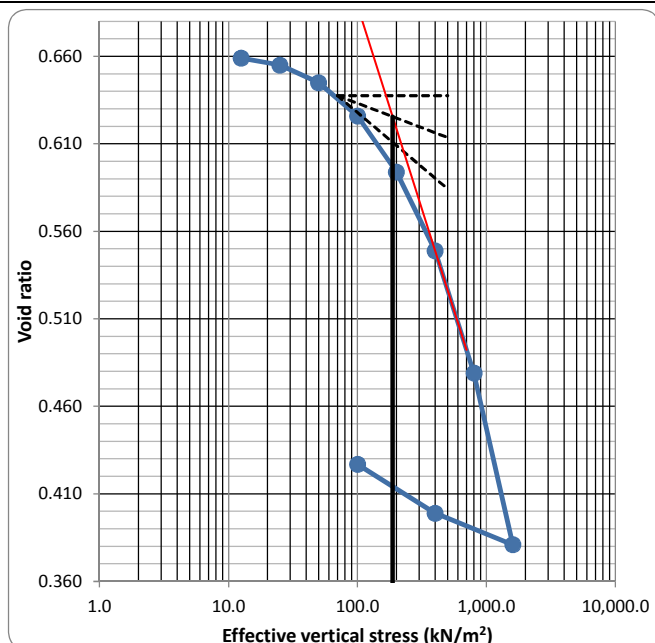
**GRAPHS**

Compression Index (Loading)	0.233	OCR > 1, Over Consolidated OCR <=1, Normal Consolidation Eoed at 485kN = 8.08mN/m2
Compression Index (Unloading)	0.038	
Preconsolidation Pressure (kN/m <sup>2</sup> )	187.3	
Overburden Pressure (kN/m <sup>2</sup> ) - approx	482.2	
Swelling Pressure (kPa)	12	
OverConsolidation Ratio, OCR - approx	0.4	
Signed by (Materials Engineer/Manager)		Received by;

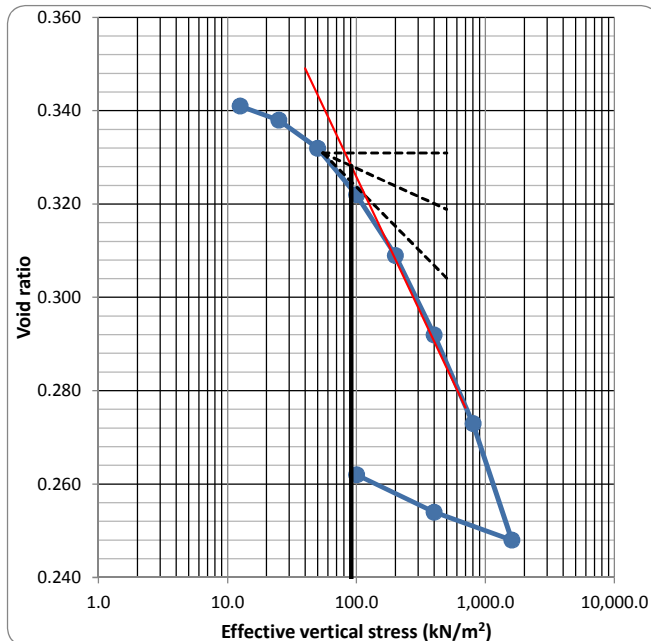
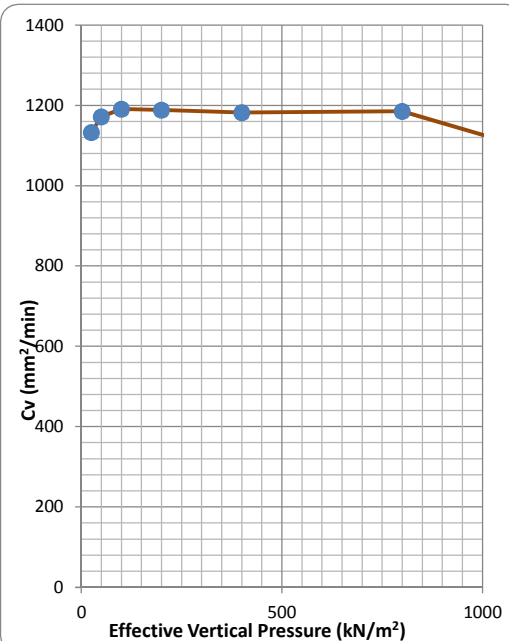
0 - 12		0.341				
12 - 25		0.338	0.02	1132.33	0.18	3.3
25 - 50		0.332	0.02	1171.83	0.18	3.4
50 - 100		0.322	0.02	1190.84	0.15	2.9
100 - 200		0.309	0.02	1188.48	0.10	1.9
200 - 400		0.292	0.02	1182.02	0.06	1.3
400 - 799		0.273	0.02	1185.17	0.04	0.7
799 - 1599		0.248	0.02	951.62	0.02	0.4
1,599 - 400		0.254				
400 - 100		0.262				
<b>GRAPHS</b>

Compression Index (Loading)	0.058	OCR > 1, Over Consolidated OCR <=1, Normal Consolidation Eoed at 25kN = 5.58mN/m2				
Compression Index (Unloading)	0.012					
Preconsolidation Pressure (kN/m <sup>2</sup> )	91					
Overburden Pressure (kN/m <sup>2</sup> ) - approx	24.1					
Swelling Pressure (kPa)	--					
OverConsolidation Ratio, OCR - approx	3.8					
Signed by (Materials Engineer/Manager)		Received by;

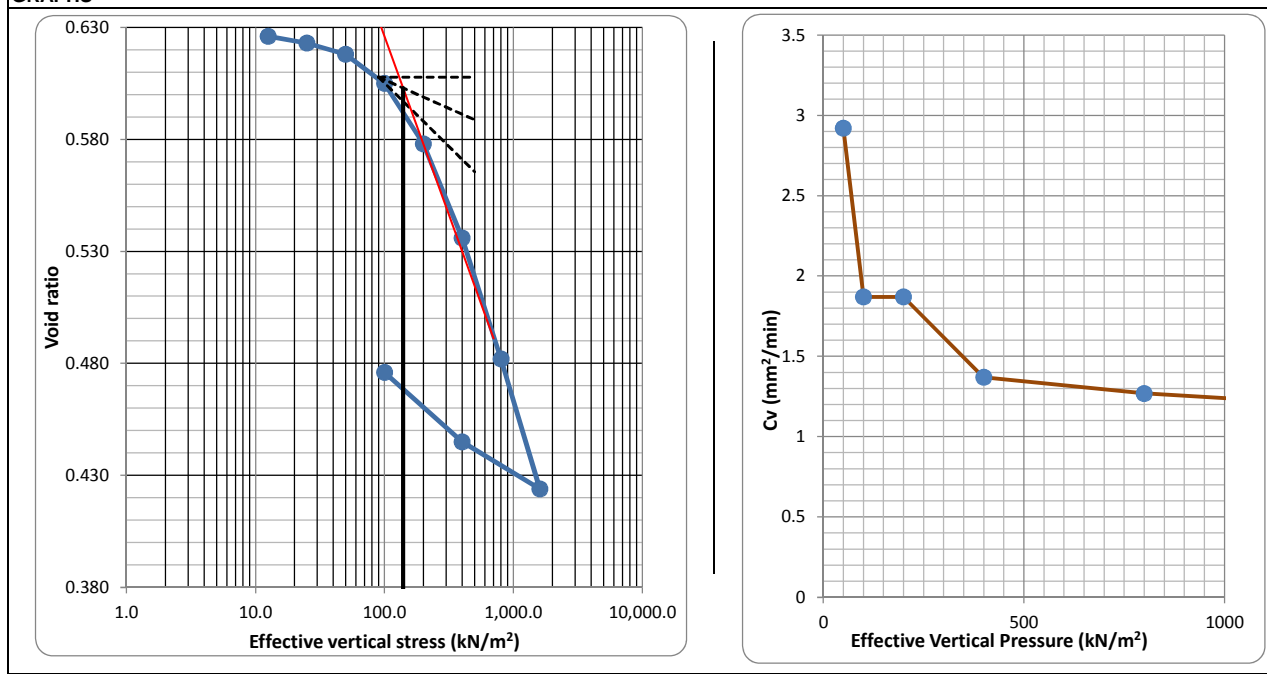
**GRAPHS**

Compression Index (Loading)	0.159	OCR > 1, Over Consolidated OCR <=1, Normal Consolidation Eoed at 100kN = 6.12mN/m2
Compression Index (Unloading)	0.043	
Preconsolidation Pressure (kN/m <sup>2</sup> )	139.5	
Overburden Pressure (kN/m <sup>2</sup> ) - approx	11.1	
Swelling Pressure (kPa)	--	
OverConsolidation Ratio, OCR - approx	12.6	
Signed by (Materials Engineer/Manager)		Received by;

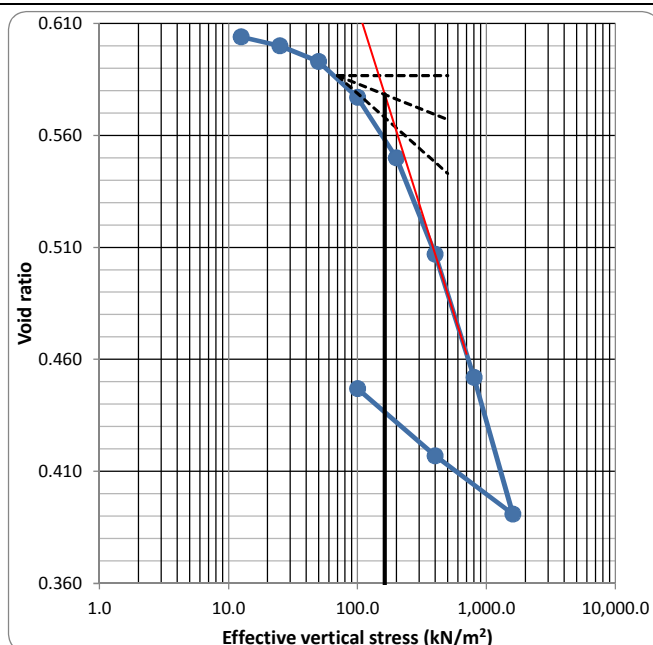
**GRAPHS**

Compression Index (Loading)	0.183	OCR > 1 , Over Consolidated OCR <=1, Normal Consolidation Eoed at 100kN = 5.23mN/m2
Compression Index (Unloading)	0.047	
Preconsolidation Pressure (kN/m <sup>2</sup> )	162.9	
Overburden Pressure (kN/m <sup>2</sup> ) - approx	84.3	
Swelling Pressure (kPa)	--	
OverConsolidation Ratio, OCR - approx	1.9	
Signed by (Materials Engineer/Manager)		Received by;

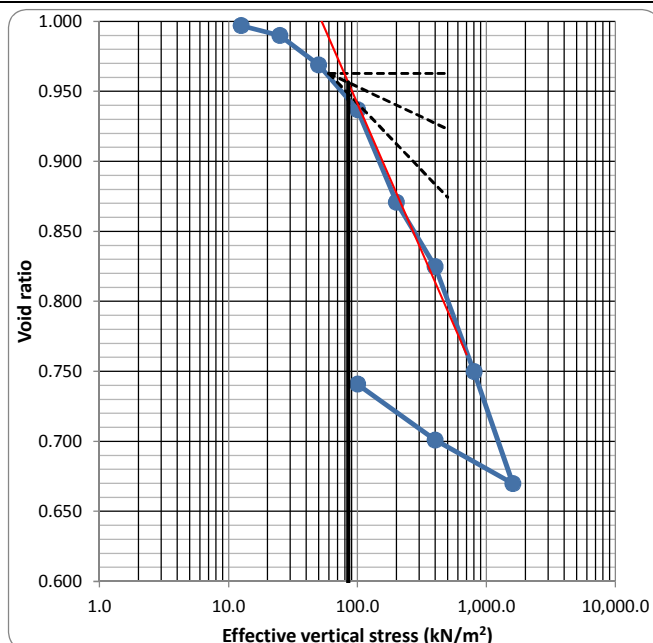
**GRAPHS**

Compression Index (Loading)	0.212	OCR > 1, Over Consolidated OCR <=1, Normal Consolidation Eoed at 150kN = 2.93mN/m2
Compression Index (Unloading)	0.059	
Preconsolidation Pressure (kN/m <sup>2</sup> )	84.9	
Overburden Pressure (kN/m <sup>2</sup> ) - approx	146.5	
Swelling Pressure (kPa)	--	
OverConsolidation Ratio, OCR - approx	0.6	
Signed by (Materials Engineer/Manager)		Received by;

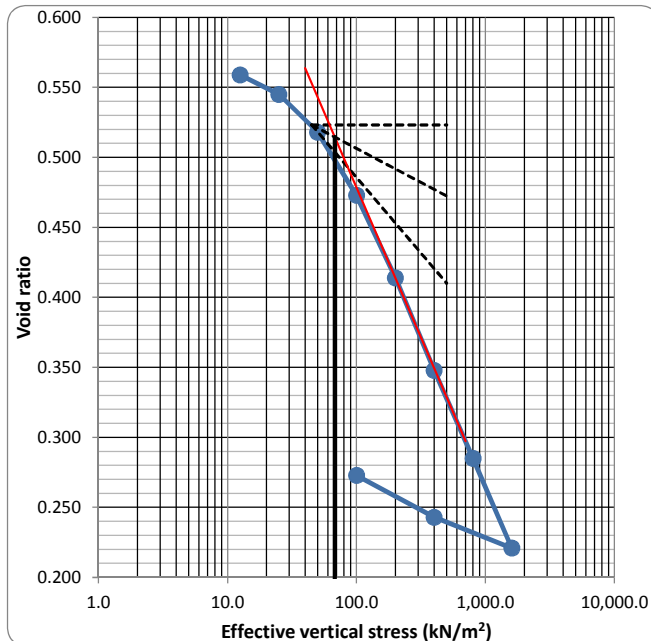
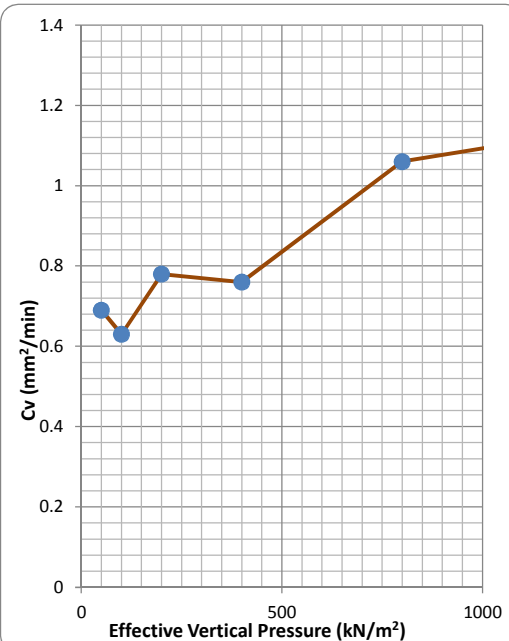
<b>TEST RESULTS</b>						
<b>Vertical Stress (kN/m<sup>2</sup>)</b>		<b>Void Ratio</b>	<b>T<sub>50</sub> (min)</b>	<b>C<sub>v</sub> (mm<sup>2</sup>/min)</b>	<b>m<sub>v</sub> (m<sup>2</sup>/mN)</b>	<b>k*10<sup>-6</sup>(cm/sec)</b>
0 - 12		0.559				
12 - 25		0.545				
25 - 50		0.518	28.84	0.69	0.70	0.0079
50 - 100		0.473	31.90	0.63	0.59	0.0061
100 - 200		0.414	25.58	0.78	0.40	0.0051
200 - 400		0.348	26.26	0.76	0.23	0.0029
400 - 799		0.285	18.88	1.06	0.12	0.0020
799 - 1599		0.221	16.79	1.19	0.06	0.0012
1,599 - 400		0.243				
400 - 100		0.273				
<b>GRAPHS</b>

Compression Index (Loading)		0.214				
Compression Index (Unloading)		0.043				
Preconsolidation Pressure (kN/m <sup>2</sup> )		67.9	OCR > 1, Over Consolidated			
Overburden Pressure (kN/m <sup>2</sup> ) - approx		10.5	OCR <=1, Normal Consolidation			
Swelling Pressure (kPa)		--	Eoed at 100kN = 1.89mN/m2			
OverConsolidation Ratio, OCR - approx		6.5

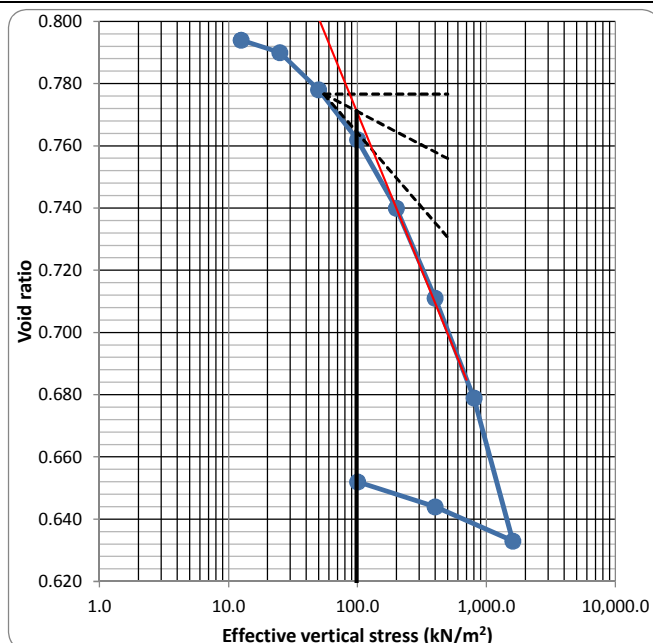
#### GRAPHS

Compression Index (Loading)	0.101	OCR > 1, Over Consolidated OCR <=1, Normal Consolidation Eoed at 100kN = 6.19mN/m2
Compression Index (Unloading)	0.016	
Preconsolidation Pressure (kN/m <sup>2</sup> )	98.5	
Overburden Pressure (kN/m <sup>2</sup> ) - approx	19.2	
Swelling Pressure (kPa)	--	
OverConsolidation Ratio, OCR - approx	5.1	
Signed by (Materials Engineer/Manager)		Received by;

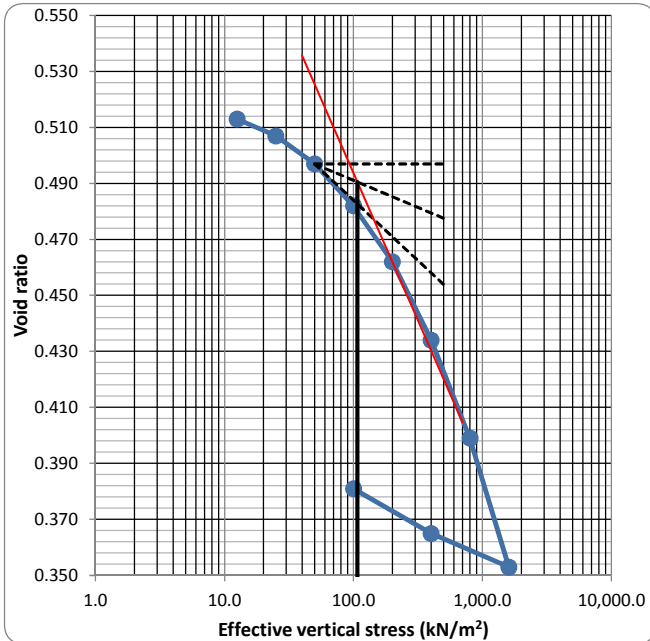
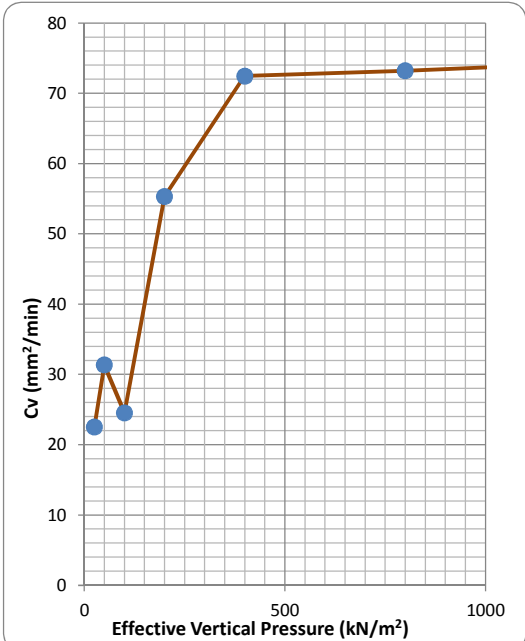
0 - 12	0.513				
	12 - 25	0.507	0.89	22.56	0.32	0.117
	25 - 50	0.497	0.64	31.36	0.27	0.136
	50 - 100	0.482	0.82	24.54	0.20	0.080
	100 - 200	0.462	0.36	55.35	0.14	0.122
	200 - 400	0.434	0.28	72.45	0.10	0.114
	400 - 799	0.399	0.28	73.21	0.06	0.073
	799 - 1599	0.353	0.27	75.11	0.04	0.051
	1,599 - 400	0.365				
	400 - 100	0.381				
<b>GRAPHS</b>

Compression Index (Loading)	0.105	OCR > 1 , Over Consolidated OCR <=1, Normal Consolidation Eoed at 260kN = 9.41mN/m2				
Compression Index (Unloading)	0.023					
Preconsolidation Pressure (kN/m <sup>2</sup> )	107.2					
Overburden Pressure (kN/m <sup>2</sup> ) - approx	259.4					
Swelling Pressure (kPa)	--					
OverConsolidation Ratio, OCR - approx	0.4					
Signed by (Materials Engineer/Manager)		Received by;

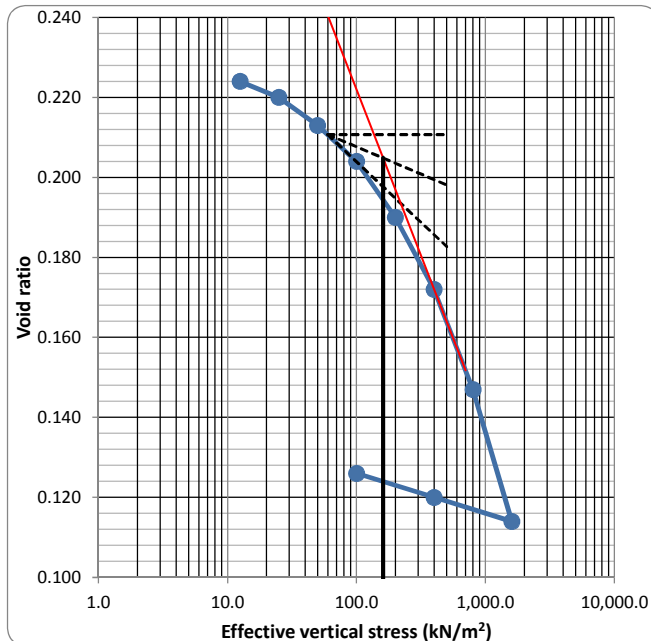
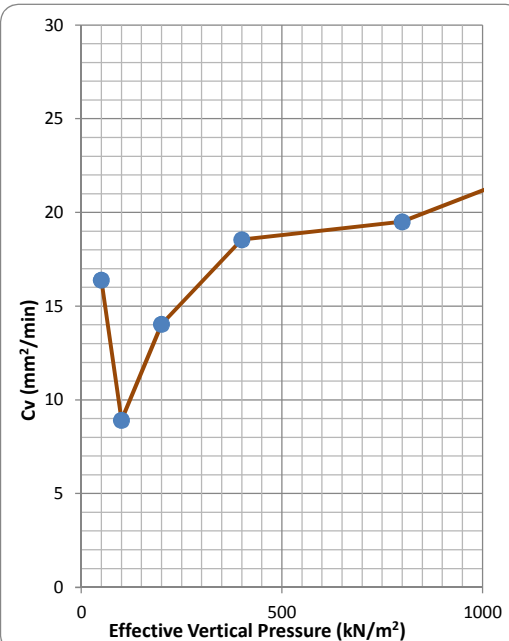
<b>Vertical Stress (kN/m<sup>2</sup>)</b>		<b>Void Ratio</b>	<b>T<sub>50</sub> (min)</b>	<b>C<sub>v</sub> (mm<sup>2</sup>/min)</b>	<b>m<sub>v</sub> (m<sup>2</sup>/mN)</b>	<b>k*10<sup>-6</sup>(cm/sec)</b>
0 - 12		0.224				
12 - 25		0.220				
25 - 50		0.213	1.22	16.40	0.23	0.062
50 - 100		0.204	2.25	8.92	0.15	0.022
100 - 200		0.190	1.43	14.04	0.12	0.027
200 - 400		0.172	1.08	18.55	0.08	0.023
400 - 799		0.147	1.03	19.50	0.05	0.017
799 - 1599		0.114	0.77	26.13	0.04	0.015
1,599 - 400		0.120				
400 - 100		0.126				
<b>GRAPHS</b>

Compression Index (Loading)	0.083	OCR > 1, Over Consolidated OCR <=1, Normal Consolidation Eoed at 100kN = 7.26mN/m2				
Compression Index (Unloading)	0.010					
Preconsolidation Pressure (kN/m <sup>2</sup> )	160.9					
Overburden Pressure (kN/m <sup>2</sup> ) - approx	12.9					
Swelling Pressure (kPa)	--					
OverConsolidation Ratio, OCR - approx	12.5					
Signed by (Materials Engineer/Manager)		Received by;

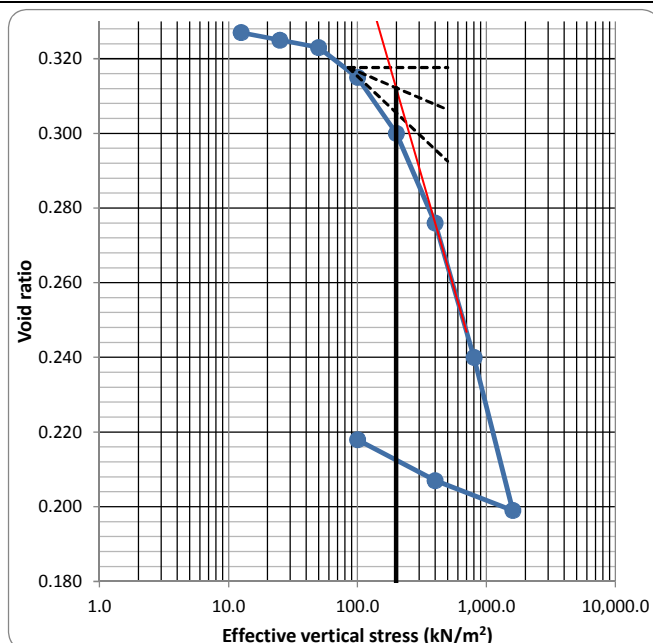
**GRAPHS**

Compression Index (Loading)	0.120	OCR > 1 , Over Consolidated OCR <=1, Normal Consolidation Eoed at 105kN = 8.46mN/m2
Compression Index (Unloading)	0.016	
Preconsolidation Pressure (kN/m <sup>2</sup> )	199.1	
Overburden Pressure (kN/m <sup>2</sup> ) - approx	100.6	
Swelling Pressure (kPa)	25	
OverConsolidation Ratio, OCR - approx	2.0	
Signed by (Materials Engineer/Manager)		Received by;

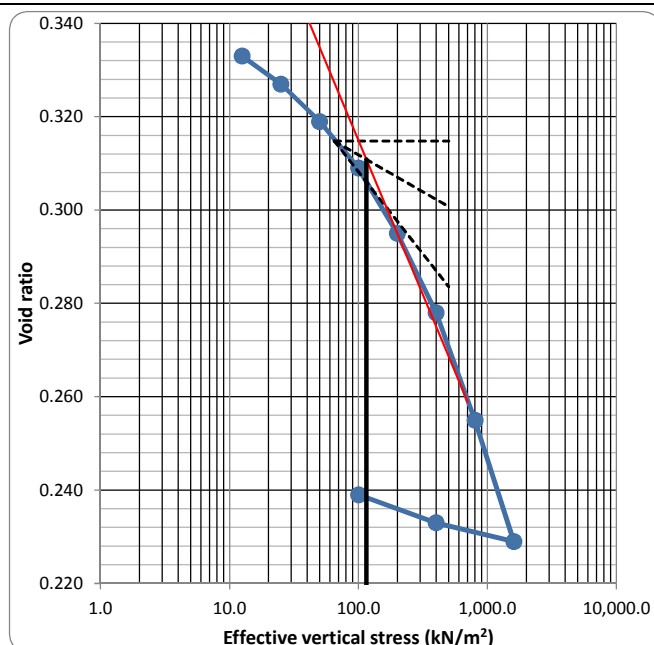
#### GRAPHS

Compression Index (Loading)	0.066	OCR > 1, Over Consolidated OCR <=1, Normal Consolidation Eoed at 150kN = 9.35mN/m2
Compression Index (Unloading)	0.008	
Preconsolidation Pressure (kN/m <sup>2</sup> )	115.3	
Overburden Pressure (kN/m <sup>2</sup> ) - approx	148.2	
Swelling Pressure (kPa)	--	
OverConsolidation Ratio, OCR - approx	0.8	
Signed by (Materials Engineer/Manager)		Received by;

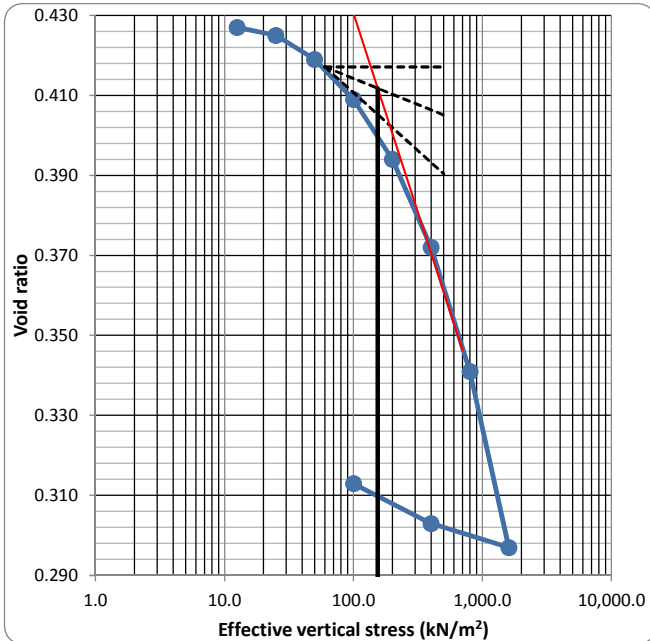
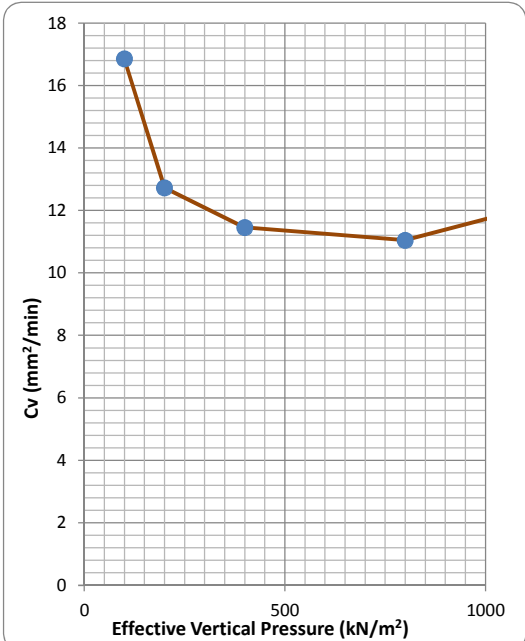
0 - 12	0.427				
12 - 25	0.425				
25 - 50	0.419				
50 - 100	0.409	1.19	16.85	0.14	0.039
100 - 200	0.394	1.58	12.73	0.11	0.022
200 - 400	0.372	1.75	11.46	0.08	0.015
400 - 799	0.341	1.82	11.05	0.06	0.010
799 - 1599	0.297	1.46	13.73	0.04	0.009
1,599 - 400	0.303				
400 - 100	0.313				
<b>GRAPHS</b>

Compression Index (Loading)	0.100				
Compression Index (Unloading)	0.013				
Preconsolidation Pressure (kN/m <sup>2</sup> )	154.1	OCR > 1, Over Consolidated			
Overburden Pressure (kN/m <sup>2</sup> ) - approx	189.5	OCR <= 1, Normal Consolidation			
Swelling Pressure (kPa)	--	Eoed at 190kN = 10.08mN/m2			
OverConsolidation Ratio, OCR - approx	0.8				
Signed by (Materials Engineer/Manager)					Received by;

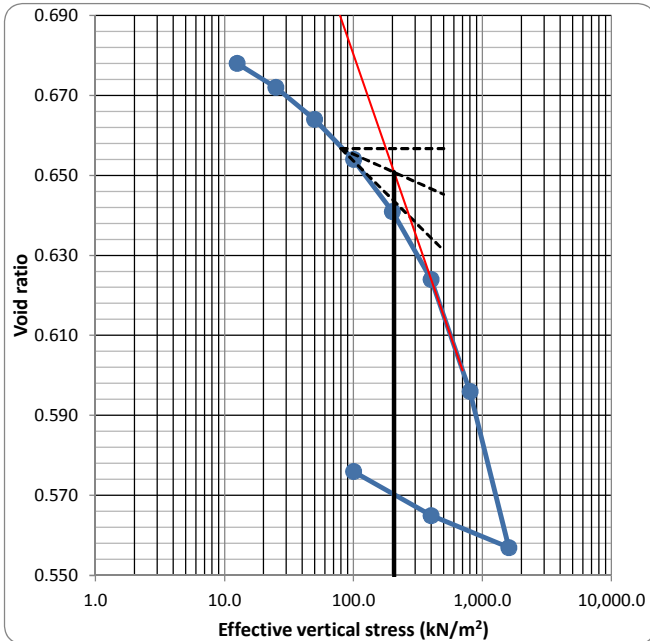
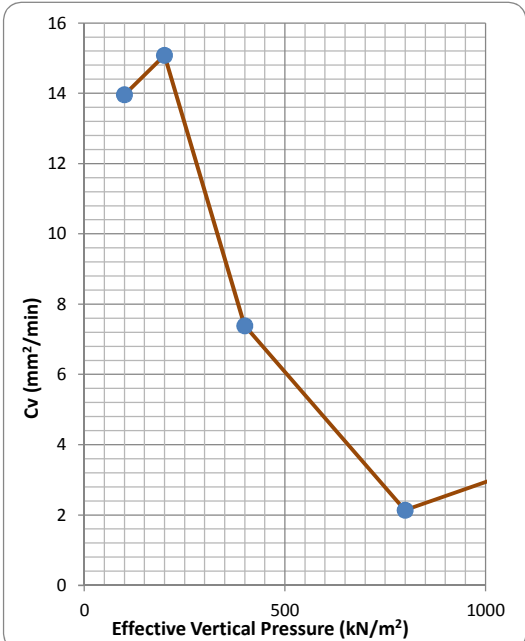
Compression Index (Loading)	0.093	OCR > 1 , Over Consolidated OCR <=1, Normal Consolidation Eoed at 175kN = 13.48mN/m2			
Compression Index (Unloading)	0.016				
Preconsolidation Pressure (kN/m <sup>2</sup> )	206.6				
Overburden Pressure (kN/m <sup>2</sup> ) - approx	172.1				
Swelling Pressure (kPa)	--				
OverConsolidation Ratio, OCR - approx	1.2				
Signed by (Materials Engineer/Manager)		Received by;

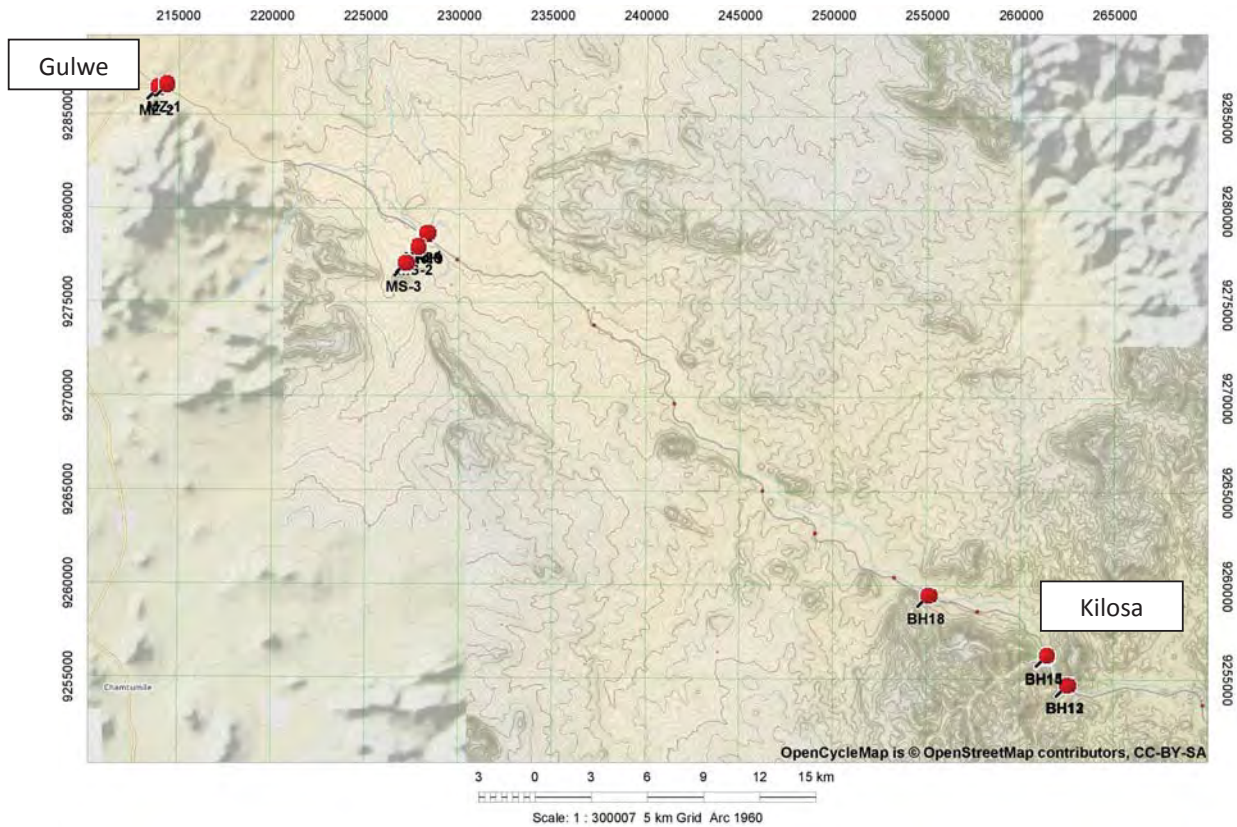
**Figure 4-A: Locations of the boreholes**

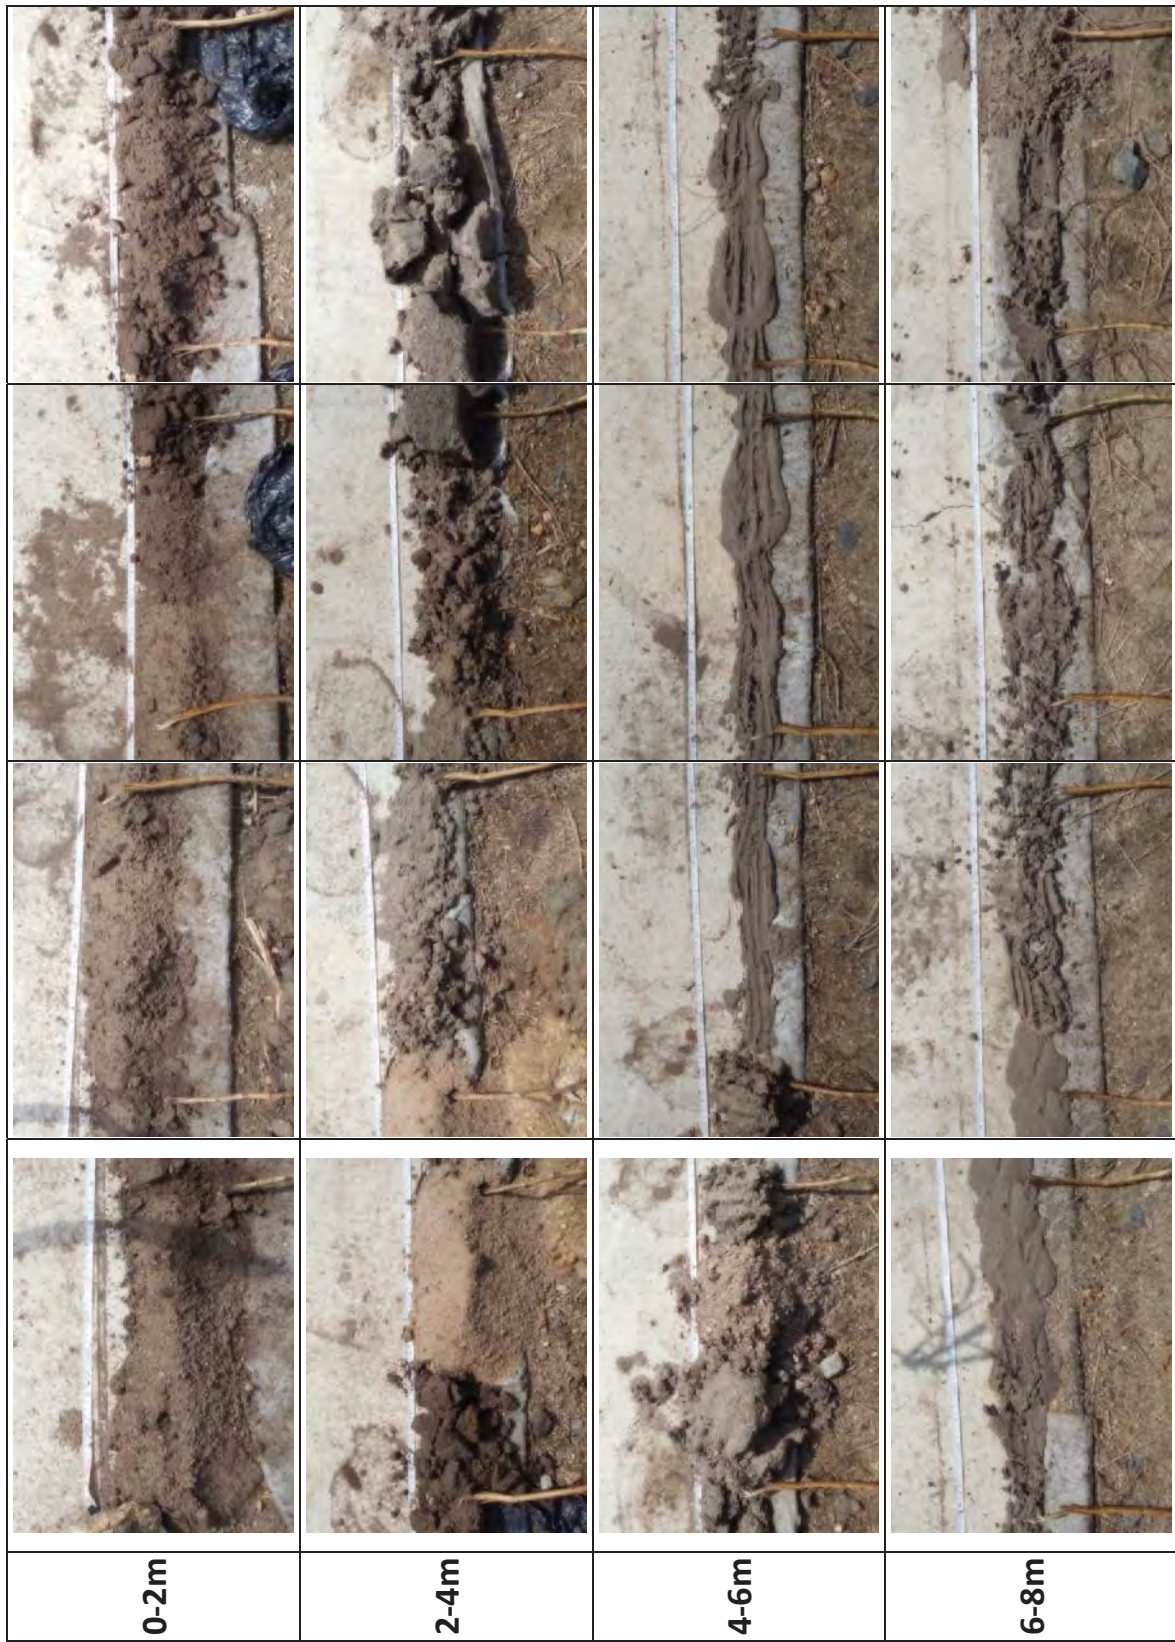
BOREHOLE 13 - PROFILE PICTURES

<b>PROJECT</b> Kilosa Gulwe Central Railway. JICA Study.										
		<b>LOCATION</b> BH 13	<b>CLIENT</b> PADECO Co. Ltd									
<b>ROCK LOG : BH 13</b>		<b>NORTHING</b> 9254633.15	<b>DRILLING METHOD</b> Rotary HQ+ NQ									
		<b>EASTING</b> 262400.22	<b>DRILL DATE</b> 14 - 17/12/2015									
		<b>SURFACE ELEV.</b> 559.611m	<b>FIELD SUPERVISOR</b> JN/Z									
ELEV (m)	DEPTH (m)	LITHOLOGY	Deg. of Weathering	STRENGTH DATA			DISCONTINUITY DATA			TCR %		
				UCS MPa	Is (50)	Hardness	Dip Angle	Type	Spacing	0	50	100
	20	(17.9 - 21.2) Blackish silty SAND										
	21	(21.2 - 22.4) Brownish SAND with gravels										
	22	(22.4 - 22.7) Weathered Quartzitic rock		● 30								
	23	(22.7 - 23.2) Brownish SAND with gravels	III			R4				50%	48	
		(23.2 - 23.5) Moderately weathered, white crystalline Quartzitic Rock
