Appendix 12

Geological Investigation

DETAILED REPORT ON THE GEOTECHNICAL WORKS FOR THE

PROJECT OF MASTER PLAN STUDY ON ROAD SLOPE MANAGEMENT IN THE KINGDOM OF BHUTAN

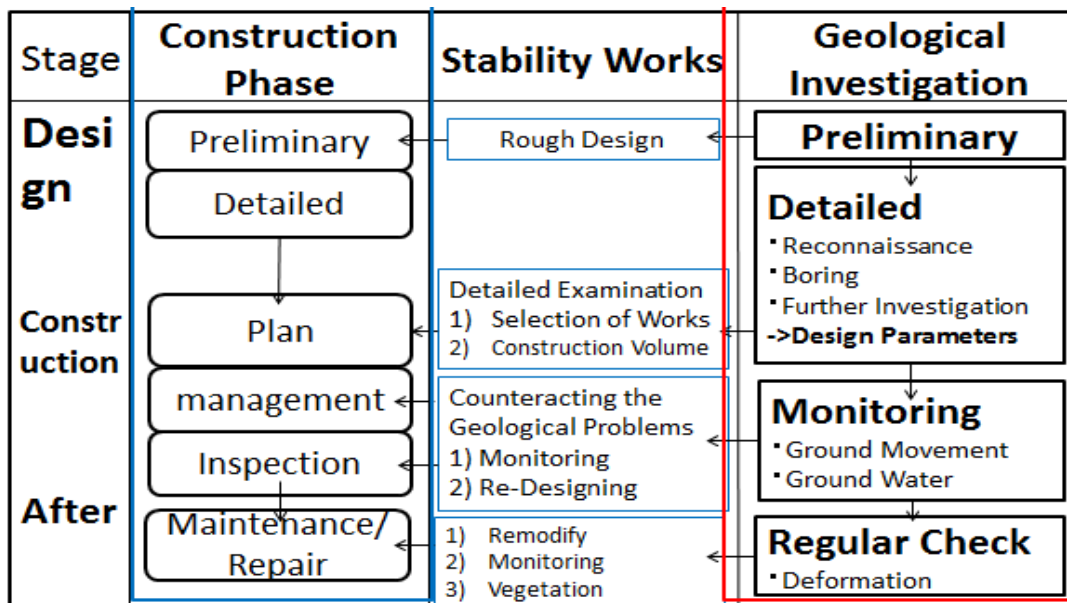
Figure 1-b Overall scheme of relationship between road construction and geological investigation in the road construction phase (from designing phase to maintenance phase) according to “Technical Guideline of Slope Stability Works in Japan (2009)”

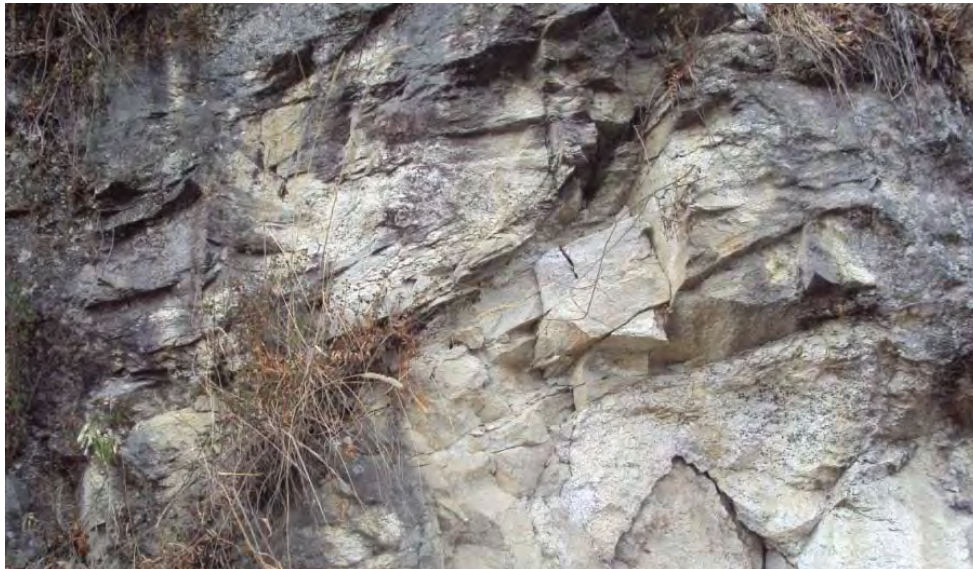
In the rock exposure seen about 400 metres away from Thomang cliff towards Trongsa, a fault with a dip direction of 200° and a dip amount of 80° could also be observed as shown in the photograph below.

Figure 4: Photograph showing the fault in the rock exposure.

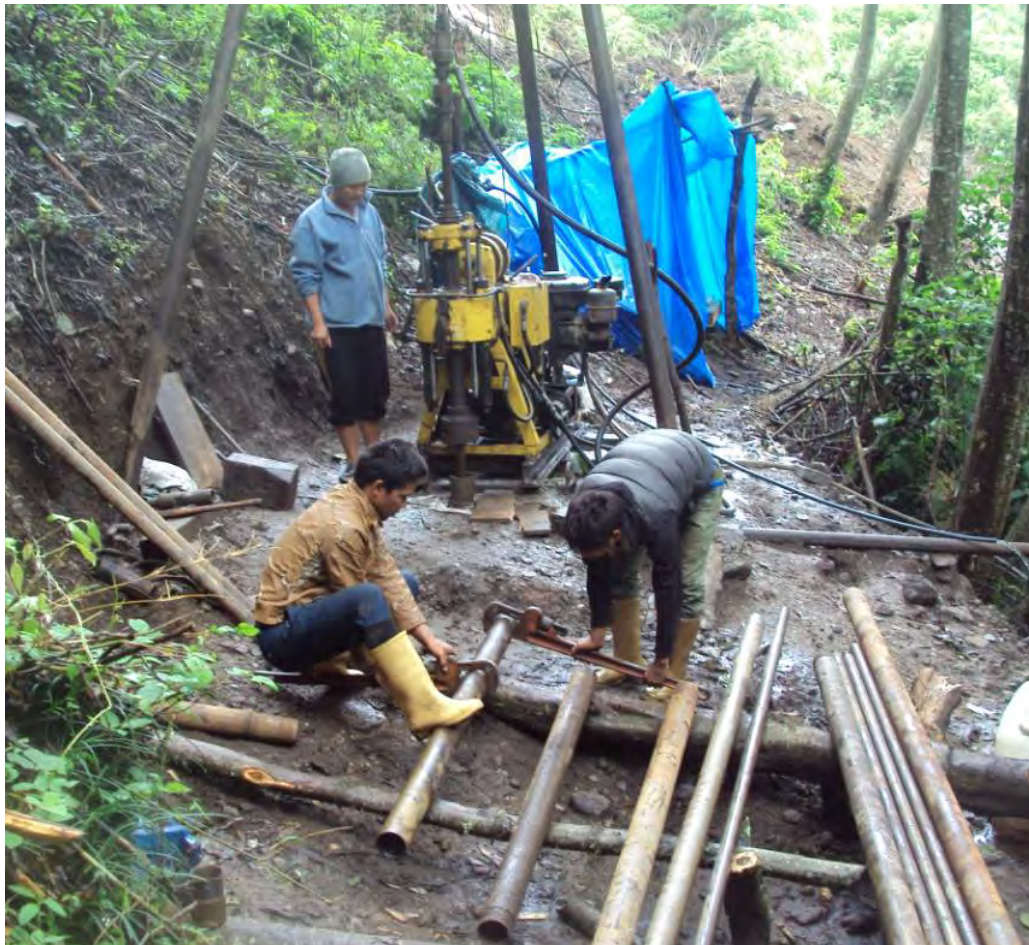
This borehole is located at Thomang cliff area and is approximately at 27°28'42.00"N latitude and 090°28'49.10" E longitude at an approximate elevation of 2280 metres above the mean sea level and is named BH-2 by the client. This location is about 30 to the north west of BH-1. This area is shown in the survey of Bhutan Toposheet No. 78 I/7. This part of the area has been explored in detail by drilling a borehole.

Figure 6: Location of BH-2

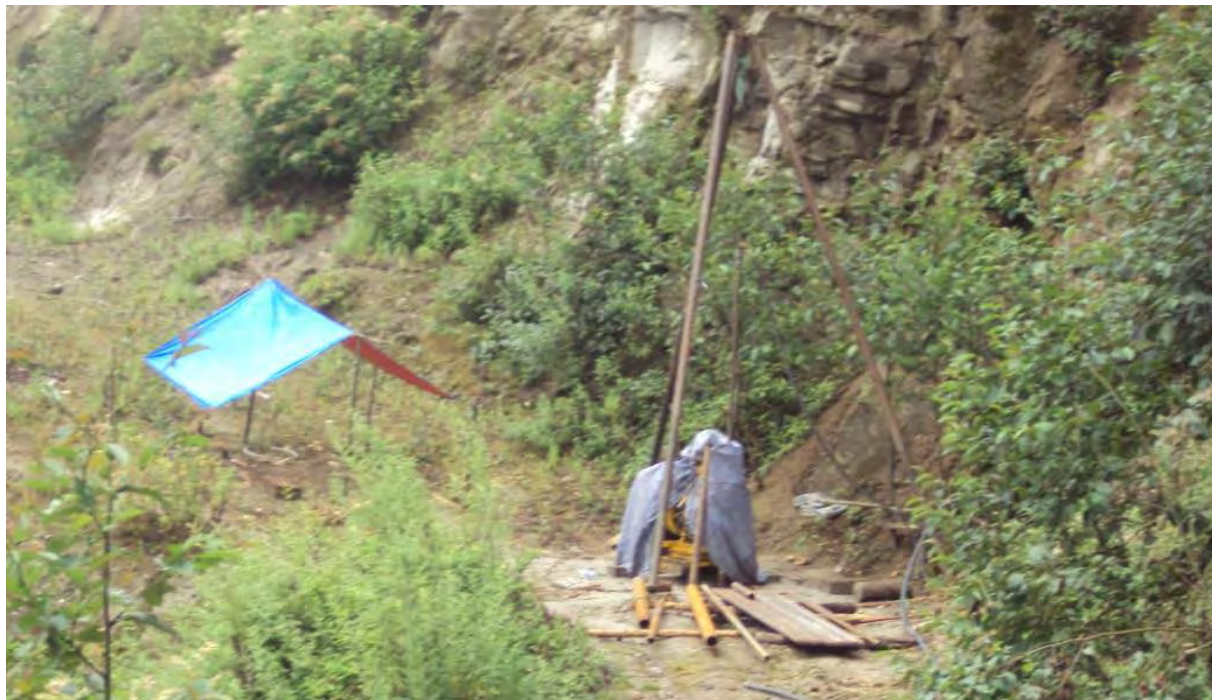
Figure 7: Location of BH-3

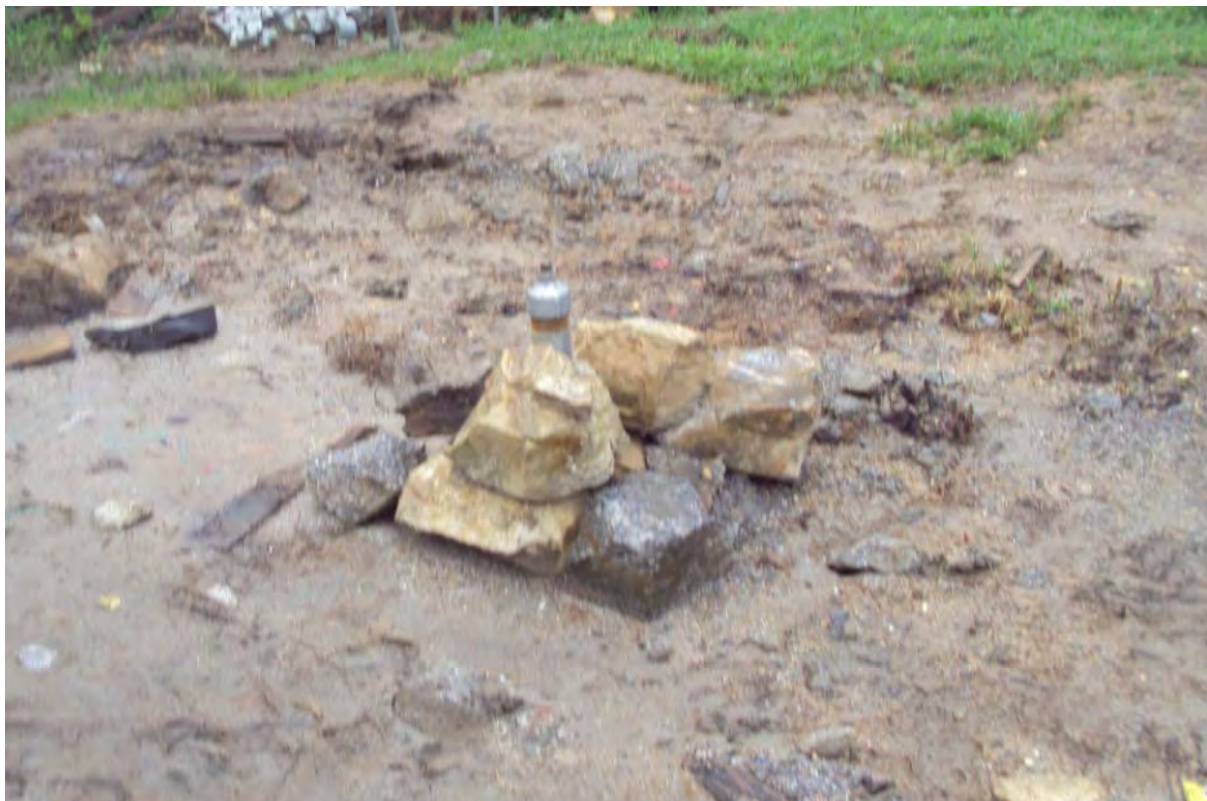
This borehole is located at Bangla Pokto area is located just below the Wangdue-Trongsa highway and is approximately at 27°27'00.60"N latitude and 090°24'24.7" E longitude at an approximate elevation of 2417 metres above the mean sea level and is named BH-5 by the client. This area is shown in the survey of Bhutan Toposheet No. 78 I/7. This part of the area has been explored in detail by drilling a borehole.

Figure 9: Location of BH-5

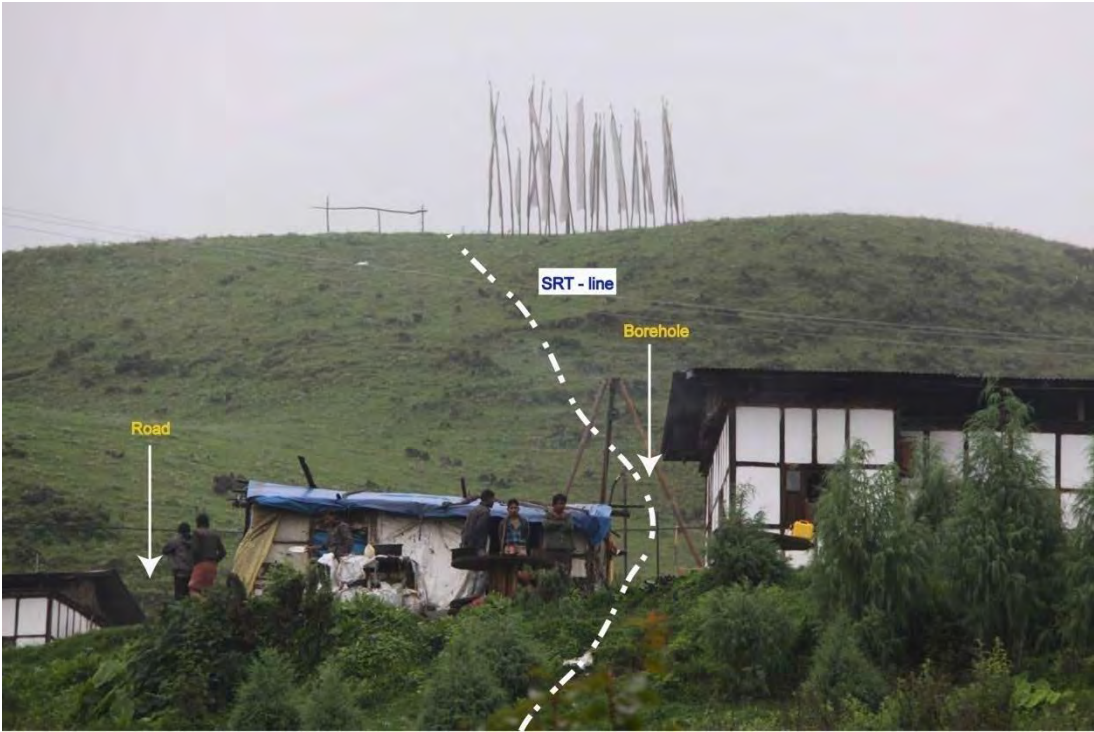
Figure 13: Photograph showing SRT line in the Bangla Pokto Area (view towards N)

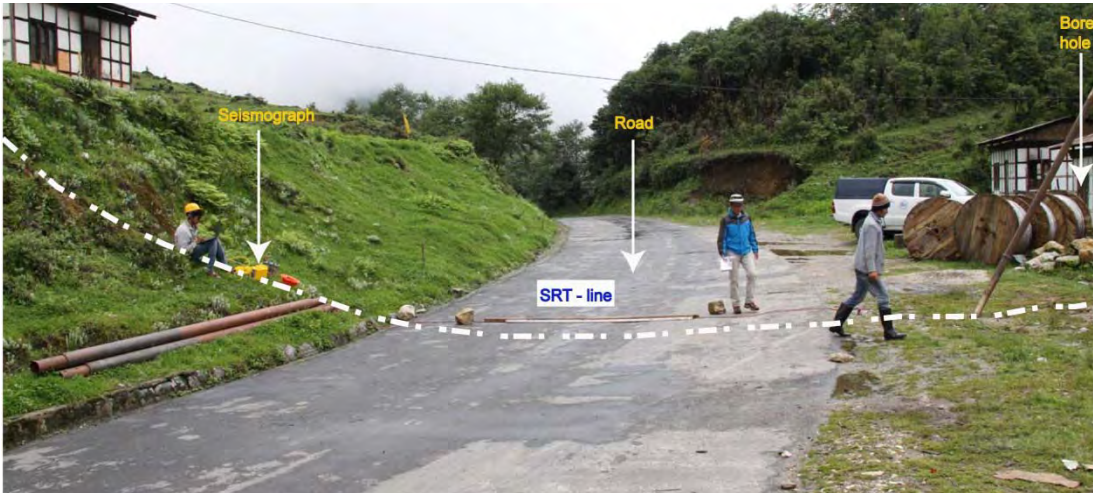
Figure 15: Photograph showing data acquisition along SRT line (white dashed line)

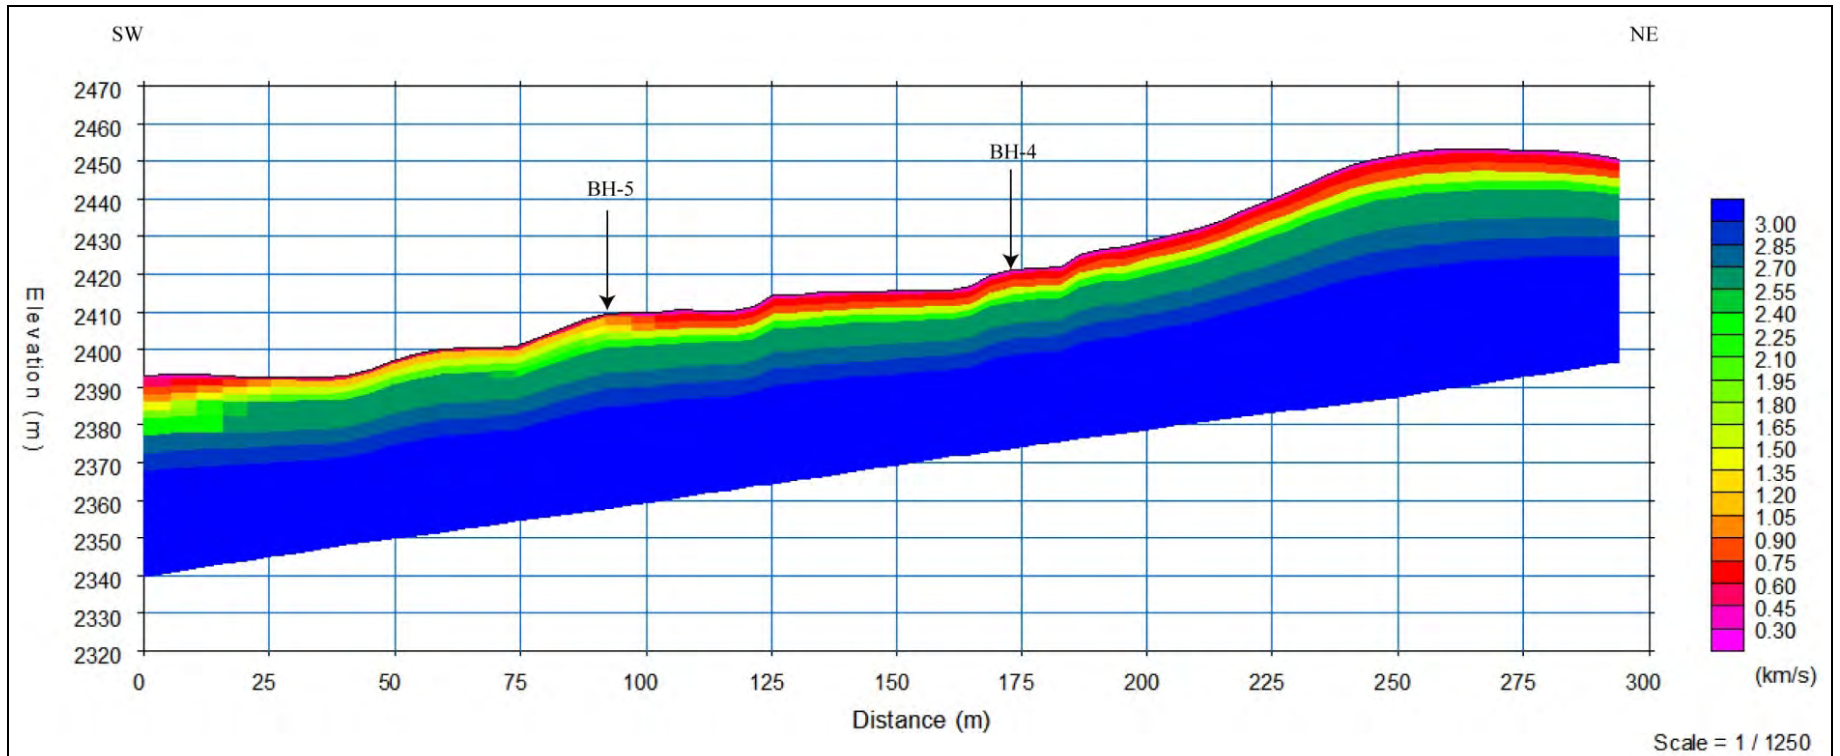
The tomogram (Figure 18) shows velocity distribution of different subsurface layers along the SRT profile in Bangla Pokto area. The tomogram reveals continuous surface layers of P-wave velocity < 750m/s. This layer is very thin between the chainage of 25m and 95m. Towards NE of BH5 average thickness of this layer is 4.5m while in the south-western corner of the profile thickness of this layer reaches up to 6.6m. These low velocity surface layers represent loose and unconsolidated soil. Velocity of subsurface layers gradually increases to the depth. Layers with P-wave velocities between 750 and

Figure 18: Seismic refraction tomogram along SRT line at Bangla Pokto area.

From slope stability point of view, the entire slope seems stable as the soil thickness is relatively thin (less than 10m) with a gentle topography. No significant slip surface is traced within soil and along soil-rock boundary. In the southernmost part of the profile relatively thick soil (12m) is observed that might move further down slope.

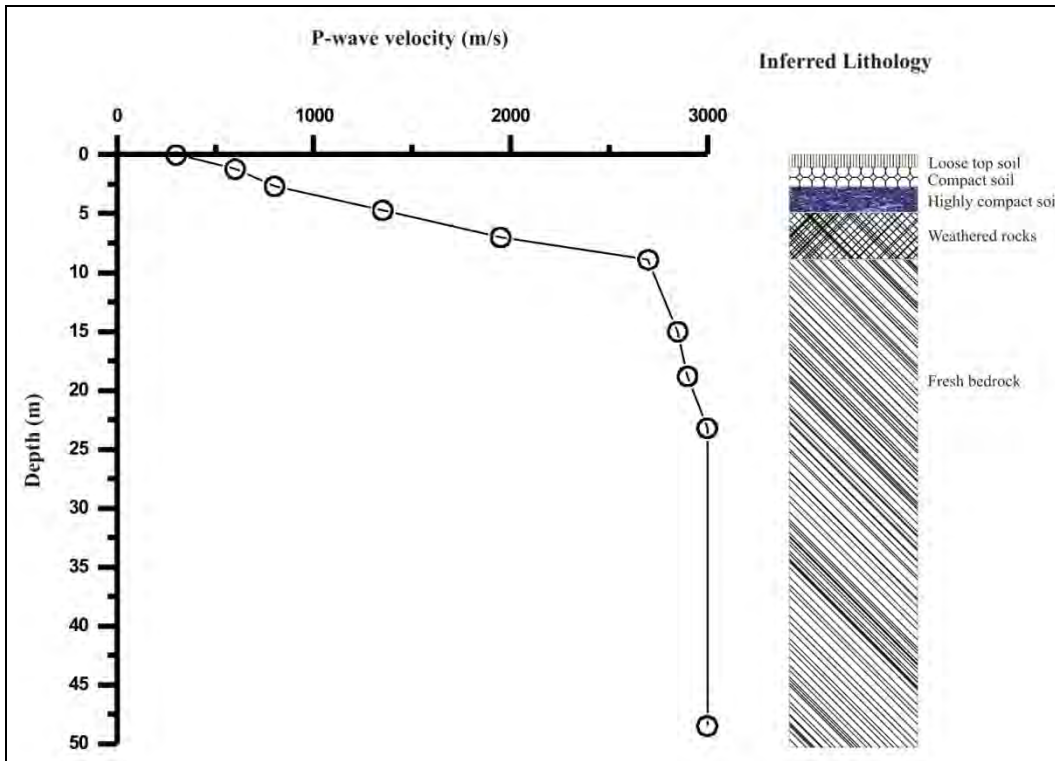
P-wave velocity distribution at boreholes BH-4 and BH-5 are shown in Figure 19 and Figure 20 respectively along with inferred lithology of the subsurface materials. As shown in Figure 19, on borehole BH-4 weathered rock is encountered at the depth of 5m. The upper 5m stratum is categorized as loose soil, compact soil and highly compact soil based on the velocity distribution. Fresh bedrocks are found at the depth of 9m. Similarly on BH-5 (Figure 20) the rock soil boundary is estimated at the depth of 6m where the P-wave velocity changes to 1700m/s from 1200m/s of the upper soil layer. Fresh bedrocks are found at the estimated depth of 9.5m.

Figure 19: P-wave velocity profile and inferred lithology at borehole BH-04

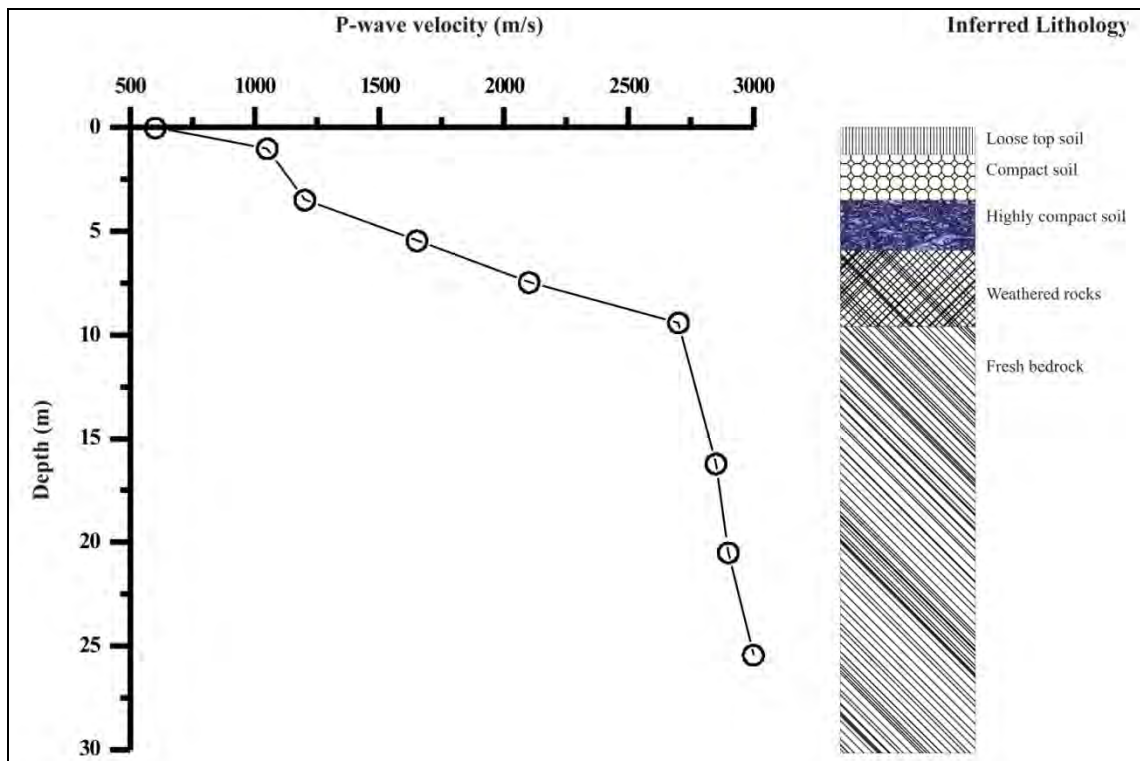
Figure 20: P-wave velocity profile and inferred lithology at borehole BH-05

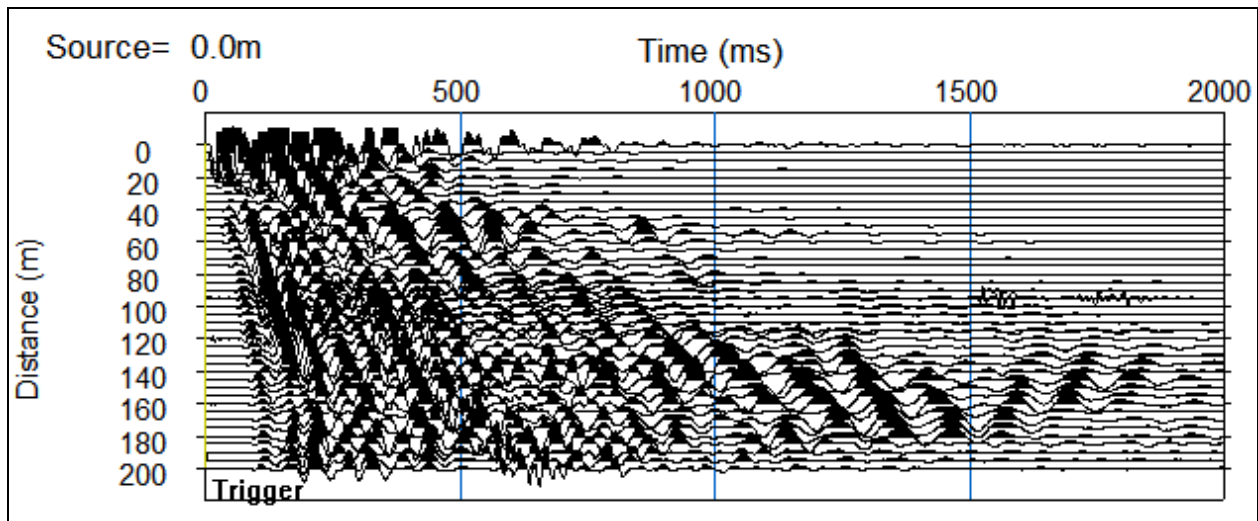
Figure 23: Raw data with source at the chainage of 0 m along the SRT-1 line in the Thomang cliff area.

Figure 22 shows raw data along the SRT-1 profile with source at 0m. Data from each shot location was processed and first arrival time was picked for each channel using *pickwin*. Figure 23 shows the travel-time curves along this profile. Seismic refraction tomogram along this profile was obtained after inverting the travel-time data.

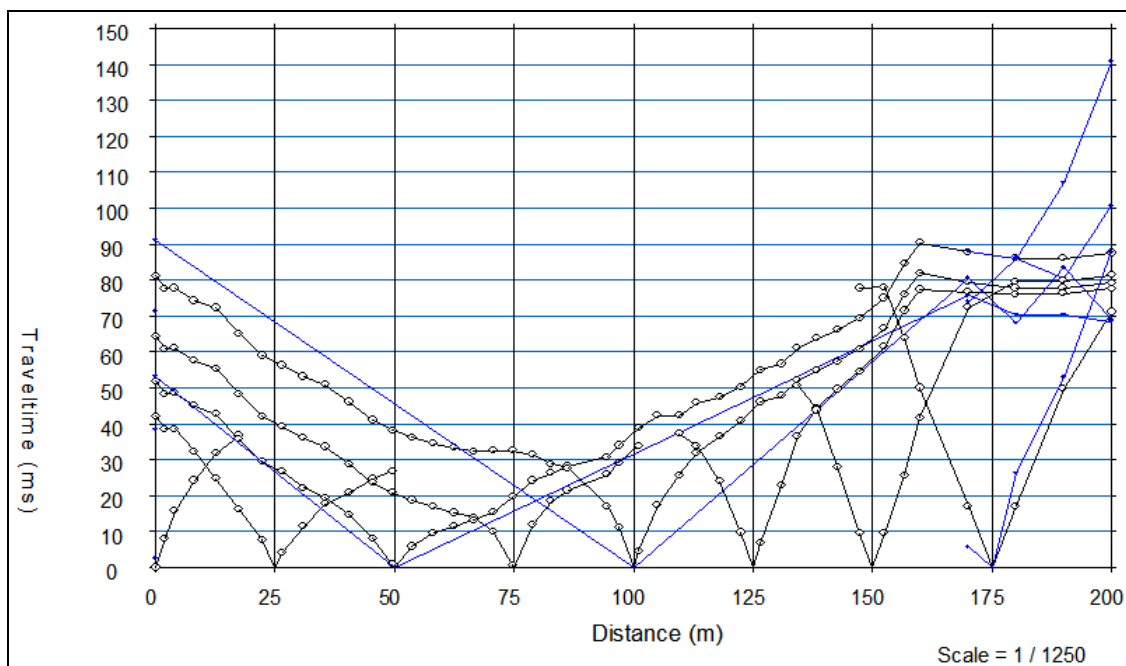
Figure 24: Travel-time curve along SRT-1 line.

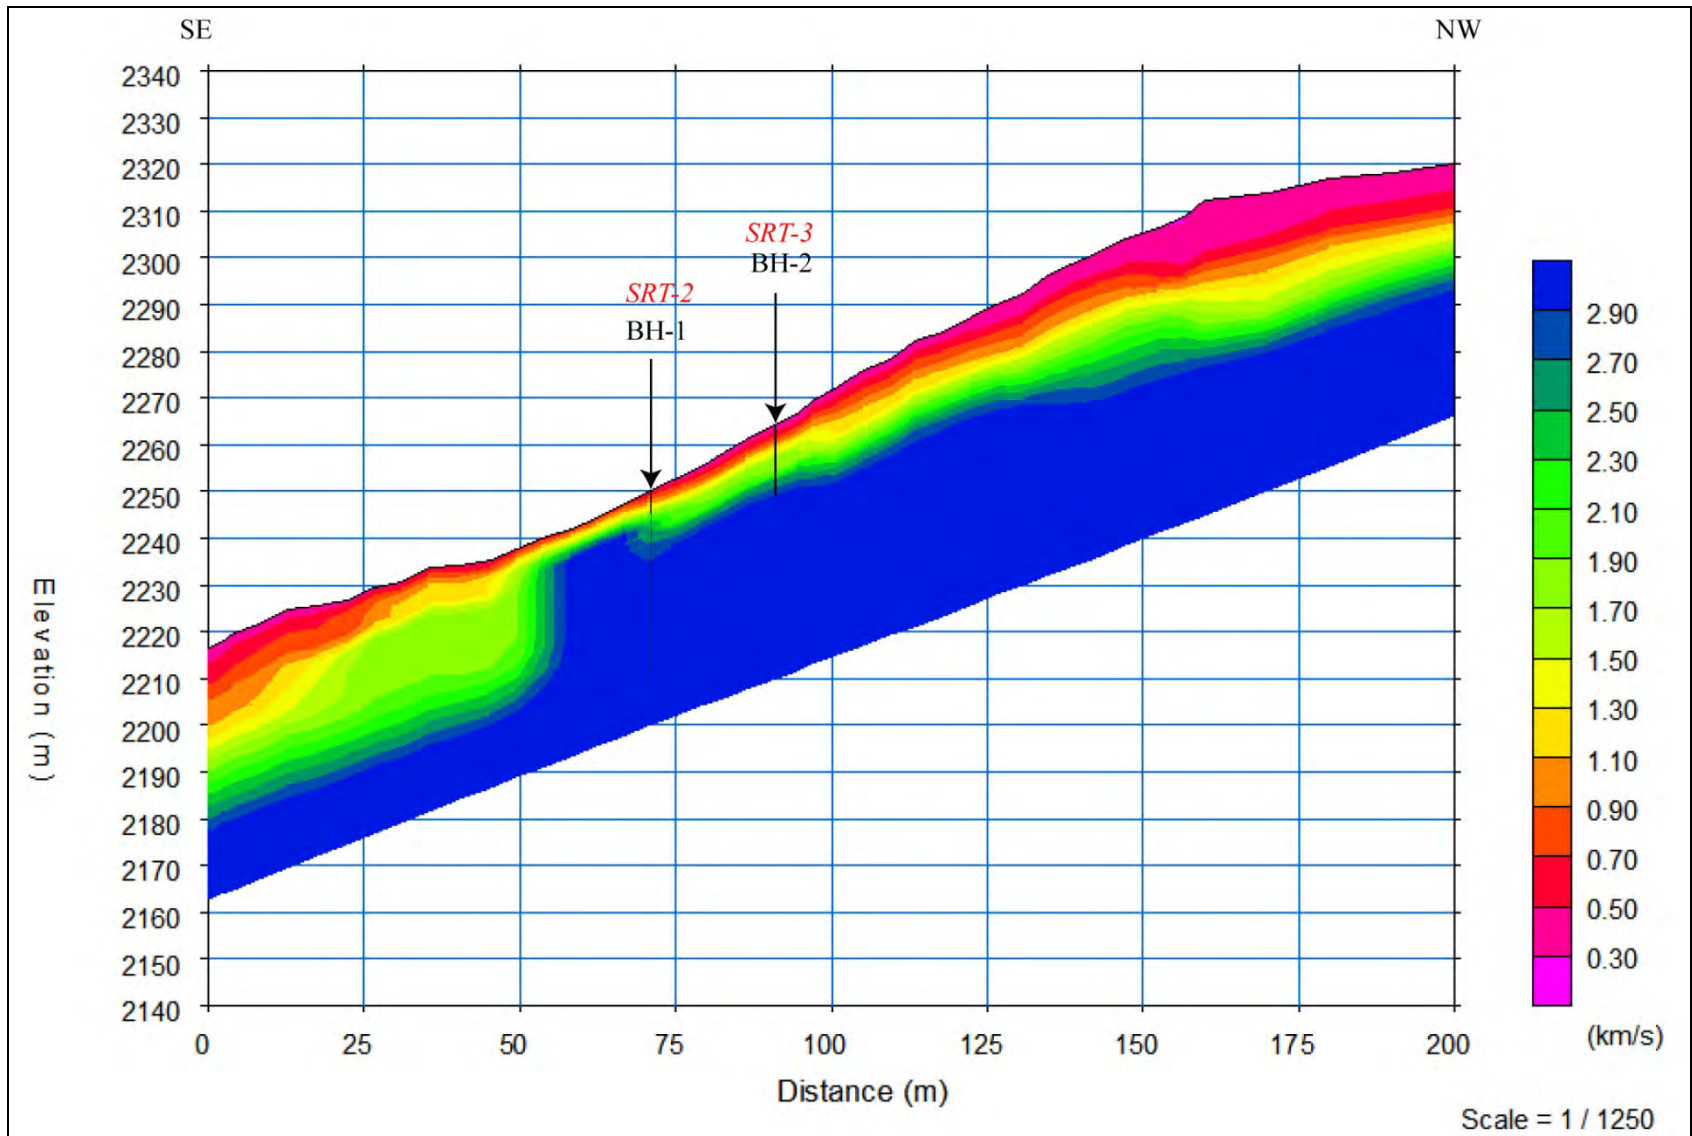
Figure 25: Seismic refraction tomogram along SRT-1.

The tomogram (Figure 24) shows velocity distribution of different subsurface layers along the profile. The tomogram reveals continuous surface layers of P-wave velocity < 700m/s. This layer is very thin between the chainage of 40m and 90m. Towards NW of BH-2 thickness of the low velocity surface layers gradually increase and reaches the maximum of 16.7m. These surface layers are correlatable with loose unconsolidated soil with occasional boulders. In the south-eastern corner of the profile these layers have a thickness of 8.1m. These relatively low velocity layers are underlain by layers with Vp between 800 and 1700m/s correlatable with compact gravel soil based on surface geological observations. Thickness of this compact soil is below 5m between the chainages of 55 and 70m and reaches the maximum of 21m at the chainage of 48m. The high velocity layers underlying the overburden soil are correlatable with the bedrocks.

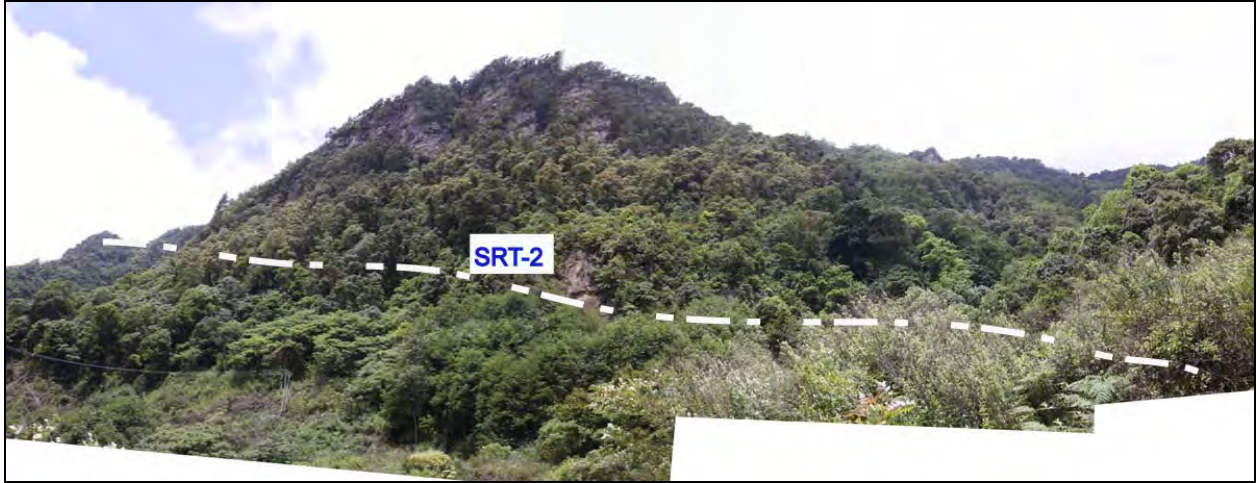
Figure 27: Photograph showing SRT-2 profile at Thomang cliff area.

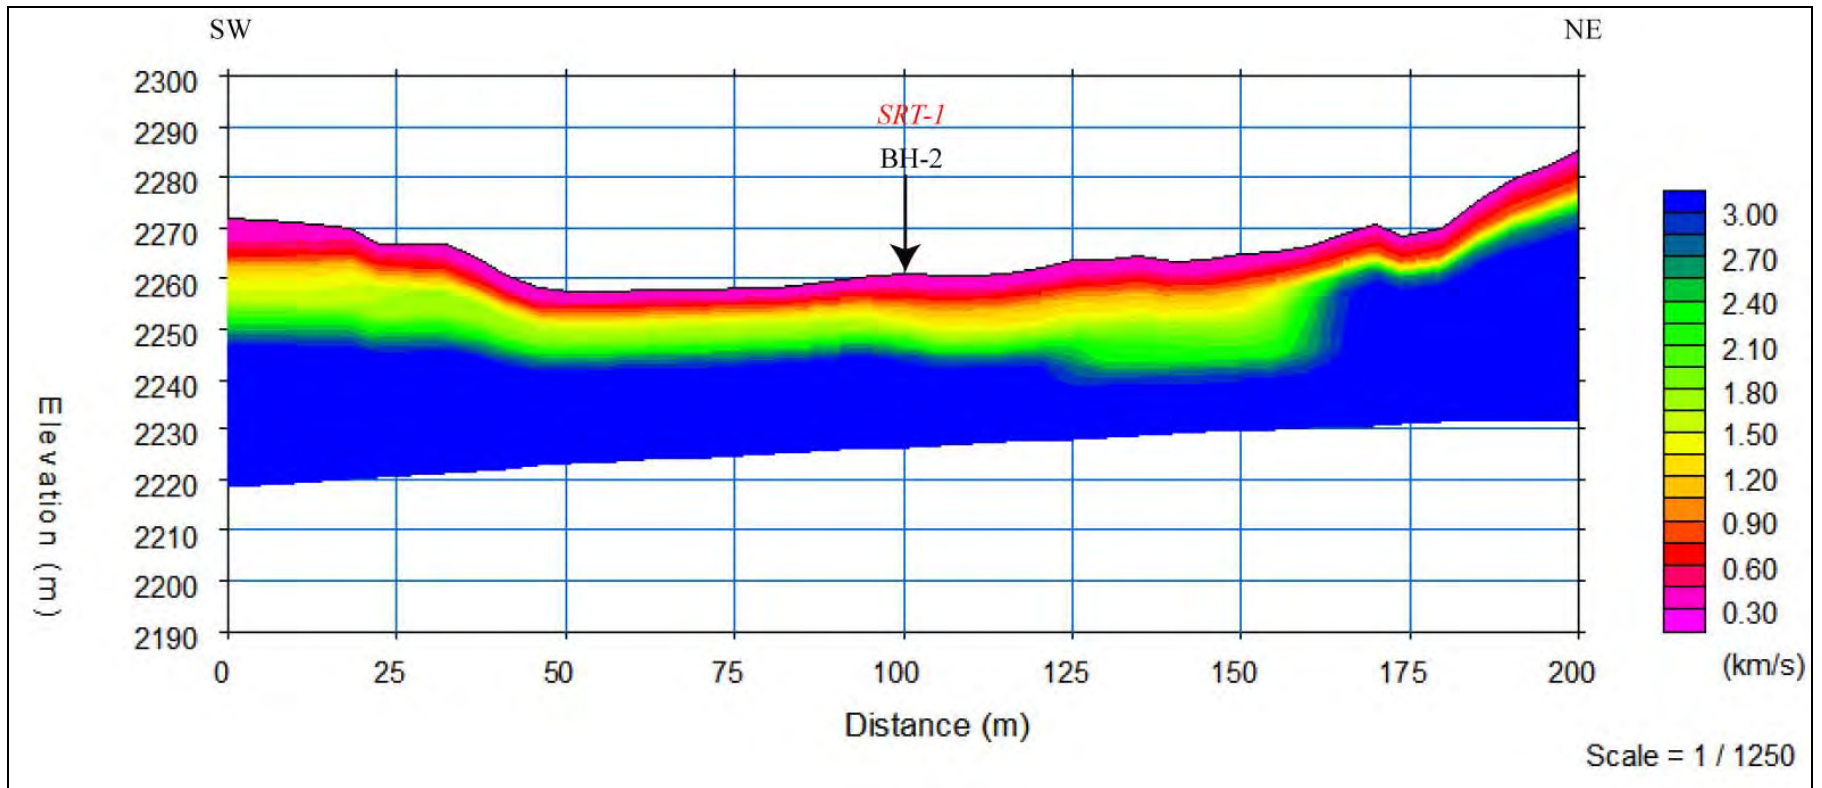
The tomogram (Figure 32) shows velocity distribution of different subsurface layers along the profile. The tomogram reveals continuous surface layers of P-wave velocity < 750m/s. This layer is somewhat uniform with an average thickness of 6m. At the central part of the profile thickness of these layers is the minimum. These surface layers are correlatable with loose unconsolidated soil with occasional boulders and are underlain by very thin layers with V_p between 750 and 1500m/s. High velocity layers ($V_p > 2000\text{m/s}$) in the deeper part are correlatable with bedrocks.

Figure 33: Seismic refraction tomogram along SRT-3 line

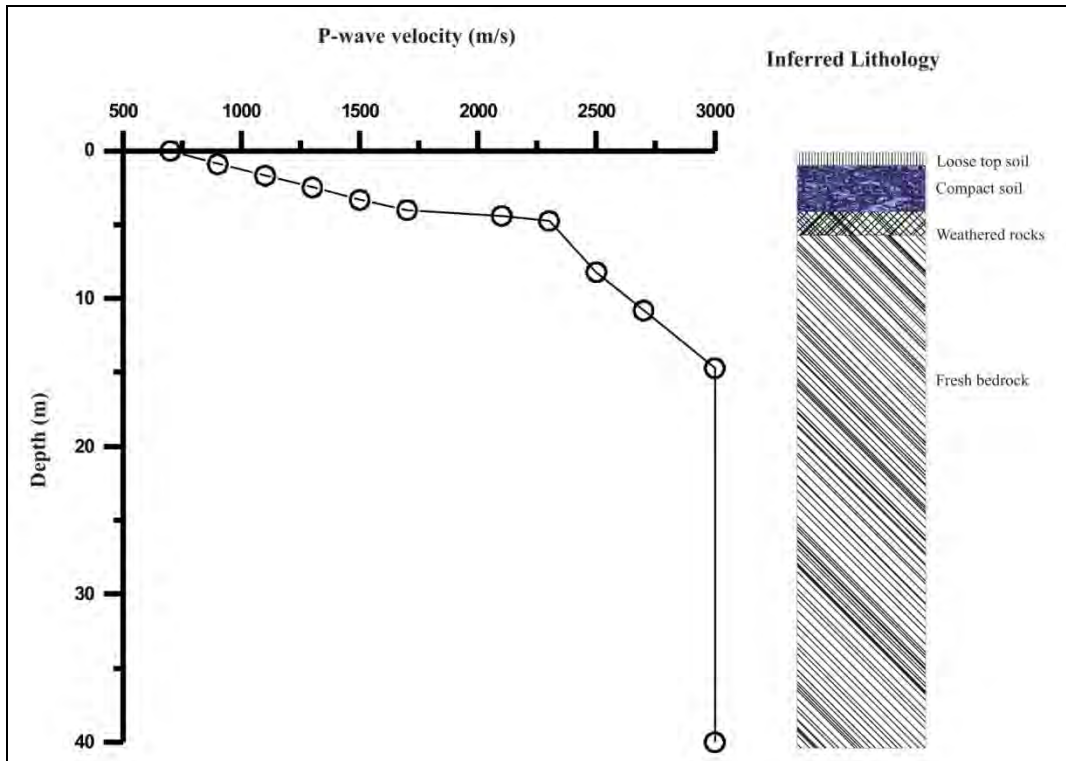
Based on the velocity profile along three lines, the P-wave velocity log is prepared on borehole BH-1 and BH-2. These logs along with inferred geology are presented in Figure 33 and Figure 34. At borehole BH-1 which lies 20m uphill from the Trongsa-Thimphu highway, an overburden of 4.5m is calculated. The overburden is comprised of a thin loose and unconsolidated top soil and about 3.5m thick compact soil. The overburden is underlain by 1.75m thick layer of weathered rocks. High velocity layers ($>2200\text{m/s}$) are interpreted as fresh bedrocks (Figure 33). On borehole BH-2, the overburden is estimated to 5.75m thick and is underlain by 3.75m thick weathered rocks. High velocity layers below 9.75m are interpreted as fresh bedrocks (Figure 34).

Figure 34: P-wave velocity profile and inferred lithology at borehole BH-1

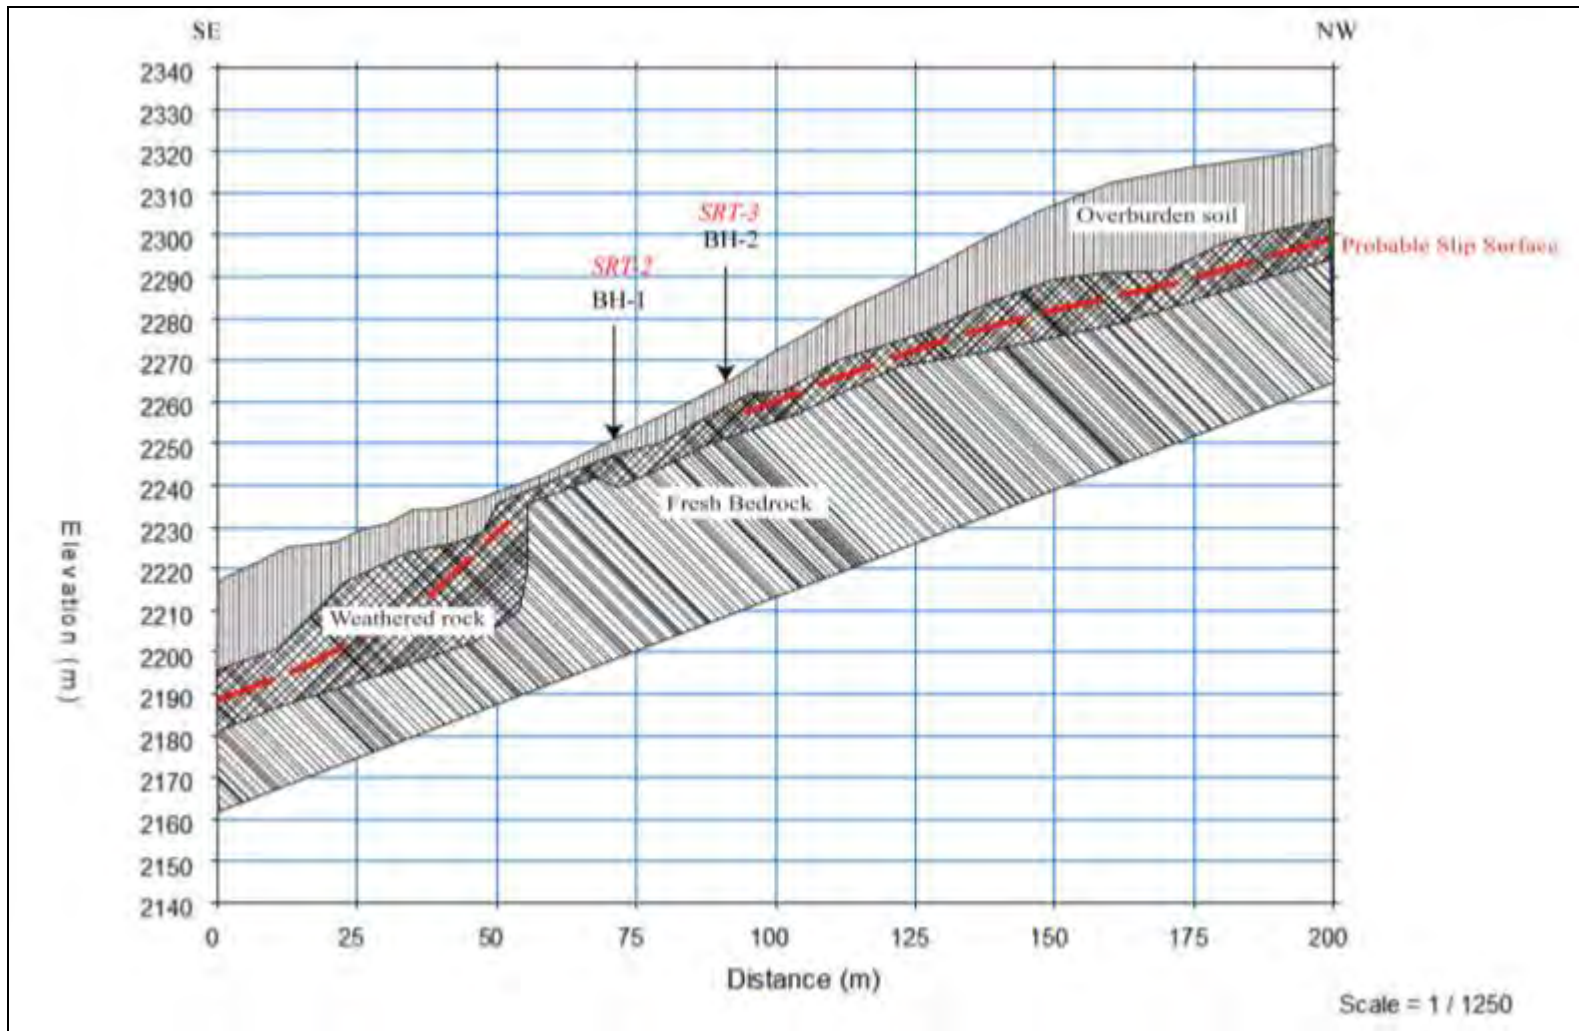
Evaluating the tomograms from three different profile lines, a passive slip surface can be inferred at the depth of 5 to 13m that dips SE (Figure 36).

Figure 36: Interpretative geological section along SRT-1 at Thomang Cliff showing interpreted passive slip surface

1. In Bangla Pokto area bedrocks are found at shallow depth (<6m) and there is no probable slip surface for heavy mass wasting phenomena.
2. In Thomang Cliff area, bedrocks are found at different depths (5m to >40m)
3. In Thomang Cliff area, a passive slip surface is inferred at the depth of 5 to 13m that dips towards southeast.
