**JAPAN INTERNATIONAL COOPERATION AGENCY (JICA)
DEPARTMENT OF ROADS, MINISTRY OF WORKS AND HUMAN SETTLEMENT
(DOR)**

**THE PROJECT FOR MASTER PLAN STUDY
ON ROAD SLOPE MANAGEMENT IN BHUTAN**

FINAL REPORT

August 2016

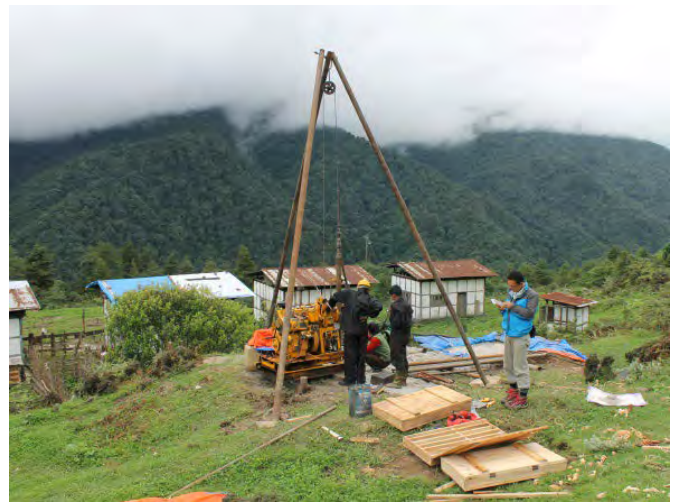
Drilling works, Bangla Pokto Area, June 2015

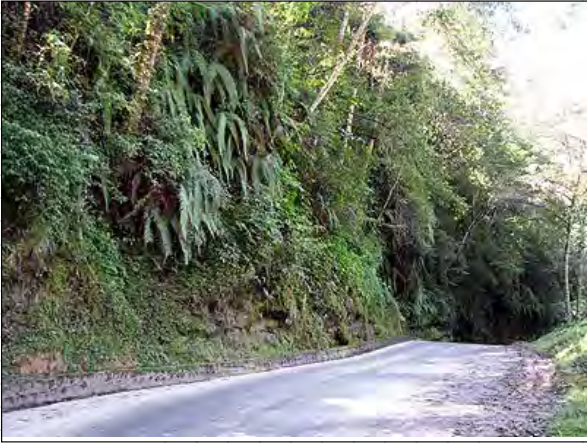
Full view of the slope at start point

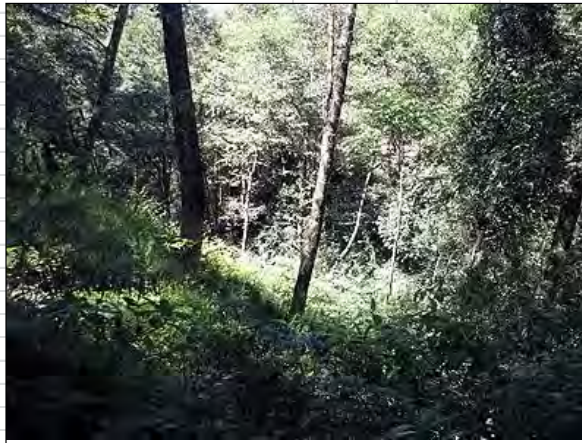
Full view of the valley side at start point

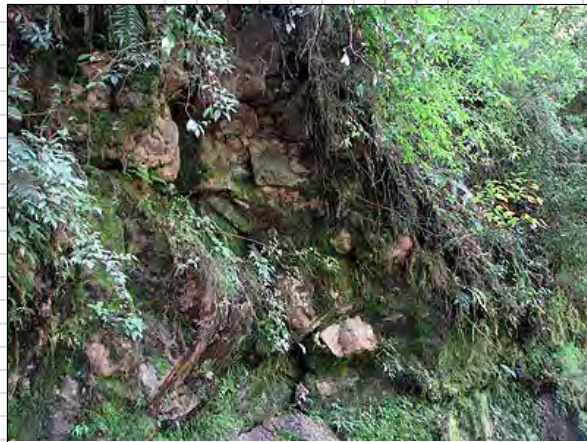
Close veiw of detached rocks at start point

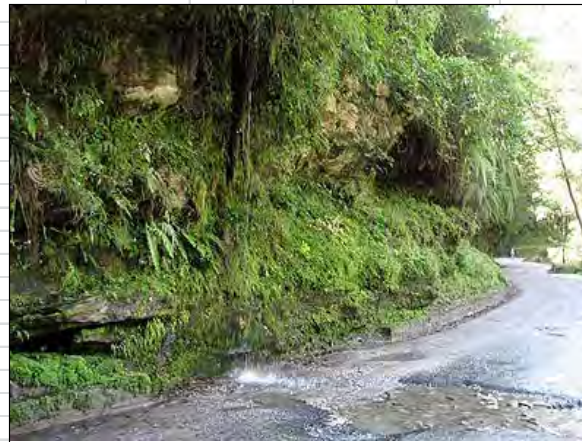
Close veiw of water flow on the rock

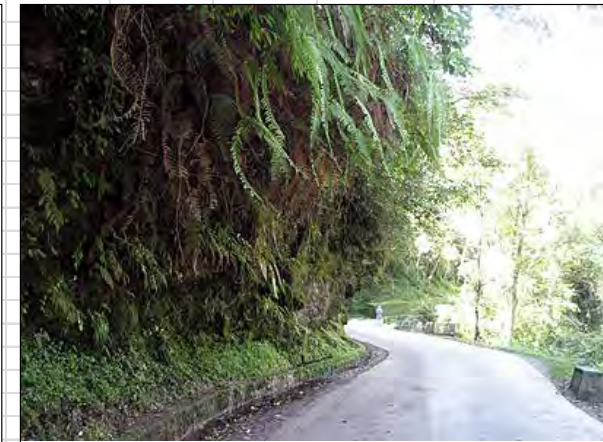
Figure 2.2.8 Example of Photo Sheet for Rock Slope Failure/Slope Failure (Source: JET)

Close view of overhung rocks at end point

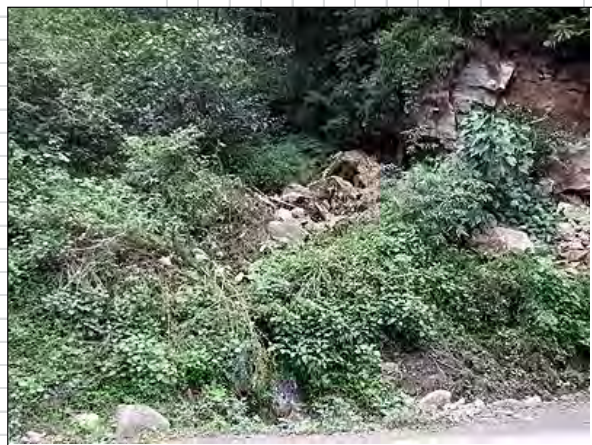
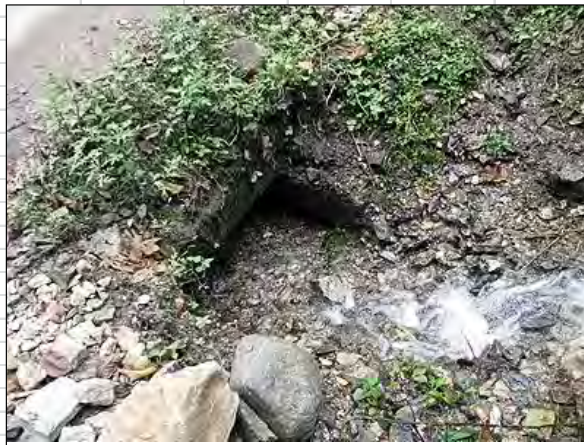
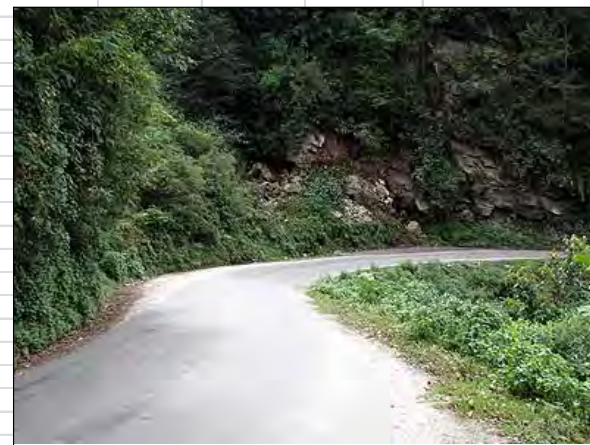
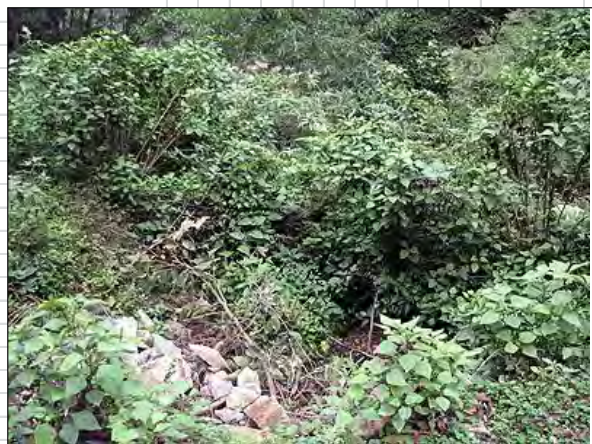
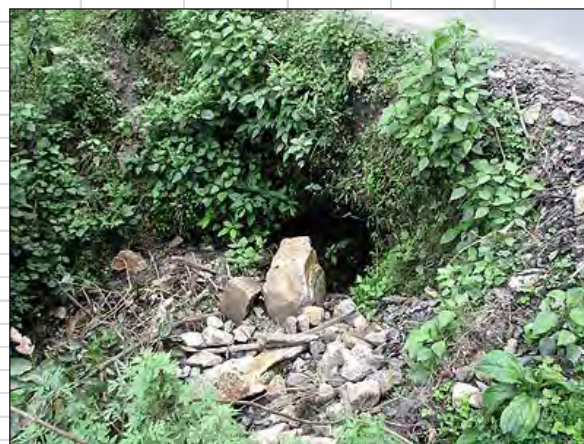
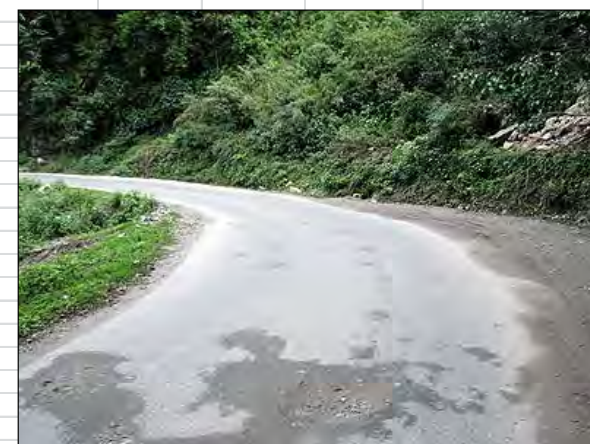
Figure 2.2.9 Example of Photo Sheet for Debris Flow (Source: JET)

Full view of the stream

Close view of the inlet

Clearance between road and the debris from start side

Full view of the valley side

Close view of the outlet

Clearance between road and the debris from end side

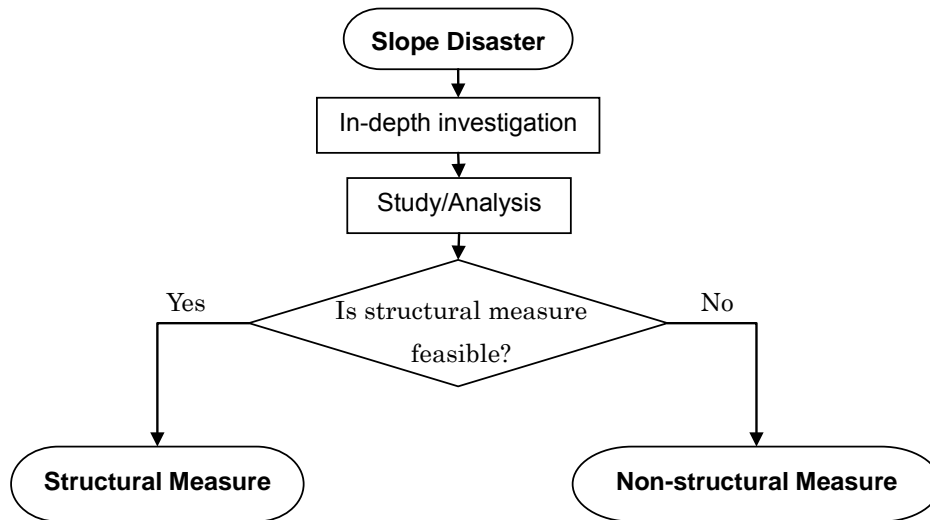
Figure 2.4.1 Flowchart to Consider the Countermeasure for Slope Disasters (Source: JET)

Countermeasures for slope disasters are divided into structural measures and non-structural measures. Basically, a structural measure shall be selected as a countermeasure for hazardous slopes. In case it is difficult to apply structural measures for hazardous slope/road sections, application of non-structural measures can be considered. Moreover, according to the site conditions, a combination of both structural and non-structural measures may also be applied.

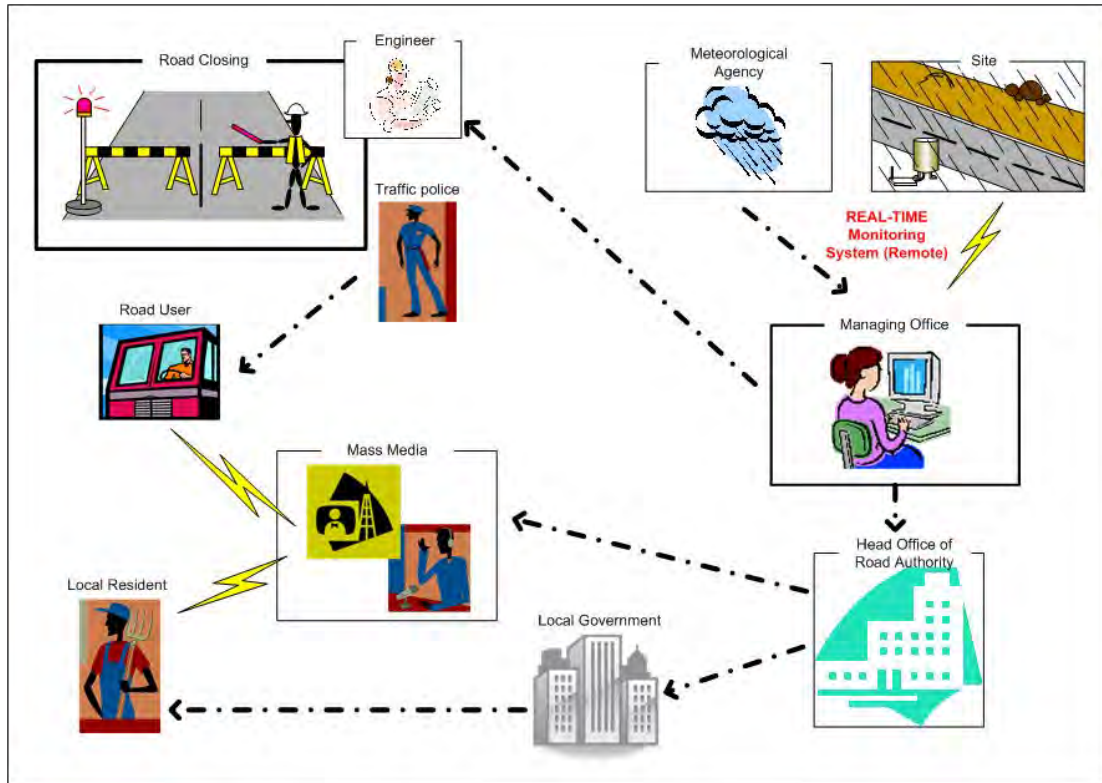
Figure 2.4.8 Schematic Flowchart of the Advance Traffic Control in Japan (Source: JET)

The schematic flow of the advance traffic control system is shown in Figure 2.4.8 below.

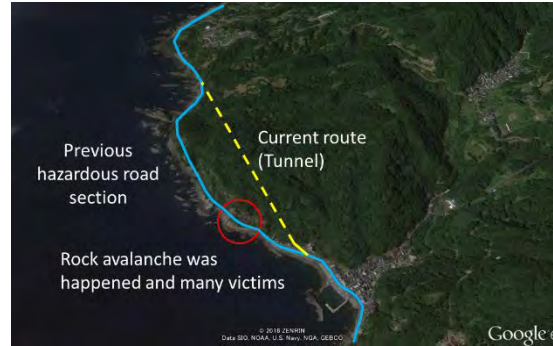
Figure 2.4.10 Case Example of Road Alignment Change due to Slope Disaster in Japan (Source: JET, base map is Google Earth)

In case the hazardous road section is a long stretch, it can be skipped by tunnel or bridge.

Site conditions, especially topography, are one of the essential factors of planning a tunnel or bridge. Additionally, not only natural conditions, but social and environmental impacts by the tunnel or bridge construction shall be considered at the planning stage.

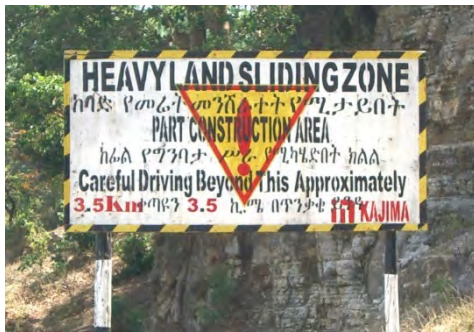
Figure 2.4.11 Photo of Sign Board to Notify a Landslide Zone (Source: JET)

It is a fundamental measure for road disaster. It can be applied with a structural or other non-structural measure.

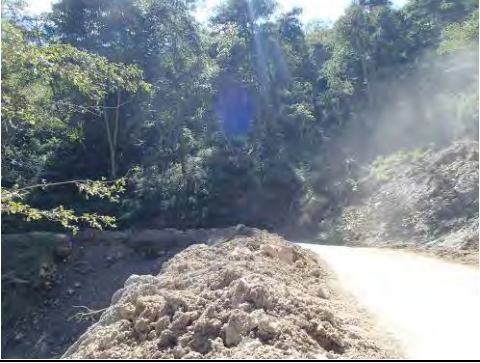
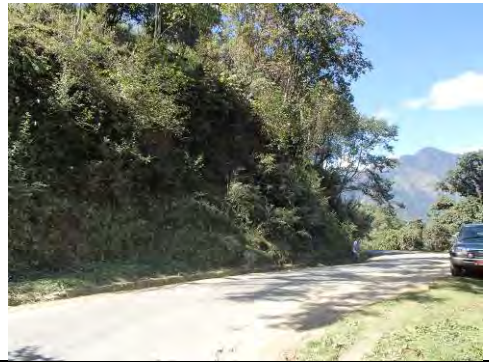
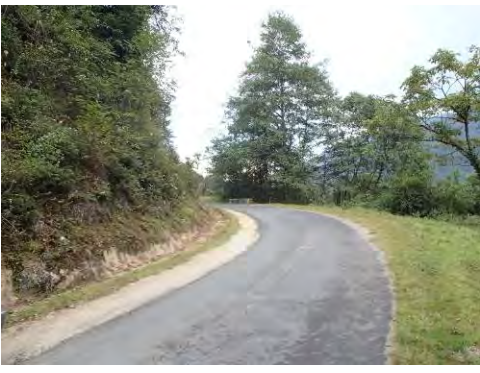
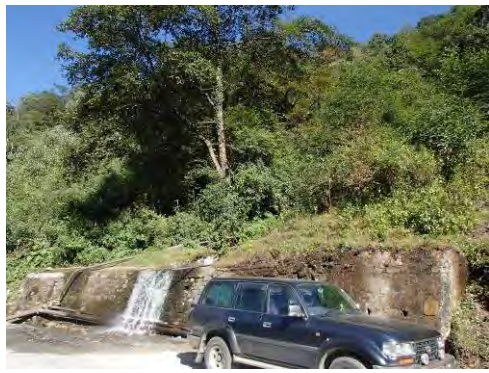
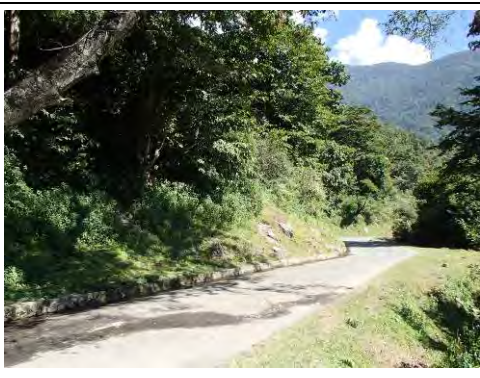
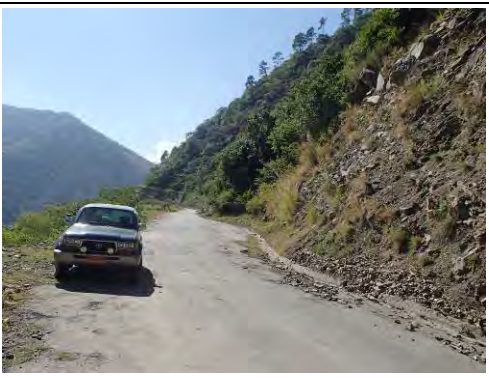
Figure 3.3.7 Image of Each Start Point and End Point in the Target Sections (Source: JET)

Start Point N 27° 29' 58.34" E 90° 04' 03.44"	End Point N 27° 32' 43.87" E 90° 08' 59.59"
Section 2

Start Point* N 27° 27' 15.48" E 90° 23' 22.59"	End Point N 27° 27' 46.48" E 90° 30' 03.37"
Section 3

Start Point N 27° 16' 54.56" E 90° 37' 15.57"	End Point N 27° 13' 35.10" E 90° 37' 28.70"

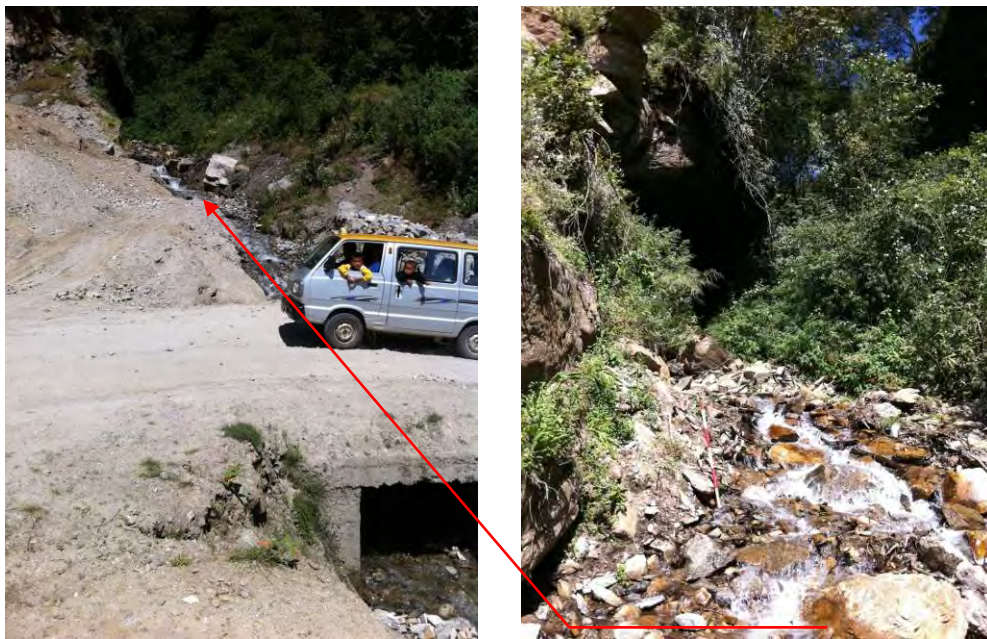
Figure 3.4.6 Example of Debris Flow in the Stream (Source: JET)

It was important in the checking the debris flow in case of (A) that the volume of the sediment along the stream was evaluated and checked in correlation with the robustness of the culvert situated downstream of the debris flow. The deposit or sedimentation is estimated to have accumulated due to multiple occurrence of debris in the past influenced by the downpour (flash flooding). The distribution of the boulder/rock is random. The debris was produced from the upstream of the valley so the topographical anomaly such as steep gradient (erosion front) or landslide shall be advisable to be checked in the map (1:10,000) before the on-site checking. The typical form of debris flow is shown in Figure 3.4.6 below. The large boulder, if any, should be checked with its dimension (width, height and depth), so as to examine the possibility where the boulder can hit the culvert downstream or not. The checking requires the measure such as a bar with alternation of indication (white & red marker).

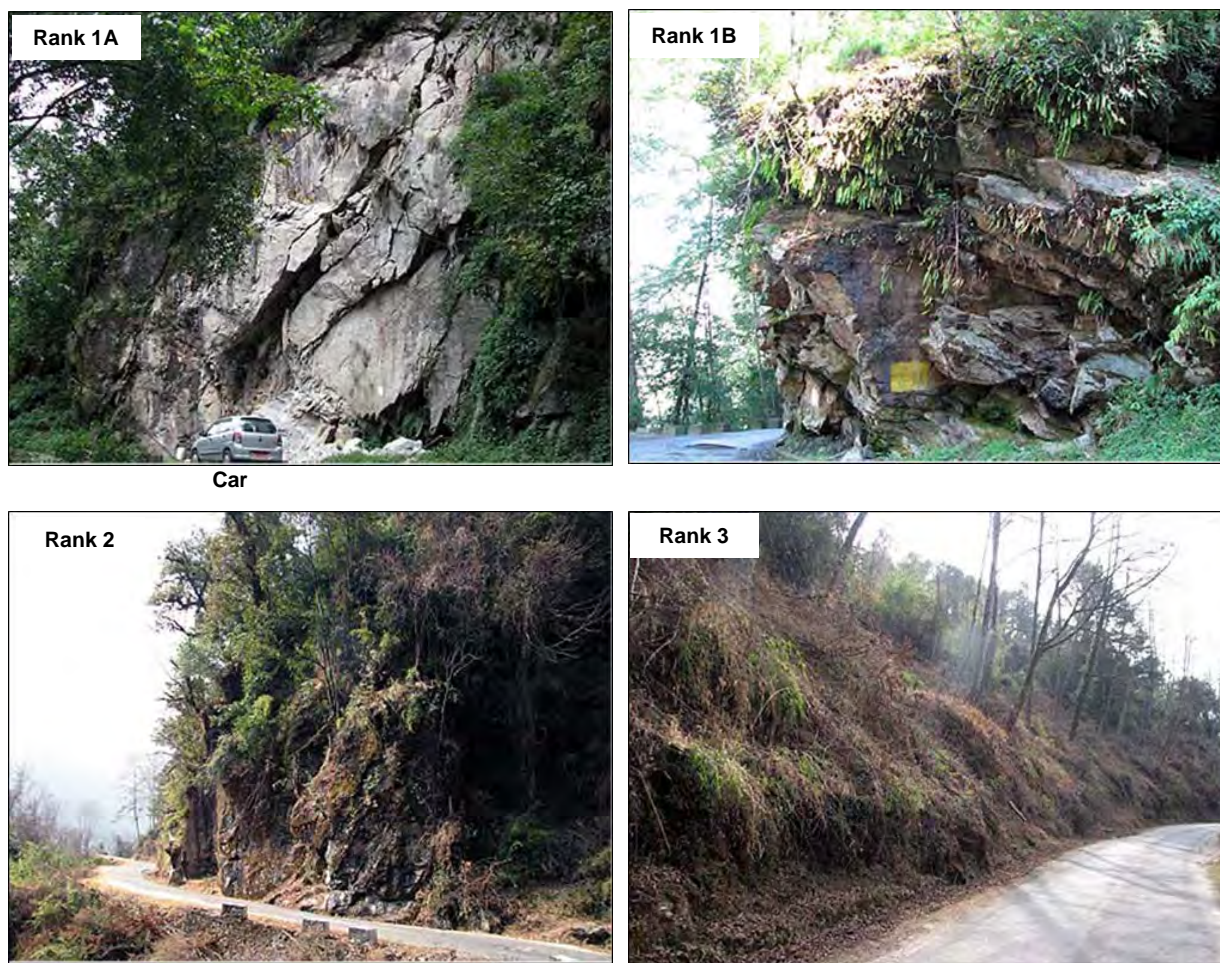
Figure 3.5.8 Typical Examples of Each Rank (Source: JET)

[Definition] Countermeasures are not needed for now because potential failure/rockfall/deformation is minor so daily maintenance by DoR is sufficient to control the slope disasters.

---> Regular check sheets are not prepared for the slope disaster. The regular check is not implemented.

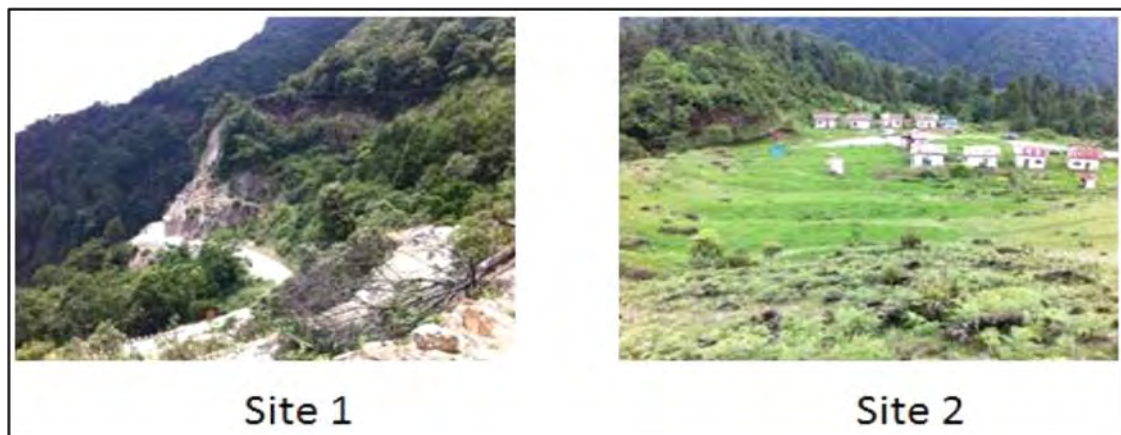
Figure 3.6.1 Overview of each site (Site 1: Thumang Cliff, Site 2: Bangla Pokto)
(Source JET)

Thumang Cliff, Site 1, was selected as the representative site for investigations in “landslide” areas, which were categorized according to the classification system used in this Project. Bangla Pokto, Site 2, was designated as the representative site for investigations in “Rock Slope Failure” areas, which were categorized according to the classification system used in this Project. Each item and volume included in each investigation activity is presented in Table 3.6.1. Both investigation activities include the survey (Topographical Mapping),

Geophysics (Elastic Wave Exploration) and Drilling (Boring).
