Appendix 12

Geological Investigation

DETAILED REPORT ON THE GEOTECHNICAL WORKS FOR THE

PROJECT OF MASTER PLAN STUDY ON ROAD SLOPE MANAGEMENT IN THE KINGDOM OF BHUTAN

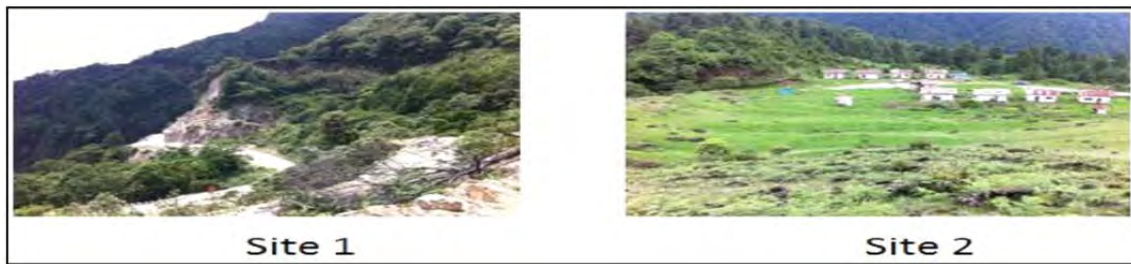
Figure 3 Overview of each site (Site 1: Thumang Cliff, Site 2: Bangla Pokto) (Source JET)

The geological investigation was implemented as a show case to demonstrate the above methodology. In the project, the two sites below were selected to showcase the methodology of how geological investigation will be implemented in the road construction project. The two selected sites are shown below (Figure 3.6.3). The scope of the geological investigation includes the subsurface investigation, the laboratory investigation and the geophysical investigation. The subsurface investigation should be carried out to obtain the geological information below the natural ground in the project area. The investigation method to be followed uses surface invasive techniques including the following:

- a) Subsurface investigations (core drilling)
- b) Standard Penetration Test (SPT)
- c) Ground water measurement
- d) Collection of undisturbed (UD) samples
- e) Laboratory Investigations
- f) Geophysical Investigations (Seismic exploration)

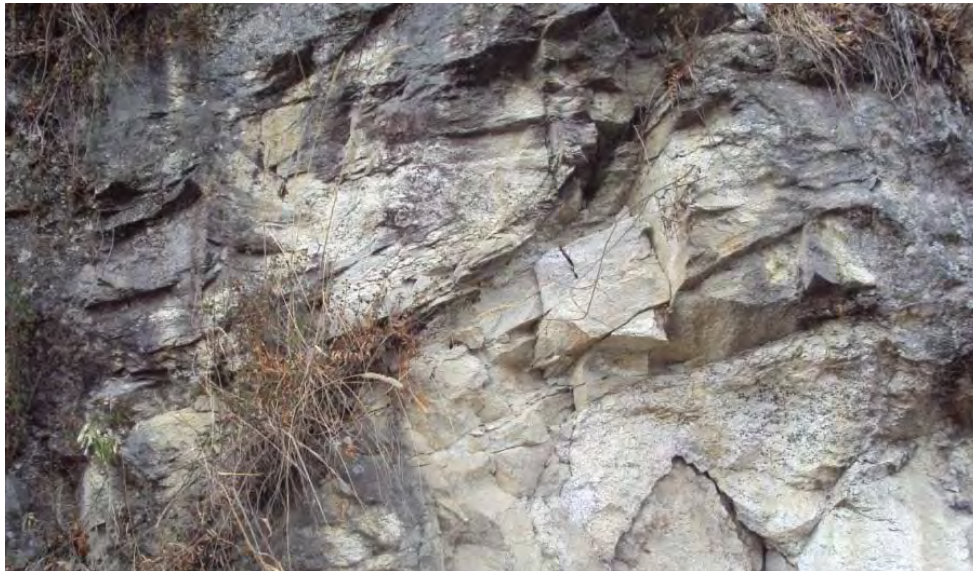
Figure 4: Photograph showing the fault in the rock exposure.

In the rock exposure seen about 400 metres away from Thomang cliff towards Trongsa, a fault with a dip direction of 200° and a dip amount of 80° could also be observed as shown in the photograph below.

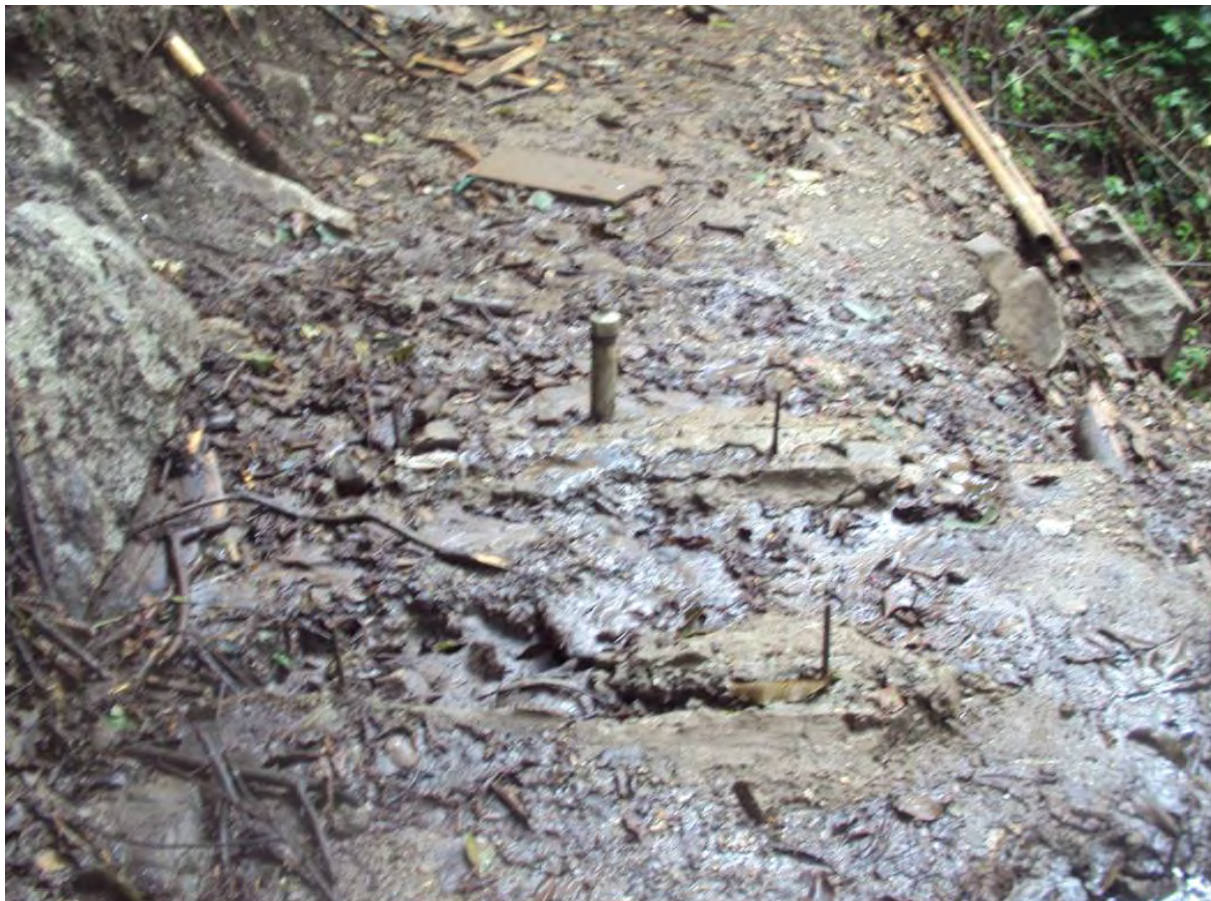
Figure 5: Location of BH-1

This borehole is located at Thomang cliff area and is approximately at 27°28'41.90"N latitude and 090°28'49.90" E longitude at an approximate elevation of 2265 metres above the mean sea level and is named BH-1 by the client. This location is about 60 metres above the Wangdue-Trongsa primary national highway and is about 16 kilometres before Trongsa. This area is shown in the survey of Bhutan Toposheet No. 78 I/7. This part of the area has been explored in detail by drilling a borehole.

Drilling work started on 10th July 2015 and completed on 19th July 2015 after drilling a total of 60.00 metres down depth. The detail of the core log is attached as Appendix A.1 and the core photographs as Appendix C.1. At the top for 30 metres are the top soil and boulders.

For the first 30 metres, the overburden consisting of gravelly sand, mostly of grey to light grey colour was observed. Boulders are of light grey fine grained crudely banded gneiss. At few places banded biotitic gneissic and pegmatite boulders were also

observed. The bed rock consisting of fine grained, grey coloured garnetiferous quartz mica (muscovite) schist could be inferred from 30 metres to 49 metres depths. Garnets are slightly bigger than pin heads. Foliation is at 80° to the core axis and is smooth undulating. The bed rock changes to banded biotite gneiss from 49 metres. A pegmatite intrusion of slightly over a metre thickness could also be observed at 55 metres depth.

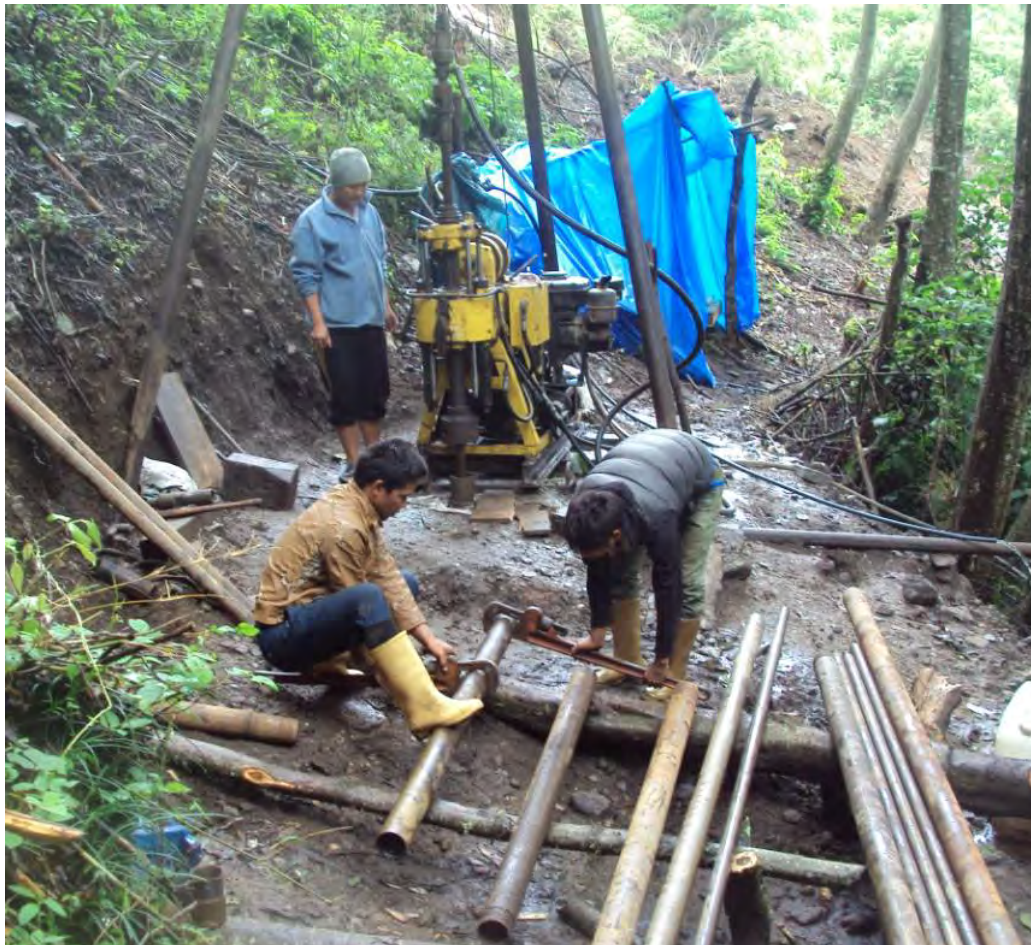
Figure 6: Location of BH-2

This borehole is located at Thomang cliff area and is approximately at 27°28'42.00"N latitude and 090°28'49.10" E longitude at an approximate elevation of 2280 metres above the mean sea level and is named BH-2 by the client. This location is about 30 to the north west of BH-1. This area is shown in the survey of Bhutan Toposheet No. 78 I/7. This part of the area has been explored in detail by drilling a borehole.

Drilling work started on 24th July 2015 and completed on 10th August 2015 after drilling a total of 50.00 metres down depth. The detail of the core log is attached as Appendix A.2 and the core photographs as Appendix C.2. At the top for 33 metres are the top soil and boulders.

For the first 33 metres, the overburden consisting of gravelly sand, mostly of grey to light grey colour was observed. Boulders are of light grey fine grained crudely banded gneiss. At few places banded biotitic gneissic and pegmatite boulders were also observed. The bed rock consisting of fine grained, grey coloured garnetiferous quartz mica (muscovite) schist could be inferred from 33 metres depths. Garnets are slightly bigger than pin heads. Foliation is at 65° to the core axis and is smooth undulating.

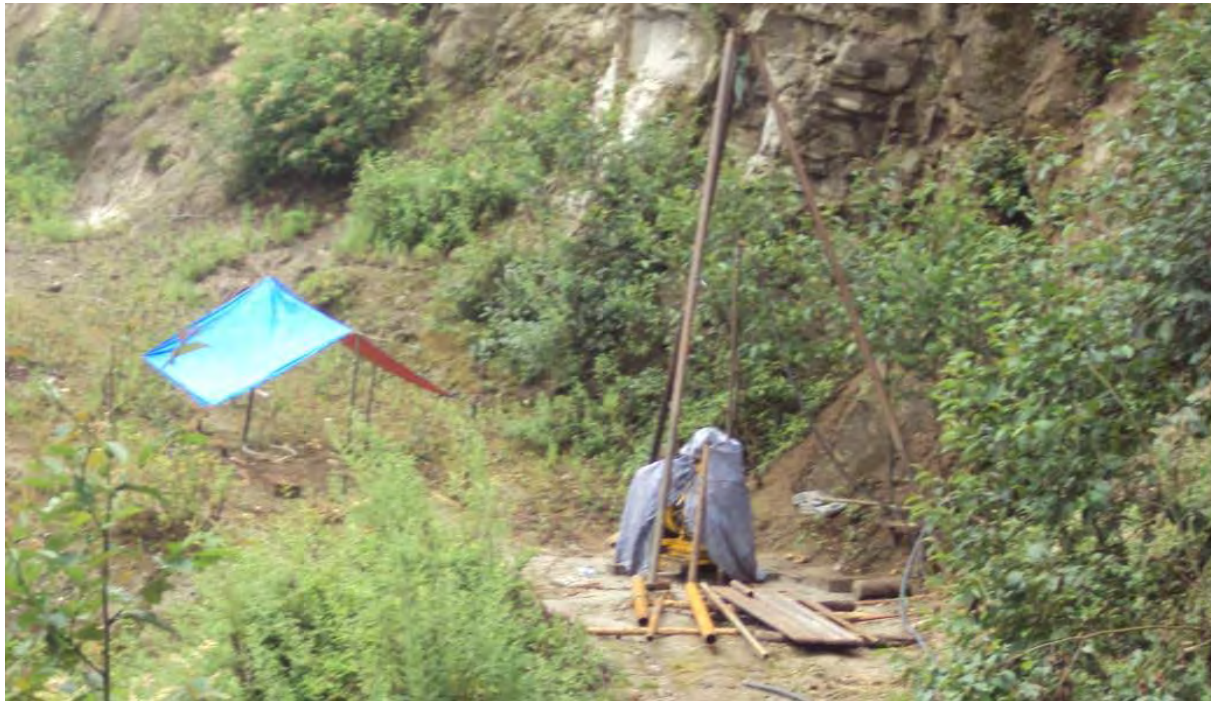
Figure 7: Location of BH-3

For the first 5 metres, it is medium to fine grained, biotite gneiss bed rock with conspicuous banding structure seen in the core samples. The rock is slight to moderately weathered. Then there is about metre thick granitic gneiss, hard and compact rock till 6 metres depth. And again from this depth the bed rock of banded biotite gneiss continues till 47 metres depth and then the gneiss shows crude banding structure. There is a cavity of about 4 metres from 23 to 27 metres depth.

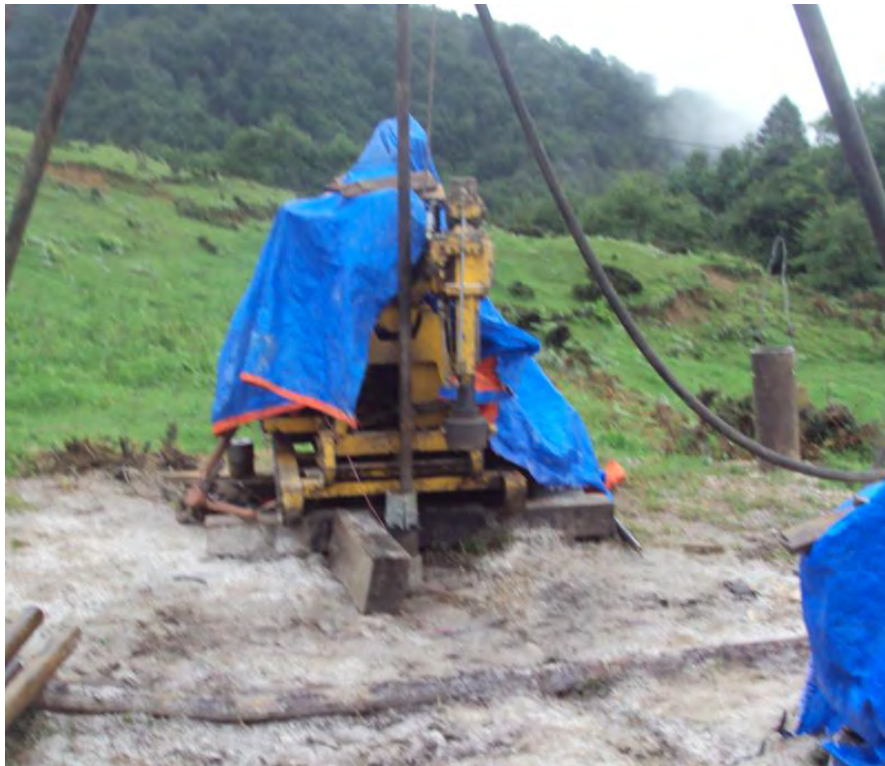
Figure 8: Location of BH-4

This borehole is located at Bangla Pokto area is located about 50 metres above the Wangdue - Trongsa highway and is approximately at 27°27'02.80"N latitude and 090°24'24.87" E longitude at an approximate elevation of 2428 metres above the mean sea level and is named BH-4 by the client. This area is shown in the survey of Bhutan Toposheet No. 78 I/7. This part of the area has been explored in detail by drilling a borehole.

Drilling work started on 23rd June 2015 and completed on 1st July 2015 after drilling a total of 25.00 metres down depth. The detail of the core log is attached as Appendix A.4 and the core photographs as Appendix C.4. The summary of the sub surface strata is as shown in the table below.

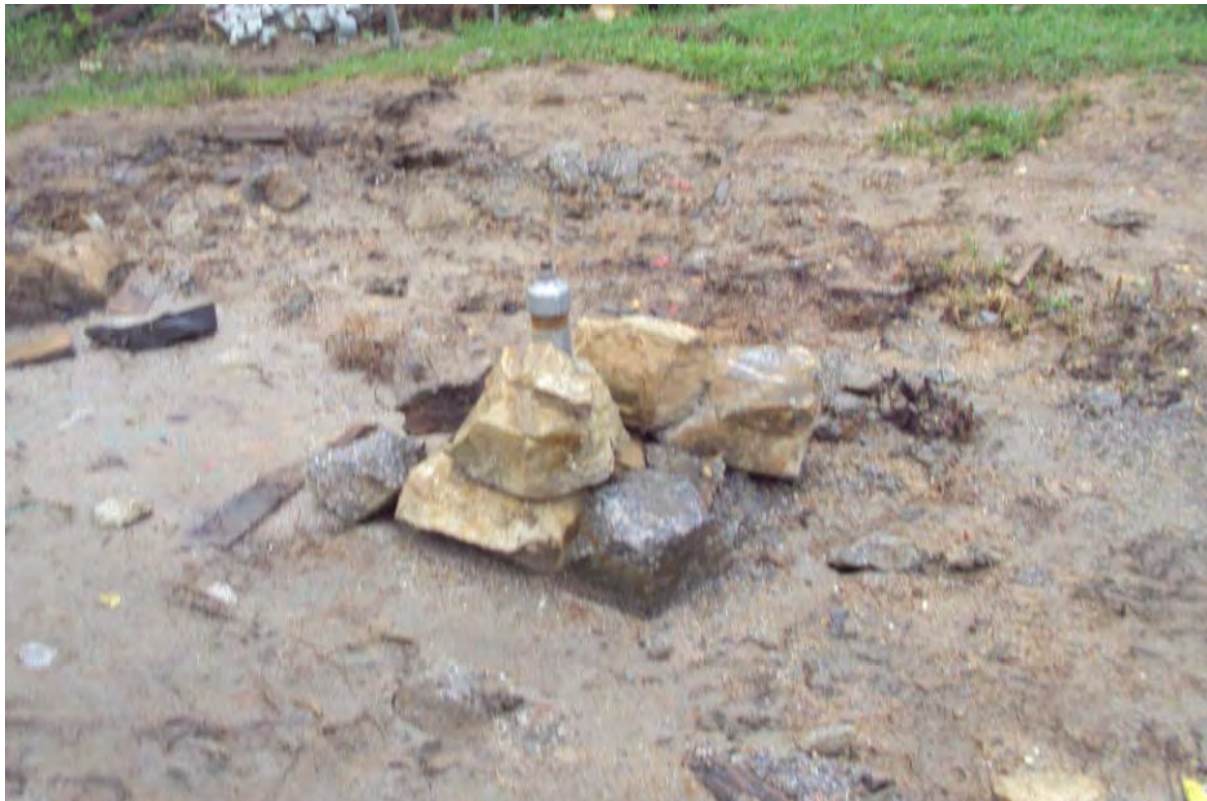
Figure 9: Location of BH-5

This borehole is located at Bangla Pokto area is located just below the Wangdue-Trongsa highway and is approximately at 27°27'00.60"N latitude and 090°24'24.7" E longitude at an approximate elevation of 2417 metres above the mean sea level and is named BH-5 by the client. This area is shown in the survey of Bhutan Toposheet No. 78 I/7. This part of the area has been explored in detail by drilling a borehole.

Drilling work started on 11th June 2015 and completed on 17th June 2015 after drilling a total of 25.00 metres down depth. The detail of the core log is attached as Appendix A.5 and the core photographs as Appendix C.5. The summary of the sub surface strata is as shown in the table below.

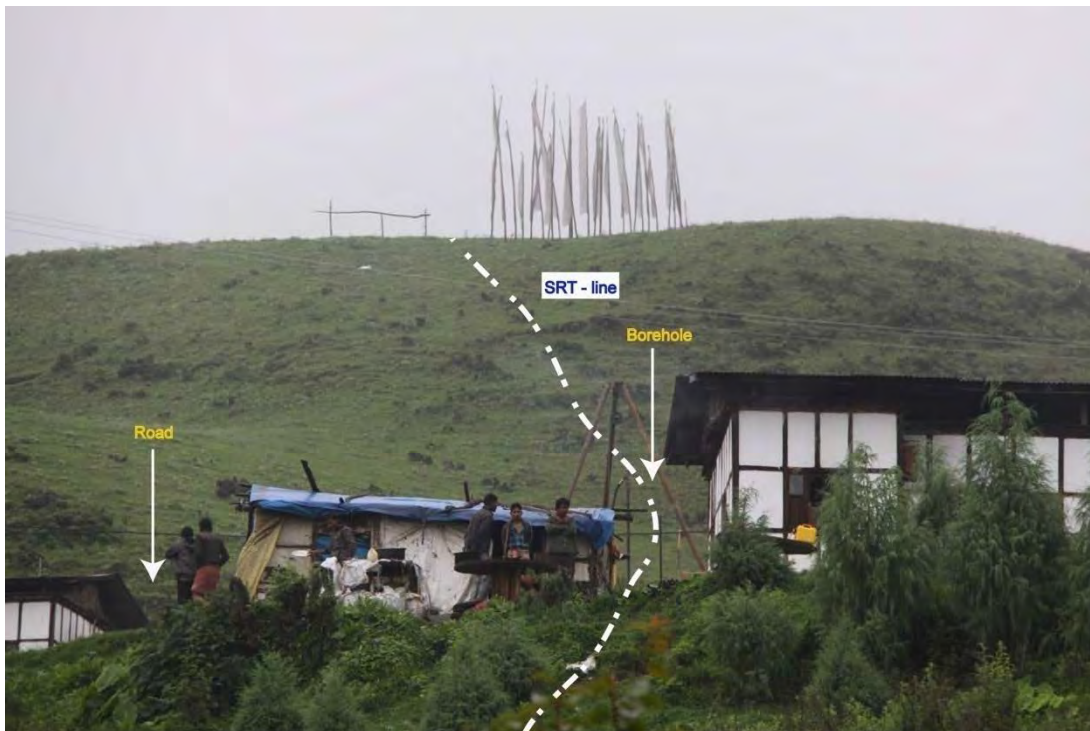
Figure 13: Photograph showing SRT line in the Bangla Pokto Area (view towards N)

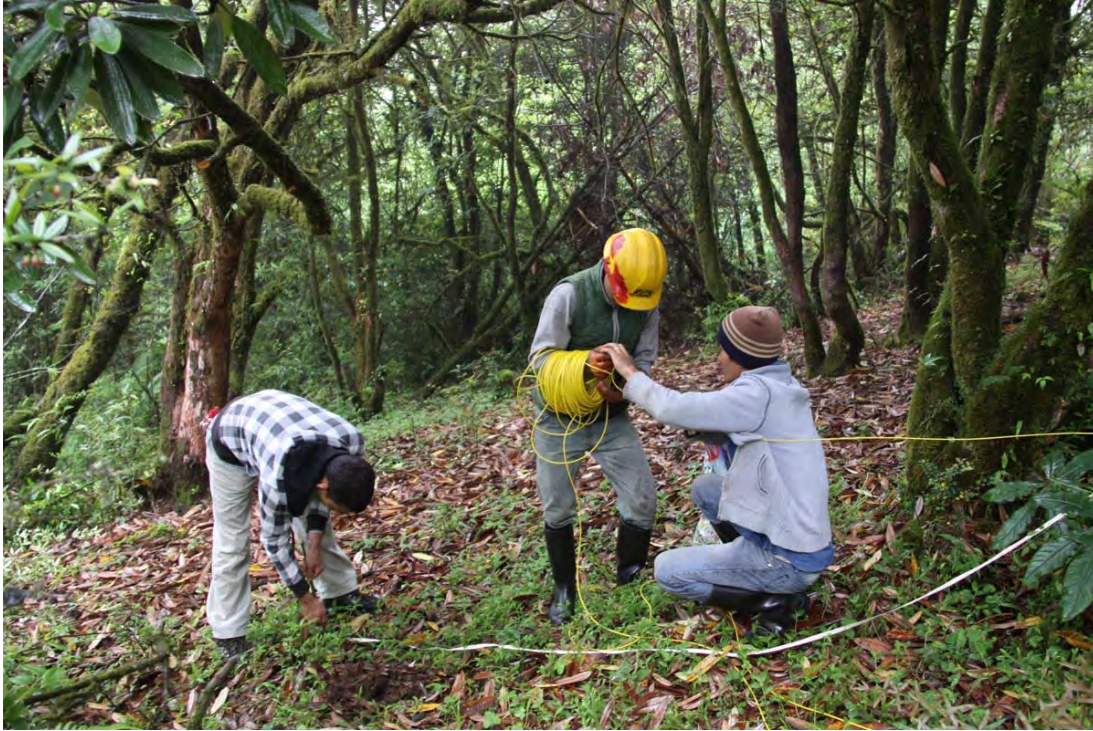
Figure 14: Photograph shows conducting blasting operation for SRT profile

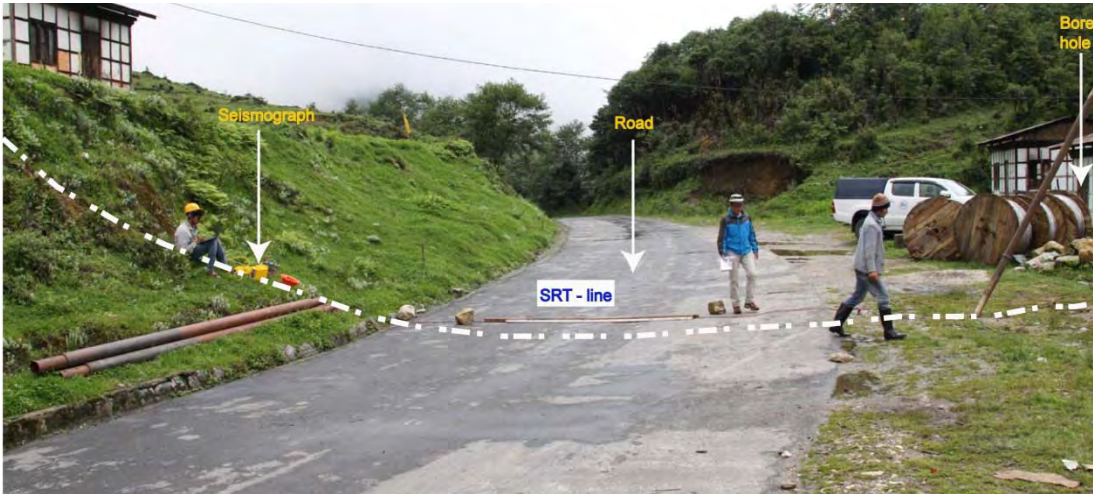
Figure 15: Photograph showing data acquisition along SRT line (white dashed line)

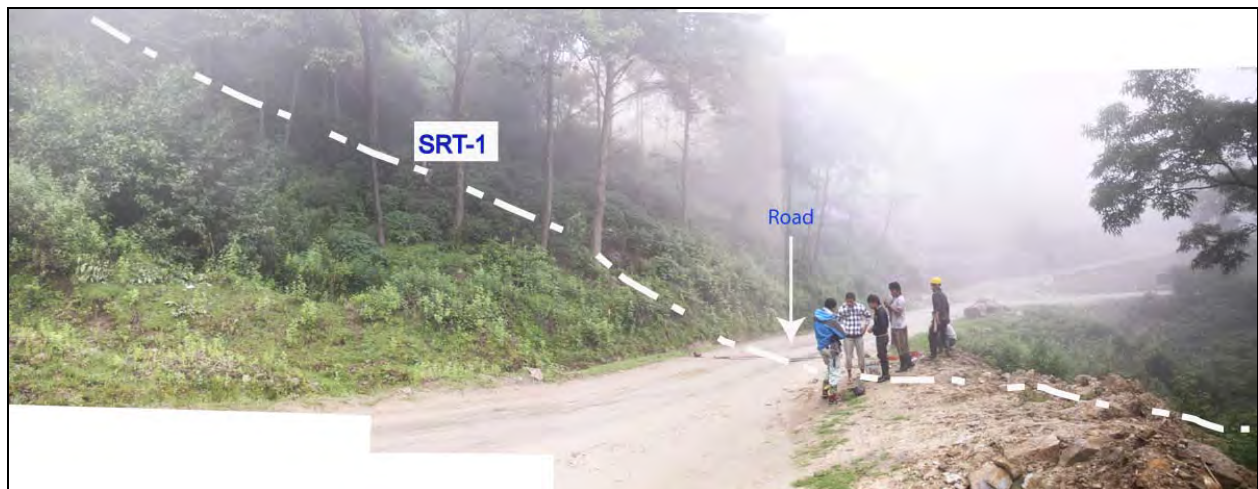
Figure 22: Photograph showing SRT-1 profile at Thomang cliff area.

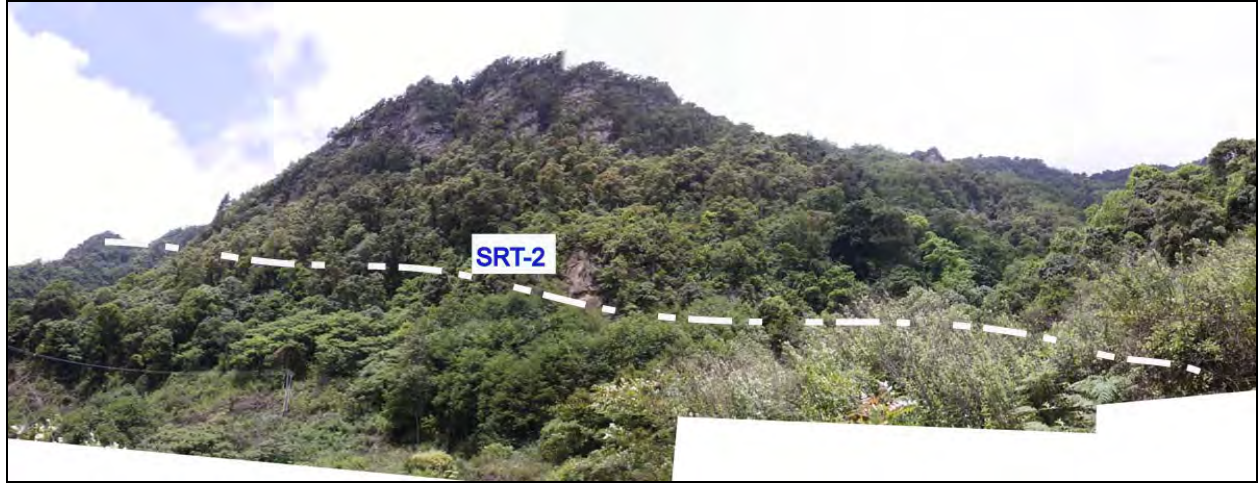
Figure 27: Photograph showing SRT-2 profile at Thomang cliff area.

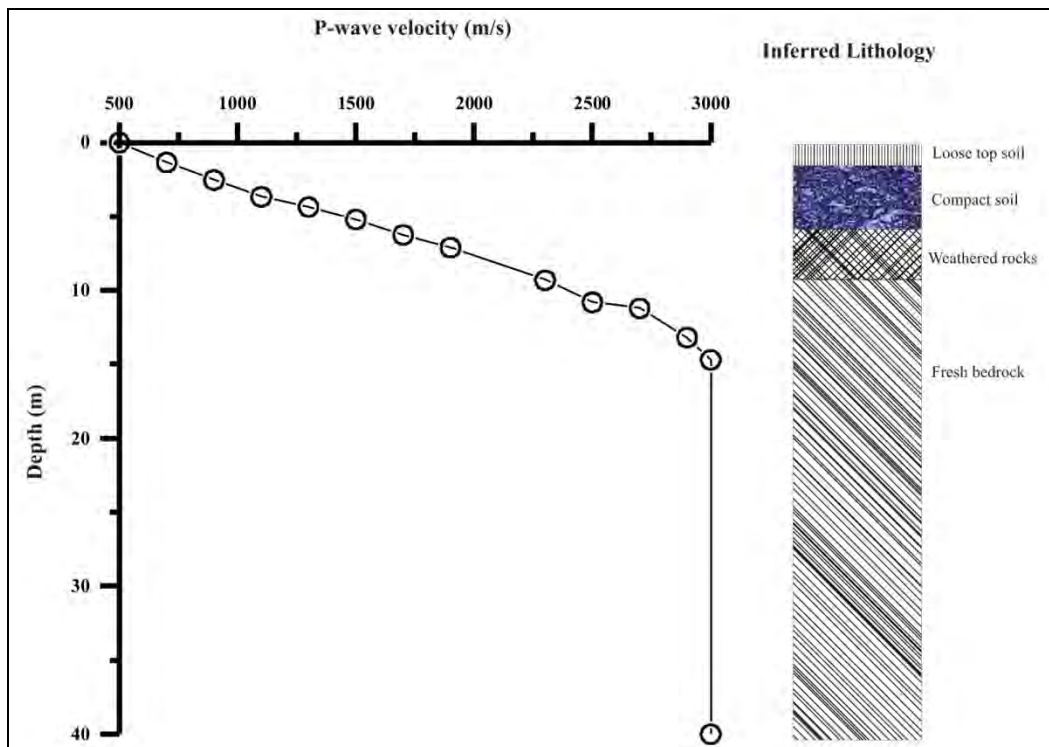
Figure 35: P-wave velocity profile and inferred lithology at borehole BH-1

Based on the velocity profile along three lines, the P-wave velocity log is prepared on borehole BH-1 and BH-2. These logs along with inferred geology are presented in Figure 33 and Figure 34. At borehole BH-1 which lies 20m uphill from the Trongsa-Thimphu highway, an overburden of 4.5m is calculated. The overburden is comprised of a thin loose and unconsolidated top soil and about 3.5m thick compact soil. The overburden is underlain by 1.75m thick layer of weathered rocks. High velocity layers ($>2200\text{m/s}$) are interpreted as fresh bedrocks (Figure 33). On borehole BH-2, the overburden is estimated to 5.75m thick and is underlain by 3.75m thick weathered rocks. High velocity layers below 9.75m are interpreted as fresh bedrocks (Figure 34).

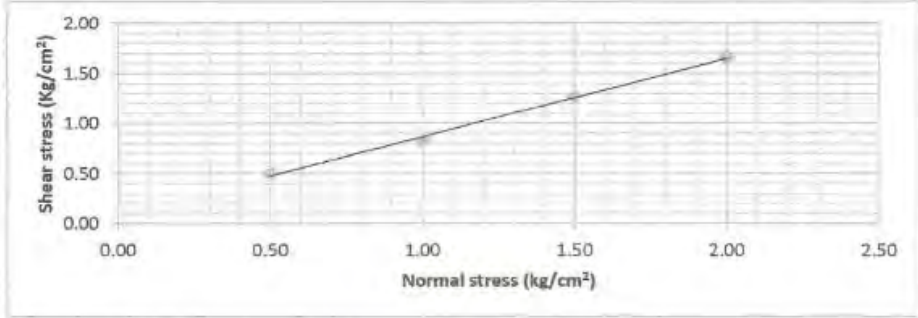
Shear Parameters:
 Cohesion, c (kg/cm²)= 0.10
 Angle of internal friction, φ= 39°11'

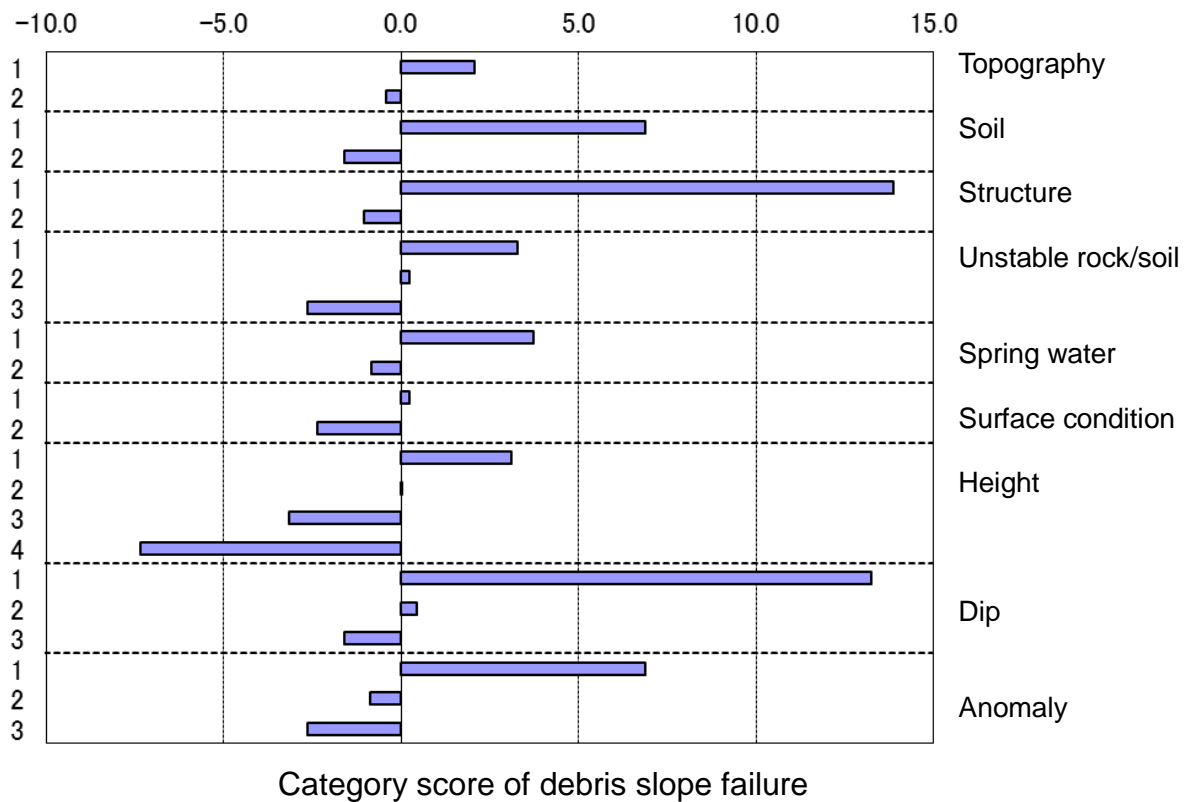
Category range and partial correlation coefficient of debris slope failure

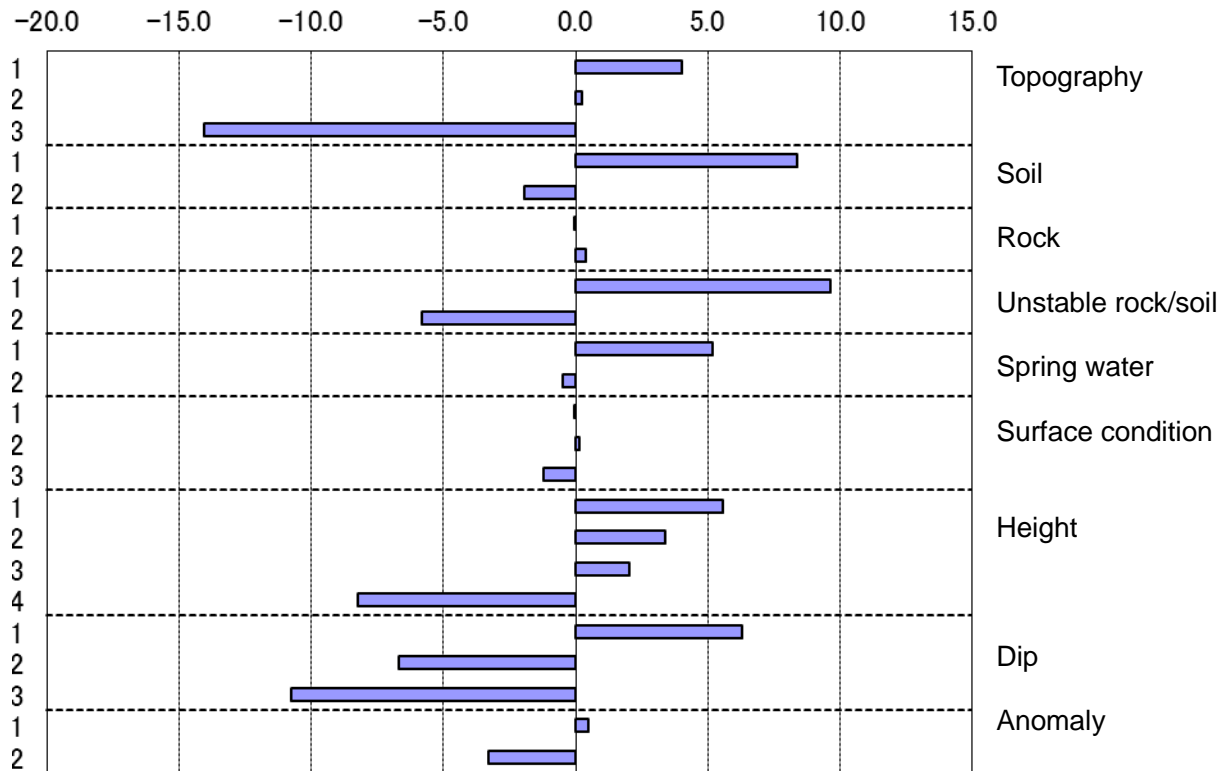
Category score of rock slope failure

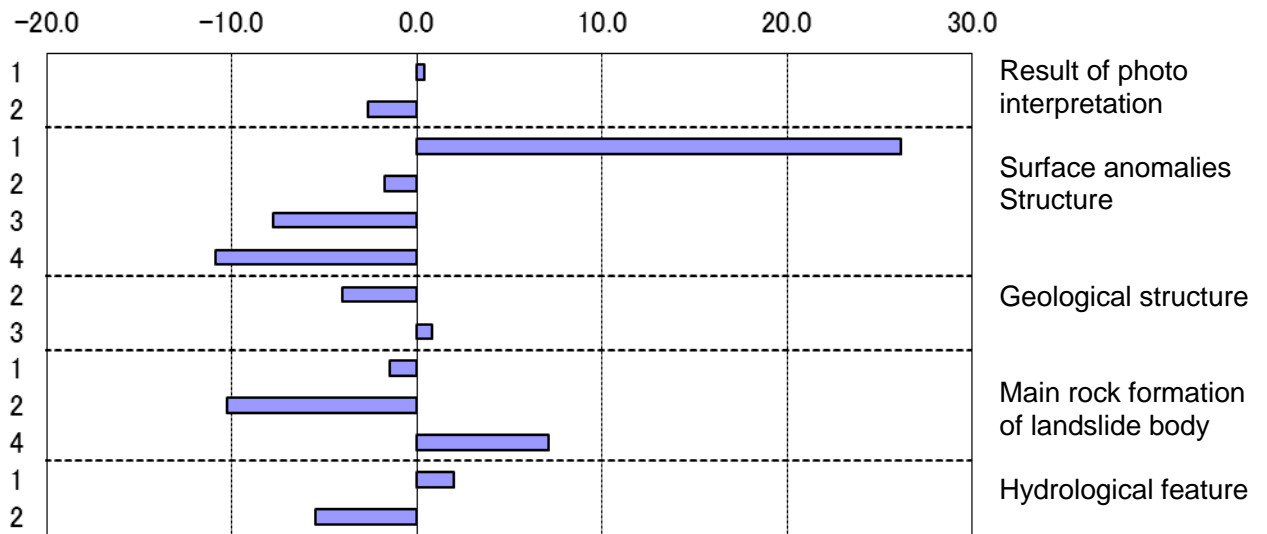
Category score of landslide
