DEPARTMENT OF ROADS,
MINISTRY OF WORKS AND HUMAN SETTLEMENT,
BHUTAN

**PREPARATORY SURVEY
ON
THE PROJECT
FOR
RECONSTRUCTION OF BRIDGES
ON
PRIMARY NATIONAL HIGHWAY NO.4
IN
BHUTAN**

FINAL REPORT

JAPAN INTERNATIONAL COOPERATION AGENCY

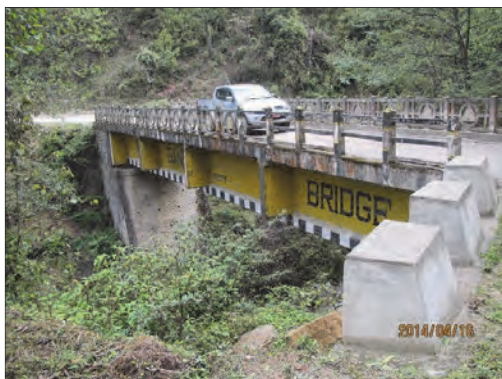
Telegangchu Bridge :
RC-T Girder Bridge
Length 25m, Width 4.5m
Construction: Year 1981

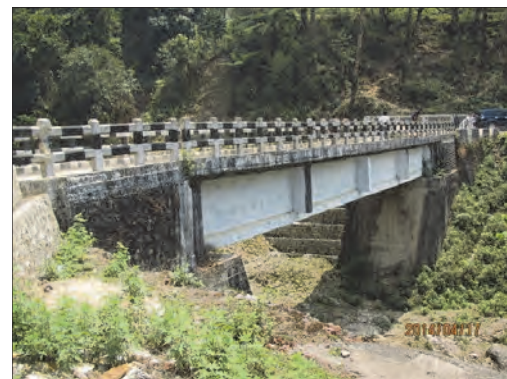
Beteni Bridge :
RC-T Girder Bridge
Length 25m, Width 4.2m
Construction: Year 1987

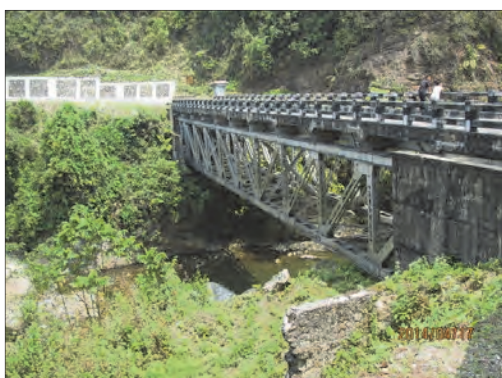
Samkhara Bridge :
Steel Truss Bridge
Length 61m, Width 4.3m
Construction: Year 2001

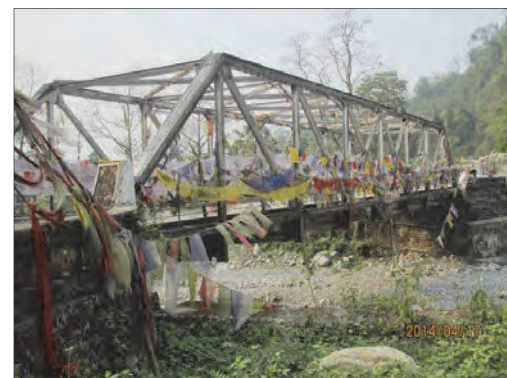
Passang Bridge :
Steel Truss Bridge
Length 40m, Width 7.5m
Construction: Year 1970

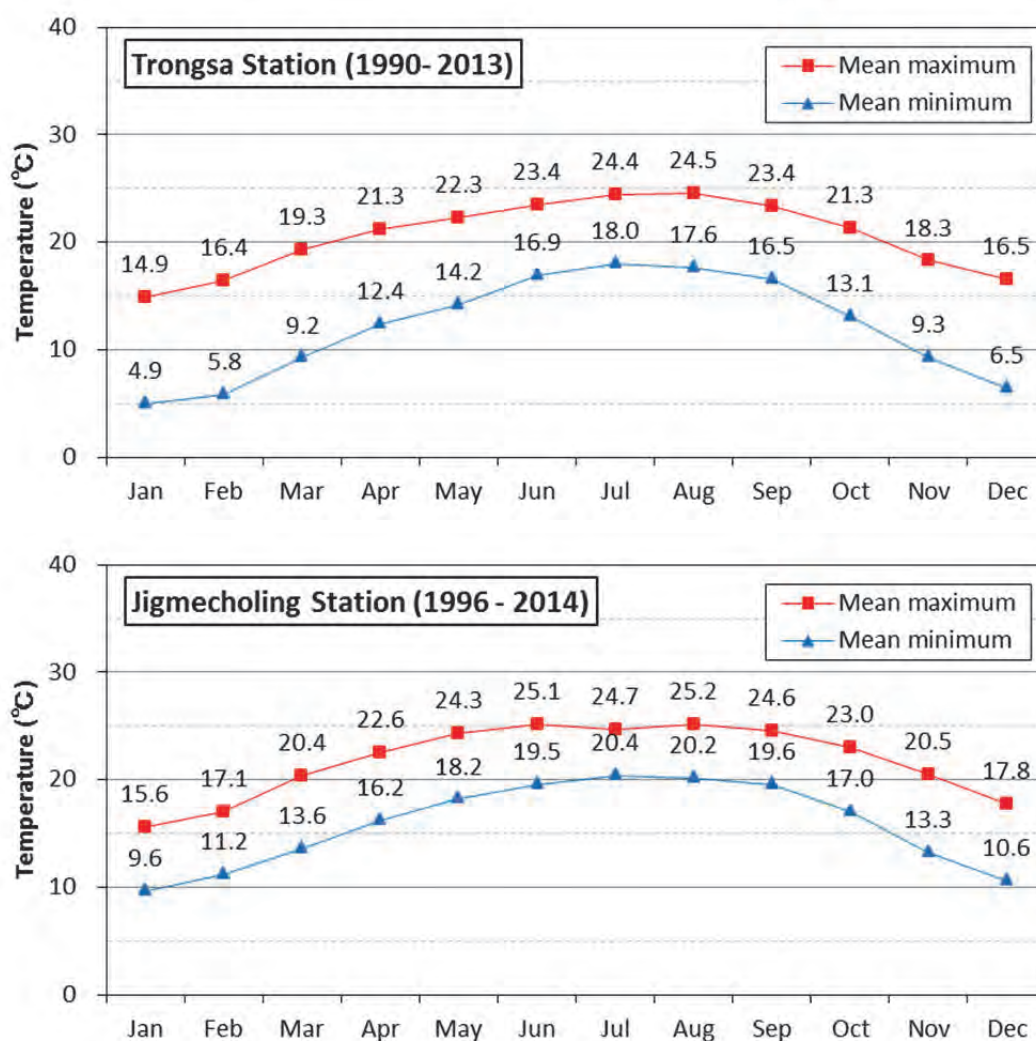
The monthly mean maximum temperature and the mean minimum temperature at the Trongsa Station and the Jigmecholing Station are shown in Figure 1.2.2. Around the Trongsa Station, the maximum temperature is about 25°C even in summer. In winter, the minimum temperature is about 5°C and may drop below freezing. Around the Jigmecholing Station, the climate is rather warmer than at the Trongsa Station; namely, the maximum temperature is 25°C or more in summer and the minimum temperature is about 10°C. The temperature difference between summer and winter is about 10°C for the Trongsa Station and about 7°C for the Jigmecholing Station.

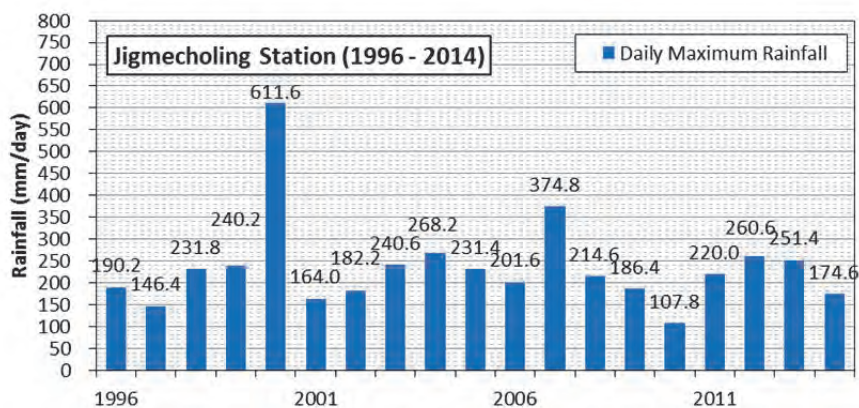
The annual maximum daily rainfall at the Jigmecholing Station is shown below, which is about 200 mm/day on an average. The daily rainfall of 611.6 mm/day observed in August 2000 was far higher than in other years. The Tokai Heavy Intensive Rain, which was designated the severe disaster, had the daily rainfall of about 500 mm, and the daily rainfall observed at Jigmecholing exceeds this level. According to the hearing with the Chief of branch office of DoR at Sarpang, the flood and other disasters of this rainfall are not recorded.

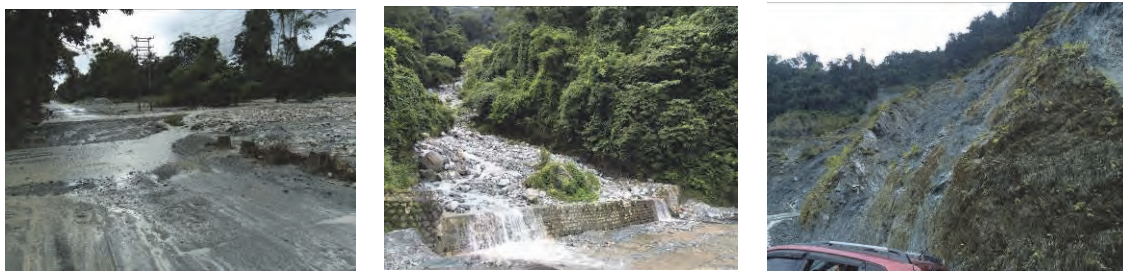
Figure 1.2.28 Observation on the Road
(From left, Sedimentation on the road, Debris flow, Fractured Zone (Boxcut Landslide))

Briefly speaking, the city of Gelephu, the starting city of the National Highway No.4, and its surroundings are situated at the hillside to the mouth of the valley. The area finds the fan deposit or talus deposit consisting mainly of the river deposit (sand and gravel). Severe surface failure can be found in the area where the topography transits from hill side through mountain side due to the affection of the fractured zone caused by the fault activity. The crops were observed ranging from the debris flow through talus deposit on top of pelitic/psammitic schist (shale, slate), luecogranite, gneiss etc. In geologically fractured zone such as Boxcut Landslide, the road has been blocked due to the rainfall and/or rock fall and/or slope failure. And in the river or valley, debris flow or talus deposit are found here and there on the slope adjacent to the shoulder of the road, that means the slope seemed to be very fragile. The figures include the observation found on the national high way. The photos were taken in the late August 2015.

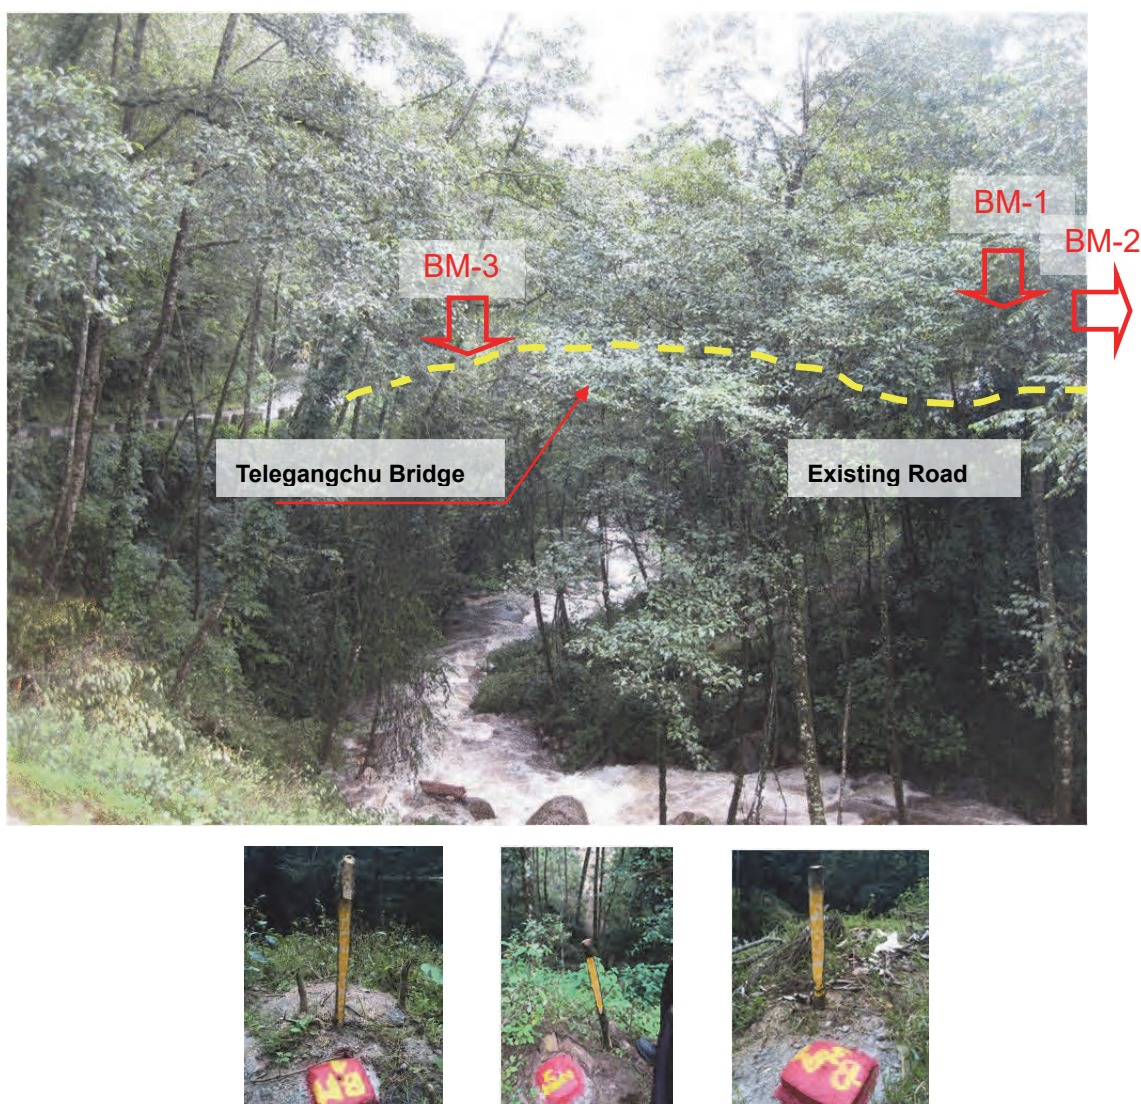
Figure 1.2.32 Telegangchu Bridge and BM-1 BM-2 BM-3

No.	E	N	Z	Location
BM-1	252363.274	541937.986	2106.055	Left Bank, 31m toward Zhemgang
BM-2	252308.765	541958.521	2100.639	Left bank, 44m at the boring BH-11
BM-3	252373.266	541989.232	2105.754	Right Bank, 27m toward Trongsa

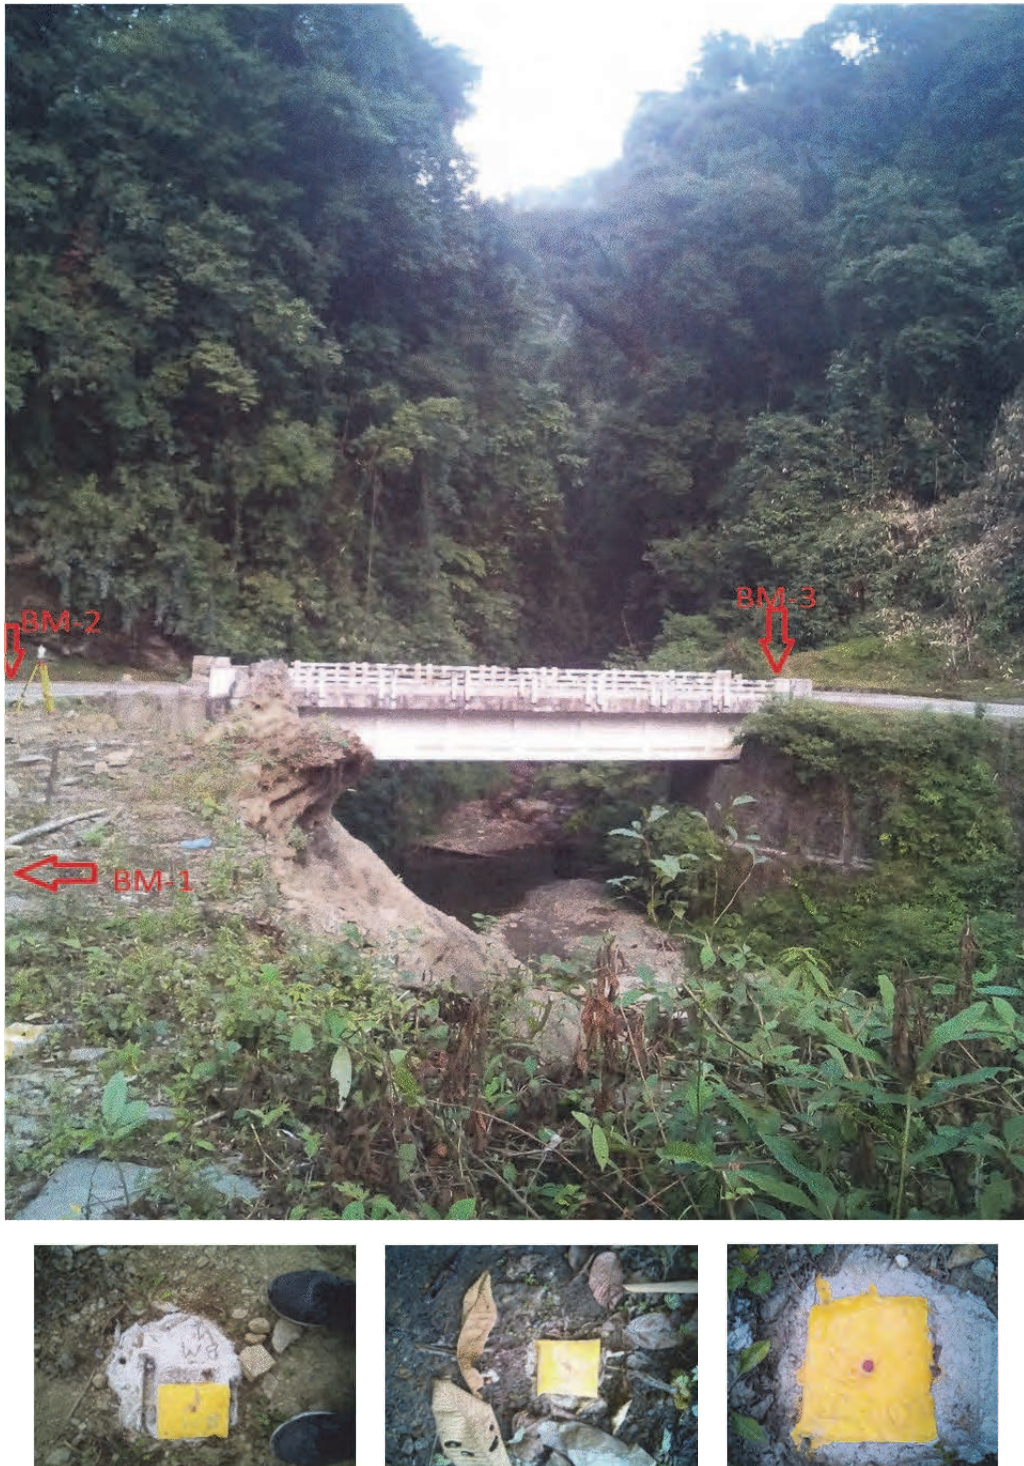
Figure 1.2.33 Chaplekhola Bridge and BM-1 BM-2 BM-3

No.	E	N	Z	Location
BM-1	285792.455	491743.214	1621.285	Right Bank, On the Talus deposit downstream
BM-2	285758.808	491766.380	1619.164	Right Bank, 13m toward Geleph along road
BM-3	491779.790	491798.781	1618.954	Left Bank, 4.5m toward Zhemgan

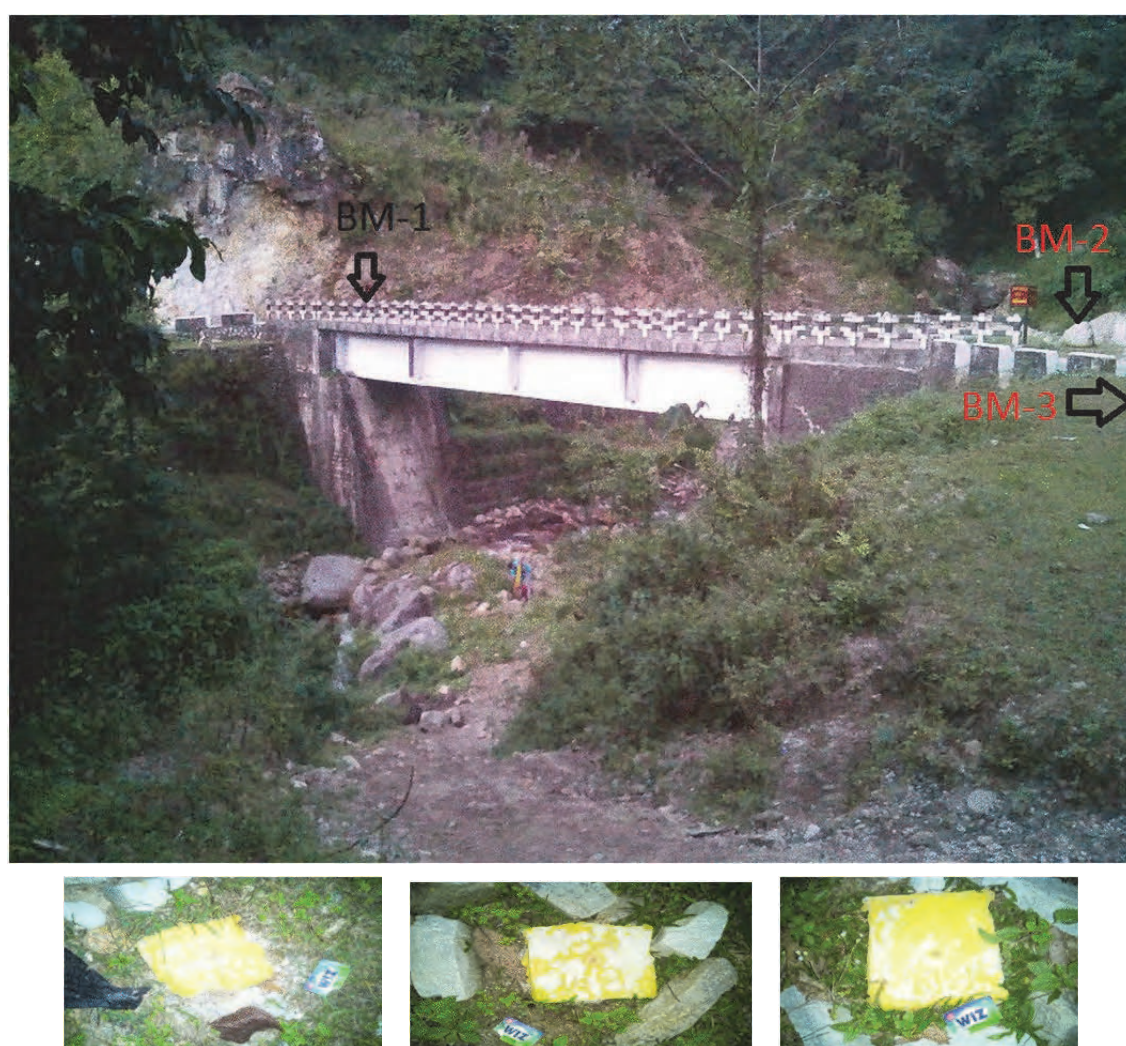
Figure 1.2.34 Beteni Bridge and BM-1 BM-2 BM-3

No.	E	N	Z	Location
BM-1	282113.410	488868.195	1087.911	Right Bank, On the gabion at the river side
BM-2	282128.304	488843.207	1087.939	Left Bank, On the gabion at the river side
BM-3	282118.993	488825.520	1088.041	Left Bank, Near the approaching road

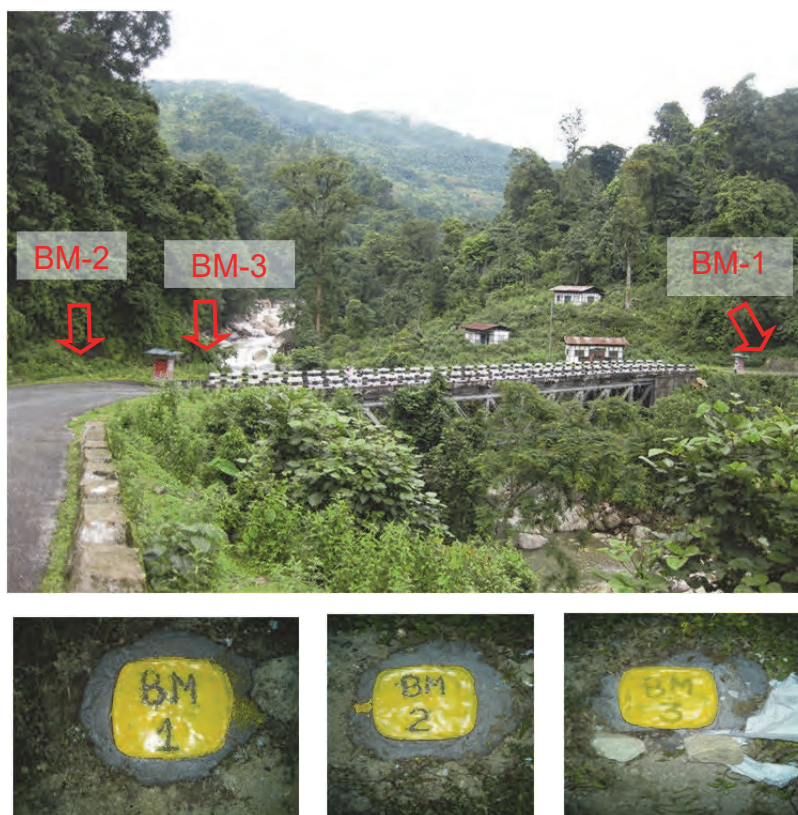
Figure 1.2.35 Samkhara Bridge and BM-1,BM-2,BM-3

No.	E	N	Z	Location
BM-1	281182.359	488765.334	942.576	Left Bank, 6m toward Geleph
BM-2	281198.232	488833.815	941.241	Right Bank, 5m toward the Zhemgan
BM-3	281145.872	488859.840	946.527	Right Bank, Near retaining wall

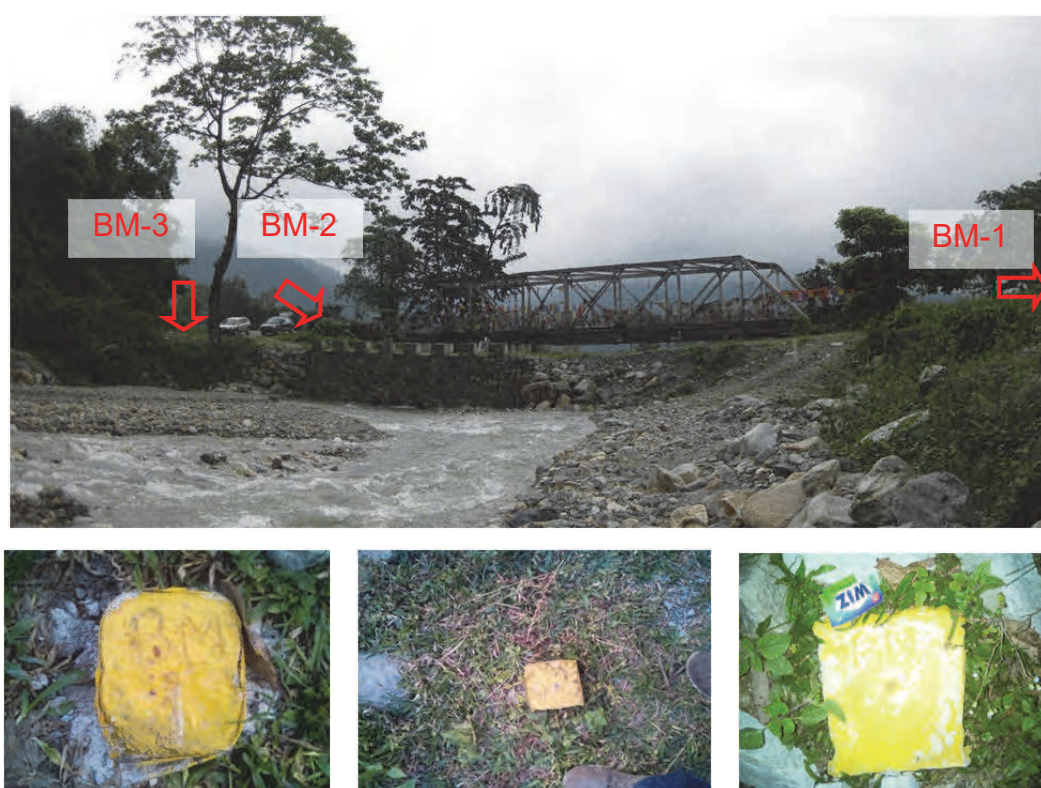
Figure 1.2.36 Passang Bridge and BM-1, BM-2, BM-3

No.	E	N	Z	Location
BM-1	273385.986	478995.619	298.542	Right Bank, Hindu temple
BM-2	273466.882	479118.977	298.084	Left Ban, Margin of the road
BM-3	273426.420	479110.888	296.538	Left Bank, Pathway

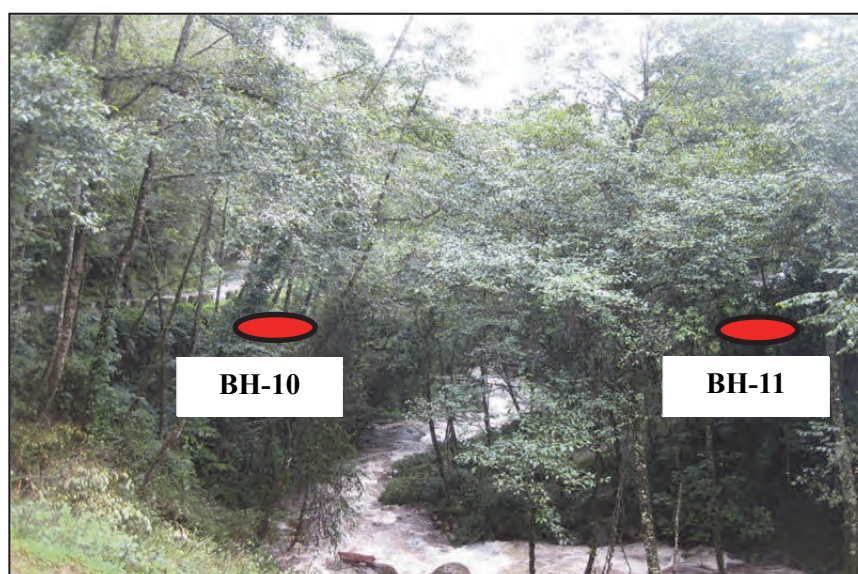
The survey site is shown in the photo. The boring was done at a total of two points. The boring (BH-10) was located on the shoulder of the road on the right bank side and designated for the confirmation of the depth of the bed rock in the right bank. The boring (BH-9) was also situated at the edge of the shoulder of the road for the purpose of confirmation of the bed rock where the foundation would be planned to be located.

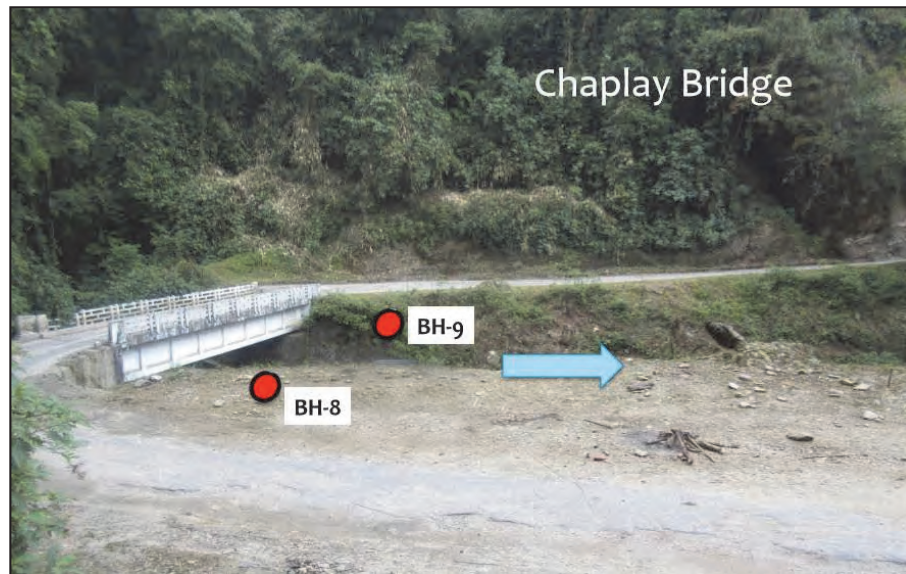
Figure 1.2.42 Boring position at Chapleykhora site

The survey site is shown in the photo. The boring was done at a total of two points. The boring (BH-8) was located on the embankment on the right bank side and designated for the confirmation of the depth of the bed rock in the right bank. The boring (BH-9) was situated on the river bed for the purpose of confirmation of the bed rock where the pier or the side wall of the culvert would be planned to be located.

In the right bank material for the embankment were found from the surface to GL-5m. The weathered silicic schist (quartzite) was found at the depth of GL-5 or deeper. In the river bed, the river deposit is overlying the hard silicic schist at the depth of around 2m.

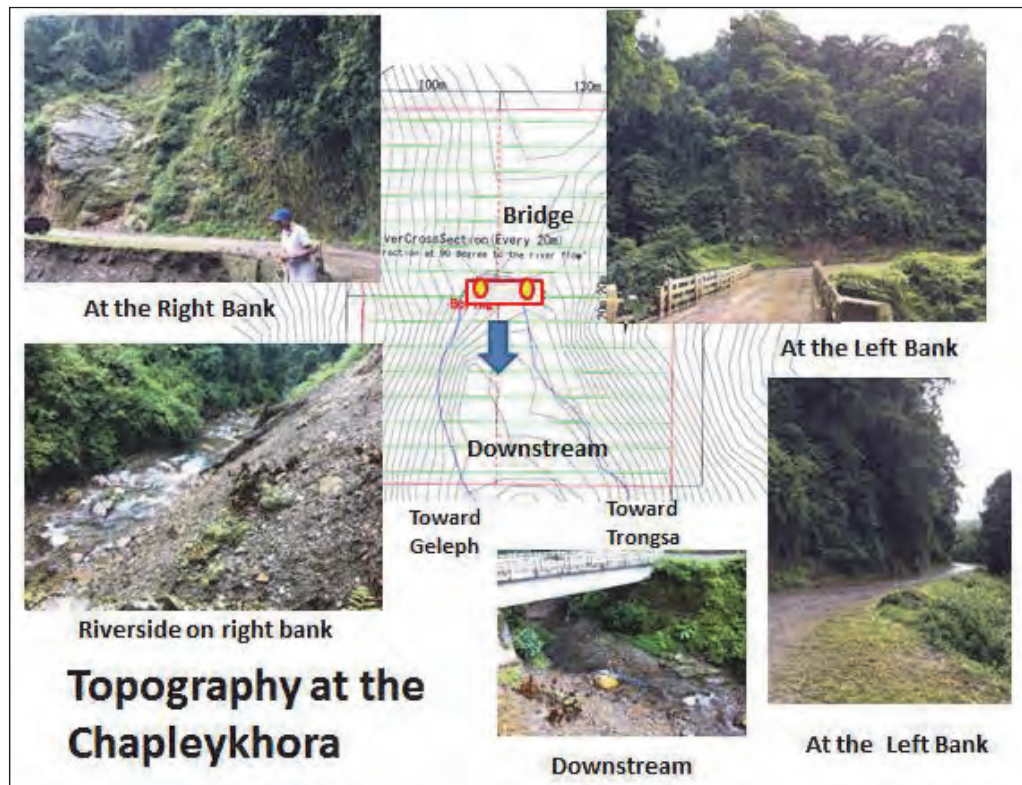
Figure 1.2.46 Topography of Chapleykhora site

The slope along the road is dotted with the outcrops consisting of the dip slope (cut slope). The rock in the outcrop is weathered slightly and is relatively hard.

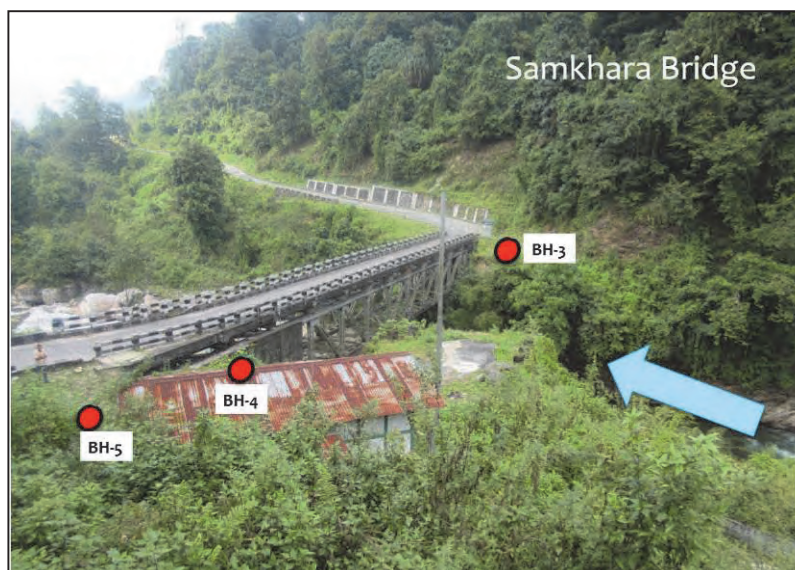
The survey site is shown in the photo. The boring was done at a total of three points. The BH-5 was designated for the purpose of confirming the depth of the bed rock where the bridge foundation will be situated.

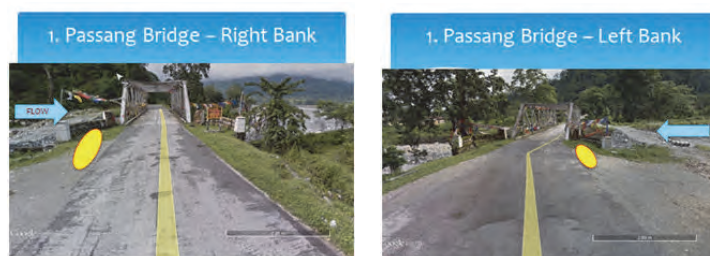
Figure 1.2.58 CBR Test Point on Passang Site
(Marked as yellow)

As for the interpretation of the results, the technical guide book of the soil property test (Japanese Geotechnical Society, P79) propose that the results below $CBR=3$ means that the specimen are not appropriate for the road material without any improvement. In this study, the minimum CBR was

7.55%, therefore all materials sampled can be judged as to appropriate subgrade for the road structure.

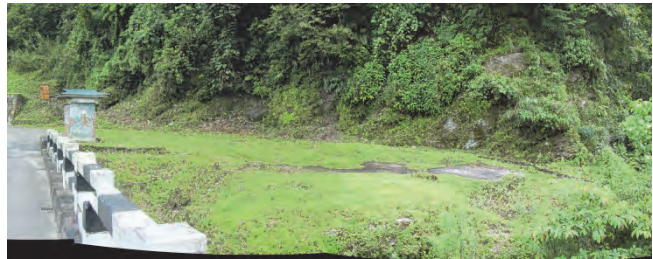
Right bank (A1)

The abutment (A1) of the right side needs the separation from slop to the abutment because this abutment is planned on the slope. This separation is to comply with the Japanese standards, and finally we planned this separation is 2.5m because of considering weathered rock from our study and putting this abutment at the center of flat ground (it is shown below picture). In the abutment (A2) of the left side, there is the former abutment. This former abutment with filling road is standing out against a ground. We planned the bottom of abutment is set under this ground level and the position of the abutment is planned by river condition. From the above the length of this bridge is 49.5m.

* A1 is set at the center of flat ground

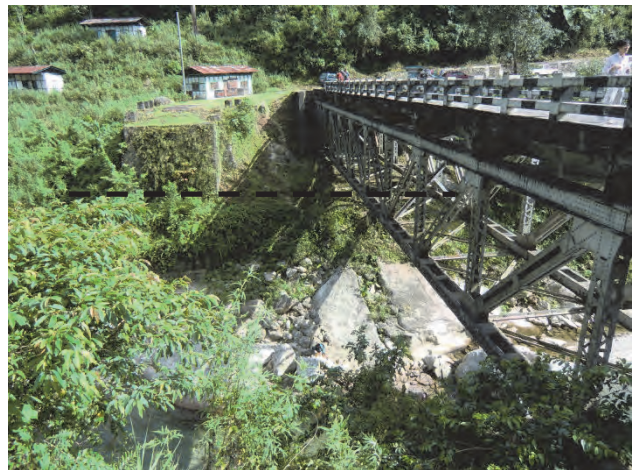
Left bank (A2)

* The bottom of A2 is under the ground level (black line).

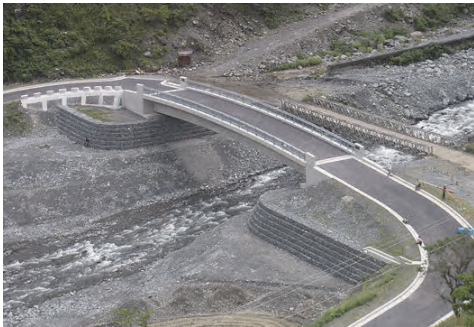
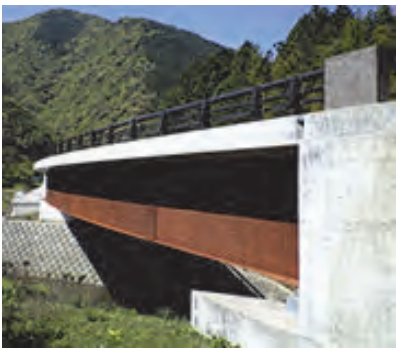
Outline of the bridge	The girders are prestressed-concrete members while the slabs are reinforced-concrete members. The sectional shape of girders is box and constructed according to the timbering construction method. Bhutan has the experience of constructing this type of bridge.	The girders are steel members while the slabs are reinforced-concrete members. The girders are manufactured in the plant, divided into components, and transported to the site. In the site, divided parts are assembled into girders, which are erected with a crane.
Site applicability	Erection is done by constructing the timbering within the river. Erection is possible when the construction is based on the river flow during non-flood season. (OK)	The girder manufacturing plant does not exist in Bhutan, so that girders are to be manufactured outside Bhutan and transported to the site. Since the site is narrow, installation of large crane is difficult. (NG)

Maintenance	It is possible to inspect the girder for the maintenance from the inspection hole. (OK)	The maintenance for girder is needless by adopting the atmospheric corrosion resisting steel for the girder. (OK)
Economy (ratio)	1.000	1.087
Evaluation	1st This type is adopted by the cost.	2nd

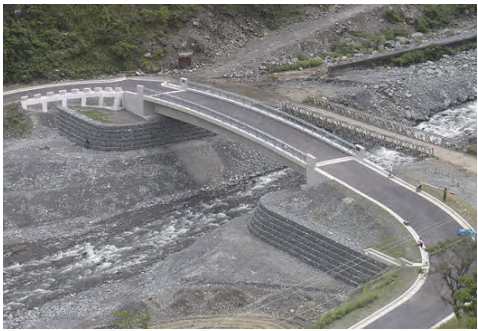
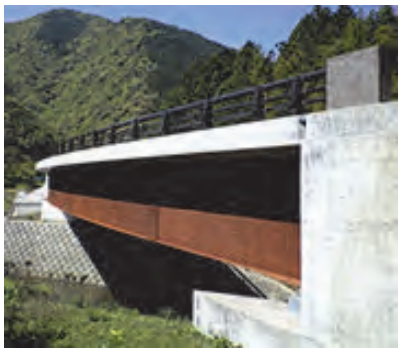
Outline of the bridge	The girders are prestressed-concrete members while the slabs are reinforced-concrete members. The sectional shape of girders is box and constructed according to the timbering construction method. Bhutan has the experience of constructing this type of bridge.	The girders are steel members while the slabs are reinforced-concrete members. The girders are manufactured in the plant, divided into components, and transported to the site. In the site, divided parts are assembled into girders, which are erected with a crane.
Site applicability	Erection is done by constructing the timbering within the river. Erection is possible when the construction is based on the river flow during non-flood season. (OK)	The girder manufacturing plant does not exist in Bhutan, so that girders are to be manufactured outside Bhutan and transported to the site. Since the site is narrow, installation of large crane is difficult. (NG)

Maintenance	It is possible to inspect the girder for the maintenance from the inspection hole. (OK)	The maintenance for girder is needless by adopting the atmospheric corrosion resisting steel for the girder. (OK)
Economy (ratio)	1.000	1.021
Evaluation	1st This type is adopted by the cost.	2nd

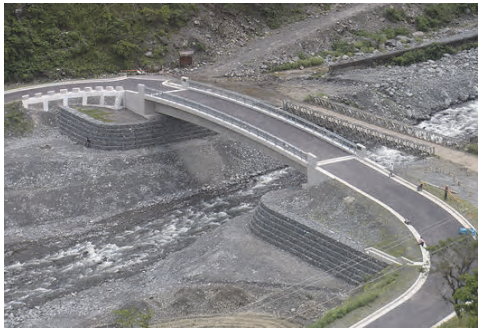
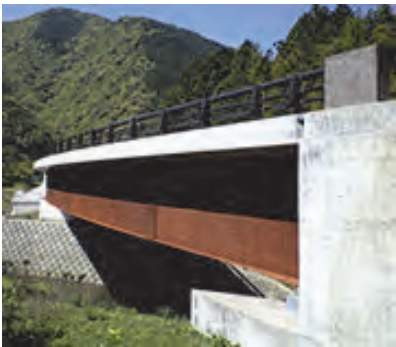
Outline of the bridge	The girders are prestressed-concrete members while the slabs are reinforced-concrete members. The sectional shape of girders is box and constructed according to the timbering construction method. Bhutan has the experience of constructing this type of bridge.	The girders are steel members while the slabs are reinforced-concrete members. The girders are manufactured in the plant, divided into components, and transported to the site. In the site, divided parts are assembled into girders, which are erected with a crane.
Site applicability	Erection is done by constructing the timbering within the river. Erection is possible when the construction is based on the river flow during non-flood season. (OK)	The girder manufacturing plant does not exist in Bhutan, so that girders are to be manufactured outside Bhutan and transported to the site. Since the site is narrow, installation of large crane is difficult. (NG)

Maintenance	It is possible to inspect the girder for the maintenance from the inspection hole. (OK)	The maintenance for girder is needless by adopting the atmospheric corrosion resisting steel for the girder. (OK)
Economy (ratio)	1.000	1.086
Evaluation	1st This type is adopted by the cost.	2nd

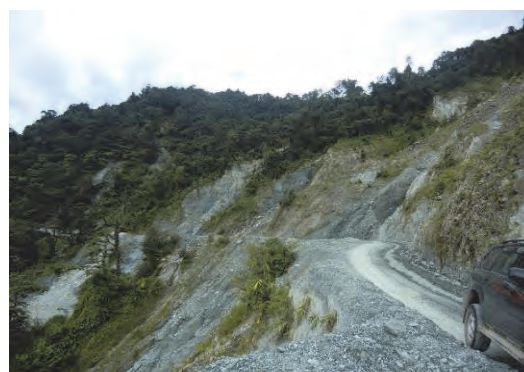
Figure 2.2.32 Traffic Choke Point

Bhutan has reinforcement bar manufacturing factory in Pasaka, from which reinforcement bars are shipped to various parts of the country. The road from Pasaka to the bridge point is dotted with points under widening work and narrow points. In particular, there is a dangerous choke point (the photo in the right) with frequent landslide between Passang Bridge and Samkhara Bridge, with the road blocked depending on the rainfall state. Heavy vehicles may suffer difficulty of passing due to

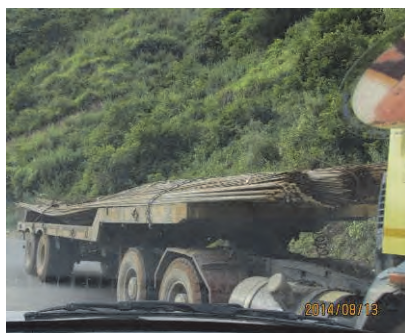
5) Medium/low floor type semi-trailer acceptable range (20 t semi-trailer)

As a result of review described in latter pages, the medium/low floor semi-trailers (20 t) run out of the road and thus their traveling is considered extremely difficult. Namely, the steel girder bridge (slab and box girders) is exempted from selection. It is also considered extremely difficult to carry

in and transport a pile driver to drive cast-in-place piles and a large crane requiring disassembly and reassembly.

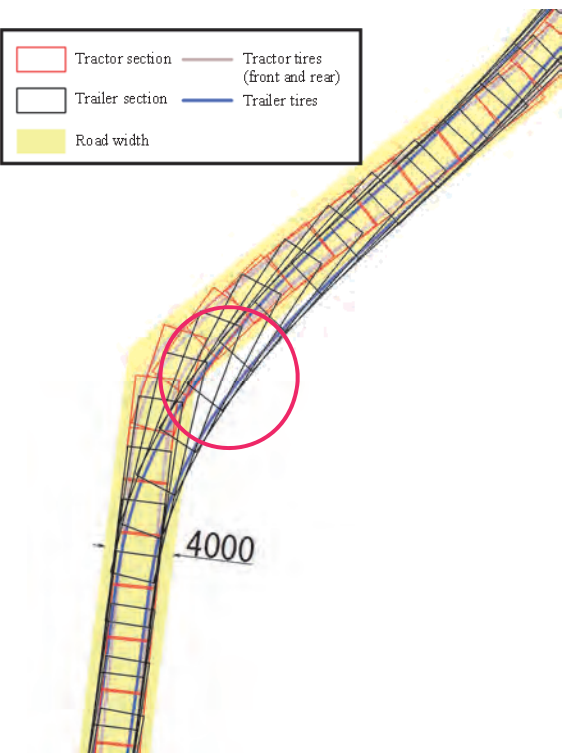
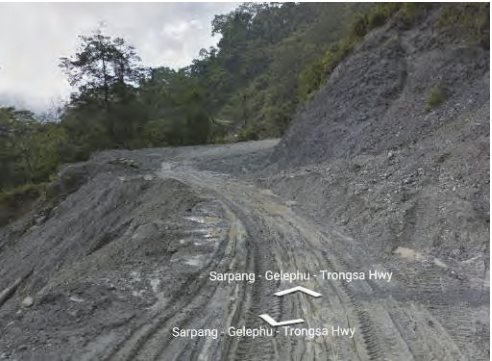
Figure 2.2.38 Trail Review Result (Semi-trailer Truck)

Result and site photograph	Trail review diagram
Review point A	<p>At an encircled point of the figure right, the car body and tires contact the mountain side. Possible measures may include removal of a part of mountain side, widening, etc. Since this is a location with frequent landslides, it is essential to take measures ensuring the road safety by using anchor, etc., instead of applying a temporary measure.</p>

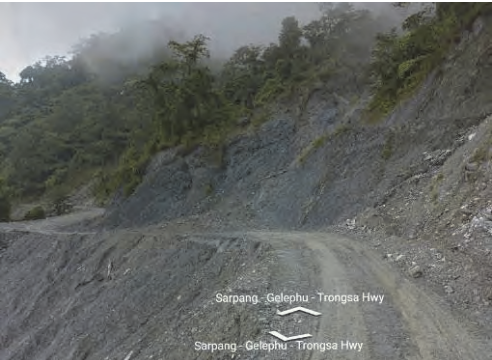
Review point B	<p>At an encircled point of the figure right, the vehicle body runs out of the road toward the valley. As the valley is deep, securing the width with embankment is difficult.</p>

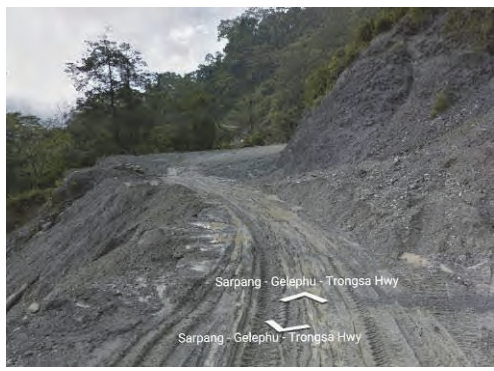
Figure 2.2.39 Trail Review Result (10t-truck)

Result and site photograph	Trail review diagram
Review point A	Traveling possible

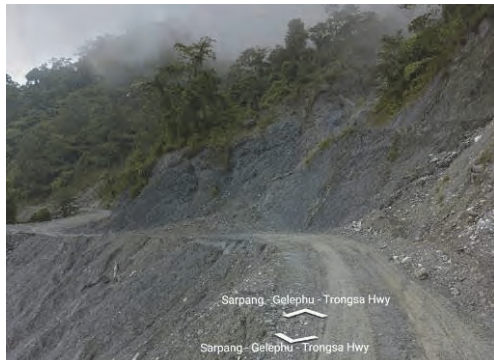
Review point B	Traveling possible

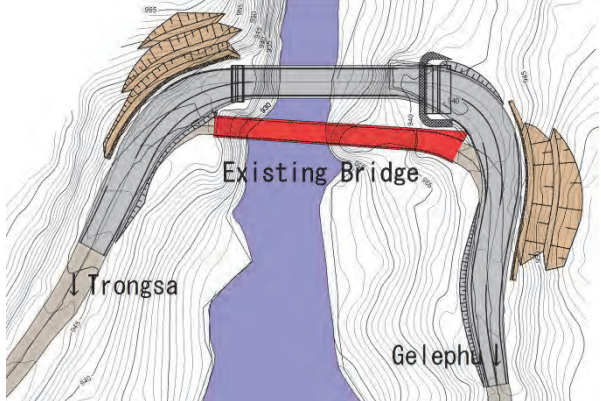
<p>[Outline] After construction of the road, the existing bridge is removed by Japan's aid. As a rule, the support used for construction of the bridge is used for removal of the existing bridge.</p> <p>[Work item] Old bridge removal</p>
