Myanma Railways,
Ministry of Transport and Communications,
The Republic of the Union of Myanmar

Data Collection Survey
on Maintenance on Rolling-Stock
in the Republic of the Union of Myanmar

Final Report

Japan International Cooperation Agency (JICA)

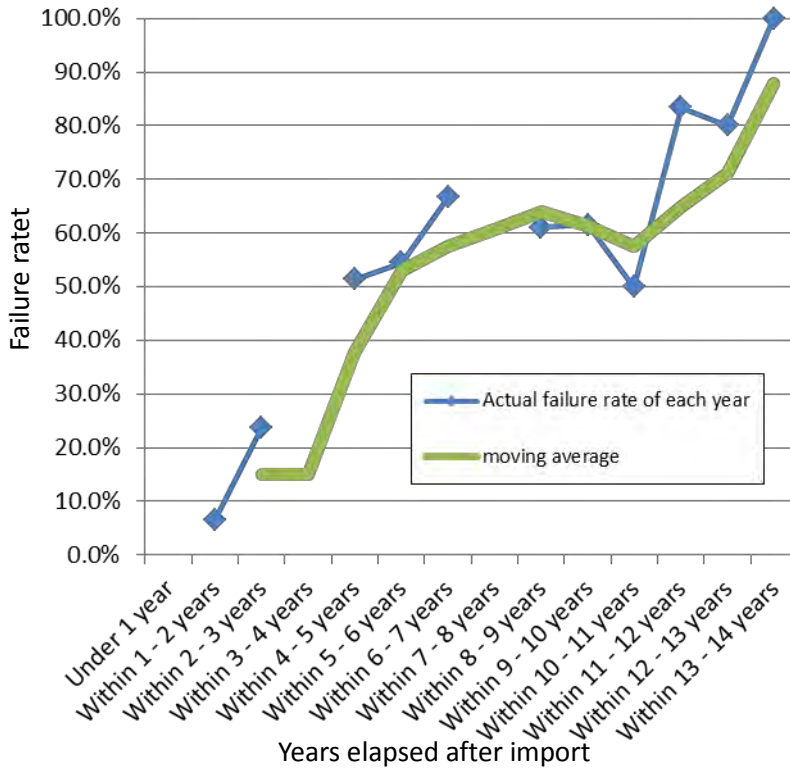
Figure 1-3-4 Actual failure rates of RBEs for years elapsed after import and their moving averages

By the calculation of the failure rates for the present RBEs for the years elapsed after import based on such conditions, the results are obtained as shown on Table 1-3-4 and Figure 1-3-4. The failure rates worked out include, besides actual failure rates, values smoothed (moving-averaged) for the changes caused by the years elapsed after import. From the table, it is understood that the failure rates increase beyond five (5) years after arrival in Myanmar. It is estimated that the wear or deterioration of some parts make an apparent impact on the failure in such term.

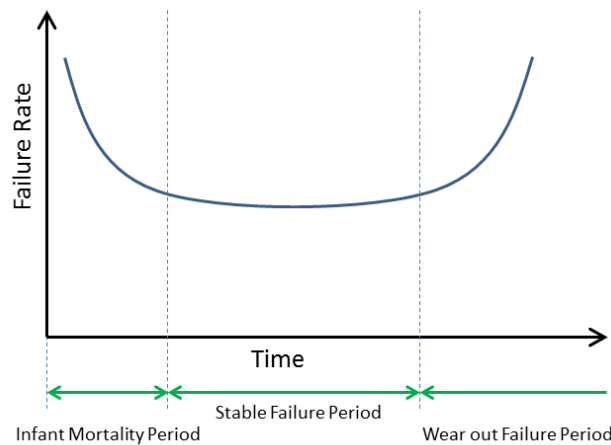
Figure 1-3-5 Bathtub curve (failure rate curve) for machines and equipment

It is generally known that, about machines and equipment, the failure rate changes with the elapse of time. The graphical representation of the change in the failure rate looks like a bathtub, as shown on Figure 1-3-5. Hence, it is called a bathtub curve (also known as a failure rate curve). The changes in the failure rate are divided into three periods, including the infant mortality period, stable failure period, and wear-out failure period. In the infant mortality period, the operation is instable at the very beginning as due to the introduction of new technologies and, as the time elapses, the operation becomes stable and the failure rate gradually decreases. In the stable failure period, the operations of

machines and equipment are the most stable and the failure rate stays low at a constant level. In the wear-out failure period, machines and equipment come close to the end of service life and the failure rate gradually increases.

The renewal of machines and equipment has the effect of reversing the elapse of time by renewing the components. It is to bring the machines and equipment in the wear-out failure period back to the stable failure period. For that reason, if the failure rate is tending to increase in the wear-out failure period, it is necessary to plan the renewal of machines and equipment to bring them back to the stable failure period.

With RBEs, considering that the vehicle service life is generally about 30 years and that they were more than 20 years old when shipped from Japan, they are considered, at this moment, to be distributed in the latter half of the stable failure period to the first half of the wear-out failure period.

In consideration of the bathtub curve, we made the judgment about their service life. With “[1] Import of used RBEs from Japan”, the imported vehicles are more than 20 years old from the time of their fabrication and are distributed in the region from the stable failure period to the wear-out failure period at the time of the import. Therefore, the remaining service life after the introduction to the Republic of the Union of Myanmar is considered short. Actual service life will be 2 years at the shortest and 5 years at the longest. With “[2] Purchase of new vehicles”, the service life will be as long as about 30 years. With “[3] Rehabilitation”, some of the parts in the wear-out failure period are renewed, it is possible to extend the service life of the relevant parts. But the service life of the vehicle depends on that of the vehicle body and bogies if such vehicle body and bogies are placed out of the scope of the renewal. Therefore, the service life will be shorter than that with “[2] Purchase of new vehicles”. Although actual service life will vary depending on the conditions of the vehicle body and bogies, it is considered as being around 10 years. With “[4] Continued use of owned vehicles”, since the vehicle is used without doing anything, the service life becomes short, naturally. Actual service life

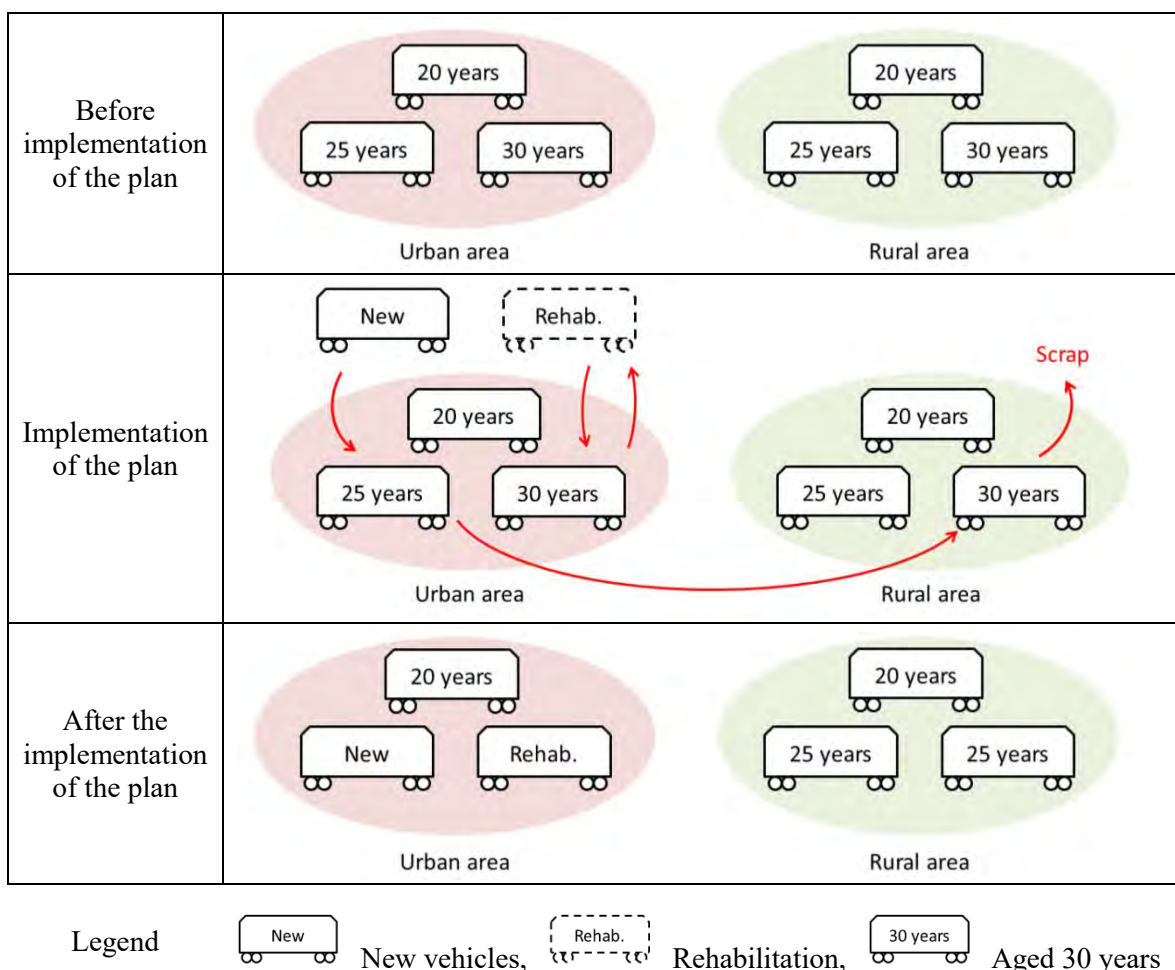
Figure 1-3-6 conceptually illustrate the above-shown rolling stock plan for the future of RBEs. In that way, the conditions of vehicles for the entire MR can be comprehensively improved.

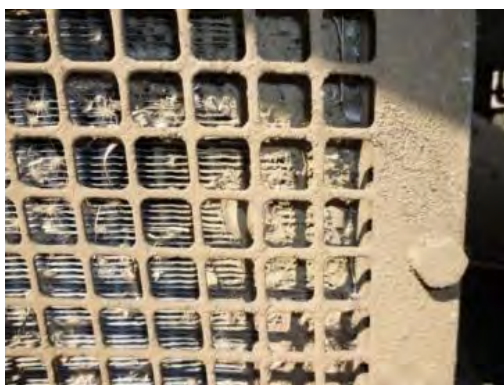
- Insufficient maintenance
 - Clogged filter caused overheating, resulting in a failure (Figure 2-2-1).
Filter was insufficiently cleaned.
 - By the wear of engine cylinders, combustion gas leaked, causing a blowby.
The gap management at the engine cylinders was insufficient.
 - Compressed air blew out from the safety relief valve.
Pressure regulator failed or was maladjusted.
 - The engine failed to start due to the clogged fuel supply pipe.
Filter was insufficiently cleaned.

Clogged filter (cause of overheating)

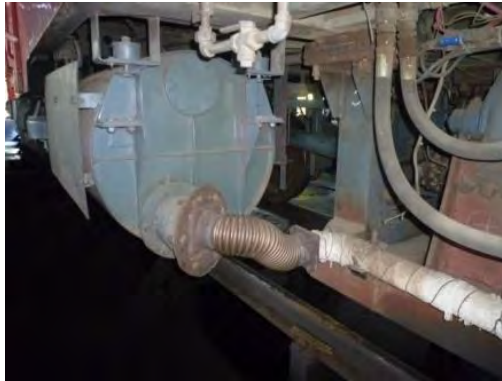
- Incorrect methods of maintenance
 - The cooling water piping corroded inside the engine and perforated, causing inclusion of water in lubrication oil.
 - Cooling water contains no rust inhibitor.
 - The exhaust pipe is kinked, hampering smooth exhaust of gas (Figure 2-2-2).
 - The exhaust pipe is defectively mounted.

Kinked exhaust pipe

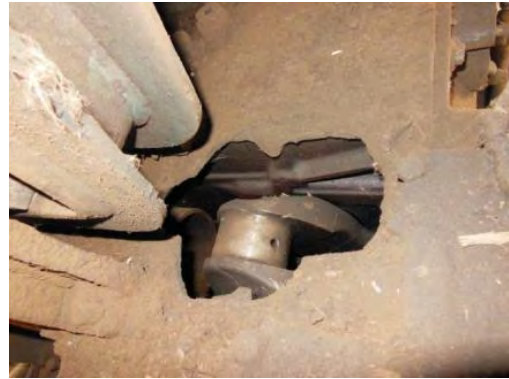
Piston connecting rod breaking through the cover after coming off

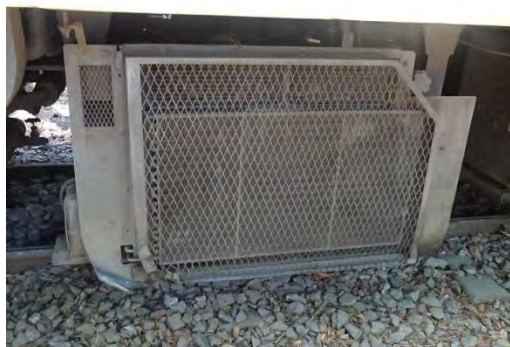
Figure 2-2-4 Example of equipment collision

- Equipment under the vehicle floor collided with something and deformed (Figure 2-2-4).

Equipment deformed as a result of collision

Collisions into the underfloor equipment of RBE are usually attributable to the presence of obstacles on the track. However, it is also possible that the collision occurred due to the swaying motions of the vehicle caused by bad conditions of MR's railway track, as shown on Figure 2-2-5.

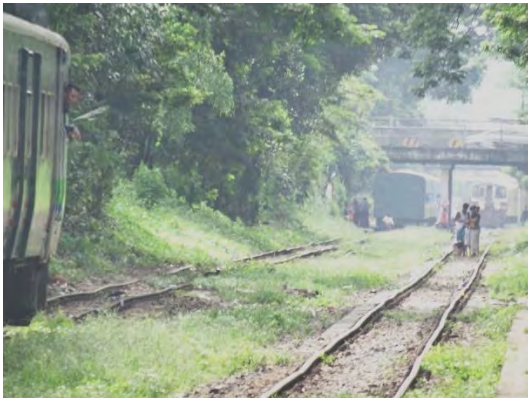
Track conditions (Yangon Circular Railway)

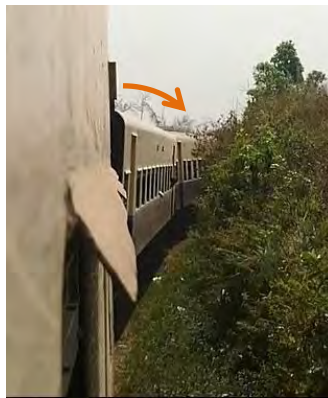
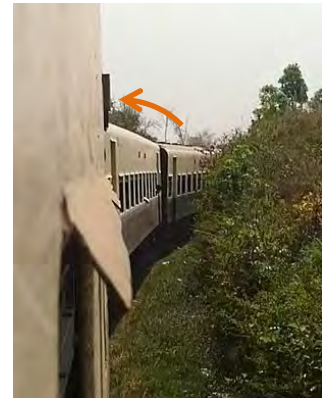
Vehicle significantly swaying

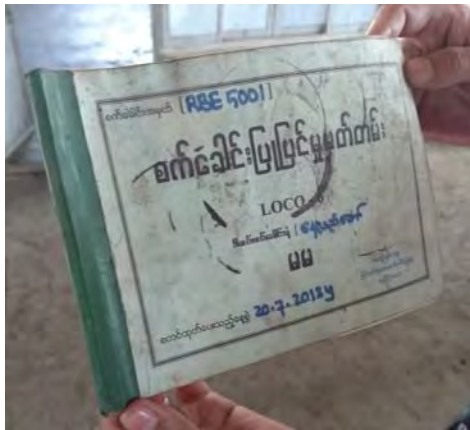
Fault report journal to be kept by the train operator (Kept on vehicle)

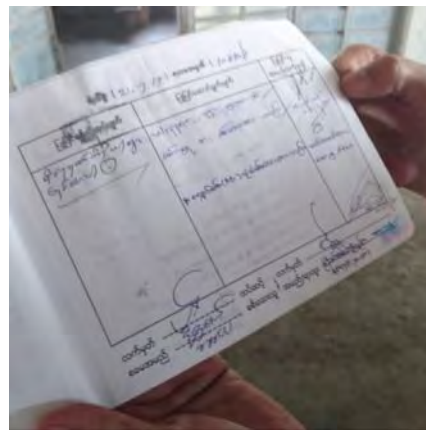
Contents of the journal on the left
(From left to right, person reporting the fault, description of the fault, person who took remedial action)

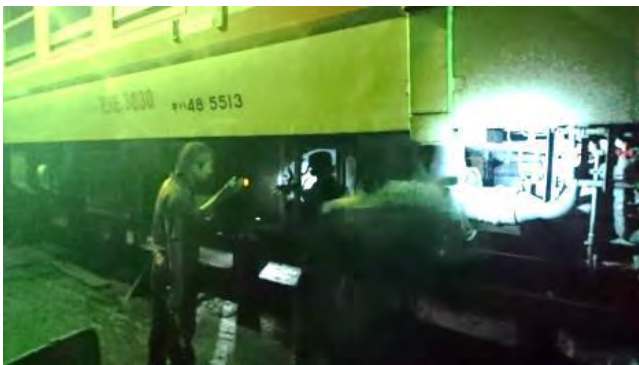
Since vehicles are operated during the day, the daily maintenance of vehicles is conducted at night at the Depots. With no reserved vehicles available for the operation while the inspection is underway, the maintenance must be conducted in a limited time window at night.

A scene of daily maintenance (M1 through M5)

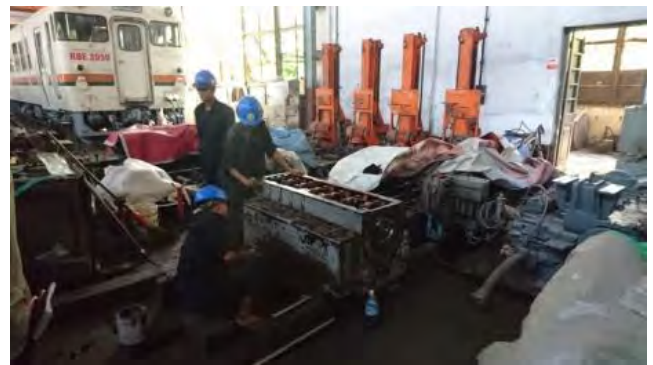
On the other hand, the overhaul of vehicle is conducted at Workshop with equipment stripped off. Since the inspection takes a maximum period of 45 days, the substitute vehicle for operation during the inspection period is selected and sent to the Depot by the Head Office on an ad hoc basis in consideration of the use of RBEs for the entire MR to minimize the effect on the operation of other trains.

A scene of overhaul (M6 through M8)

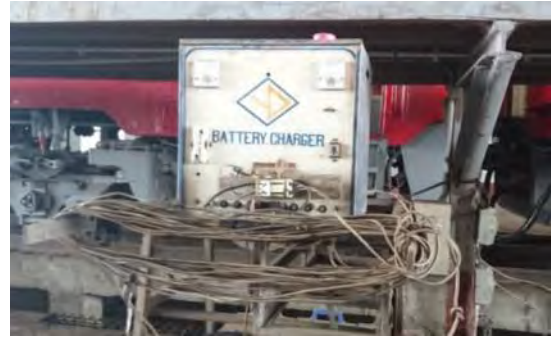
Battery charger

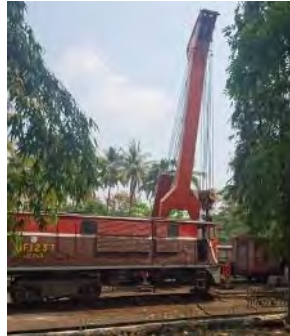
Crane
(substitute for lifting jack)

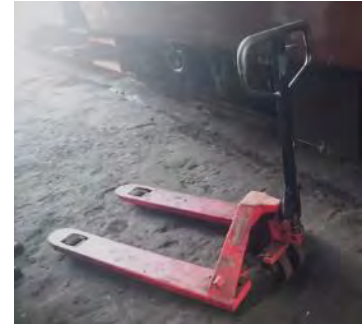
Transfer cart
(for mounting/removing
underfloor equipment)

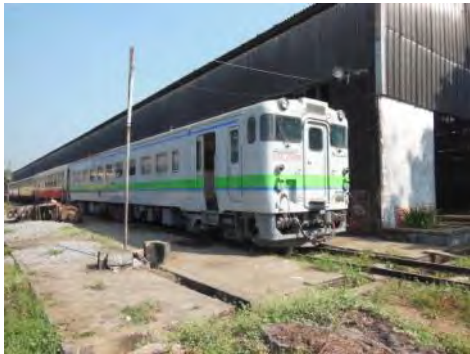
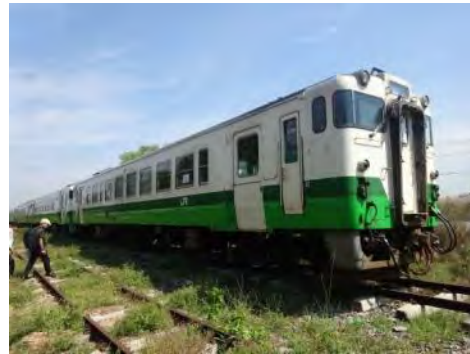
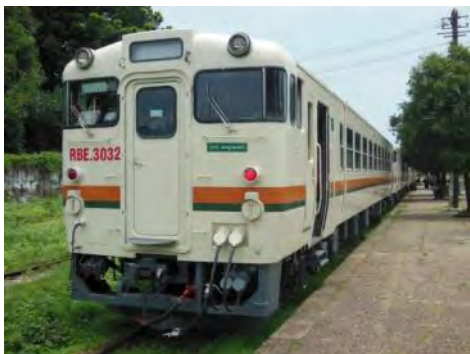
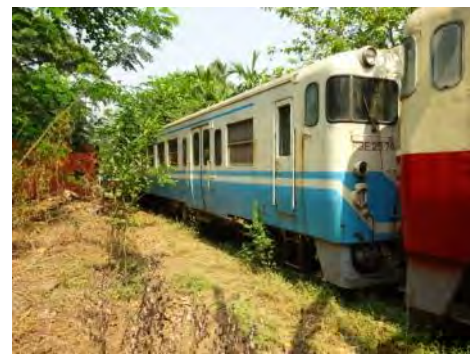
Figure 4-2-1 Photo of the present state of Kiha 40 Series

A total of 60 vehicles were transferred, including 8 from JR Hokkaido, 19 from JR East (including 9 transferred at the end of March 2016), 30 from JR Central, and 3 from JR Shikoku. The 49 vehicles transferred from JR East and JR Central are those transferred in FY 2015 and, therefore, are relatively in good conditions. Out of the remaining 11 vehicles, the 3 vehicles transferred from JR Shikoku, with more than a year passed since they were placed out of operation, are deteriorating on bodies and parts. And the bogies, engines and other major components were removed. Out of 8 vehicle transferred from JR Hokkaido, 5 vehicles that were equipped with air conditioners. But the air conditioners were not working well and were being subjected to the maintenance work. Three (3) other vehicles were being operated without any particular problem.

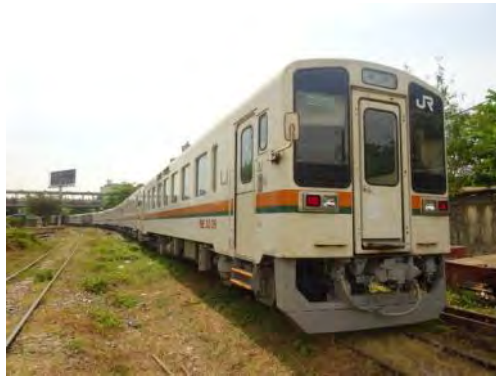
Figure 4-2-2 Photo of the present state of Kiha 11 Series

In FY 2015, 21 vehicles were transferred from JR Central. Since little time has passed since the transfer, the conditions are good. However, probably by the effect of the modification to lower the room at the air conditioner mounting part for the purpose of avoiding any interference with the rolling stock gauge, they are suffering a problem of weak air conditioning.

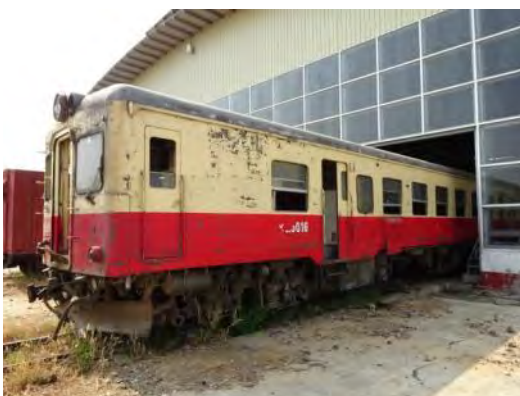
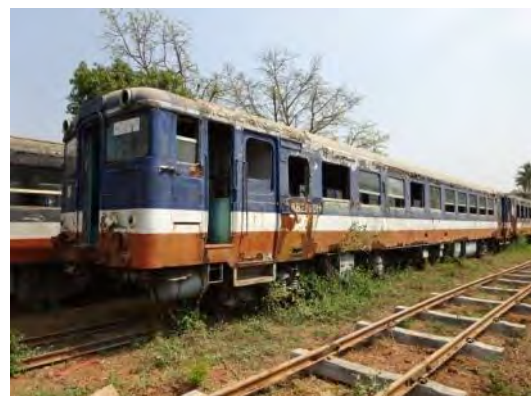
A total of 32 vehicles were transferred, including 20 from JR East and 12 from JR West. Since 4 of them were converted into passenger coaches, 28 vehicles are remaining on register at present. Although 8 vehicles are still drivable, they are, with their bodies badly corroded, in a barely drivable condition. The remaining 20 vehicles are suffering severe corrosion of their bodies and some of them are warped (buckling) beyond repair. MR is not thinking of repowering such vehicles and is planning to deregister them.

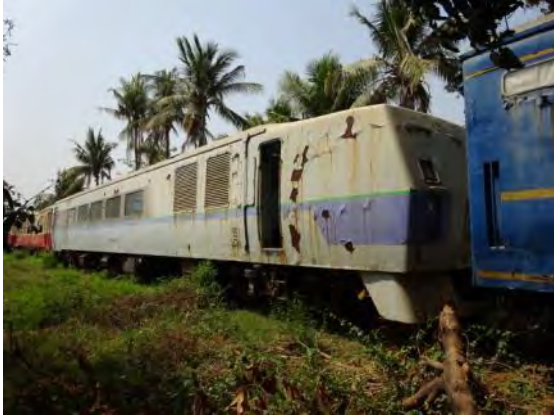
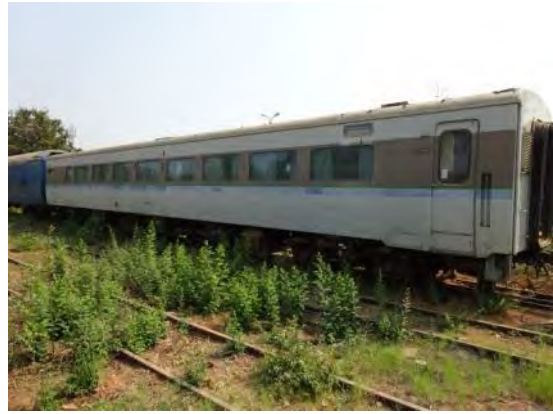
Figure 4-2-4 Photo of the present state of Kiha 183 Series

A total of 19 vehicles were transferred from JR Hokkaido. All vehicles are placed out of operation. Since some vehicles equipped with driving cab have a high roof, a modification work was started to get them within the rolling stock gauge but it is left uncompleted. The rest of the vehicles are in relatively good conditions. But there is no clear plan for their future use and they are left unused.

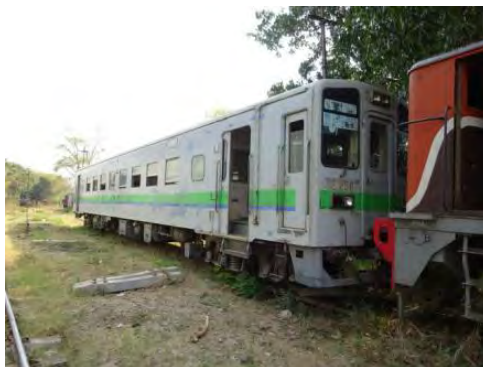
Figure 4-2-5 Photo of the present state of Kiha 141 Series

A total of 22 vehicles were transferred from JR Hokkaido. Excluding 2 vehicles that are to be subjected to corrective grinding of wheels, all vehicles are placed in operation. Since many of them are deployed to local Depots and were being used in operation, the investigation was made with only one (1) vehicle. The vehicle was in good conditions and no problem was identified at the moment. But it should be noted that, since its bogies and hydraulic transmission are reuse from a vehicle deregistered when it was registered at JR Hokkaido, it is aged.

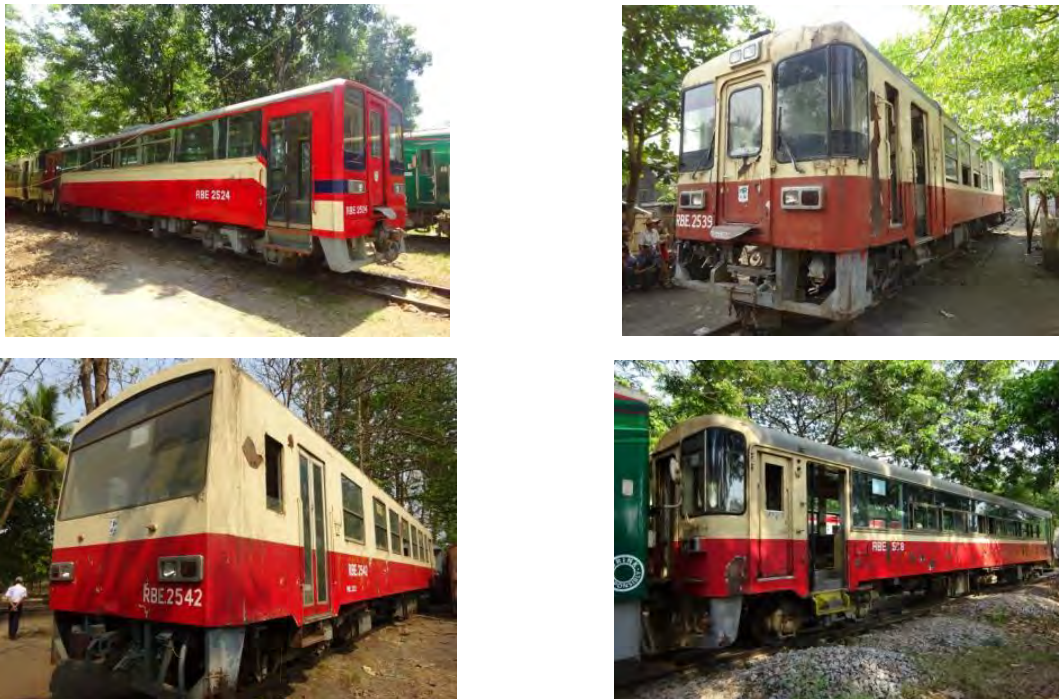
A total of 85 vehicles were transferred from a total of 13 private railway companies and joint public-private companies. Vehicles types are varied and so the types of major components are varied as well. Among the RBEs, many of them went through many years after having been transferred to MR and those in undrivable state count 39 vehicles, which is close to a half of the total number of vehicles. That is partly because there are a variety of part types. Since it is difficult to obtain the maintenance parts, the vehicles need to be left waiting for repair. Furthermore, since they have been left outdoors unattended for an extended period of time, their body underframes are badly corroded. It was observed that some vehicles could hardly maintain sufficient body strength. Many of the vehicles of a type called LE-car are of a rivet-assembled construction for the purpose of realizing light weight and low cost. Since they are made of thin sheet steel and therefore cannot be repaired by regular arc welding, those suffering significant body corrosion are beyond repair.

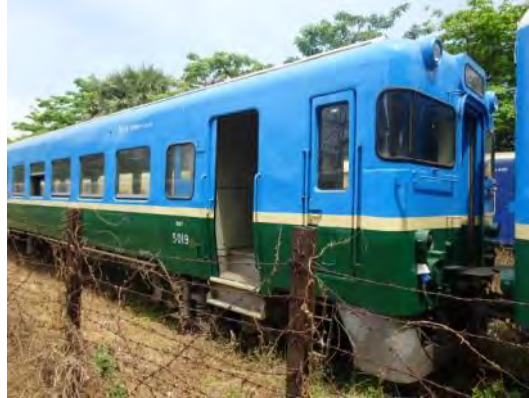
Figure 4-2-7 Photo of the present state of former Kiha 58 Series

Among RBEs introduced to MR, some, primarily those that became unusable due to the failure of major components, were modified into passenger coaches. There are a total of 11 vehicles of that sort, including 1 converted from Kiha 47 Series, 4 from Kiha 52- 58 Series and 6 from rail bus type. With all pieces of equipment removed, excluding brake parts, such vehicles cannot be restored to RBEs any more.

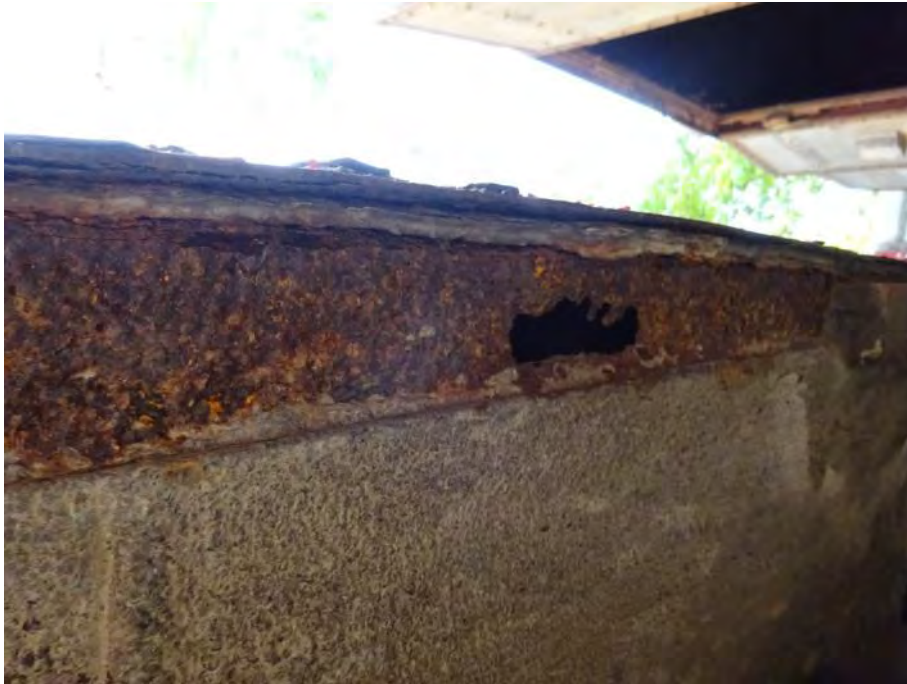
flakes off when touched with hand. On such vehicles, both outer panels and frameworks are eroded to the depth by rust and any partial cut-off and replacement may accelerate the reduction in strength by the heat of welding. Therefore, it will be difficult to maintain the strength of entire vehicle body. Concerning the underframe, in particular, since it is a critical part for the strength of vehicle body, any such work may cause a warpage (buckling) of the vehicle body by the welding heat, potentially resulting in further reduction in the service life. For that reason, those vehicles with rust on the underframe should be placed out of the object of the repowering work.

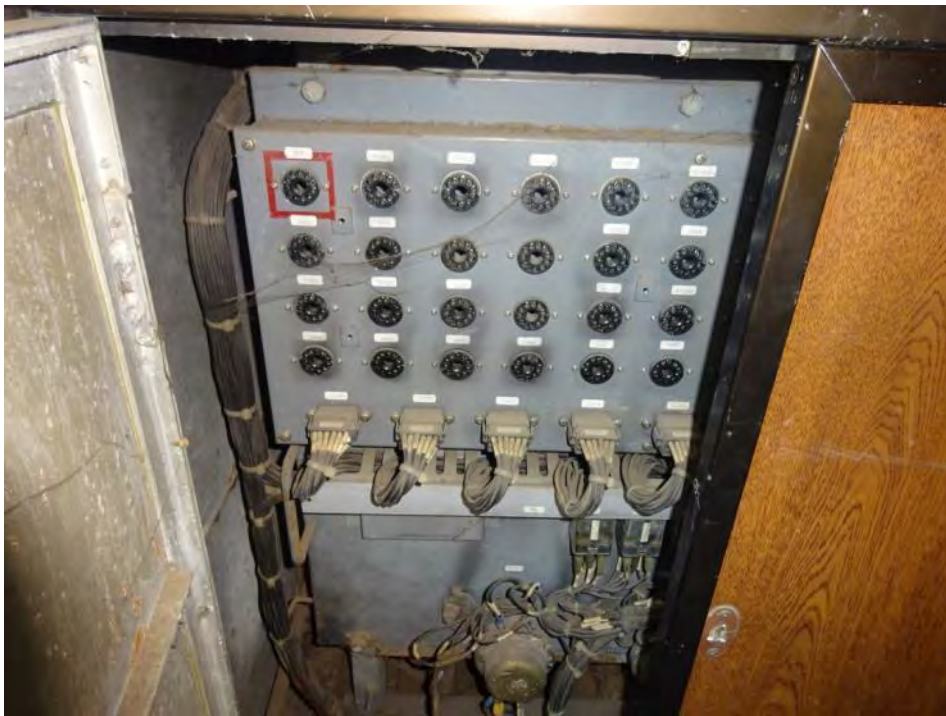
Vehicles that have been placed out of operation for an extended period of time are most likely to be deprived of parts for the repair of other vehicles besides those made unusable by failures. Not a few of them are to be replaced in the repowering work and therefore such parts need to be procured anew. Those parts, like the afore-mentioned corroded and deteriorated parts, involve problems, such as: Detailed investigation is required to identify necessary parts; Takes time for the procurement; Repowering work process will be extended; Costs will become large, etc. For that reason, in our view, they should be eliminated from the object of repowering work.

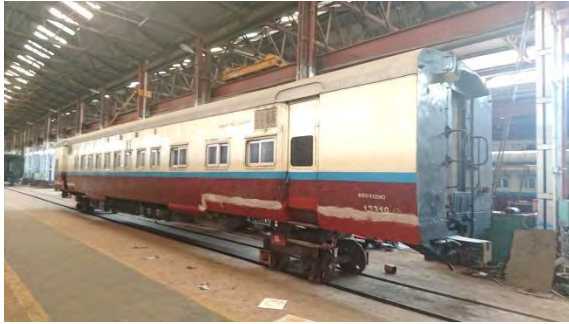
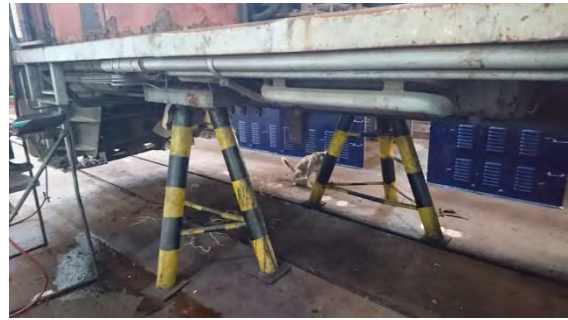
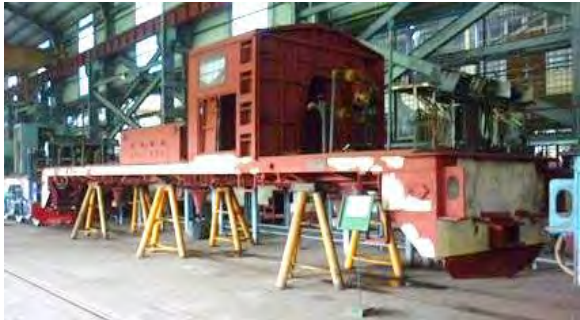
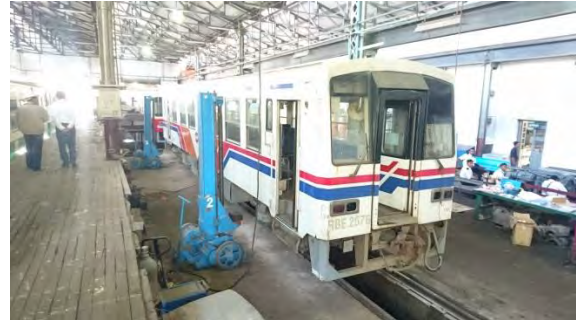
Figure 4-3-8 Underfloor work equipment of different Workshops (vehicle body supporting equipment)

Myitnge Workshop (temporary bogies)

Ywahtaung Workshop (support frame)

Insein Workshop (support frame)

RBE Workshop (lifting jack)

Concerning Myitnge Workshop that is considered the second best, since it is distant from Yangon Port, which is the center of Myanmar’s maritime logistics, it has a disadvantage of increased transportation distance within Myanmar. But it is no necessarily a big issue. As seen from the underfloor work skills point of view, it also has an issue that it has no experience in the work of mounting engine and other major components. But the issue may be solved by gathering experienced technicians from other workshops. For the equipment of the facility, the conditions are the same at any workshop as shown on Figure 4-3-8 and Figure 4-3-9.
