PREPARATORY SURVEY FOR YEGHVARD IRRIGATION SYSTEM IMPROVEMENT PROJECT

FINAL REPORT (FR)

NOVEMBER 2016

JAPAN INTERNATIONAL COOPERATION AGENCY (JICA)

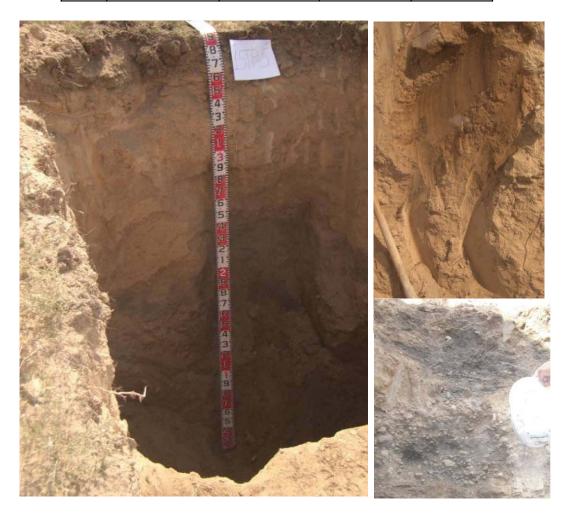
Figure 4-3-4.2 Typical Test Pit Log and the Profile Photos

Test Pi	t ; 15TP-5			
Depth (m)	Color	Classification etc.	Moisture content	Cohesion
	greyey black	top soil		
0.5	yellowish blown	silt	low	a little
1.0	-	(SM)		
1.5	black	coarse/volcanic sand		
2.0		sand-and-gravel	dry	
2.5				
3.0	yellowish blown	silty sand	low	almost non
3.5				
4.0

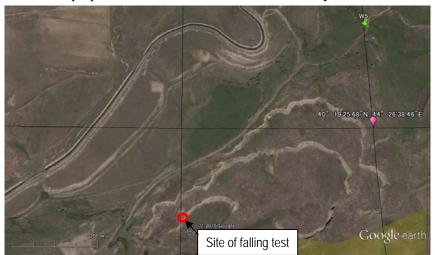
Figure 4-3-4.3 Location Map of the In-situ Falling Test

zoned fill-type dam. Based on such circumstances and conditions, this in-situ falling test of sand-an-gravels was carried out in а manner of sand-and-gravels excavated from the vacant lot of quarry site being fallen down along the cliff left in the vacant lot. The location map of the survey point is shown in the Figure 4-3-4.3.

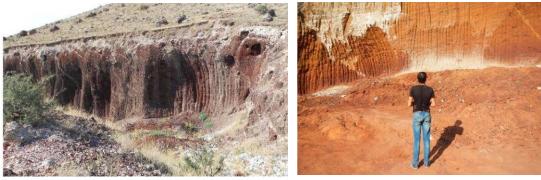
Figure 4-3-4.13 Outcrop of Scoria

There are reddish brown high cliffs along the regional road, H6 line, on the hill south side to the reservoir from where Scoria has been being mined for the use of pumice blocks to the fine portion and heat insulating layer of the building roof to the coarse portion. This scoria layer is estimated geologically to exist under the uppermost lava layer and extend widely with about 20 meter of the layer thickness. To examine the possibility of utilizing this scoria as the filter material, sampling was done in the mining site. The layer's feature and the locations of scoria cliffs around the reservoir are as shown in Figure 4-3-4.13 to 4-3-4.15.

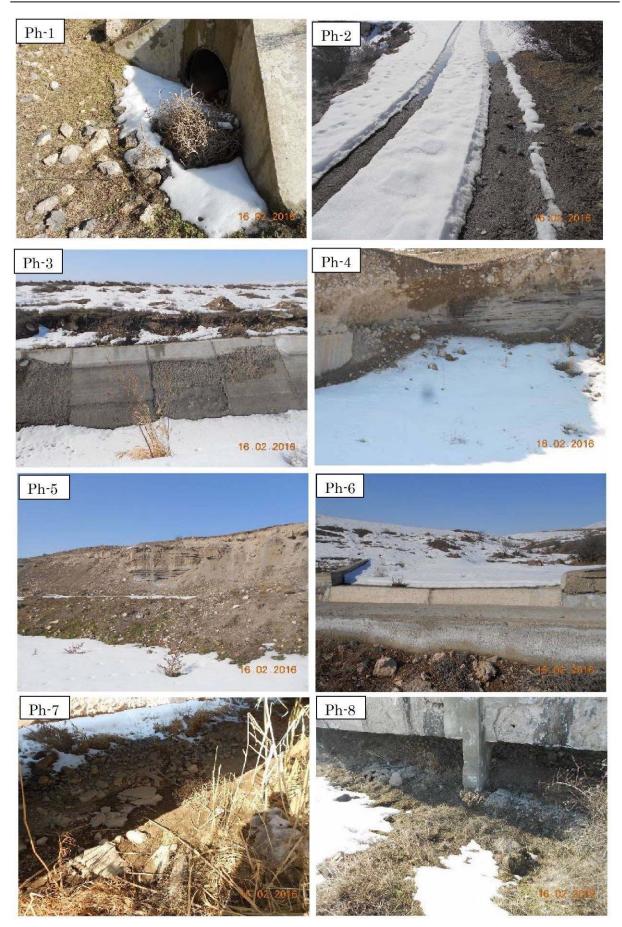
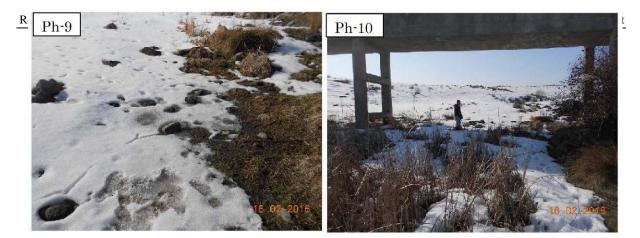
Survey point	Catchment area (km2)	Depth of snow (cm)	Existence of stream (volume of stream)
1		10cm	No water under the water-way bridge and in front of the culvert pipe (Ph-1), Small pond on the road (Ph-2)
2	2.1	10cm	No water. The canal wall is wetted partly. (Ph-3)
3	1.0	20cm	No water under the water-way bridge A partial wetting on the cut slope (Ph-4), but totally seepage of water cannot be seen on the cliff. (Ph-5)
4		15cm	No water comes to the cutout mouth of the canal wall. (Ph-6)
5	0.5	10cm	No water under the water-way bridge. (Ph-7)
6		10cm	No water under the water-way bridge. (Ph-8)
Ø	18.1	15cm	Small pond under snow, no move, no stream(Ph-9,10)
8	7.2	10cm	No water under the water-way bridge. (Ph-11)

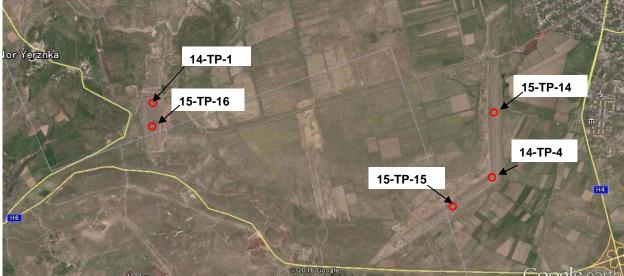
Figure 4-3-7.3 Test-pit Location for the Investigation of Dam Bodies

Test-pit excavations were conducted on the existing dam bodies, TP-1 and TP-16 on the Dam No.1 and TP-4, TP-14 and TP-15 on the Dam No.2, to confirm their actual conditions. The depth of test-pits was decided to be 1.5 m considering the disappearance of dried-up condition brought from the surface. Test-pit conditions of each are shown as Figure 4-3-7.3 and 4-3-7.4.
