4-3-5 Laboratory Soil Test

4-3-6 Investigation for the Anti-infiltration Works to the Reservoir Basin

4-3-7 Conditions of Existing Dam Bodies

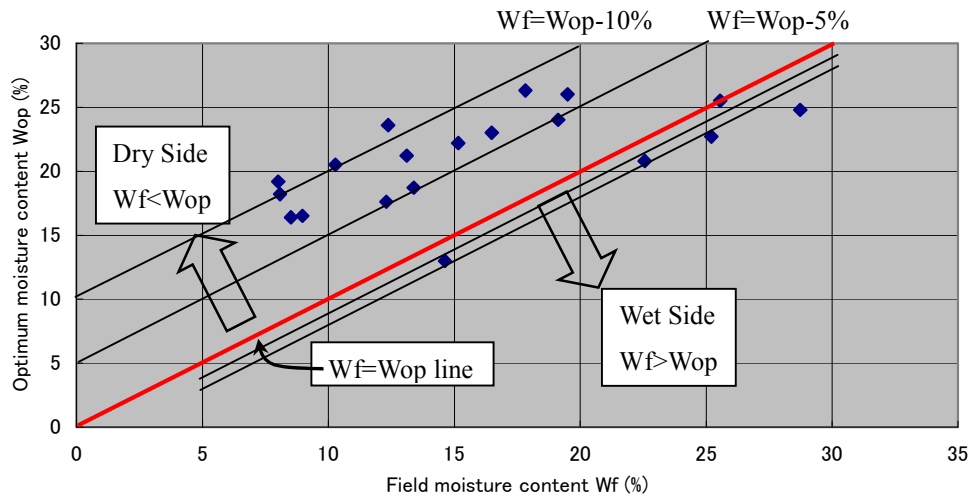
Figure 4-3-5.1 Relationship between Field Moisture Content and Optimum Moisture Content

Most of the soils have the field moisture content lower than the optimum moisture content by 5% to 12% except for the some exceptional ones with the field moisture content higher than the optimum moisture content by 1% to 2%, so that to conduct the compaction work to the soils with optimum moisture content condition, a large amount of water shall be needed.

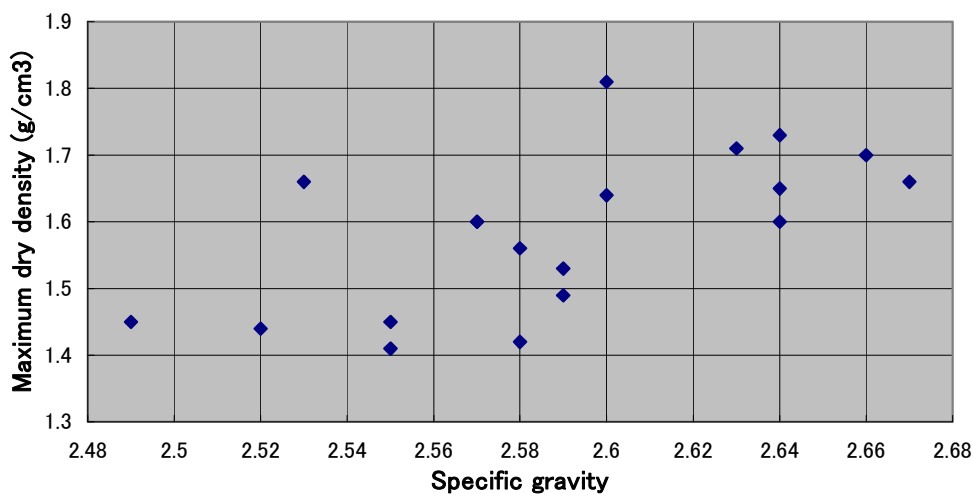
Figure 4-3-5.2 Relationship between Specific Gravity and Maximum Dry Density

The specific gravities range from 2.49 to 2.67. Considering the value of common soil to be around 2.60 to 2.75, the low values of specific gravity around 2.49 or so would be related to its origin, i.e. volcanic ash. An obscure positive-relativity exists between the specific gravity and the maximum dry density in the standard compaction test according to Figure 4-3-5.2.

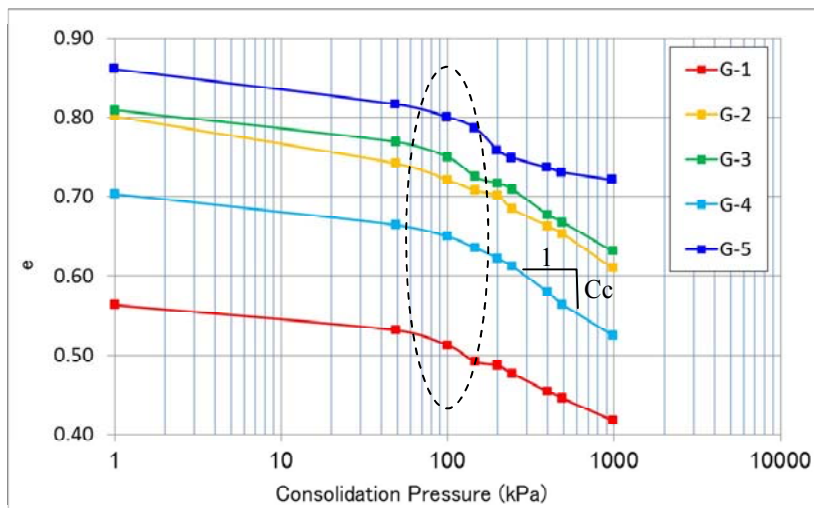
Figure 4-3-5.11 Result of the Consolidation Test

Consolidation tests are conducted at one (1) testing point, Point B, per one sample considering the wettest-side condition in moisture content making the specimen’s consolidation settlement maximum comparing with other specimens with other moisture content conditions and the same dry density level. In spite of the specimens having different void ratios, all specimens reach the consolidation yield stress at around 100 kPa and indicate almost the same compression index C_c as shown in Figure 4-3-5.11.

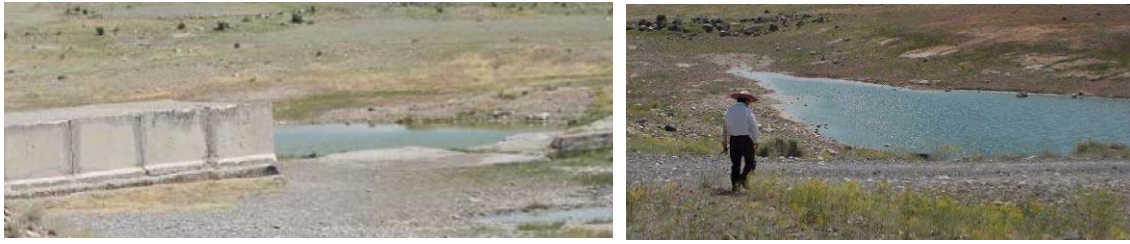
Figure 4-3-6.5 Ponds on the Reservoir Bottom at the Upstream of Dam-No.1

1) There are two ponds on the reservoir bottom just upstream side of the Dam No.1. Their long-term existences almost all through a year suggest a possibility of ground water flowing down toward the reservoir bottom in the hill-side areas. It must be noted that there might be a possibility of the back pressure arising against the bottom of the impervious zone of Dam-No.1 or from behind the anti-infiltration work in the upstream side of Dam No.1.

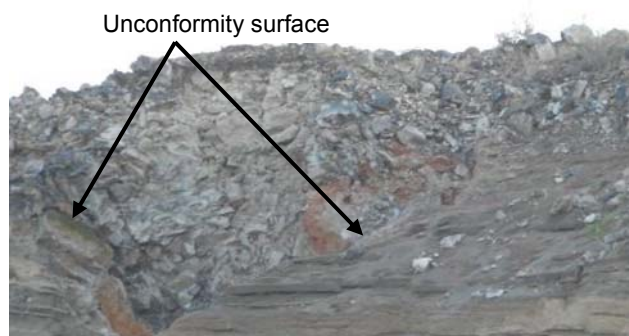
Figure 4-3-6.7 Unconformity Surface on the Lava cliff

- 3) On the slope south-side to the reservoir, the stratified structure of volcanic products is assumed to be inclined toward the reservoir based on the observation to the existing trench and the outcrops of lava on the south hill slope of Dam No.1 as shown in Figure 4-3-6.7. And an unconformity surface, which is not rare to function as an impervious plane, exists between the uppermost lava layer and the lower pyroclastic flow deposits. It is probable for the water stored on an unconformity surface to become pressurized and act as the back pressure against the anti-infiltration work because of its inclined stratified structure.

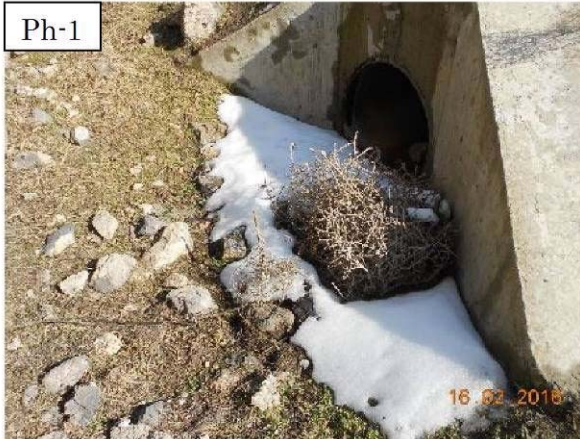
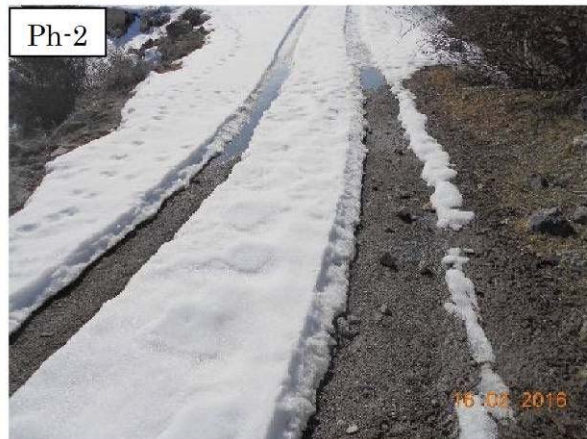
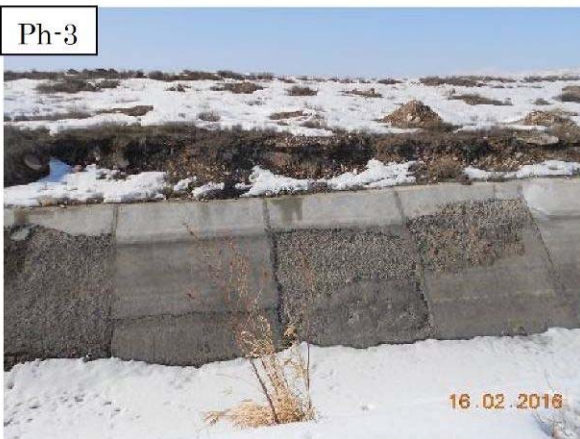
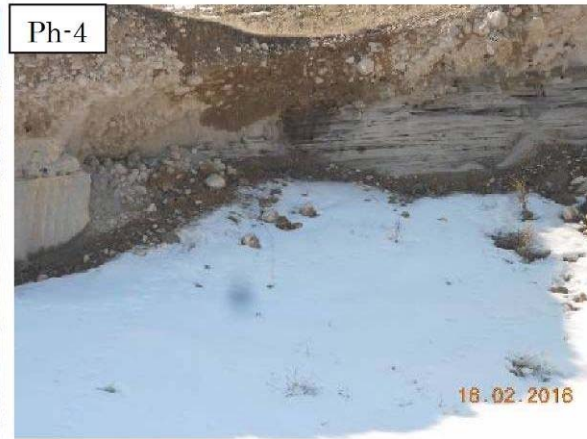
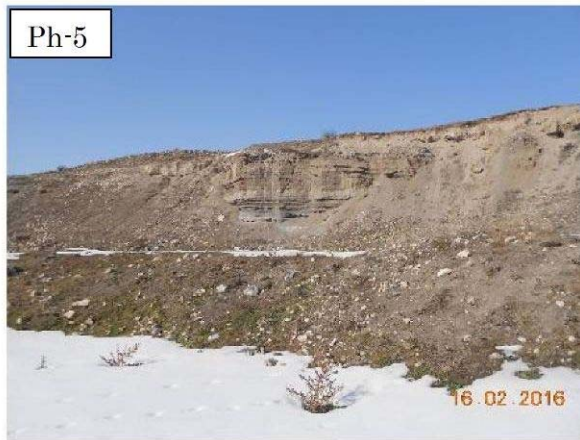
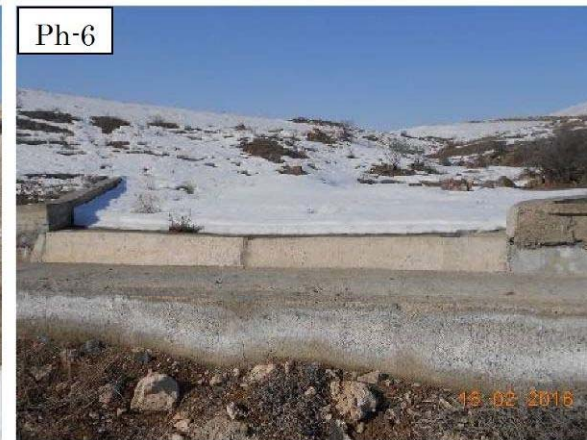
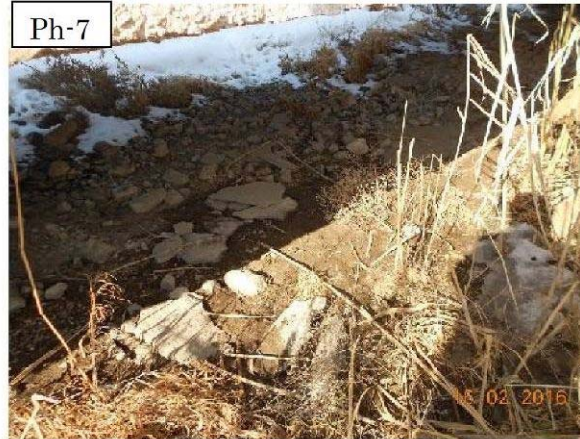
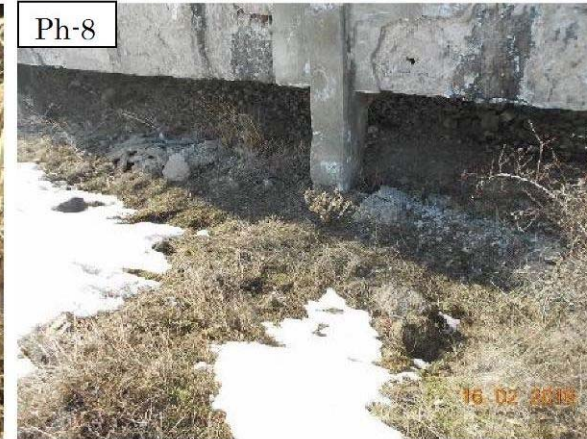
Survey point	Catchment area (km2)	Depth of snow (cm)	Existence of stream (volume of stream)
①		10cm	No water under the water-way bridge and in front of the culvert pipe (Ph-1), Small pond on the road (Ph-2)
②	2.1	10cm	No water. The canal wall is wetted partly. (Ph-3)
③	1.0	20cm	No water under the water-way bridge A partial wetting on the cut slope (Ph-4), but totally seepage of water cannot be seen on the cliff. (Ph-5)
④		15cm	No water comes to the cutout mouth of the canal wall. (Ph-6)
⑤	0.5	10cm	No water under the water-way bridge. (Ph-7)
⑥		10cm	No water under the water-way bridge. (Ph-8)
⑦	18.1	15cm	Small pond under snow, no move, no stream(Ph-9,10)
⑧	7.2	10cm	No water under the water-way bridge. (Ph-11)

Figure 4-3-6.9 Photo of the Survey on 16th of February, 2016

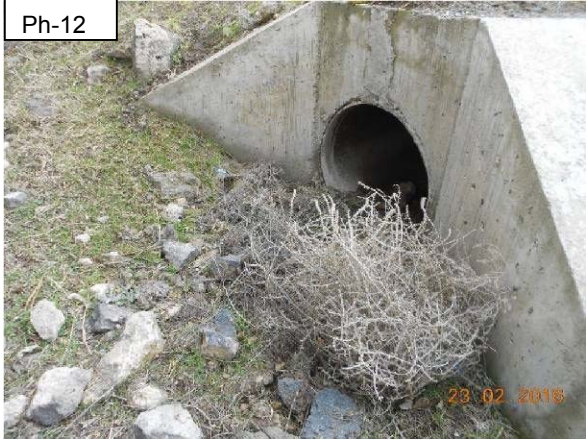
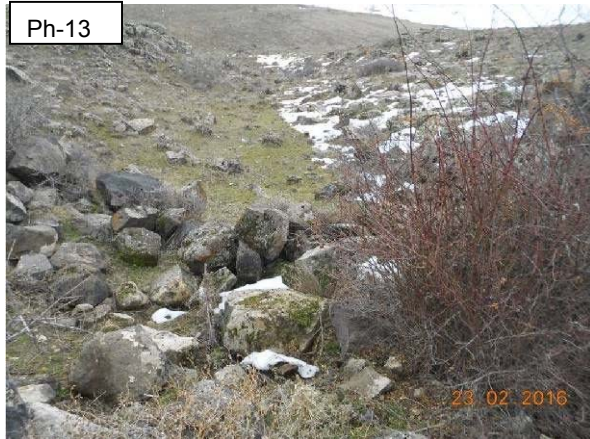
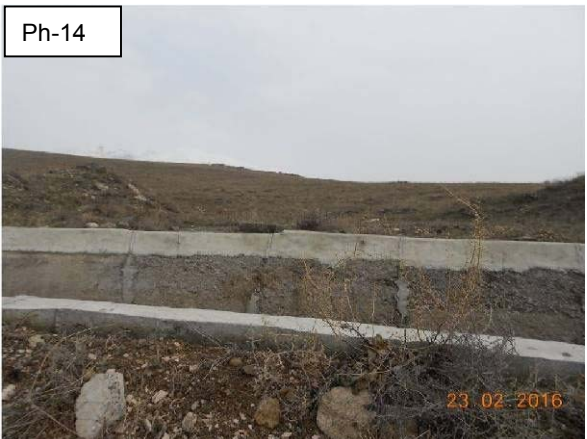
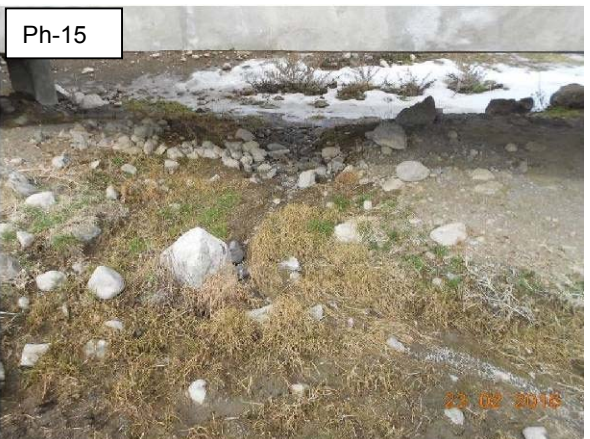
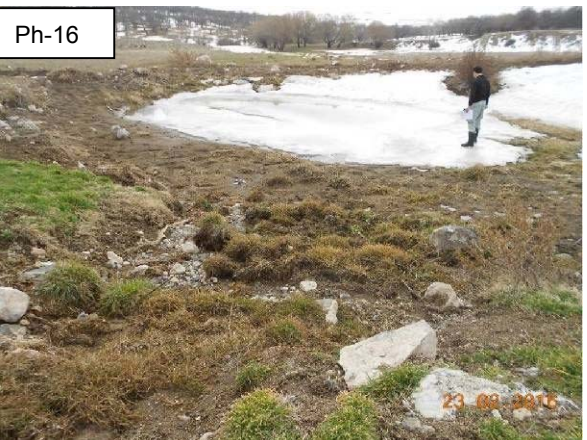
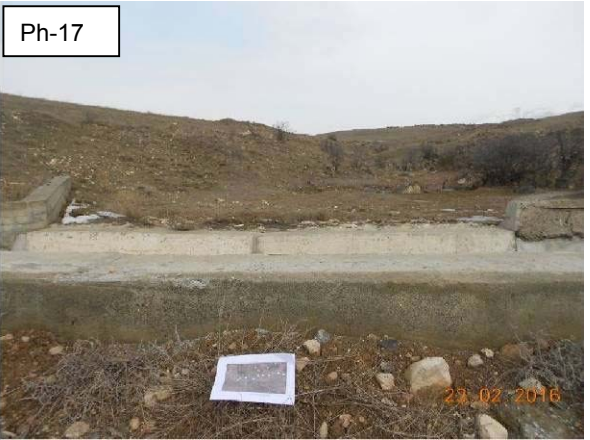
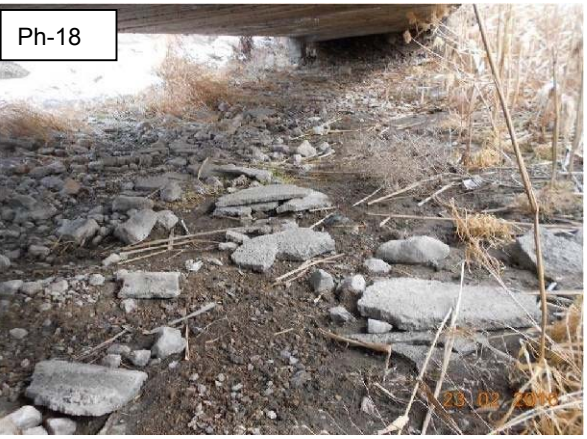
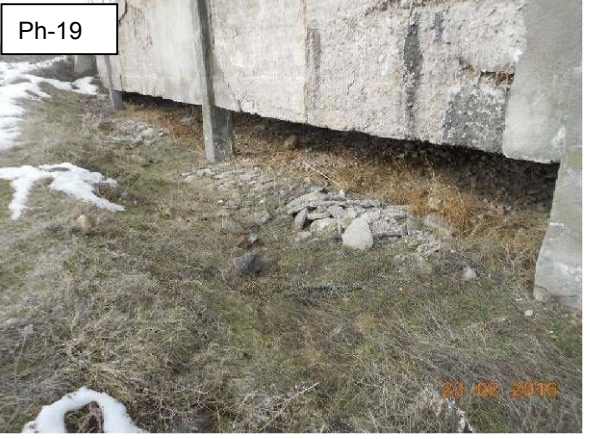
Survey point	Catchment area (km ²)	Depth of snow (cm)	Existence of stream (volume of stream)
①		0 cm	Wet ground but no water in front of the culvert pipe (Ph-12), No water in the downstream valley(Ph-13)
②	2.1	0 cm	No water. The canal wall is dry. (Ph-14)
③	1.0	0 cm	No water is seen under the water-way bridge, but the ground surface corresponding to the watercourse is eroded. (Ph-15) Now water in the watering pond for cow. (Ph-16)
④		0 cm	No water comes to the cutout mouth of the canal wall. (Ph-17)
⑤	0.5	0 cm	Wet but no water (Ph-18)
⑥		0 cm	No water under the water-way bridge. (Ph-19)
⑦	18.1	0~5 cm	Small stream, In-flow volume under the water way bridge is 20 ~ 30 l/sec. (Ph-20) Water is led by a earth canal (Ph-21, 22) and disappears in a meadow (Ph-23). This water shall be increased in early summer and makes a swamp around the foot of the north slope (Ph-24).
⑧	7.2	10cm	Small ripple and swamp under the water-way bridge. (Ph-25) Quantity is uncountable.

Figure 4-3-6.10 Photo of the Survey on 24th of February, 2016

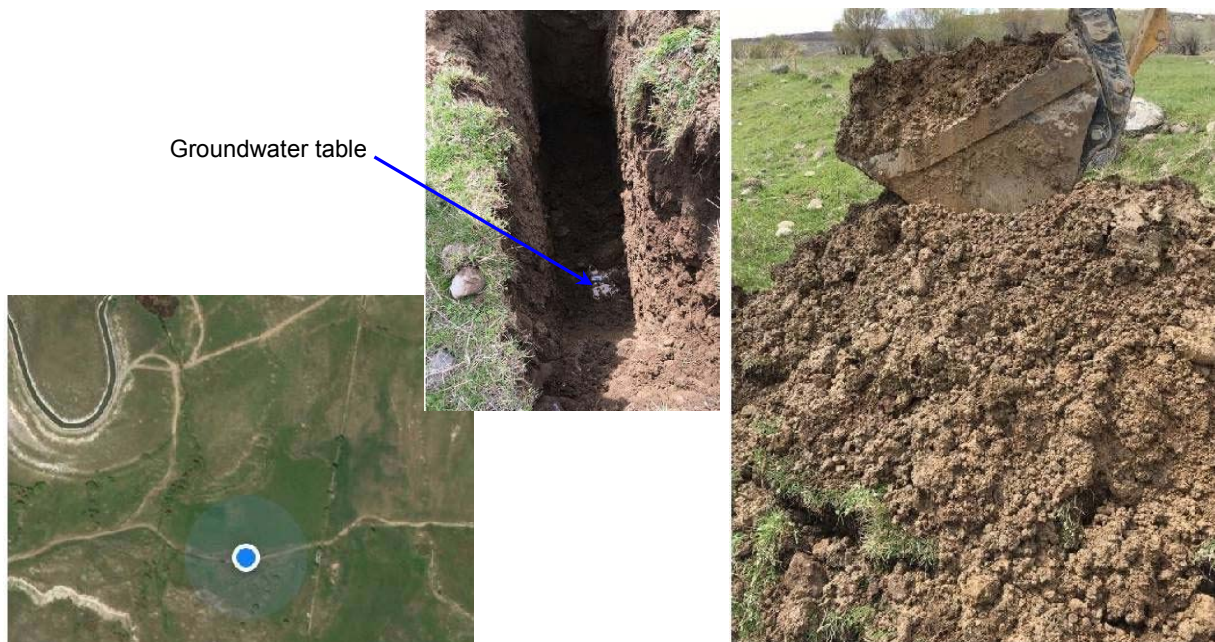
Figure 4-3-6.12 High Groundwater Table in the North Eastern Slope

TP.67 was excavated on 30th of March in the pit excavation survey. At that time, it was found that the sand-and-gravel layer was muddy and the groundwater table appeared on the pit bottom about 3m deep. It is assumed that this groundwater was borne and brought from the snow-melt water at point-⑦. If this groundwater has the same origin as the observation well W-5 where it is said sound of water dropping into the observation well is audible, a relatively wide expansion of high groundwater table shall be required to take account of in the reservoir design.

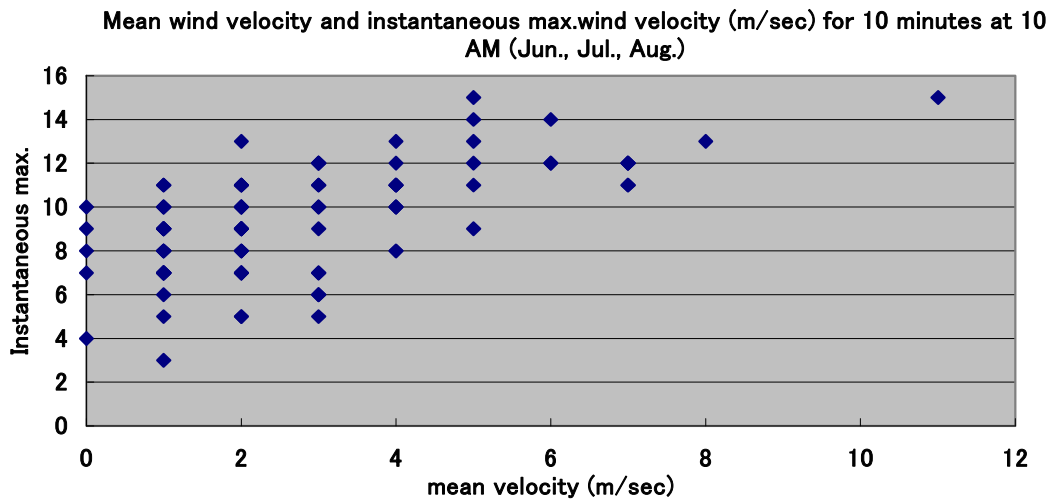
Figure 4-3-6.15 Relationship between Mean Wind Velocity and Instantaneous Wind Velocity

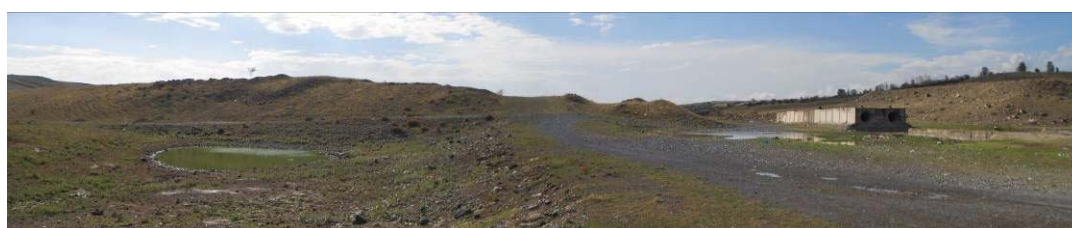
The existing dam bodies consist of sand-and-gravel materials only. The vacant lots where these materials were obtained are left on the hills or gentle slopes north-eastern side to the reservoir as shown in Figure 4-3-7.1 and 4-3-7.2.

Figure 4-3-7.1 Existing Dam Body (Dam No.1)

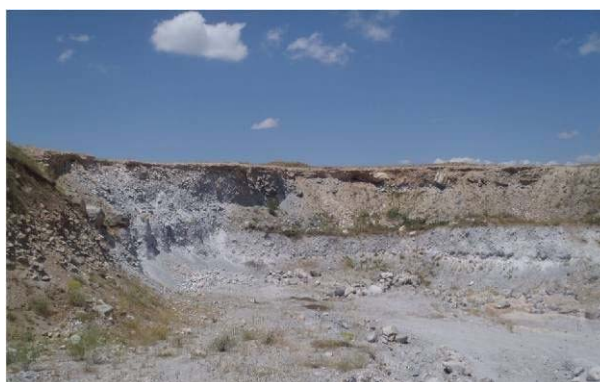
Figure 4-3-7.2 Vacant Lots of the Sand-and-Gravel Quarry

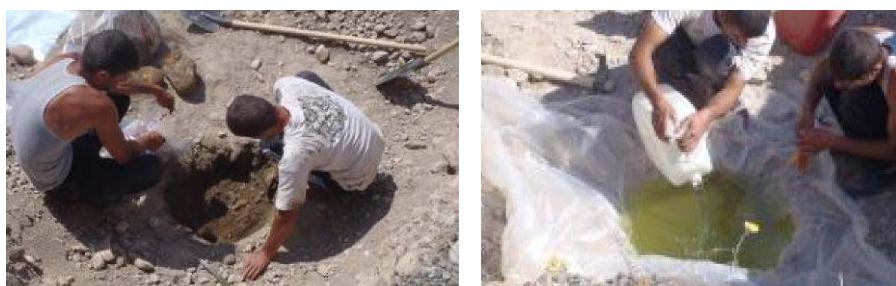
Figure 4-3-7.5 Circumstances in the Field Density Test

The field density tests by the water-replacement method were carried out on the bottom surface of the test-pits. The size of the testing hole was 60 cm in diameter and 40 cm in depth as shown in Table 4-3-7.2.

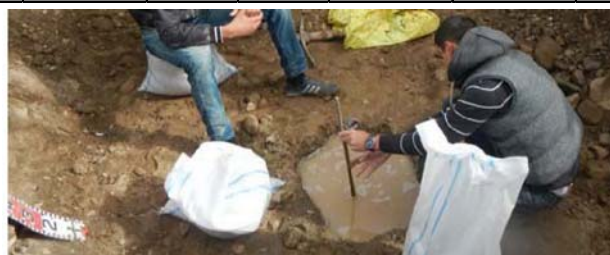
Figure 4-3-7.6 Circumstances in the Field Permeability Test

Table 4-3-7.3 Field Permeability Coefficient of the Existing Dam Bodies

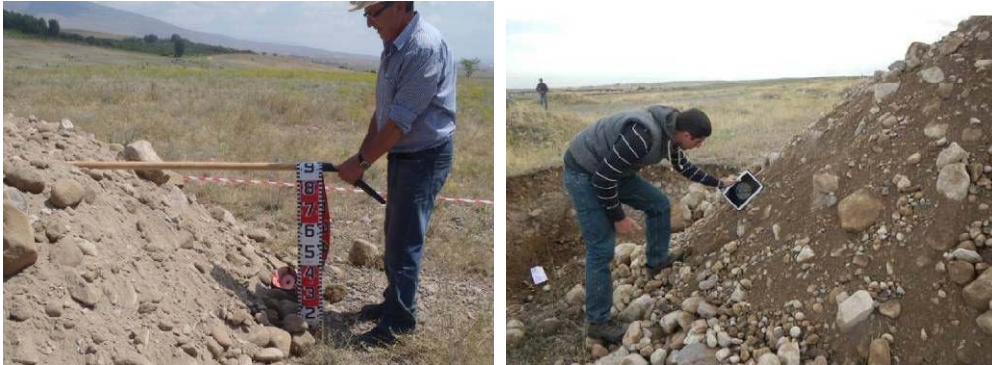
Figure 4-3-7.7 Circumstances in the Repose Angle Measurement

Repose angles were measured on the natural slope caused by the backhoe's dumping work of excavated materials.

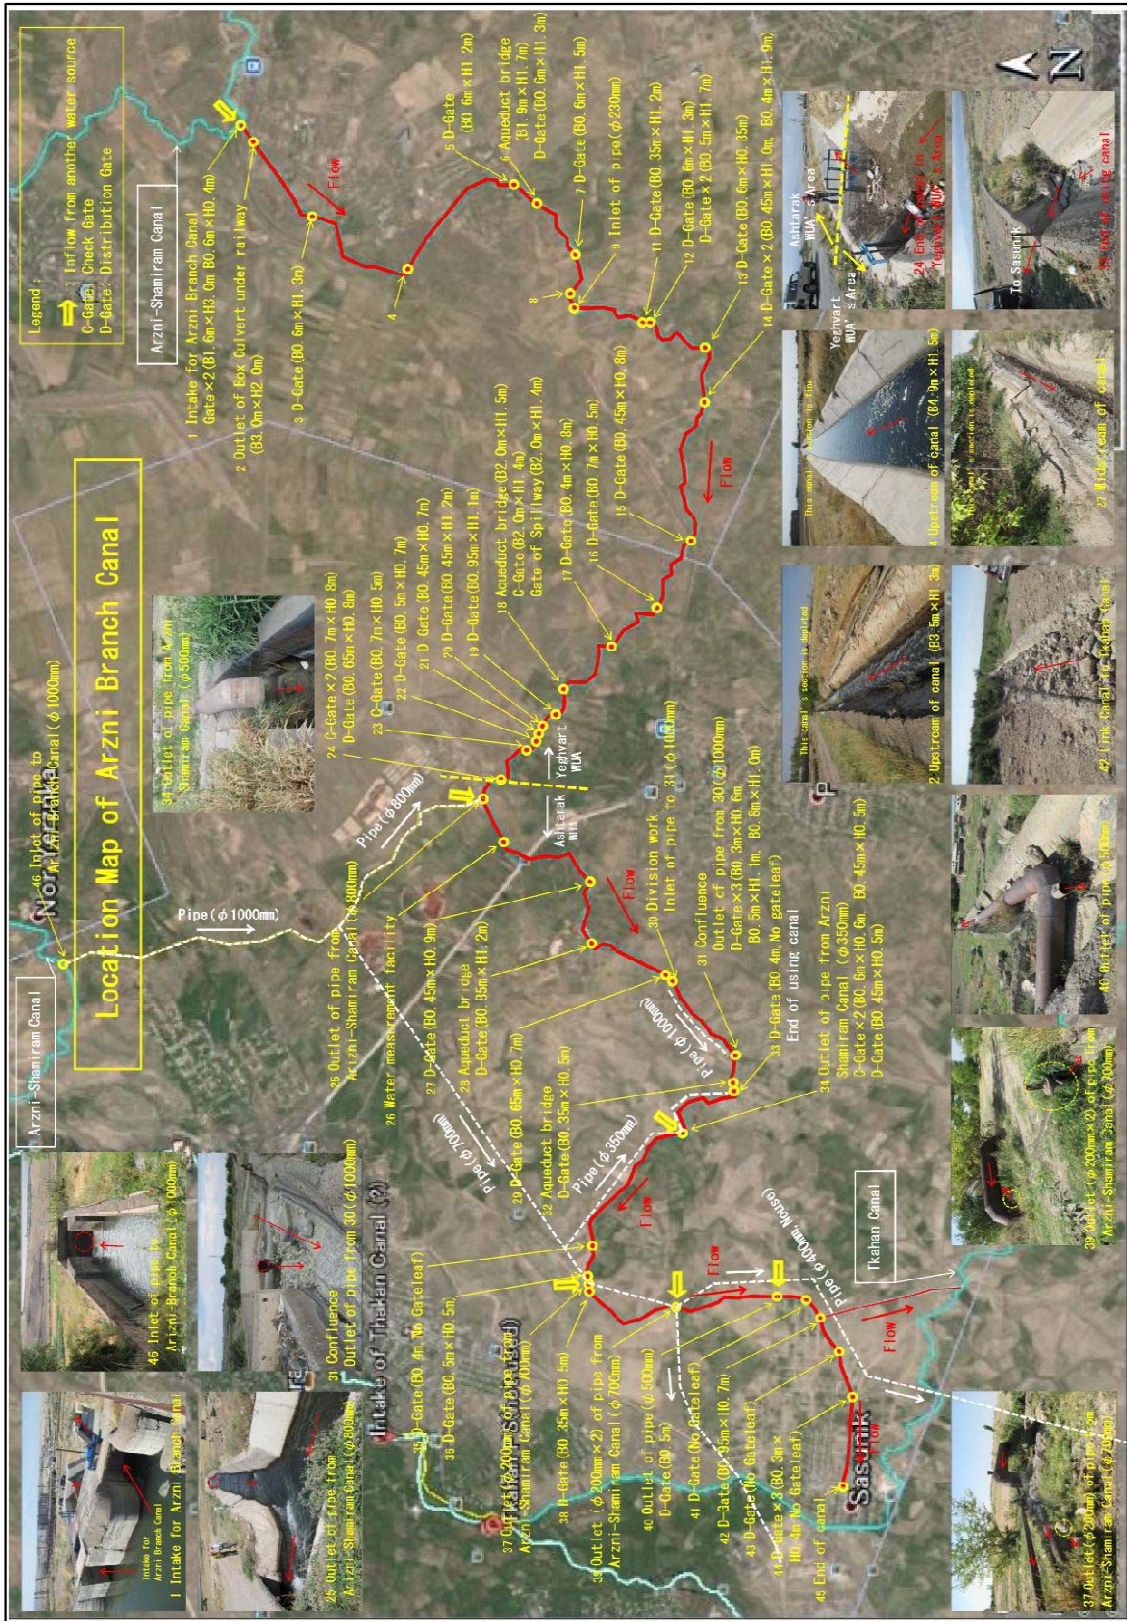
Figure 4-4-2.2 Location of the Irrigation Facilities of Arzni Branch Canal

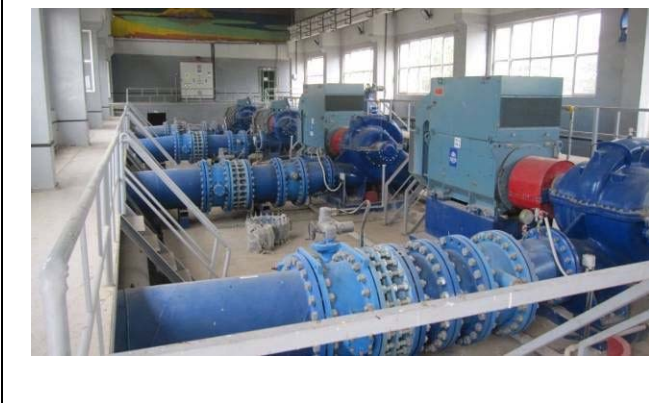
<u>Pump station (out view)</u>	<u>Pump station (inside)</u>	
Ranchpar PS. 2	Constructed in 1985 yr Major rehabilitation in 2011 by Millennium Challenging Cooperation(MCC) 4pumps made in Turkey are re-installed. P1 :0.92m ³ /s P2: 0.92m ³ /s P3 :1.30m ³ /s P4 :1.30m ³ /s

Figure 4-4-2.9 Situation of Existing Pump Stations

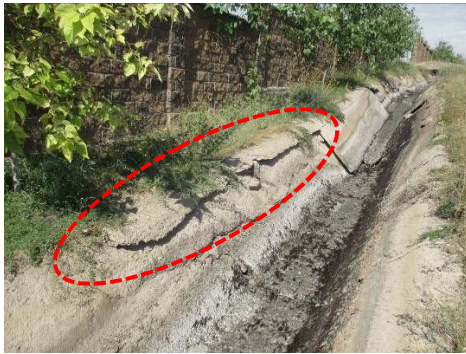
Figure 4-4-4.1 Crack at Side Wall of Canal (Arzni-Branch Canal at No.26)

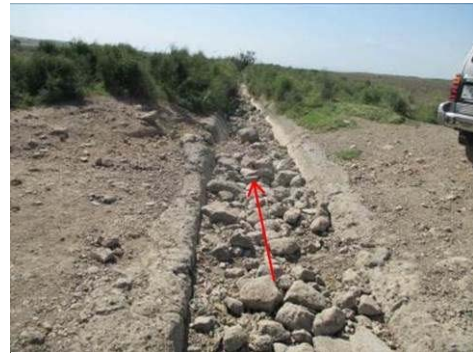
Figure o 4-4-4.2 Connection Canal to Takahan Canal (Arzni-Branch Canal at No.42)

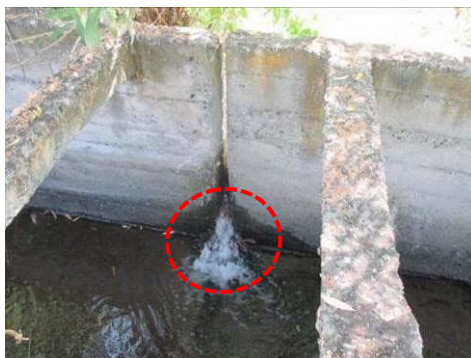
Figure 4-4-4.3 Leakage at Separation of Joint at Sidewall (No.33)

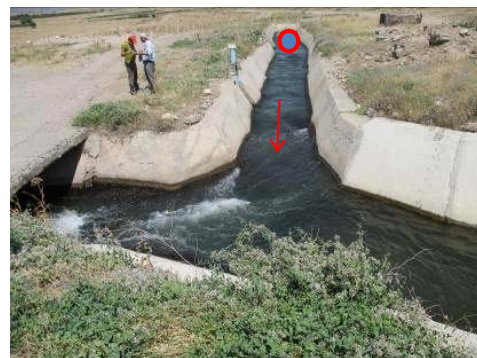
Figure 4-4-4.4 Outlet of Pipe from Arzni-Shamiram Canal (ø800mm) (Arzni-Branch Canal at No.25)
