**MINISTRY OF PUBLIC WORKS AND TRANSPORT,  
THE KINGDOM OF CAMBODIA**

**PREPARATORY SURVEY REPORT  
FOR  
THE PROJECT FOR REHABILITATION  
OF THE CHROY CHANGWAR BRIDGE  
IN  
THE KINGDOM OF CAMBODIA**

**March 2016**

**JAPAN INTERNATIONAL COOPERATION AGENCY (JICA)**

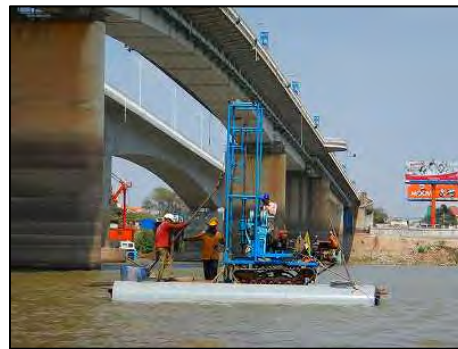
Photo 1-2-2 P3 pier boring (river)

| No. | Location | Type | Geological outline<br>(on-site findings) | Geological conditions |
|---|---|---|---|---|
| Br. No4 | P3pier | River | Deposited sediment for 1.0 m<br>from the river bed surface. A very<br>hard sand soil layer was found<br>from the 2.0 m mark, with rock<br>appearing from about 2.5 m. | |

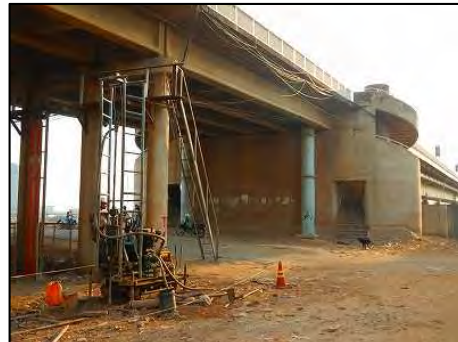
Photo 1-2-4 P8 pier boring (land)

| No. | Location | Type | Geological outline<br>(on-site findings) | Geological conditions |
|---|---|---|---|---|
| Br. No7 | P8pier | Land | Low N-value cohesive soil layer<br>and sandy soil layer continues for<br>17 m from surface. Very high N-<br>value gravel-mixed cohesive soil<br>confirmed beneath this.<br>Extremely hard rock layer found<br>from the 20 m mark. | |

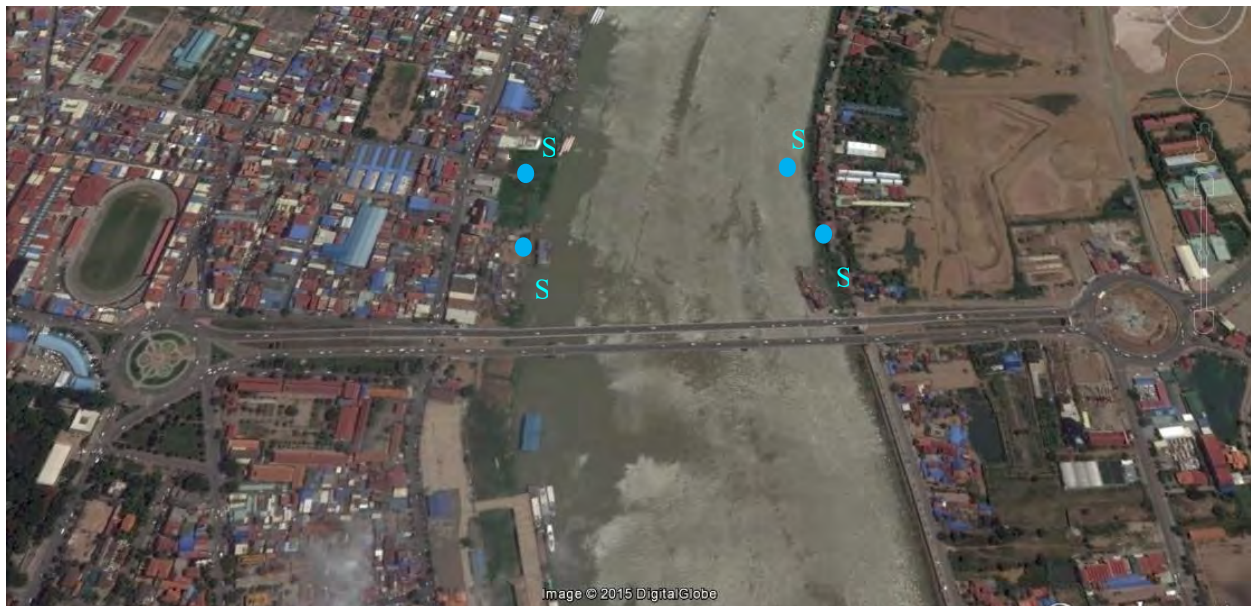
As a baseline study before the start of the project, water quality was surveyed for Tonle Sap River at the points shown in Figure 1-3-2.

Figure 1-3-2 Water quality survey points

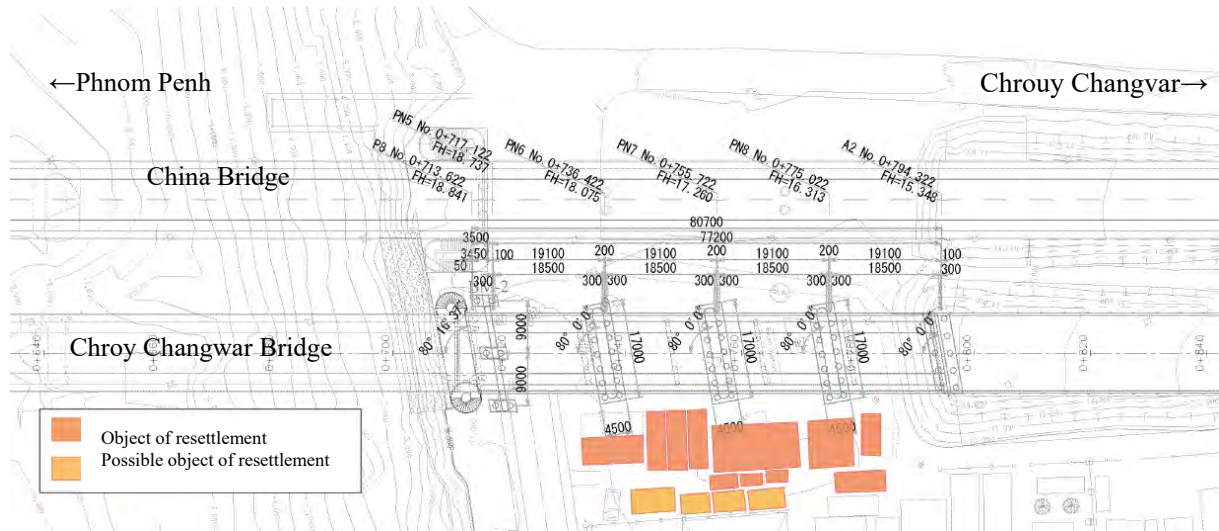
There will be involuntary resettlement near the bridge during construction for this project for repair and rehabilitation of the existing bridge. All households expected to be affected by the project are on the Chrouy Changvar side, numbering at most 21 households (see Figure 1-3-6. No residents on the Phnom Penh side will be affected. As the average household in Cambodian urban areas houses 4.8 people, involuntary resettlement is likely not to exceed 200 people. With this number of people being resettled, this should not impact the JICA environmental category.

Figure 1-3-6 Scope of land acquisition and resettlement (Chrouy Changvar side)

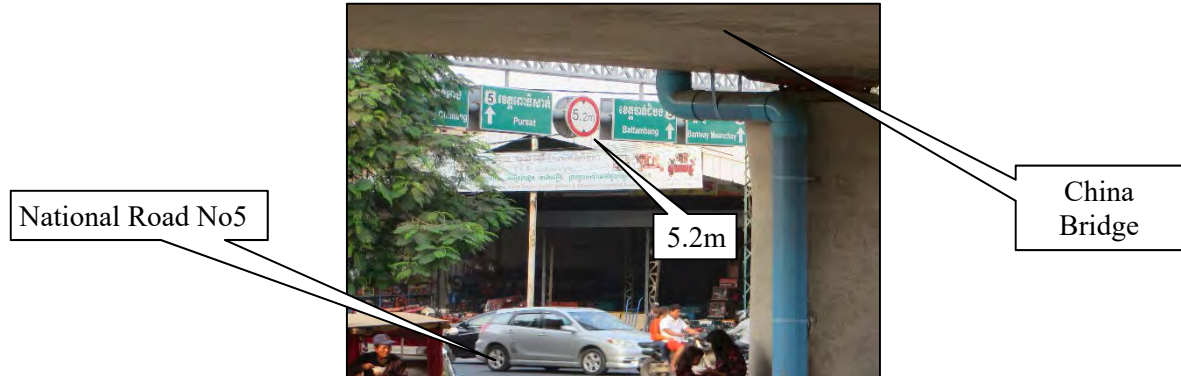
Photo 2-2-1 shows the vehicle height restriction sign (5.2 m) above National Route No. 5 near the Chroy Changwar Bridge.

Photo 2-2-1 Vehicle Hight Restriction Sign

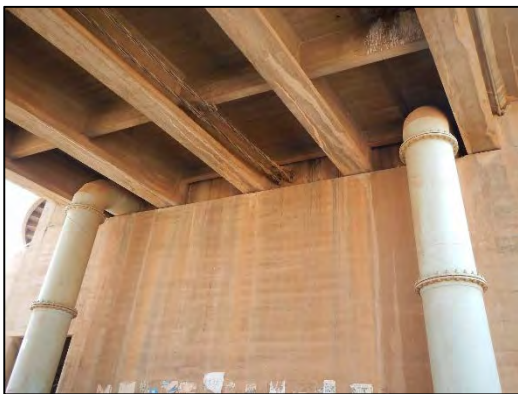
Water pipes on the wall of the pier ( $\phi 800 \times 2$ )

The present situations of utilities attached to the bridge are as follows.

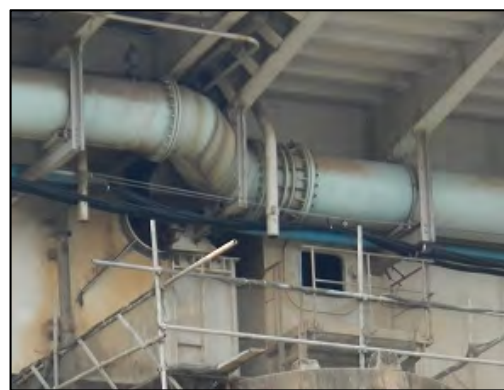
Water pipes attached to the steel box girder ( $\phi 800$ )

It has been confirmed through DPWT in field survey that 12 companies have attached utilities to bridges.

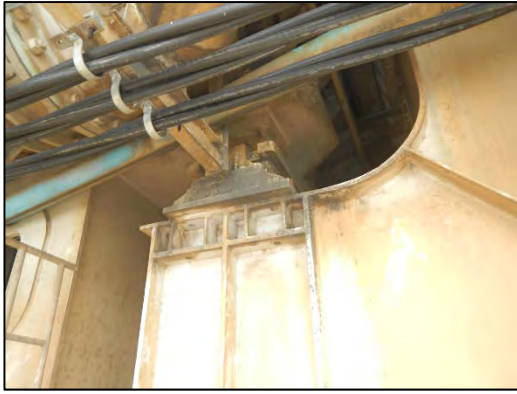
High-voltage cables attached to the steel box girder (22kv × 3)

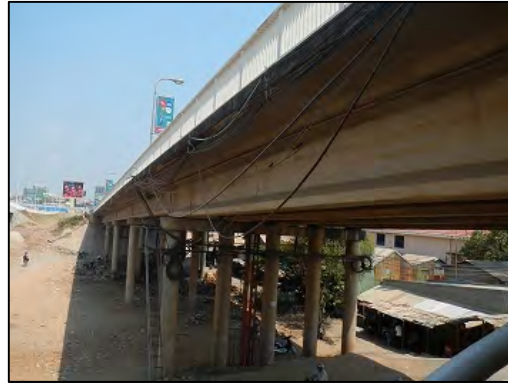
Communication cables attached to PC bridge (Optical fiber cables, etc)
