## 資料一6 サイト調査結果一覧(無線端末設置候補地)

## 6. サイト調査結果一覧(無線端末設置候補地)

Summary of the Site Survey for the Base Radio Stations (Group-B)

## 資料－10 地盤・地質調査結果

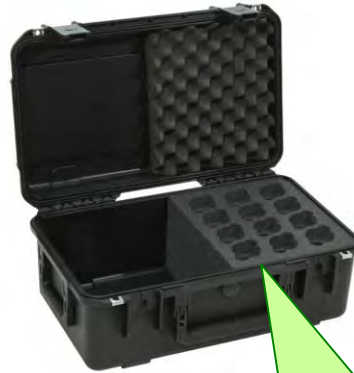
**Carton No.3 (Handheld Radio)**

1.3 (3) Portable Radio Station for Community  
5) Hand held Radio x10

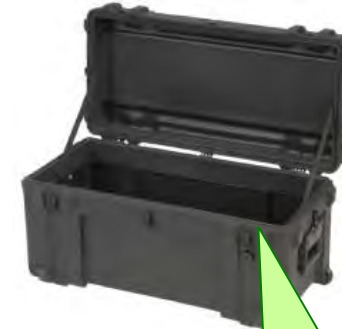
**Carton No.4 (Cable & Accessory)**

1.3 (3) Portable Radio Station for Community  
Cables and Others

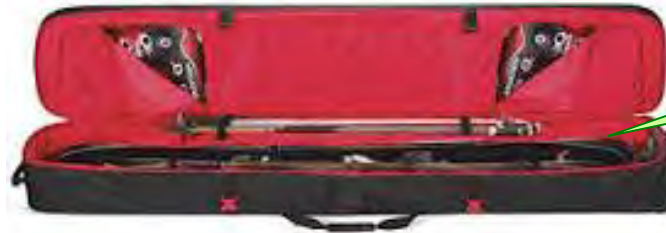
**Carton No.5 (Antenna & Poles)**

1.3 (3) Portable Radio Station for Community  
Antenna & Poles

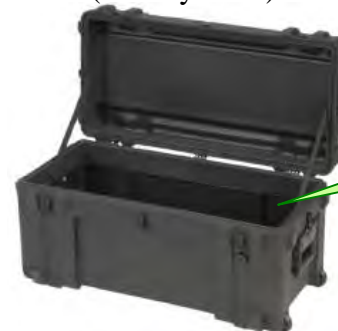
**Carton No.6 (Battery Case)**

1.3 (3) Portable Radio Station for Community  
4) Power Supply System

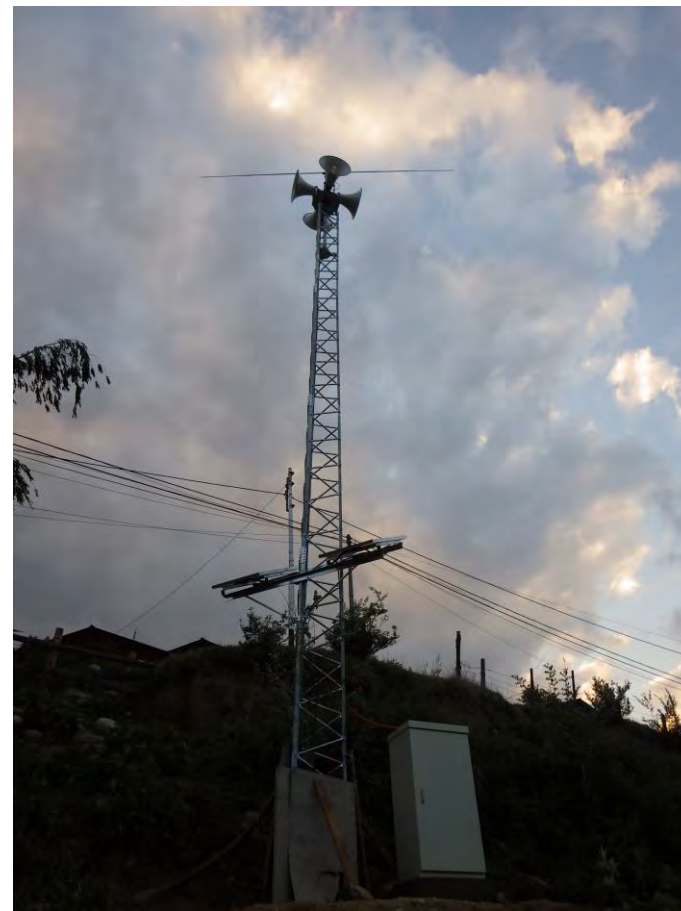
Siren Tower with Solar Panel and Outdoor Equipment Rack (Sample for reference)

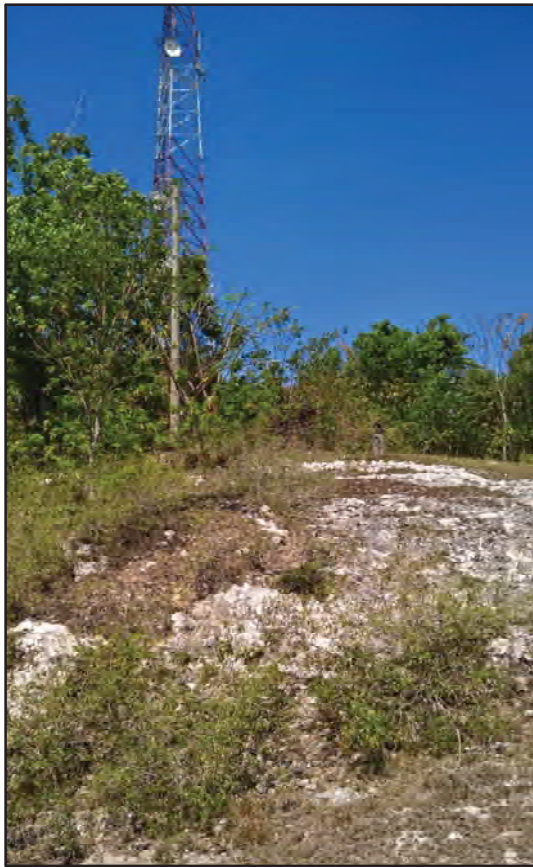
An outcrop sample taken from this site indicates it is a coralline limestone with benthic forams. It is a grain stone representing possibly the Coastal Group or the impure limestones of the Yellow Limestone Group (Fisher and Mitchell 2012). This area has not been adequately studied and as such no references are found in literature.

Figure 11. Picture showing outcropping of bedrock at the Mt. Airy Tower site

Soil development at the target site in the Mount Airy area is poor to non-existent with limestone bedrock outcropping extensively. At the tower site the surface is covered by a thin, loose layer of alluvial aggregate (gravel with sand), spread over the working area within a perimeter fence.

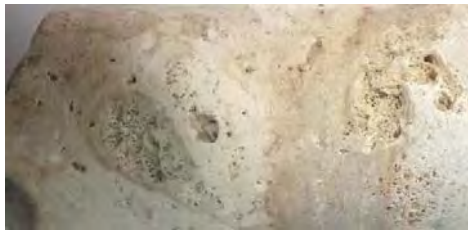
| Description | | Photo-documentation |
|---|---|---|
| Colour | Creamish white | |
| External Features | Cavities (small vugs) | |
| Mineralogy | Calcite | |

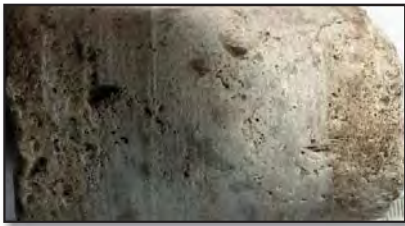
| Description | | Photo-documentation |
|---|---|---|
| Colour | Creamish white | <p style="text-align: center;">1cm</p> |
| External Features | Cavities (small vugs) | |
| Mineralogy | Calcite | |

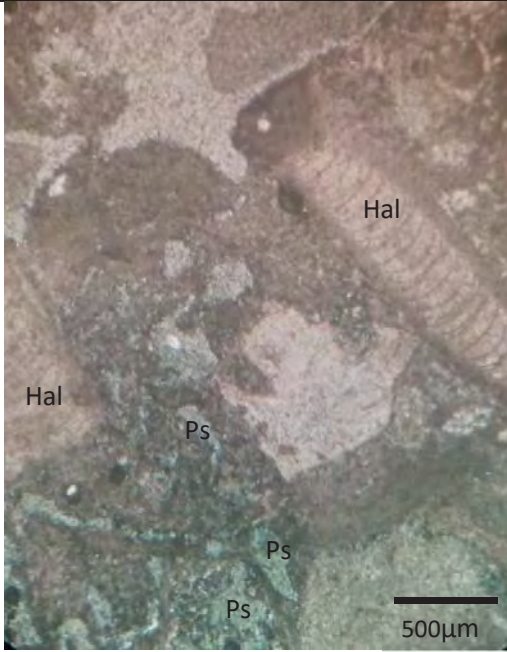
| Description | | Photo-documentation |
|---|---|---|
| Dunham Classification | grainstone | |
| Porosity | high | |

| Fossils | Benthic Foram,<br>algae | |

Comments: The sample is an algae foraminiferal biosparite. The presence of algae and benthic foraminifera makes the limestone a shallow water limestone. The sample is consolidated as the allochems are cemented to each other by calcite cement. There is pore space between allochems (fossils).

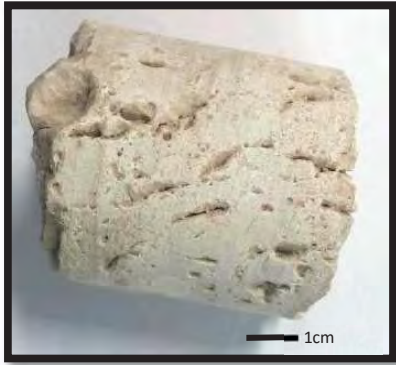
| Description | | Photo-documentation |
|---|---|--|
| Colour | Cream | |
| External Features | Cavities (small vugs) about a ≤ 5mm | |
| Mineralogy | Calcite | |

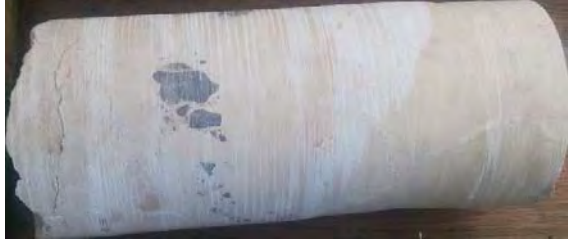
| Description | | Photo-documentation |
|---|---|---|
| Colour | Creamish white | |

| External Features | Chert nodules, calcite veins | <p>2cm</p> |
| Mineralogy | Calcite, Chert | |
| Allochems | No visible fossils or other allochems | |

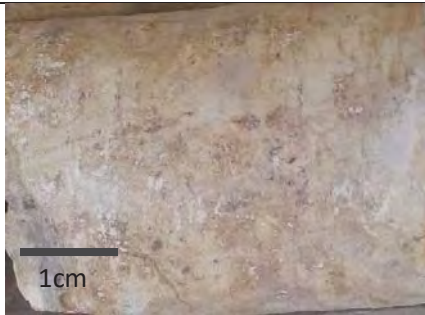
| Description | | Photo-documentation | |
|---|---|--|--|
| Colour | Creamish white | | |
| Mineralogy | Calcite | | |

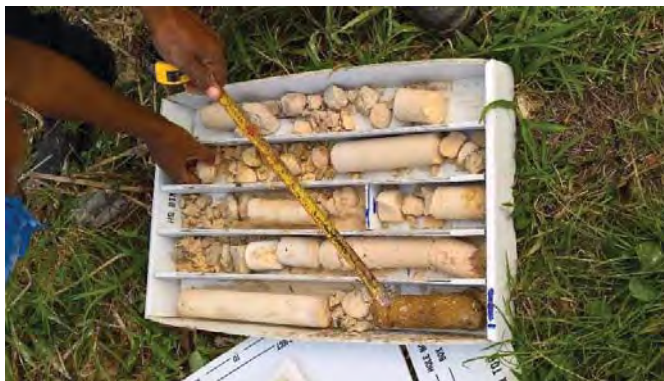
A single borehole was cored to a depth of 4.9 metres and core recovery averaged 93.7 percent while the RQD<sup>2</sup> ranged from 11.7-47.0 percent. (See fig. 23). Initially 0.7 metres of brown clay mixed with some gravel material was encountered atop the limestone rock. The Limestone was cream to light grey in colour and tended to be moderately hard and moderately fractured with some slightly weathered areas. (See fig.24). There were also small cavities infilled with either clayey or sandy material encountered within the top and bottom 1.5 metre runs. The rock sample encountered between depths of 1.8-3.3 metres was the most fractured with a large fraction of cobble sized fragments returned.

Figure 23 Picture showing core samples collected from Shafton, Westmoreland

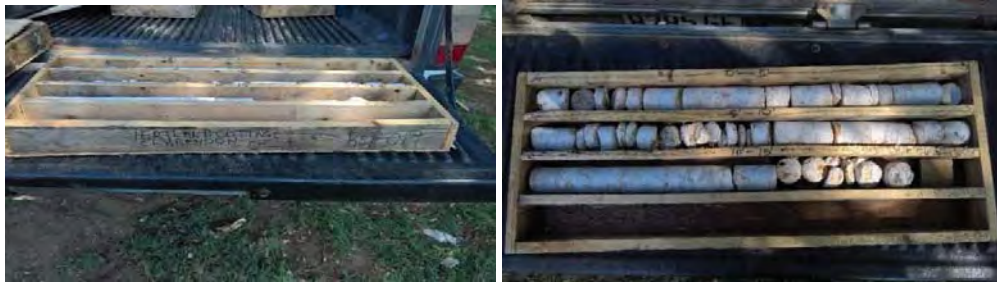
A single borehole was cored to a depth of 4.6 metres and core recovery averaged 50 percent while the RQD<sup>3</sup> ranged from 10-25 percent. (See fig.26). The rock core sample won from this site indicates that the bedrock at this site remains relatively unchanged from the medium hard cream limestone that was encountered at surface. (See fig. 27). Some fracturing of core was evident.

Figure 27 Pictures showing core samples collected from Portland Cottage, Clarendon

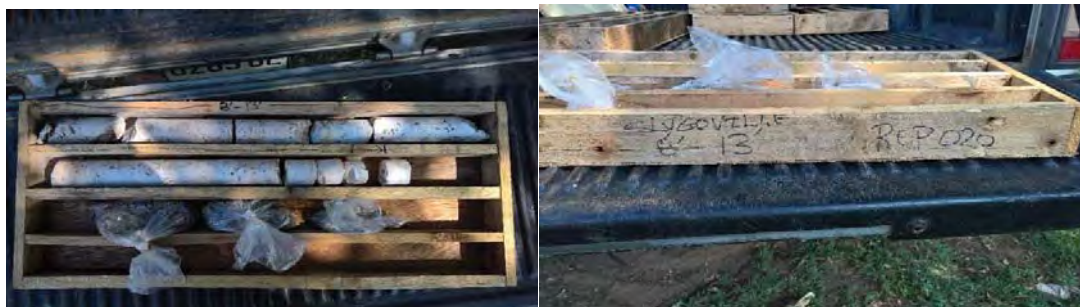
A single borehole was cored to a depth of 4.3 metres and core recovery averaged 81 percent while the RQD<sup>4</sup> was 50.0 percent. (See fig. 29). Boring initially encountered 0.3 metres of a gravel fill. The boring then transitioned to a hard brown silty clay with some sand and gravel which increased in density and compaction until refusal at eight feet / 2.4 meters. Grain size distribution analysis indicates that this horizon is a well-graded gravel with sand. This granular material overlaid a hard cream coloured limestone. (See fig. 30). A low to moderate void density was observed in limestone with very little fracturing.

Figure 30 Picture showing core samples from borehole at Sligoville, St. Catherine

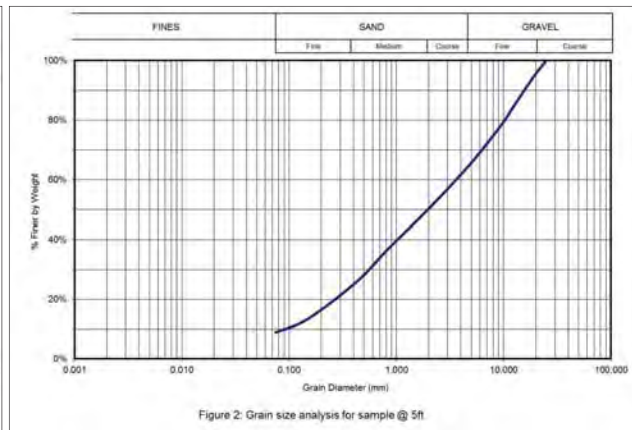
Individual gran size distribution graphs are presented below. A summary report showing all graphs and the moisture content determination can be seen in the Appendices attached. Grain size distribution graphs below indicate a fining upward sequence of the sands within the first 8ft.

Figure 33. Grain size distribution graphs for sieve analyses done @ 2ft 6", 5ft & 7ft 6"

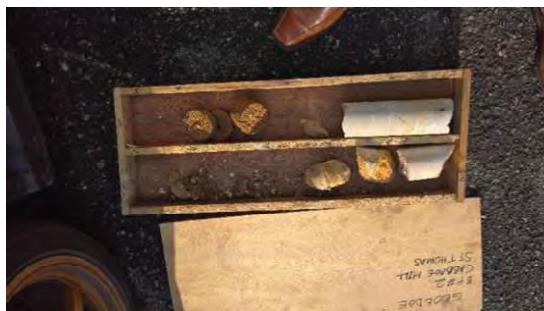
A single borehole was cored to a depth of 2 metres using concrete coring machine which did not produce reliable results to calculate core recovery. (See fig. 35). RQD<sup>5</sup> was however recorded at 60.0 percent.

Figure 36 Picture showing core samples collected from borehole, Cabbage Hill, St. Thomas

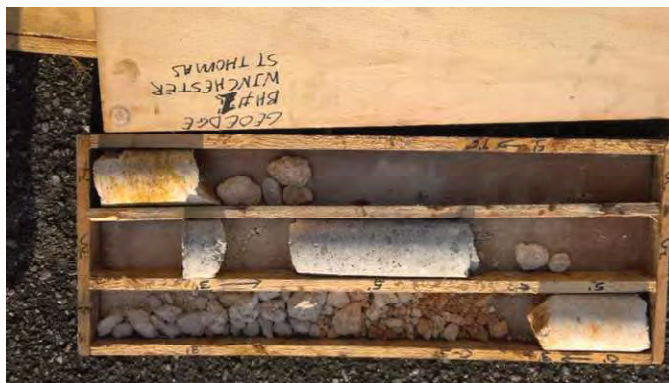
Figure 41 Picture showing core sample collected from borehole, Winchester, St. Thomas
