資料一6 サイト調査結果一覧(無線端末設置候補地)

6. サイト調査結果一覧(無線端末設置候補地)

PROJECT NAME	EXECUTING AGENCY	TITLE	SCALE	DATE	DESIGNED	CHECKED	APPROVED	DWG No.
The Project for Improvement of Emergency Communication System in Jamaica	ODPEM	Overall of DECOM System	---	Apr. 2016	K. Harikae	K. Tanaka	T. Kobayashi	DS-01
				YACHIYO ENGINEERING CO., LTD. TOKYO, JAPAN

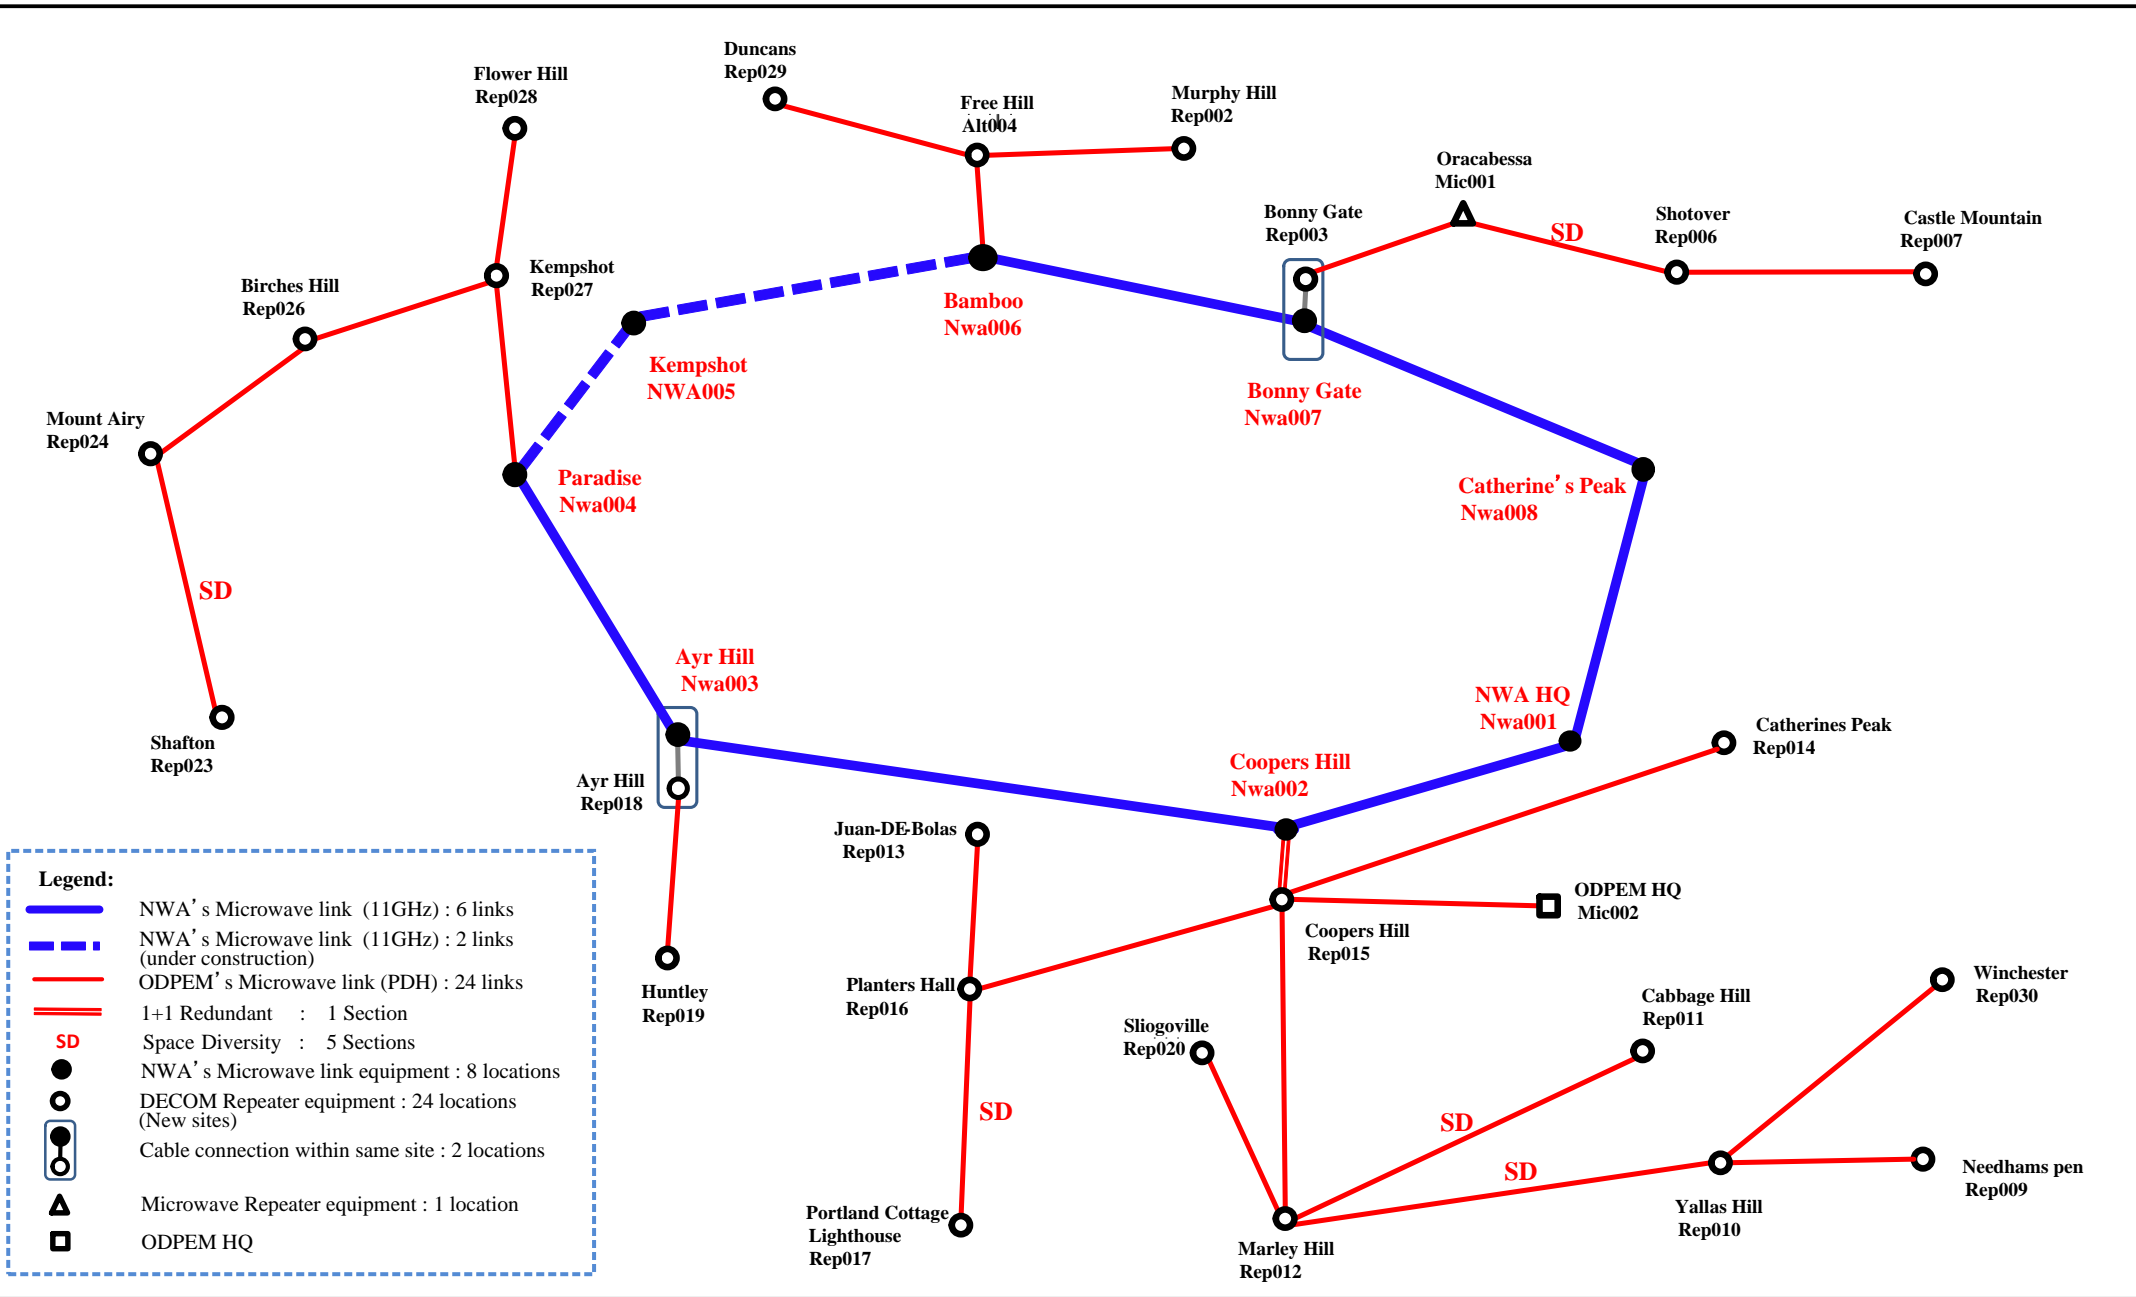
A-8-V

PROJECT NAME	EXECUTING AGENCY	TITLE	SCALE	DATE	DESIGNED	CHECKED	APPROVED	DWG No.
The Project for Improvement of Emergency Communication System in Jamaica	ODPEM	Network Diagram of DECOM	---	Sep. 2016	K. Harikae	K. Tanaka	T. Kobayashi	DS-02
				YEC YACHIYO ENGINEERING CO., LTD. TOKYO, JAPAN

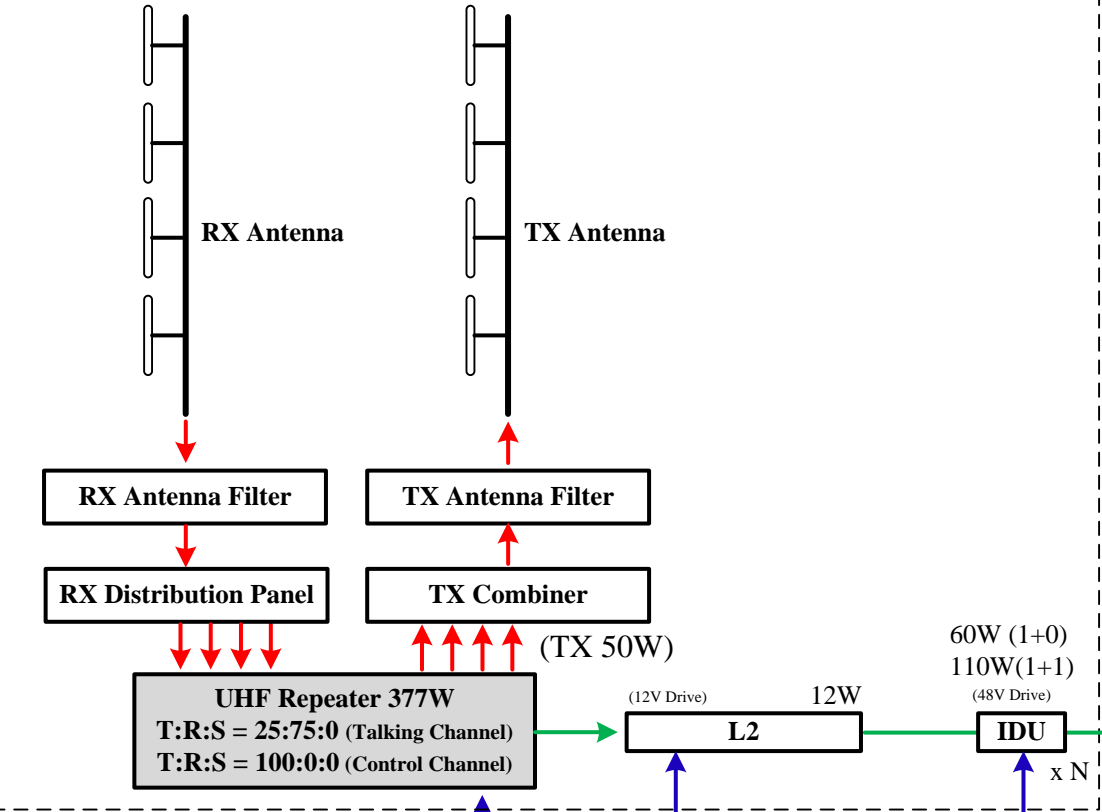
1.1 (1) Fixed UHF Repeater Station (4ch Type)

Legend
 LVD : Low Voltage Disconnect
 NFB : Non Fuse Breaker
 TX : Transmitter
 RX : Receiver

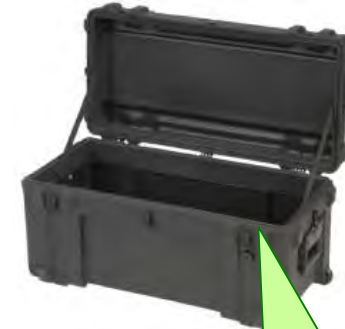
Carton No.4 (Cable & Accessory)

1.3 (3) Portable Radio Station for Community
Cables and Others

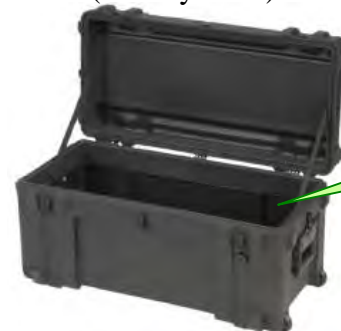
Carton No.6 (Battery Case)

1.3 (3) Portable Radio Station for Community
4) Power Supply System

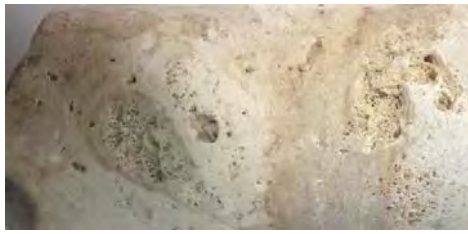
Description		Photo-documentation
Macroscopic		
Colour	Creamish white

<p>1cm</p>
External Features	Cavities (small vugs)	
Mineralogy	Calcite	
Allochems	fossils (corals)	
Spar cement or Mud	Spar	
Microscopic		
Folk Classification	biosparite

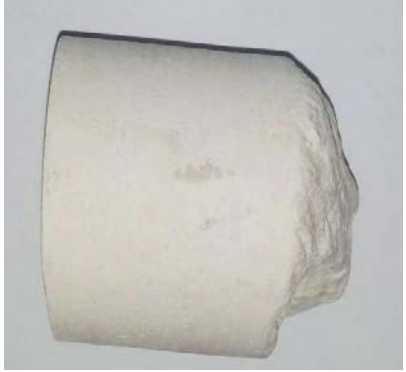
Sample ID : No ID _(9ft)

Description		Photo-documentation
Macroscopic		
Colour	Cream

External Features		
Mineralogy	Calcite	
Allochems	No visible fossils or other allochems	
Spar cement or Mud	Mud	
Microscopic		
Folk Classification	Biomicrite	
Dunham Classification	Wackestone	
Porosity	Low	
Fossils	Planktonic Foram (high percentage) Benthic Foram (low percentage)

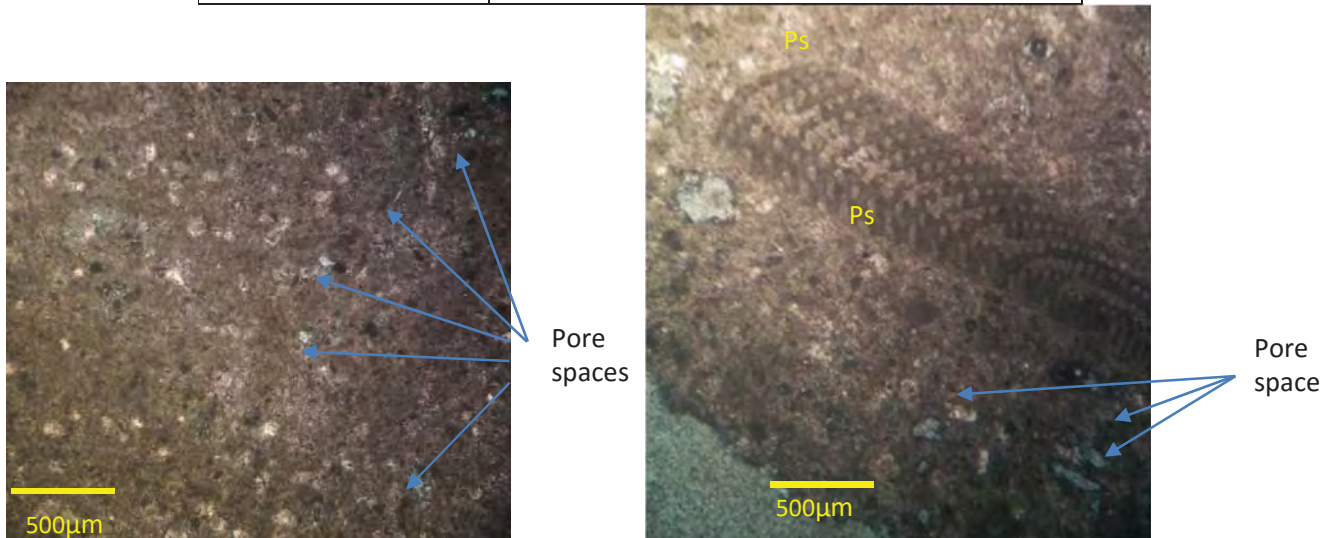
Figure 18 Photo micrograph of sample showing (5) micrite with pore spaces and sample showing (6) Foraminifera (F) within micrite matrix with pore spaces indicated by blue dye

Microscopic	
Folk Classification	Dismicrite
Dunham Classification	Mudstone
Porosity	moderate

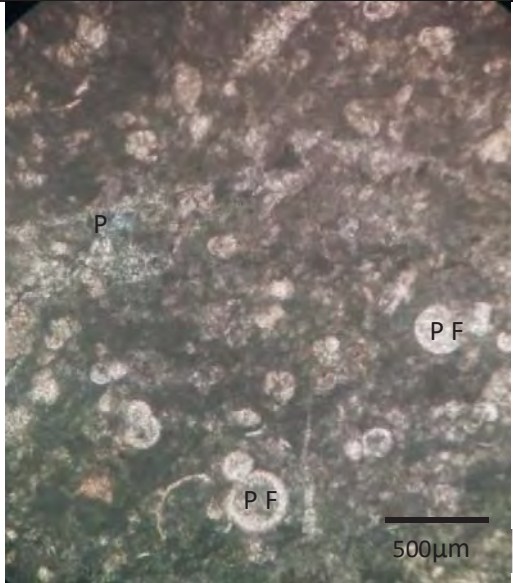
<p>500µm</p> <p>Photo micrograph of sample showing recrystallized Planktonic Forams (PF) within micrite matrix</p>
Dunham Classification	Wackestone	
Porosity	moderate	
Fossils	Planthic Foram	
Other	Veins with recrystallized calcite, chert

Comments: The sample is a deep water limestone which is term chalk. Deep water limestone due to high percentage of planktic Foraminifera as well as chert. The sample is consolidated, which may be due to presence of microcrystalline silica (chert) making the sampling harder. Pore space is observed between the cert and the chalk interface.

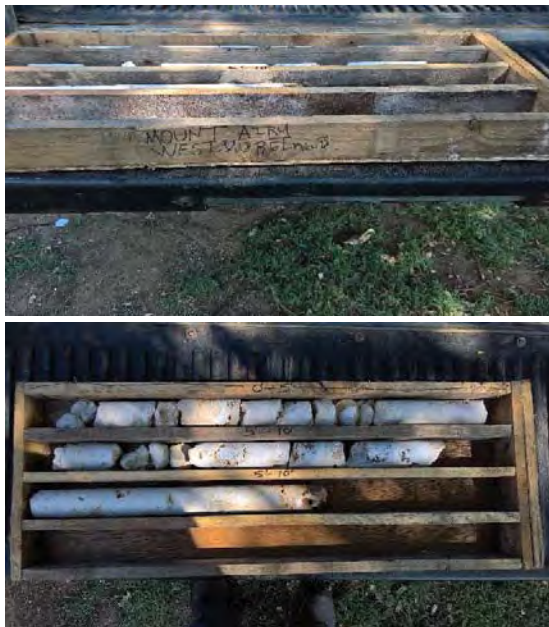
Figure 21 Picture showing core samples collected from borehole, Mt. Airy, Westmoreland

A single borehole was cored to a depth of 3.1 metres and core recovery averaged 58.3 percent while the RQD¹ ranged from 25-40 percent. (See fig.21). Initially the coring encountered a creamish calcareous coarse fine sand and gravel which transitioned to a medium cream porous limestone at three feet (3ft). The rock formation remains relatively unchanged downhole, (see fig.22). The rock sample exhibited a number of small voids filled with calcite and trace amounts of clay within sections of the core.

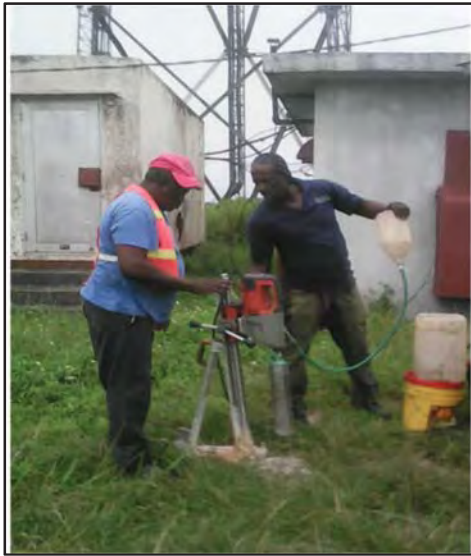
As planned for similar tower sites, boring should have been achieved with use of drill rig employing HQ coring rods. The equipment that was earmarked for use was a truck mounted Mobile B40 drill rig. On the days that the boring was attempted occurred shortly after a number of days of consistent, heavy rainfall. Due to the extremely steep and unstable slopes, narrow unpaved road network, and prolonged torrential rainfall, access to the site using a mobile B40 truck-mounted drill rig proved futile. In addition, access to the site by a water truck was also a major challenge. Due to the inaccessibility, a portable coring machine was employed to carry out subsurface drilling.

Figure 35. Picture showing use of coring machine at Cabbage Hill, St. Thomas

A single borehole was cored to a depth of 2 metres using concrete coring machine which did not produce reliable results to calculate core recovery. (See fig. 35). RQD⁵ was however recorded at 60.0 percent.
