- APPENDIX A1 - EXPLORATION LOGS – MOUNT AIRY, WESTMORELAND**
- APPENDIX A2 - LAB REPORT – MOUNT AIRY, WESTMORELAND**
- APPENDIX A3 - PETROGRAPHIC ANALYSIS – MOUNT AIRY, WESTMORELAND**

| Project Upgrade of Emergency Communication System, Jamaica. | | NQ Coring & 95.25mm HAS |

REPORT ON ROCK STRENGTH TESTS:

| Project: Repeater Station Soil Investigation | Report No. G/805/01494 |

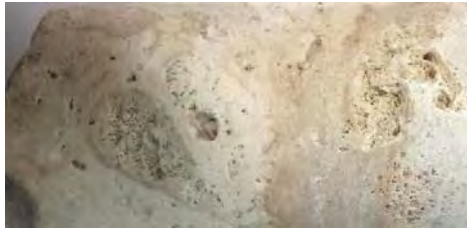
Sample ID: Mt. Airy (5ft)

| Description | | Photo-documentation |
|---|---|---|
| Colour | Creamish white | <p>1cm</p> |
| External Features | Cavities (small vugs) | |
| Mineralogy | Calcite | |

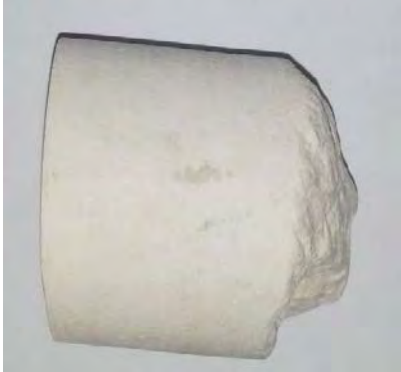
| Description | | Photo-documentation |
|---|--|--|
| Colour | Cream | <p style="text-align: center;">1 cm</p> |
| External Features | | |
| Mineralogy | Calcite | |

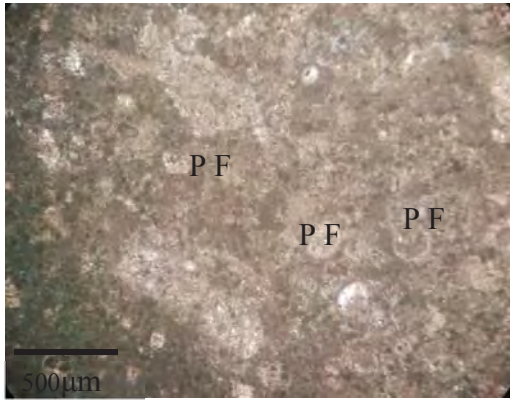
| Description | | Photo-documentation |
|---|--|--|
| Folk Classification | Biomicrite | <p style="text-align: center;">Photo micrograph of sample showing Planktonic Forams (PF) within micrite matrix</p> |

Comments: The sample is a deep water limestone which is term chalk. Deep water limestone due to high percentage of planktonic Foraminifera while low benthic Forams content. The sample is poorly consolidated, which makes water absorption high

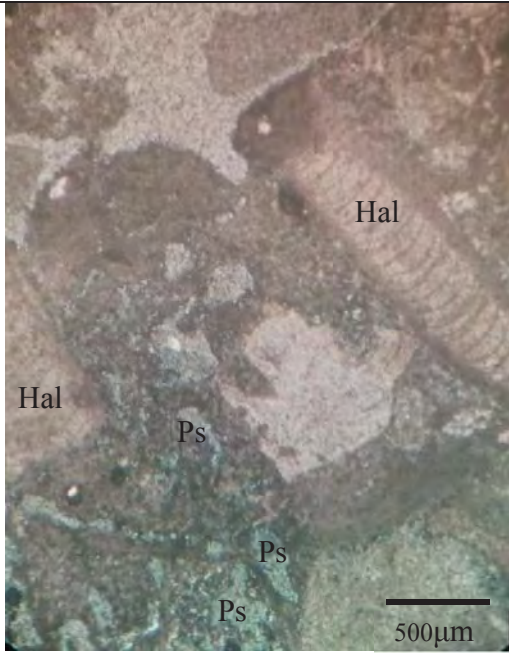
Portland Cottage

| Description | | Photo-documentation |
|---|---|---|
| Folk Classification | biosparite | |
| Dunham Classification | grainstone | |
| Porosity | high | |

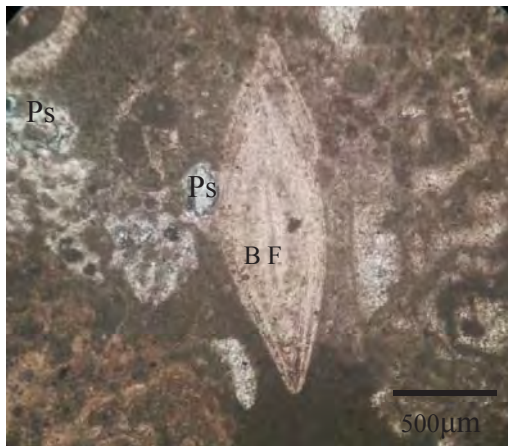
Photo micrograph of sample showing Benthic Forams (BF) within micrite matrix. Pore spaces (Ps) are observed indicated by the blue dye

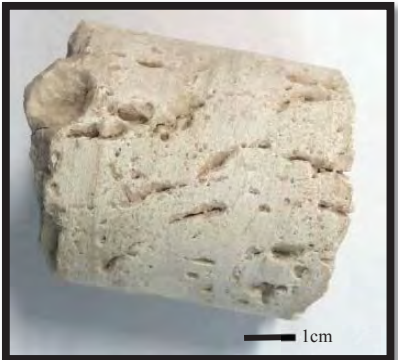
Sample ID: Sligoville 8-13' A

| Description | | Photo-documentation |
|---|---|---|
| Colour | Cream | |
| External Features | Cavities (small vugs) about a $\leq 5\text{mm}$ | |
| Mineralogy | Calcite | |

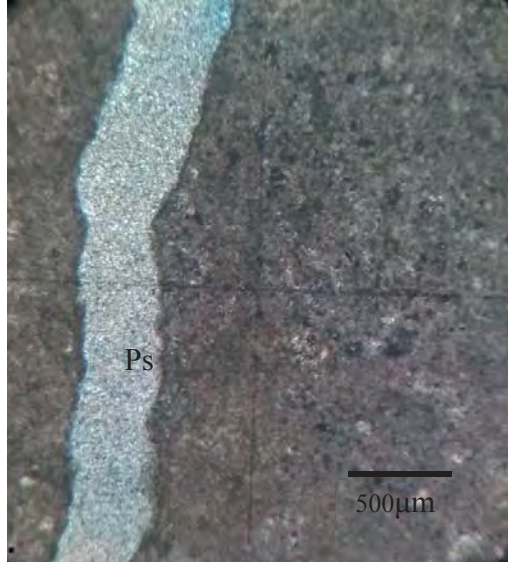
| Description | | Photo-documentation |
|---|---|---|
| | | <p>Photo micrograph showing sample in plane polarized light with large cavity</p> |

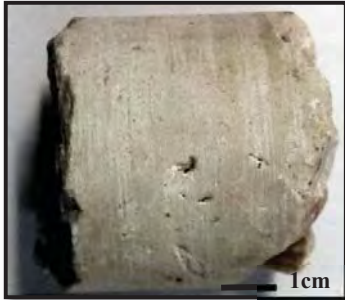
| Description | | Photo-documentation |
|---|--|---|
| Colour | Cream | |
| External Features | Cavities (small vugs) about a \leq 1mm | |
| Mineralogy | Calcite | |

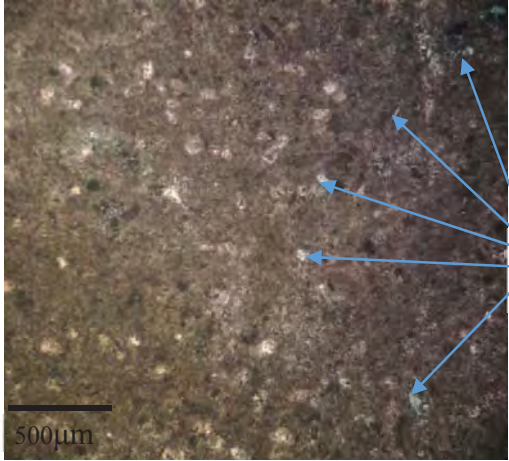
| Description | | Photo-documentation |
|---|--|---|
| | | <p>Photo micrograph of sample showing micrite with pore spaces</p> |

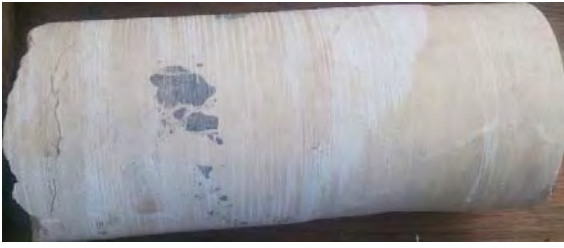
| Description | | Photo-documentation |
|---|--|---|
| Colour | Creamish white | <p style="text-align: center;">— 2cm</p> |
| External Features | Chert nodules, calcite veins | |
| Mineralogy | Calcite, Chert | |

Comments: The sample is a deep water limestone which is term chalk. Deep water limestone due to high percentage of planthic Foraminifera as well as chert. The sample is consolidated, which may be due ro presence of microcrystalline silica (chert) making the sampling harder. Pore space is observed between the cert and the chalk interface.

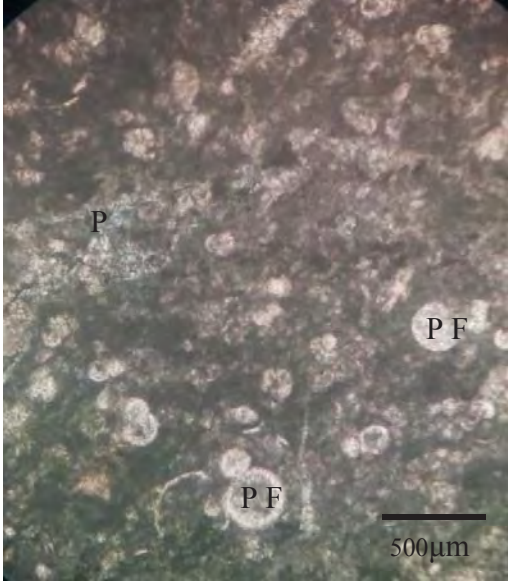
| Description | | Photo-documentation |
|---|--|---|
| Folk Classification | Biomicrite | <p style="text-align: center;">Photo micrograph of sample showing recrystallized Planktonic Forams (PF) within micrite matrix</p> |

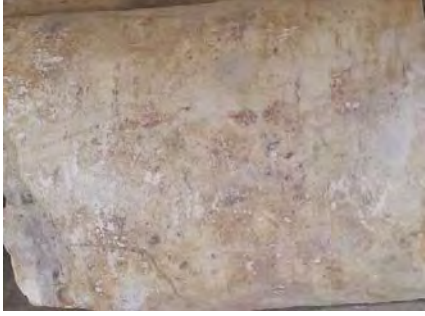
| Description | | Photo-documentation |
|---|---|---|
| Colour | Creamish white | <p style="text-align: center;">1 cm</p> |
| External Features | | |
| Mineralogy | Calcite | |

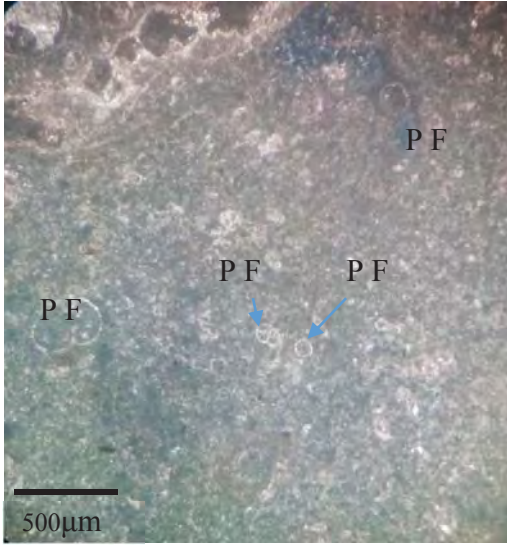
| Description | | Photo-documentation |
|---|---|---|
| Folk Classification | Biomicrite | <p style="text-align: center;">500µm</p> <p style="text-align: center;">Photo micrograph of sample showing Planktonic Forams (PF) within micrite matrix</p> |

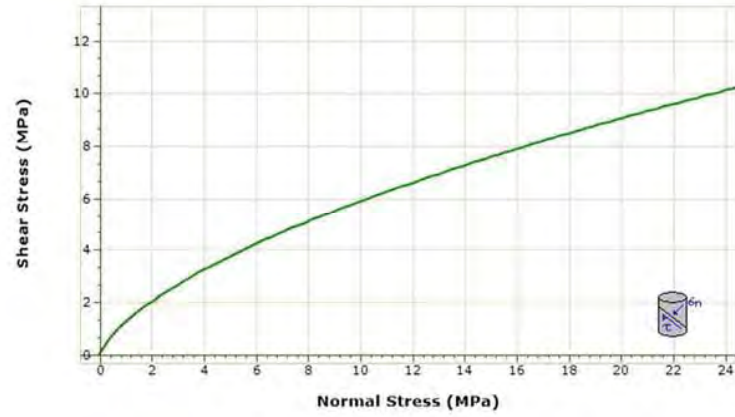
— Winchester Sample - Principal Stress Envelope
 — Winchester Sample - Shear vs. Normal Stress Envelope

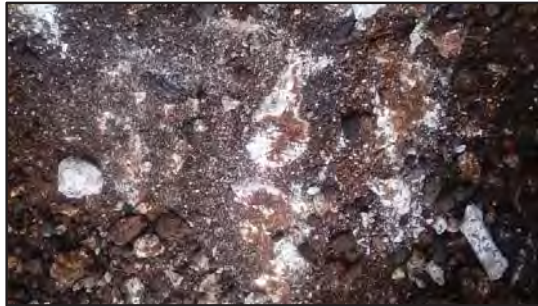
Figure 5. Picture showing bedrock at the Shotover Tower site

The geology of the Shotover district is defined by the dominance of Gibraltar Bonnygate Limestone formation that is the primary lithological unit in the area. It is an Eocene Age White Limestone formation and is composed of evenly bedded white micrites typically chalky and porous. These white chalky limestones contain planktonic foraminifera such as *Porticulasphaera mexicana* and *Hantkenina alubamensi* in the lower sequences and *Globigerina ampliaptarec* in the upper sequences. Bioclastic layers include *Lepidocyclina pustulosa* and *L. chaperi* at the lower levels and *L. yurnagunesis*, *L. undosa* and *Pararotolia* sp. towards the top

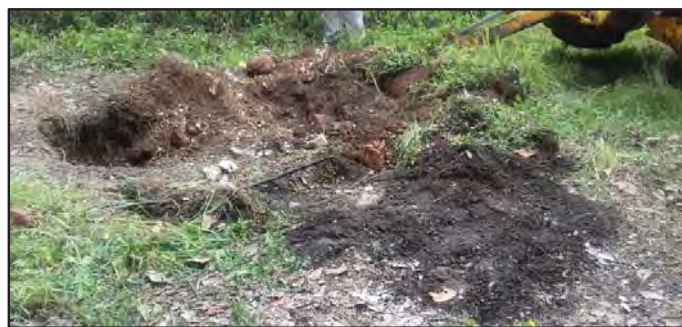
Figure 7 Picture showing unearthed soil at site

At the site within the fenced area the ground is covered with a thin, dark organic matter which lies just below the vegetation which quickly transitions to a yellow-brown stony (limestone gravels and pebbles) loam. The soil development here however reflects some modification to the original soil horizons as a top layer of gravels, which consist of a darker gravelly layer, is reminiscent of the local supply of alluvial aggregate sourced from nearby rivers. (See fig 7). Particle size distribution analysis indicate a poorly graded gravel. The site is covered by a fairly thick undergrowth of short grasses. The surrounding hillside exhibits a similar poor soil development supporting irregular subsistence farming

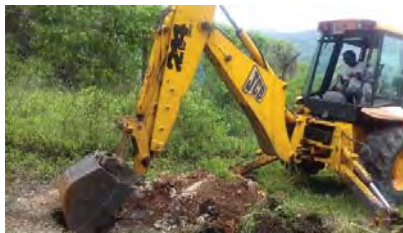
Figure 9 Picture of equipment used in digging of geological pit

A single borehole was dug through topsoil for approximately one meter through the top and lower soil horizons. A hard limestone was then encountered. This limestone represents a cap (hardened / recrystallized limestone) typical relict karstified surface found in similar geology in Jamaica. Drilling was attempted until refusal then a bucket excavator/ bucket loader (JCB 214) was employed to dig a geological pit to give access to lower horizons.
