スリランカ国  
土砂災害対策強化プロジェクト  
中間レビュー報告書

平成28年10月  
(2016年)

独立行政法人国際協力機構  
地球環境部

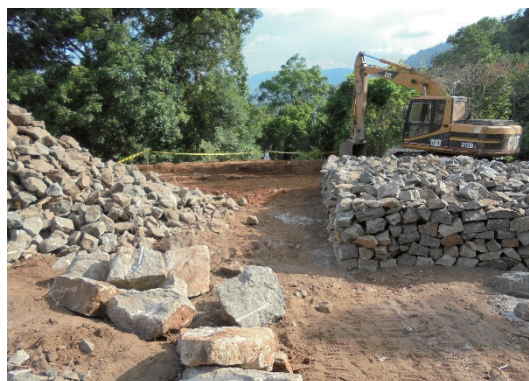
マタレ県の施工現場（落石対策工）

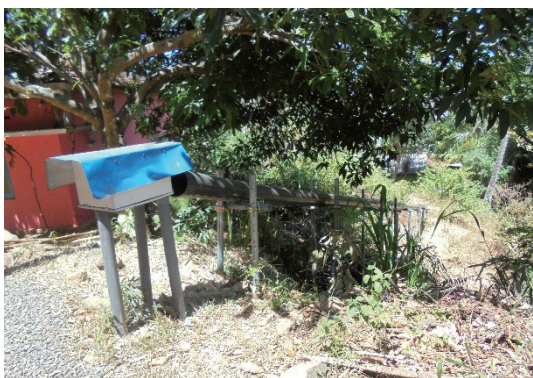
ヌワラエリア県のパイロット地区に設置されている観測機材

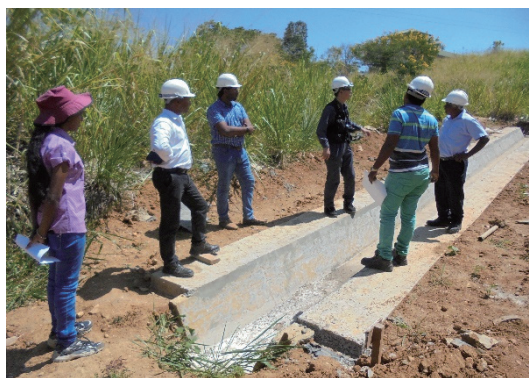
バドゥツラ県の施工現場（地すべり対策工）
