(၂၀၁၅)ခုနှစ်ရေကြီးမှုစစ်တမ်းအစီရင်ခံစာ

Survey Report on 2015 Floods

The Project on Establishment of
End-to-End Early Warning System
for Natural Disaster

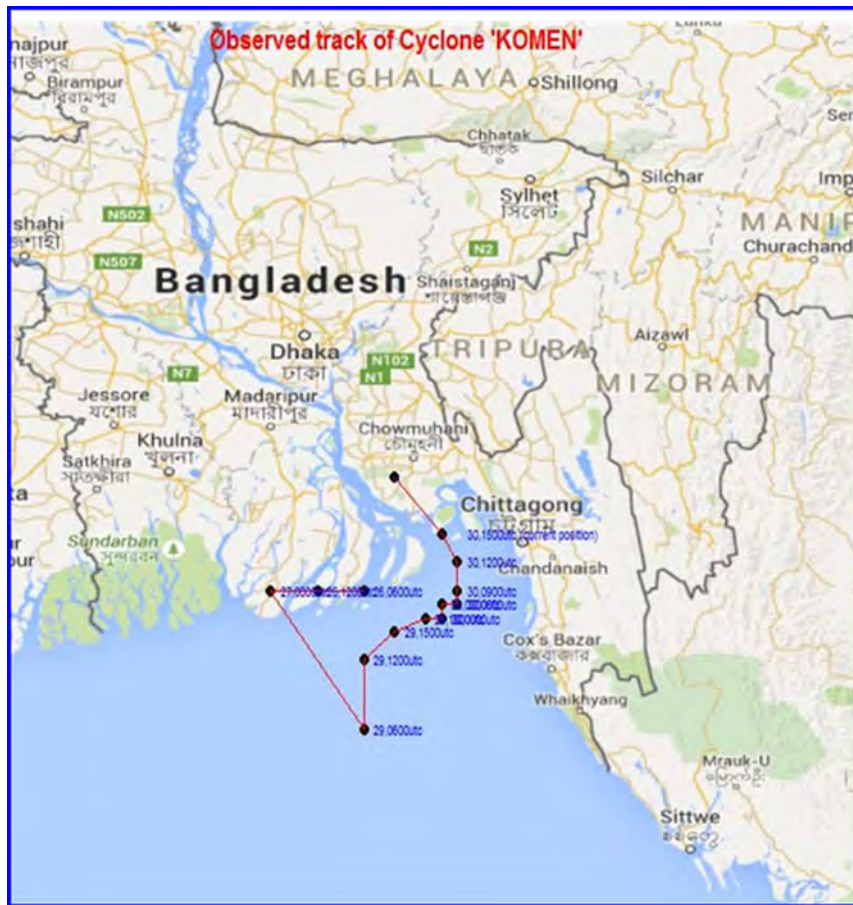
Figure 3-11 Track of Cyclone Komen

In late July, the monsoon trough became very evident, and a *depression* was generated on the 26th of July. In a few days, it developed into a *deep depression* on the 29th, and developed into a *cyclonic storm* on the 30th with a maximum wind speed of 50 mile/hour and a minimum air pressure of 983 hPa. The track of Cyclone Komen shown in Figure 3-11, the daily weather charts and satellite images in Figure 3-12, and the list of warnings on Cyclone Komen in Table 3-1 show how Cyclone Komen developed and how slow it moved. This was the first time that a cyclonic storm developed in the Bay of Bengal in July since 1989, based on the database by the India Meteorological Department.

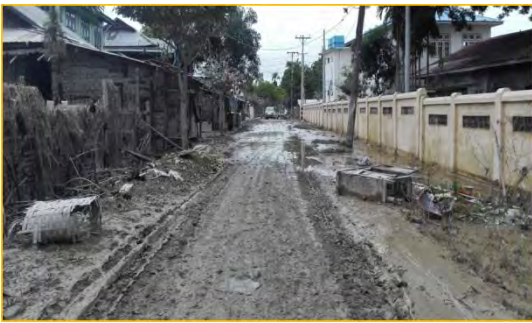
<p>Collapsed bridges in Main way to KaLay Township</p>	<p>Muds in Kalay Township</p>
