(၂၀၁၅)ခုနှစ်ရေကြီးမှုစစ်တမ်းအစီရင်ခံစာ

Survey Report on
2015 Floods

The Project on Establishment of
End-to-End Early Warning System
for Natural Disaster

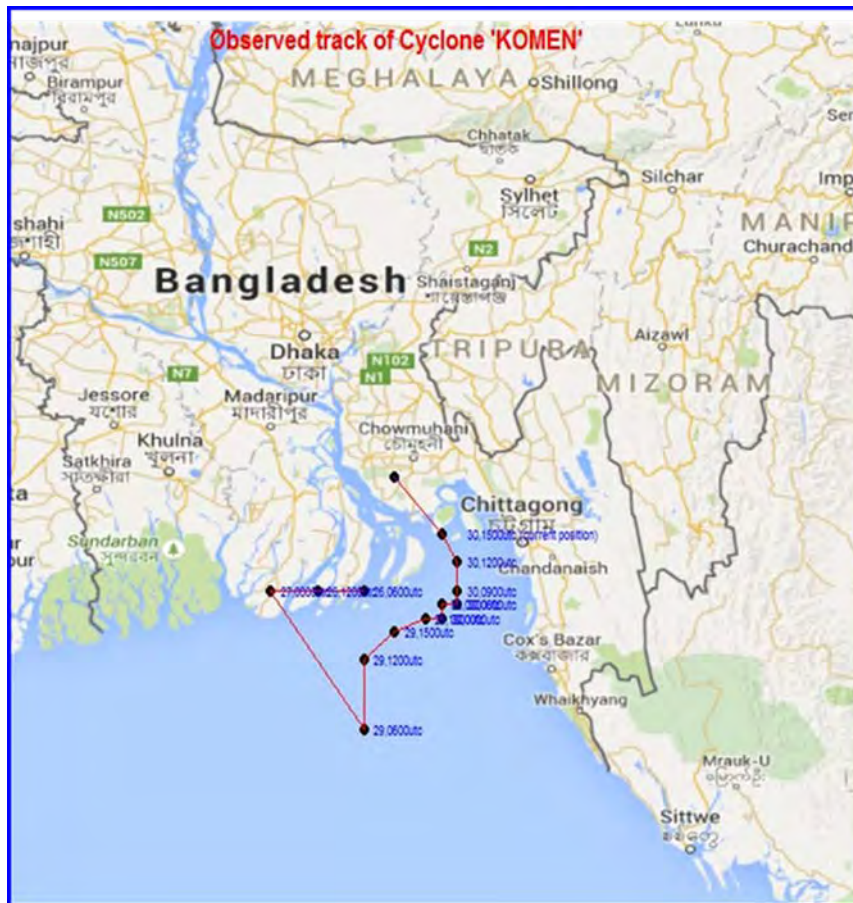
Figure 3-11 Track of Cyclone Komen

In late July, the monsoon trough became very evident, and a *depression* was generated on the 26th of July. In a few days, it developed into a *deep depression* on the 29th, and developed into a *cyclonic storm* on the 30th with a maximum wind speed of 50 mile/hour and a minimum air pressure of 983 hPa. The track of Cyclone Komen shown in Figure 3-11, the daily weather charts and satellite images in Figure 3-12, and the list of warnings on Cyclone Komen in Table 3-1 show how Cyclone Komen developed and how slow it moved. This was the first time that a cyclonic storm developed in the Bay of Bengal in July since 1989, based on the database by the India Meteorological Department.

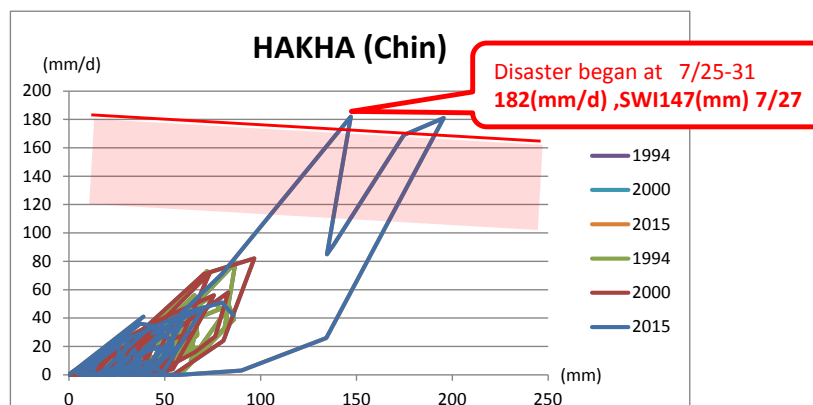
A so-called “snake line” was calculated and drawn by utilizing the daily rainfall data at Hakha station. In addition, the critical line was estimated using the disaster record in 2015. As is shown in the probability analysis, the return period of the rainfall amount in Hakha at the time of disaster is more than 100 years. Since there is a big difference from the conditions with and without disasters, the accuracy of the critical line needs to be improved by the accumulation of disaster records.
