## **資料-11**

#### **(4) 物理探查結果**

## Result of Geophysical Survey and Drilling Points Siting

The Preparatory Survey on the Project for Rural Water Supply Phase III in Lake Kyoga Basin, Eastern Uganda in the Republic of Uganda

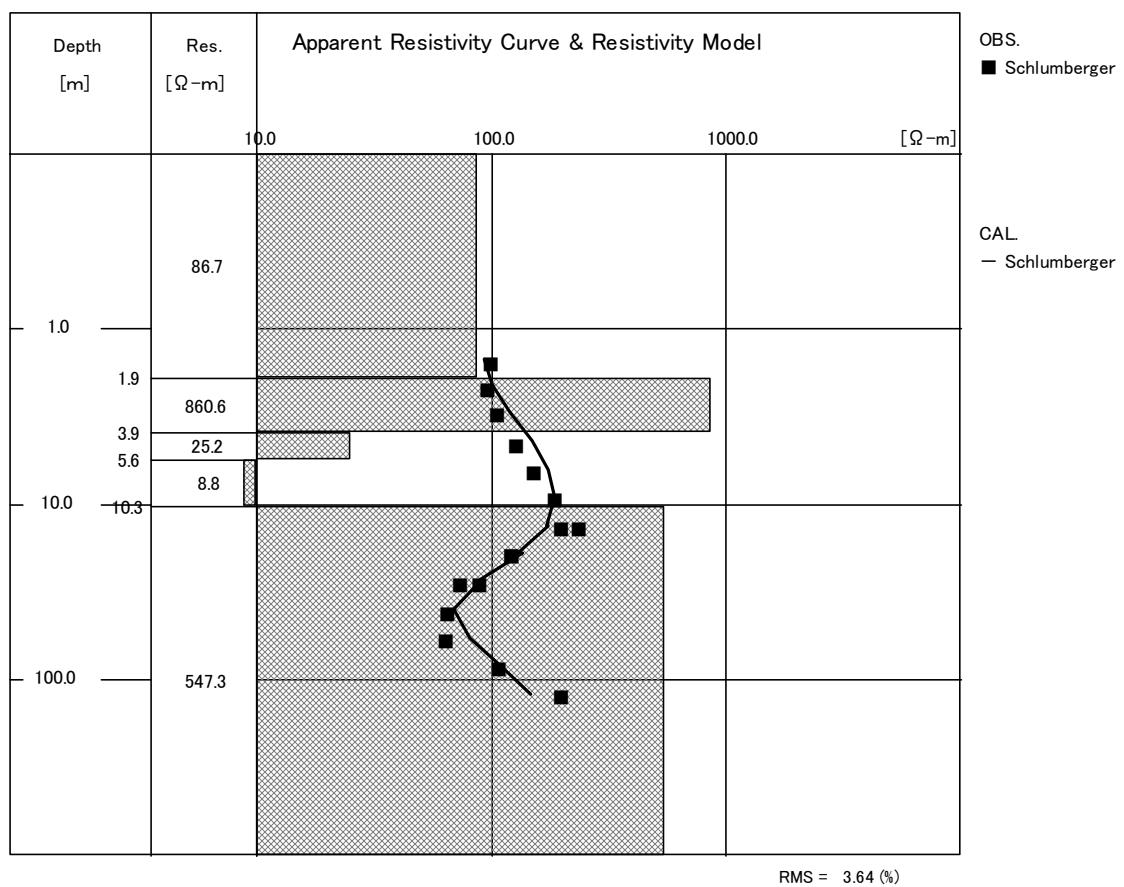
Line Name : P-02-VES-Cal

(3) Vertical Electrical Sounding Result in P-02 Kasassira
