資料-5 ソフトコンポーネント計画書

エチオピア国バハルダール市上水道整備計画
ソフトコンポーネント計画書

資料-7(1) 概略設計図

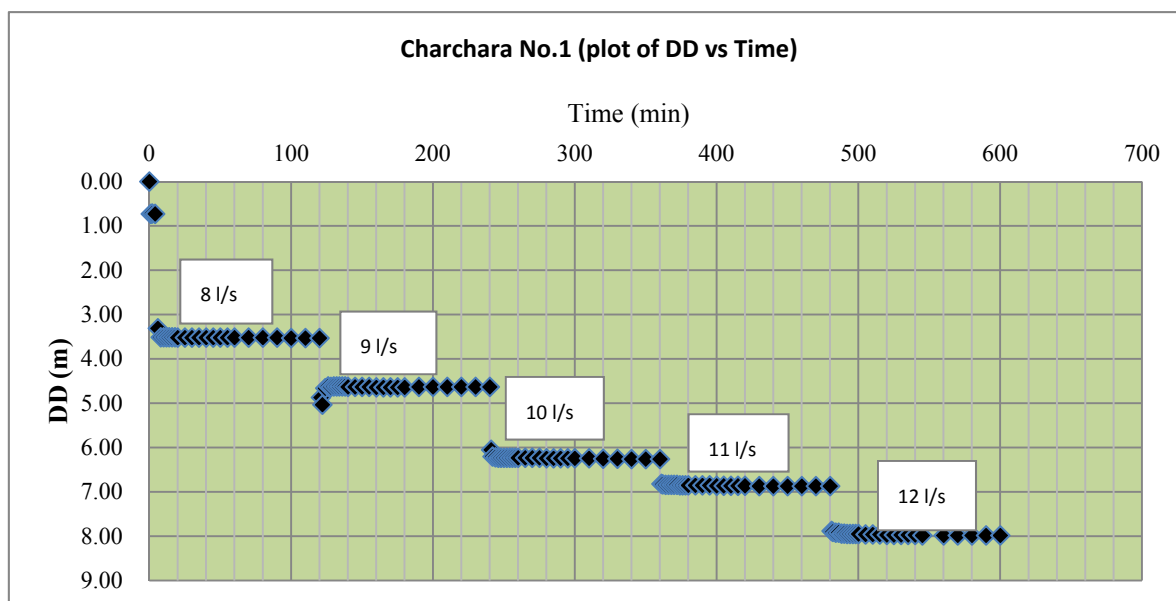
図-1 段階揚水試験結果

段階揚水試験の揚水量は、8、9、10、11、12 L/秒の 5 段階とし、各段階 2 時間の揚水を実施した。各段階の揚水量-水位降下量グラフを図-5 に示す。また、揚水量-水位降下量の両対数グラフを図-6 に示す。

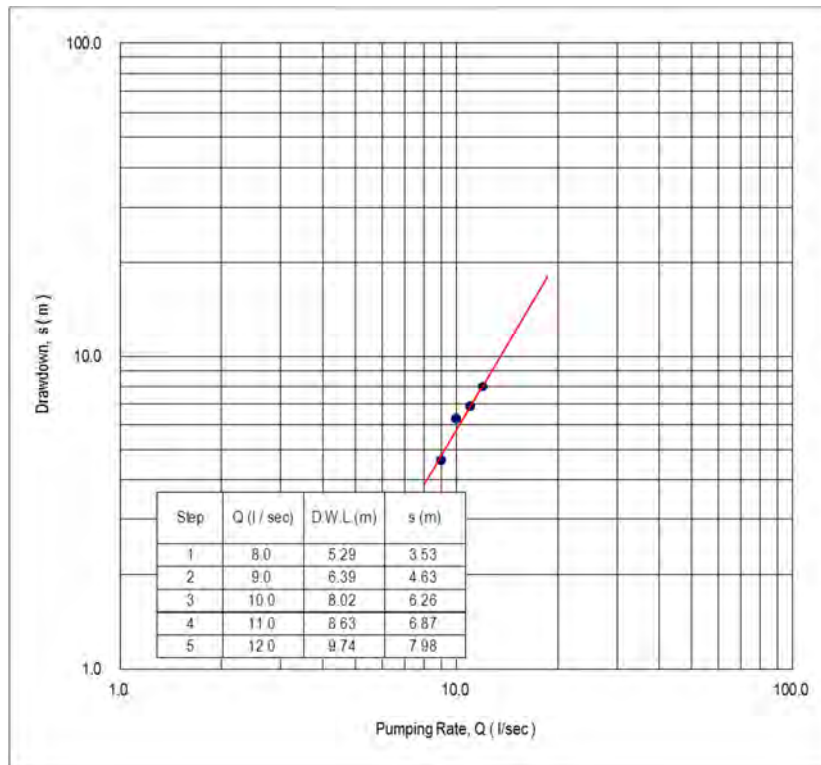
図-2 揚水量－水位降下量

図-2 に示すように、12 L/秒では限界揚水量には達していないものと認識される。しかし、現地ではこれ以上の高い能力のポンプが得られないため、現状では 12 L/秒を限界揚水量と見なすこととする。これから、 $12 \times 0.7 = 8.4$ L/秒 が適正揚水量と見なされる。この井戸では、段階揚水試験の結果から、井戸損失が非常に大きいことが指摘される。

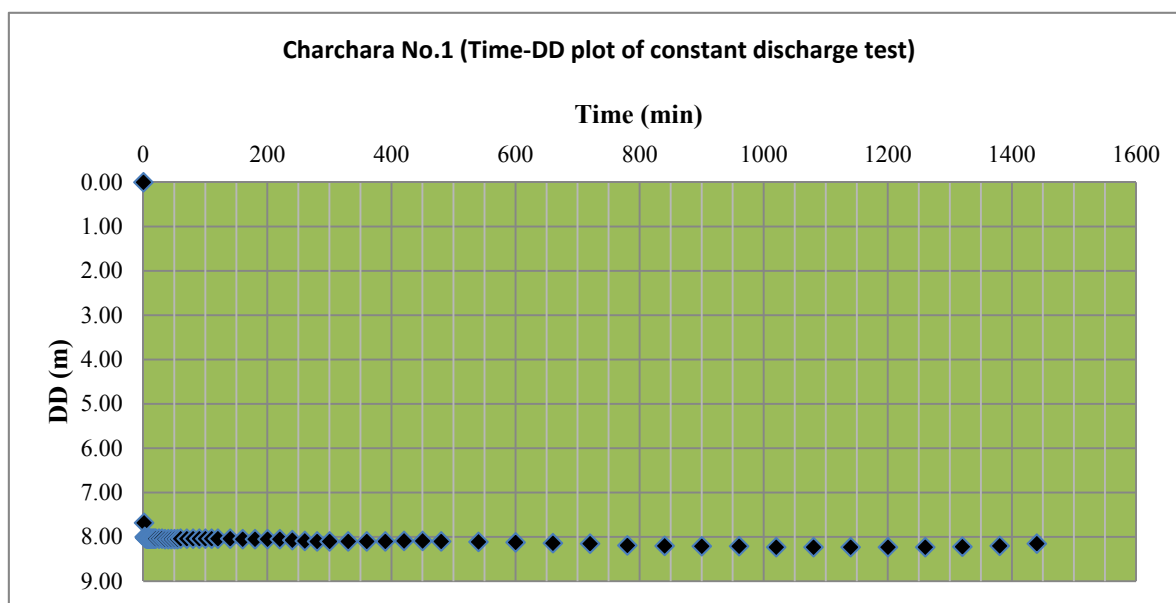
図-3 連続揚水試験結果

最大揚水量の 12 L/秒で 24 時間の連続揚水試験を実施した。その結果を図-3 に示す。最大の水位低下量は 8.23m であった。

24 時間の連続揚水試験の実施中、4 時間を経過した時点で一旦水位低下が落ち着いて、平衡に達したと見られた後に、水位が最大 18cm 低下する現象が見られた。これは、Charchara No.1 井戸の水位低下に伴い影響圏が拡大し、相次いで Charchara No.2、No.3、No.4 井戸の影響圏に達して、それぞれの井戸との干渉による影響があったものと推定される。

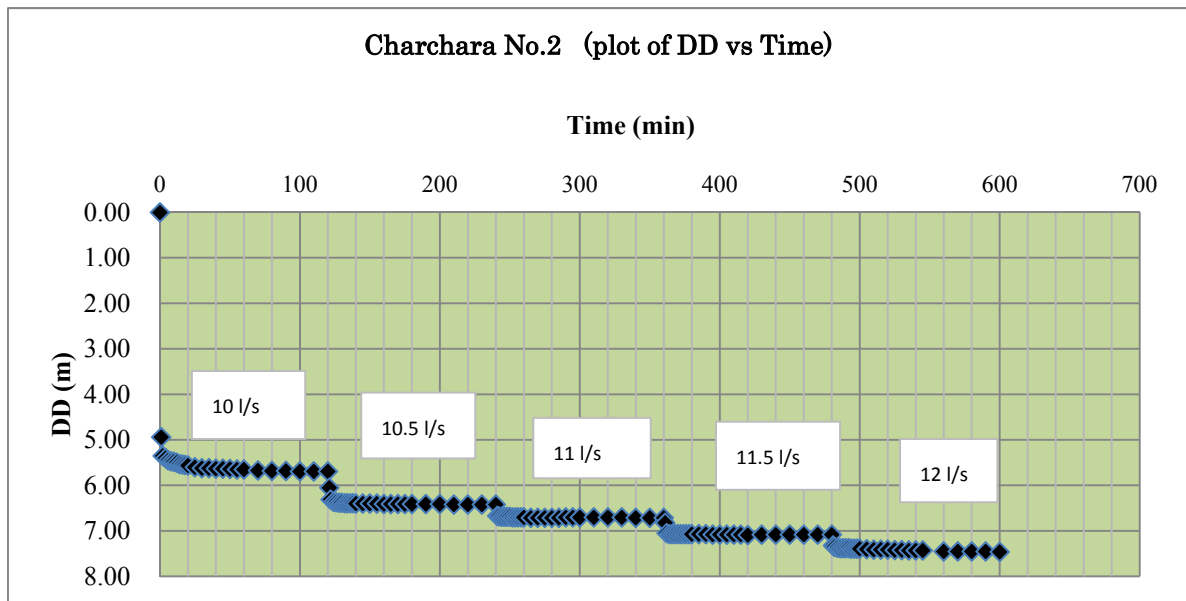
図-4 段階揚水試験結果

予備揚水試験結果から、図-4に示すとおり、揚水量を10.0、10.5、11.0、11.5、12.0 L/秒の5段階とした。また、図-5に揚水量-水位低下量の両対数グラフを示す。

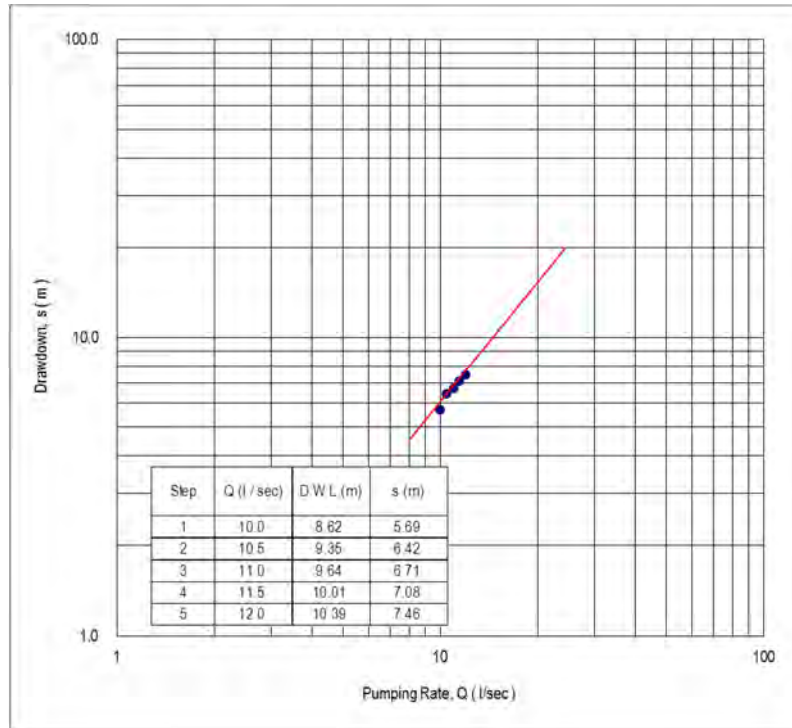
図-5. 揚水量－水位降下量

この結果から、12 L/秒 では、限界揚水量には達していないものと判断される。しかし、現地ではこれ以上容量の大きなポンプが得られないことから、この値を暫定的に限界揚水量と見なすこととする。従って、 $12 \times 0.7 = 8.4$ L/秒 を適正揚水量とする。この井戸の井戸損失は、非常に小さいことが、この段階揚水試験の結果から指摘される。

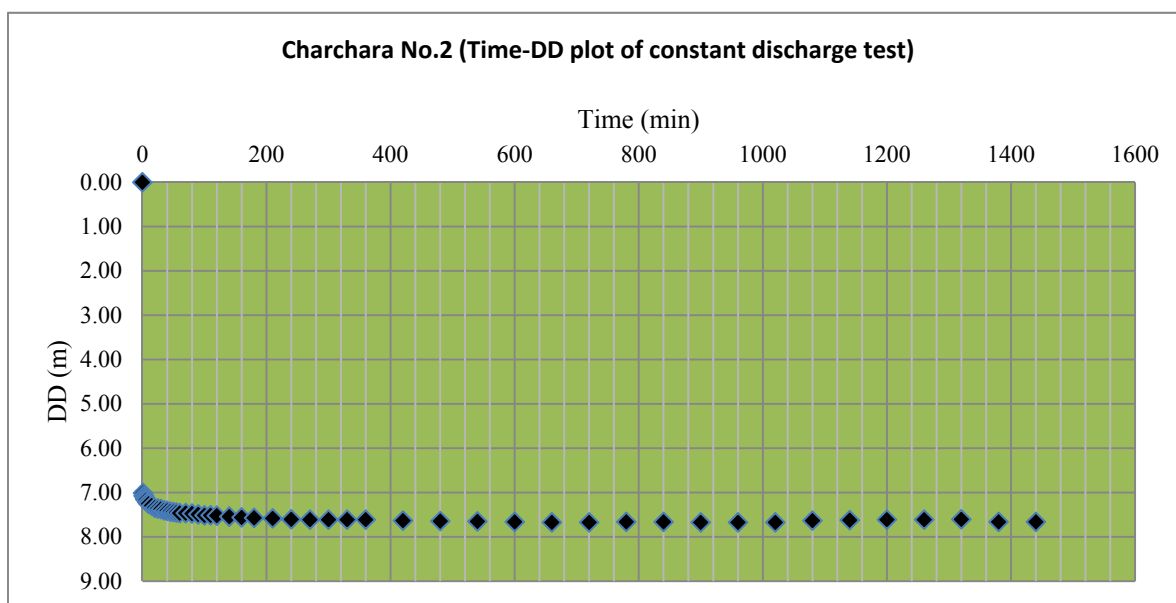
図-6. 連続揚水試験結果

最大揚水量の 12 L/秒 で 24 時間の連続揚水試験を実施した。図-6 に試験結果を示す。

連続揚水試験開始 17 時間後に Charchara No.3 井戸の稼働が停電のため停止すると、Charchara No.2 井戸の動水位が直ちに 4cm 上昇し、22 時間後までに最大 7cm 上昇した。その 23 時間後、Charchara No.3 井戸の稼働が再開すると水位は瞬時に 6cm 低下した。この 6~7cm の水位変動は Charchara No.3 井戸との干渉の影響とみられる。

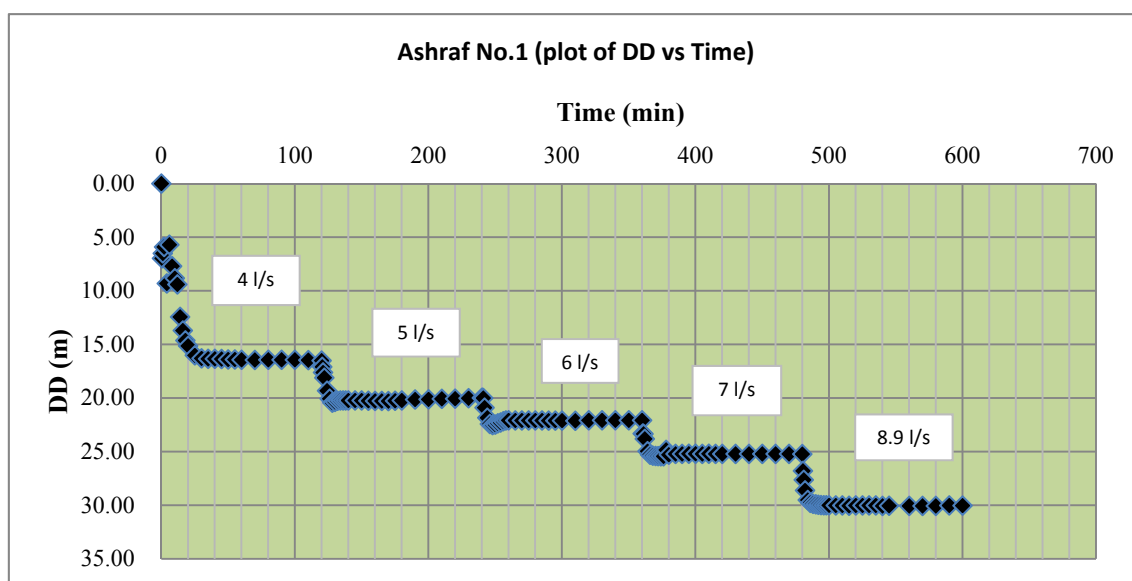
図-7 段階揚水試験結果

段階揚水試験結果を図-7 に示す。また、揚水量－水位降下量の両対数グラフを図-8 に示す。

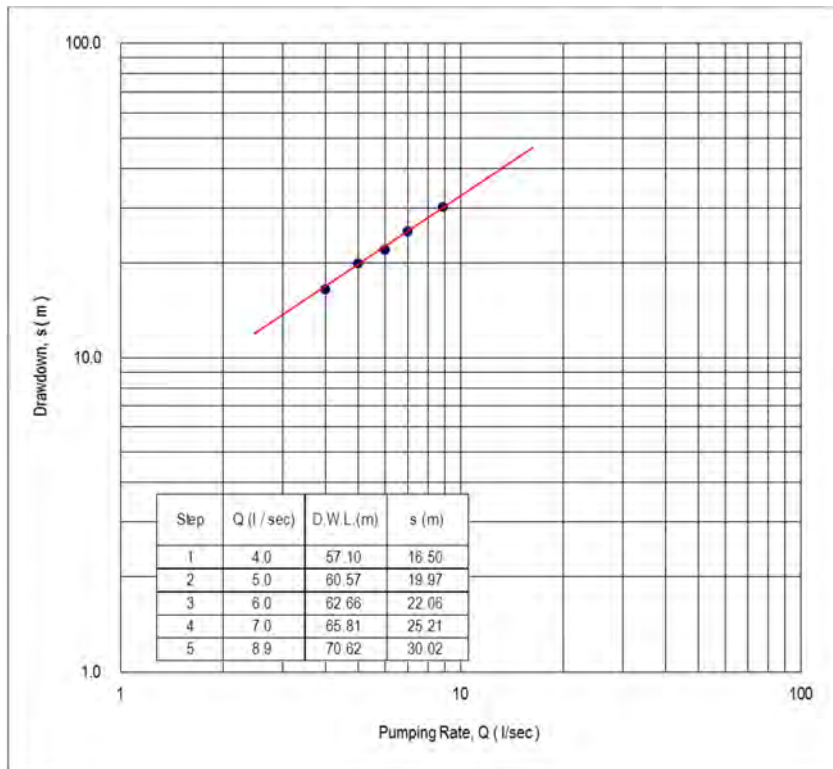
図-8 揚水量－水位降下量

図-8 に示されるように、最大揚水量の 8.9 L/秒 でも限界揚水量に達していないものと見なされる。しかし、より容量の大きなポンプが得られないことから、この値を暫定的に限界揚水量と見なすこととする。従って、適正揚水量は、 $8.9 \times 0.7 = 6.2$ L/秒 となる。

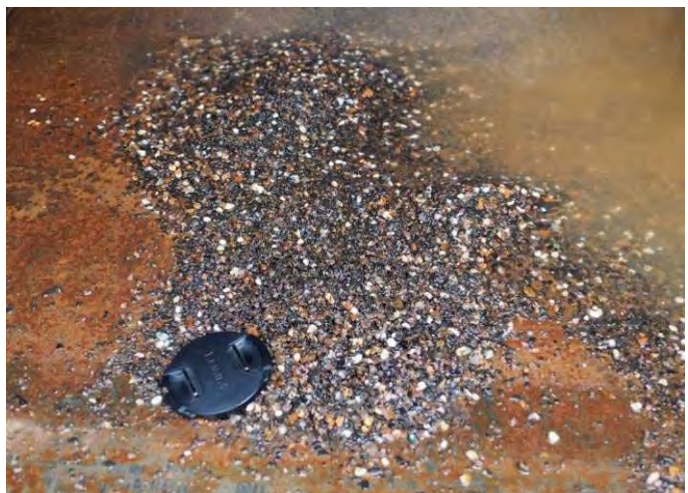
Ashraf No.1 井戸の 5 段階揚水試験では、限界揚水量に達することが出来なかったため、容量のより大きなポンプを設置して、さらなる段階揚水試験を実施するべく、11kw ポンプを井戸から取り外した。その際にケーシングが動くことが判明し、さらには V ノッチの中に相当量の裏込めしたグラベルや、岩片が水と一緒に巻き上げられていることが判明した（写真-3）。即ち、この井戸の PVC ケーシングは破損しており、破損した箇所から裏込めしたグラベルや周囲の岩片が

写真-1 揚水試験時に V ノッチ内に上がったグラベル等

井戸内に混入し、井戸内に約 12m 堆積していることが判明した。また、ケーシングが上下に動くと言う事実は、破損した箇所ではケーシングが2つ以上に分かれていることでもある。このような事情から、井戸にこれ以上ダメージを及ぼすこと、並びに新たに設置したポンプの故障を避けるため、さらなる段階揚水試験および連続揚水試験の実施を中止した。

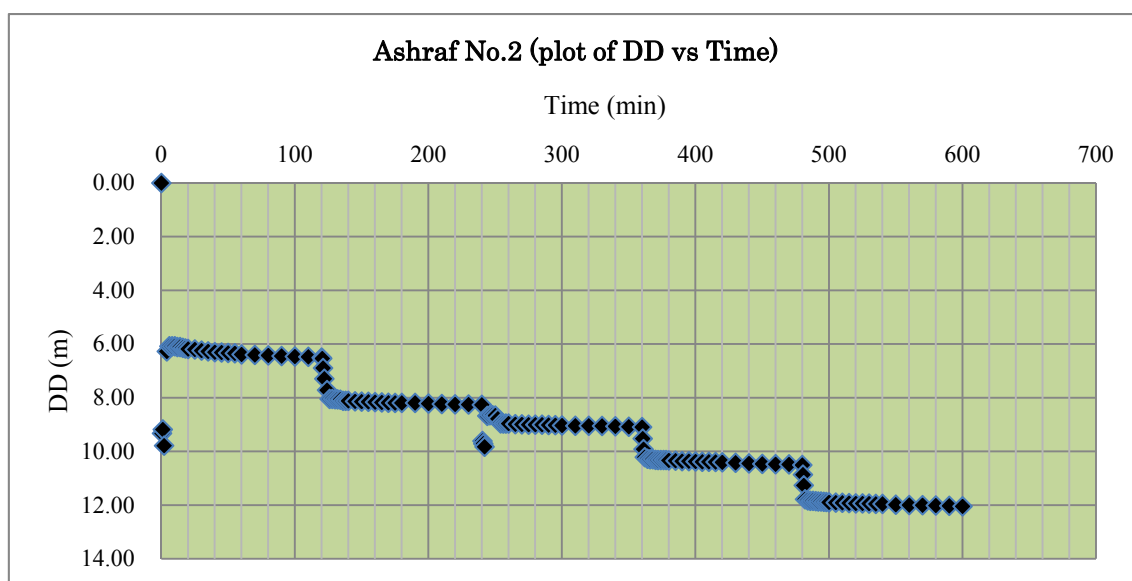
図-9 段階揚水試験結果

図-9 に段階揚水試験結果を示す。また、図-10 に揚水量－水位降下量グラフを示す。

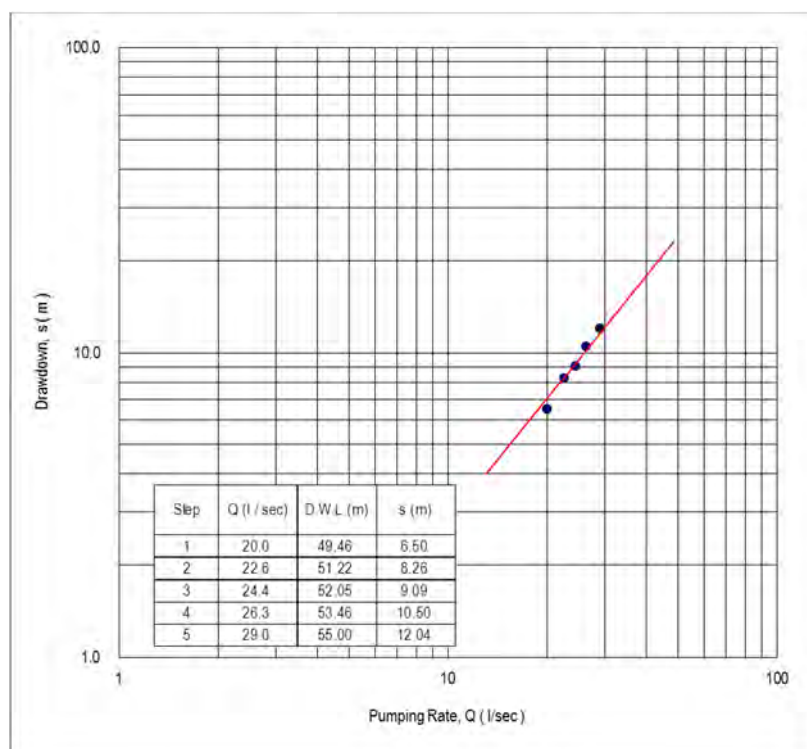
図-10 揚水量－水降下量グラフ

図-10 に示すように、最大揚水量の 29 L/秒 では限界揚水量に達していないものと推測される。しかし、これ以上容量の大きなポンプは得られないことから、この最大揚水量をもって限界揚水量と見なすこととする。従って、 $29 \times 0.7 = 20.3$ L/秒 が適正揚水量と見なされる。

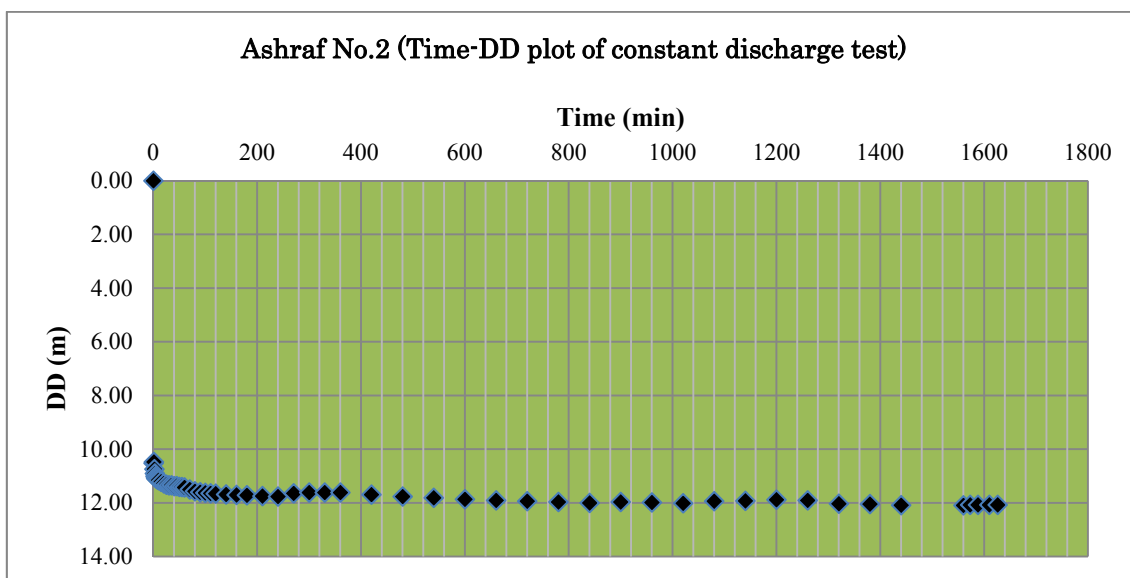
図-11 連続揚水試験結果

最大揚水量の 29 L/秒で 27 時間の連続揚水試験を実施した。試験結果を図-11 に示す。

連続揚水試験を開始後 21 時間で、水位降下量は 11.90m で平衡に達したものと認識された。しかし、直後に Ashraf No.1 井戸の稼働が開始されると、即座に水位降下量は 13cm 低下した。その後低下量は 19cm まで増加したが、3 時間後に 17cm に落ち着き、平衡に達している。この 17cm の水位低下は Ashraf No.1 井戸との干渉による影響と見なすことが出来る。

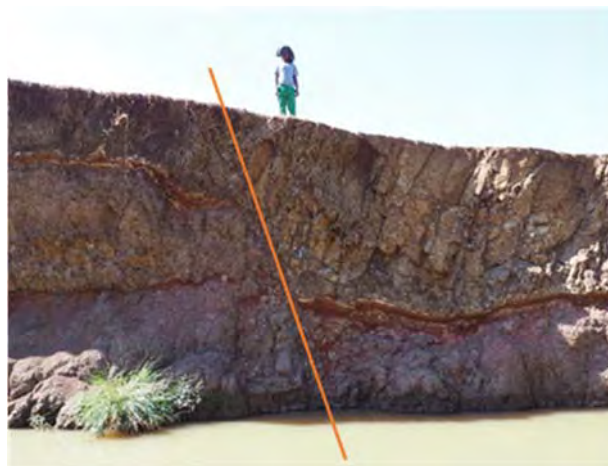
Chimbl 川近隣では、塊状で気孔の少ない Qv2B 溶岩層が分布しており、表層部は風化した赤色の土壌に覆われているため、降雨は地下に浸透せず、大部分が表面流出している。しかし、北東—南西方向に流れる Chimbl 川に沿って断層の存在が想定されること（写真-7）。その断層の破碎帯に Chimbl 川の水が浸透することで地下水が涵養されることが想定されることから、電気探査によって、断層破碎帯の存在を探索することとした。

写真-7 Chimbl 川沿いの小断層（落差 2m）

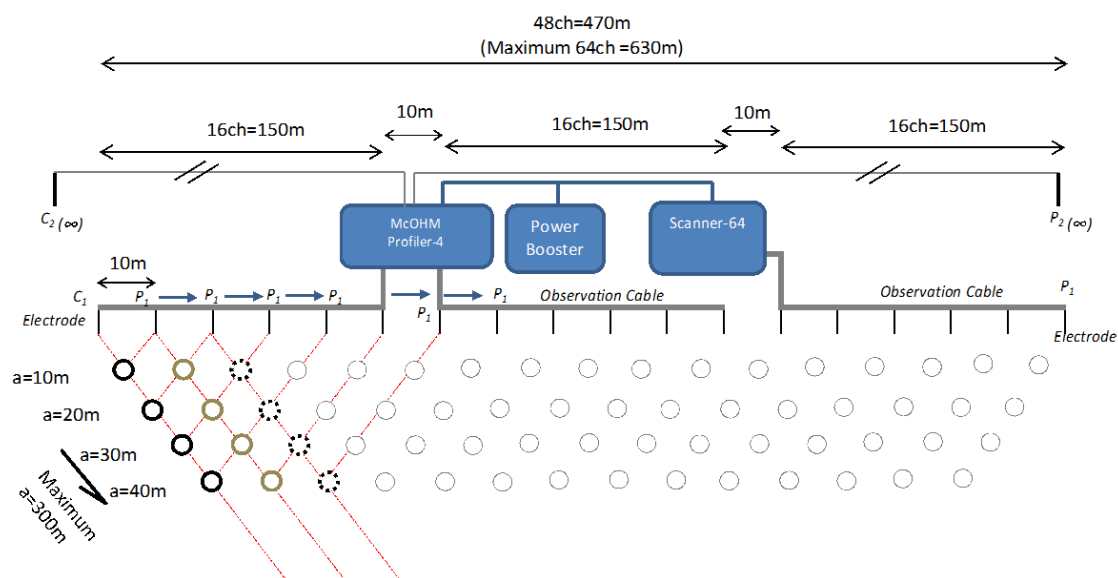
図-2. McOHM-Profiler4 システム概念図

このシステムは、McOHM profiler 4、パワーブースター、3本の観測線、48本の電極からなる。観測線は16芯の多芯ケーブルであり、McOHM profiler 4と全ての電極を同時に接続することが可能である。McOHM profiler 4はスキャナーを内蔵し、電流電極と電位電極の組合せを自動で切り替えることが可能である。本調査では基本的に電極間隔を 10m、

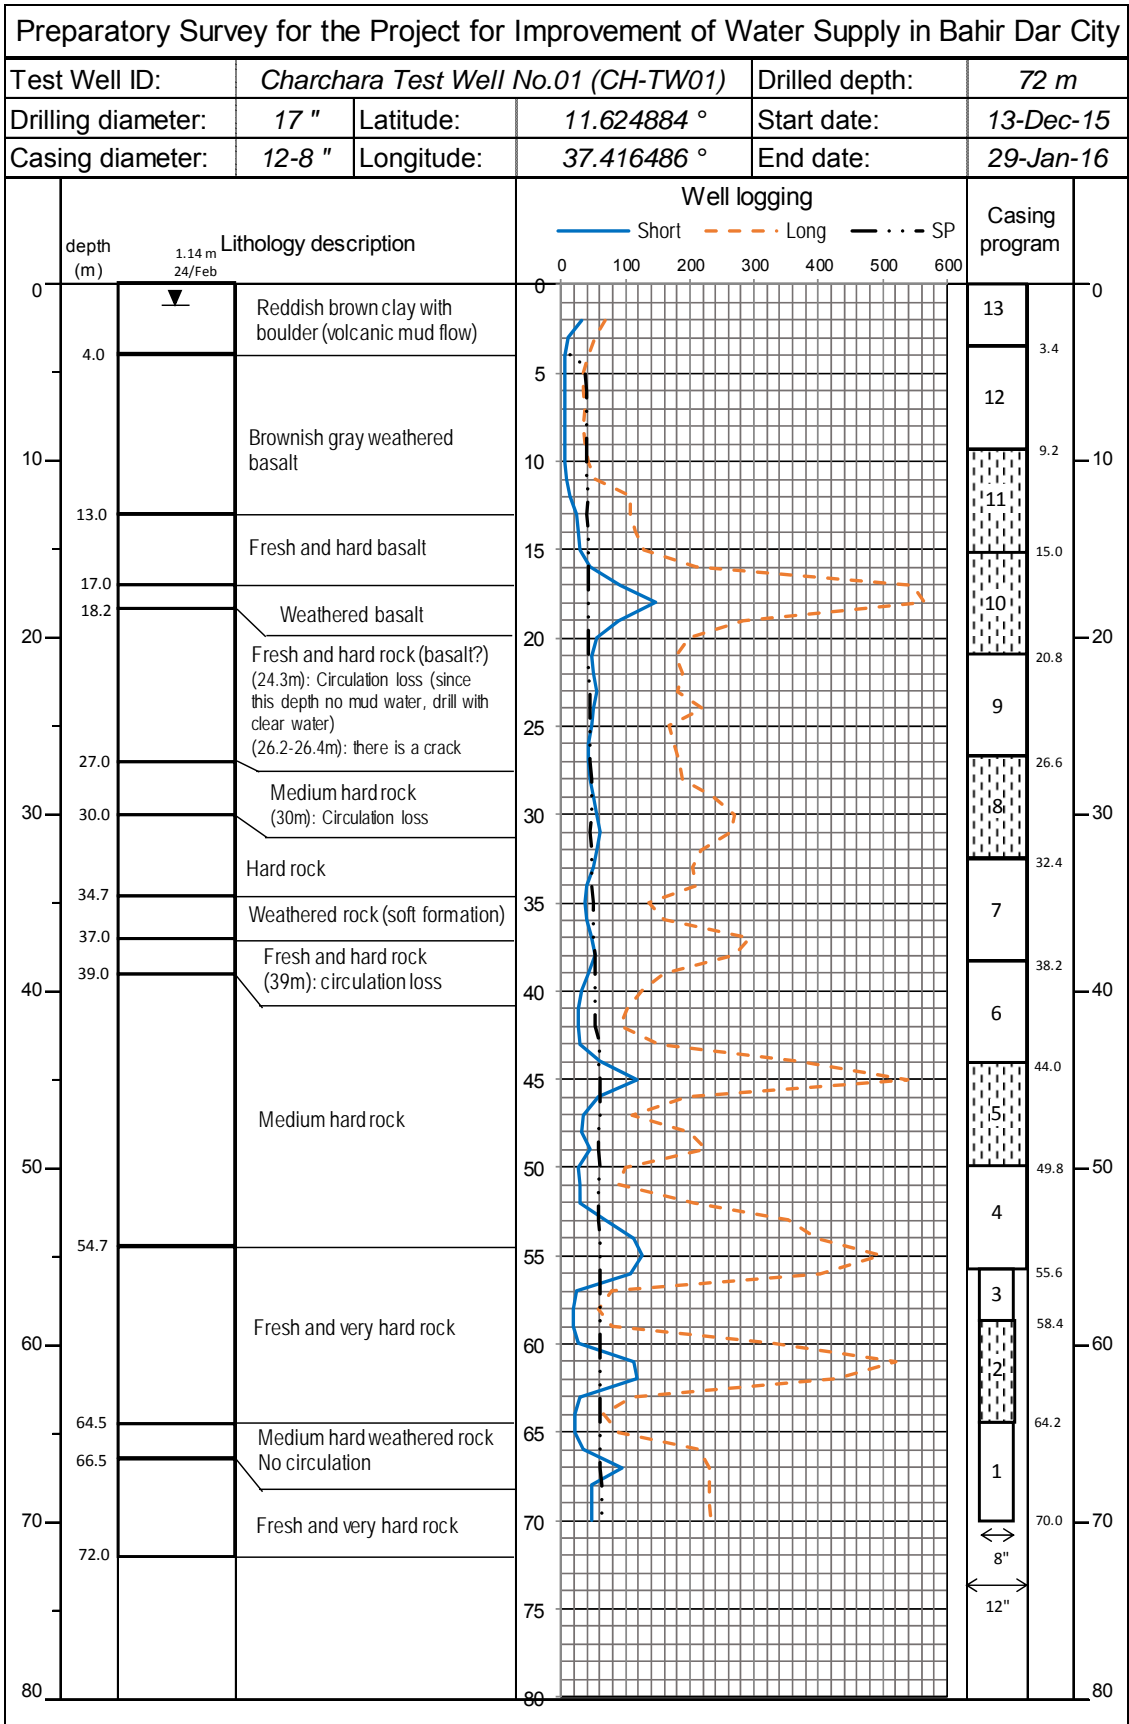
図-1. Charchara TW-No.1 - 地質柱状図およびケーシングプログラム

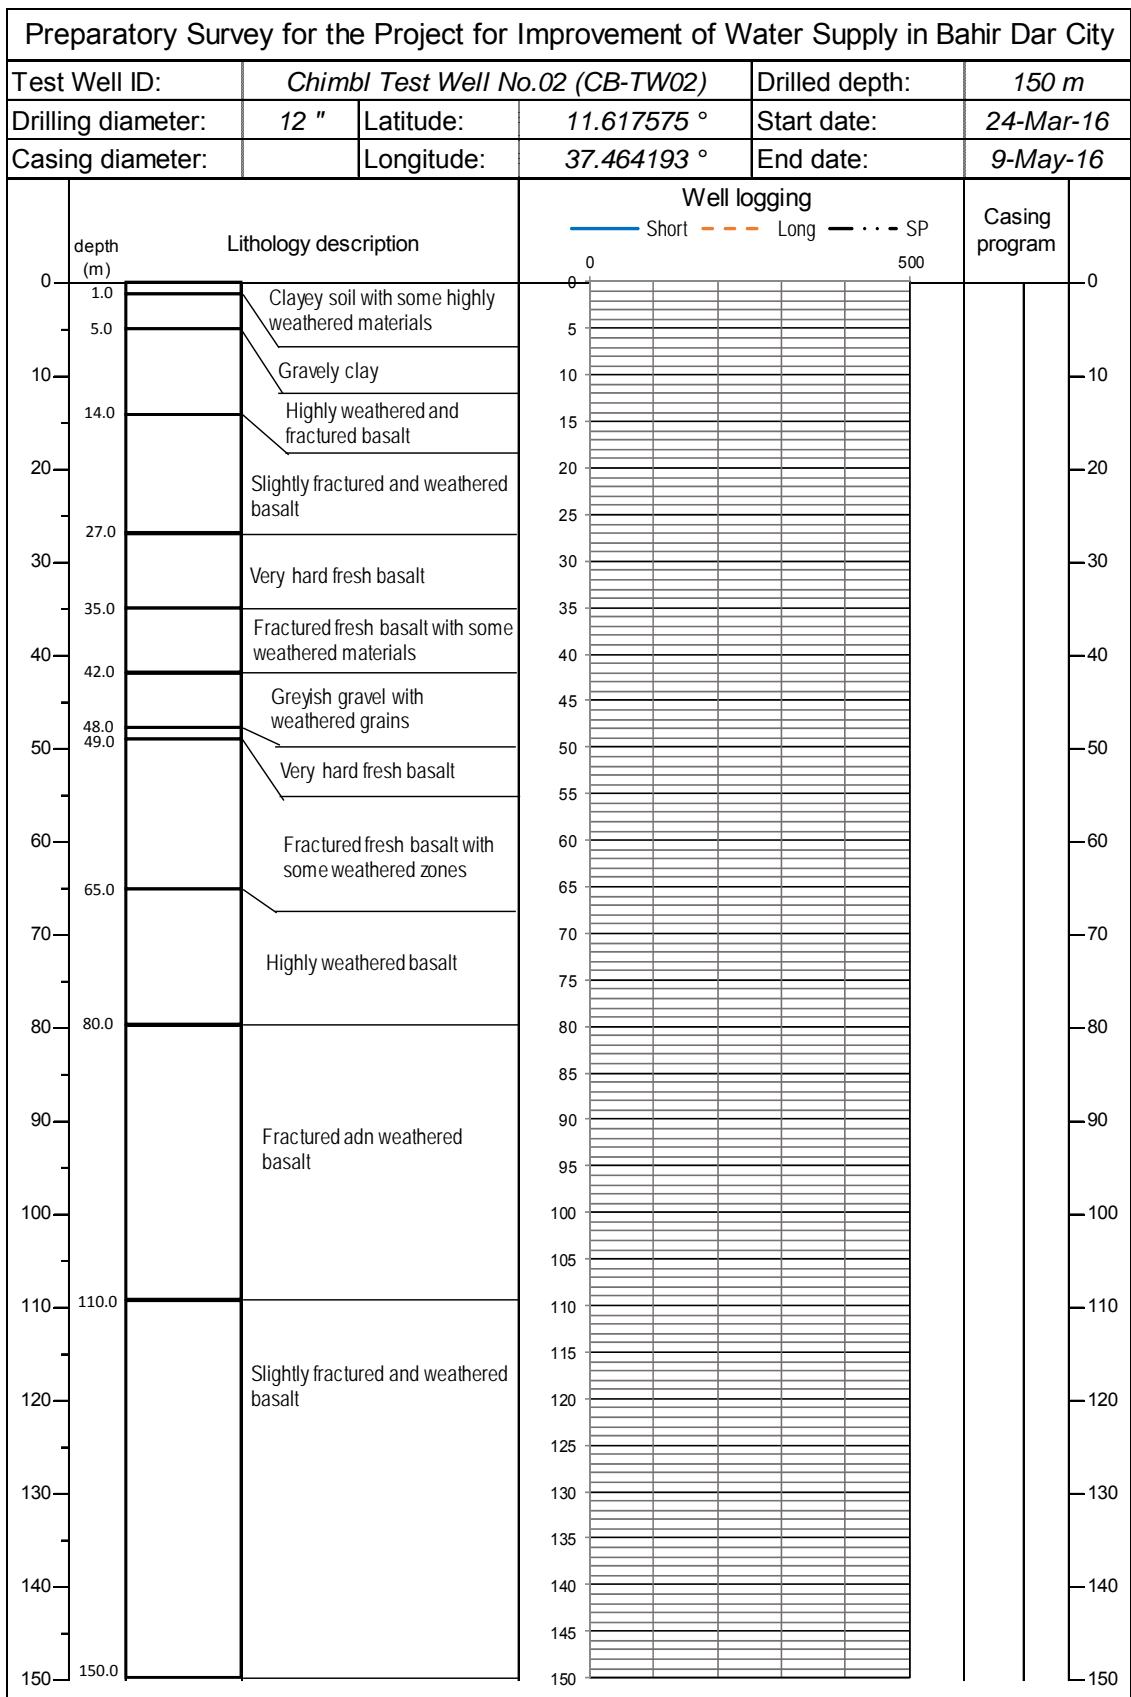
この掘削地点では、全体に新鮮な玄武岩溶岩層の中に、風化した玄武岩溶岩層が挟在されている。二次元電気検層結果から、この試験井では深度 40～70m 付近に帯水層が存在する可能性が推定された。しかし、図-8 に示す如く、深度 35～110m まで一部新鮮な玄武岩層を含む、風化した玄武岩溶岩層が続くものの、帯水層を示す兆候は見られなかった。110m より下方では新鮮な玄武岩溶岩層が連続しており、150m より下方で帯水層に当たる可能性も低いものと判断し、深度 150m で掘留とした。

本試験井では、表層部の深度 6m 付近に、近傍の 6 か所の手堀井戸が取水している薄く宙水的な帯水層 (0.5 L/秒未満) が存在している。しかし、この試験井にハンドポンプを設置して、この帯水層から取水すると、近傍の手堀の浅井戸が干上がってしまう可能性があるため、この試験井にはケーシングを設置せず埋め戻すこととした。図-8 に地質柱状図を示す。

図-8. Chimbl TW-No.2 - 地質柱状図およびケーシングプログラム

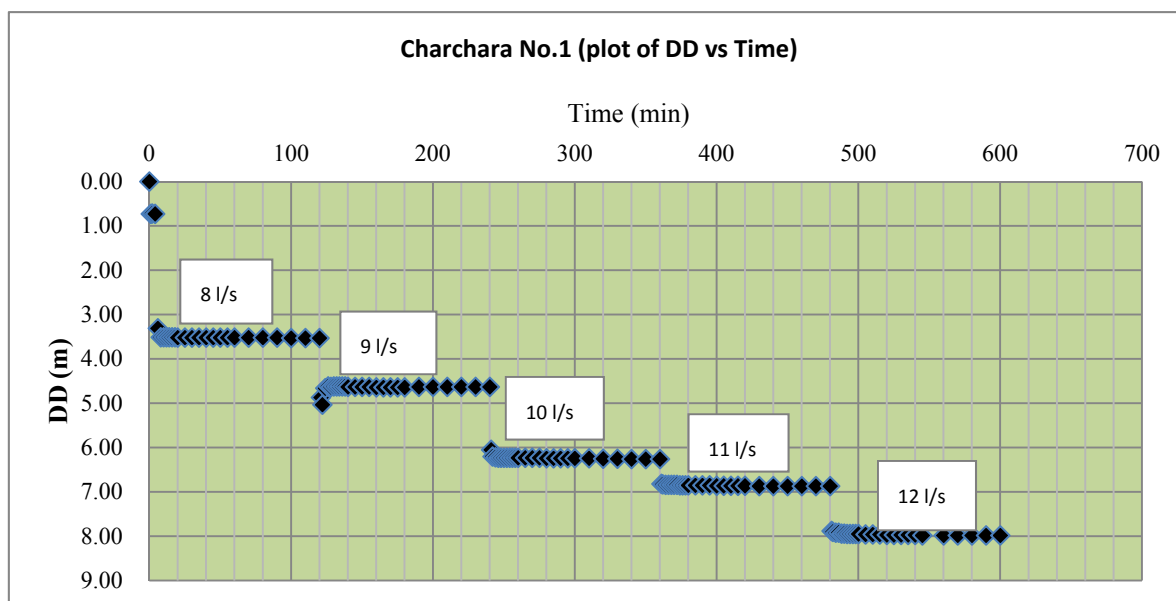
図-1 段階揚水試験結果

段階揚水試験の揚水量は、8、9、10、11、12 L/秒の 5 段階とし、各段階 2 時間の揚水を実施した。各段階の揚水量－水位降下量グラフを図-5 に示す。また、揚水量－水位降下量の両対数グラフを図-6 に示す。

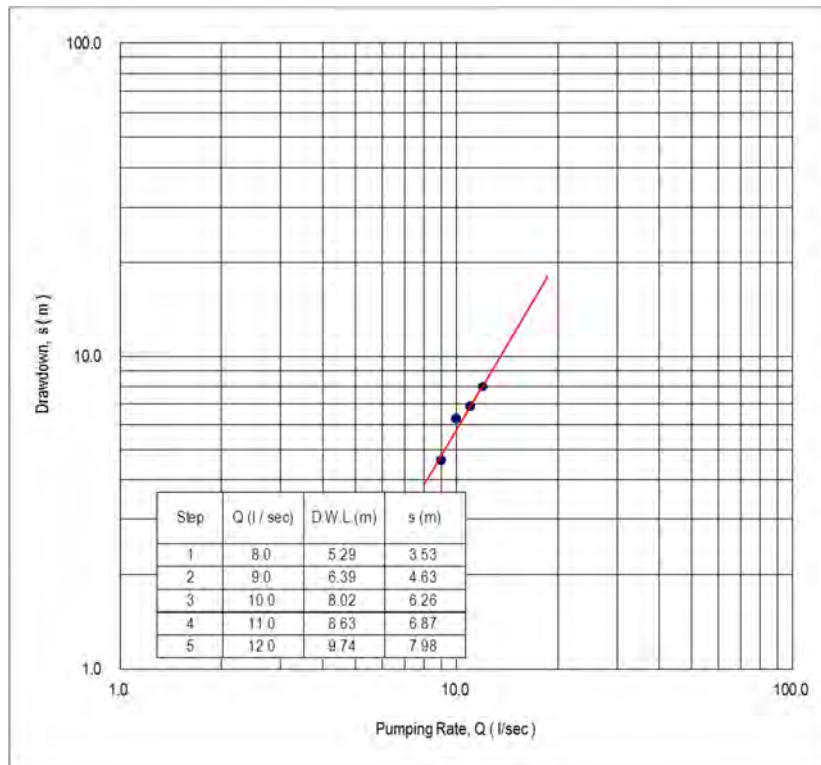
図-2 揚水量－水位降下量

図-2 に示すように、12 L/秒では限界揚水量には達していないものと認識される。しかし、現地ではこれ以上の高い能力のポンプが得られないため、現状では 12 L/秒を限界揚水量と見なすこととする。これから、 $12 \times 0.7 = 8.4$ L/秒 が適正揚水量と見なされる。この井戸では、段階揚水試験の結果から、井戸損失が非常に大きいことが指摘される。

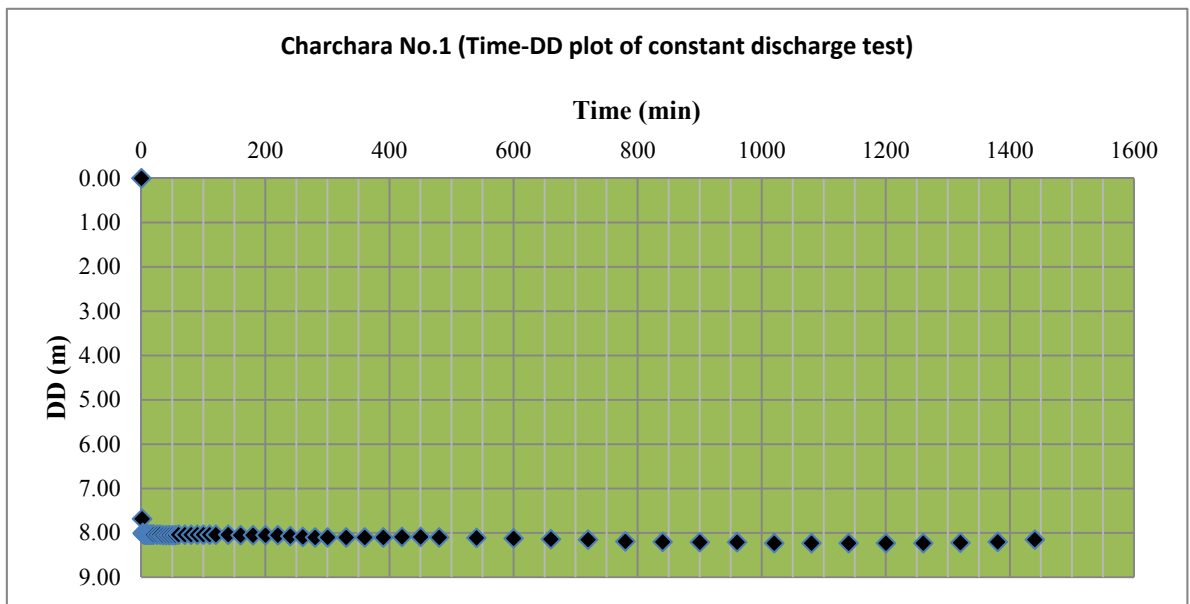
図-3 連続揚水試験結果

最大揚水量の 12 L/秒で 24 時間の連続揚水試験を実施した。その結果を図-3 に示す。最大の水位低下量は 8.23m であった。

24 時間の連続揚水試験の実施中、4 時間を経過した時点で一旦水位低下が落ち着いて、平衡に達したと見られた後に、水位が最大 18cm 低下する現象が見られた。これは、Charchara No.1 井戸の水位低下に伴い影響圏が拡大し、相次いで Charchara No.2、No.3、No.4 井戸の影響圏に達して、それぞれの井戸との干渉による影響があったものと推定される。

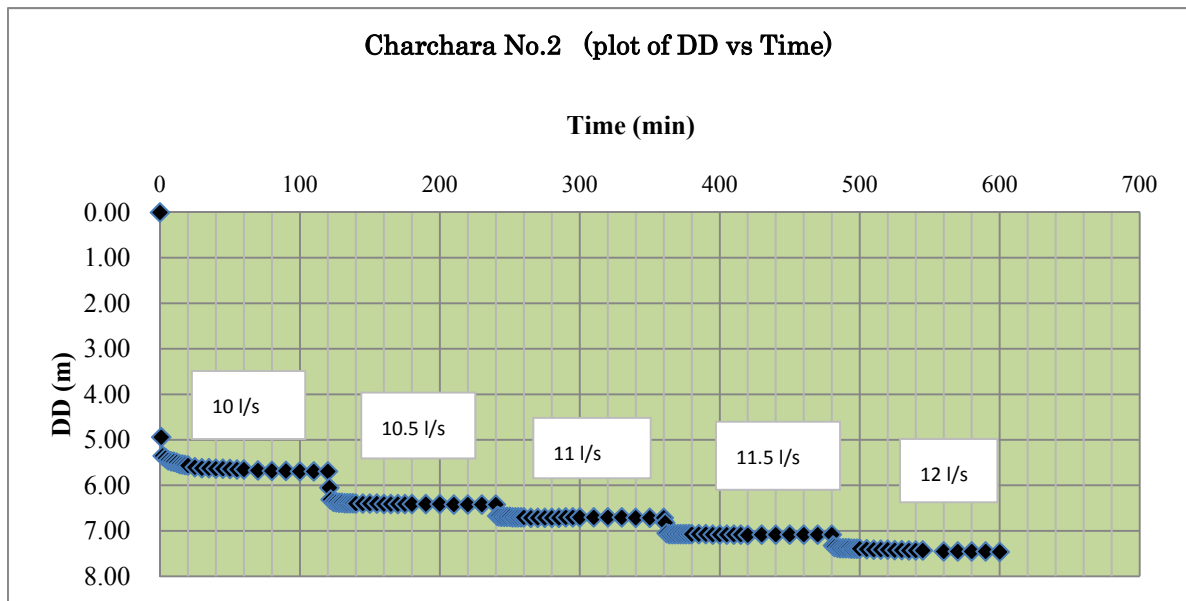
図-4 段階揚水試験結果

予備揚水試験結果から、図-4に示すとおり、揚水量を10.0、10.5、11.0、11.5、12.0 L/秒の5段階とした。また、図-5に揚水量－水位低下量の両対数グラフを示す。

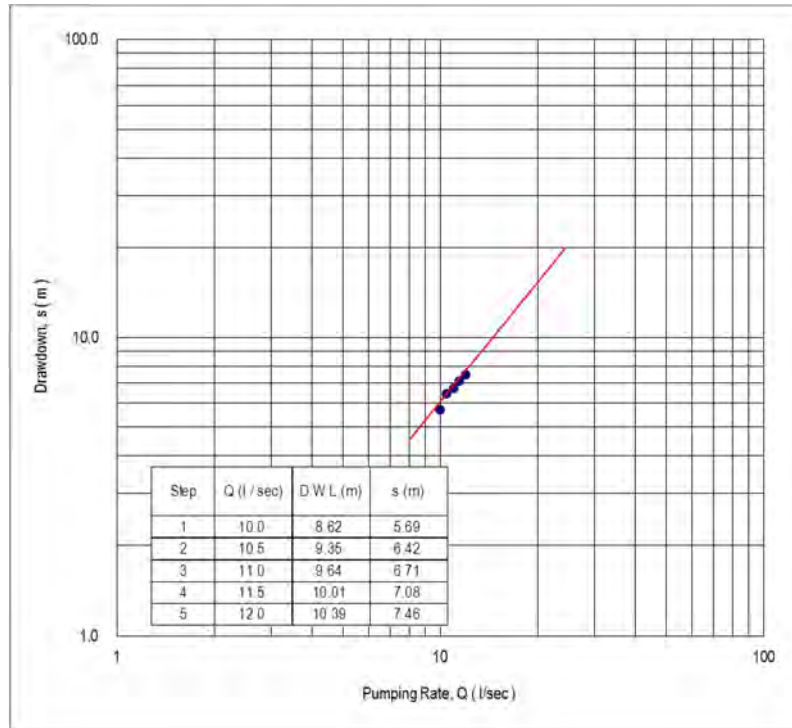
図-5. 揚水量－水位降下量

この結果から、12 L/秒 では、限界揚水量には達していないものと判断される。しかし、現地ではこれ以上容量の大きなポンプが得られないことから、この値を暫定的に限界揚水量と見なすこととする。従って、 $12 \times 0.7 = 8.4$ L/秒 を適正揚水量とする。この井戸の井戸損失は、非常に小さいことが、この段階揚水試験の結果から指摘される。

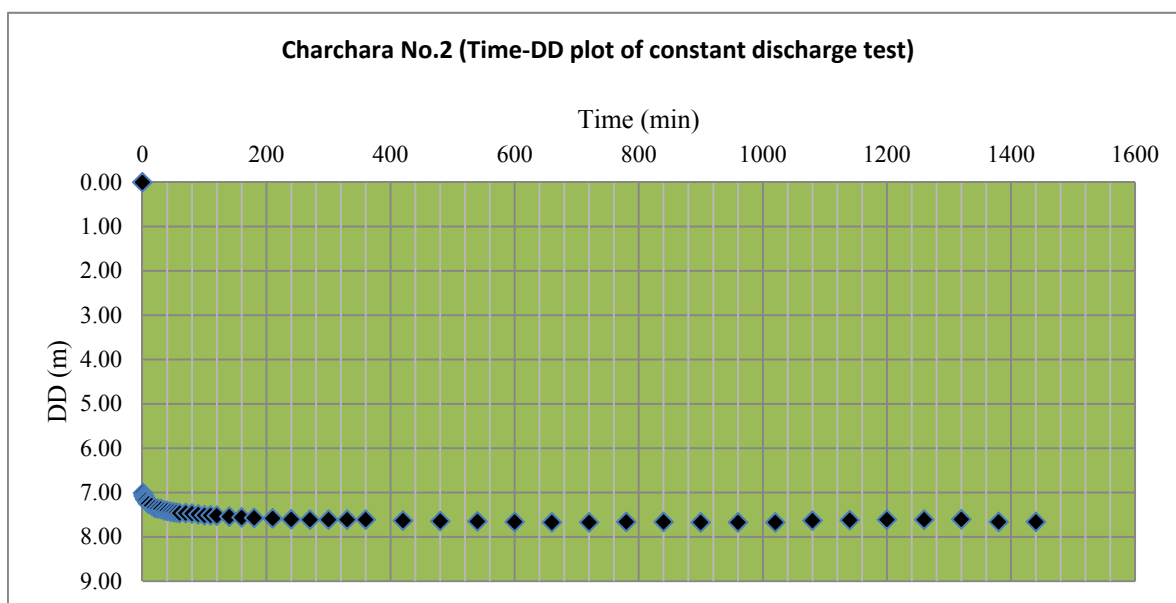
図-6. 連続揚水試験結果

最大揚水量の 12 L/秒 で 24 時間の連続揚水試験を実施した。図-6 に試験結果を示す。

連続揚水試験開始 17 時間後に Charchara No.3 井戸の稼働が停電のため停止すると、Charchara No.2 井戸の動水位が直ちに 4cm 上昇し、22 時間後までに最大 7cm 上昇した。その 23 時間後、Charchara No.3 井戸の稼働が再開すると水位は瞬時に 6cm 低下した。この 6~7cm の水位変動は Charchara No.3 井戸との干渉の影響とみられる。

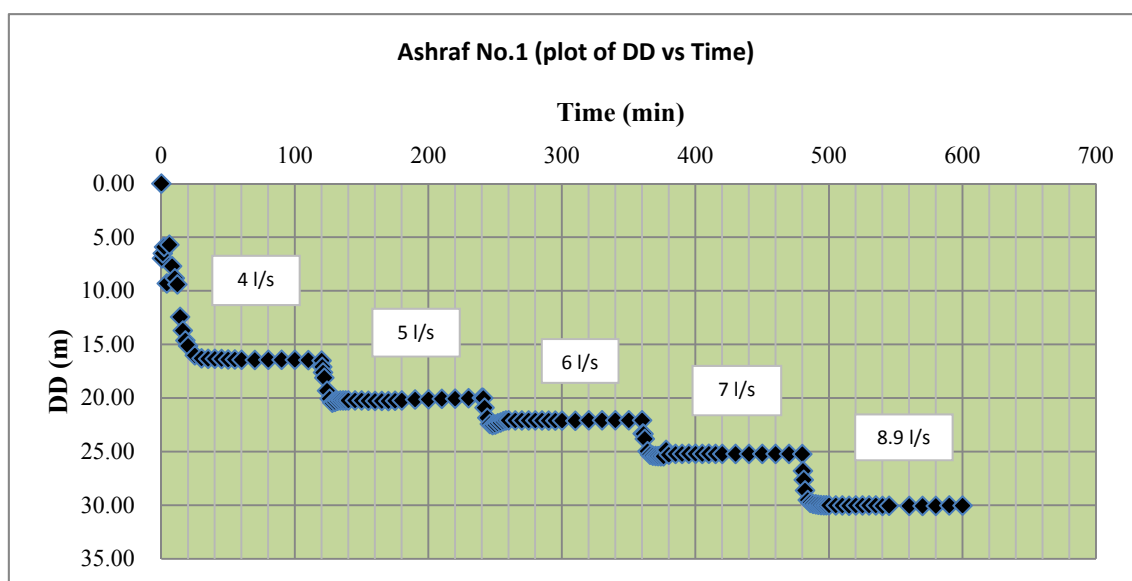
図-7 段階揚水試験結果

段階揚水試験結果を図-7 に示す。また、揚水量－水位降下量の両対数グラフを図-8 に示す。

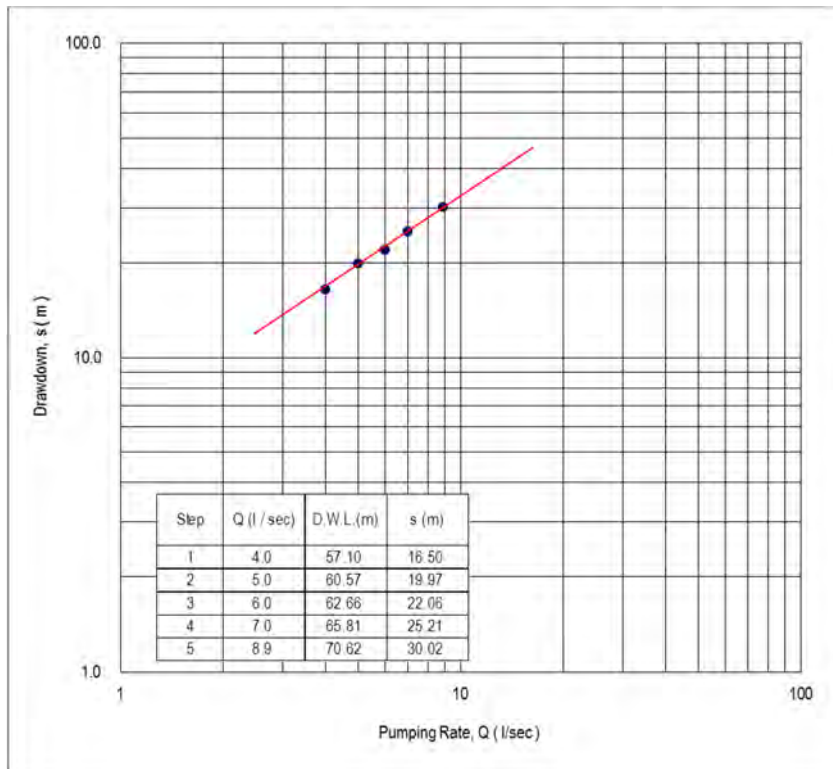
図-8 揚水量－水位降下量

図-8 に示されるように、最大揚水量の 8.9 L/秒 でも限界揚水量に達していないものと見なされる。しかし、より容量の大きなポンプが得られないことから、この値を暫定的に限界揚水量と見なすこととする。従って、適正揚水量は、 $8.9 \times 0.7 = 6.2$ L/秒 となる。

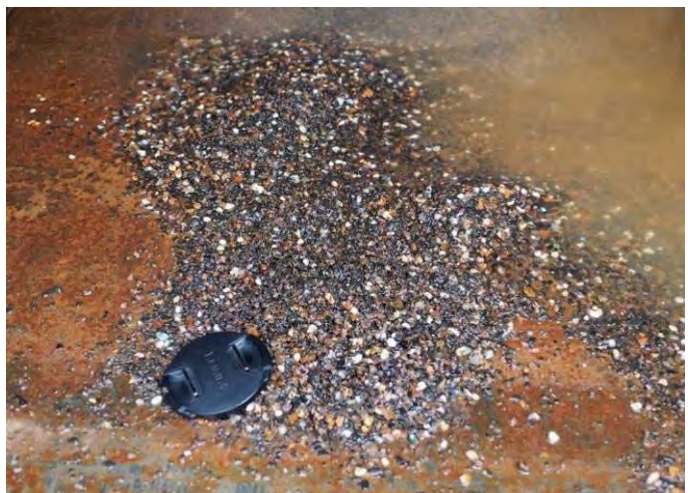
Ashraf No.1 井戸の 5 段階揚水試験では、限界揚水量に達することが出来なかったため、容量のより大きなポンプを設置して、さらなる段階揚水試験を実施するべく、11kw ポンプを井戸から取り外した。その際にケーシングが動くことが判明し、さらには V ノッチの中に相当量の裏込めしたグラベルや、岩片が水と一緒に巻き上げられていることが判明した（写真-3）。即ち、この井戸の PVC ケーシングは破損しており、破損した箇所から裏込めしたグラベルや周囲の岩片が

写真-1 揚水試験時に V ノッチ内に上がったグラベル等

井戸内に混入し、井戸内に約 12m 堆積していることが判明した。また、ケーシングが上下に動くと言う事実は、破損した箇所ではケーシングが2つ以上に分かれていることでもある。このような事情から、井戸にこれ以上ダメージを及ぼすこと、並びに新たに設置したポンプの故障を避けるため、さらなる段階揚水試験および連続揚水試験の実施を中止した。

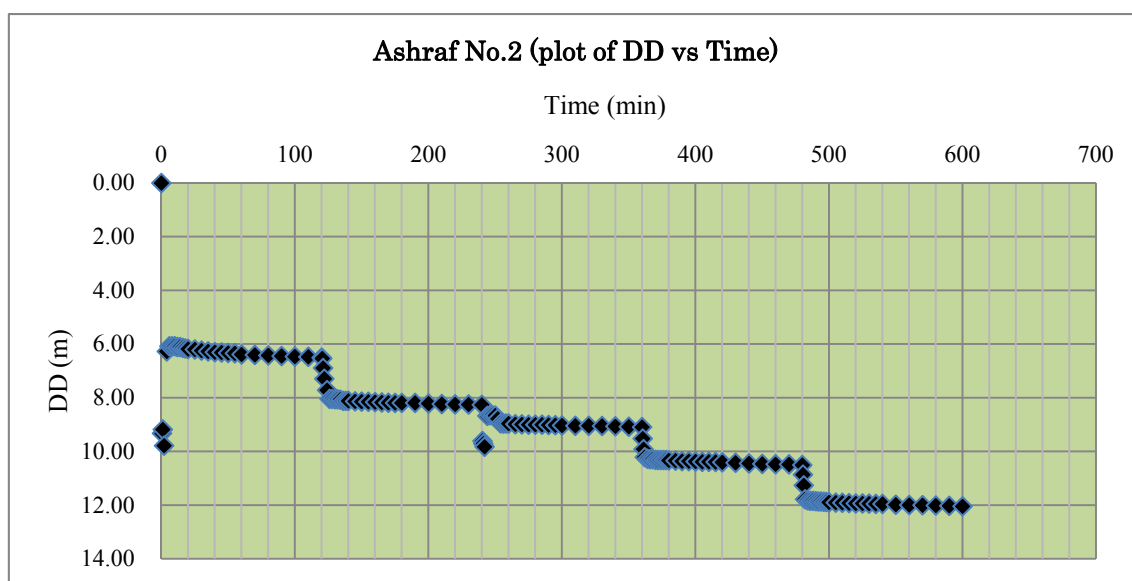
図-9 段階揚水試験結果

図-9 に段階揚水試験結果を示す。また、図-10 に揚水量－水位低下量グラフを示す。

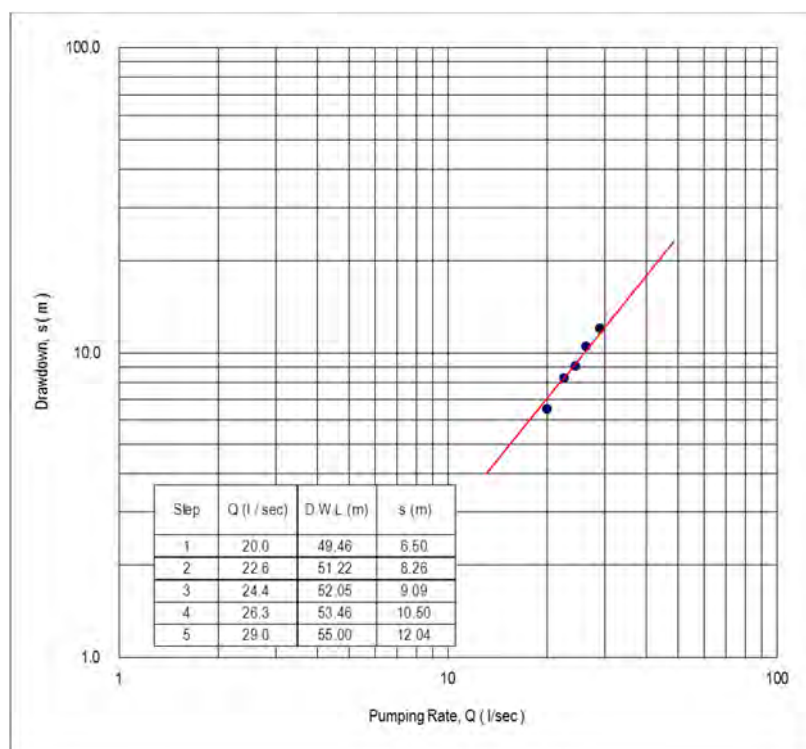
図-10 揚水量－水降下量グラフ

図-10 に示すように、最大揚水量の 29 L/秒 では限界揚水量に達していないものと推測される。しかし、これ以上容量の大きなポンプは得られないことから、この最大揚水量をもって限界揚水量と見なすこととする。従って、 $29 \times 0.7 = 20.3$ L/秒 が適正揚水量と見なされる。

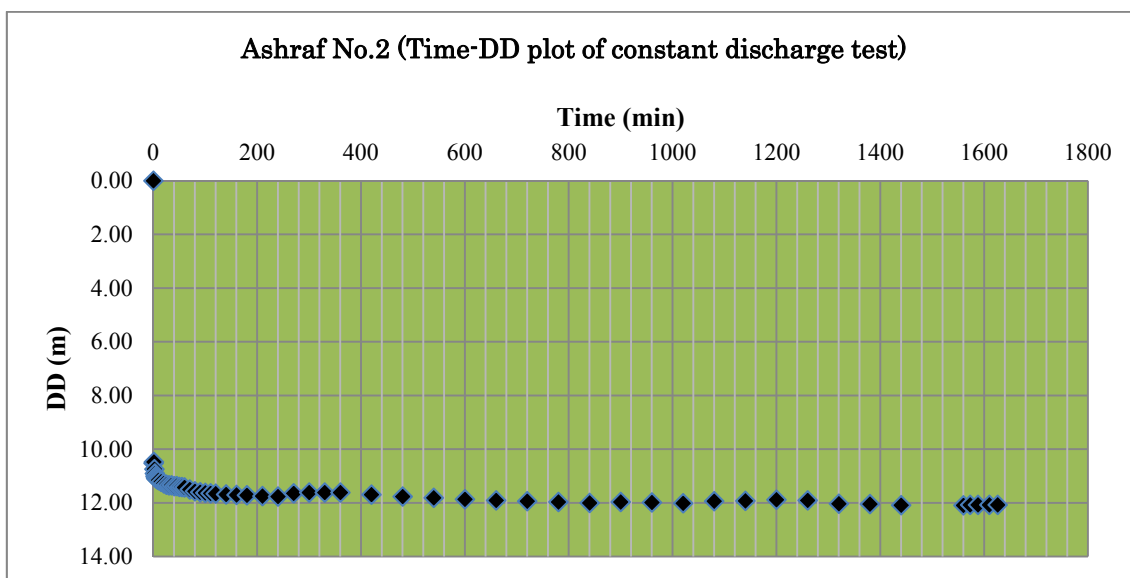
図-11 連続揚水試験結果

最大揚水量の 29 L/秒で 27 時間の連続揚水試験を実施した。試験結果を図-11 に示す。

連続揚水試験を開始後 21 時間で、水位降下量は 11.90m で平衡に達したものと認識された。しかし、直後に Ashraf No.1 井戸の稼働が開始されると、即座に水位降下量は 13cm 低下した。その後低下量は 19cm まで増加したが、3 時間後に 17cm に落ち着き、平衡に達している。この 17cm の水位低下は Ashraf No.1 井戸との干渉による影響と見なすことが出来る。
