The Project for Improvement of Water Supply in Bahir Dar City in Ethiopia Soft Component Plan

APPENDIX 7 (2) RESULTS OF PUMPING TEST OF EXISTING WELLS

APPENDIX!7(5) TEST WELL DRILLING

APPENDIX 7 (6) RESULTS OF PUMPING TEST OF TEST WELLS

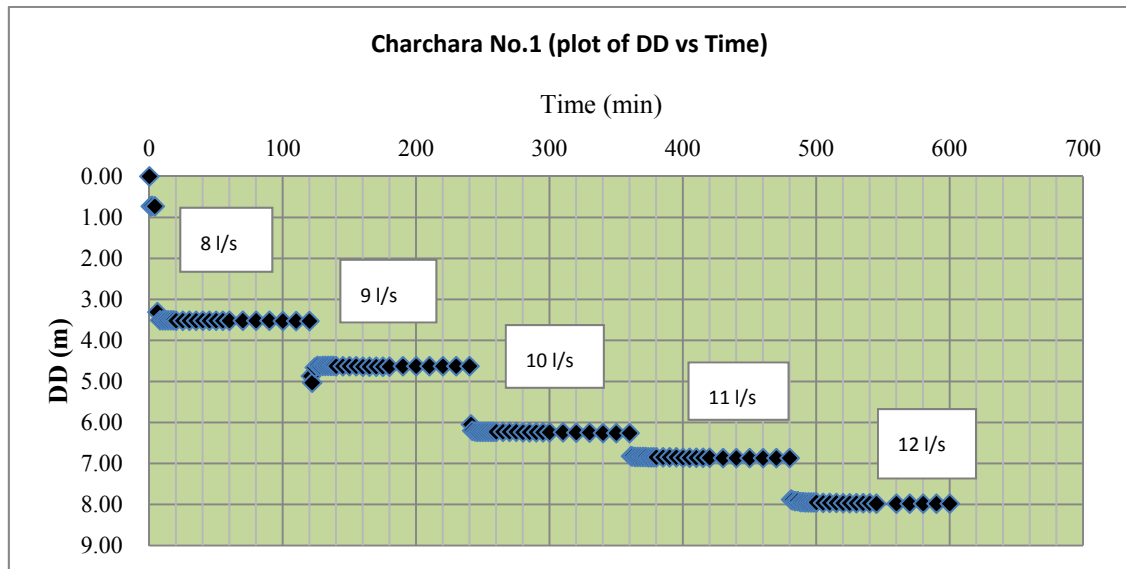
Figure-1 Result of Step Drawdown Test

The step drawdown test was conducted by 5 steps at the pumping rates of 8, 9, 10, 11 and 12 L/sec and pumped for 2 hours at each step. Figure-1 shows the Drawdown – Time graph at 5 steps and Figure-2 shows Discharges – Drawdown logarithmic graph.

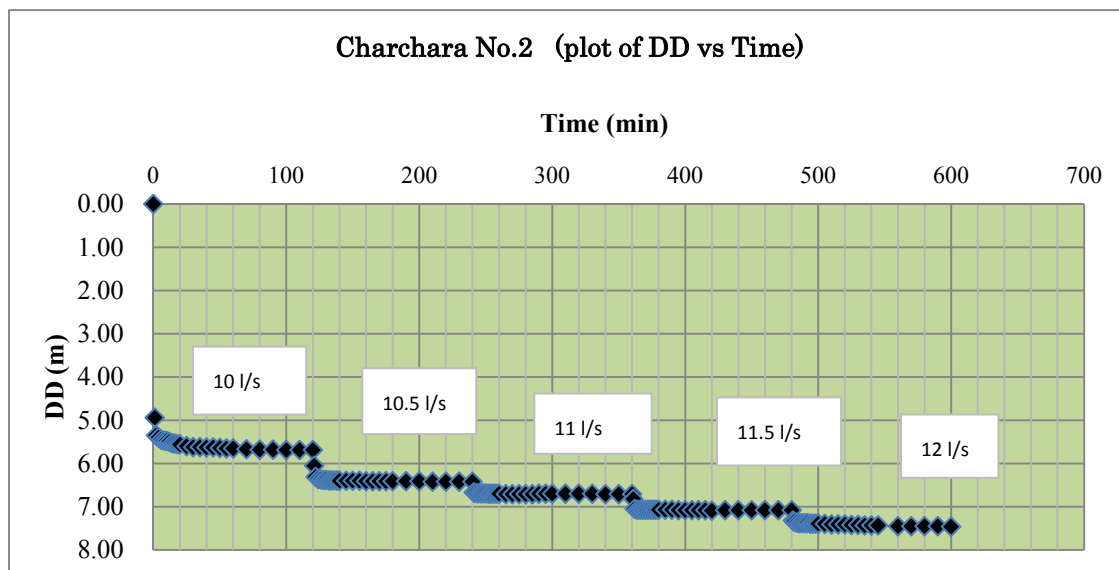
Figure-4 Result of Step Drawdown Test

The step drawdown test was carried out at the discharge rates of 10.0, 10.5, 11.0, 11.5 and 12.0 L/s. Drawdown – Time graph is shown in Figure-4 and Discharge – Drawdown logarithmic graph is shown in Figure-5.

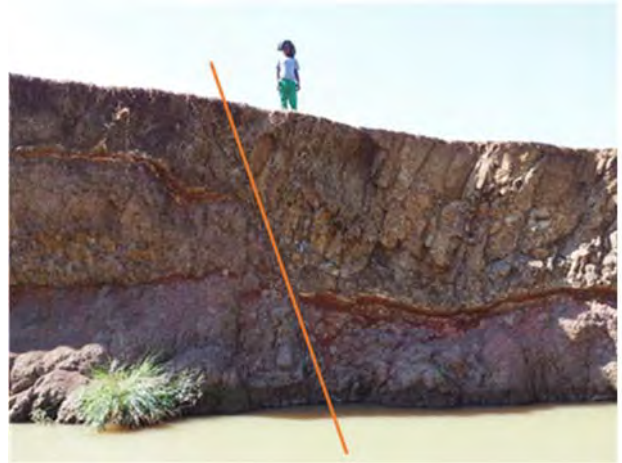
A massive Qv2-B lava formation with little pores is distributed in the vicinity of Chimbl River and its surface is covered with weathered reddish soil, so that the most of rain does not infiltrate to underground, running off from the surface. However, the existence of a fault (see photo in the right) is assumed along the Chimbl River flowing northeast to southwest direction and since it is supposed that the groundwater is recharged by infiltrating the fractured zone of the said fault, it was decided to confirm the existence of this fault by carrying out a geophysical survey.

Photo-7 Small fault along Chimbl River (gap: 2m)

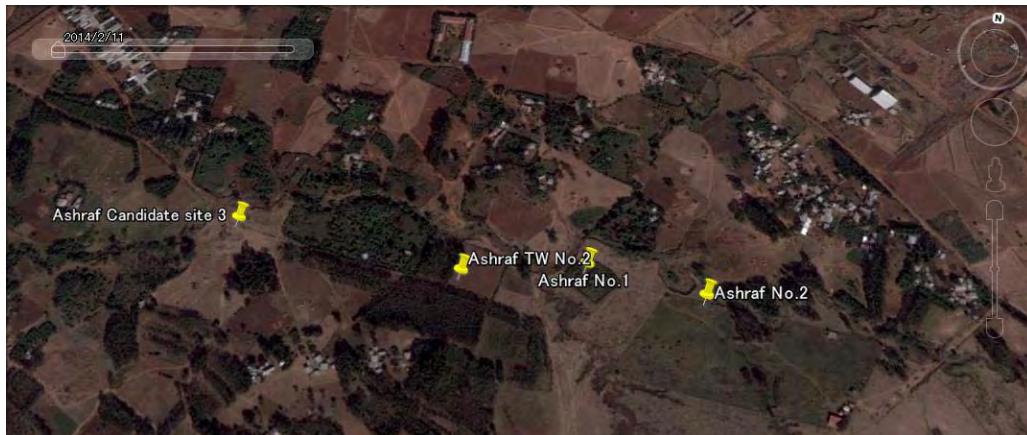
Figure-5. Location Map of Wells of Ashraf Well Field

Figure-5 shows the location of the wells of Ashraf Well Field. The distance between Ashraf No.1 well and Ashraf No.2 is 140m, the distance between Ashraf No.1 well and Ashraf TW-No.2 test well is 137m and the distance between Ashraf TW-No.2 and Ashraf TW-No.3 test wells is 262m.
