LANDSLIDE DISASTER MANAGEMENT PROJECT IN THE REPUBLIC OF ARMENIA

Studies of Landslide Sites at the Arapi Community,
Shirak Marz of RA and at the Getahovit Community
Tavoush Marz of RA

Yerevan 2015

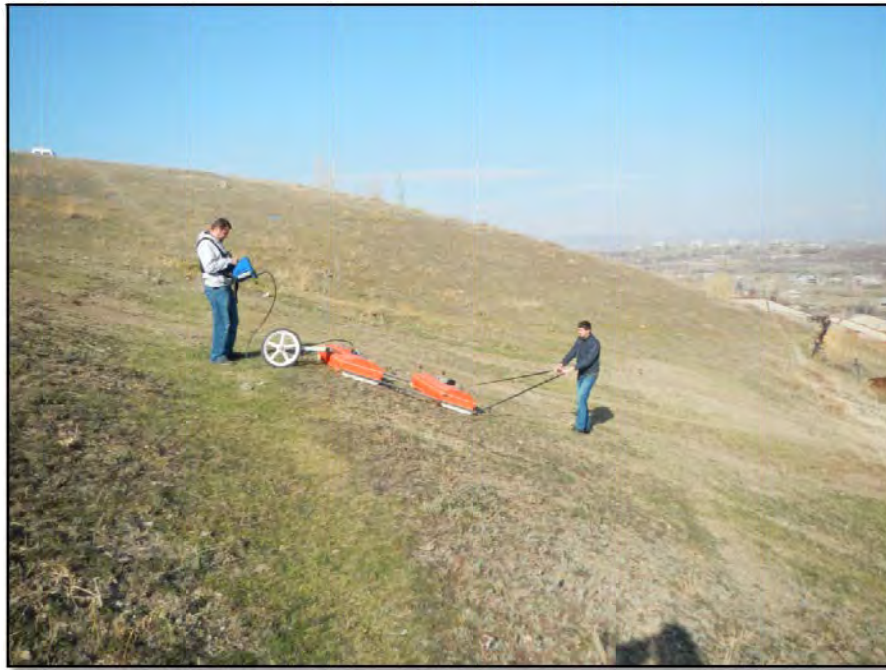
Figure 2.1: The recording device of the SIR-3000 geo-radar system and the process of field measurements

For the purposes of geo-radar surveys in the Arapi and Getahovit communities, SIR-3000 geo-radar system (USA, 2008) with the 200 MHz antenna was applied (Fig. 2.1).

The system scans geological section by means of pulsed electromagnetic waves, providing the greatest sounding accuracy. The system responds to distribution of densities within the geological section.

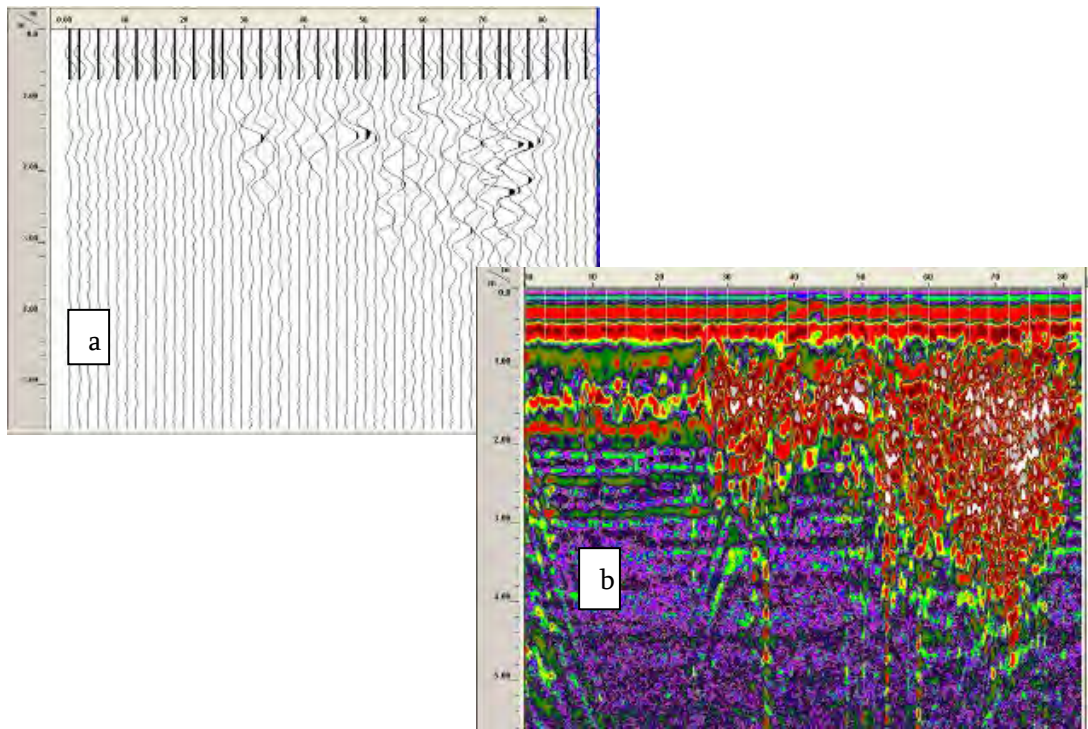
Figure 2.5: a) a group of radar records and b/ the plotted geological section (an example)

Therefore, the color-based distinction of radar records corresponds to natural vibration periods of a medium or a soil, or their typical amplitudes, hence, the distribution of densities (Fig. 2.5).

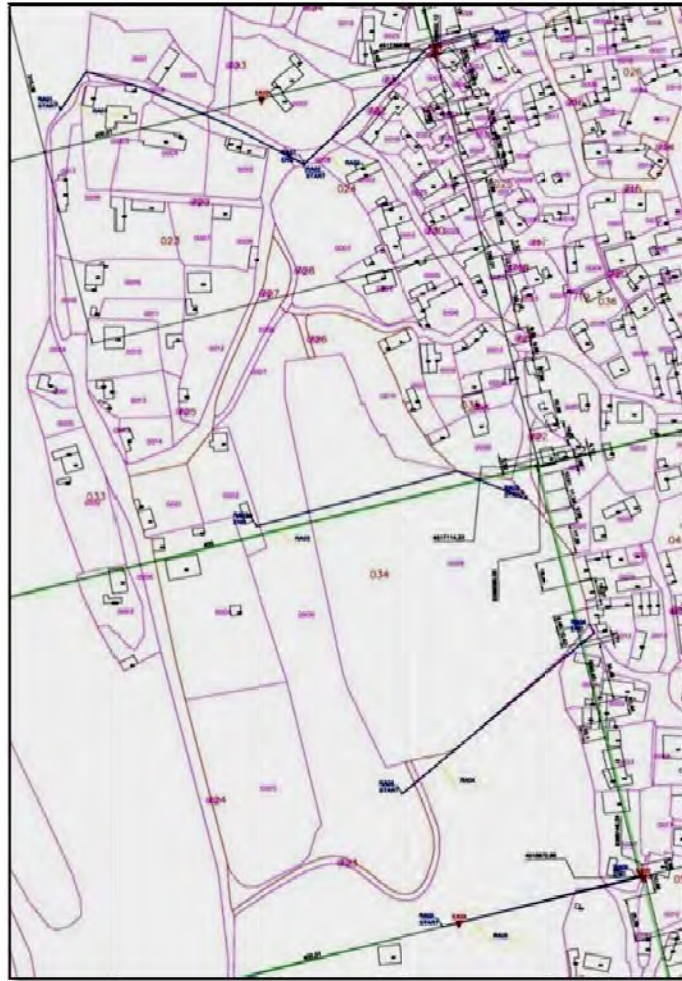
Figure 2.6: Actual location of the geo-radar survey profiles in the Arapi community

In each selected rural community, geo-radar survey covered 500 meters as shown in Figs. 2.6 and 2.7.

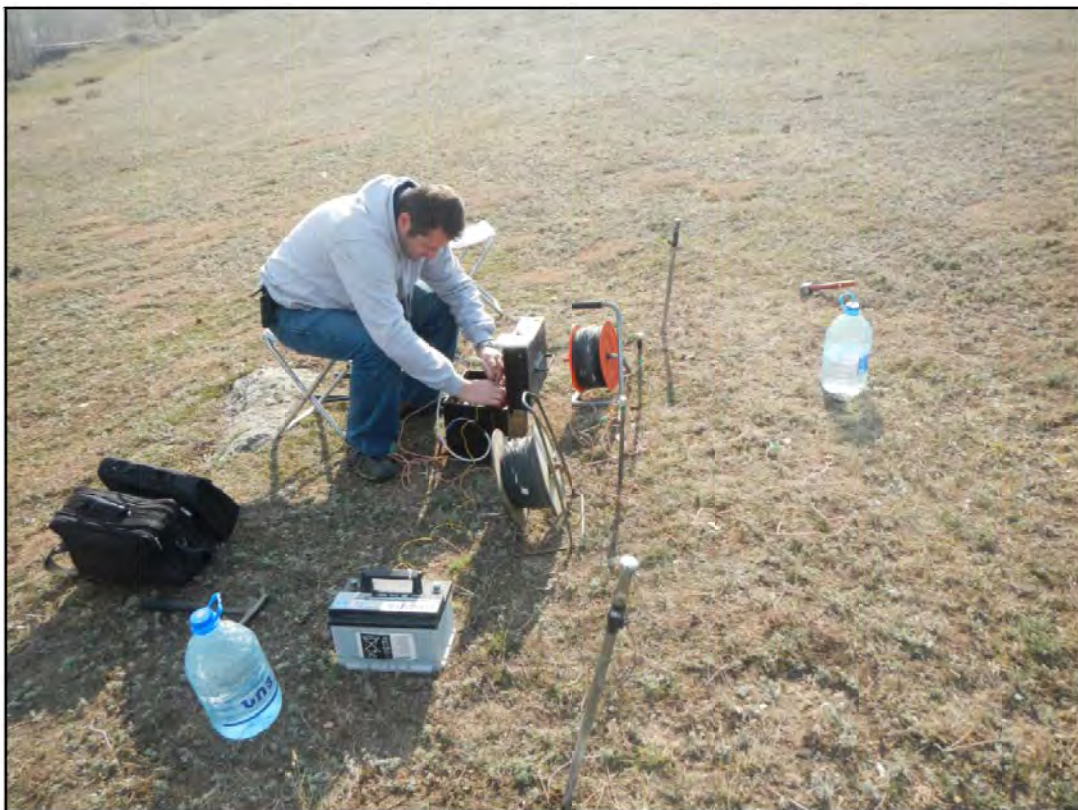
Figure 2.8: CYCLE-VPS digital electrical sounding station, field measurements

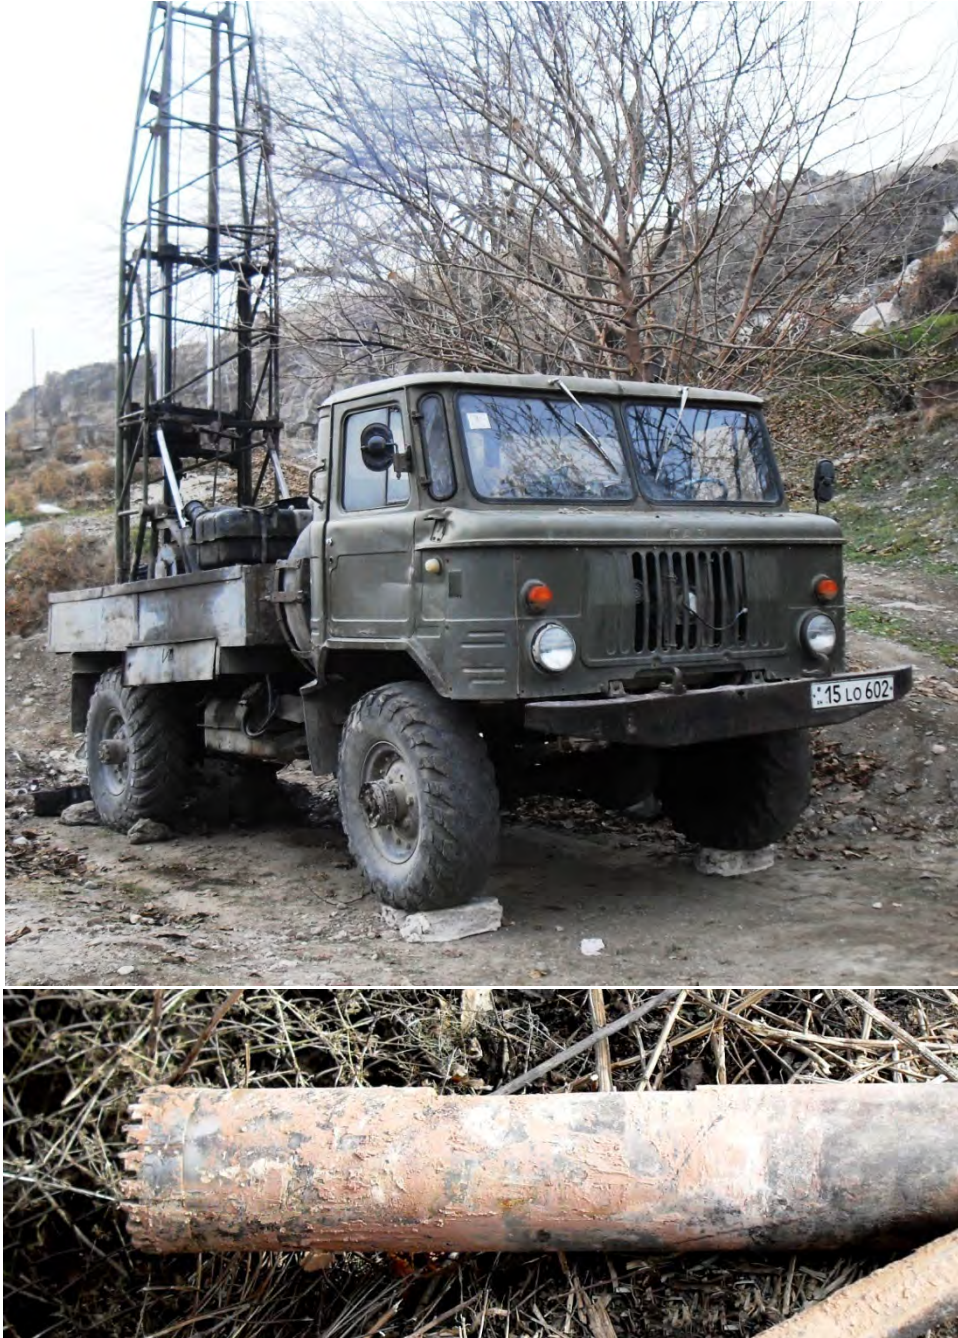
Figure 3.2.2: УТБ-50 drilling rig and the core bit 151 mm in diameter attached to the drilling rod

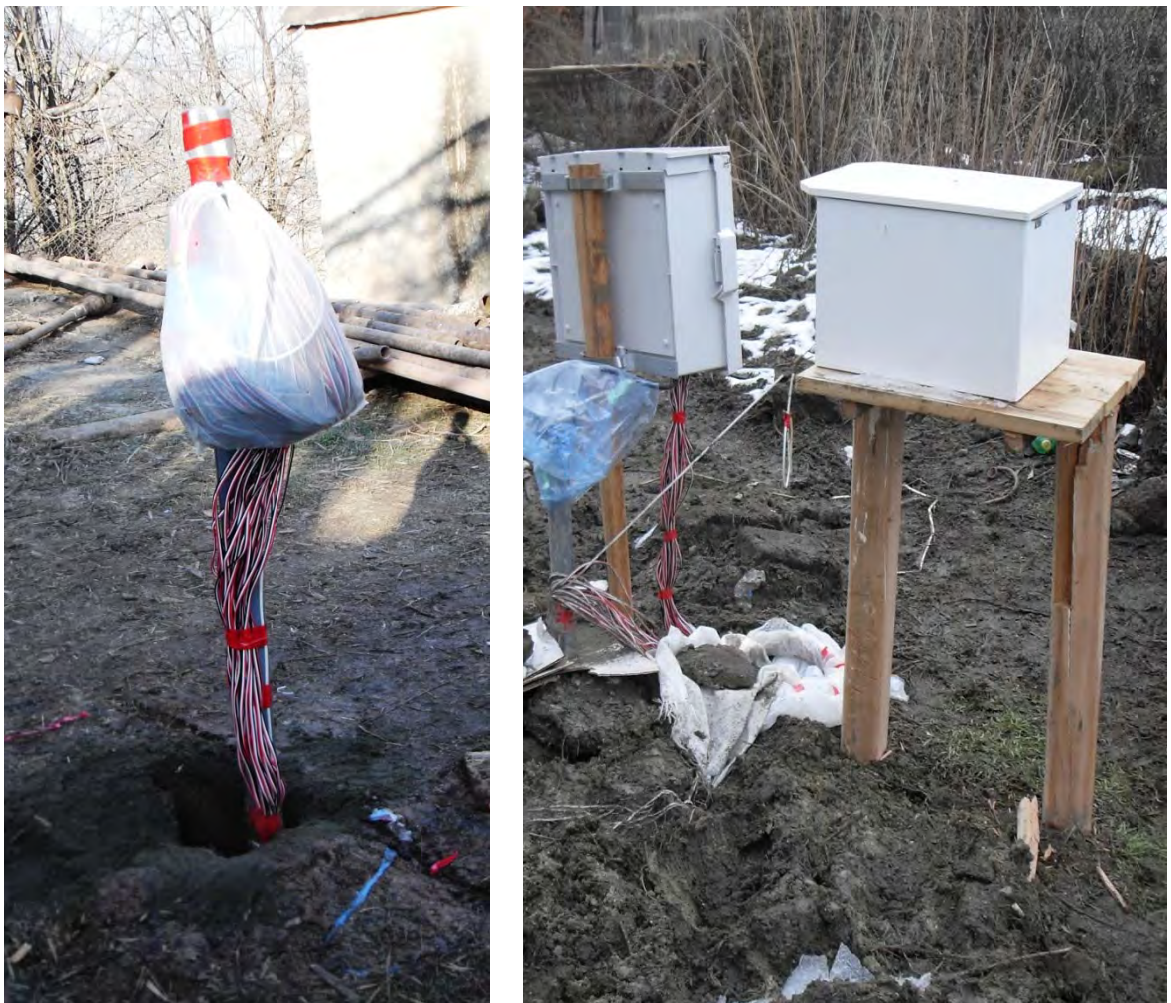
Figure 3.2.4: Installation of a PVC pipe affixed to the sensors into the borehole to record ground water levels and deformation data

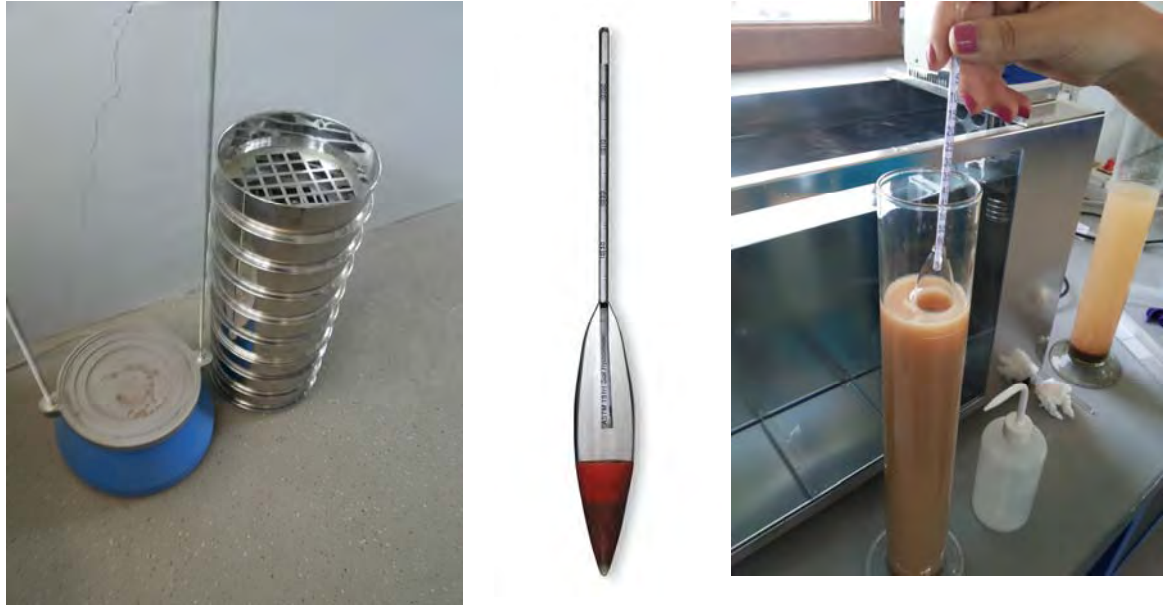
Fig.3.3.4. ASTM Sieves and ASTM 152-H-type Hydrometer

The ASTM sieves and ASTM 152-H type hydrometer were used (Fig. 3.3.4).

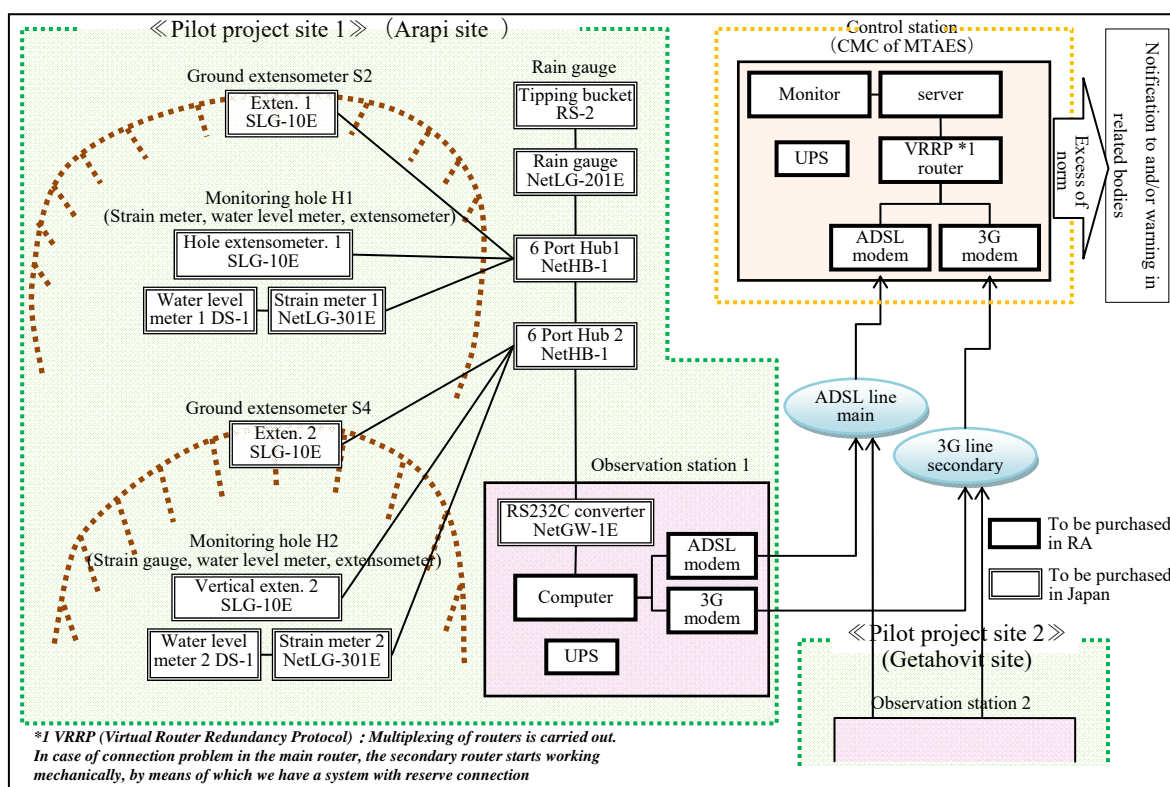
Figure 10 General feature of real-time monitoring system

The person in charge of the JICA Expert Team and the Head of the Crisis Management Center and the person in charge of the system will prepare a design of the system and a general plan (design) related to installation and operation of the system with joint efforts which will be discussed and approved by WG. The general feature of the system is mentioned in Figure 10.

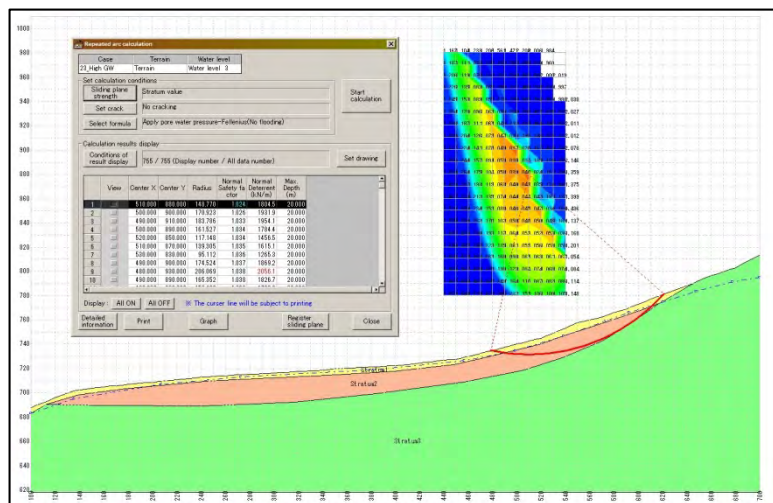
Case 3

GWL: nearly at the ground surface
