**THE PROJECT FOR
CAPACITY DEVELOPMENT OF MANAGEMENT
FOR SUSTAINABLE WATER RELATED
INFRASTRUCTURE
IN
THE PEOPLE'S REPUBLIC OF BANGLADESH**

PILOT PROJECT REPORT

JICA EXPERT TEAM

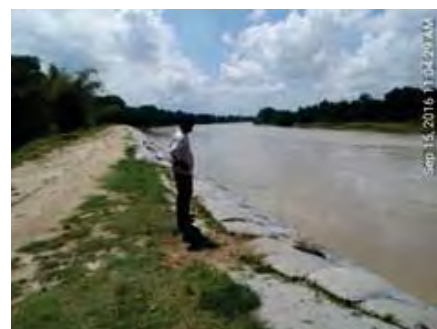
Photo 3.2. River water level of 11.00m (PWD) marked highest on this season on site. From down-stream to up-stream 15 Sept 2016.

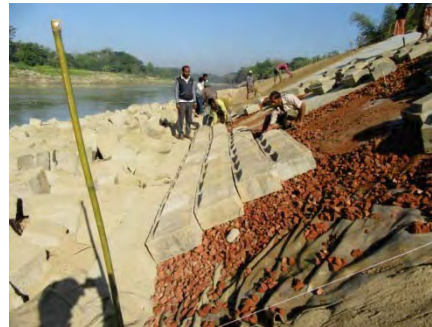
Photo 3.7. Slope protection; sand mat, geo- sheet & CC-block, on 26 January 2017

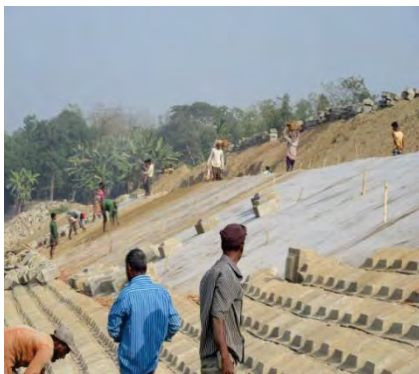
Photo 3.8: Slope protection; sand mat, geo- sheet & CC-block (on 02 Feb 2017)

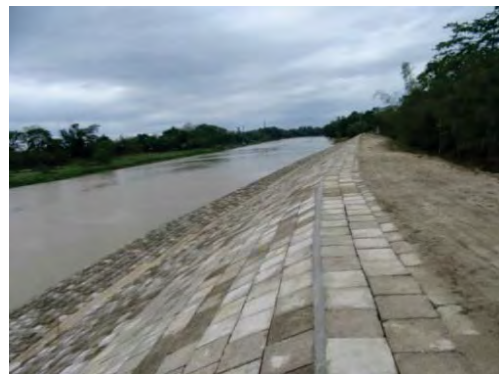
Photo 3.9: Completed Slope Protection from middle toward downstream view on 30 March 2017

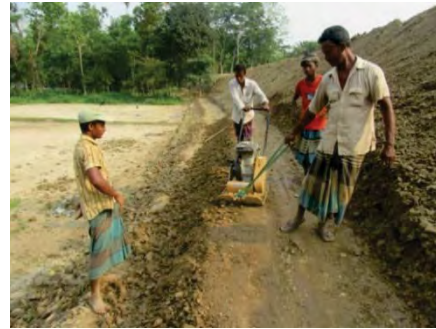
Photo 3.10. Embankment country side slope compacted by plate compactor (on 15 April 2017)

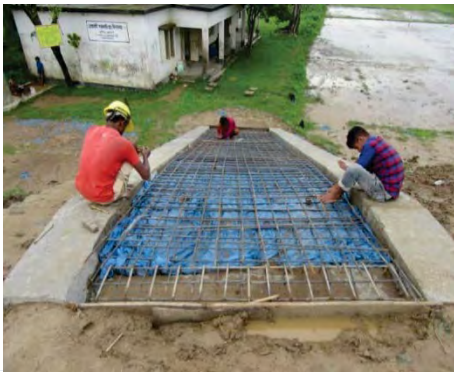
Photo 3.11 Top layer M S reinforcement for StairCase. (on 22 April 2017)

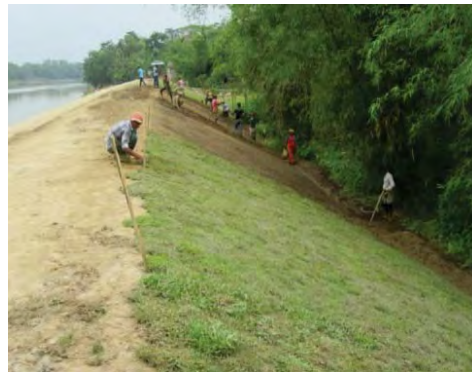
Photo 3.12: Dressing and turfing on country side slope (13 May 2017)

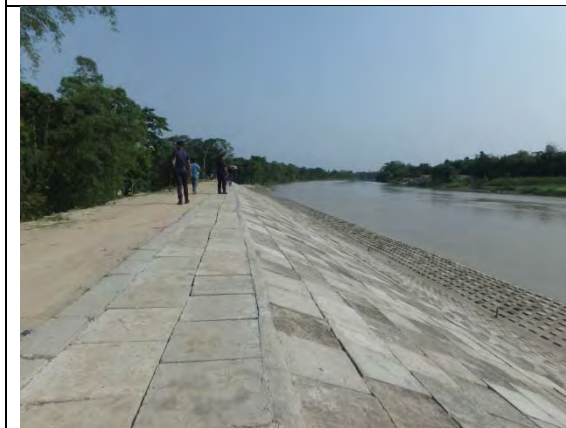
8	Improved embankment	The strengthened embankment stood firm against flood water level of 10.5m (PWD) recorded On April 6, 2017. Moderate horizontal sedimentation belt was observed on the berm. This is an expected effect brought by the projected concrete cubic blocks. Environmentally, this event may be a birth of ecology with newly constructed slope protection works. Official of Moulvibazar O&M Circle, BWDB appreciated idea of the projected concrete cubic block and its introduction in the Pilot Project highly. He also commented that this embankment will last long with proper maintenance works.

Improved embankment and the Manu River

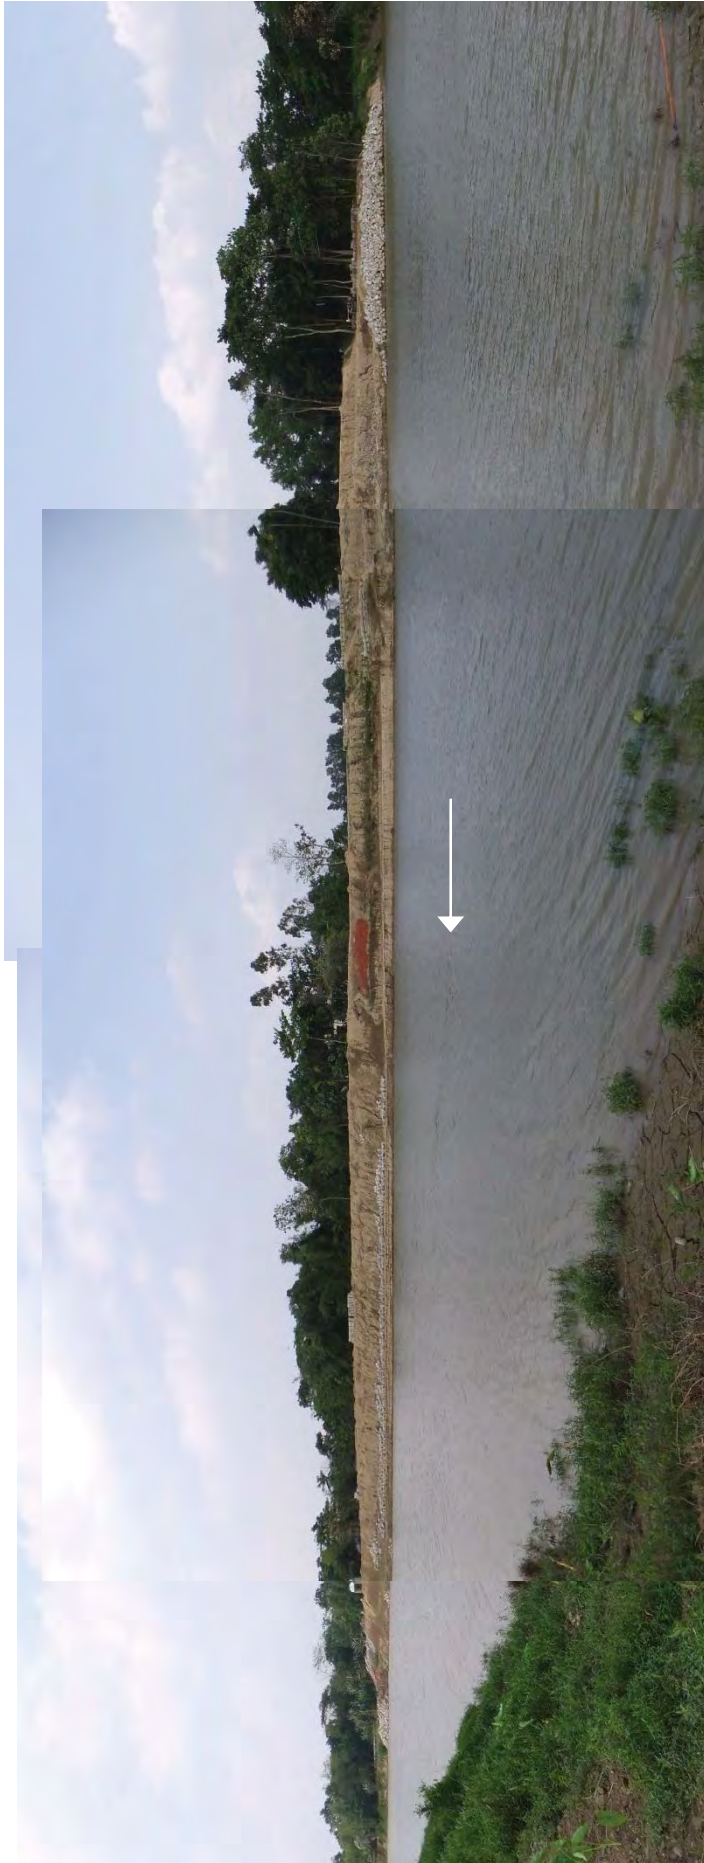
Photograph: Overall View of Pilot Repair Works (from the opposite bank on 21/Apr/2016)

WL at site: PWD +7.73 m

C.C. Blocks for dumping to the Launching Apron are tentatively kept on the design berm (PWD +9.1 m) of embankment.

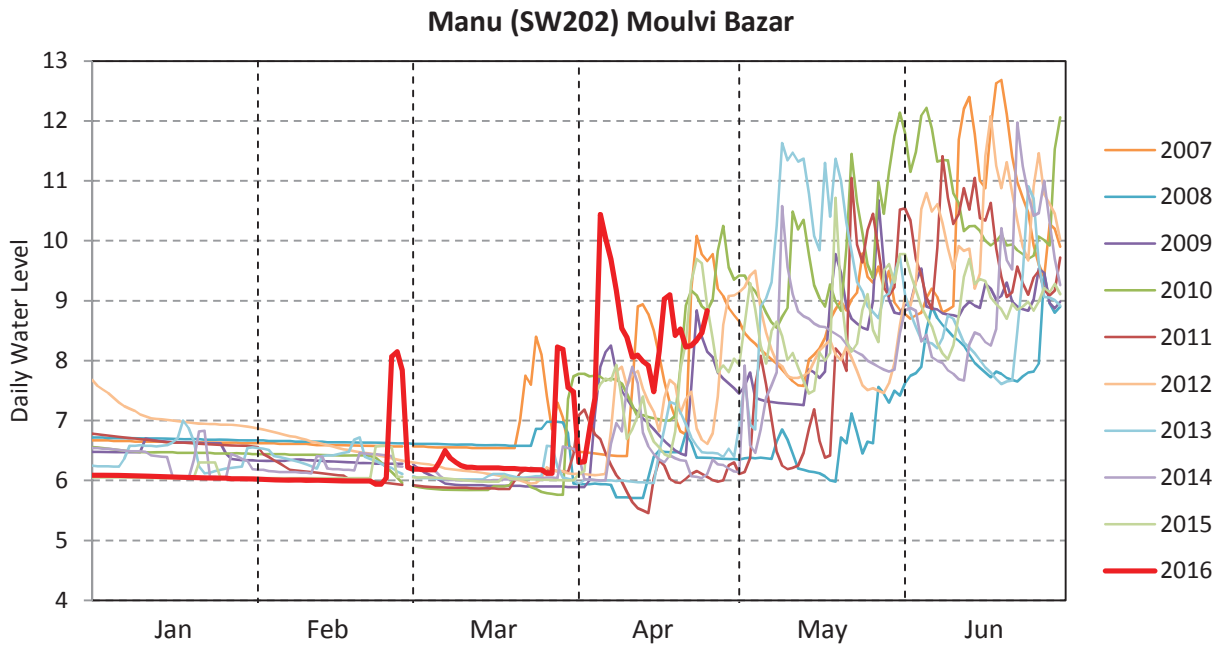
Figure 3 Water Level of Manu River (SW202, Moulvi Bazar)

Note: Moulvibazar station is located at the upstream site of the Pilot Project Site. (refer to Figure 2). WL of the Pilot Site are below about 1.5m from WL of Moulvibazar Station, in case of no backwater from Kushivara River.

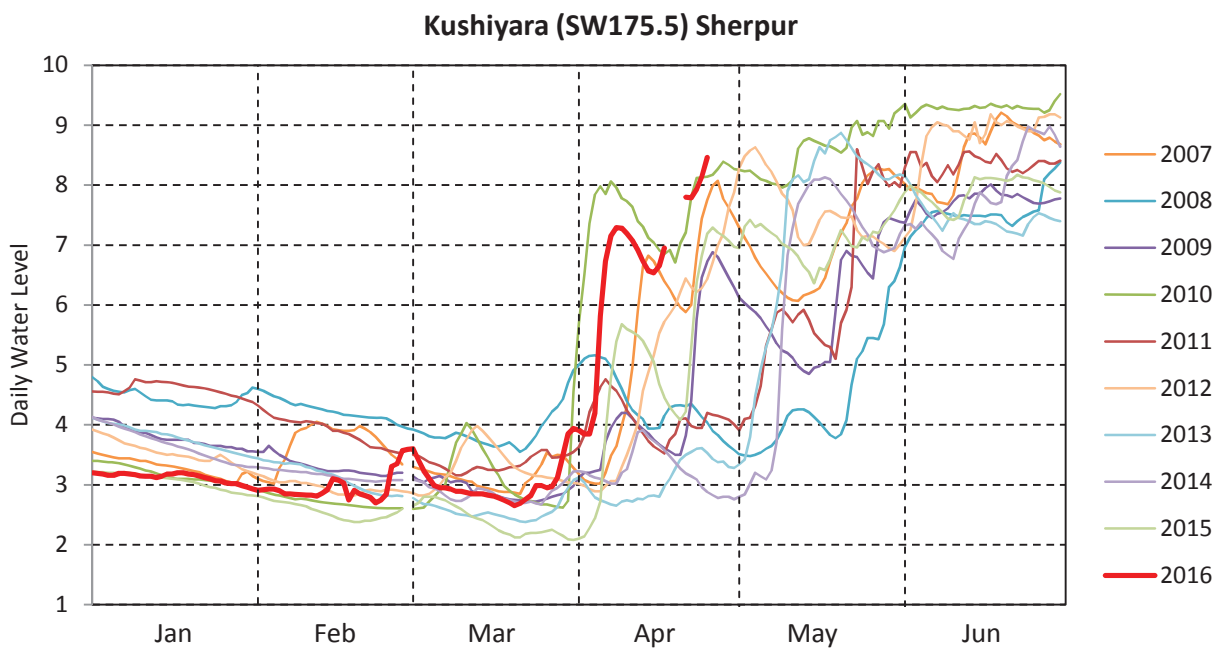
Figure 4 Water Level of Kushiyara River (SW175.5, Sherpur)

Note: Sherpur station is located at the downstream site of the Pilot Project Site. (refer to Figure 2).

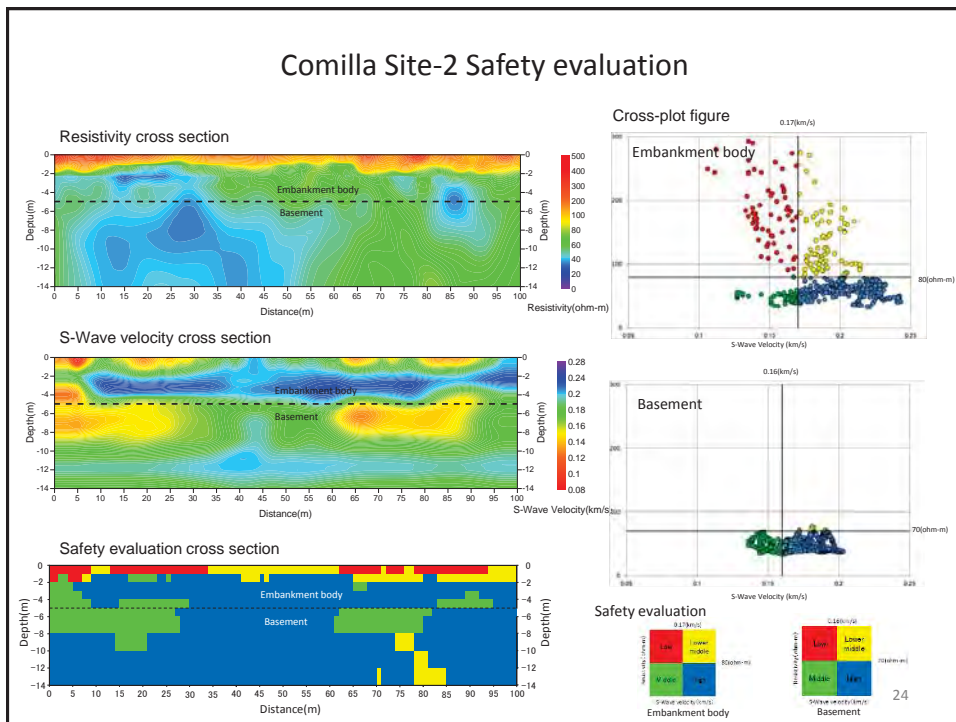
- As for the embankment body, the red zone (a-rank) is up to surface layer 1m. There are few red zone (a-rank) in the place deeper than 2m.
 - The red zone (a-rank) is limited to the surface like Site-1. So this is not serious problem of the embankment.

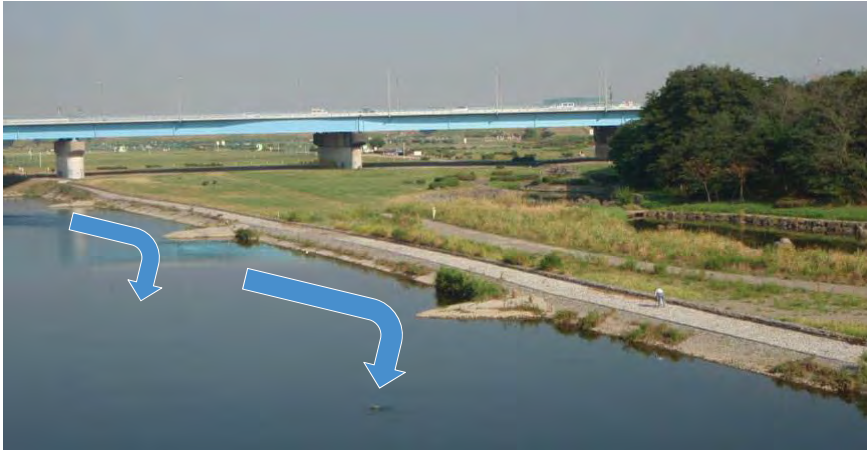
Function of groyne/super dike is ...
to reduce the flow velocity near the bank by directing the flow away from the bank.
