資料一7 対象校地盤・地質・水質調査結果

Project: Building a school on the site A8 of ENTA Marché in the commune of Matoto.

Part :
geotechnical study of the site.

TECHNICAL REPORT.

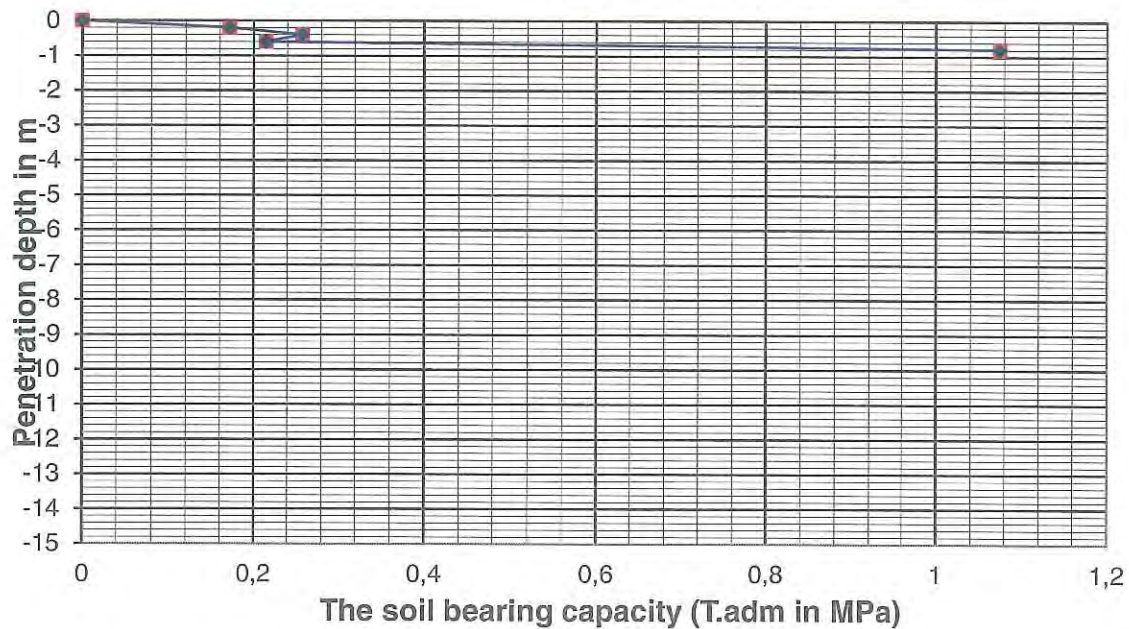
Penetration curve of the CPT1 drilling

Profond (m)	N C	Qd (bars)	T adm (bars)
0,00 -0,20	4	34,4	1,72
0,20 -0,40	6	51,6	2,58
0,40 -0,60	5	43	2,15
0,60 -0,80	25	215	10,75

<u>Legend</u>	<u>The characteristics of the device</u>
Depth: penetration depth in m	Mass of threshing sheep: 63.5 kg
NC: number of blow for 20 cm pressing	Lost section point: 15.9 cm ²
Qd: dynamic resistance of the stack bars	Drop height: 50 cm
T. Adm: admissible work rate or soil bearing capacity (bars)

Following the admissible charge rate, we can name the following grounds (see curves):

- a. **Soil with less bearing capacity:** that part of the ground is constituted with less bearing capacity soils, its admissible charge rate varies from **0.17 to 0.38 MPa**. In this interval, we note the colluvium materials wrapped up in a sandy loam with high content in organic matters, with the mechanic character going from medium to feeble, with a non-negligible collapse risk.

- b. **Resistant soil:** that horizon is essentially composed with hard ferruginous cuirass; it is a natural soil which is the product of a residual alteration. This level is very resistant, and the admissible charge rate is superior or equal to **10.75 \approx 11 bars, let be 1.1 MPa**. These prove that this horizon has a good mechanical character. Although this layer has given a very good resistance value, it presents a high risk in building heavy works; it sometimes contains caverns and pocket of clays within it. So, the detailed studies are necessary before the definitive implantation of the work.

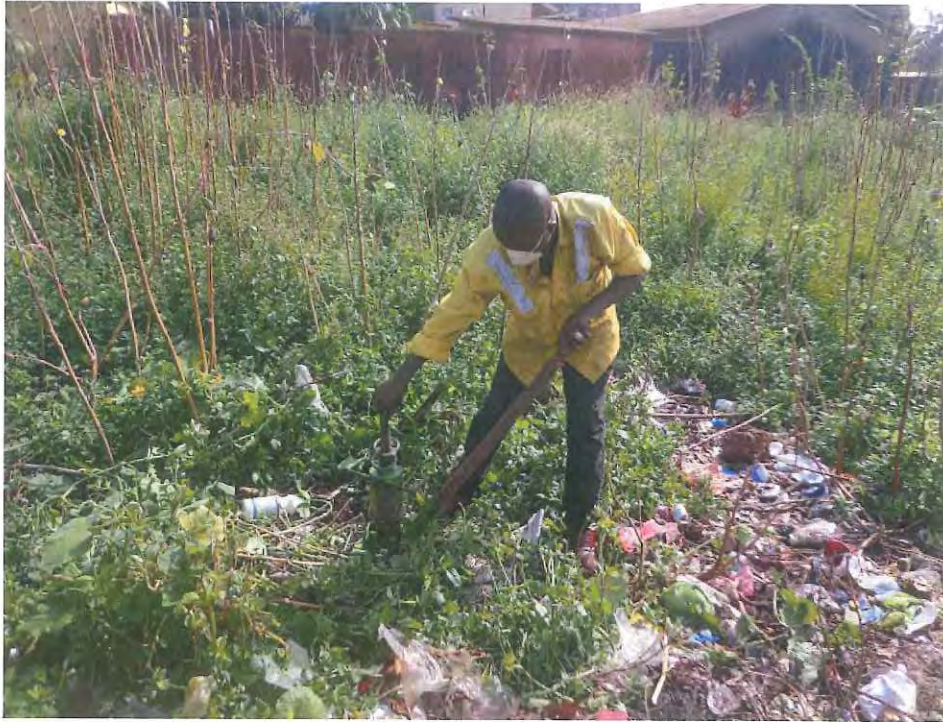
The rise of the stems at the point CPT1

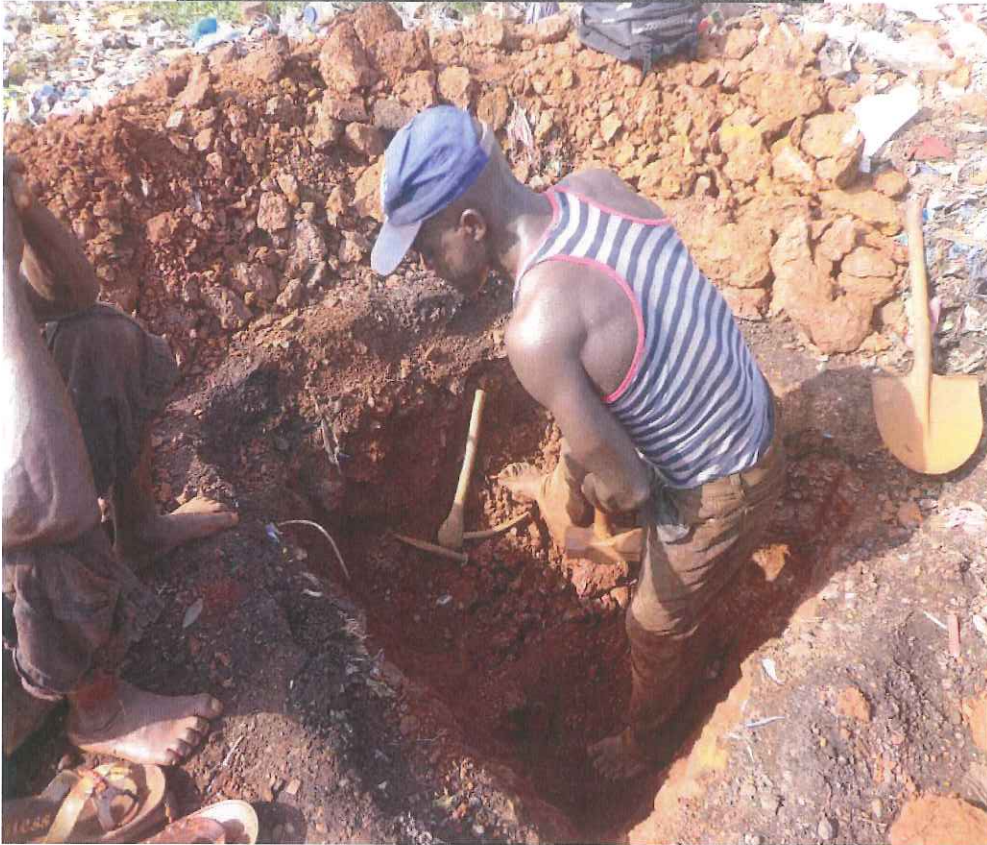
Site A8 Enta Marché Excavation well P01

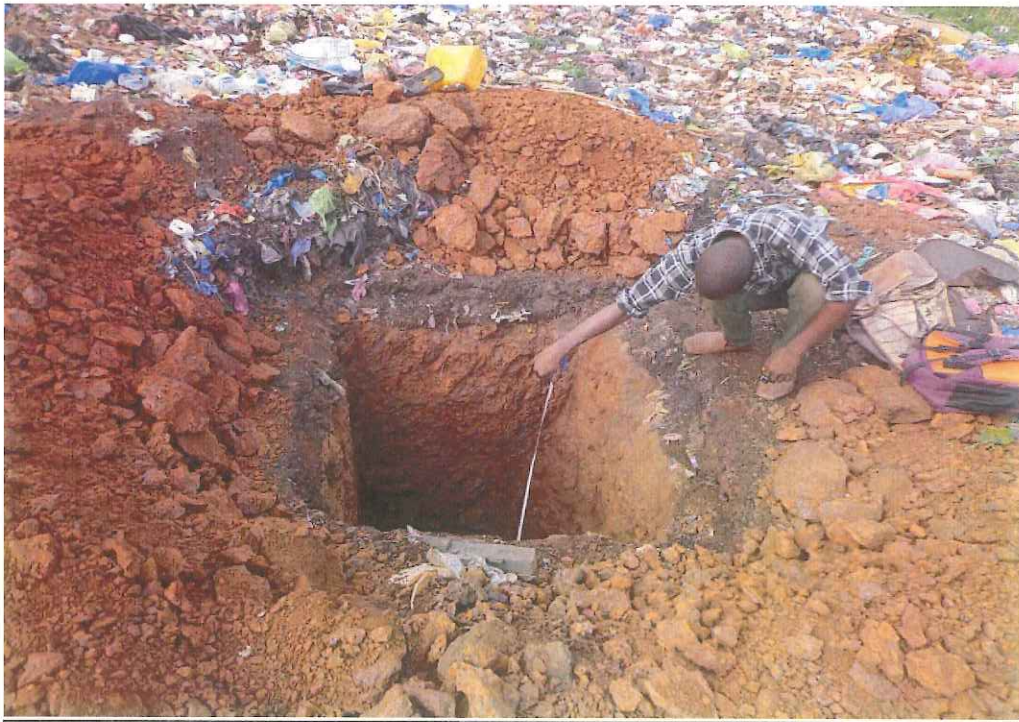
Site A8 Enta Marché Well P01 ; Depth : 1,50 m ; Surface :1 m²

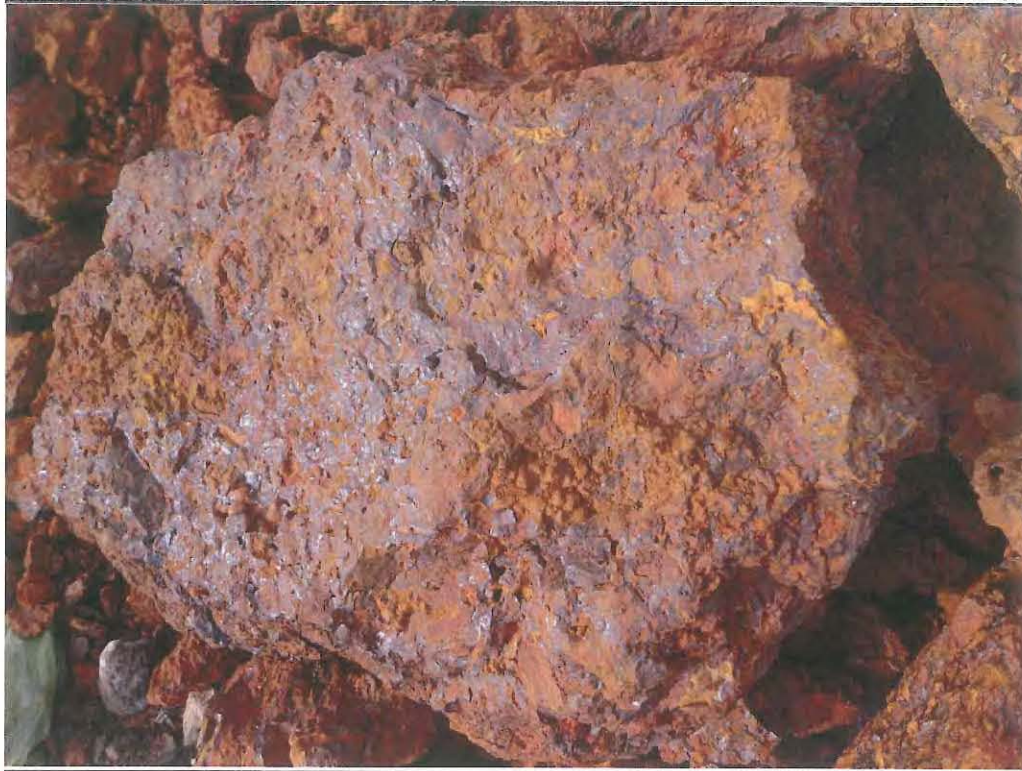
Site A8 Enta Marché: ferruginous cuirass excavated in the well P01

- Lateritic cuirass:** it is a very hard and compact ferruginous lateritic shield, having voids covered with yellowish products, with variable thickness on the site.

It flushes almost everywhere in the Kaloum peninsula, apart from some areas where it is covered with colluvium deposits. It is an excellent layer for heavy works foundation.

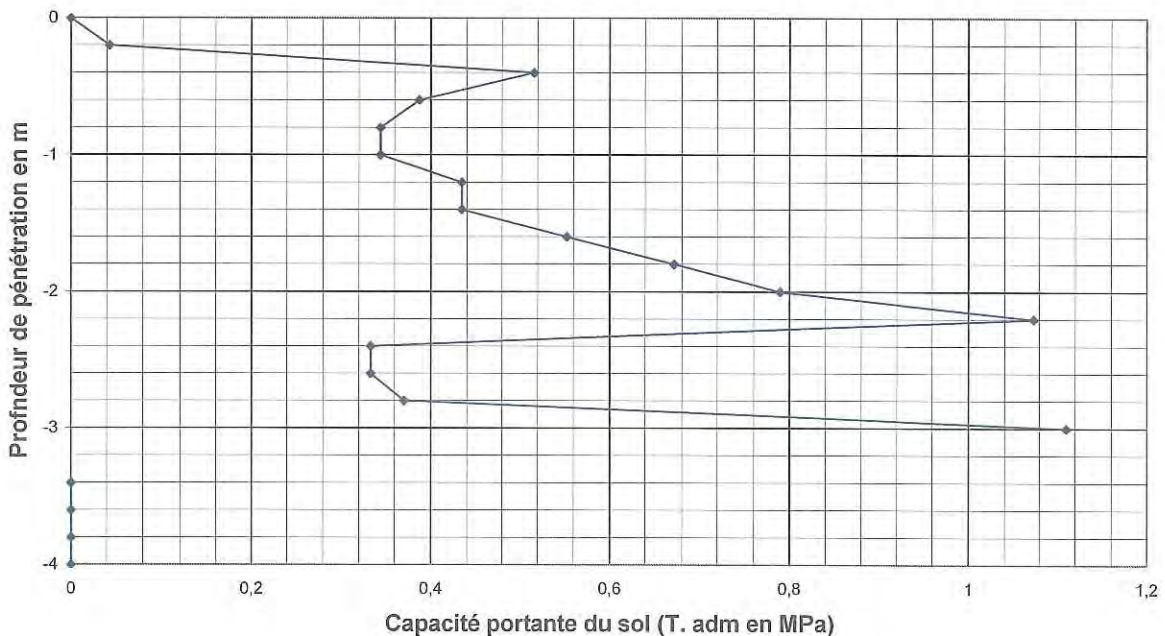
Courbe de pénétration

Masse du mouton de battage: 63,5kg
 Pointe perdue de section: 15,9cm²
 Hauteur de chute: 50cm

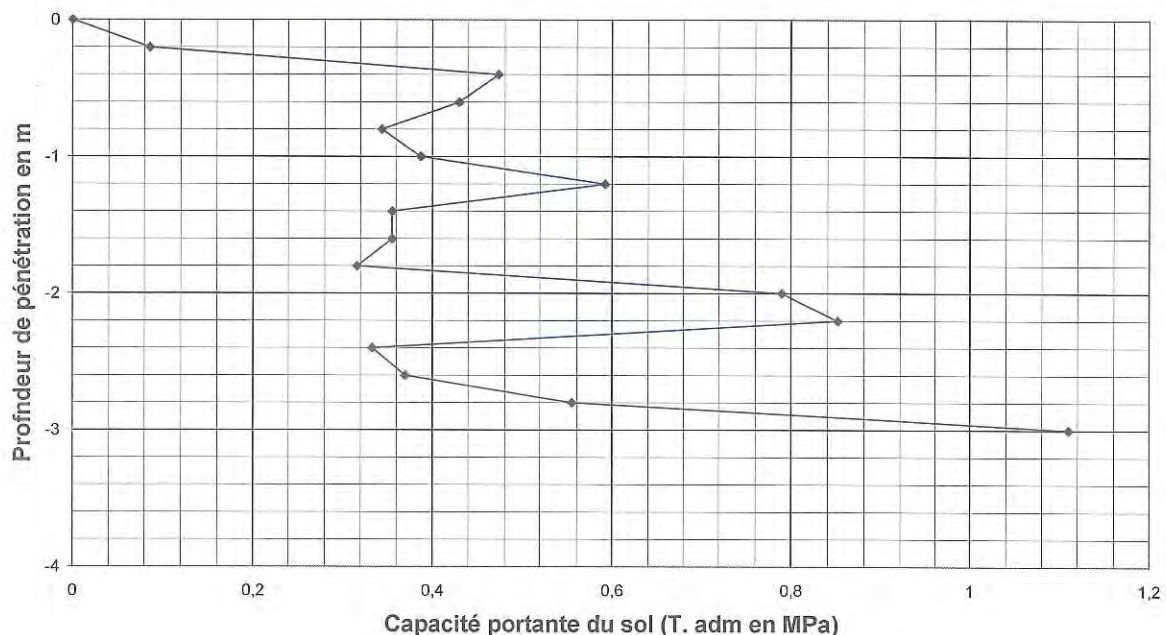
Courbe de pénétration

Masse du mouton de battage: 63,5kg
 Pointe perdue de section: 15,9cm²
 Hauteur de chute: 50cm

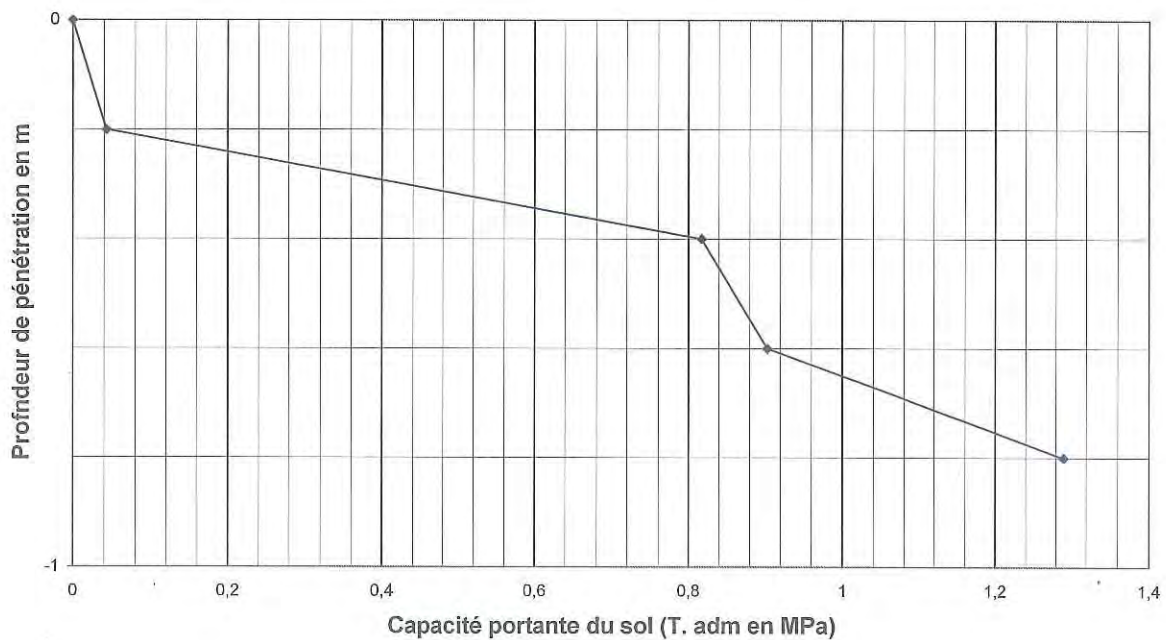
Courbe de pénétration

Masse du mouton de battage: 63,5kg
 Pointe perdue de section: 15,9cm²
 Hauteur de chute: 50cm

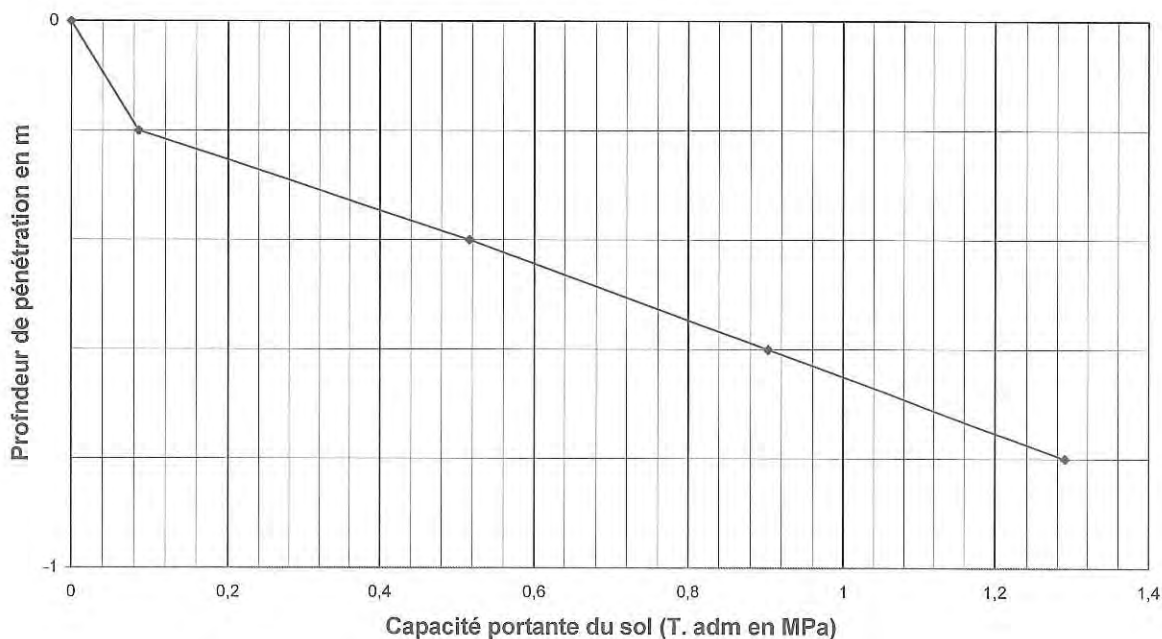
Courbe de pénétration

Caractéristiques de l'appareil
 Masse du mouton de battage: 63,5kg
 Pointe perdue de section: 15,9cm²
 Hauteur de chute: 50cm

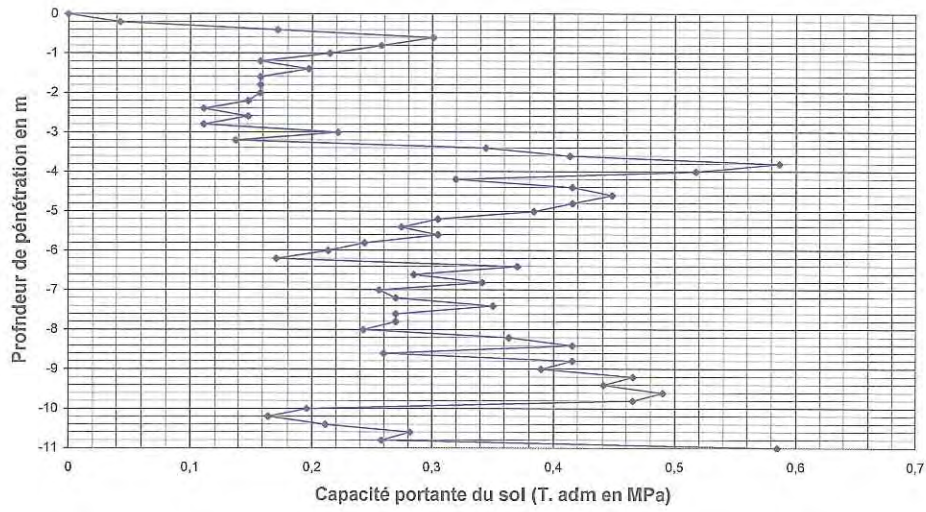
Courbe de pénétration

Masse du mouton de battage: 63,5kg
 Pointe perdue de section: 15,9cm²
 Hauteur de chute: 50cm

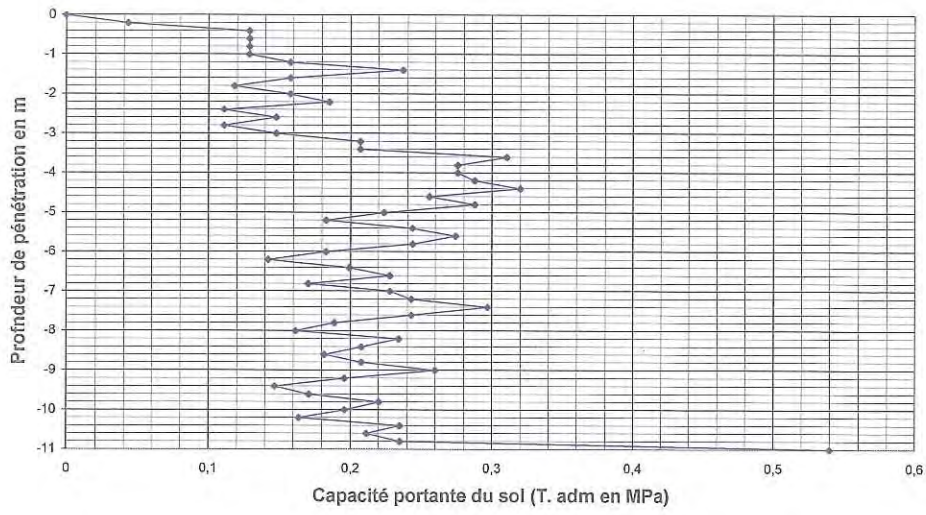
Courbe de pénétration

Masse du mouton de battage: 63,5kg
 Pointe perdue de section: 15,9cm²
 Hauteur de chute: 50cm
