**DATA COLLECTION SURVEY
ON
DRAINAGE CAPACITY IN GEORGETOWN
IN
THE CO-OPERATIVE REPUBLIC OF GUYANA**

FINAL REPORT

**JAPAN INTERNATIONAL COOPERATION AGENCY
CTI ENGINEERING INTERNATIONAL CO., LTD.**

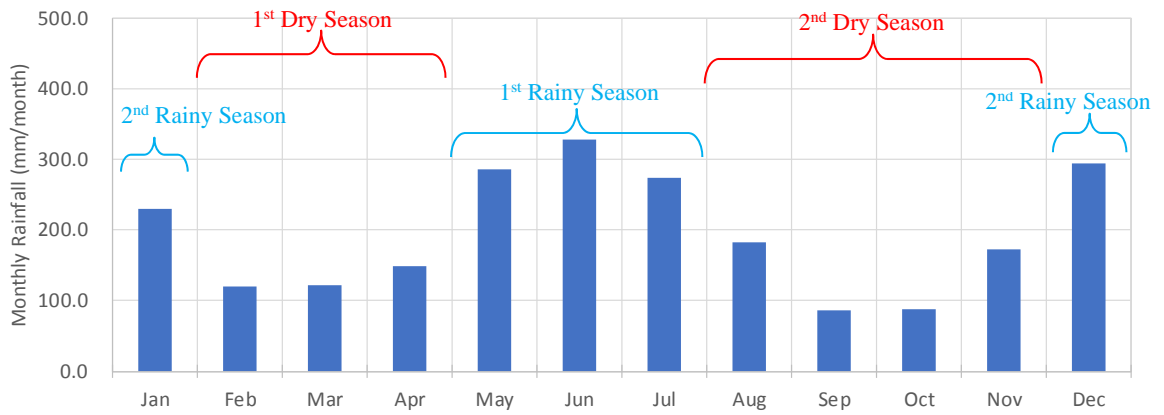
Fig. R 1.3.2 Mean Monthly Rainfall in Georgetown (1886-2016)

Fig. R 1.3.3 shows daily maximum, monthly maximum and annual rainfall in Georgetown from 1886 to 2016. **Table R 1.3.1** shows the ranking of daily maximum, monthly maximum and annual rainfall in Georgetown between 1886 and 2016. The trend of increasing rainfall is not indicated in **Fig. R 1.3.3**. However, the recent floods of 2005, 2014 and 2015 were caused by rainfall in the upper part of ranking during approximately 130 years of observation.

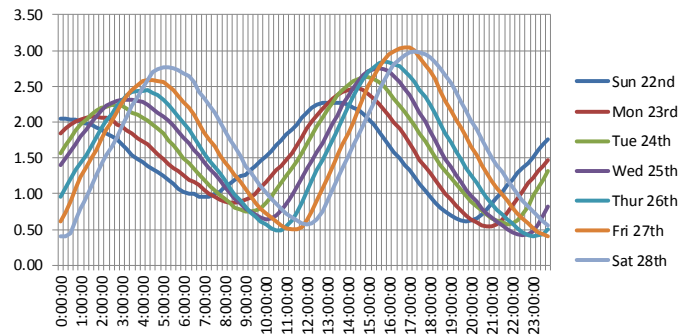
Fig. R 1.3.5 Observed Tidal Data in Georgetown (January 22, 2017 to January 28, 2017)

Tide level data in Georgetown is observed by pressure type water gauge, radar type water gauge, and watermarks. The tide data have been automatically observed every 15 minutes by pressure type water gauge and radar type water gauge since January 2007. The tide data have been observed at high tide and low tide by watermark from 1962 to 1983, during working hours of MARAD-MPI, from 8:00 AM to 4:00 PM since 1984. MARAD-MPI analyses the astronomical tide level and publishes tide tables every year.

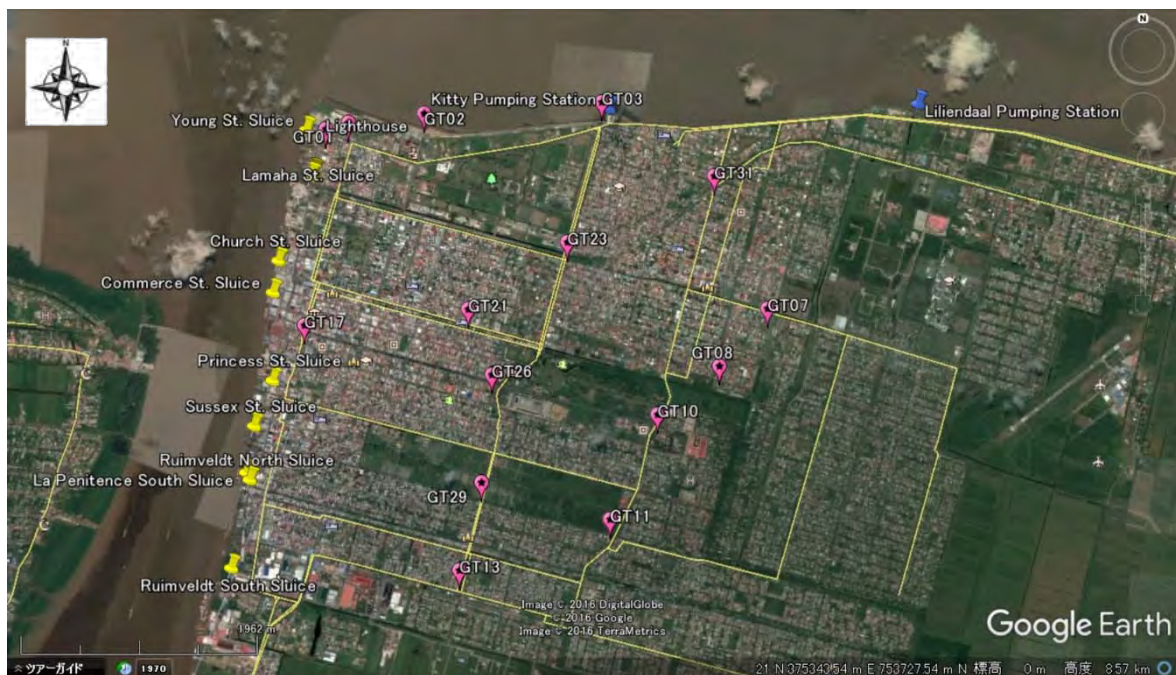
The locations of benchmark in Georgetown are as given in **Fig. R 1.3.7**. The GL&SC's benchmarks in Georgetown includes GT1 to GT31. However, several benchmarks are not used presently, because of deterioration, buried under pavement or embankment, unidentified at site, etc.

Source: Verification of Benchmark by JICA Survey Team and Local Survey Company (Surveying & Project Management Inc.) based on Information from GL&SC

It is desirable that GL&SC periodically conduct survey to verify the accuracy and elevation, and situationally recover and relocate the inadequate benchmarks.

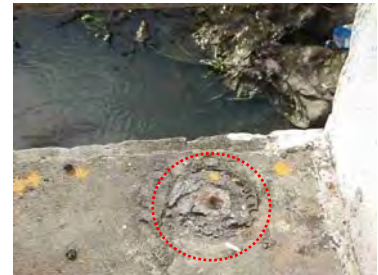
Photo R 1.3.3 Condition of Existing Benchmarks

GT20 on Bridge across Church St. Channel. (GT20 is unavailable due to loss of steel rod)

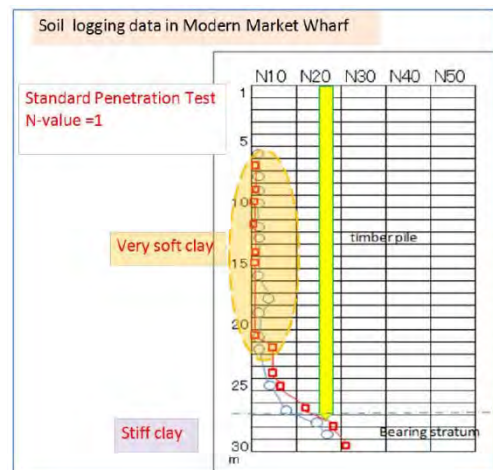
According to the Georgetown Water and Sewerage Master Plan (1994) Guyana Water Authority [hereinafter called M/P (1994)], urban development is not as influential as it is in other urban areas as the impermeable nature of the underlying clays in Georgetown means that seepage is negligible and that infiltration of rainwater is limited to the topsoil. **Fig. R 1.3.8** shows that the topsoil of Georgetown has low N-value and layer of clay.

Thus, it is supposed that rainfall penetrated into the ground poorly and run off into the channel largely in Georgetown even before the urbanization.

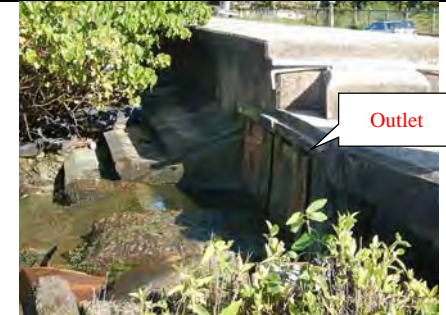
<p>Outlet</p>
		NDIA Report 2015	Drainage Area: 243 ha, Pump Capacity: 4.3 (m ³ /s)
		M/P (1994)	Drainage Area: 243 ha, Pump Capacity: 1.2 m ³ /s by 2 units, constructed in 1968 (Rehabilitated in 1993)
		Hearing Result	According to the Operator of pumping station, NDIA replaced the unit of pump except building to enhance the capacity around 2009.
3	Young St.

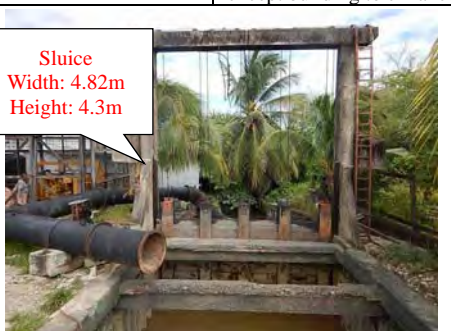
<p>Sluice Width: 4.82m Height: 4.3m</p>

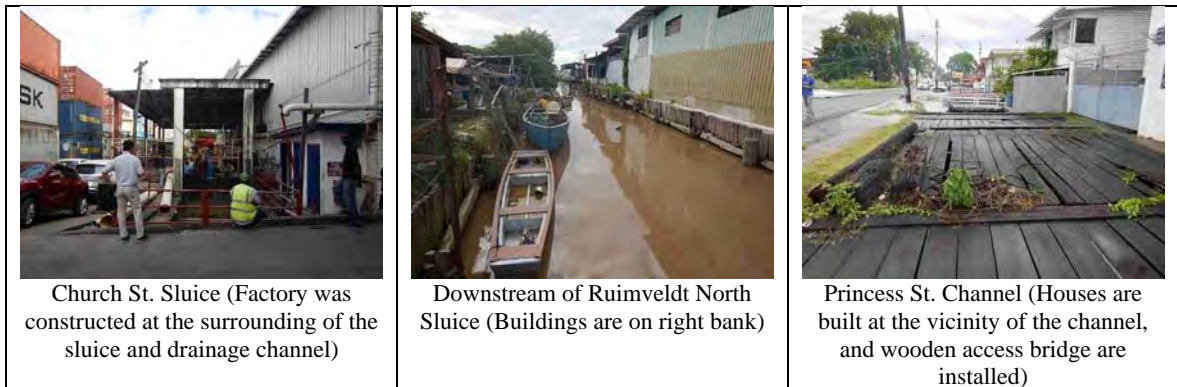
Photo R 2.1.2 Facilities/Buildings along Drainage Channel

On the other hand, the legal system in Guyana for drainage has the “Laws of Guyana (Chapter 64-03, Drainage and Irrigation Act)”. According to this Act, the area within twelve feet shall be kept free for maintenance work by NDIA and continue to be the property of the NDIA. In fact, however, there are many facilities and buildings along the existing drainage channel.

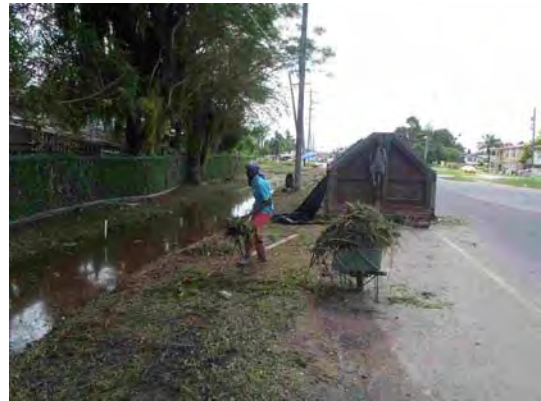
Photo R 2.2.1 Mowing at Drainage Channel

Regarding the maintenance of drainage channels, manual desilting and mowing in the channel are carried out in Georgetown (refer to **Photo R 2.2.1.**) Although M&CC cleans and desilts the drainage channels with assistance from related agencies, the maintenance work is not executed at enough frequency due to the long extent of the drainage channel.

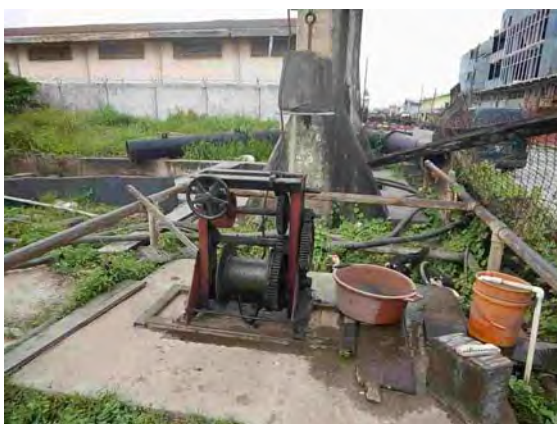
Wire Rope Winch Type (Princess St. Sluice)
