スリランカ民主社会主義共和国
における豪雨災害に対する
国際緊急援助隊・専門家チーム
活動報告書

平成29年8月
(2017年)

独立行政法人国際協力機構
国際緊急援助隊事務局

**THE INVESTIGATION OF THE
DAMAGES FROM THE FLOODS AND LANDSLIDES
CAUSED BY THE HEAVY RAINFALL IN DEMOCRATIC
SOCIALIST REPUBLIC OF SRI LANKA**

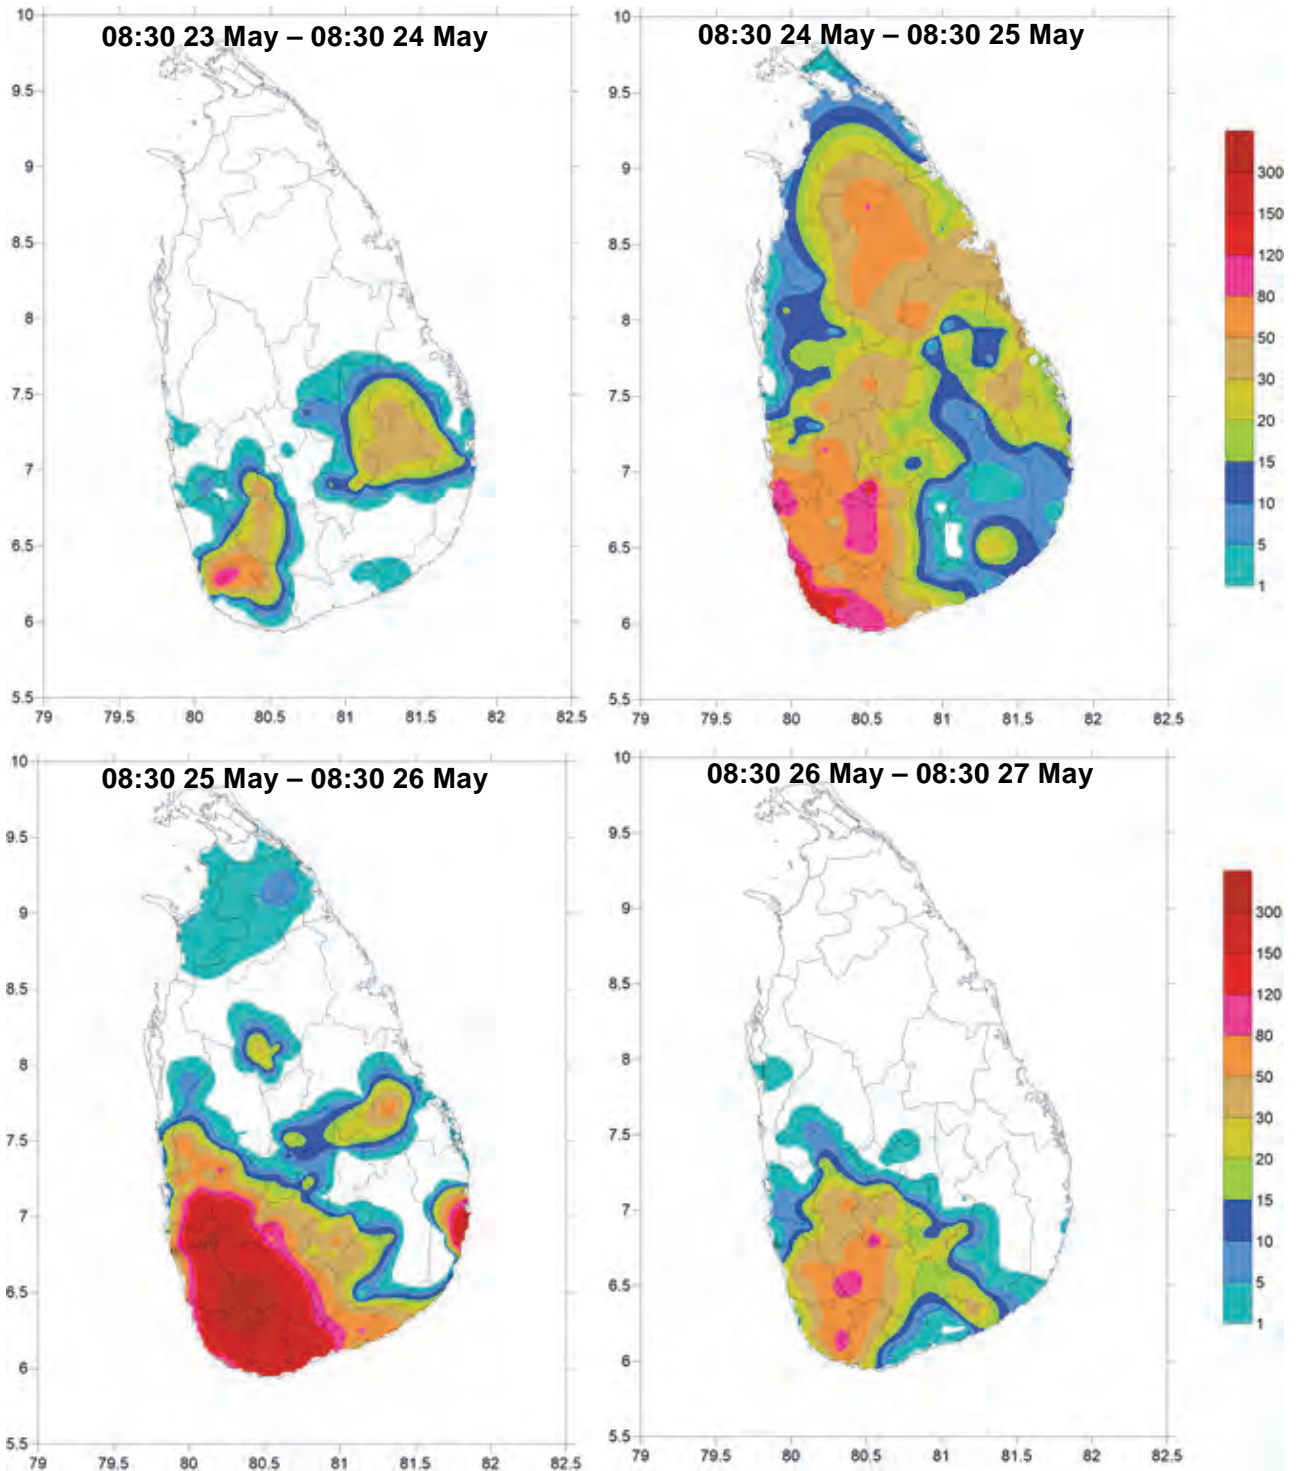
図 3-3 2017 年 5 月 24～27 日の各日 08:30 スリランカ時から翌日 08:30 時における日雨量分

図 3-3 の日雨量分布に示すように、スリランカ南西部の豪雨は 5 月 25～26 日にかけての期間に発生した。

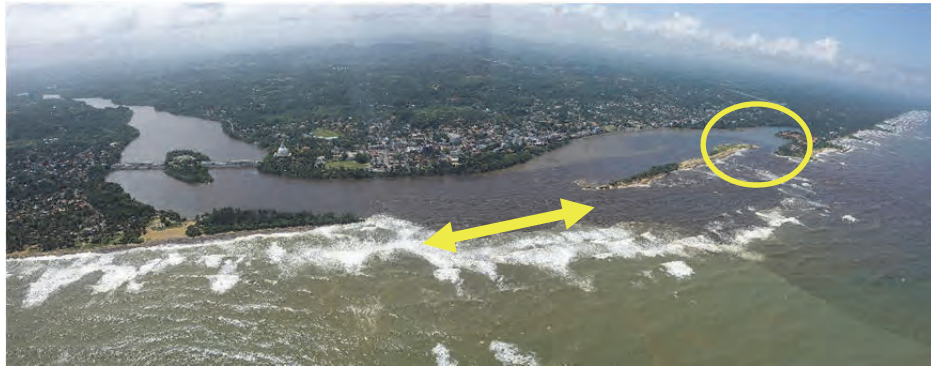
写真3-1

カル川の河口部は河口閉塞が著しく、南側の丸印の狭窄部がもともとの河口部である。これが下流部氾濫の主原因というのが灌漑局の見解であった。このため、洪水初期に灌漑局では砂州の開削により下流氾濫の低減を図っている。

河口砂州の閉塞部を洪水初期に右岸側から機械開削し流下能力の確保を図ったとのこと

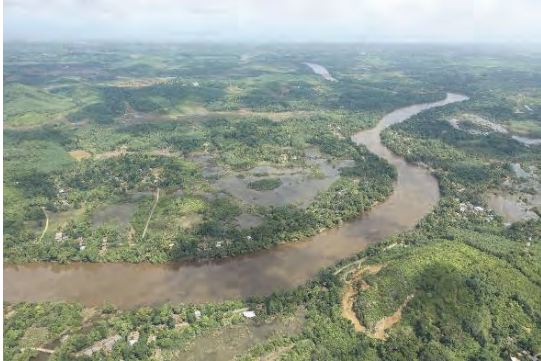
写真 3 - 3 下流部

下流部、中流部とも、本川に堤防がないことから堤防破堤による一気の氾濫というよりは、本川の洪水位上昇により同時に発生する越水氾濫と内水の滞留、と推察できる。

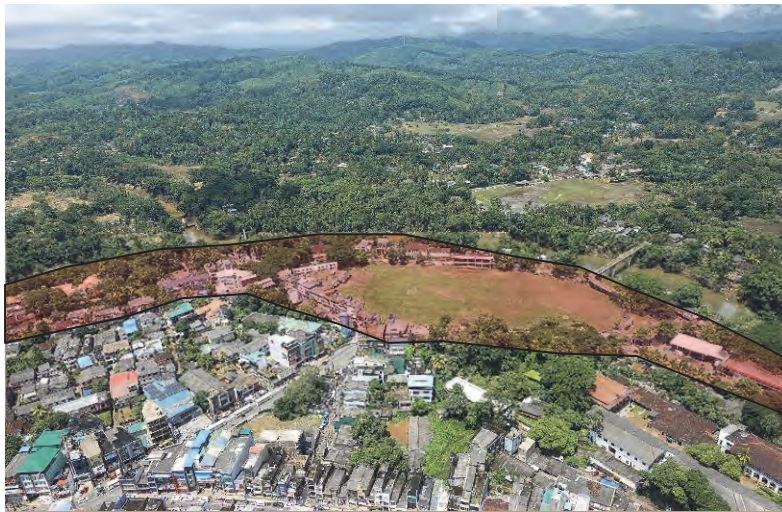
写真 3-5 ラトナプラ市街地の常襲氾濫域

川沿いの洪水常襲地帯といわれる市街地中心部は上の写真のエリアがおおむね毎年から数年に1回は氾濫するというのが、ラトナプラ市の責任者の弁である。氾濫防止対策としての堤防には明言はしなかったが抵抗があるような気配であった。

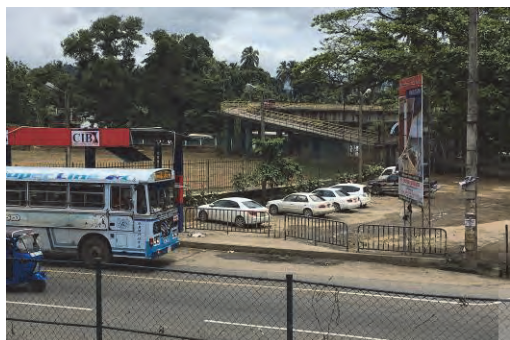
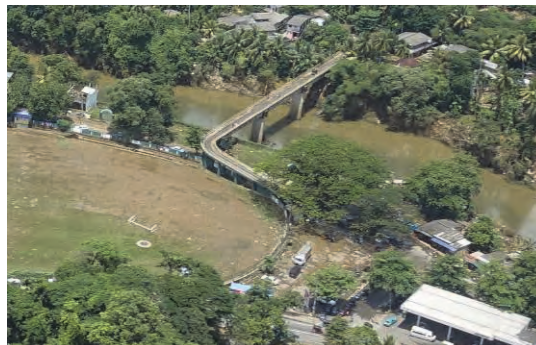
写真 3-7 本川の橋梁と市街地・道路の高さの差

本川を渡る橋梁が現地盤からの高さからしてこのエリアの想定洪水水位が川沿いの道路や市街地よりいかに高いかが分かる。

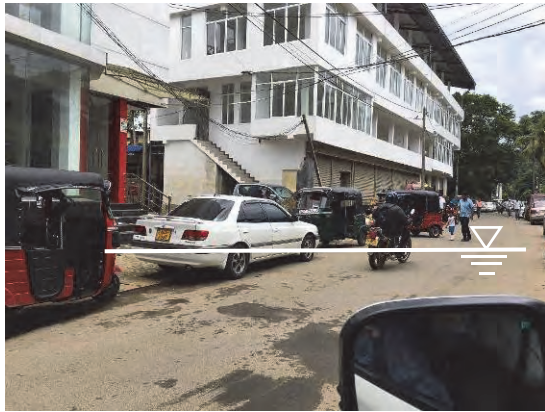
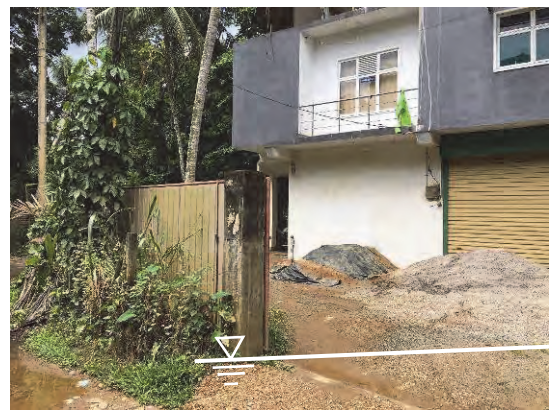
写真 3 - 9 ラトナプラ道路沿い市街地の洪水位

写真 3 - 10 ラトナプラ左岸支川合流部付近の洪水位

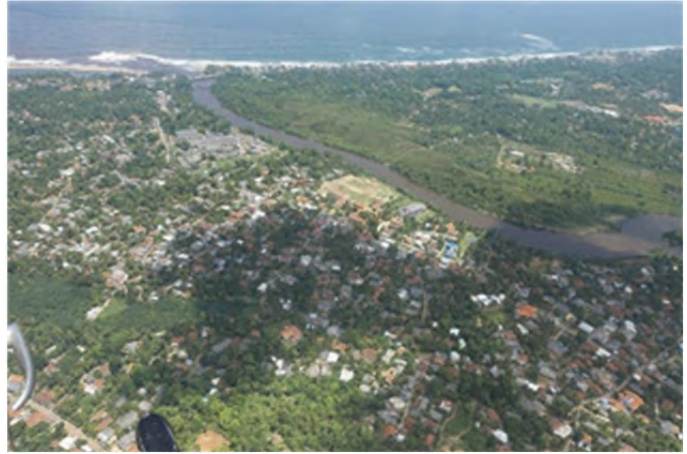
河口閉塞もそれほど顕著ではなく、河口部の海岸砂丘状の微高地にできた市街地も比較的被害は小さかったように見える。

写真3-11 ギン川河口部及び最下流の密集エリア

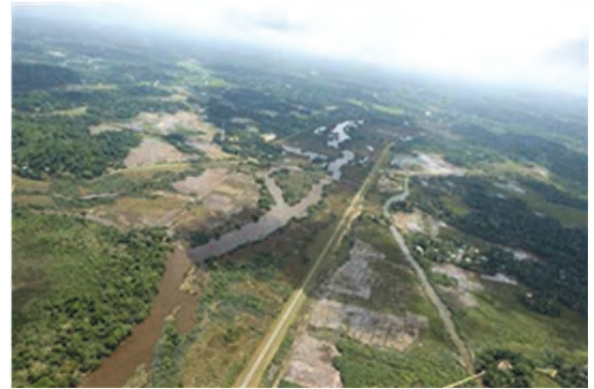
写真3-12 ギン川下流部の立派な築堤

ギン川では下流部に長大な堤防が築堤されており、一方本川があまり氾濫していないように見えるものの、堤内地の左岸側（下の写真で右側）では内水氾濫が発生しているようにも見え、既存治水施設の効果など詳しく調べておく必要があるようにも見える。

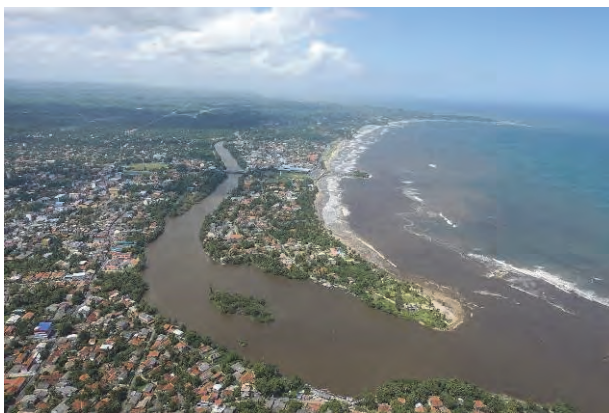
ニルワラ川の河口閉塞もそれほど顕著ではなく、河口部の海岸砂丘状の微高地に広がる市街地も比較的被害は小さかったように見える。

写真3-13 河口部

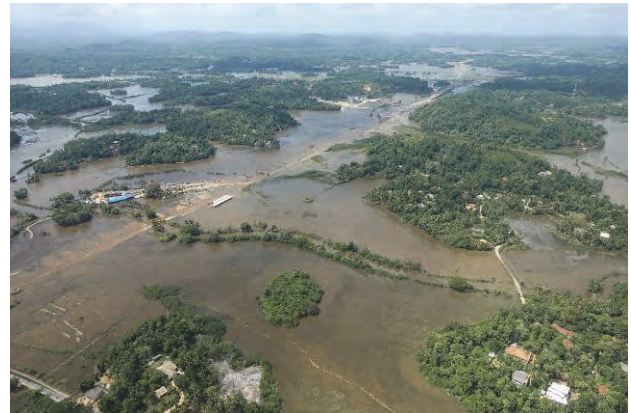
写真3-14 下流部の氾濫

下流部の氾濫は他の2河川に比べて広大である。ただし、人家も少なく農地の被害が主たるものと思われる。

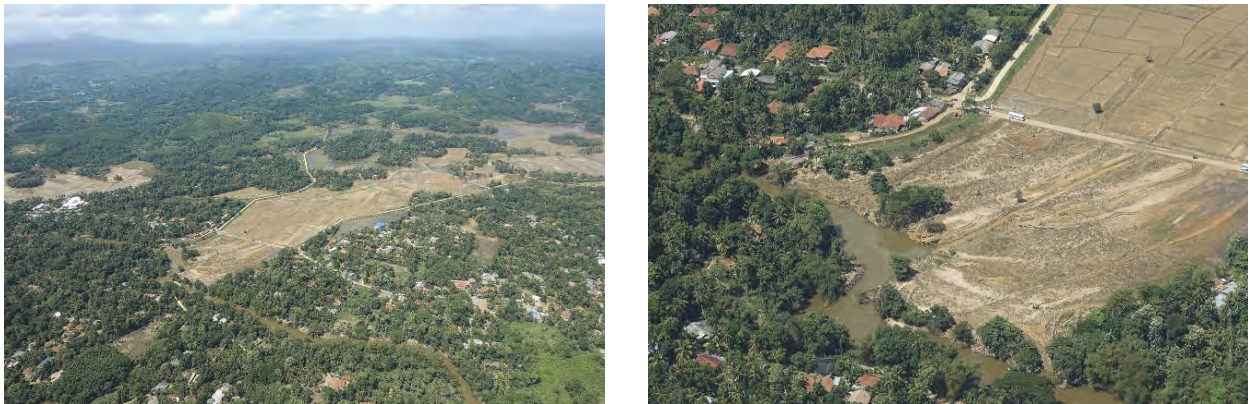
中流部も氾濫源となる低平地は農地利用に限定されており比較的経済被害は少ないと思われるが、一部河川からの氾濫が卓越していたような場所も見受けられた。

写真3-15 中流部：河川からの氾濫が卓越したと見える場所もある

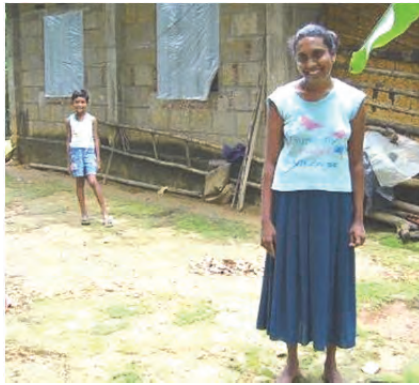
なお、灌漑局はカル川流域では6カ所の Historical Station での観測を長期にわたって行っており、近年にはうち2カ所をテレメーターでのデータ送信も行っているが、平時3時間ごと、洪水時毎時の人力観測は継続している。このいわゆる「水守」は Gauge Keeper と呼ばれ世襲で親から受け継いでいる例も多いとのこと。

写真 3-18 父親から世襲した Gauge Keeper の女性と観測記録簿

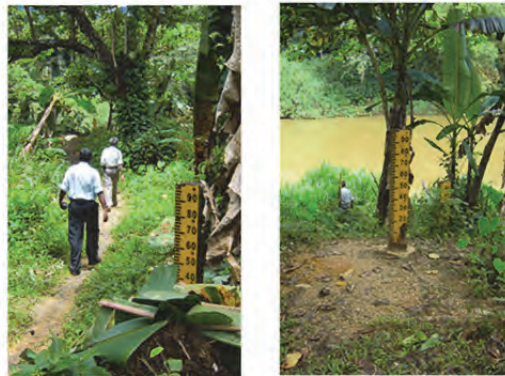
写真 3-19 水位標による観測

ほぼ 10 年後に同じ観測所を訪問したところ、同じ女性が Gauge Keeper として継続して、平時は 3 時間おき、洪水時には 1 時間ごと 365 日水位観測を行い、本部への報告を行っていた。

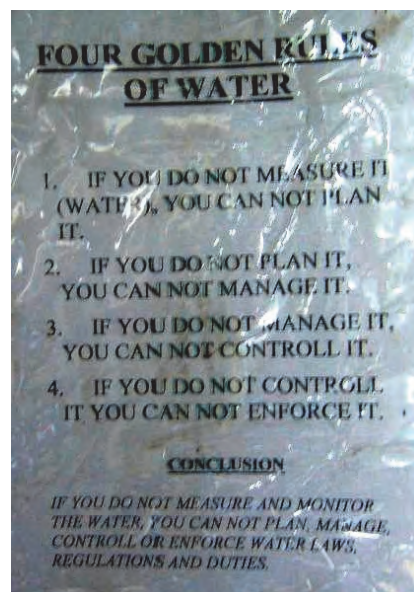
それには、“**Four Golden Rules of Water**” として、“**If you do not measure it, you cannot plan it**” と観測がすべてのベースにあることを記しており、それらが大事に引き継がれているという、“**Primitive but Practical**” を体現・実践しているすばらしい事例である。

なおこの紙は、2007年当時のヒアリングでは写真 3-21 の灌漑局本部の洪水管理責任者が自ら作成したものとのことであった。

図 3-22 観測小屋の壁に貼られていた観測哲学

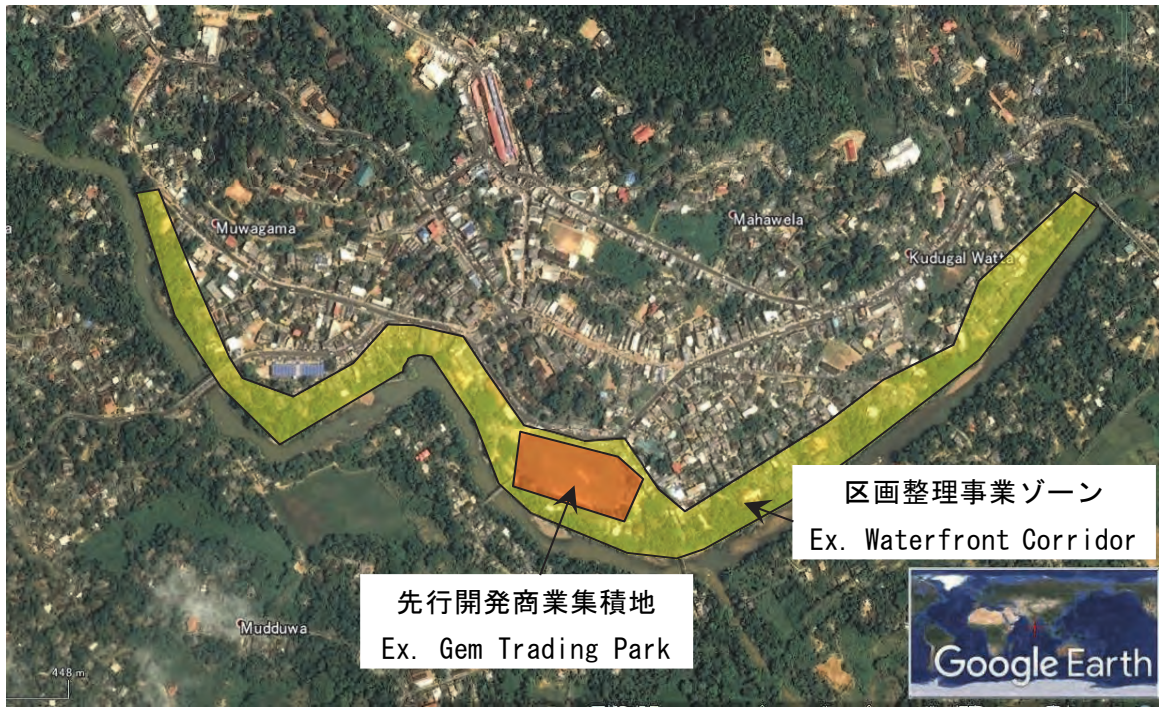
図 3-15 土地区画整理事業とセミスーパー堤防のイメージ

これらの背景からも、従来の提案のラトナプラ堤防は、土地区画整理事業のような概念も導入し、一時移転と最終形も想定して、商業地区機能を維持できるような都市再開発と合わせた大胆な計画の可能性も希求しないと実現が難しい可能性もある。

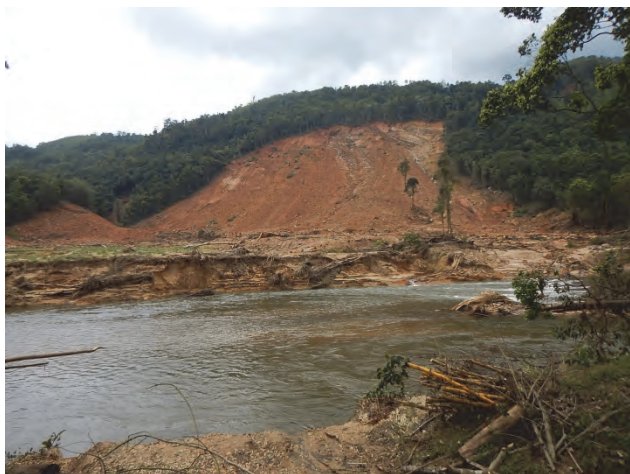
- ・短時間の強い降雨に対応し、集中して発生する表層崩壊の典型的な事例である(写真3-23)。
- ・崩壊斜面の高さに比して、崩土が流動化し長距離を流下しているのが特徴である(写真3-24)。
- ・崩壊斜面滑落崖付近からの再崩落や亀裂からの再崩落の危険は依然として残されている。

写真 3-23 表層崩壊の事例 (Kosgulana)

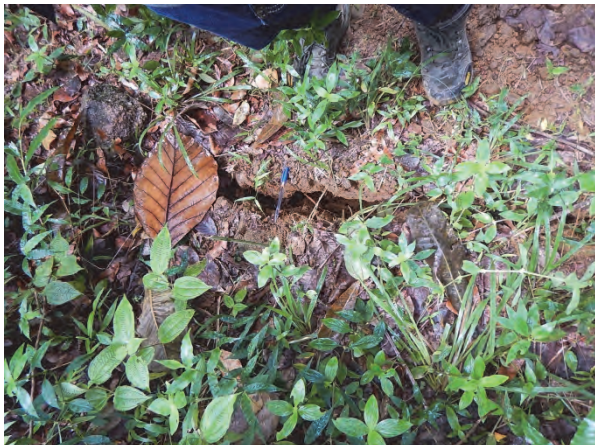
- ・斜面崩壊発生箇所では、滑落崖付近や崩壊斜面内に不安定な土砂が残存している箇所が見られるほか、亀裂が確認されたため、再崩落による二次災害が発生する恐れがある（写真 3-25）。
- ・再崩落の危険が高い斜面は、以下の条件を有すると考えられ、留意する必要がある。
 - ① 滑落崖上部に不安定土砂が残存している場合
 - ② 滑落崖周辺に亀裂が見られる場合
 - ③ 30度以上の急斜面に崩土が堆積している場合
 - ④ 崩土上に表流水や湧水が豊富に見られる場合
- ・再崩落の危険を有する斜面においては、小崩落や落石、湧水量の急な増加や濁った色への変化、斜面の変状など前兆現象に注意を払う必要がある。
- ・前兆現象が見られた場合は、すぐに避難する。また、降雨時は斜面下には立ち入らないこと。
- ・亀裂が確認された斜面では、亀裂の拡大に対する監視を継続する。変化が見られず、消滅する傾向の場合は危険が少ないと考えられる。
- ・降雨量に注意を払い、大雨時には躊躇せず避難することが重要である。降雨に対しては、集落単位で降雨量の観測が可能な簡易な雨量計が有効である（写真 3-26）。

写真 3-25 滑落崖付近に見られる亀裂

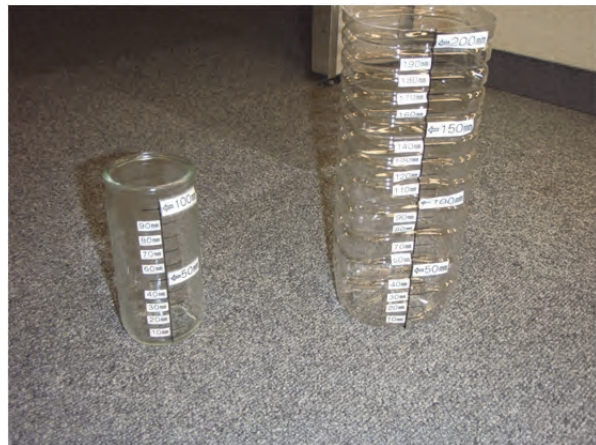
写真 3-26 簡易な雨量計の事例

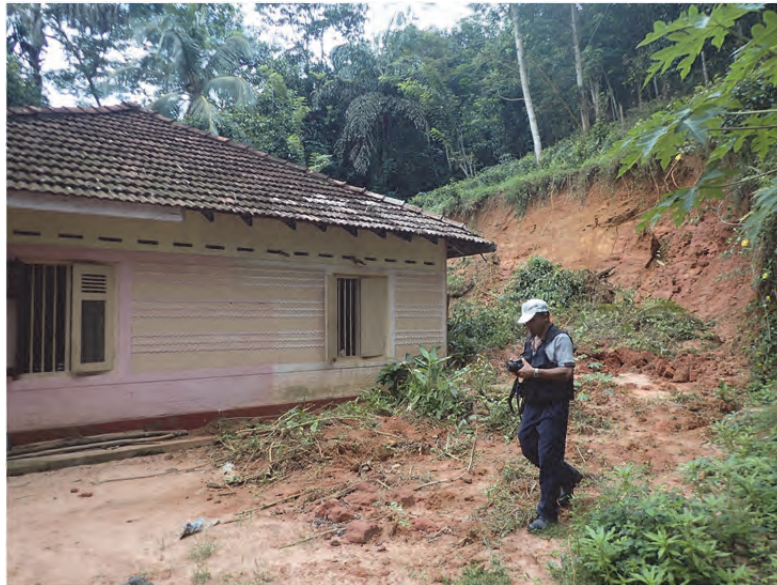
写真 3-27 切土して宅地造成した斜面が崩壊した事例

- ・不安定な斜面を切土することにより、宅地や耕地を設置することは避ける。特に斜面基部の切土は斜面全体の不安定化を促進するため、避けるべきである（写真 3-27）。

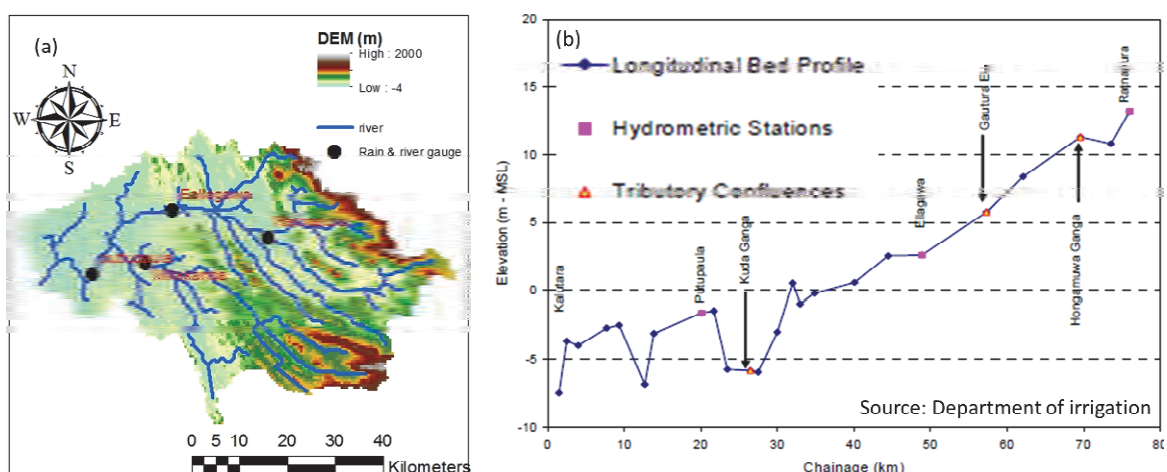
Fig. 7 Plots for digital Elevation Map (DEM) of Kalu Ganga basin, river network, rain and discharge gauges, and longitudinal profile along the river

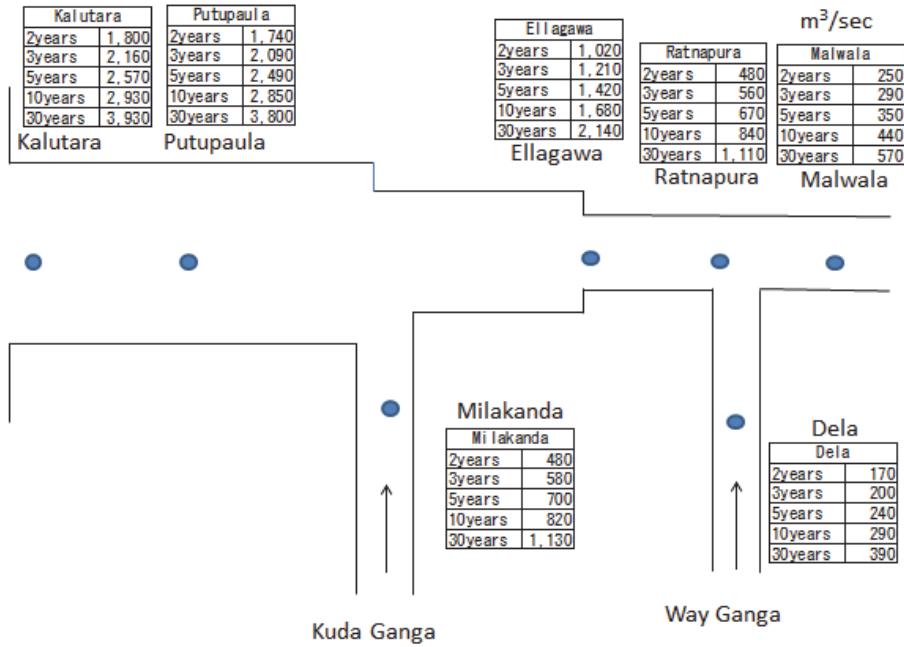
According to the JICA study conducted in 2011³, the estimated return period and corresponding river discharges at each control point are in Fig. 8.

Fig. 8 Plots for estimated return period and corresponding river discharges in main Kalu Ganga and tributaries

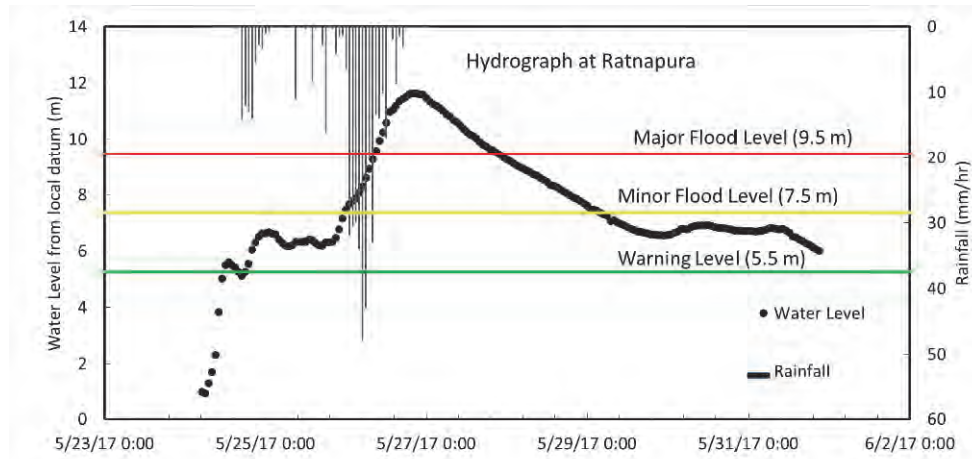
Fig. 9 Plot for rainfall and water level during the flooding at Ratnapura gauging station (data was obtained from the irrigation department, Ratnapura branch)

Fig.9 shows the rainfall and water level time series during the May 2017 flooding. Time lag between peak rainfall events and peak discharge as well

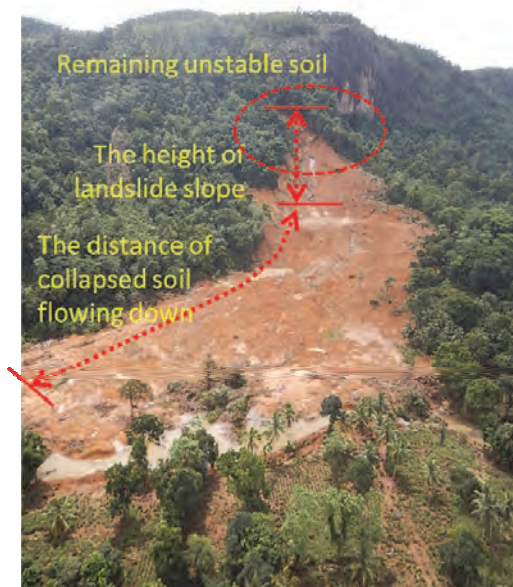
Fig. 10 Landslide at Pahiyangala

- There are still possibilities for the secondary landslide because of the remaining of unstable soil mass on the slope and tension cracks around the scarps and on the collapsed slopes.

- a) The remaining of unstable soil mass in the upper portion of the scarp
- b) The tension cracks are identified around the landslide scarp.
- c) The remaining of unstable soil

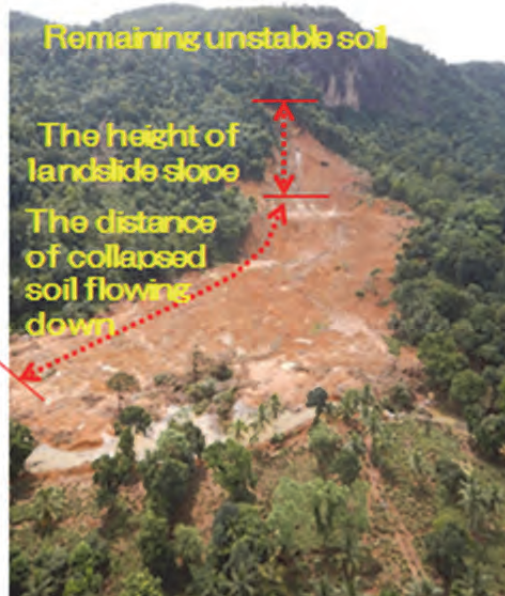
General Findings of Field Survey

- A lot of shallow landslides
- Collapsed soil flowing down for long distance
- The risk of secondary landslide occurrence

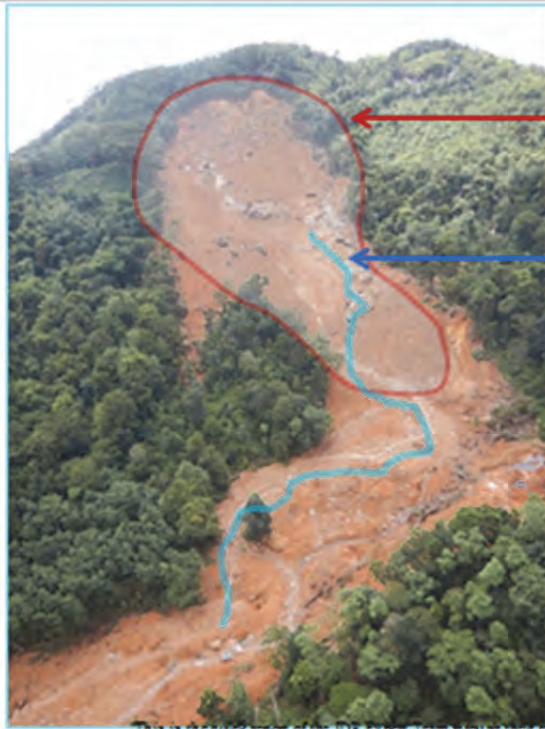
To Avoid the Secondary Landslide

Unstable soil

Spring water
Surface flow

Tension crack

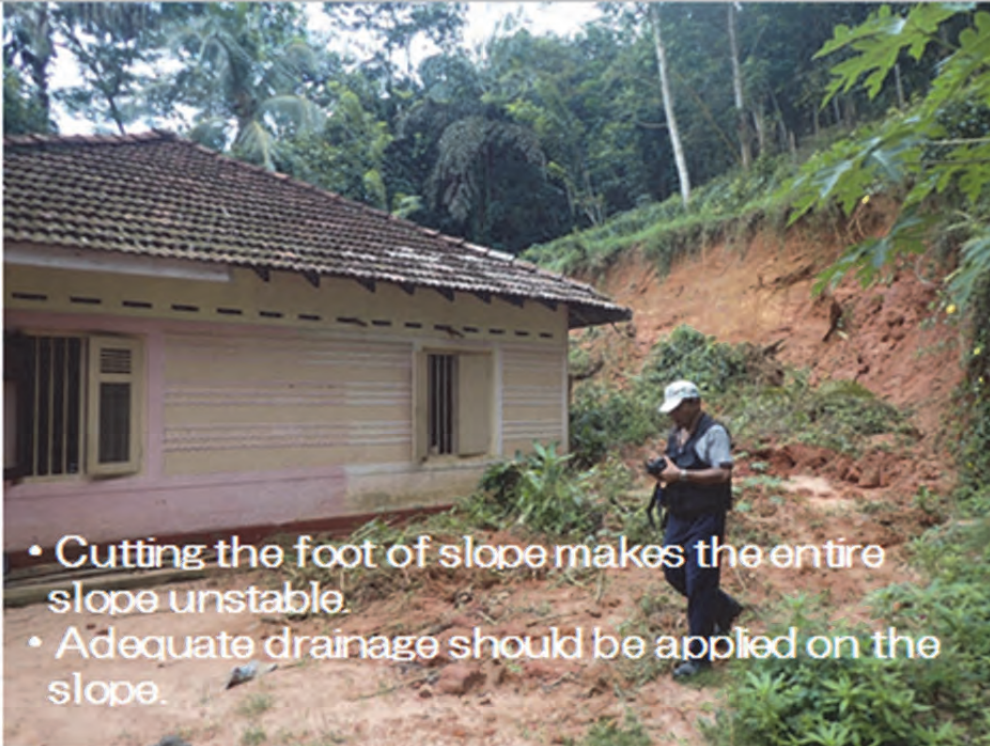
Artificial Change of the Slope

- Cutting the foot of slope makes the entire slope unstable.
- Adequate drainage should be applied on the slope.

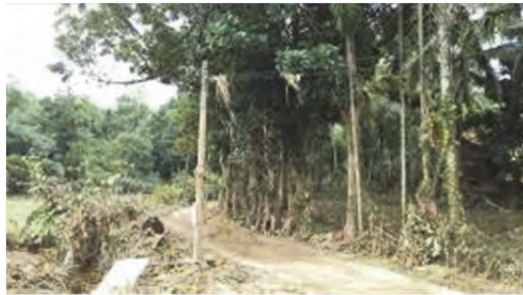
カル川と支流のクダ川の合流点近く。電線の高さに漂流物があり、洪水がこの位置まで来たことを示す。

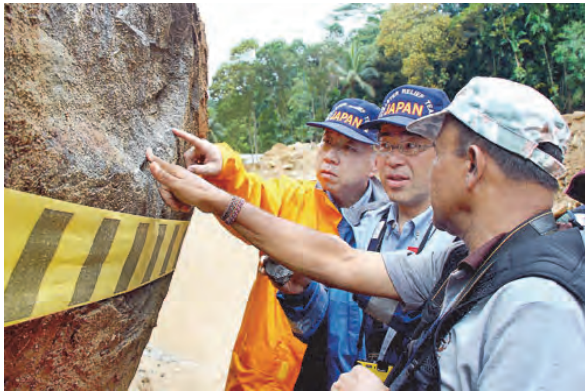
In the aftermath of the floods and landslides, Japanese experts rushed to Sri Lanka to examine the cause of the landslides and how to prevent future calamities. The disaster risk reduction experts are seen inspecting the rocks at Baduraliya. Please see story on Page 10. Pic by Indika Handuwala

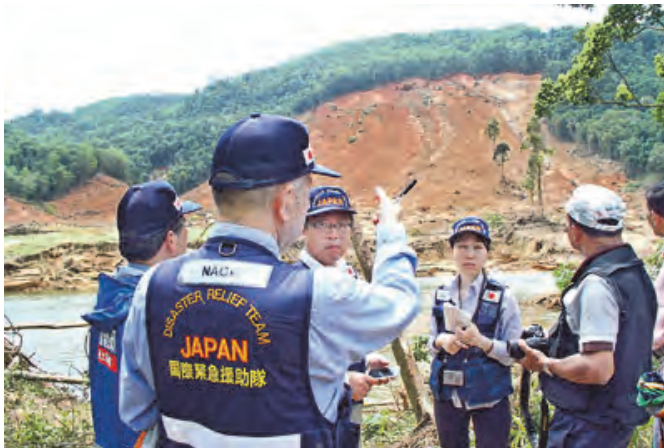
The Japanese team at the site of a landslide in Kosgulana, Baduraliya. Pic by Indika Handuwala
