スリランカ民主社会主義共和国における ごみ処分場堆積物崩落に対する 国際緊急援助隊・専門家チーム派遣 活動報告書

独立行政法人国際協力機構
国際緊急援助隊事務局

緊 援
J R
17-006

**THE INVESTIGATION OF THE DAMAGE CAUSED
BY THE COLLAPSE OF A GARBAGE MOUND
AT THE DISPOSAL SITE IN MEETHOTAMULLA, COLOMBO,
DEMOCRATIC SOCIALIST REPUBLIC OF SRI LANKA**

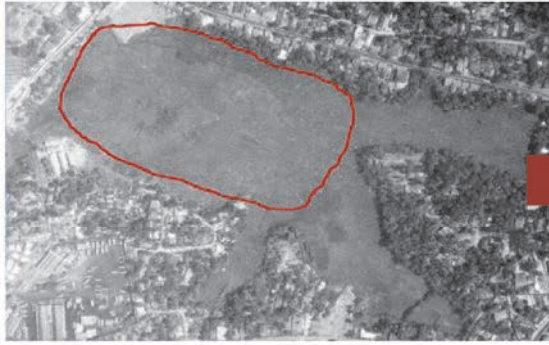
図 3-1 埋立前（1990 年以前、湿地帯）
by National Building Research Organization

ミートタムッラ処分場は、コロンボ市庁舎から北東へ直線距離で約 4 km、最寄りのデマタゴタ (Dematagoda) 駅からは西へ約 1 km のコロンボ市街地内に位置する。コロンボ市の現場管理により（土地所有は UDA）、コロンボ市内で発生する都市ごみ等を日量 800 t 受け入れていた、面積約 8 万 m² の処分場である。埋立前は図 3-1 のとおりの湿地帯で、1990 年代に地盤対策を施さないまま湿地帯への廃棄物埋立が始まった。今回の大規模斜面崩壊の約 8 カ月前の様子は図 3-2 のとおりで、2017 年 4 月 14 日の崩壊前は最大高さ約 48 m（平均高さは 40 m 弱）まで廃棄物が積み上げられていた。

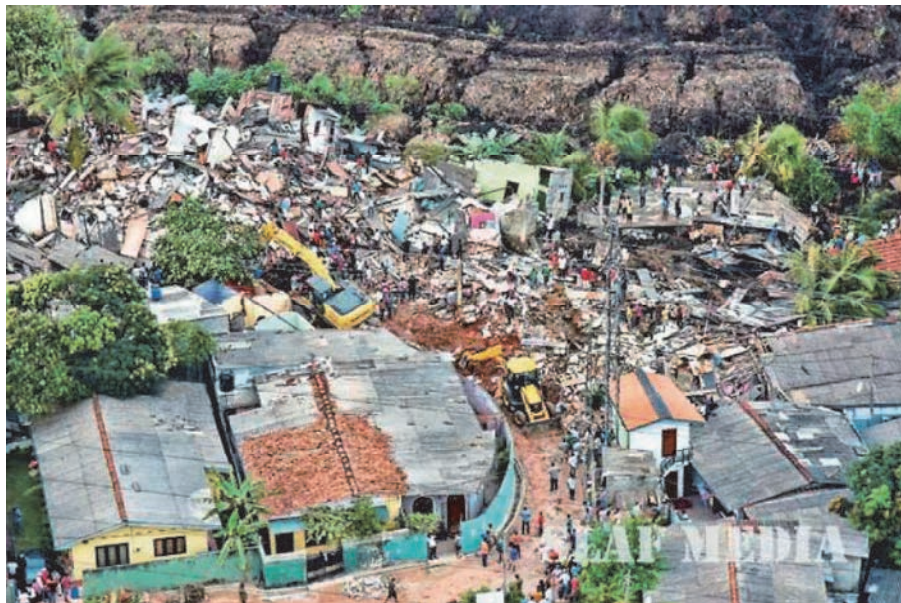
斜面崩壊により崩落廃棄物が周辺住宅を襲う（図 3-4、図 3-5）とともに、周辺住宅地では地盤のスライドと隆起（3 m 程度）が生じ、それによる住宅倒壊等の被害が生じた（図 3-4 中央部、図 3-6）。また、廃棄物層周縁の排水路が長さ 200 m にわたって崩落廃棄物に埋没した。

図 3-4 周辺住宅地の被災状況
 (中央部は地盤のスライドや隆起による被災とみられる)
 Photo by Sri Lanka Air Force

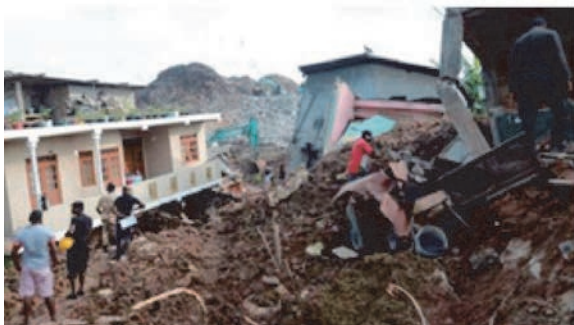
図 3-5 崩落廃棄物による住宅被害
 By Sunday Times

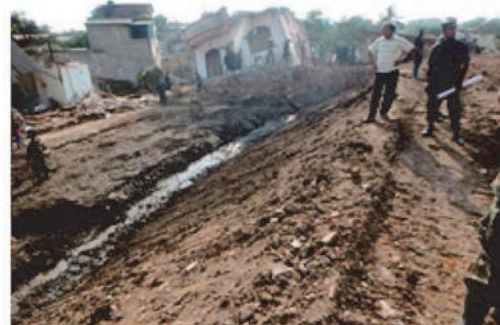
図 3-6 地盤のスライド、隆起による被害
 (2017 年 4 月 20 日)

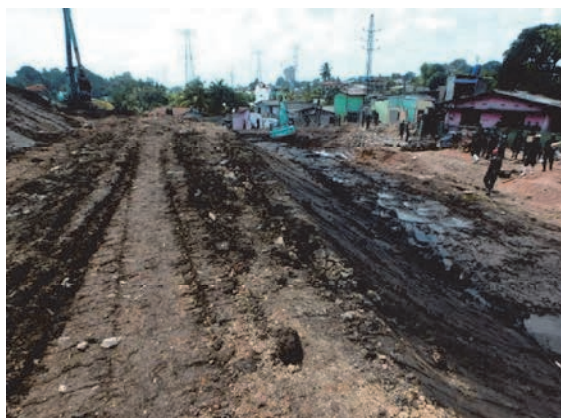
図3-7 水が浮いている軟弱地盤
(2017年4月21日)

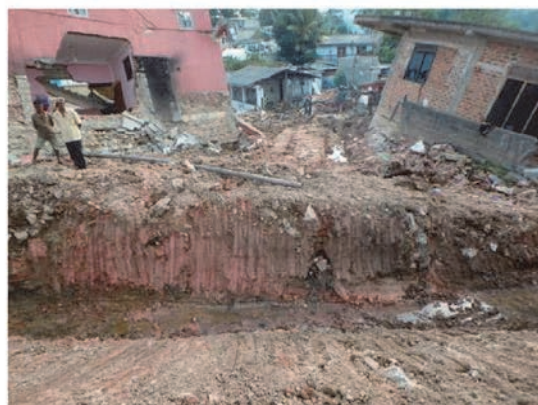
図3-8 崩壊斜面法先でみられたヒービング
(2017年4月20日)

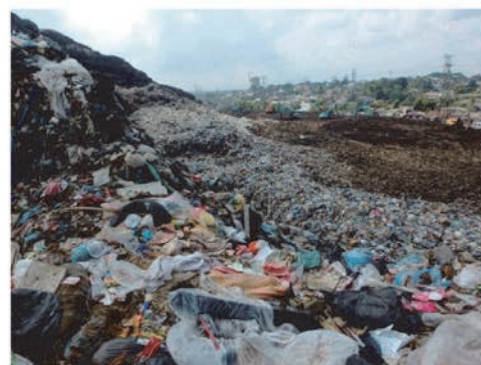
図 3-11 階段状の斜面崩壊
(2017 年 4 月 21 日)

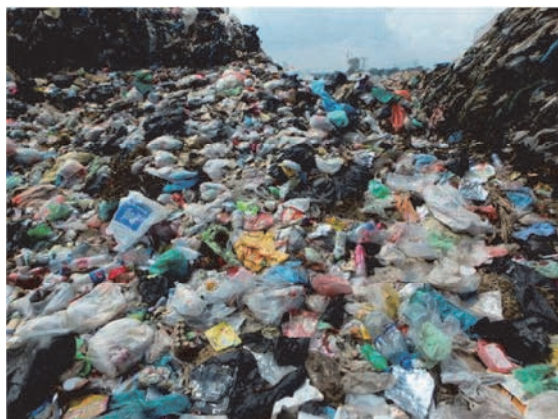
加えて、締固めを十分に行わずに積み上げられた廃棄物層（図 3-12）は、崩壊後、不安定な形状で残存しており（図 3-13）、廃棄物層内での崩れの発生も考えられる。これらのリスクの存在は、廃棄物層の頂上付近に現在も大規模なクラックがある（図 3-14）ことから判断できる。

図 3-12 締固めが十分でない頂上付近
(2017 年 4 月 21 日)

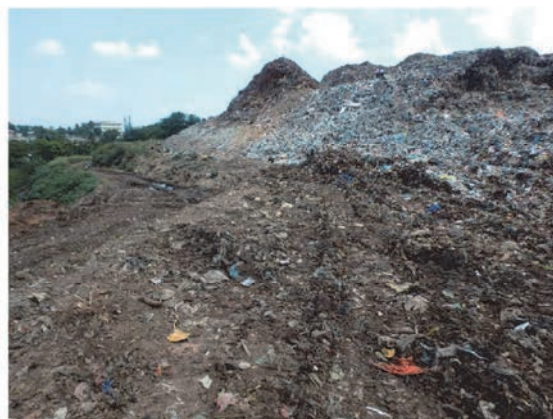
図 3-13 不安定な形状の残存廃棄物層
(2017 年 4 月 21 日)

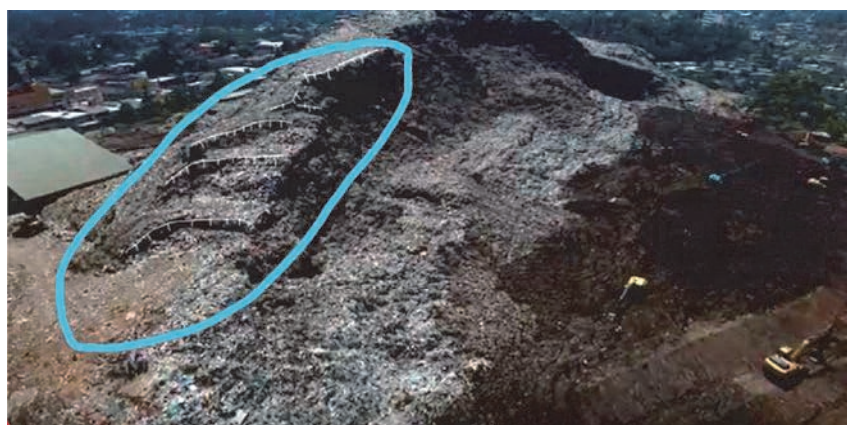
図 3-14 残存するクラック
by drone
(,2017 年 4 月 21 日)

The JDR team recommends that slope shaping of the remaining garbage mound should be done only after stabilization of the dump confirmed through all monitoring indicators. Movement of the garbage mound including crack growth should be monitored during and after rainfall, so as to confirm its stabilization. Slope shaping, such as cutting and filling before stabilization may trigger further collapse, since the remaining part may not be stable after the collapse.

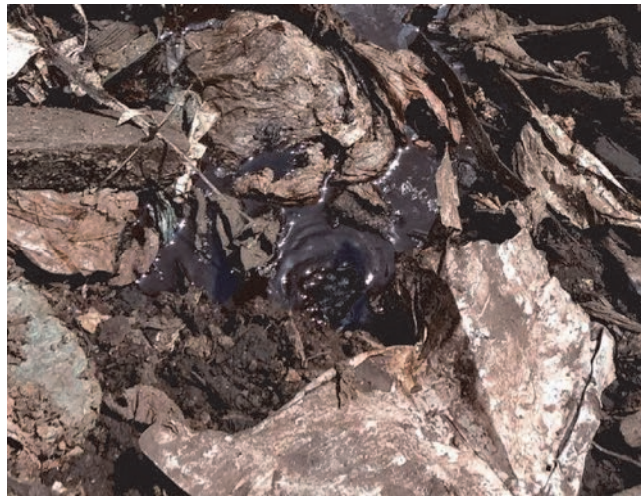
JDR 専門家チームは、4 月 21 日と 22 日に、崩壊現場において予察的な埋立地ガス調査を実施した。調査には、MSA Altair 5X マルチガスセンサーを用いた。調査の結果、現場全域において酸素濃度に大きな変化はなく通常の値を示し、可燃性ガス（COMB；LEL%）、一酸化炭素（CO；ppm）、硫化水素（H₂S；ppm）などの有害なガスは極微量検出されたのみであった。ただし、崩壊法面基底部付近の 2 カ所（当時、整地工事がなされていた）においてのみ高い濃度の可燃性ガスが検出され、16 及び 26（LEL%）を示した。この可燃性ガスは廃棄物層中において微生物の作用によって形成されたガスであると考えられ、今回の突然の崩壊によってトラップされていたガスが崩壊面から漏出したものと推定することができる。

事実、高濃度検出地点付近には、図 3-15 に示すような、活発なガス発泡を呈する浸出水たまりが複数認められ、こうしたガス発泡が可燃性ガスを放出しているものと考えられる。

図 3-15 崩壊法面底部付近の浸出水たまりに認められたガス発泡状況

*画面中央の水面には多数の泡を観察することができる。

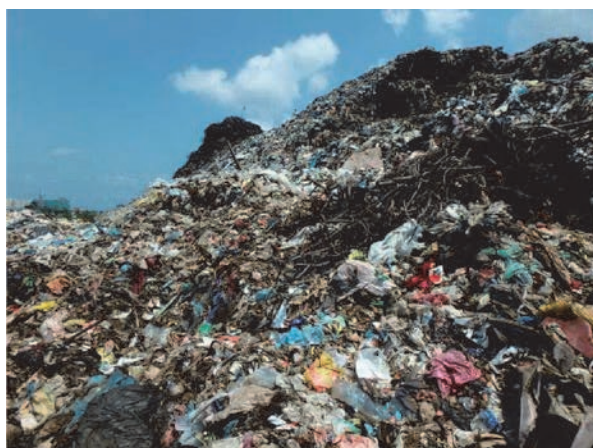
斜面が安定する最大の勾配である安息角は、崩れた廃棄物の勾配から 30～40 度とみられる（図 3-16）。これに対し、軍が行った斜面下部の 3 段の斜面整形の勾配を計測したところ、25～35 度で安息角以下となっており、整形斜面内での崩れは生じにくいと判断できる（図 3-17）。

図 3-16 崩壊後の廃棄物（勾配 30～40°）
（2017 年 4 月 21 日）

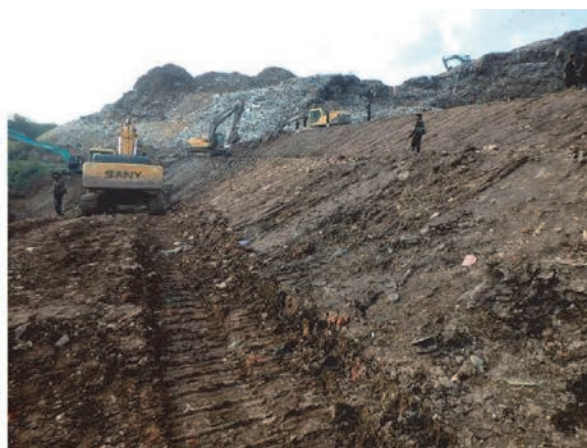
図 3-17 軍による斜面整形（勾配 25～35°）
（2017 年 4 月 20 日）

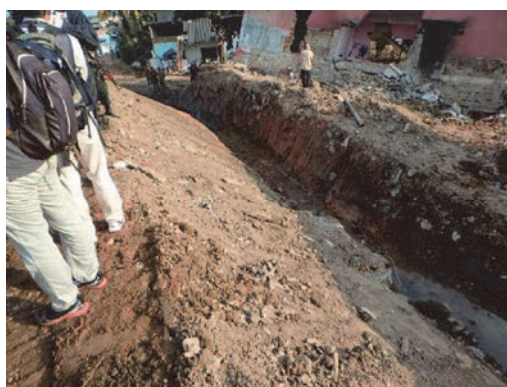
また、斜面崩壊を防止するためには、廃棄物層の重量を抑制するための迅速な雨水排水が極めて重要であり、緊急対策として構築したトレンチは有効である。以上から、軍のこれまでの緊急対応は効果的であると判断される。

図 3-18 軍が構築した斜面下のトレンチ
（2017 年 4 月 20 日）

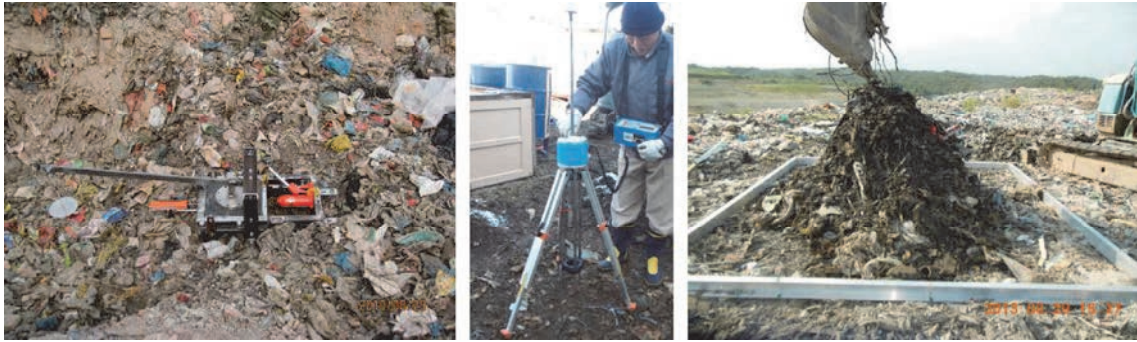
図 3-20 廃棄物層の現場試験法（左から一面せん断試験、衝撃加速度試験、安息角試験）

スリランカ NBRO による斜面安定解析では、軟弱地盤の強度定数には英国基準に基づいた試験値を与えているが、廃棄物層については文献値により推定した強度定数を与えている。廃棄物層の実際の強度定数を知ることができれば、より正確な安定解析につながるだけでなく、安定な整形断面の設計にもつながる（図 3-19）。このため、廃棄物層の強度定数を調べるための現場試験（図 3-20 に例示）を行うことを推奨する。

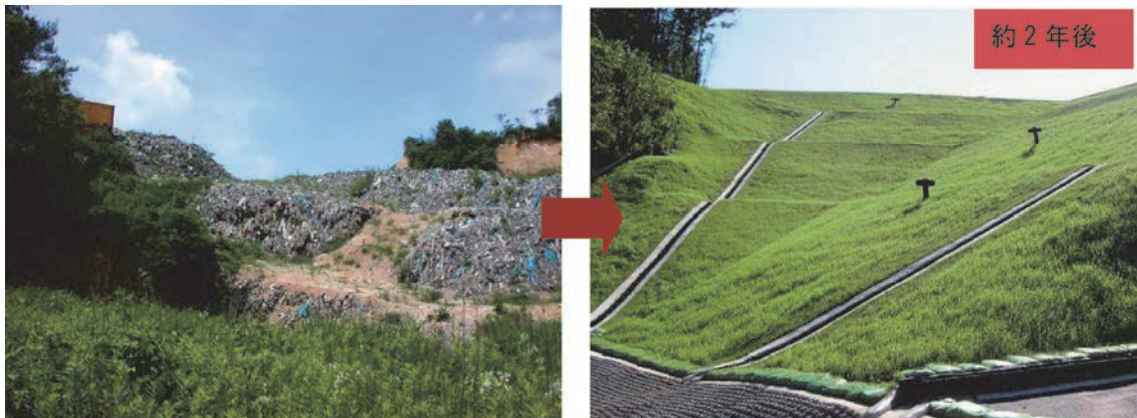
日本での産業廃棄物の不適正処分（過剰受入れ）事案への対策例を図 3-21 に示す。わが国の産業廃棄物の不適正処分事案の処理責任は投棄行為者が基本的に負うが、行為者が資力不足等の場合が多く、行政により対応がなされることがある。この場合、不適正処分による周辺環境への支障を除去するための対策がとられ、図 3-21 に示すように、安定勾配の確保、覆土、排水側溝整備、表面緑化、ガス抜き対策がなされることが一般的である。

図 3-21 中部地方の産業廃棄物不適正処分事案への対策例

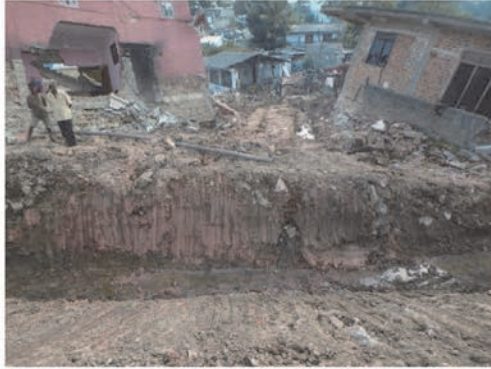
- Heaving of the soft layer was observed in front of toe of the garbage mound, (Ref. Figure 1),
- The top of sliding mass of wastes has a terraced shape, (Ref. Figure 2)
- The soft layer has thickened in the southwestern direction where the landslide has occurred.

Figure 1. Heaving of the soft layer in the forefront of the garbage mound.

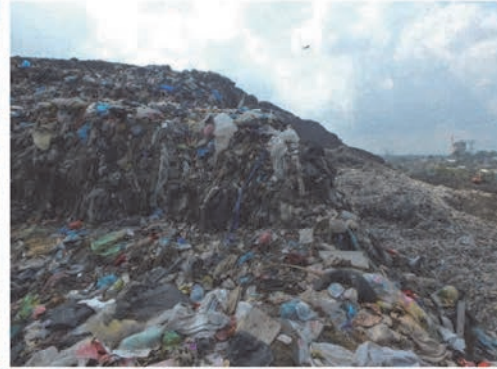
Figure 2. Insufficient compaction of the garbage mound and terraced shape collapse.

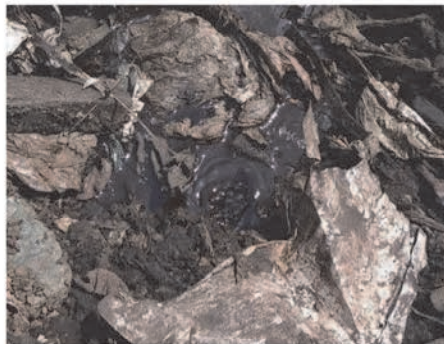
The JDR team conducted preliminary gas survey in the Meethotamulla dumpsite using a MSA Altair 5X multi gas sensor on April 21 and 22. The results indicate that the oxygen concentration was normal throughout the site and very low level concentration of hazardous gases such as combustible gases (COMB), carbon monoxide (CO), and hydrogen sulfide (H₂S) were detected in most parts of the site. However, at two locations along the base zone of the collapsed cliff, high concentration of COMB was detected; 16 and 26 (LEL%¹). The combustible gases were probably generated in the waste deposit layers by micro organic activities and released from newly created exposures caused by the sudden collapse of the garbage mound (Ref. Figure 3). The combustible gases raise the risk of a fire accident.

Figure 3. Bubbling of gas at leachate seepage in the dumping site. Photo taken by Yoshida at around 11:00, 21st April 2017.

The JDR team strongly recommended prohibiting any firing activities including smoking to avoid fire at the disposal site. Once a fire breaks out at the site, it would take a very long time to be extinguished, which will significantly inhibit smooth recovery and stabilization operation of the collapsed site. The JDR team also

The JDR team also recommends that the GOSL plans continuous monitoring of hazardous gases concentration at the site for environmental safety. Based on the result of monitoring, taking countermeasures against disposal site gases, such as installing pipes for gas ventilation, is recommended.

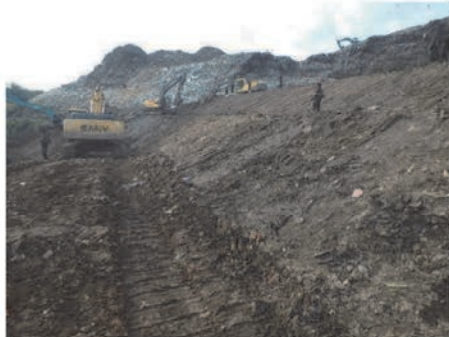
Considering the angles of the slope formed after the collapse, the repose angle, which is the maximum or the range of angle that the slope of the garbage mound can be stable, is assumed to be between 30 degrees to 40 degrees. The angles of the slope shaped for reconstruction by the Army consisting of three stages embankments, are between 25 degrees to 35 degrees, which is within the repose angle of the collapsed garbage mound. Therefore, the JDR team supposes that since the slopes are stable, and therefore so, the risk of a surface collapse in the shaped slope maintain low (Ref. Figure 4).

Figure 4. Slope and trench

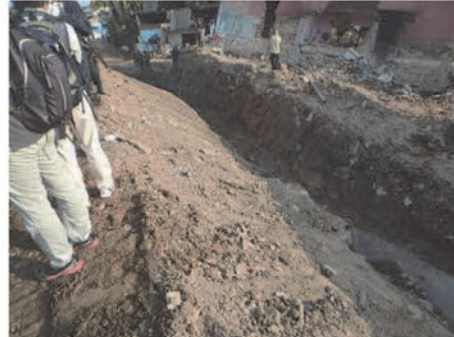
In order to prevent the entire slope to fail, the rapid drainage of liquid from the garbage mound (e.g., rainfall and pore water) is a key for avoiding increase of the garbage weight. Therefore, construction of a trench is an effective emergency measure (Ref. Figure 5).

Figure 5. Trench

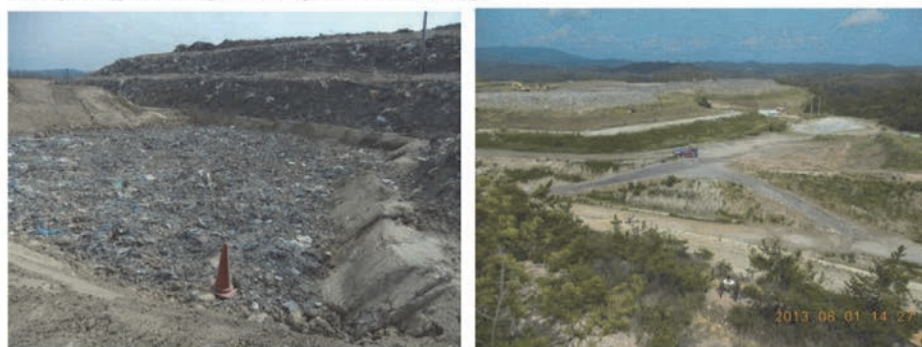
Figure 6. Japan's Experiences; a time consuming effort(3 years approx)

The JDR team recommends that after the waste landfill in a proper shape, the entire waste landfill should be covered with about 1 m thickness of soil to prevent exposure of the waste. Covering the landfill with soil improves hygienic condition (including prevention of mosquito breeding, flies and malodor) and enhances the stability of the landfill by preventing infiltration of liquids including rainwater. In addition, it will suppress methane gas generation, which would also contribute to mitigating the impact on global warming.
