Chapter 7. Output 3: Road and Bridge Repair Capacity of RID is Enhanced

7.1. To Review and Establish Road Repair Manual

7.2. To Review and Establish Bridge Repair Manual

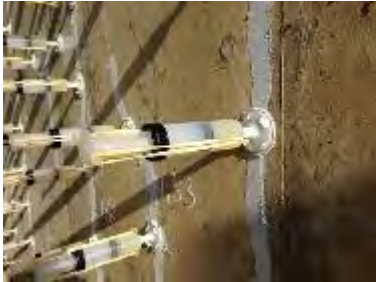
Bridge Repair	Road Repair
Outline	<p>Injection of concrete bond to the cracks on concrete bridges [Emergence Repair/ Preventive Maintenance]</p>

Objective	<p>Injection of concrete bond is the most typical and easy repair method for concrete bridges. The materials and tools can be imported from Japan. This method can be applied to any concrete bridge with relatively small scale cracks.</p>	<p>This is to apply for the pothole patching for emergence purpose. Due to very short required time for the work, this method is good for heavy congested roads or intersections to minimize negative impact to traffic flow. Typical work as preventive maintenance of the Asphalt Concrete maintenance.</p>
Period	January to February 2016	January to February 2016
Work Methods Tools and equipment	<ul style="list-style-type: none"> • Epoxy resin 15 sets • Concrete crack seal 100 sets • Injection tools 1000 nos 	<ul style="list-style-type: none"> • Ready mix cold asphalt (Excel patch) 100 bags (1 bag 15 kg) • Compress washer 4 nos

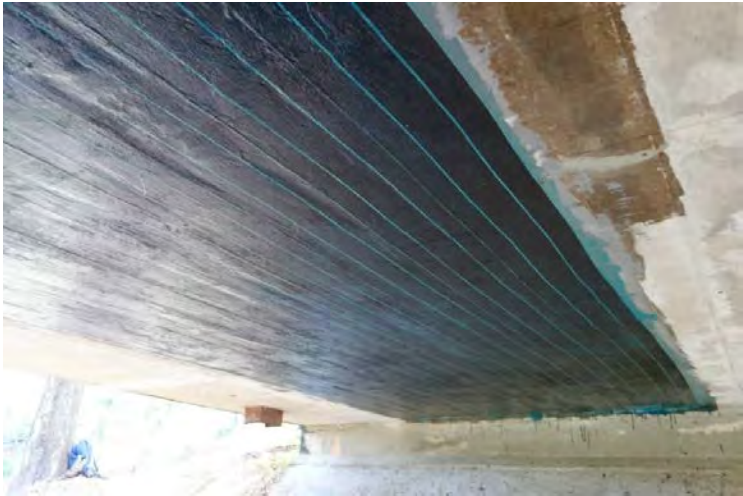
Bridge Repair	Road Repair
Outline	CFC Reinforcement method	Pothole patching using cold mix asphalt Using locally produced Excel Patch

Objective	Repair and reinforcement of bridge slab and column	Verification of better use of local made products - Work organization of target DPWT for pothole patching - Technical specification (recommendation for better use) - Verification of cost effectiveness
Period	January to February 2017	January to February 2017
Work Methods Tools and equipment	<i>Carbon fiber sheet</i>	Excel patch 200 bags
Remarks	*No traffic regulation needed *Incremental weight is very small *Easier construction procedure	Excel patch is the product of IKEE company.

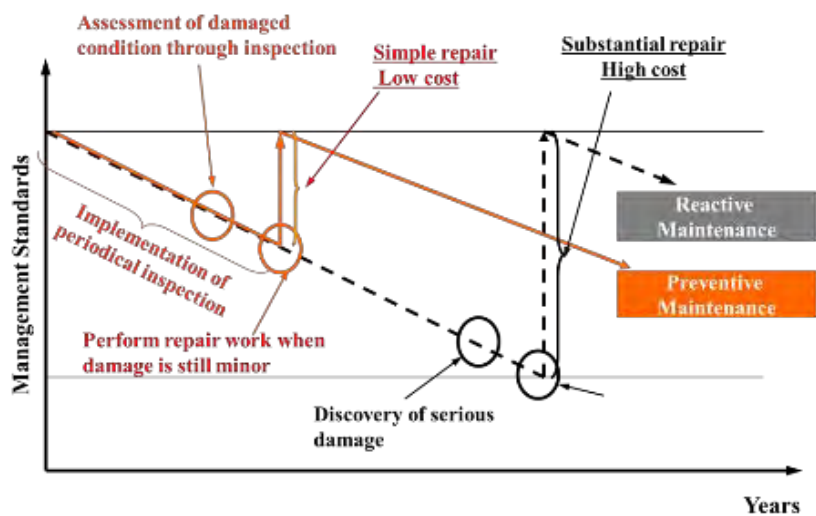
Figure 7-2 Concept of Preventive Maintenance

Invasion of rusting factor, such as water, oxygen and salt, into inner areas through the cracks	By expanding pressure, surface concrete becomes detached. Exposure of rebar to rusting factors and rusting is accelerated	The whole structure becomes weaker and weaker	Continued loading of a weakened structure causes further damage.
Counter measures	Injection of epoxy resin into cracks	Covering the exposed rebar with mortar	Reinforcement	Replacement
Repair cost	Low	←—————→		High

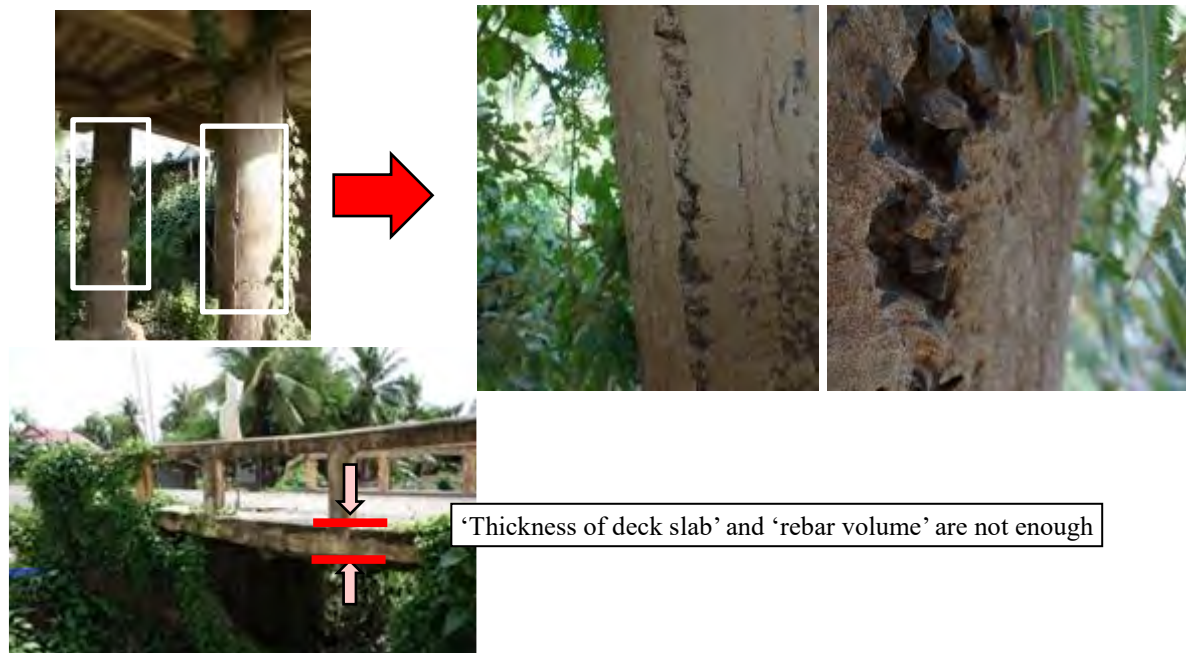
Photo 7-5 Insufficient strength capacity

Case 1: Insufficient strength capacity due to non-conforming work or design deficiency (Photo 7-5)

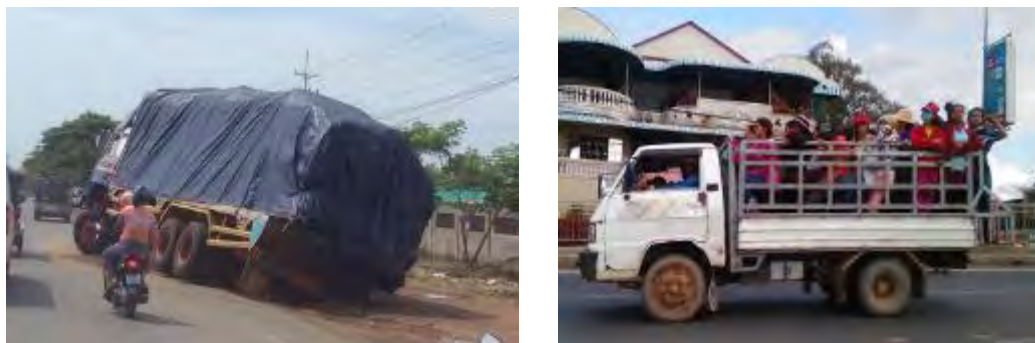
Photo 7-6 Overloading

Case 2: Overloading (Photo 7-6)

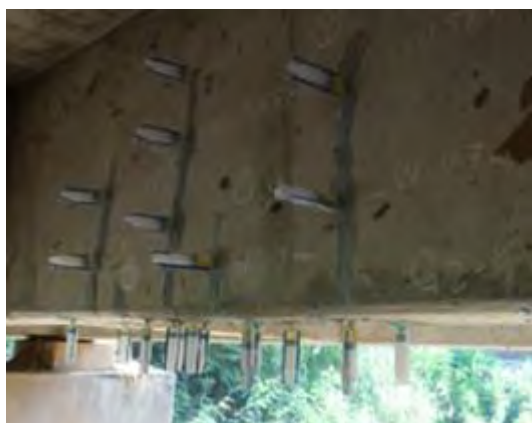
(a) Crack Sealing (1st Pilot project)

**Protection for Rusting factor
(water, oxygen etc.)**

Reinforcement or Retrofit

Figure 7-3 Bridge Repair Image (Bridge Repair Pilot project)

The repair purpose image is shown in Figure 7-3.

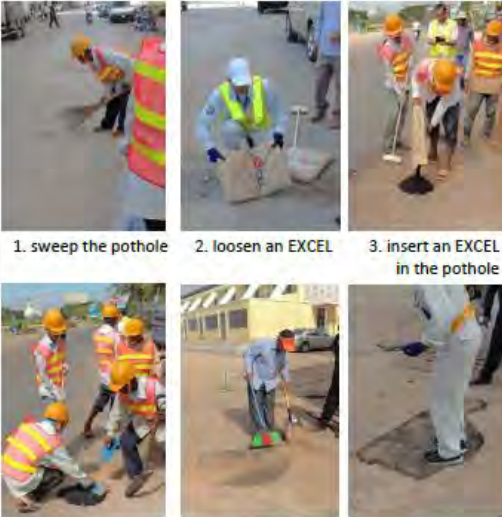
<p>Activity: Pothole repair – Excel Patch (m²)</p>		
<p>Description: Urgent patching Application to pothole (maximum diameter 1.0 m, depth 50 mm ~ 100 mm)</p>		
<p>Possible Cause:</p> <ul style="list-style-type: none"> • Poor quality DBST surfacing mix • Incorrect compaction of the mix during construction • Infiltration of water • Break away of material under the action of traffic • Final stage in the development of depression 		
<p>Work method:</p> <ol style="list-style-type: none"> 1. Sweep the pothole. Clear and remove sands and soil from edge of the pothole by brushing 2. If pothole more than 5 cm depth, coarse material should be fill prior EXCEL patch 3. Loosen EXCEL Before open the bag, loosen EXCEL in the bag. 4. EXCEL in the pothole. Put Excel into the pothole. 40% surplus is recommended for even compaction. (see Figure) (1-2cm) 5. Level surface. Level surface of the Excel patching with trowel and shovel 6. Spread Sand on an EXCEL. Spread sand even on the surface of Excel 7. Compaction by foot or car tires/ vibrating plate compactor, compacting steel plate="elephant leg" Compact surface by foot or tire of vehicle 8. Spread sand onto the EXCEL to reduce friction of EXCEL and car tires

<p>1. sweep the pothole 2. loosen an EXCEL 3. insert an EXCEL in the pothole</p> <p>4. smooth a surface 5. sprinkle sand 6. compaction by foot</p>

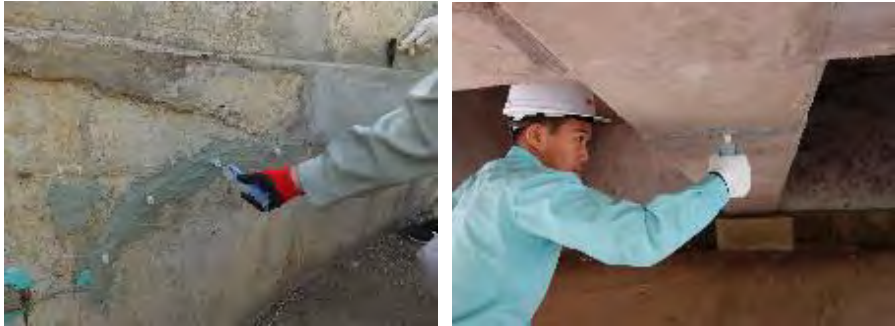
3 rd day	
1 Site meeting	—
2 Site cleaning	—
3 Removal of the cylinder

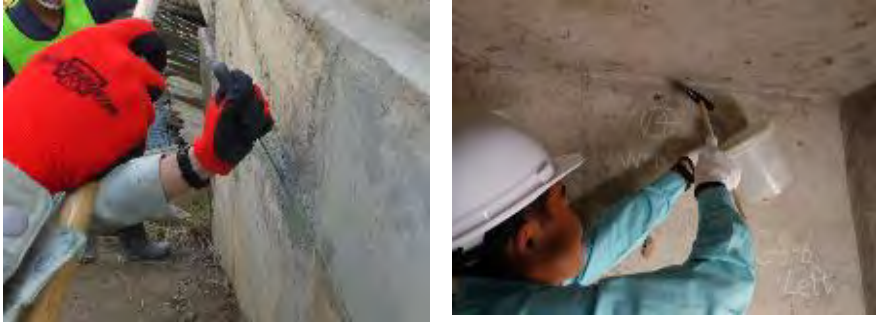
4 Removal of the washer

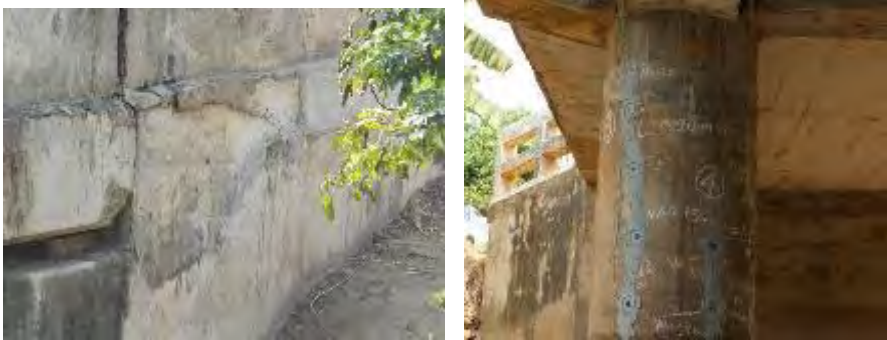
5 Completion

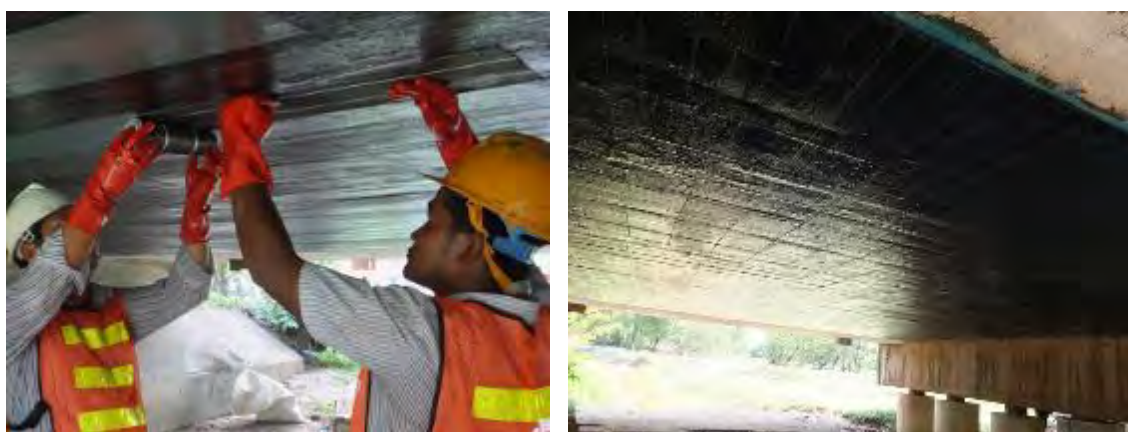
Photo 7-16 CFC Method

The standard usage weight per unit area of CFC is show in Table 7-33. The execution of the little resin weight causes the deterioration of the reinforcement.

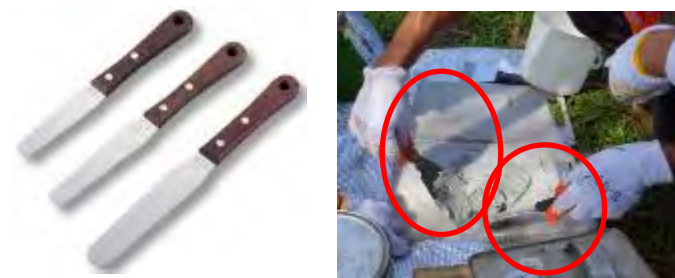
Process	Tool	Photo
Sectional repair Surface preparation	Spatula

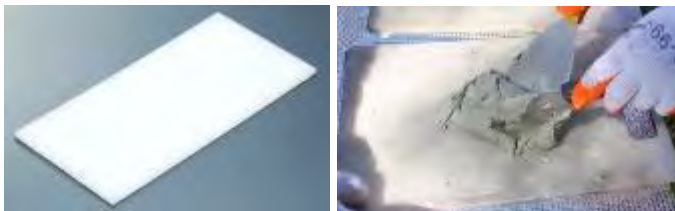
Board (Plastic type)

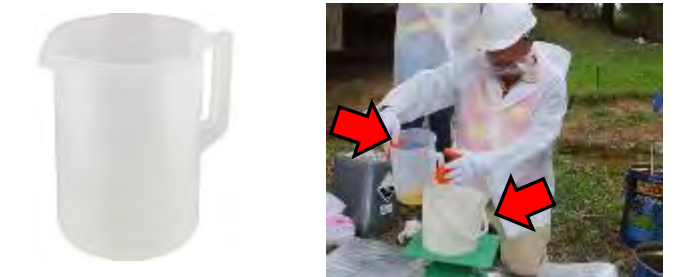
Jug

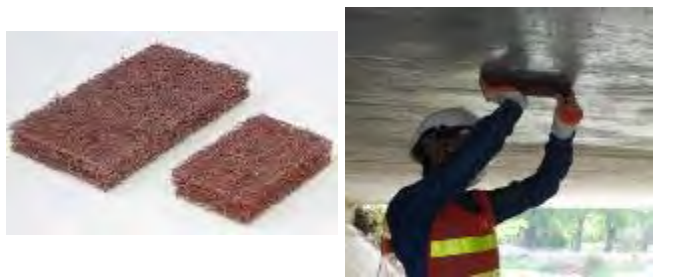
Polishing sheet

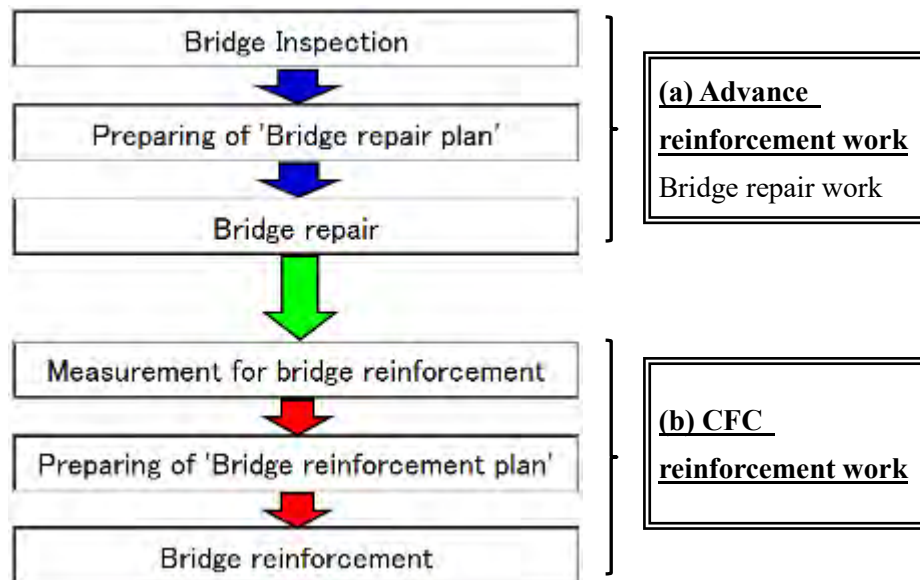
Figure 7-17 CFC Workflow

The CFC workflow is shown in Figure 7-17.

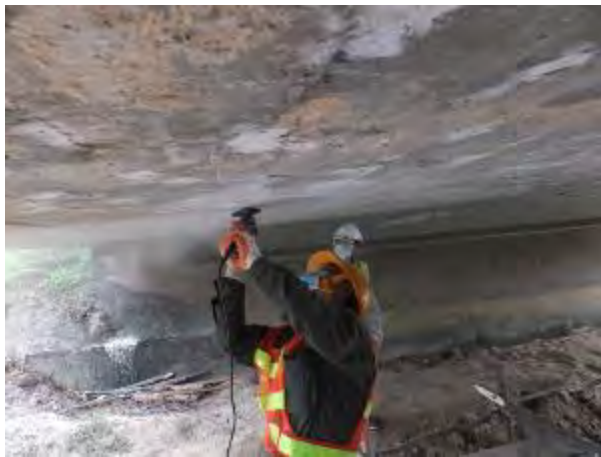
(a) To flatten by disk grinder

Surface difference in level or edge of the corner causes bad bonding and breakage of the carbon fiber. Therefore, the surface difference is flattened by a disk grinder (Photo 7-18 (a)) for a surface less than 1 mm in difference level or put resin mortar (for a difference larger than 30 mm in radius).

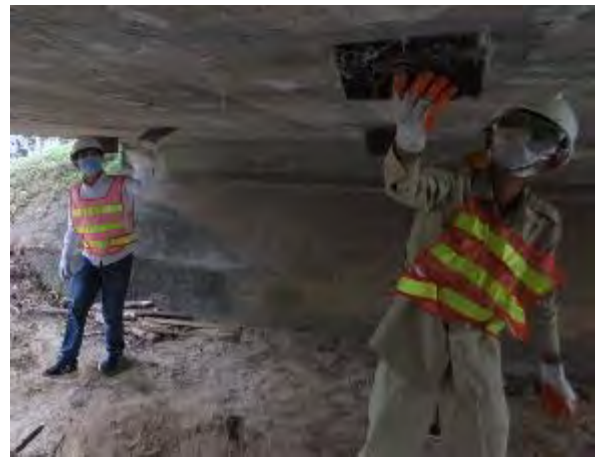
Photo 7-18 Surface Preparation

(b) To remove dust by polishing scrubbing

The mortar, oil and dust should be removed to expose the sound concrete by a disk grinder or a wire brush and by polishing scrubbing (Photo 7-18 (b)).

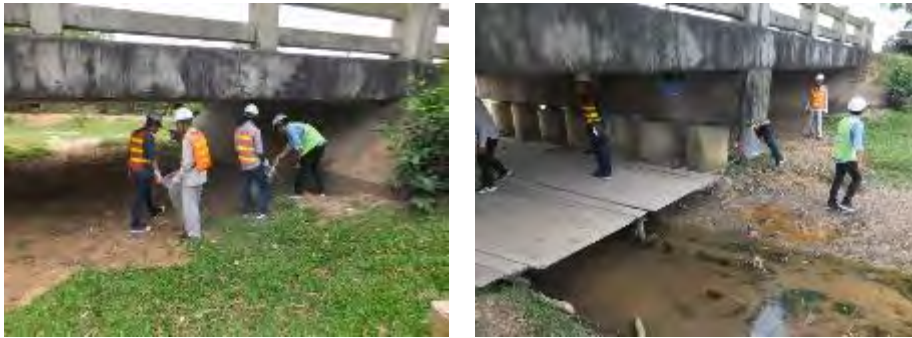
1st day's work (Primer work)	
1 Site meeting	 
2 Site cleaning

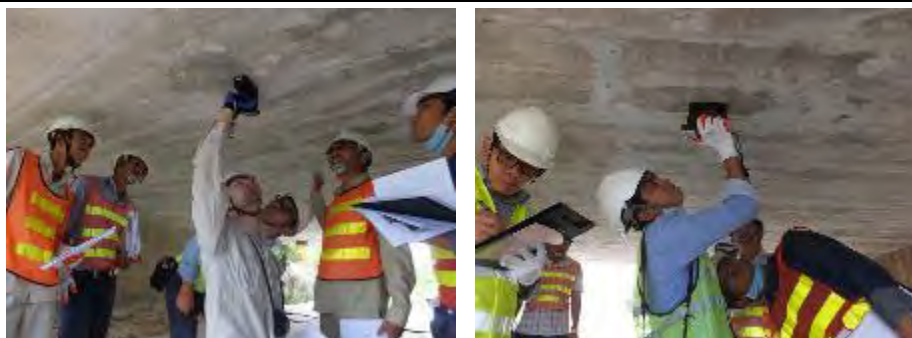
3 Confirmation of temperature and surface humidity

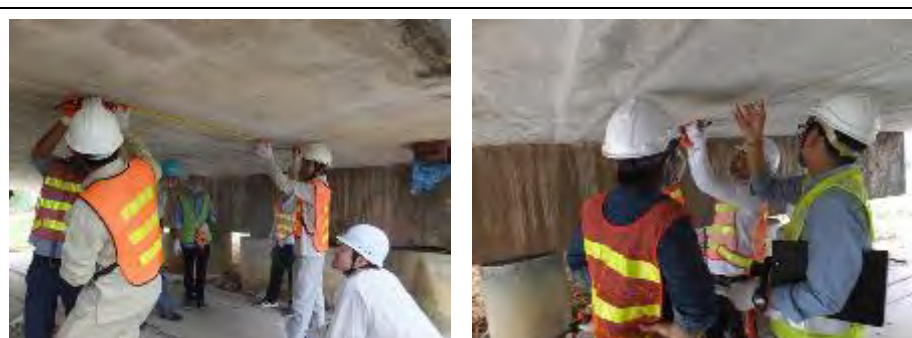
4 Measurement of constructed range

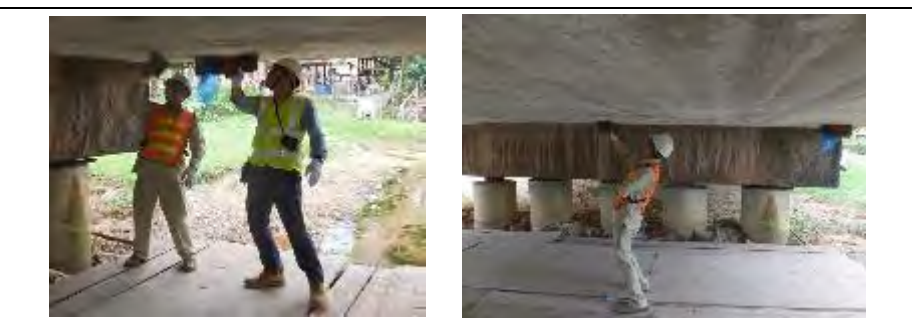
5 Surface cleaning

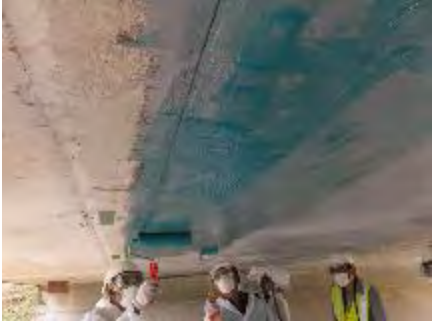
<p>5 Measurement of CFC construction range</p>	 	 
<p>6 Cutting CFC</p>	 	 
<p>7 Preparation of impregnating resin material</p>	 	 
<p>8 Making of impregnating resin material</p>	 	 
<p>9 Applying 1st impregnating resin</p>

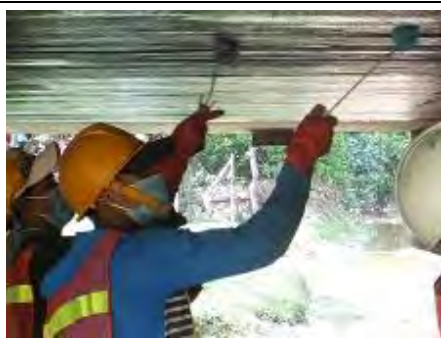
<p>10 Setting CFC</p>	 	 
<p>11 Pushing out air bubbles by paddle roller</p>	 	 
<p>12 Applying 1st impregnating resin (once again)</p>

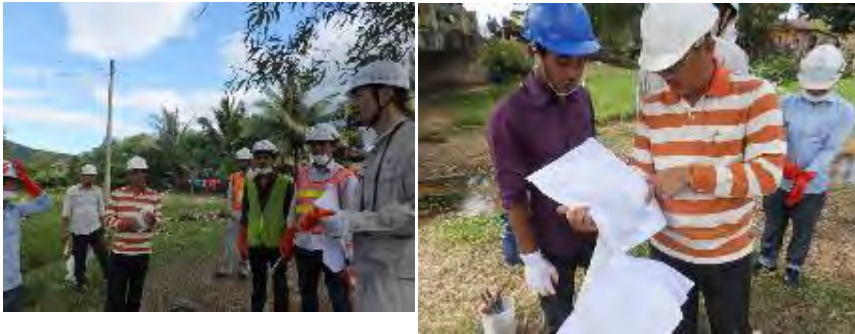
4th day's work (2nd CFC layer work)	
1 Site meeting

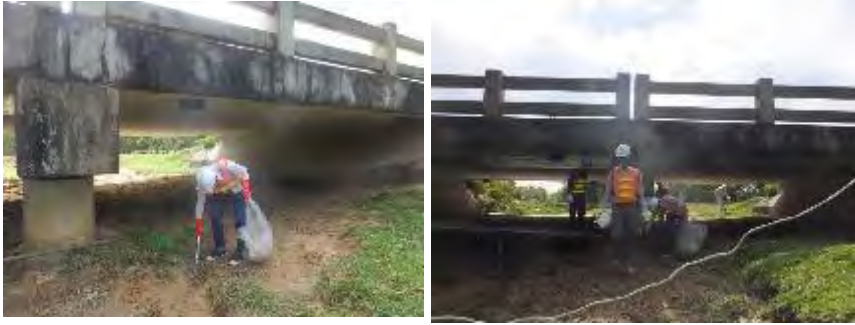
2 Site cleaning

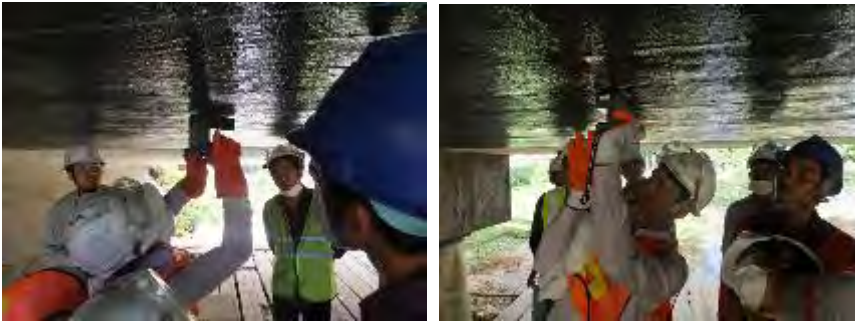
3 Confirmation of temperature and surface humidity

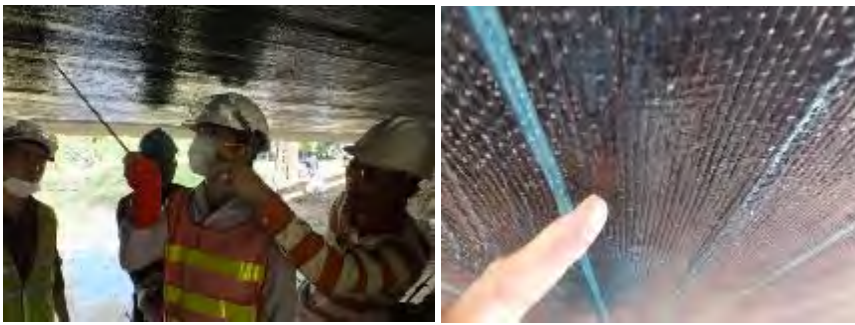
4 Confirmation of pushing out air bubbles

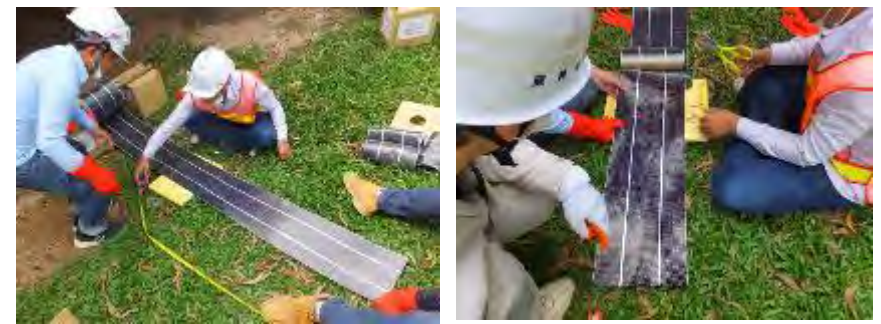
<p>8 Cutting CFC</p>

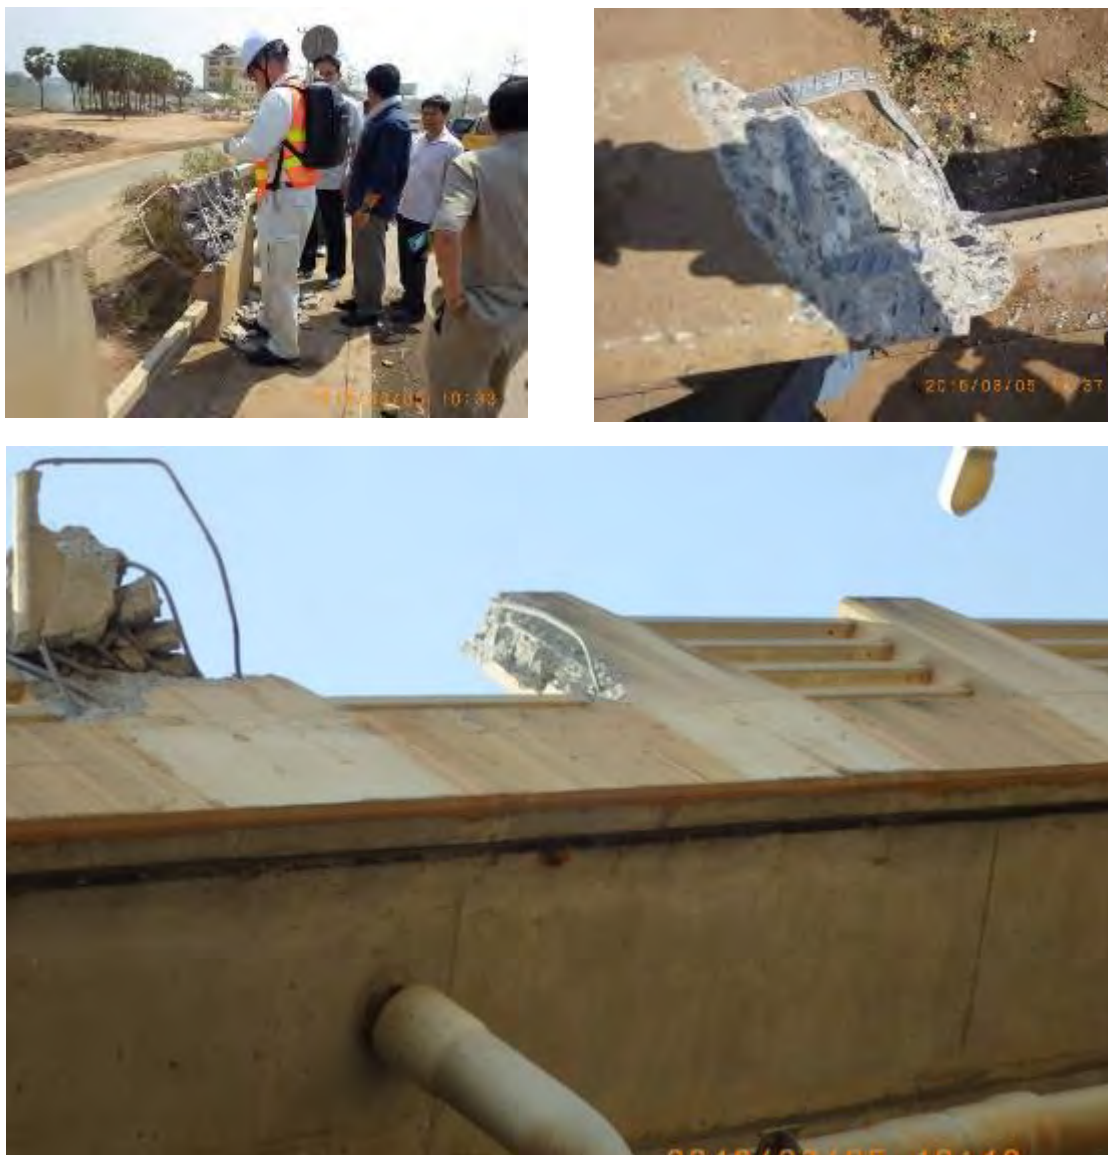
Photo 7-21 Site Photos

- Railing pole x 3 nos,
- Railing,
- Slab

- Removal of the damaged pole
- Re-casting of concrete after re-arrangement of reinforcement
- Sealing crack of the slab using crack sealing method

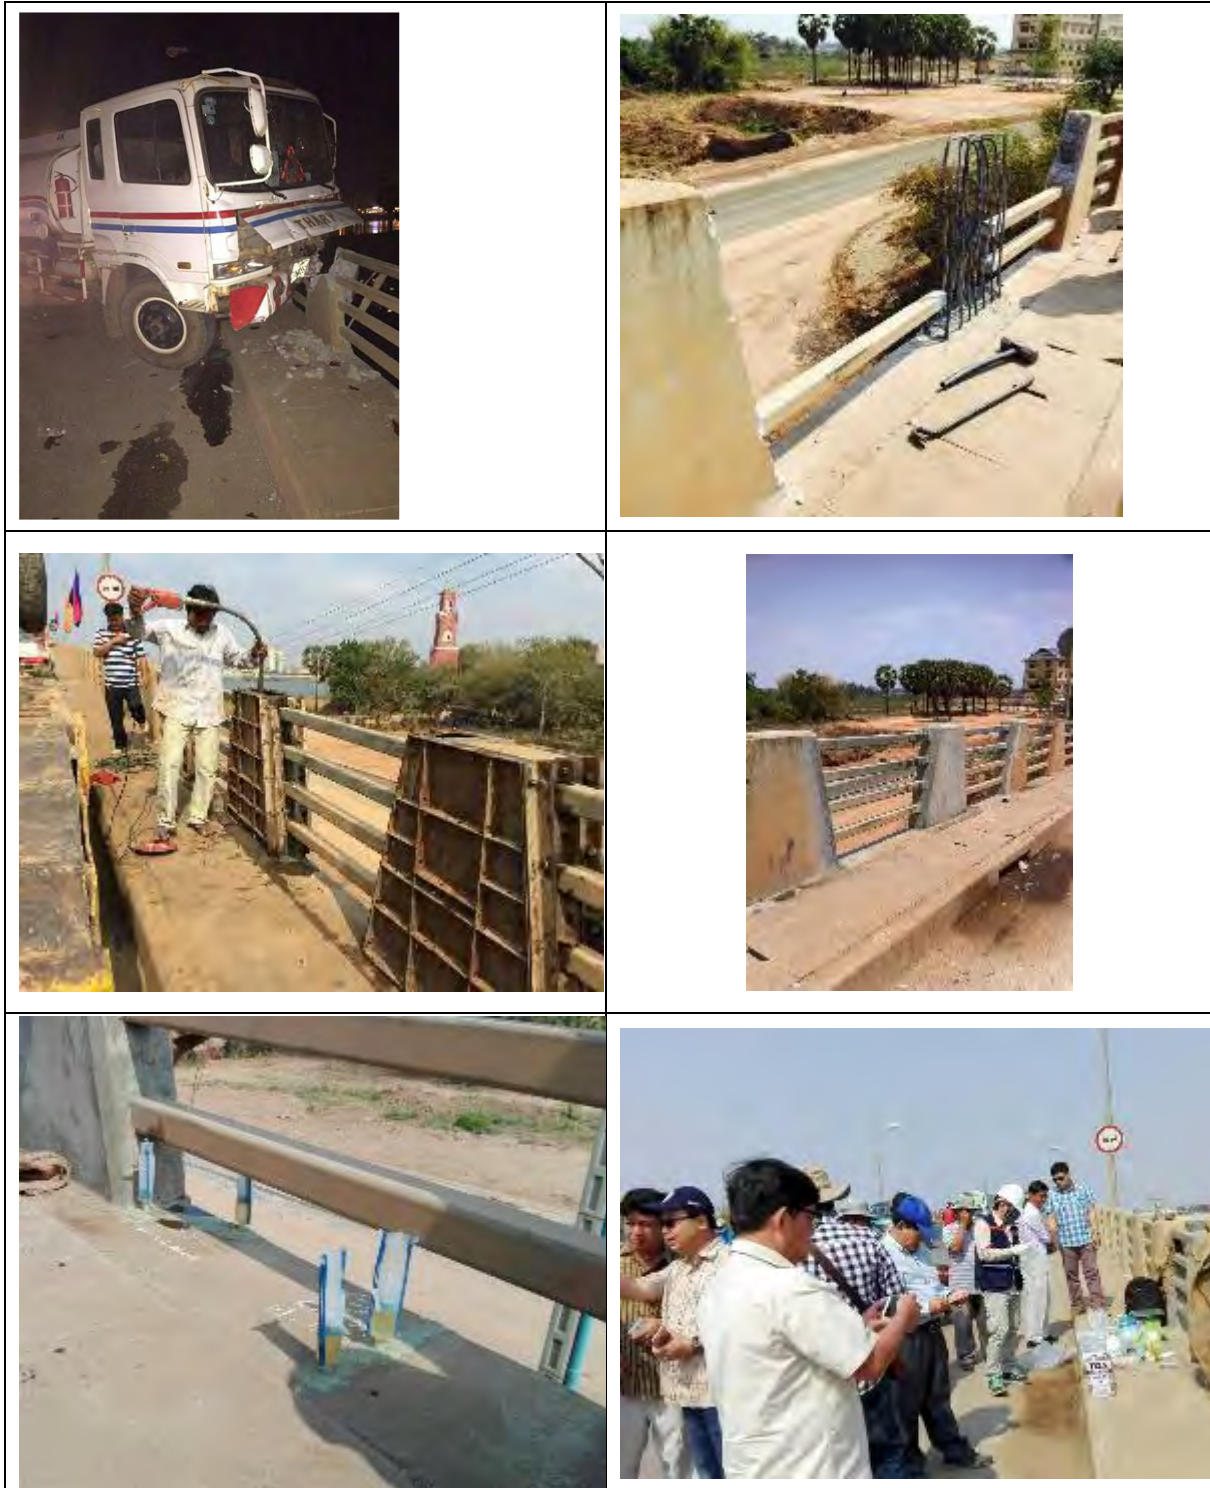
Photo 7-22 Repair of the Damage at Kizuna Bridge and Demonstration of Crack Sealing Method

The bridge was repaired by DPWT Kompong Cham. Crack sealing method was demonstrated by RID engineers inviting neighboring DPWTs.

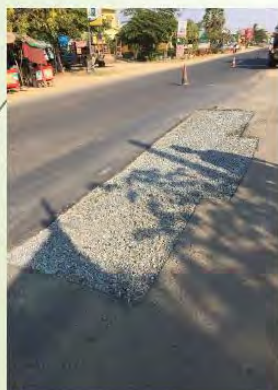
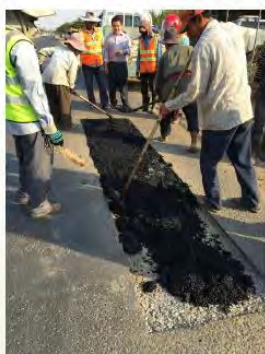
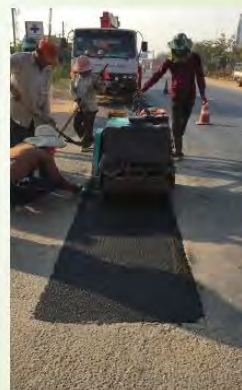
National Road 8 : 3 location (3 - March -2016)

1. PK 27+150 RHS pothole size 1x2.5m with depth of 3cm were filled and compacted with approximately 8 bags of Excel Patch material

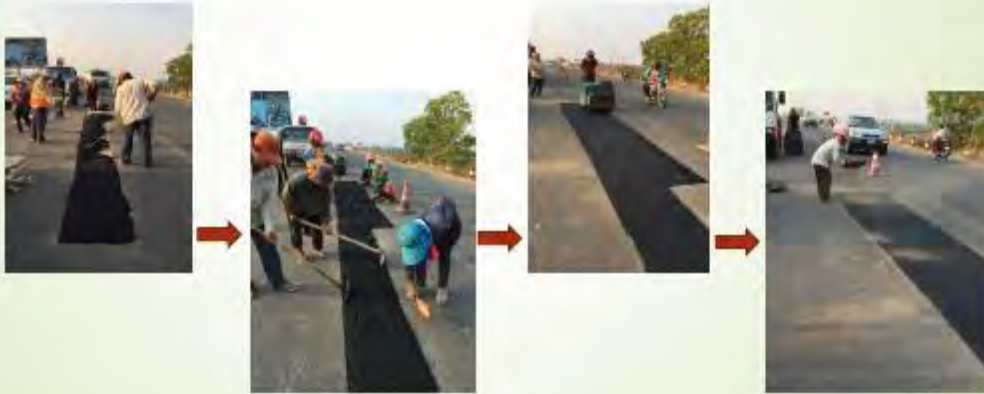
3 . PK 31+200 RHS pothole size 0.5x10m with depth of 3cm were filled and compacted with 20 bags of Excel Patch material

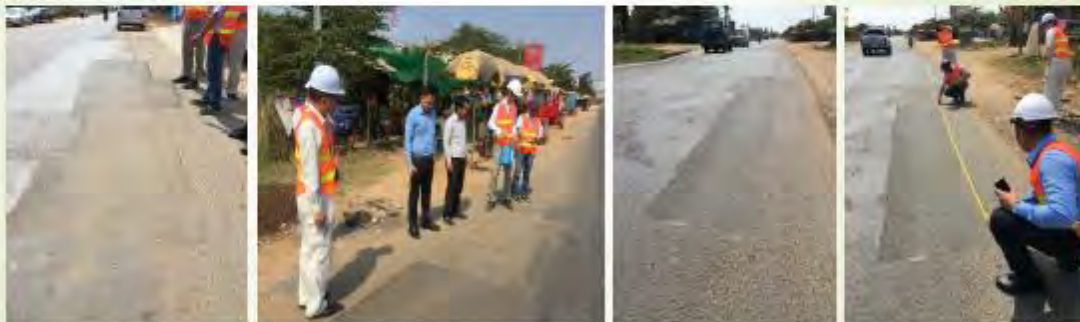
PK 27+150 RHS & PK 27+250 RHS : No settlement were found

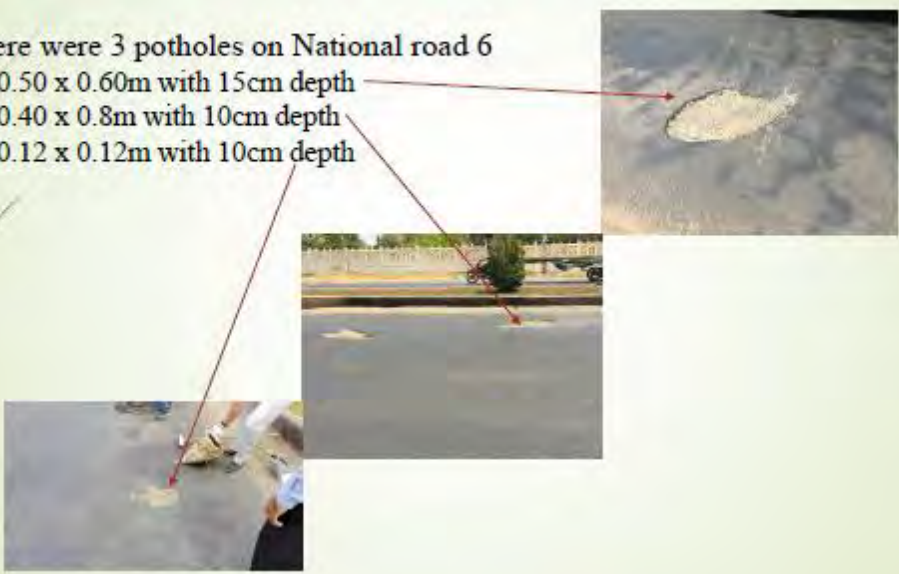
National Road 6 : PK 3+200 LHS (09- March- 2016)

There were 3 potholes on National road 6

- 0.50 x 0.60m with 15cm depth
- 0.40 x 0.8m with 10cm depth
- 0.12 x 0.12m with 10cm depth

- Before application, loosen the material by squeezing the bag
- Pour water to the sides/walls of pothole to clean the dirt
- If pothole require more than one bag of Excel patch, always compact after every bags
- After finish applying, spray sand all over the patched surface to prevent Excel Patch from sticking to the car tires

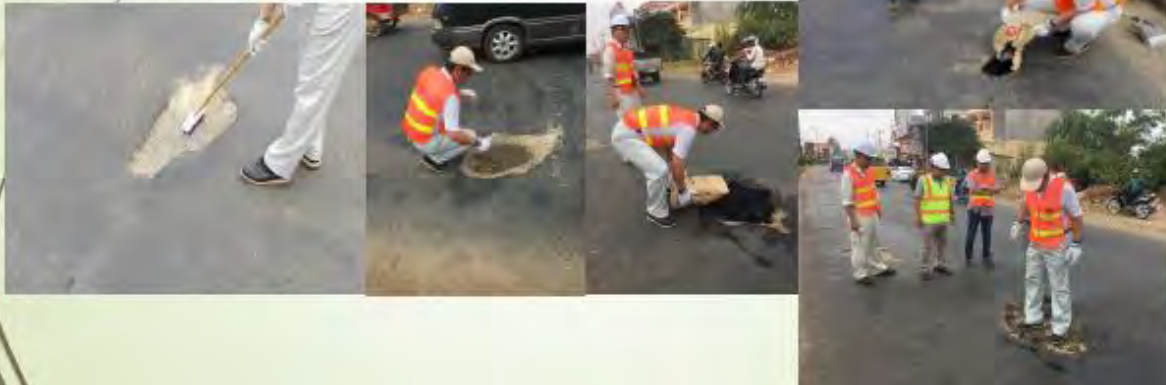
National Road 6 : PK 3+200 LHS (09- March- 2016)

- 4.5 bags of Excel patch were used for the 3 potholes

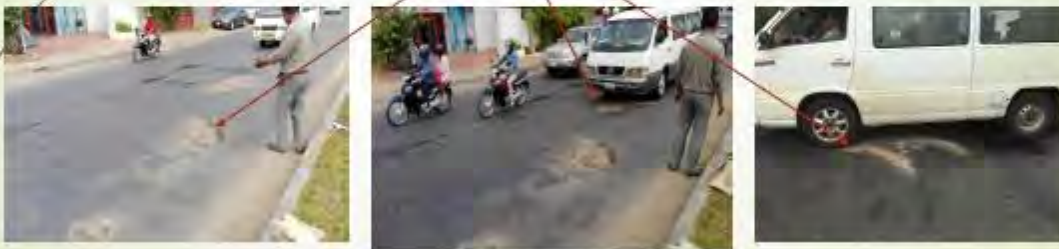
- After allowing drying time of 5-10 minutes, road were resumed to traffic and a few trucks run over the pothole caused a bit of settlement (1-1.5cm)

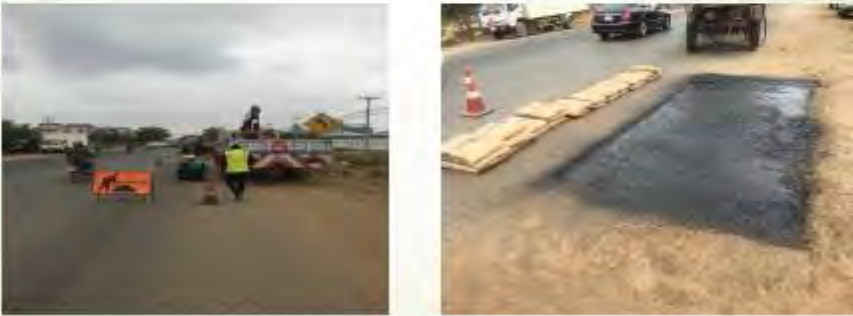
National Road 4 : PK23+500 LHS (11- March- 2016)

Pothole size: 1.8 x 4.5m depth of 5 cm

- Pothole was already cut by Kandal Dpwt
- In this last pilot project, Jica requested to use different approach by putting on prime coat before applying the excel patch

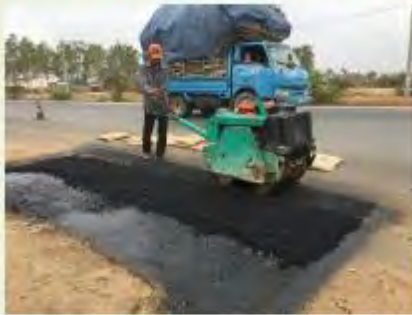
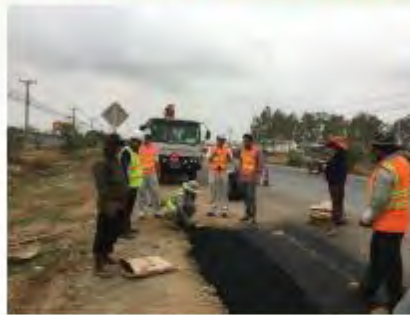
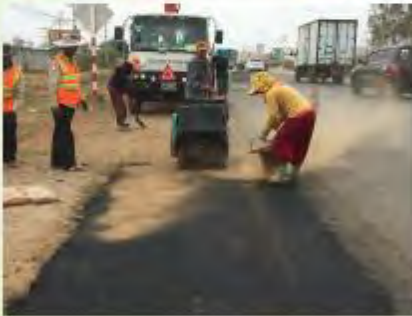
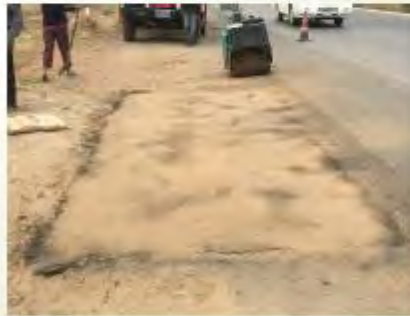
National Road 4 : PK23+500 LHS (11- March- 2016)

- All excel bags were soften before apply
- Number of bags: 28 bags of excel patch were used
- Duration: 45 minutes (Start at 10am)
- Safety practices and measures were implemented by the team
- Road resume to traffic immediately

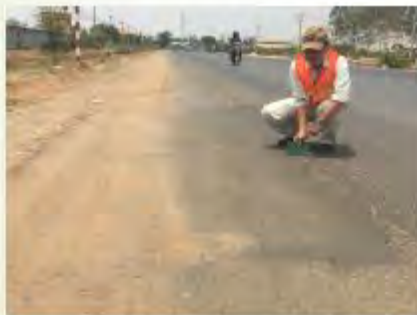
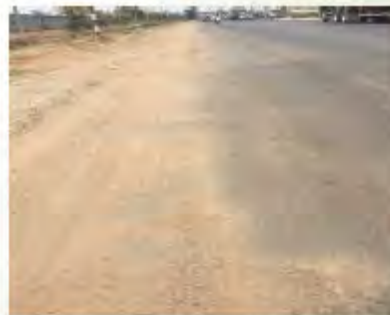
Inspection The Result NR 4 (23-March-2016 after 12 days repair)

The EXCEL Patch is still fixed and No settlement were found

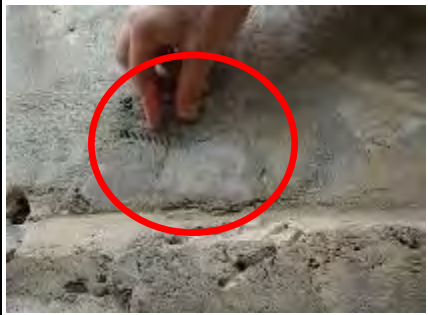
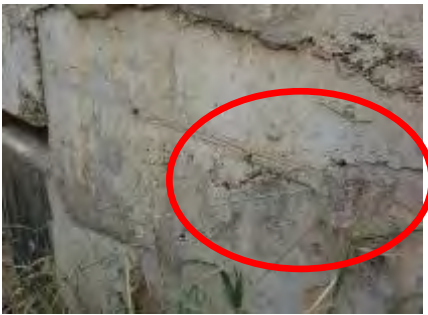
Table 7-52 Follow-up Inspection of 1st Pilot Project (Phnom Penh, No. 1)

Crack No. 1	Crack No. 2		
The damage situation (11/2015)

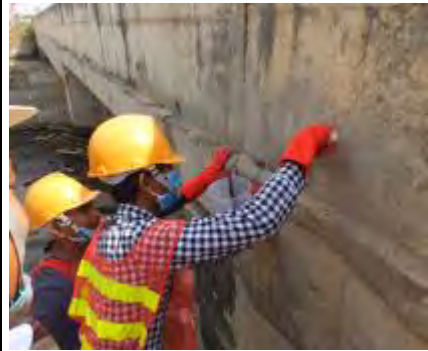
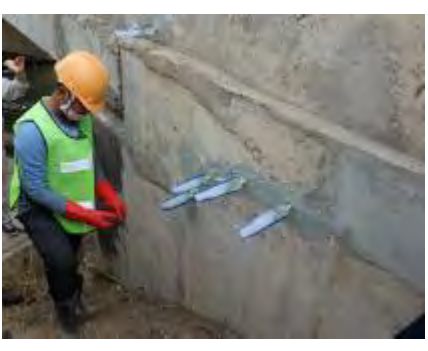
N/A	N/A
The repair situation (02/2016)

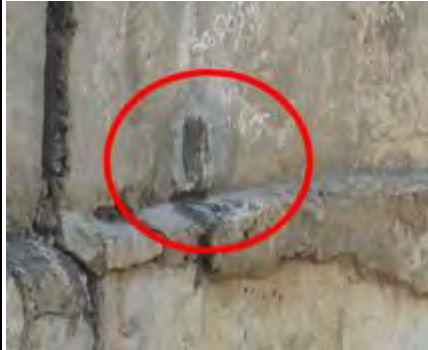
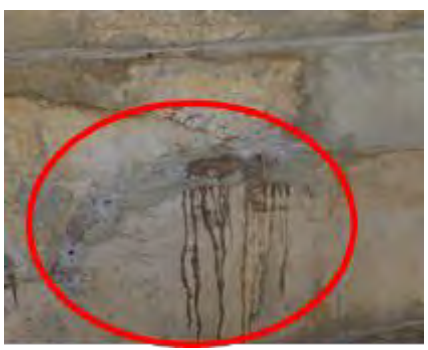
N/A	N/A
Immediately after repair (02/2016)

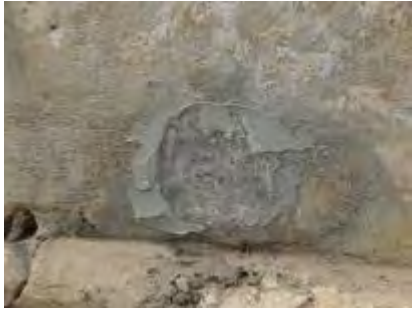
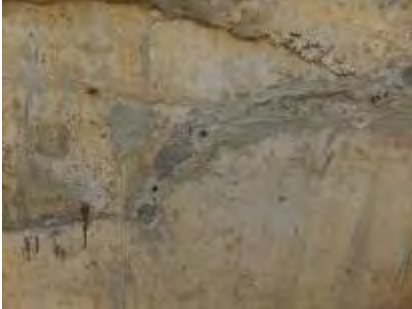
Table 7-53 Follow-up Inspection of 1st Pilot Project (Phnom Penh, No. 1)

Crack No. 1	Crack No. 2		
Follow-up inspection (3 months after) (05/2016)	<ul style="list-style-type: none"> ▪ It is still of good quality ▪ (By hammering Test) ▪ There is no rust, lifting, or any new crack

<ul style="list-style-type: none"> ▪ It is still of good quality ▪ (By hammering Test) ▪ There is no rust, lifting, or any new crack

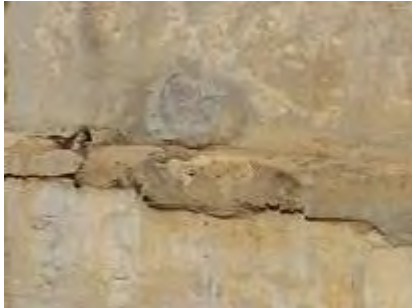
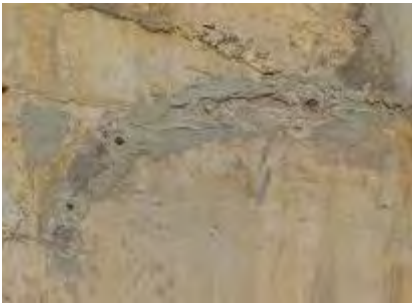
N/A	N/A
Follow-up inspection (7 months after) (09/2016)	<ul style="list-style-type: none"> ▪ It is still of good quality ▪ (By hammering Test) ▪ There is no rust, lifting, or any new crack

<ul style="list-style-type: none"> ▪ It is still of good quality ▪ (By hammering Test) ▪ There is no rust, lifting, or any new crack

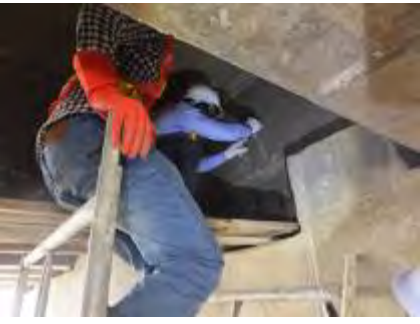
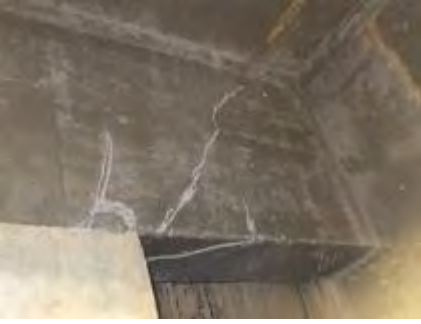
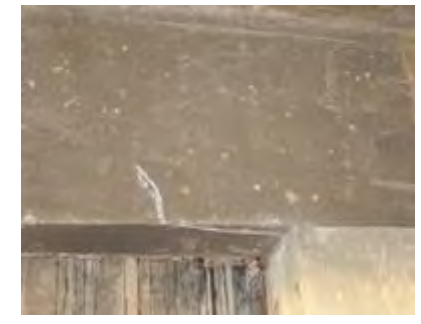
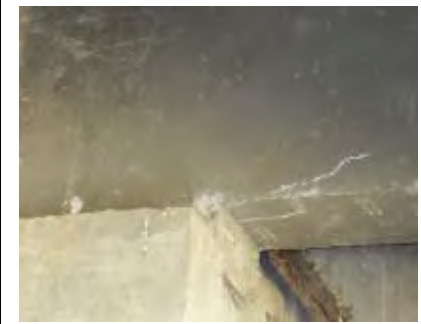
Table 7-54 Follow-up Inspection of 1st Pilot Project (Phnom Penh, No. 2)

Crack No. 1	Crack No. 2	Crack No. 3	Crack No. 4
The damage situation (11/2015)

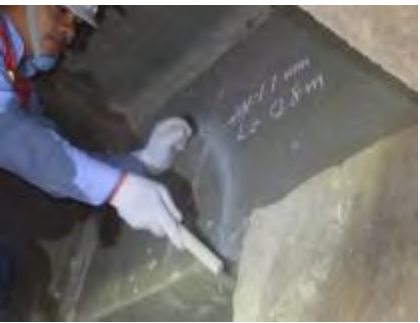
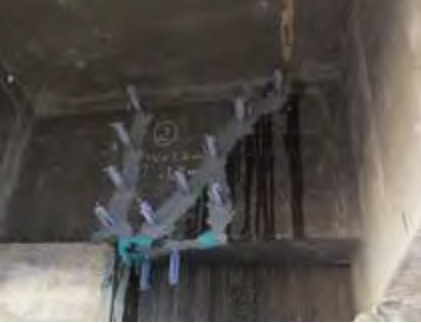
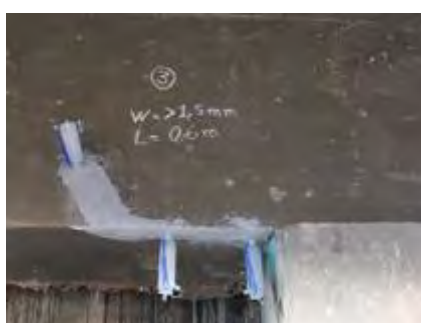
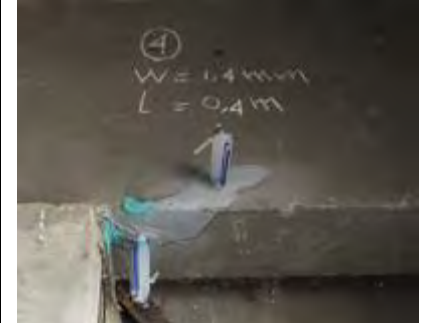
The repair situation (02/2016)

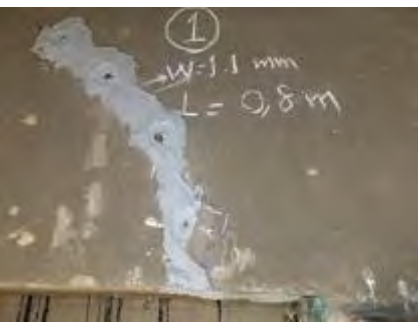
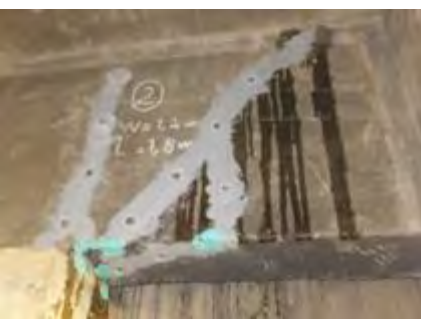
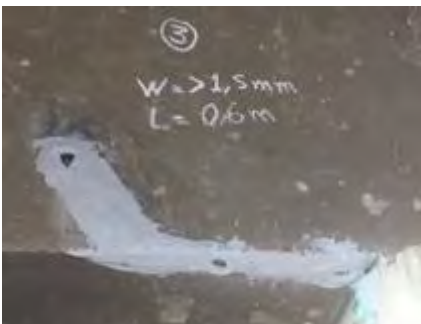
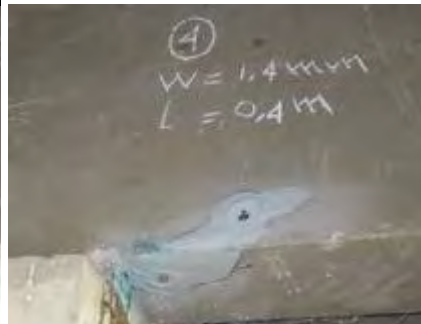
Immediately after repair (02/2016)

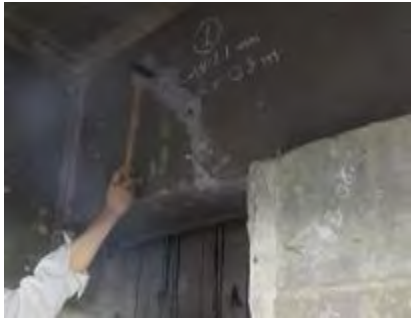
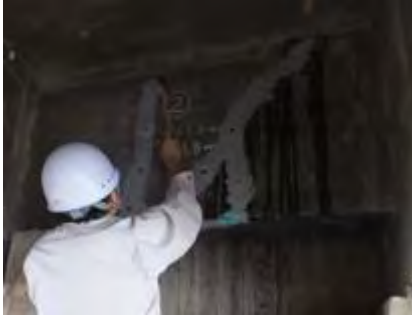
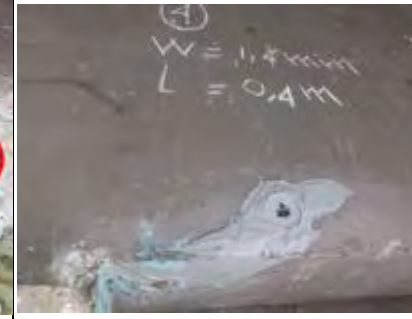
Table 7-55 Follow-up Inspection of 1st Pilot Project (Phnom Penh, No. 2)

Crack No. 1	Crack No. 2	Crack No. 3	Crack No. 4
Follow-up inspection (3 months after) (05/2016)	<ul style="list-style-type: none"> It is still of good quality (By hammering Test) There is no rust, lifting, or new crack

<ul style="list-style-type: none"> It is still of good quality (By hammering Test) There is no rust, lifting, or new crack

<ul style="list-style-type: none"> It is still of good quality (By hammering Test) There is no rust, lifting or new crack

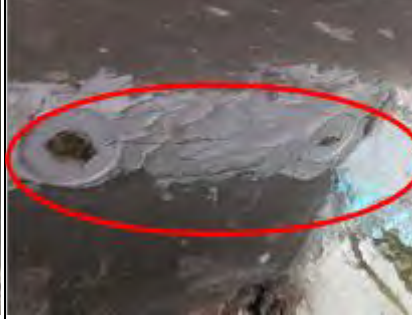
The repair works were still of good quality except for one crack (in May 2016). This crack was found on Prek jrey bridge (Phnom Penh, No. 2, Crack No. 3, No. 4; Table 7-18).

The cause is not ‘non-conforming repair work’, but is due to:

Since the crack is caused due to structural deficiency, there is a possibility that new cracks might occur on other repaired parts in the future.

<ul style="list-style-type: none"> A new crack occurs due to overloading of vehicles.

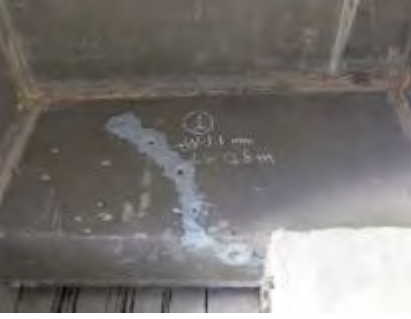
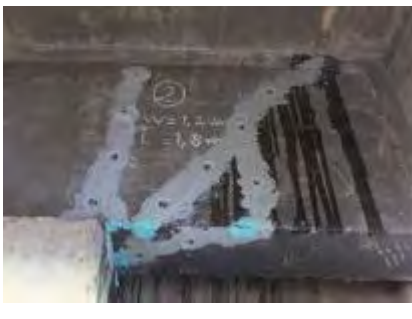
Follow-up inspection (7 months after) (09/2016)	<ul style="list-style-type: none"> It is still of good quality (By hammering Test) There is no rust, lifting, and new crack

<ul style="list-style-type: none"> It is still of good quality (By hammering Test) There is no rust, lifting, and new crack

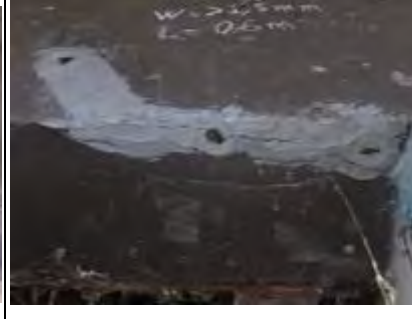
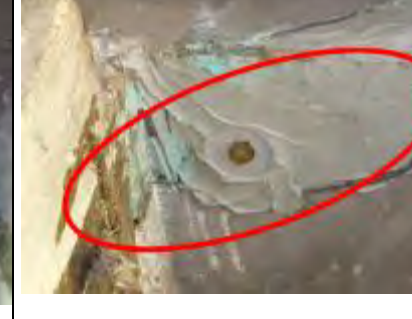
<ul style="list-style-type: none"> Cracks are progressing due to overloading of vehicles.

<ul style="list-style-type: none"> A new crack occurs due to overloading of vehicles.
