Chapter 7. Output 3: Road and Bridge Repair Capacity of RID is Enhanced

7.1. To Review and Establish Road Repair Manual

7.2. To Review and Establish Bridge Repair Manual

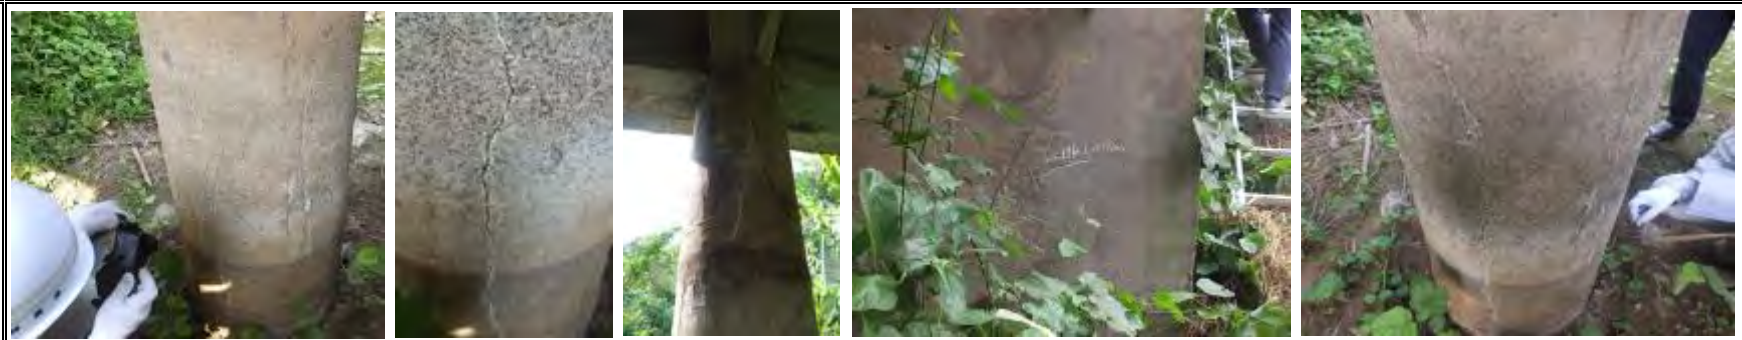
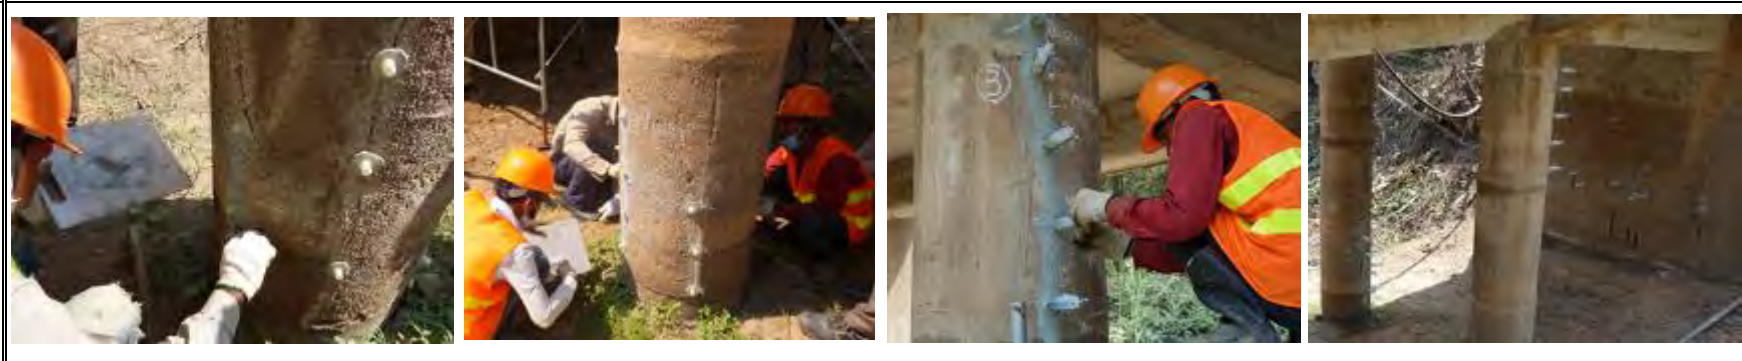
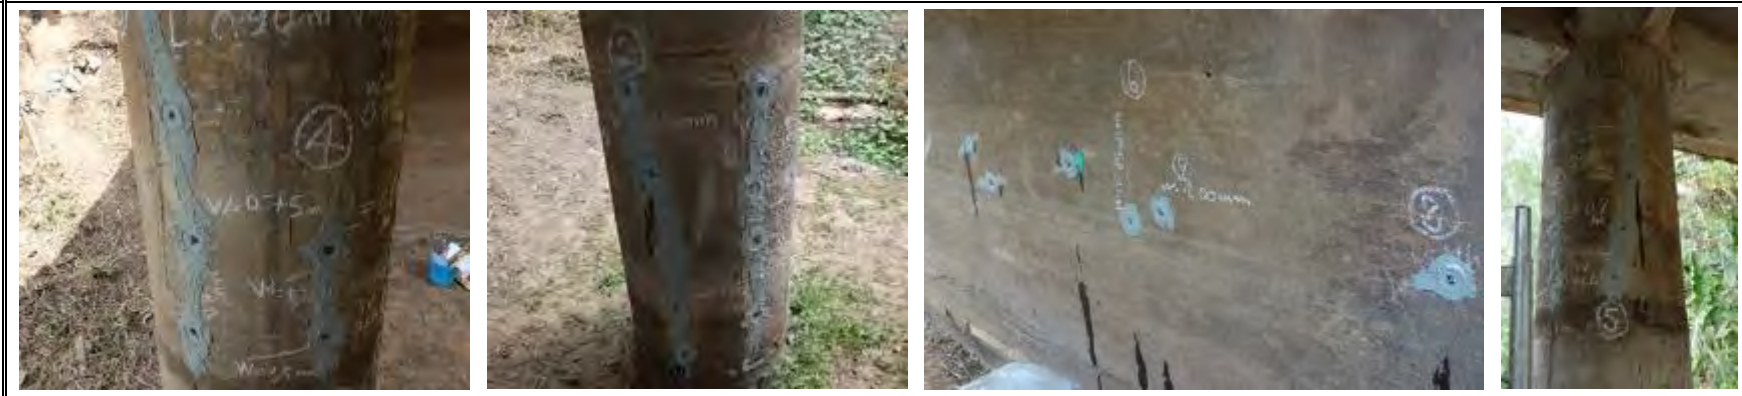
Table 7-57 Follow-up Inspection of 1st Pilot Project (Kandal, No. 1)

Crack				
<p>The damage situation (11/2015)</p>

<p>The repair situation (02/2016)</p>

<p>Immediately after repair (02/2016)</p>

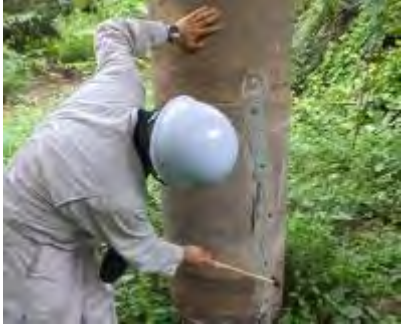
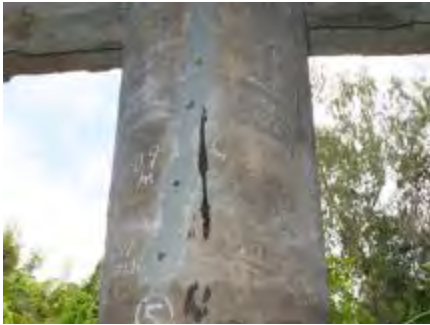
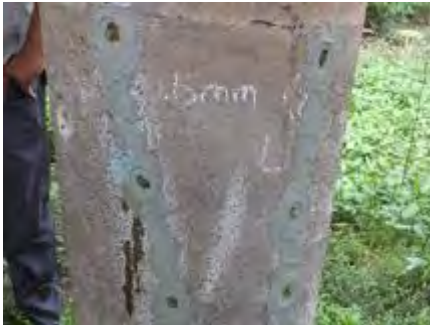
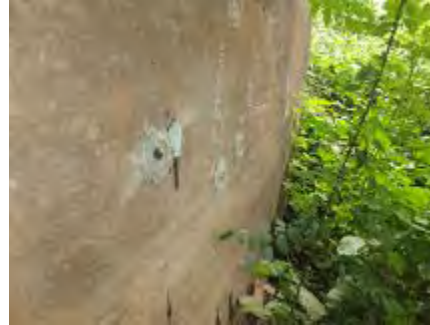
Crack
<p>Follow-up inspection (3 months after) (05/2016)</p>	<ul style="list-style-type: none"> ▪ It is still in good quality (by hammering Test) ▪ There is no rust, lifting or new crack <div style="display: flex; justify-content: space-around;">

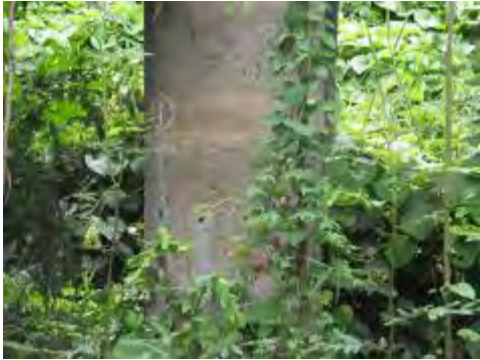
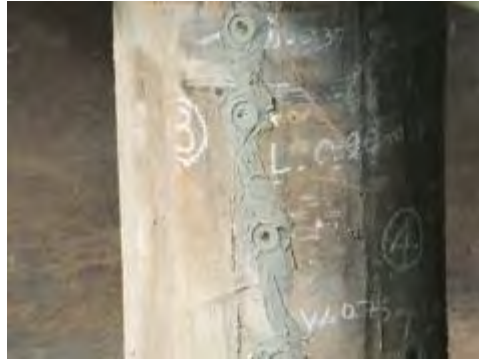
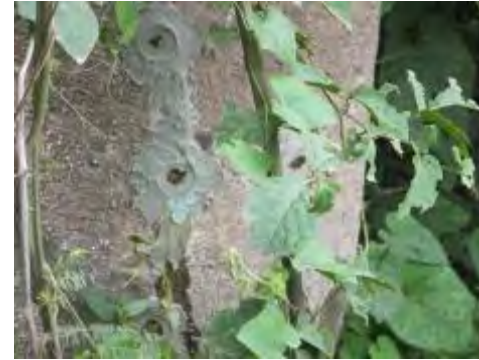
</div>
<p>Follow-up inspection (7 months after) (09/2016)</p>	<ul style="list-style-type: none"> ▪ It is still of good quality. ▪ There is no rust, lifting or new crack <div style="display: flex; justify-content: space-around;">

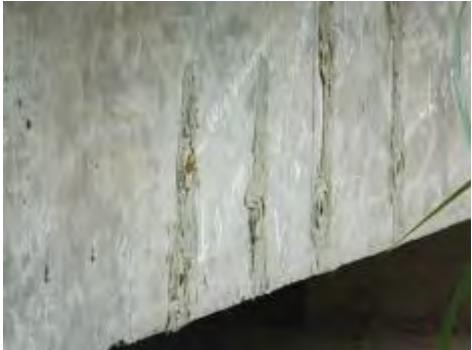
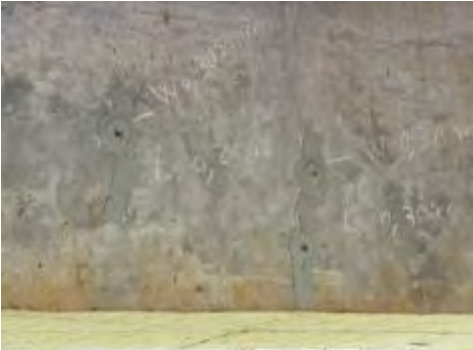
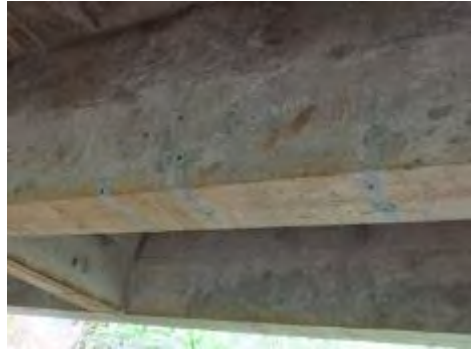
Table 7-59 Follow-up Inspection of 1st Pilot Project (Kandal, No. 3)

Crack
<p>Follow-up inspection (3 months after) (05/2016)</p>	<ul style="list-style-type: none"> ▪ It is still of good quality (By hammering Test) ▪ There is no rust, lifting, or new crack <div style="display: flex; justify-content: space-around;">

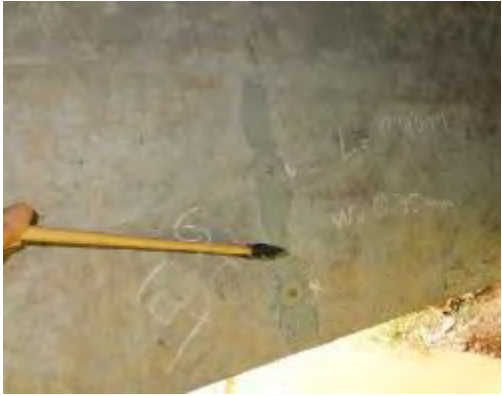
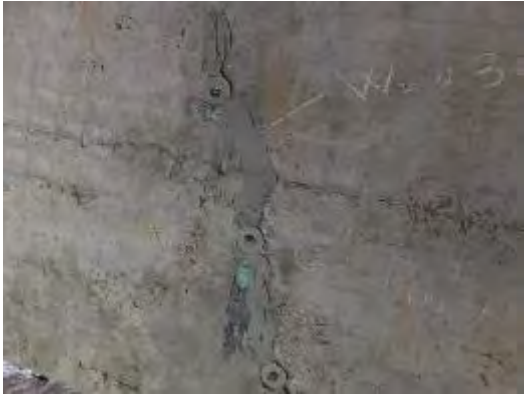
</div>
<p>Follow-up inspection (7 months after) (09/2016)</p>	<ul style="list-style-type: none"> ▪ It is still of good quality (By hammering Test) ▪ There is no rust, lifting, or new crack <div style="display: flex; justify-content: space-around;">

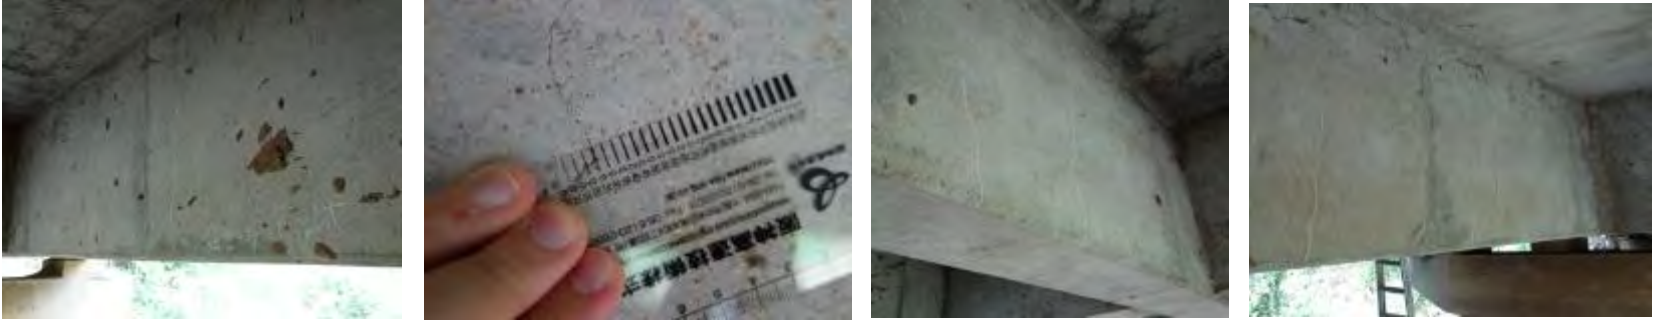
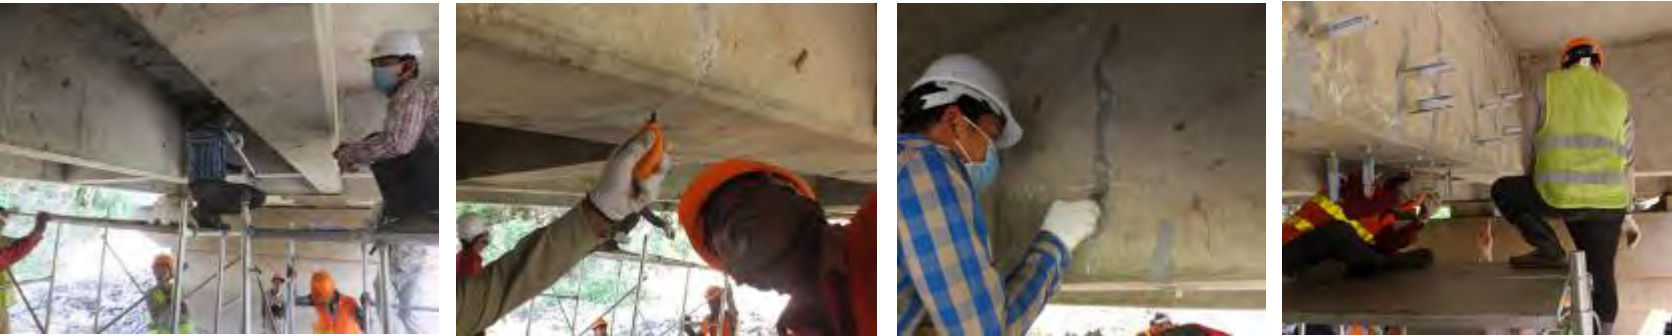
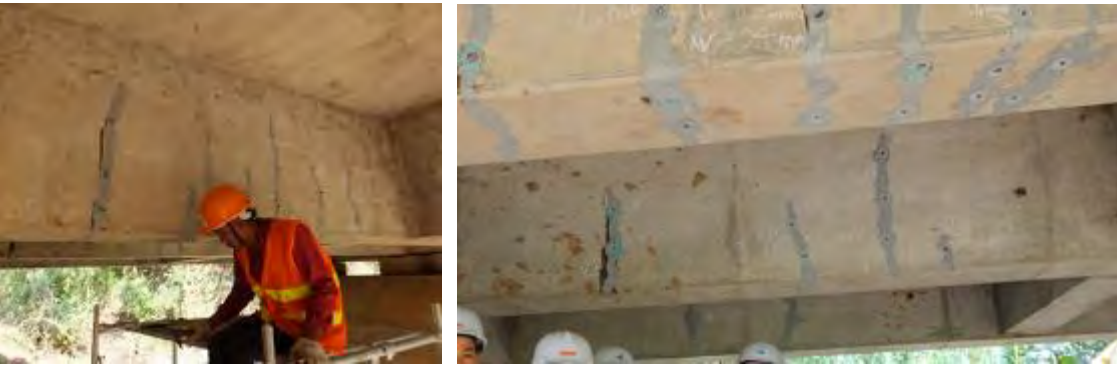
Table 7-61 Follow-up Inspection of 1st Pilot Project (Kandal, No. 4)

Crack			
<p>The damage situation (11/2015)</p>

<p>The repair situation (02/2016)</p>

<p>Immediately after repair (02/2016)</p>

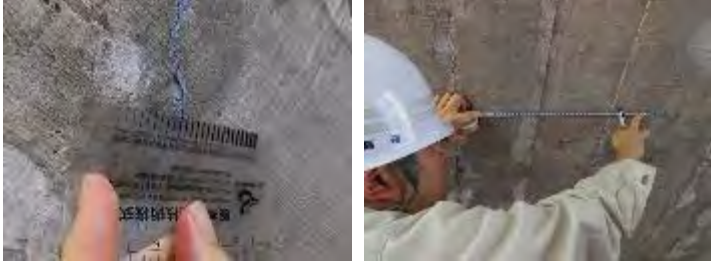
Situation
<p>The damage situation (06/2016)</p>

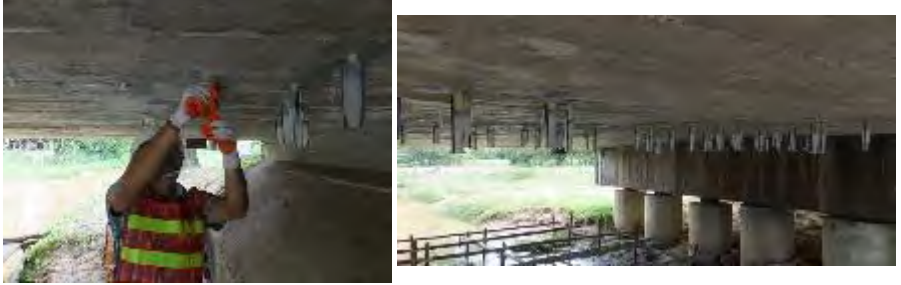
<p>The repair situation (Crack repair method by Epoxy Resin) (12/2016)</p>

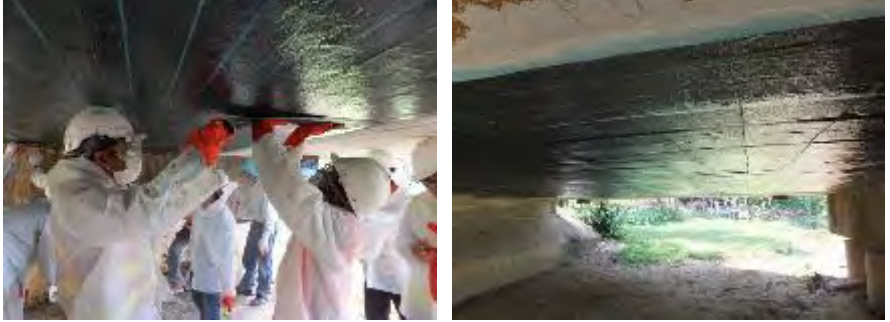
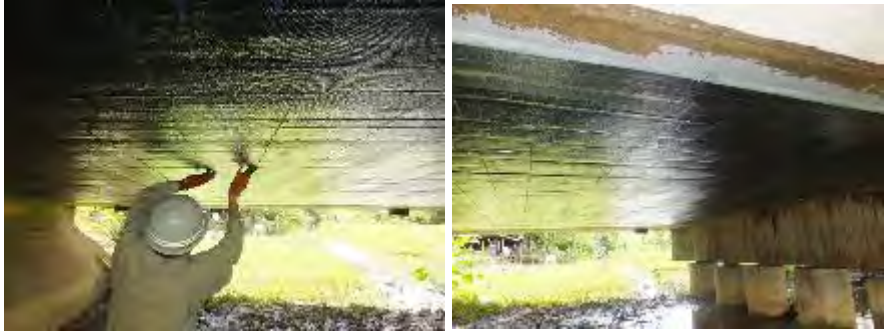
<p>The repair situation (CFC reinforcement work) (01/2017)</p>

<p>Follow-up inspection (5 months after) (06/2017)</p>	<p>• It is still of good quality (Floating and peeling of CFC was not confirmed)</p>

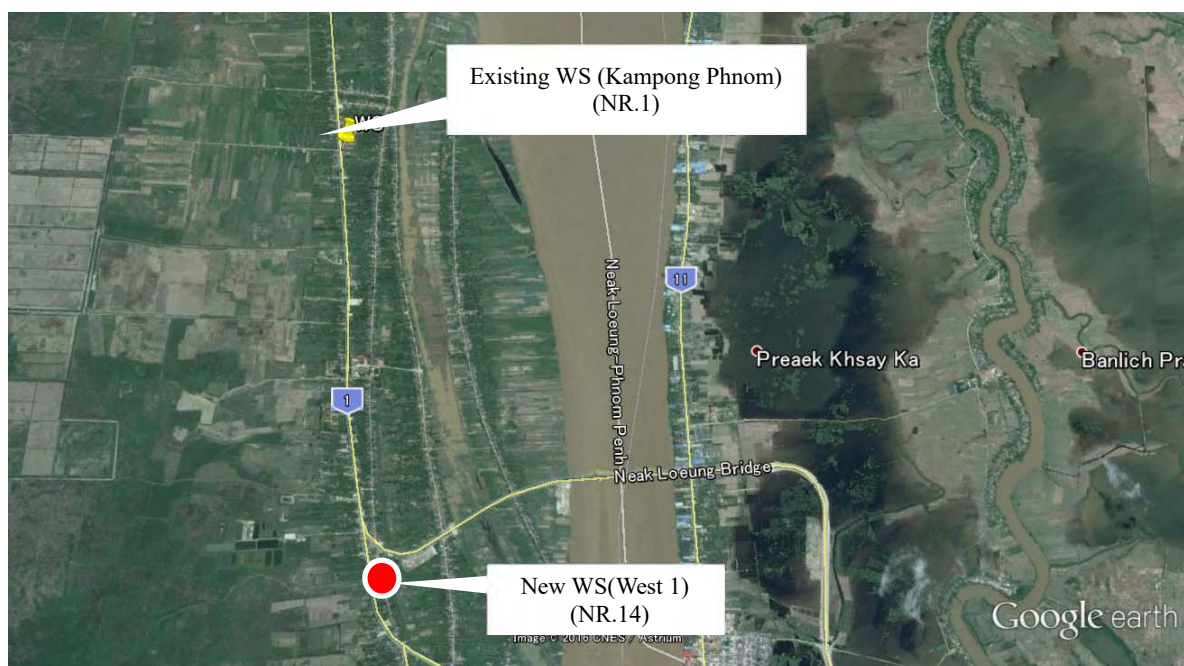
Figure 9-2 Temporary Solution for the West side

1. (From Phnom Penh by NR.1)
Use of existing weigh bridge station at Kampong Phnom (west side of the road) to weigh the trucks.
2. (From south by NR.14)
Step 1: Guide the suspected vehicle to the existing weigh bridge station at Kampong Phnom. The weight of the vehicle shall be checked there.
This is the most practical and fast temporary solution. However, this allows the suspected vehicle take NR.1 up to the weigh bridge station.
Step 2: Install temporary office (container house) of 40 ft at NR.14 for a 24-hour operation and identify overloaded vehicle at the site. (Option West 1). Estimated cost is 24,150 USD.

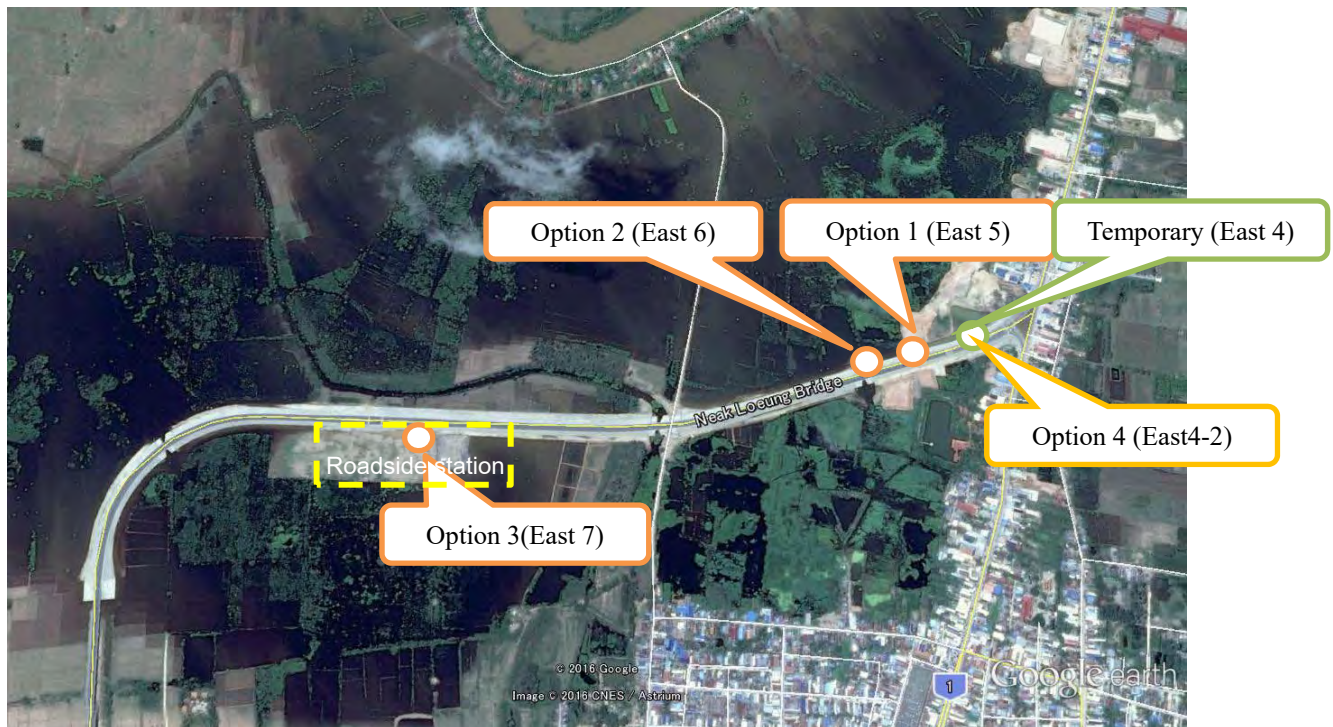
Figure 9-12 Location of the options

Three (3) options are compared and option 2 (East 6) is recommended due to the following reasons:

1. The option 2 (East 6) is easier for operation since it is close to the existing intersection.
2. Ease of construction (better soil condition)
3. Option 3 (East 7) is favorable because land is already available, even though the weigh bridge station will be in the opposite side of the traffic direction.

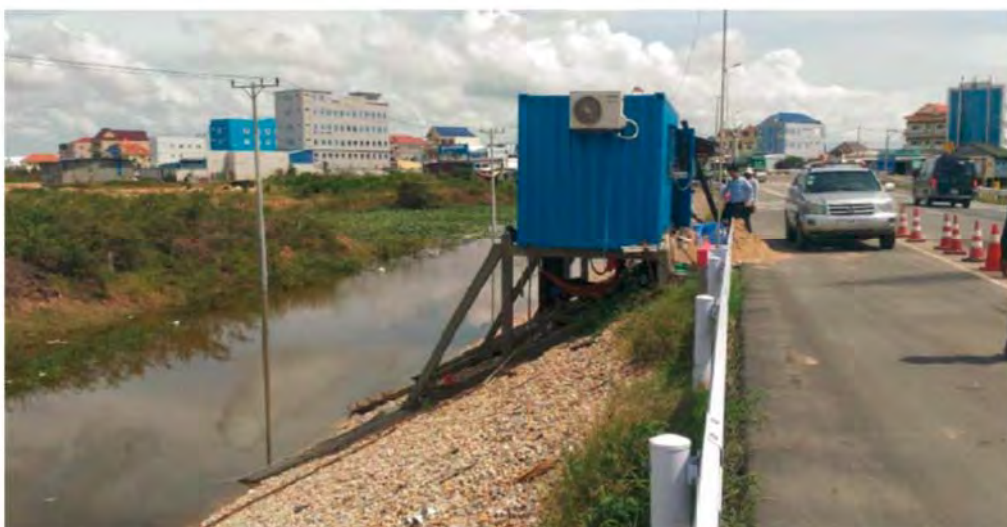
Operation House of East Neak Loeung Weigh Station

Mobile station at the east is located along NR 1 as shown in Figure 9-24 with a container house.

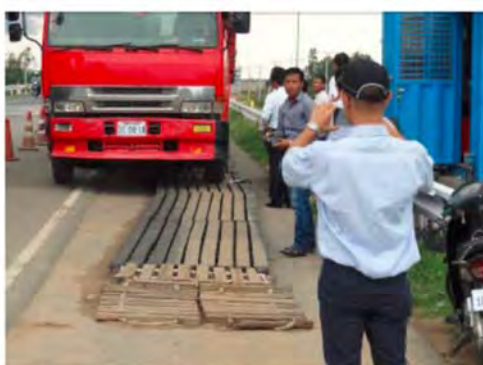
Not enough space and imbalance
ground elevation for load measurement

➔
AC Overlay

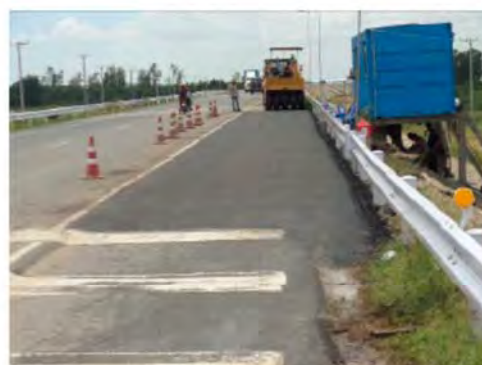
AC Overlay, East Neak Loeung Weigh Station

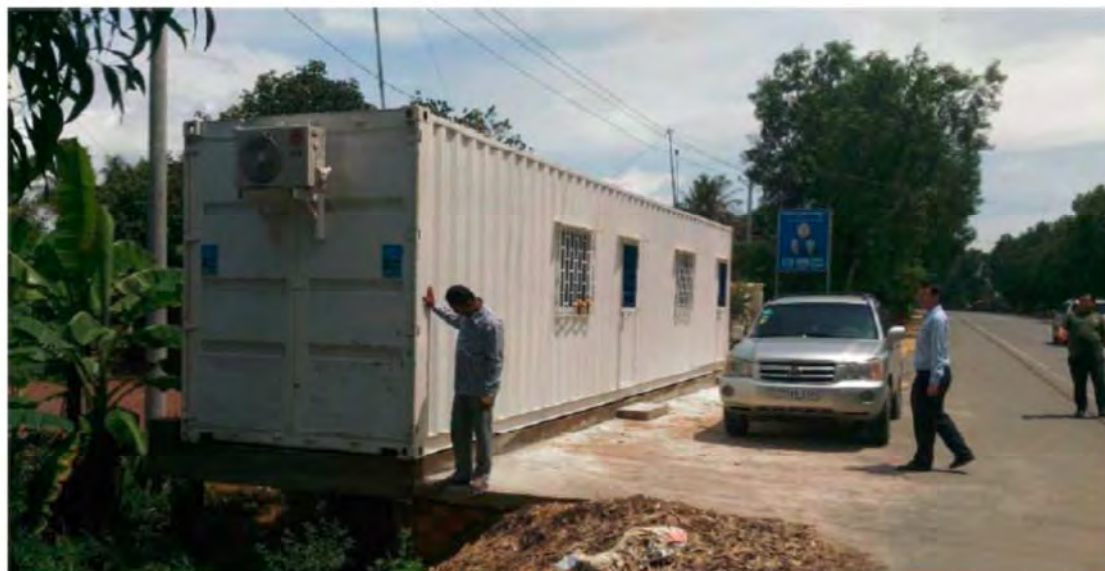
Operation Office of West Neak Loeung Weigh Station

The portable scale and container house are located in the west as well as shown in Figure 9-26.

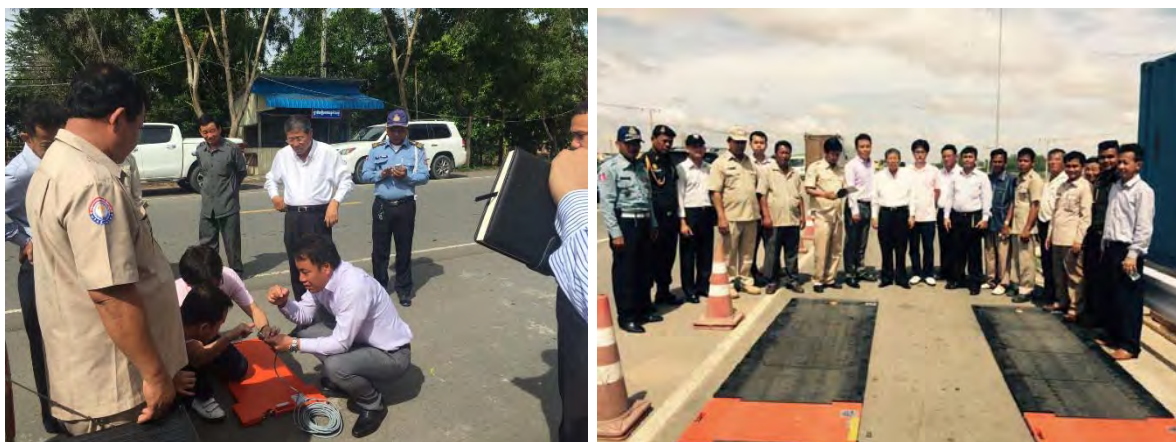
Figure 9-30 Overweight Scale at Site

Portable scale PTS-II was selected as mobile scale at the pilot project.

Figure 9-30 shows the current national monthly report. It shows the number of inspected vehicles, overloaded vehicles, warning and penalty for all the 25 enforcement stations. No. 19 corresponds to Tsubasa (Nak Leung) East.

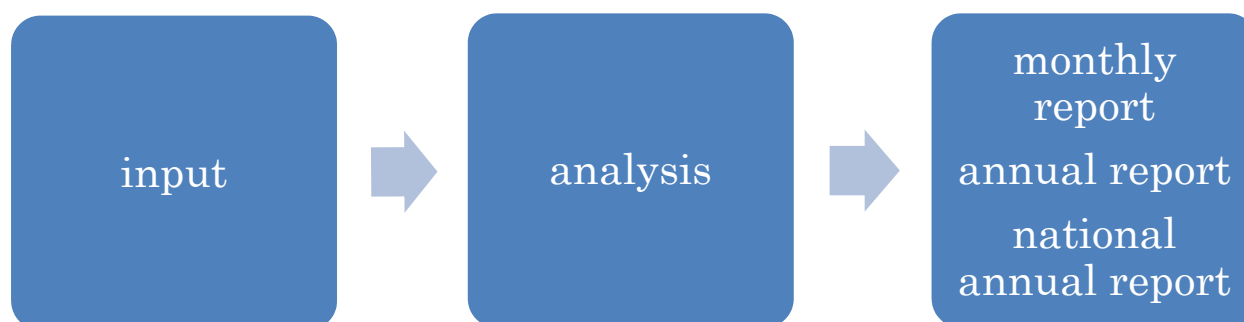
Figure 9-38 Report Flow

As for the routine report, first, data collection is done, and then follows the analysis and reporting.

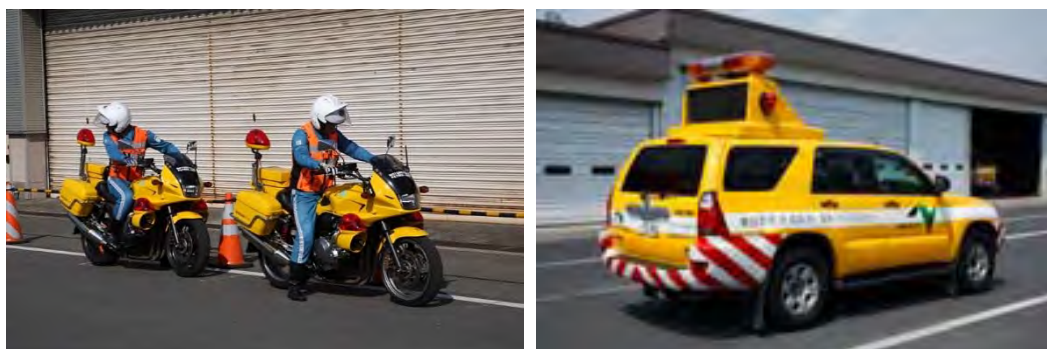
Figure 9-40 Road Patrolling

For daily reports, the report items should cover pavement, miscellaneous, bridge, ROW under bridge. An observation note should be prepared. Figure 9-40 below the shows a future image of road patrolling.

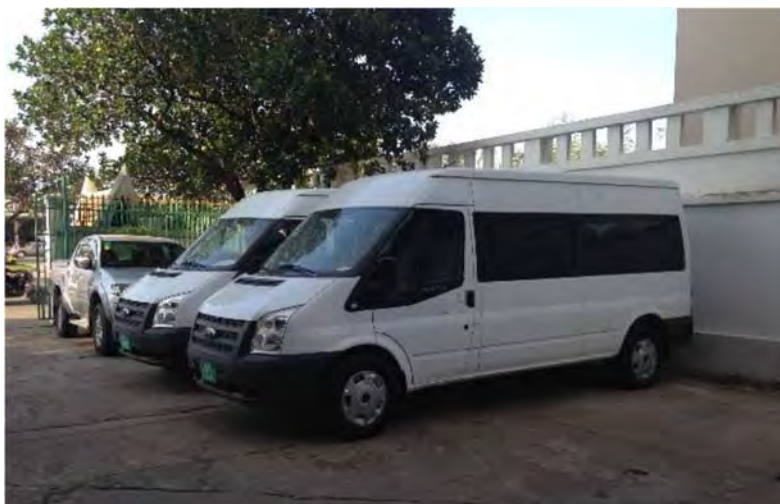
Figure 9-49 Mobile Scale Vehicle at MRD

Monthly report had been collected for several months, however, since March 2017, it became impossible to collect the report. Even though it is paper based, it requires a lot of administrative procedure to take. In the August report, in addition to 25 existing overloading enforcement stations, there is a “mobile” station. The capturing result was report as 100%. In this case, if 5 vehicles are inspected all the 5 are identified to be overloaded. It is known that an experienced officer at the station can tell if a vehicle is overloaded just from appearance before even scaling the vehicle.

A “mobile” station is similar to a mobile vehicle as seen in Figure 9-49 at MRD offices. The donor team presented two mobile vehicles to MRD office.
