公共インフラ・陸上交通省 地すべり対策ユニット

# モーリシャス国斜面災害対策支援

## 業務完了報告書

独立行政法人  
国際協力機構(JICA)  
国際航業株式会社

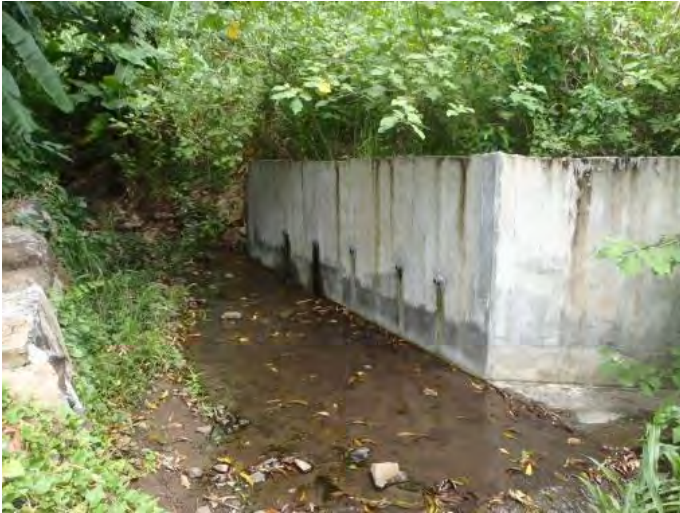
Landslide countermeasure constructed under the Previous JICA Project, Chitrakoot

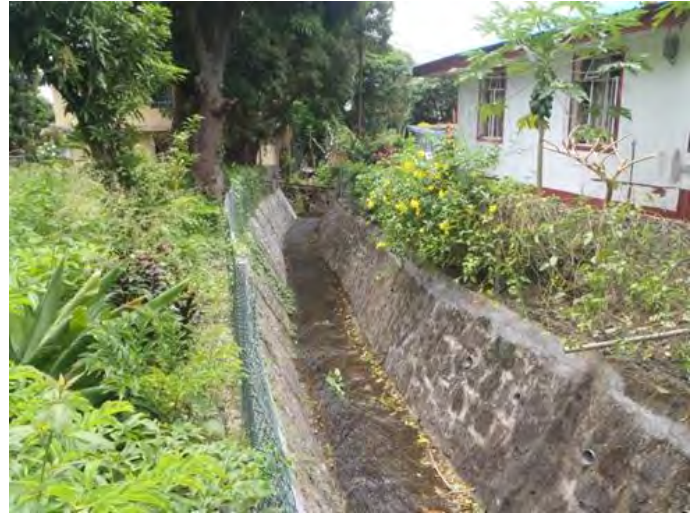
Landslide countermeasure constructed under the Previous JICA Project, Chitrakoot

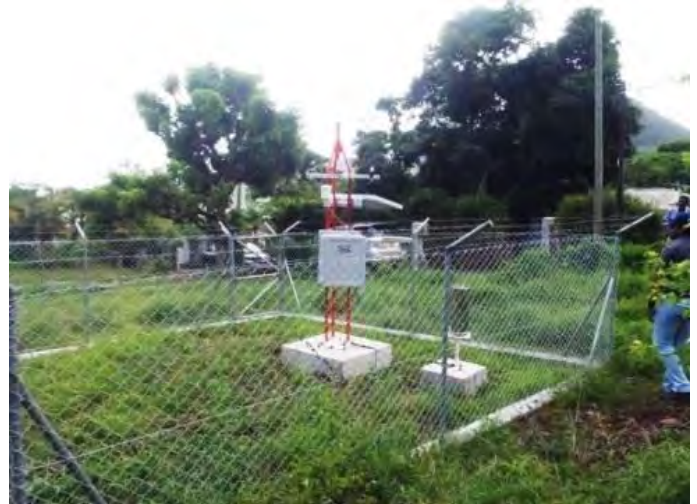
Automatic Weather Station (AWS) for early warning installed by the Mauritius Meteorological Services (MMS), Chitrakoot

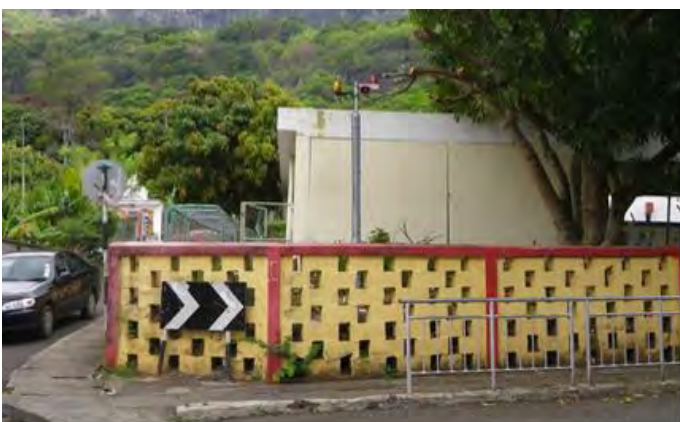
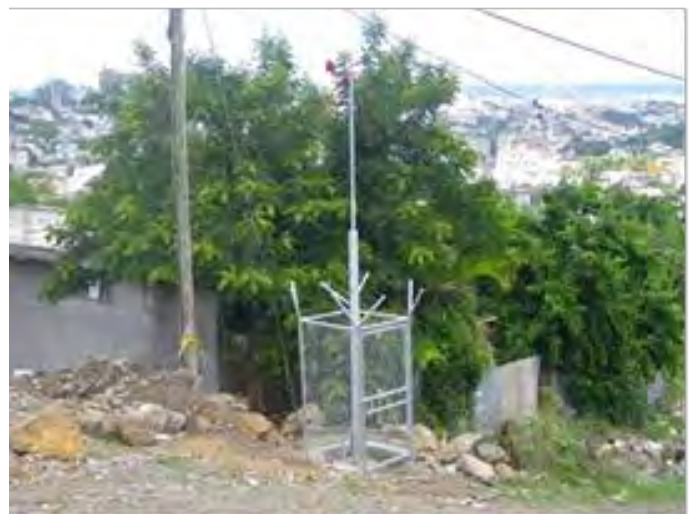
Early warning system, Vallée Pitot

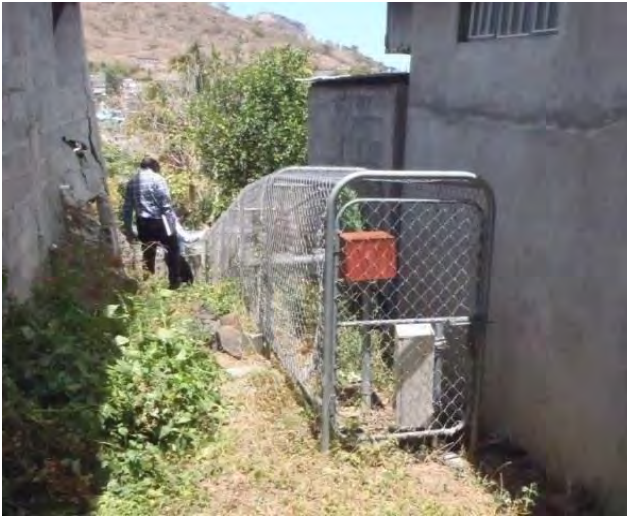
Extensometer maintained by MPI/LMU, Vallée Pitot

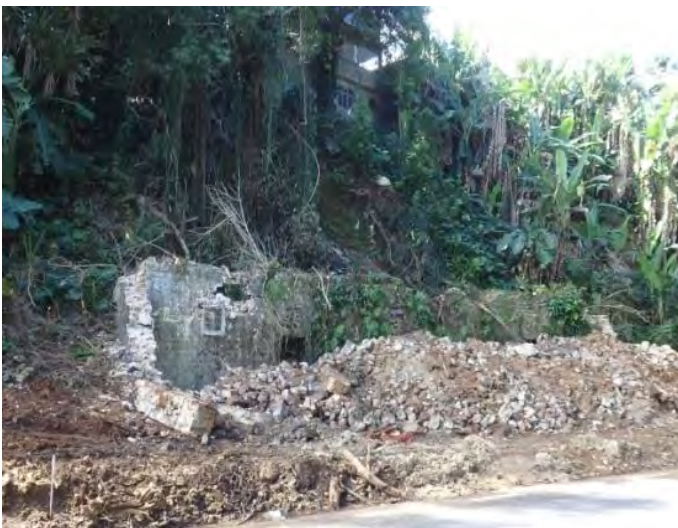
The slope in which a retaining wall (1.5 m high) is to be applied, Batelage

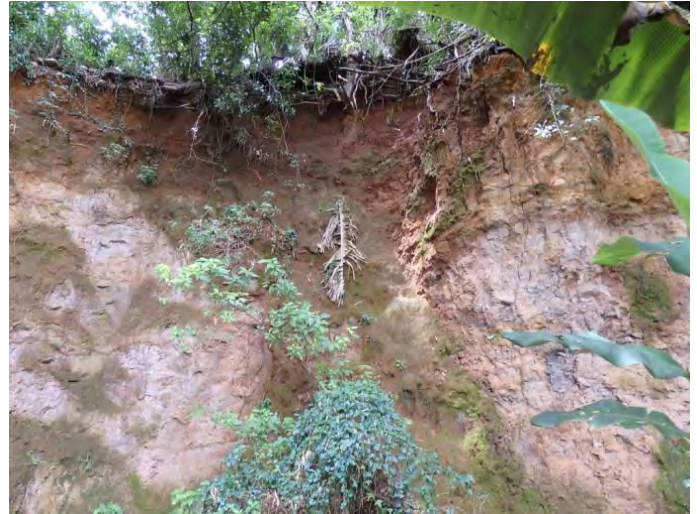
Cut slope failure, Pilot Bel Air

11 Pitit Bel Air (cut 切 土 slope failure)	<ul style="list-style-type: none"> <li>➤ River des Creoles の河口近くにある住宅背後の切土 slope である。</li> <li>➤ 下位の住宅建設のために、掘り出しやすい強風化の basalt を重機で掻き出した。</li> <li>➤ 原因は slope 下方の住民の不適切な掘削によるものである。</li> </ul>	<ul style="list-style-type: none"> <li>➤ 上方の住民の水処理について調査したが、特に問題はない。</li> </ul>
12 Vallée Pitot (bank slope failure 盛土 failure 対策)	<ul style="list-style-type: none"> <li>➤ 対象箇所は slope 下部の住宅開発箇所である。</li> <li>➤ 強雨によるフラッシュフラッドと盛土の failure が発生した。</li> <li>➤ 被害は周辺の住宅の浸水、盛土 retaining wall の failure、それに伴う道路陥没、コンクリートブロック retaining wall が押し出された。</li> </ul>	<ul style="list-style-type: none"> <li>➤ フラッシュフラッド対策</li> <li>➤ 整備不良の道路盛土の改良</li> <li>➤ 不良排水施設の改善と retaining wall の強度増</li> <li>➤ slope を含む流域管理の考え方が必要である。</li> </ul>
13 Long Mountain (住宅背後の河岸 slope failure)	<ul style="list-style-type: none"> <li>➤ 河川の崖に接近した住宅の下方の slope failure とそれによる基礎の洗い出し</li> </ul>	<ul style="list-style-type: none"> <li>➤ 住宅からの表流水対策</li> <li>➤ 基礎の補強で対応</li> </ul>

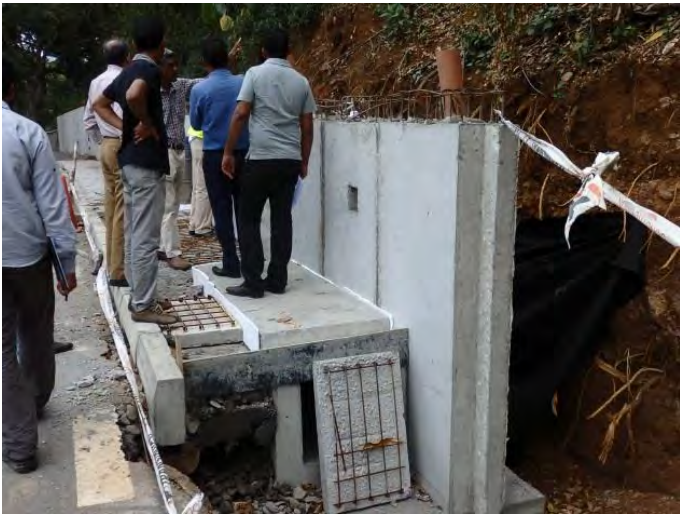
Construction of retaining wall at a place of possible slope failures, Batelage

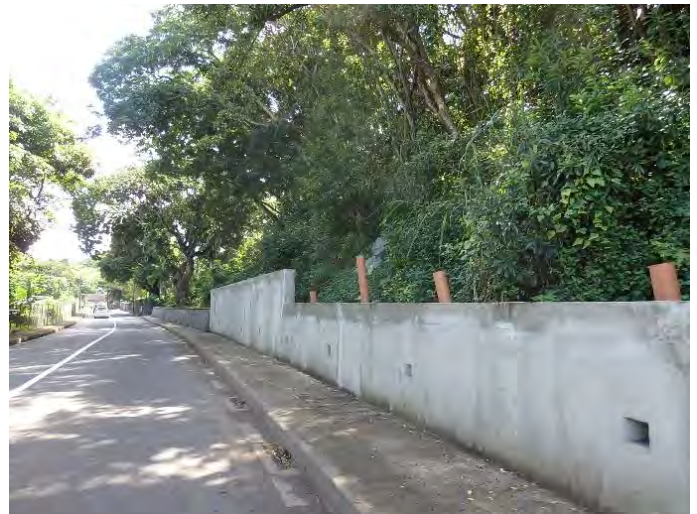
Completed countermeasure work, Batelage

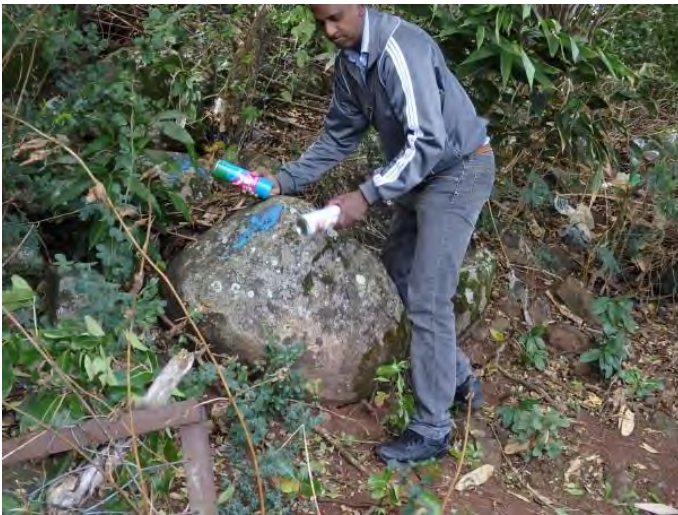
Consideration of measures (blue spray: stabilisation), Ruisseau Des Creoles

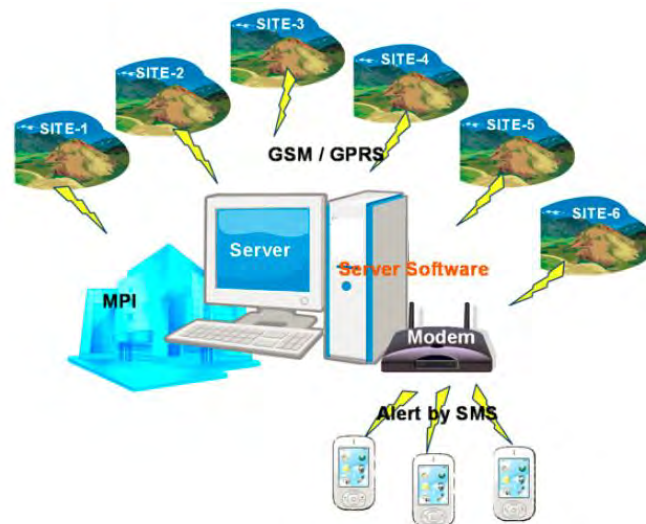
Figure 3.3.2 Image of the remote monitoring system (Source: JET)
