**Subject: Confirmation for Location of Mandalay Port Development Project**

***Preparatory Survey for the Project for Development of Mandalay Port  
In the Republic of the Union of Myanmar***

### 6-1 Urban Development Plans and Candidate Port Locations

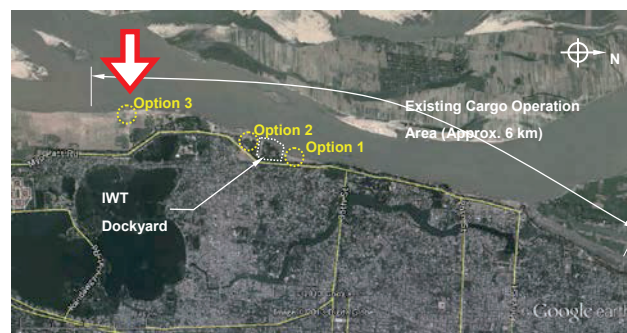
Feasibility Study on Inland Water Transport  
Facilities Improvement and Development Project  
JICA 2014

*Note: Option 3 (At Proposed Port Development location of Mandalay Urban Development Conceptual Plan) was selected during Feasibility Study*

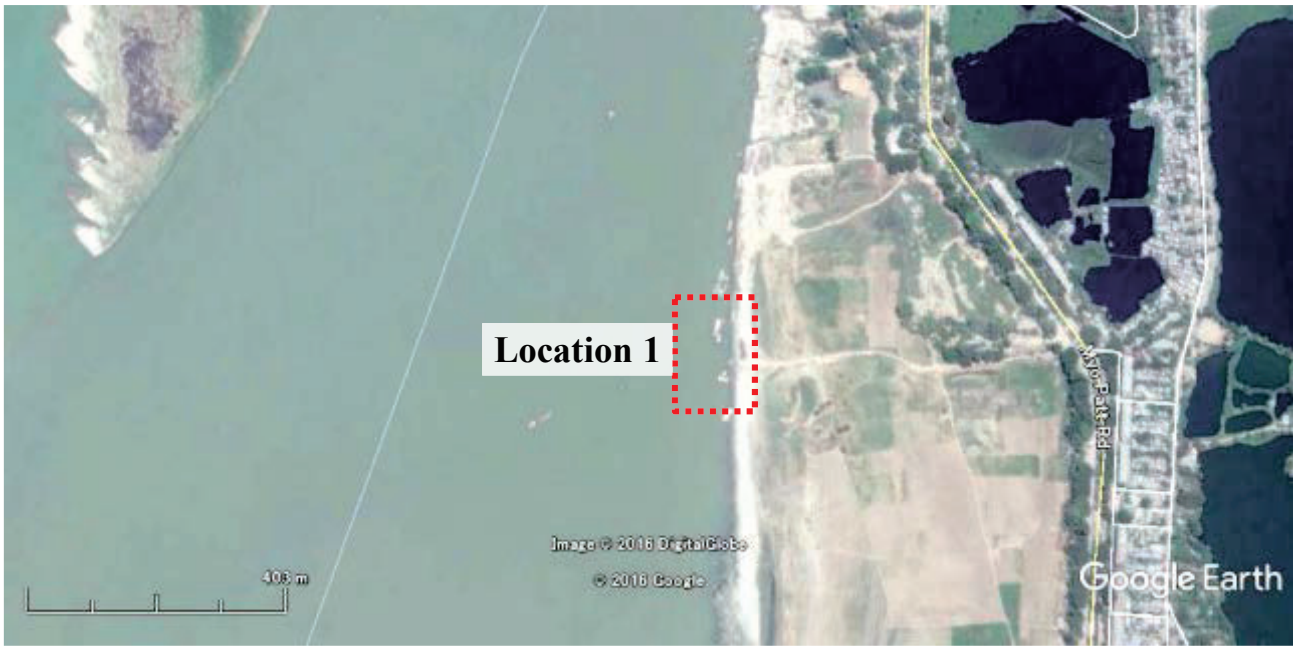
Location 1

Description
<ul style="list-style-type: none"><li>● <b>General:</b> This location was proposed in the Feasibility Study (JICA 2014).</li><li>● <b>Water Depth:</b> Jetty was proposed at the location -2.0m below lowest water level</li><li>● <b>Ground Condition:</b> Soil borings at 3 points were conducted. Soil condition is generally good.</li><li>● <b>Sedimentation Risk:</b> Relatively low.</li><li>● <b>Consistency to City Plan:</b> Consistent to the Mandalay Urban Development Conceptual Plan MOC Myanmar, 2013.</li><li>● <b>Future Expansion Area:</b> Wide space on dry river bed is available.</li><li>● <b>Influence to City Traffic:</b> Generally low. (access to Myo Patt Rd. proposed outer ring rd. by Conceptual City Plan 2016)</li><li>● <b>Social Environment:</b> There are a few seasonal farmers cultivating dry river bed during low-water season.</li><li>● <b>Land ownership:</b> Owned by government and under DWIR's administration. There is cultivated land for only dry season.</li><li>● <b>Construction Cost:</b> Feasibility Study estimated 3 ~ 4 Billion. JPY (30 ~ 40 Million USD)</li><li>● <b>Others:</b> EIA report had already been submitted to MONREC (to be confirmed).</li></ul>

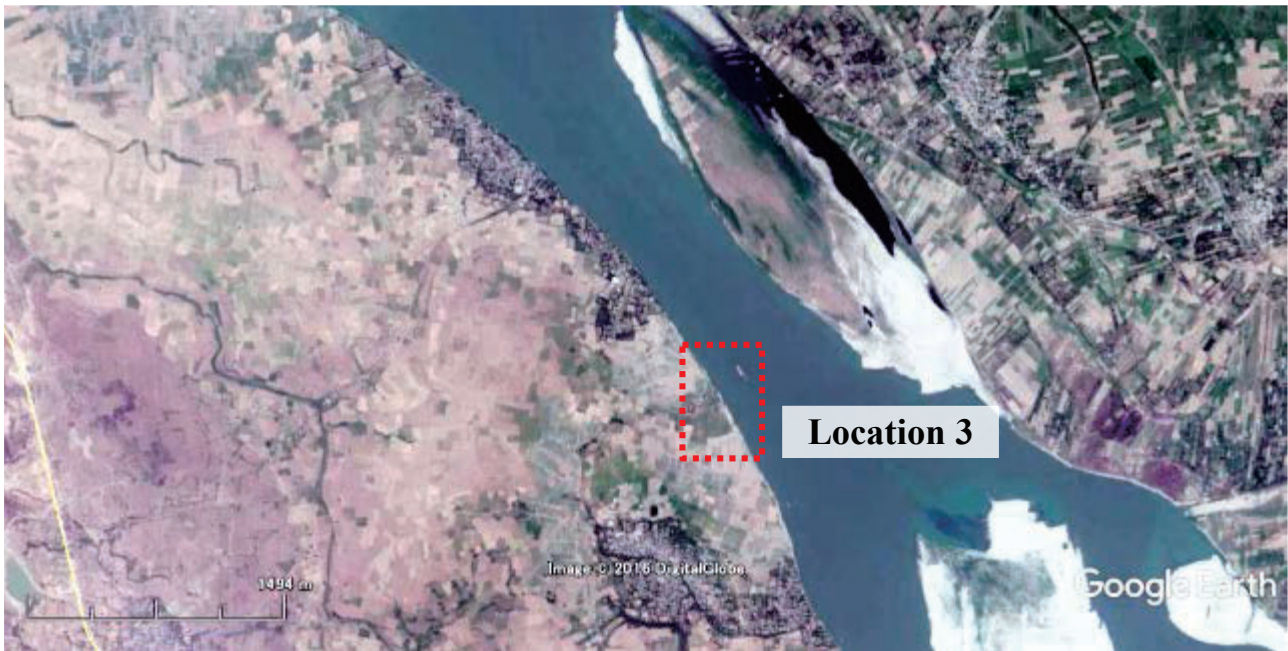
### Location 3

- **General:** This location is located approximate 30 ~ 40 km distant from Mandalay City Center.
- **Water Depth:** To be confirmed. It seems generally deep.
- **Ground Condition:** Availability of soil investigation to be confirmed.
- **Sedimentation Risk:** Low.
- **Consistency to City Plan:** Location is out of Mandalay City. Not mentioned in the City Plan.
- **Future Expansion Area:** Wide space in cultivated land is available.
- **Influence to City Traffic:** Generally low.
- **Social Environment:** Land area is the permanent cultivated land. Re-settlement will be required.
- **Land ownership:** Outside the land under DWIR's administration. There is cultivated land for all seasons.
- **Construction Cost:** Higher than Location 1 (to be confirmed). The cost for access road will be higher. (approximately 20 km of road improvement will be required)
- **Others:**

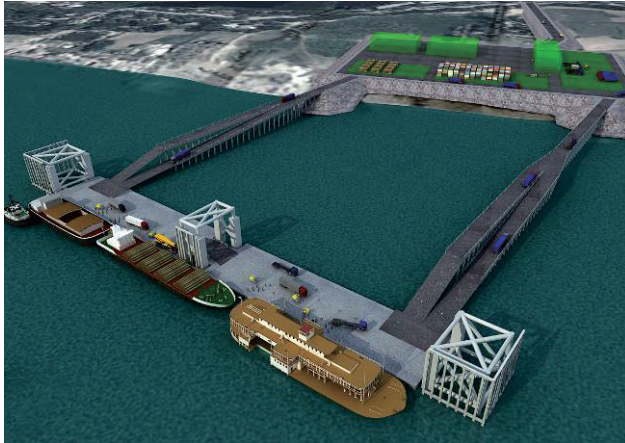
Fig.1 Floating Type Jetty

However, the feasibility study pointed out the serious risk of the floating type jetty that river siltation might cause damage on the floating body. If the water depth under the large floating jetty would become shallower than the draft of the floating jetty, the jetty bottom will touch to the riverbed, which causes uneven bending moment in the floating body and may cause damage. It is not easy to repair the large floating body if this risk occurs.

Floating (B): Floating-type jetty contains movable joints between access-bridge and floating jetty. Berthing force of cargo barge will cause a risk of damages to these movable joints. Frequent inspections, maintenances and repairing works will be required.

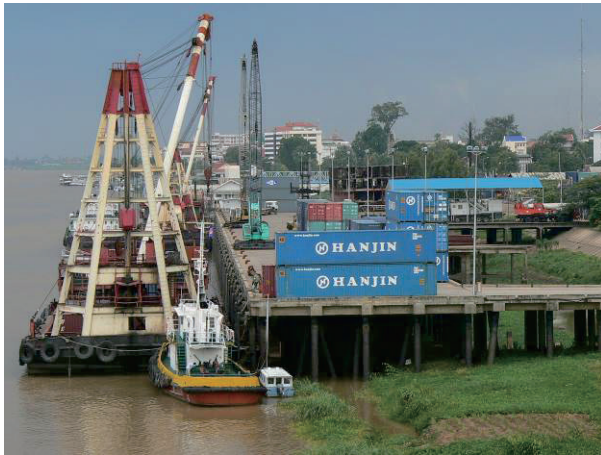
Fig. 5 Old Port (Phnom Penh Port)

The Port of Phnom Penh was built in 1990's by Japan's Grant-Aid project. Considering the scale of the city (Phnom Penh has approx. 2 million population) and the fact that the port was designed for the initial introduction of equipment cargo handling to the existing manual operations before building port, the project of Mandalay Port is similar to the Phnom Penh Port in terms of its scale and purpose of the project.

In the case of Phnom Penh Port, the total cargo volume during the opening of the port (Old Port, end of 1996 start operation) was approximately 600,000 tons/year. Before opening this port, all cargoes were handled by labors without equipment, which is similar to the condition of the present Mandalay Port.

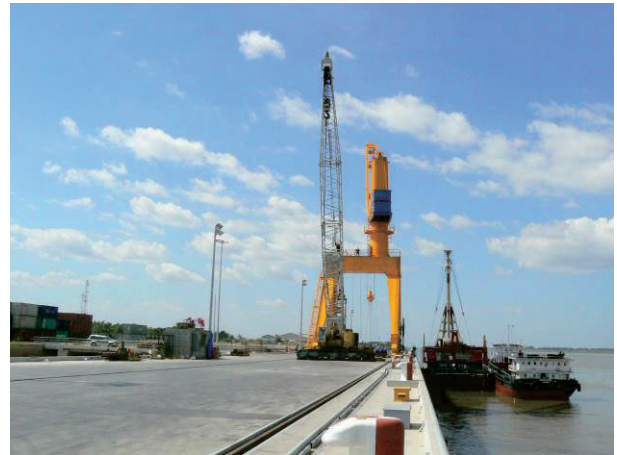
Fig. 6 New Port (Phnom Penh Port)

After installation of crane equipment, the cargo volume has been rapidly increased, particularly the port became to handle containers. The containerization has been rapidly spread taking the event of this project, as shown in the Fig.7 below, the latest handling volume is approximately 130,000TEU/year (2014).

Taking into account the rapid increase of the cargo volume, Port Authority has built a new port facilities at 30km downstream of Mekong River in 2013 (New Port). New Port is equipped with the rail-mounted quay gantry cranes which can handle both container and general cargoes.

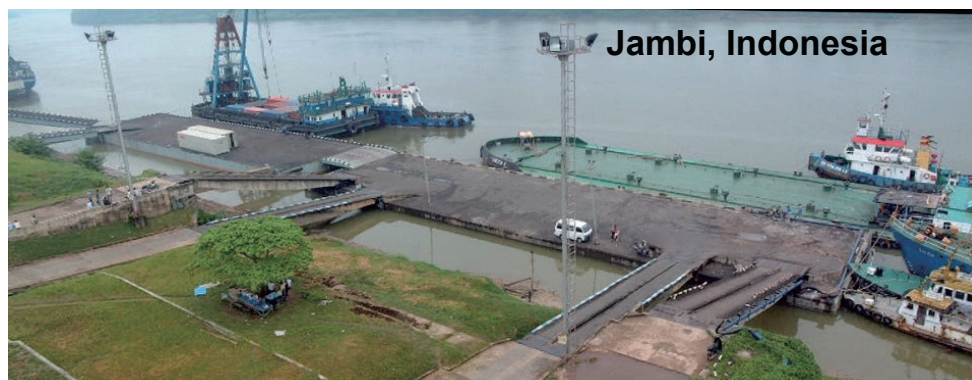
Fig 7. Jambi Port

Jetty of Jambi Port was designed as floating type in initial phase to accommodate 1,000 DWT barge (approx. L 40 m B 16 m D 2.5 m). Since initial opening of the port, there have been frequent damage and repairing at movable joints between bridge and floating jetty. In order to deal with the increasing cargo volume, the port constructed fixed type jetty to accommodate large vessels, while the initial floating type jetty is currently used for smaller vessels (up to 200 DWT).

- In order to achieve convenience in cargo handling under the conditions of large change in water levels of river port, floating type jetties were installed such as Jambi Port and Semeikhon Port. However, Jambi was required to carry out frequent repairing, while Semeikhon is still conducting remedial measures against siltation of the river. Both floating type jetty projects needed much effort for practical operation.
- Phnom Penh Port is one of the similar projects of Mandalay Port, where fixed type jetty was installed during transition period between primitive manual cargo handling and utilization of heavy equipment.

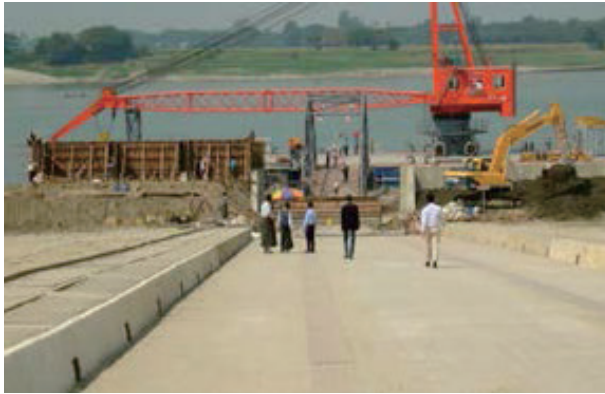
Fig 8. Semeikhon Port

The floating jetty was installed at the port in 2016. During flood season in 2016, the surrounding area of jetty was suffered from river siltation. A remedial measure against future siltation is under construction at present. It is needed to see the effect of remedial measure until full operation will be achieved.

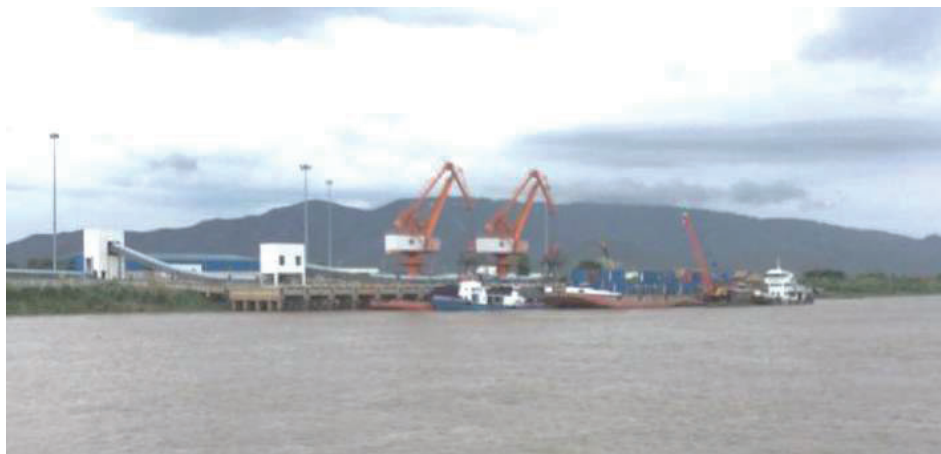
Fig. 9 Takaung Port

Takaung jetty was built for private nickel factory. The jetty is used for loading container cargoes enclosing nickel mine products. (Takaun jetty will be surveyed during the 2<sup>nd</sup> Field Survey scheduled in the end of April)
