THE PROJECT FOR CAPACITY ENHANCEMENT IN ROAD MAINTENANCE PHASE-II

Final Report

VOLUME 3.4: PHOTO ALBUM FOR ROAD FACILITY DEFECTS

March 2018

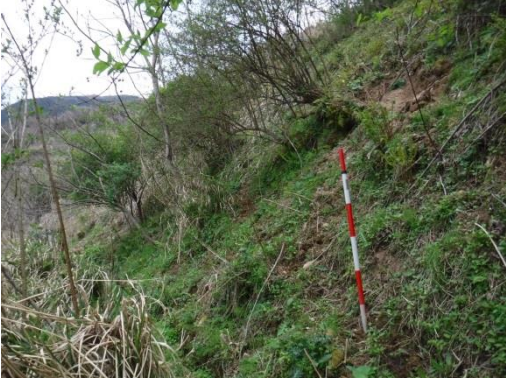
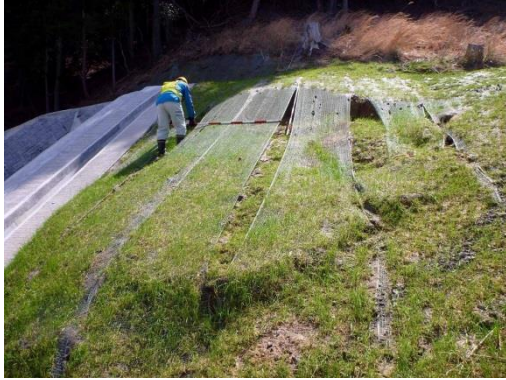
Element	Defect	Defect rating	Element	Defect	Defect rating
General slope	Collapse	C	General slope	Collapse	D
Local collapse of slope			Large-scale collapse of slope (repair work done)

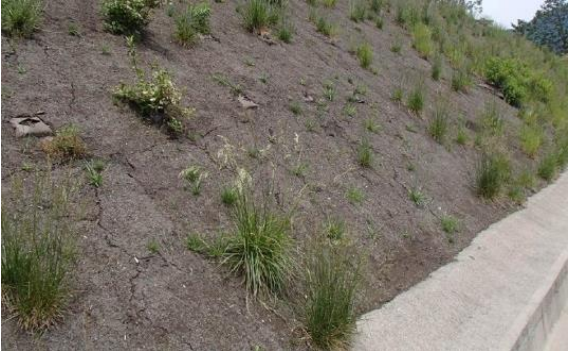
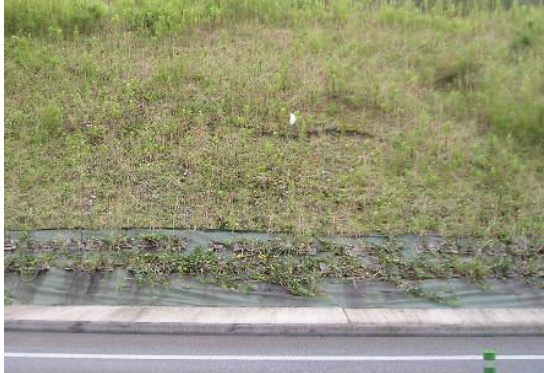
2.1.3 Cracks

Element	Defect	Defect rating	Element	Defect	Defect rating
General slope	Cracks	C	General slope	Cracks	D
Surface minor cracks			Deep cracks which may lead to slope failure

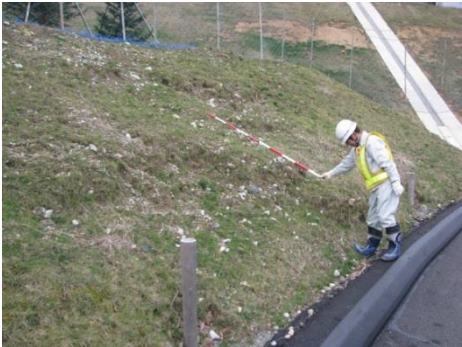
2.1.4 Swelling

Element	Defect	Defect rating	Element	Defect	Defect rating
General slope	swelling	C	General slope	swelling	D
Small-scale swelling

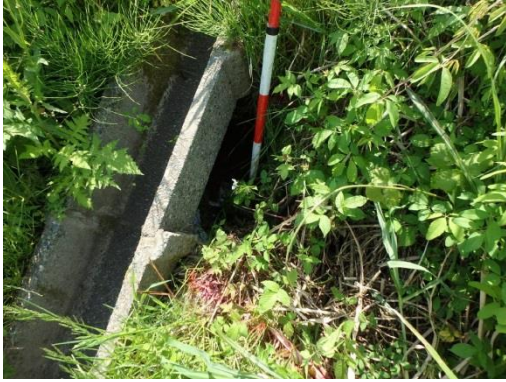
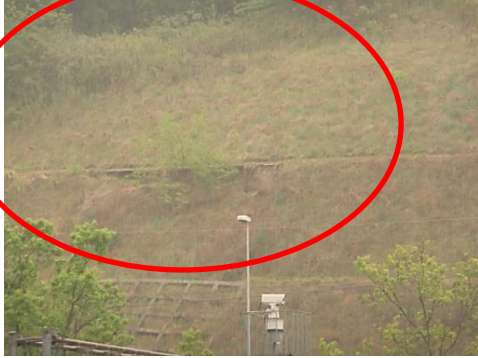
Element	Defect	Defect rating	Element	Defect	Defect rating
General slope	settlement	C	General slope	settlement	D
Small-scale settlement at the side of drainage			Large-scale settlement at the side of drain ditch on berm

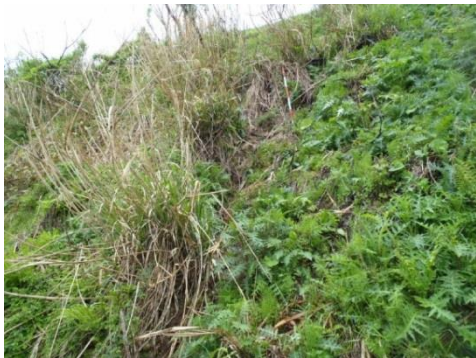
2.1.6 Surface Erosion

Element	Defect	Defect rating	Element	Defect	Defect rating
General slope	Surface erosion	C	General slope	Surface erosion	D
Narrow are surface erosion			Wide area surface erosion

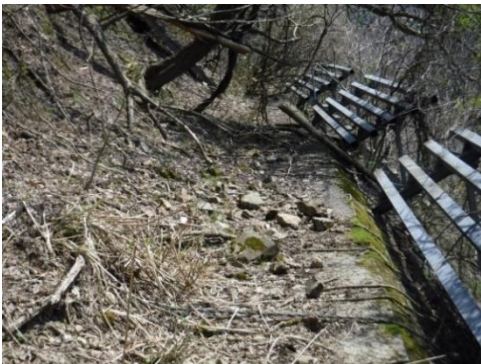
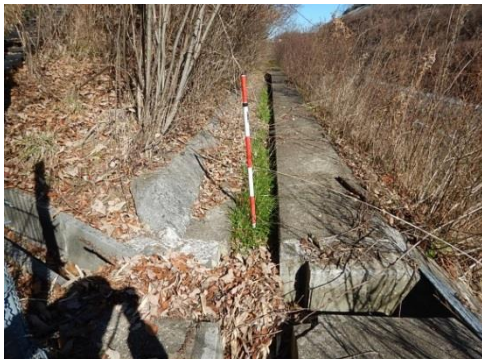
2.1.7 Piling of debris on slope steps

Element	Defect	Defect rating	Element	Defect	Defect rating
General slope	Piling of Debris on slope steps	B	General slope	Piling of Debris on slope steps	C
Small-scale piling of debris on slope steps			Deposits of soil and stone which do not hinder the drain ditch on berm

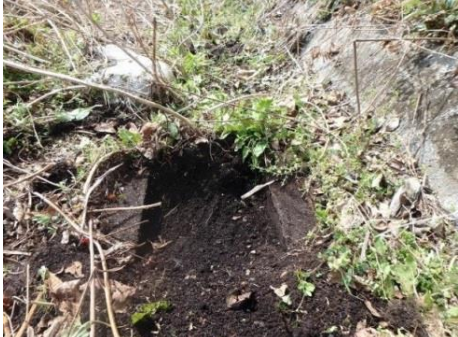
2.1.8 Piling of debris on Slope steps

Element	Defect	Defect rating	Element	Defect	Defect rating
General slope	Piling of Debris on slope steps	D			
Deposits of soil and stone hinder the drain ditch on berm

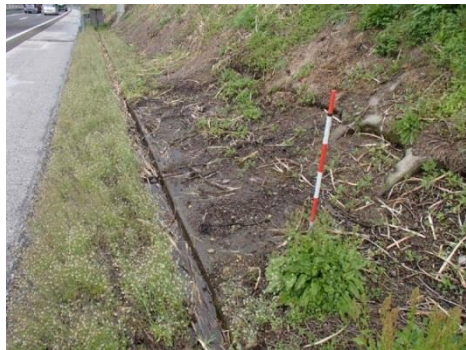
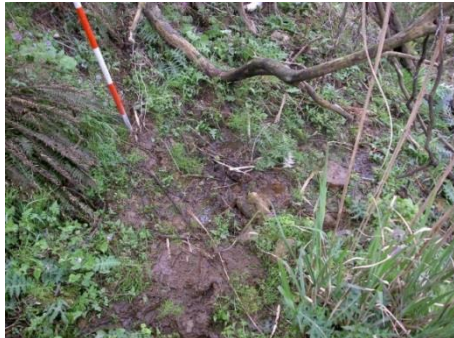
2.1.9 Spring water

Element	Defect	Defect rating	Element	Defect	Defect rating
General slope	Spring water	B	General slope	Spring water	C
Small amount of spring water on the slope			Some amount of spring water on the slope from limited range

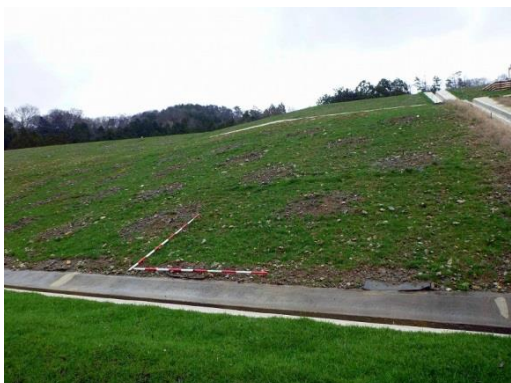
Element	Defect	Defect rating	Element	Defect	Defect rating
General slope	Spring water	D			
Much of spring water in entire slope when rain falls

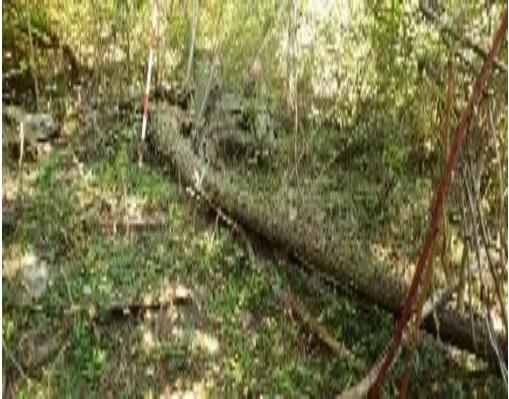
Element	Defect	Defect rating	Element	Defect	Defect rating
General slope	Tree fall	B	General slope	Tree fall	C
Weeds which overran a wide area of slopes			Fallen tree

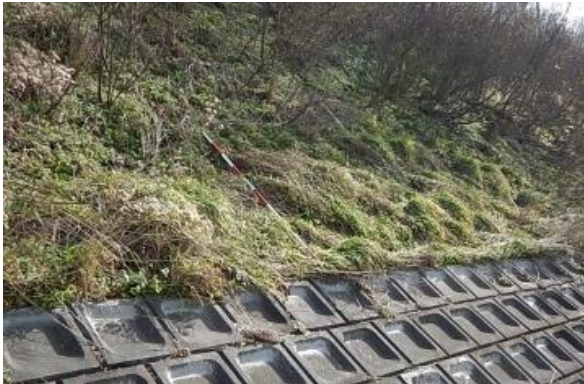
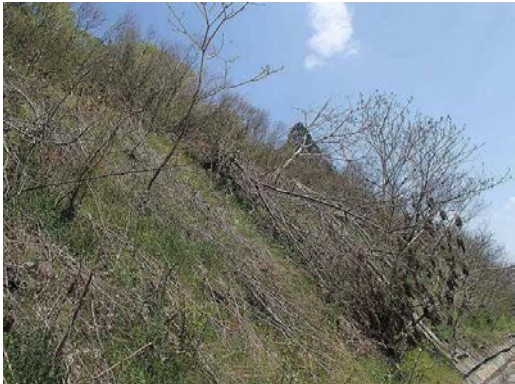
Element	Defect	Defect rating	Element	Defect	Defect rating
General slope	Plant death	B	General slope	Plant death	C
Lawn coverage more than 30% and less than 70%			Lawn coverage less than 30%

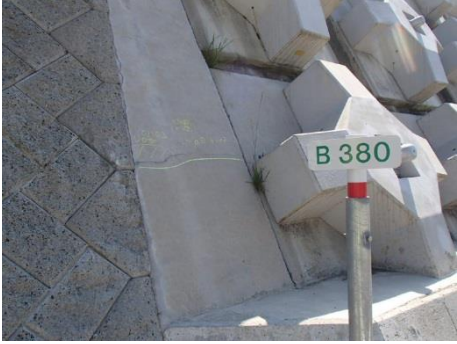
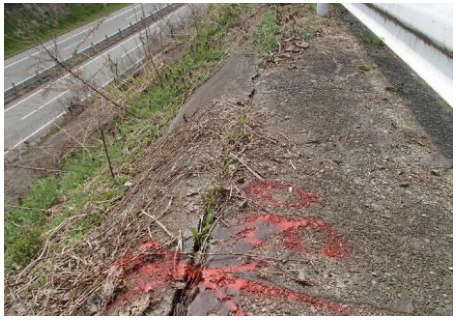
2.2.2 Cracks

Element	Defect	Defect rating	Element	Defect	Defect rating
Concrete frame (in Site/Precast)	Cracks	B	Concrete frame (in Site/Precast)	Cracks	C
Cracks which spread over part of the area			Cracks which widespread over the area.

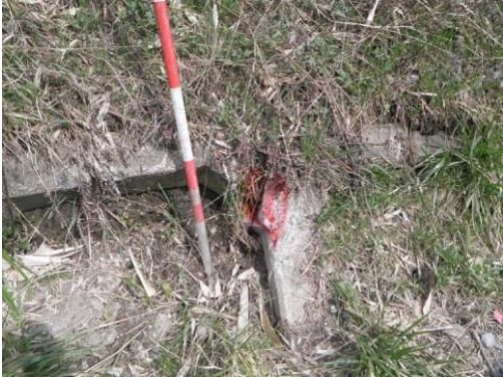
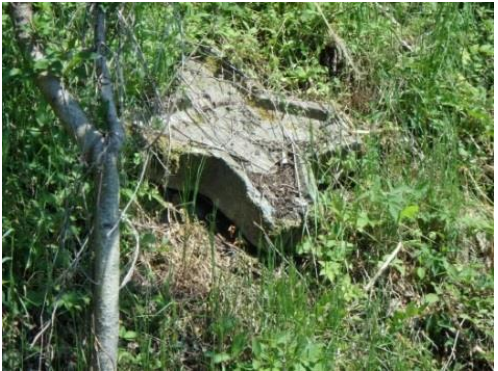
Element	Defect	Defect rating	Element	Defect	Defect rating
Concrete frame (in Site/Precast)	Peeling	B	Concrete frame (in Site/Precast)	Peeling	C
Concrete peeling which spread over part of the area.			Cracks or concrete peeling which widespread over the area.

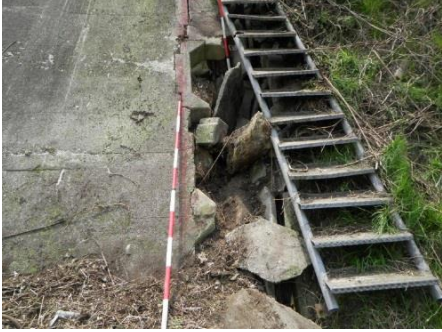
2.2.5 Peeling

Element	Defect	Defect rating	Element	Defect	Defect rating
Concrete frame (in Site/Precast)	Peeling	D			
Severe cracks or concrete peeling, which may cause falling of concrete or collapse

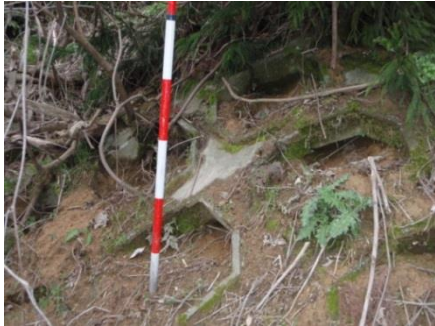
2.2.6 Looseness

Element	Defect	Defect rating	Element	Defect	Defect rating
Concrete frame (in Site/Precast)	Looseness	C	Concrete frame (in Site/Precast)	Looseness	D
Looseness is seen on the facilities.			Serious looseness is seen on the facilities which may lead to failures.

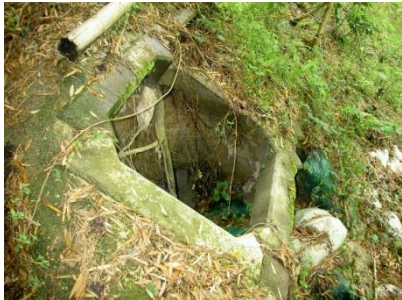
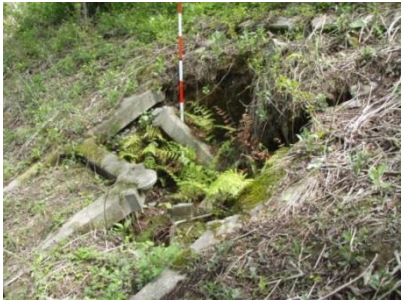
2.2.8 Settlement

Element	Defect	Defect rating	Element	Defect	Defect rating
Concrete frame (in Site/Precast)	Settlement	C	Concrete frame (in Site/Precast)	Settlement	D
Settlement is seen on the facilities.			Serious settlement is seen on the facilities which may lead to failures.

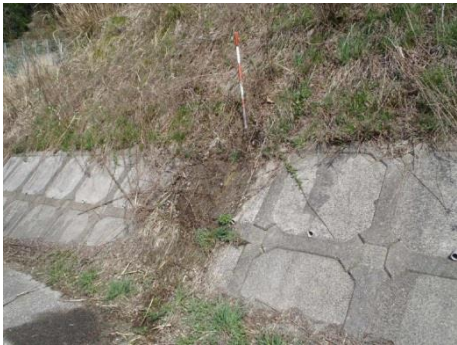
2.2.9 Spring water/ Drain Water

Element	Defect	Defect rating	Element	Defect	Defect rating
Concrete frame (in Site/Precast)	Spring water/ Drain water	B	Concrete frame (in Site/Precast)	Spring water/ Drain water	D
Spring water from facility joints			A large amount of spring water from facility joints and drain malfunction by drain pipes filled with soil which has high potential of causing slope failures.

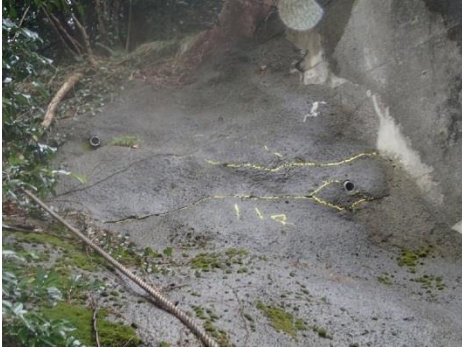
2.3.2 Cracks

Element	Defect	Defect rating	Element	Defect	Defect rating
Mortal spray/Concrete spray	Cracks	B	Mortal spray/Concrete spray	Cracks	C
Small cracks

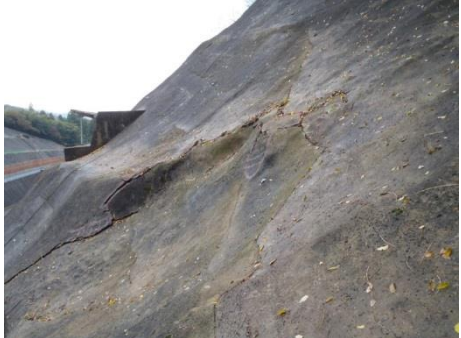
Cracks which may not lead to slope failures soon, but may lead to the failure in the long run

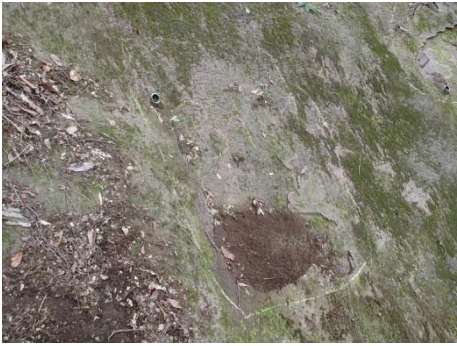
2.3.4 Peeling

Element	Defect	Defect rating	Element	Defect	Defect rating
Mortal spray/Concrete spray	Peeling	B	Mortal spray/Concrete spray	Peeling	C
Small peeling

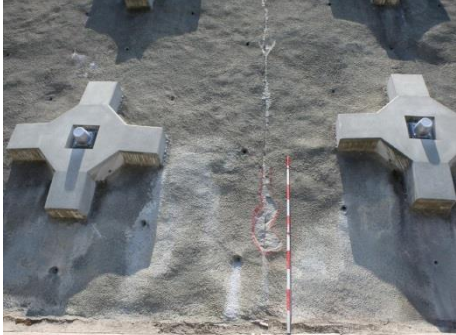
Peeling which may not lead to slope failures soon, but may lead to the failure in the long run.

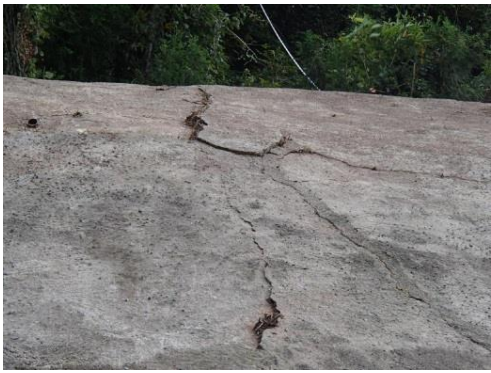
Element	Defect	Defect rating	Element	Defect	Defect rating
Mortal spray/Concrete spray	Loosening	B	Mortal spray/Concrete spray	Loosening	D
Slope edge push-out

Slope edge push-out at construction joints which may lead to slope failures.

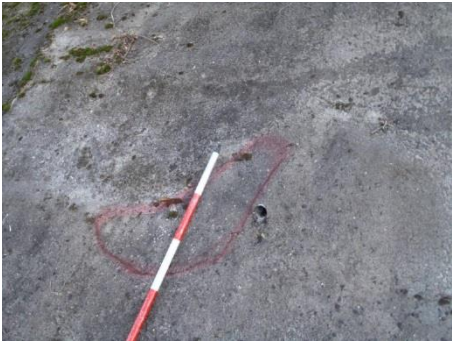
2.3.9 Voids

Element	Defect	Defect rating	Element	Defect	Defect rating
Mortal spray/Concrete spray	Voids	B			
Vids behind the surface concrete or mortar.

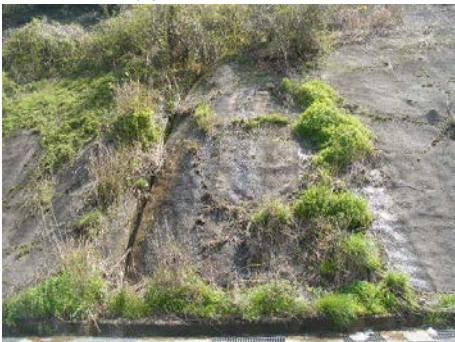
2.3.10 Spring water / drain water

Element	Defect	Defect rating	Element	Defect	Defect rating
Mortal spray/Concrete spray	Spring water/ Drain water	B	Mortal spray/Concrete spray	Spring water/ Drain water	D
Spring water from facility joints			A large amount of spring water from facility joints and drain malfunction by drain pipes filled with soil which has high potential of causing slope failures.

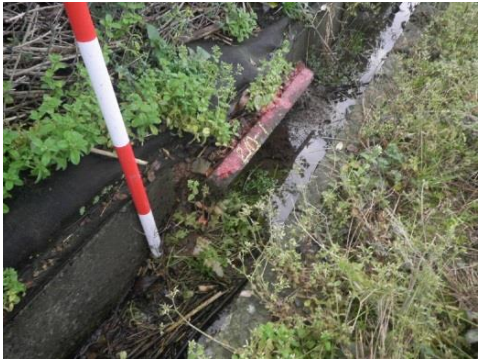
Element	Defect	Defect rating	Element	Defect	Defect rating
Drainage system	Damages to drainage body	C	Drainage system	Damages to drainage body	D
Medium damages of drainage systems which hinder drain functions.			Heavy damage of drainage systems which cause water overflow and rain infiltration

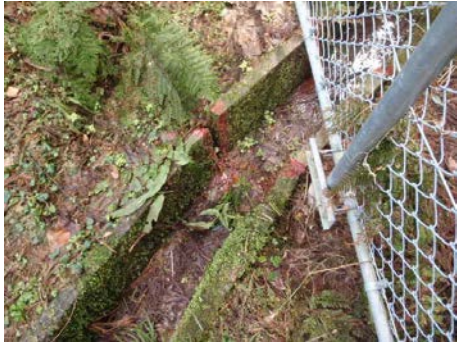
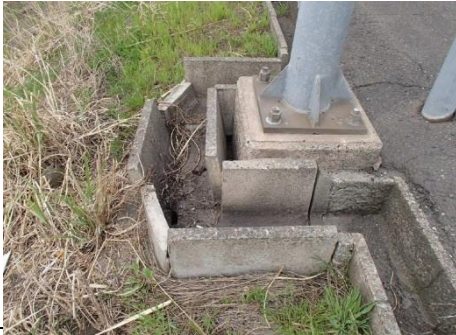
3.1.3 Improper drainage joints

Element	Defect	Defect rating	Element	Defect	Defect rating
Drainage system	Improper drainage joints	B	Drainage system	Improper drainage joints	D
Small water leakage which does not lead to slope failures.			Heavy damage of drainage joints which cause water leakage from joints and rain infiltration into slopes

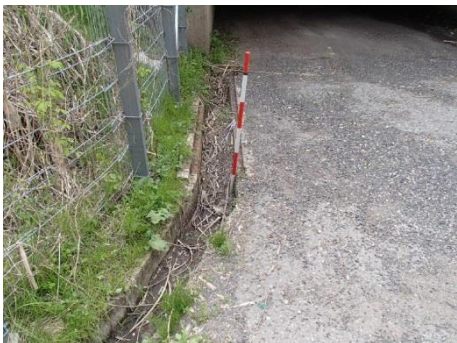
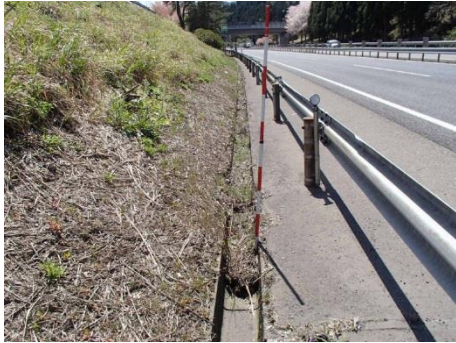
3.1.4 Debris / soil accumulation

Element	Defect	Defect rating	Element	Defect	Defect rating
Drainage system	Debris/ soil accumulation	B	Drainage system	Debris/ soil accumulation	C
Limited piling of soils and debris			Piling of soil and debris which hinder drain functions.

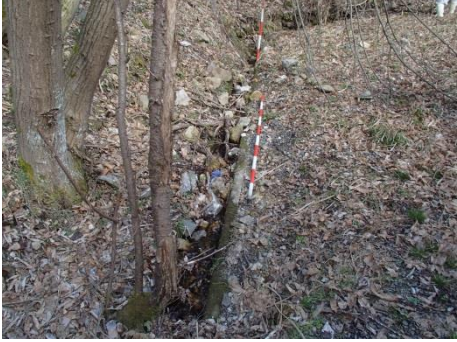
3.1.5 Debris / soil accumulation

Element	Defect	Defect rating	Element	Defect	Defect rating
Drainage system	Debris/ soil accumulation	D			
Large piling of soil and debris

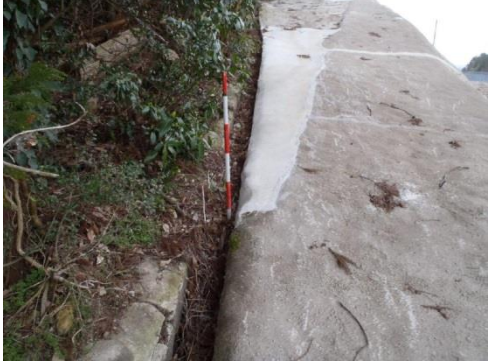
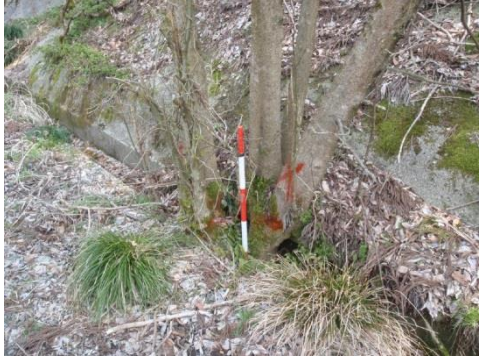
Element	Defect	Defect rating	Element	Defect	Defect rating
Drainage system	Hindrance of drain function by weeds	B	Drainage system	Hindrance of drain function by weeds	D
Small hindrance of drain functions			Heavy hindrance of drain function by weed

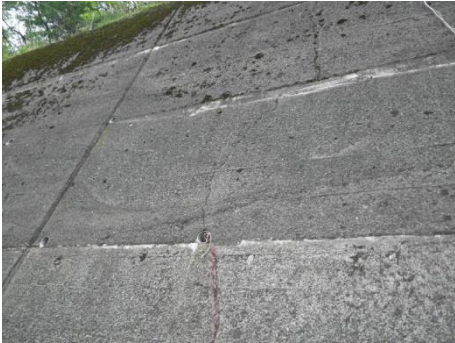
4.1.2 Cracks / Corner

Element	Defect	Defect rating	Element	Defect	Defect rating
Retaining wall	Cracks/ corner	B	Retaining wall	Cracks/ corner	C
Small cracks running parallel with wide gaps which do not reach inner steel bars.

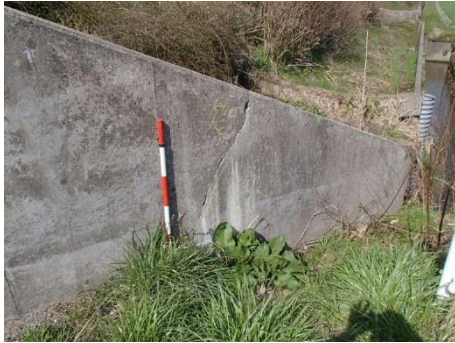
Small cracks running parallel with narrow gaps which reach inner steel bars.

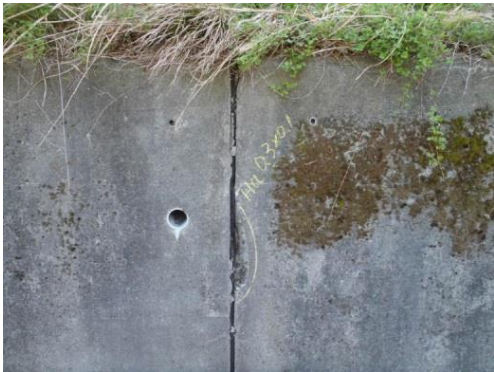
Element	Defect	Defect rating	Element	Defect	Defect rating
Retaining wall	Concrete Peeling	B	Retaining wall	Concrete Peeling	C
Partial peeling

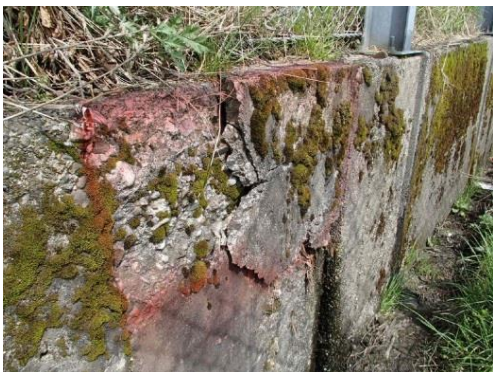
Extensive concrete peeling or creep

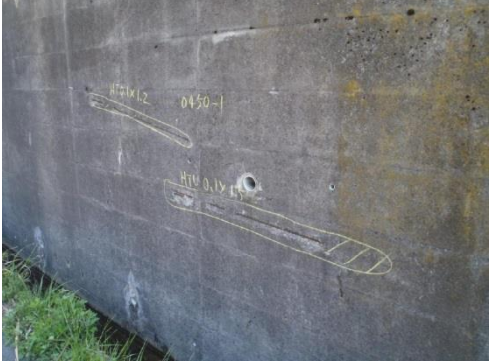
4.1.5 Steel bar exposure and corrosion

Element	Defect	Defect rating	Element	Defect	Defect rating
Retaining wall	Steel bar exposure and corrosion	B	Retaining wall	Steel bar exposure and corrosion	C
Partial steel bar exposure

Severe steel bar exposure with the progress of corrosion.

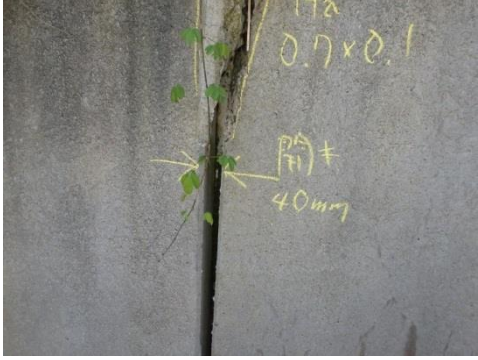
Element	Defect	Defect rating	Element	Defect	Defect rating
Retaining wall	Damages on structural joints	B	Retaining wall	Damages on structural joints	C
Joint gaps, but they do not lead to collapse.

Joint gaps which do not lead to collapse soon, but lead to collapse in the long run.

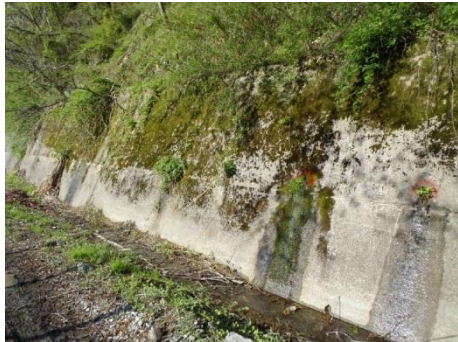
4.1.12 Drainage / spring water

Element	Defect	Defect rating	Element	Defect	Defect rating
Retaining wall	Drainage / spring water	B	Retaining wall	Drainage / spring water	D
<p>Spring water from facility joints, but they do not lead to slope failures.</p>			<p>A large amount of spring water from facility joints and drain malfunction by drain pipes filled with soil which has high potential of causing slope failures.</p>

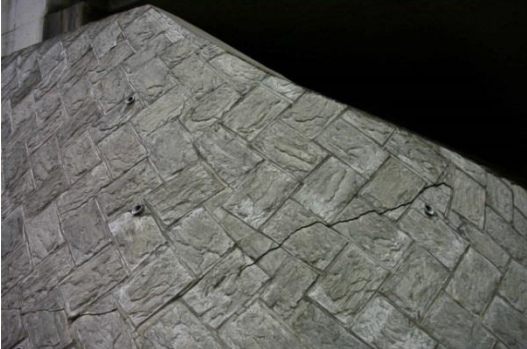
Element	Defect	Defect rating	Element	Defect	Defect rating
Retaining wall	Cracks/ Swelling	B	Retaining wall	Cracks/ Swelling	C
Small cracks running parallel with wide gaps which do not reach inner steel bars.

Small cracks running parallel with narrow gaps which reach inner steel bars.

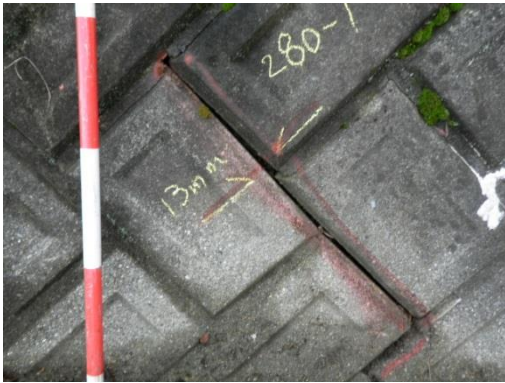
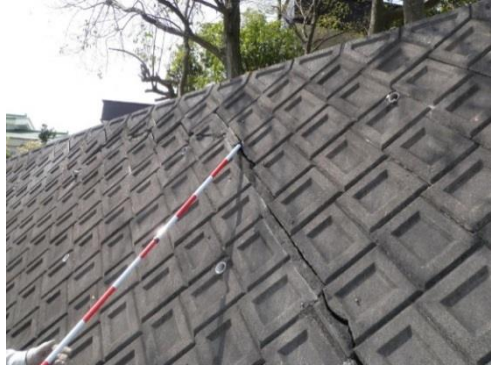
Element	Defect	Defect rating	Element	Defect	Defect rating
Retaining wall	Abnormal joint gap	B	Retaining wall	Abnormal joint gap	C
Joint gaps, but they do not lead to collapse.			Joint gaps which do not lead to collapse soon, but lead to collapse in the long run.

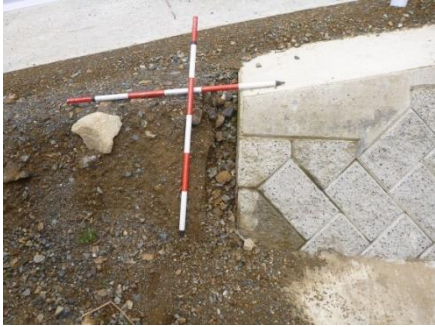
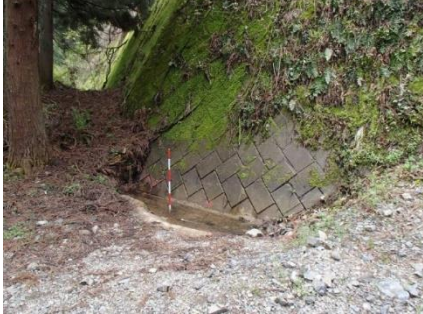
5.1.8 Scouring

Element	Defect	Defect rating	Element	Defect	Defect rating
Retaining wall	Scouring	B	Retaining wall	Scouring	C
Scouring around the main body, but they do not lead to collapse.			Scouring around the foundation which do not lead to collapse soon, but lead to collapse in the long run.

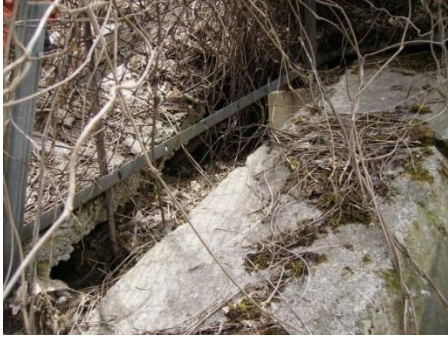
5.1.9 Scouring

Element	Defect	Defect rating	Element	Defect	Defect rating
Retaining wall	Scouring	D			
Severe scouring around the main body which may lead to collapse

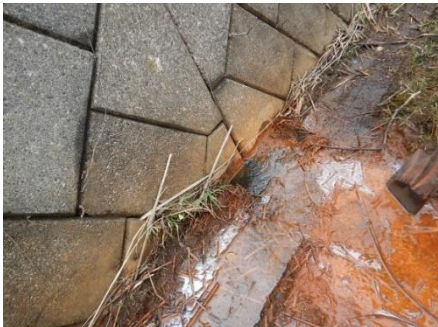
5.1.10 Poor drainage and spring water

Element	Defect	Defect rating	Element	Defect	Defect rating
Retaining wall	Poor drainage and spring water	B	Retaining wall	Poor drainage and spring water	D
Spring water from facility joints, but they do not lead to slope failures.			A large amount of spring water from facility joints and drain malfunction by drain pipes filled with soil which has high potential of causing slope failures.

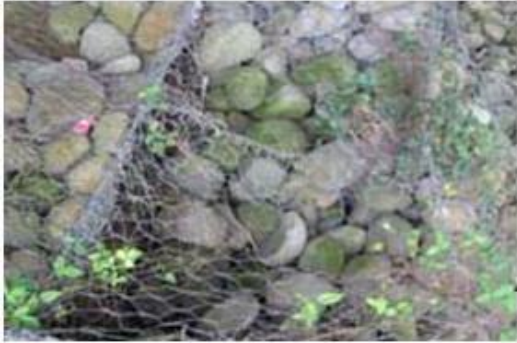
Element	Defect	Defect rating	Element	Defect	Defect rating
Retaining wall	Wire corrosion and rupture	B	Retaining wall	Wire corrosion and rupture	C
Wire corrosion and rupture, but stones for filling do not outflow			Wire corrosion and rupture which may lead to outflow of stones for filling

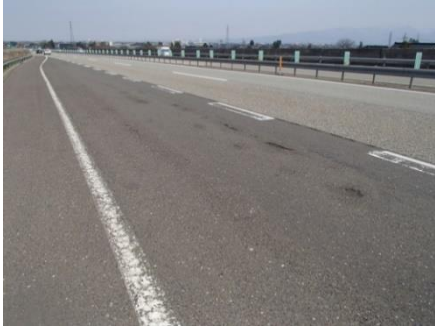
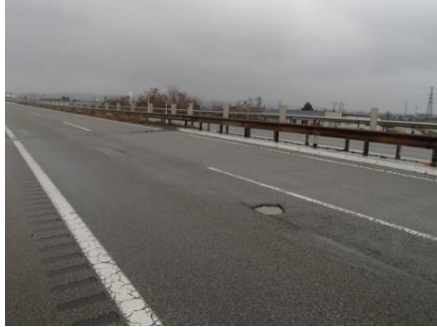
7.1.2 Pot holes/ Peeling/ Depressions

Element	Defect	Defect rating	Element	Defect	Defect rating
Asphalt road pavement	Pot holes/ Peeling/ Depressions	C	Asphalt road pavement	Pot holes/ Peeling/ Depressions	D
20 cm-40cm in diameter or 30 mm-40 mm in depth			Over 40 cm in diameter or Over 40 mm in depth.

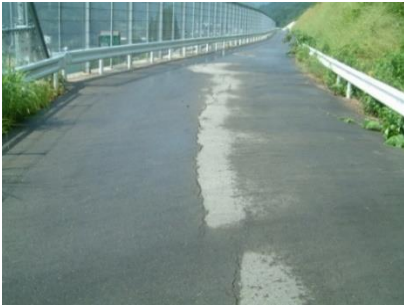
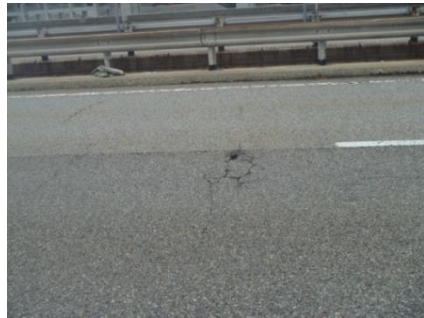
7.1.3 Crack ratio

Element	Defect	Defect rating	Element	Defect	Defect rating
Asphalt road pavement	Crack ratio	B	Asphalt road pavement	Crack ratio	C
Crack ratio : 10% - 30%			Crack ratio : 30% - 40%

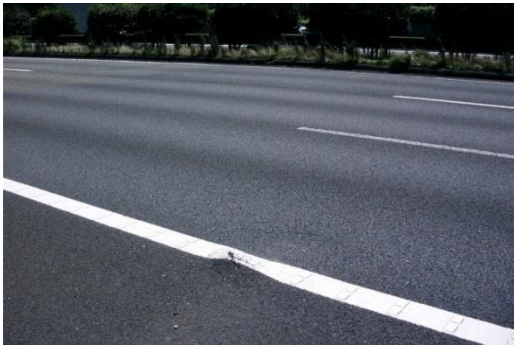
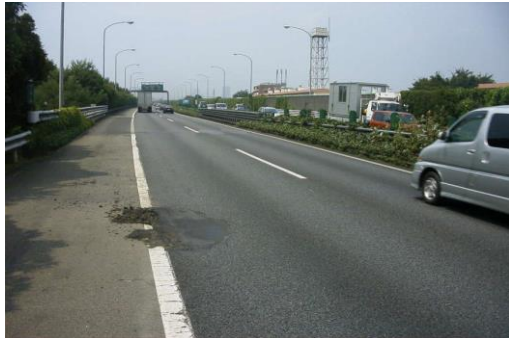
Element	Defect	Defect rating	Element	Defect	Defect rating
Asphalt road pavement	Corrugations	C	Asphalt road pavement	Corrugations	D
Surface level difference 10 mm – 30 mm			Pavement width less than design lane width or Surface level difference over 30mm.

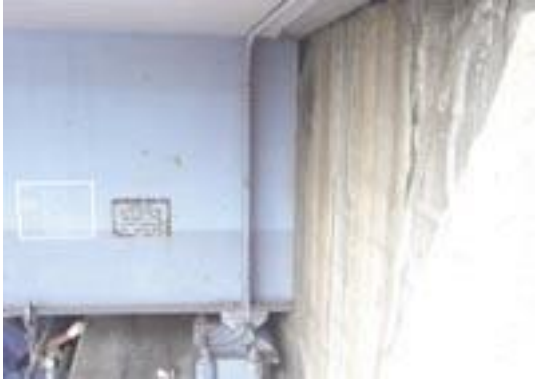
Element	Defect	Defect rating	Element	Defect	Defect rating
Entire bridge	Settlement, Movement	C	Entire bridge	Settlement, Movement	D
<p>An abutment tilling forward a little.</p>

<p>A girder end touching to the parapet wall of the abutment due to movement of the abutment.</p>

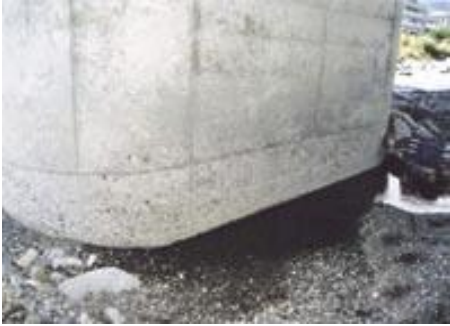
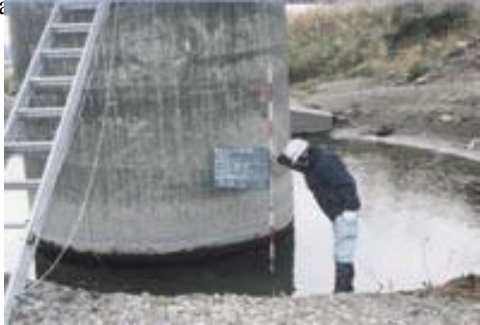
8.2.3 Scouring

Element	Defect	Defect rating	Element	Defect	Defect rating
Pier	Scouring	C	Pier	Scouring	C
Gravel/soil at surrounding area of the pier was washed away.			Gravel soil at surrounding area of the pier was washed away.

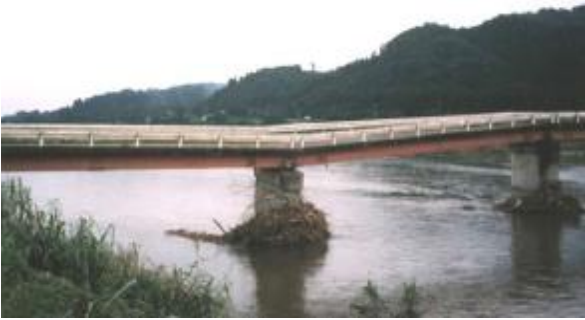
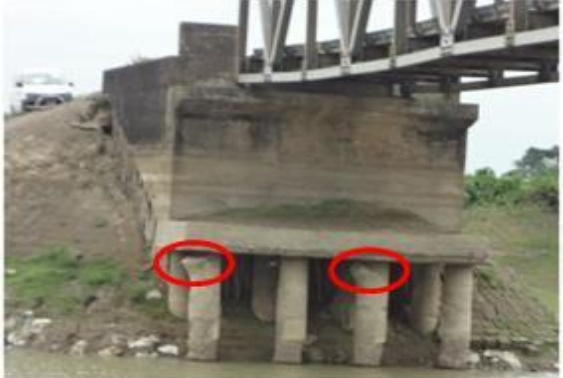
Element	Defect	Defect rating	Element	Defect	Defect rating
Pier	Settlement due to scouring	D	Abutment	Tilting and exposure of piles	D
A pier sank seriously due to scouring.			An abutment tilted and piles exposed due to serious scouring.

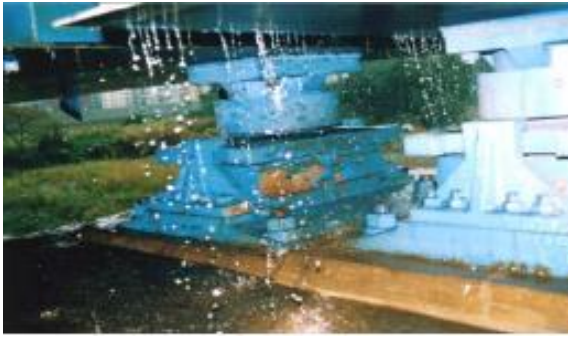
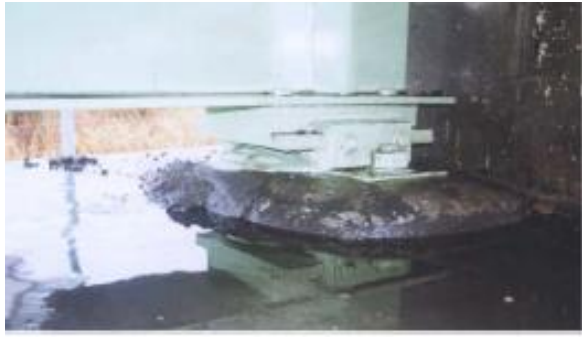
Element	Defect	Defect rating	Element	Defect	Defect rating
Expansion joint	Water leakage, Puddling	B	Bearing shoe bed	Water leakage, Puddling	C
Leaking water from expansion joint on rainy days.			Puddling water on the bearing shoe bed regardless of weather condition.

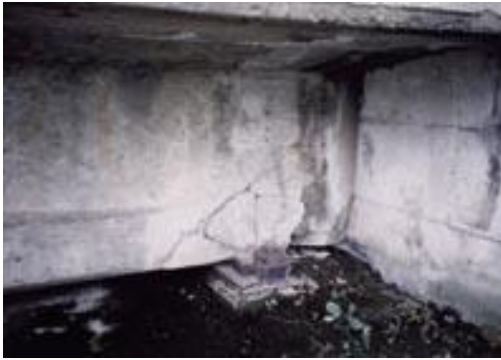
Element	Defect	Defect rating	Element	Defect	Defect rating
Concrete girder	Crack	B	Concrete girder	Crack	C
Small cracks extending vertically or diagonally near bearings			Large crack on the bearing due to load concentration.

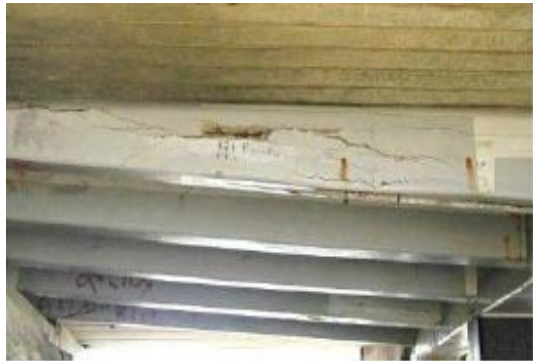
Element	Defect	Defect rating	Element	Defect	Defect rating
Concrete girder	Crack	B	Concrete girder	Crack	C
Small cracks are observed on the lower flange or the web of a main girder.			Large longitudinal crack at the web of the girder with rusty fluid due to rebar corrosion.

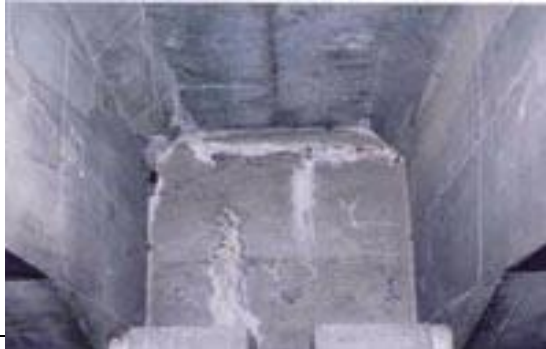
Element	Defect	Defect rating	Element	Defect	Defect rating
Concrete Cross beam, Diaphragm	Crack	B	Concrete Cross beam, Diaphragm	Crack	C
Cracks at long intervals do not reached to rebar depth			Large crack on the diaphragm with free lime.

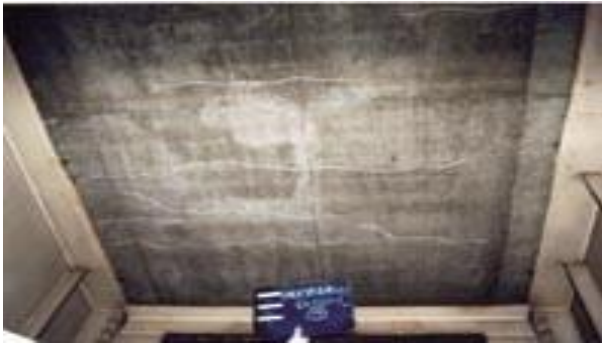
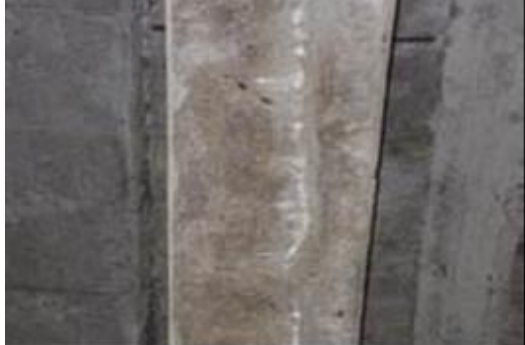
8.4.1.16 Concrete Deck slab

Element	Defect	Defect rating	Element	Defect	Defect rating
Concrete Deck slab	Crack	B	Concrete Deck slab		C
One direction crack on a concrete deck slab due to drying shrinkage.			Large transverse crack at the bottom of the girder with free lime.

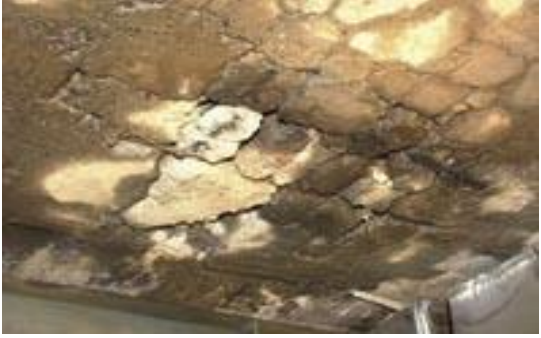
8.4.1.17 Concrete Deck slab

Element	Defect	Defect rating	Element	Defect	Defect rating
Concrete Deck slab	Crack	D			
Crocodile crack losing sheering strength and become concrete blocks. These will drop at anytime.

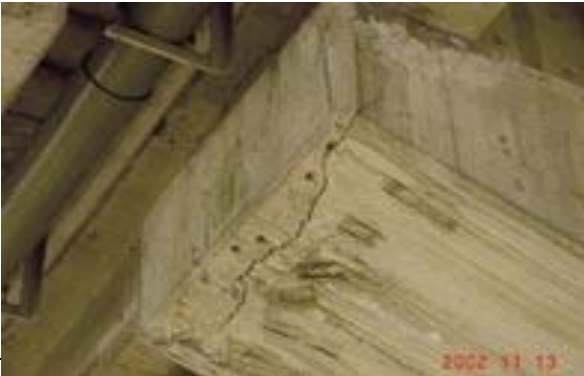
Element	Defect	Defect rating	Element	Defect	Defect rating
Pier column/Pier head beam	Crack	B	Pier column/Pier head beam	Crack	C
Crack at long intervals do not reached to rebar depth			Large crack at under bearing shoe of a pier head.

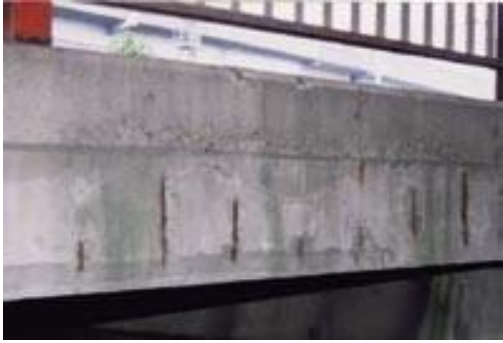
Element	Defect	Defect rating	Element	Defect	Defect rating
Deck slab	Rebar exposure, Corrosion	B	Girder	Rebar exposure, Corrosion	B
Rebars exposing on a web area of girder due to lack of concrete cover for stirrup rebars.

Stirrup rebars and election rebars exposing at a bottom of a pier head beam due to lack of concrete cover.

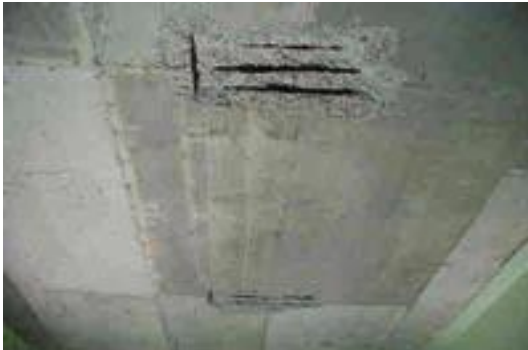
Element	Defect	Defect rating	Element	Defect	Defect rating
Deck slab	Rebar exposure, Corrosion	C	Pier head beam	Rebar exposure, Corrosion	C
Peeling concrete and rebars exposing with rusting.

Peeling concrete at the bottom of a pier head and exposed rebars are rusting.

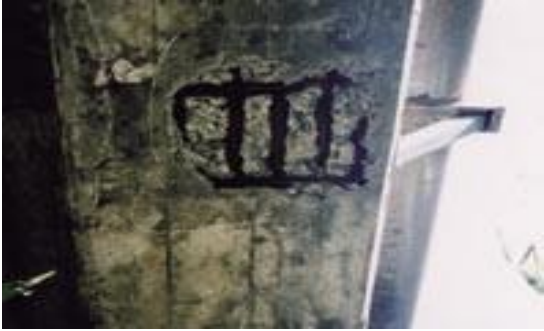
Element	Defect	Defect rating	Element	Defect	Defect rating
Deck slab	Rebar exposure, Corrosion	C	Abutment wall	Rebar exposure, Corrosion	C
Exposed rebars due to peeling of concrete. Area is not large however corrosion progress is serious.

Exposed rebars rusted in wide area.

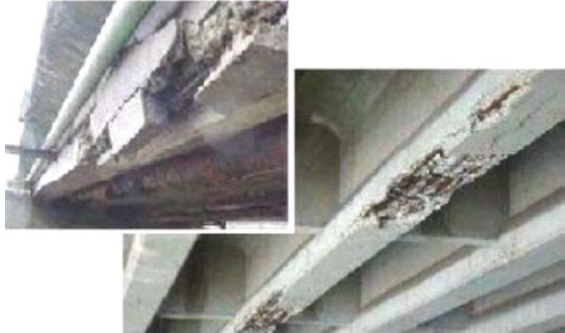
Element	Defect	Defect rating	Element	Defect	Defect rating
Concrete girder	Rebar exposure, Corrosion	D			
<p>Spalling concrete due to expanding rebar area caused by severe corrosion.</p>

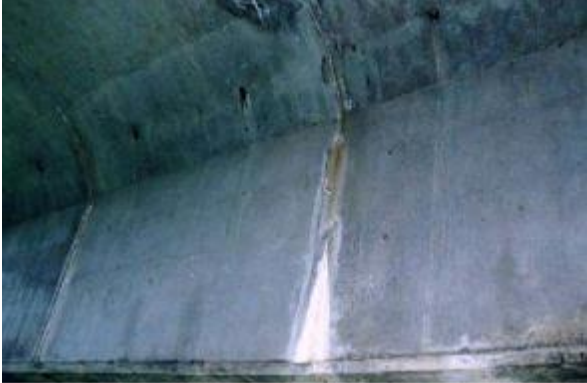
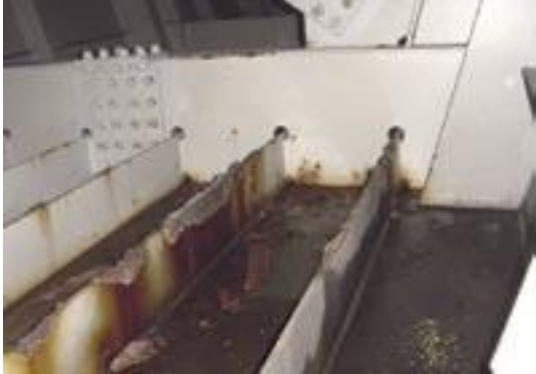
Element	Defect	Defect rating	Element	Defect	Defect rating
Concrete girder	Water leakage, Paddling	B	Steel girder	Water leakage, Paddling	C
Trace of water leakage with free lime at the segment junction of girder during raining.			Leaked water puddle at corner of inside of box section steel girder regardless of weather.

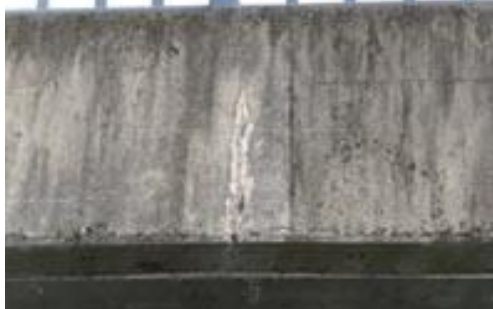
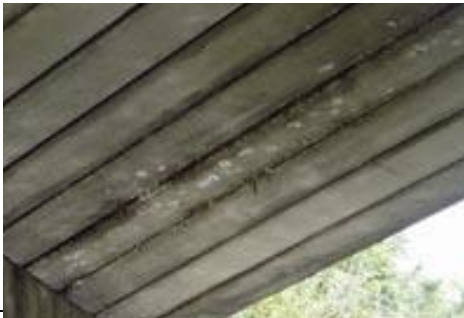
8.4.5.3 Free lime

Element	Defect	Defect rating	Element	Defect	Defect rating
Deck slab	Free lime	B	Girder	Free lime	B
Free lime from construction joint of cantilever slab.			Free lime from a joint of filling concrete between girders.

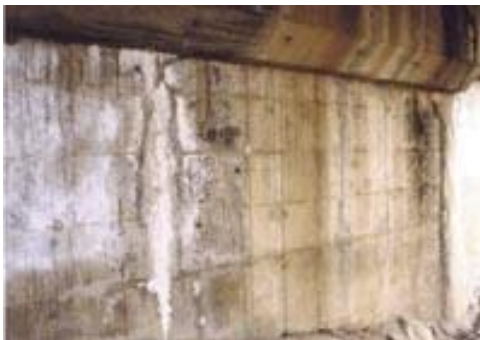
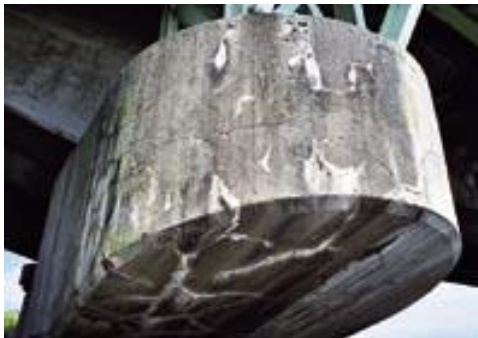
8.4.5.4 Free lime

Element	Defect	Defect rating	Element	Defect	Defect rating
Deck slab, Abutment and Wing wall, Pier and Pier head, Foundation	Free lime	C	Deck slab, Abutment and Wing wall, Pier and Pier head, Foundation	Free lime	C
Free lime from crack of an abutment wall. Rusty fluid is not confirmed.			Free lime from a pier head beam near shoe. It is anticipated some of cracks due to concentrated load from shoe.

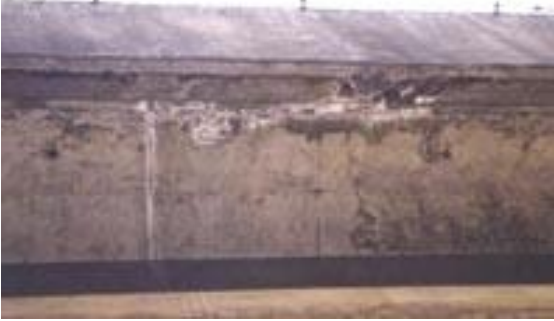
Element	Defect	Defect rating	Element	Defect	Defect rating
Concrete girder	Rusty fluid	B	Concrete girder	Rusty fluid	C
Rusty fluid with free lime from bottom of the girder.

Serious rusty fluid is observed, in particular, from rebars or PC cables.

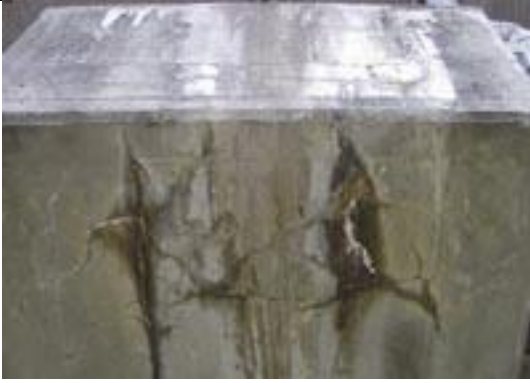
Element	Defect	Defect rating	Element	Defect	Defect rating
Pier head beam	Rusty fluid	B	Pier head beam	Rusty fluid	C
Some water leakage and rusty fluid are observed			Rusty fluid come from cracks at a bottom of pier head beam

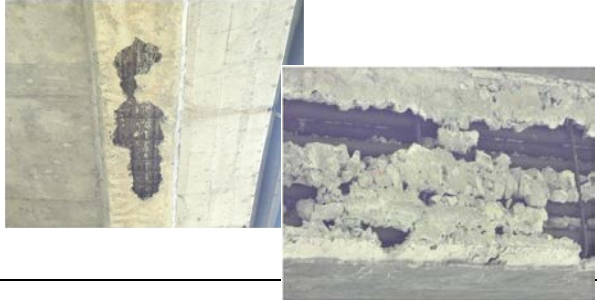
Element	Defect	Defect rating	Element	Defect	Defect rating
Concrete girder, Cross beam, Diaphragm	Honey comb, Void	B	Above structures	Honey comb, Void	C
Some of honey-combs and voids are observed, but not many			Large honey comb at the bottom of the girder due to inadequate compaction of concrete during concrete placing work.

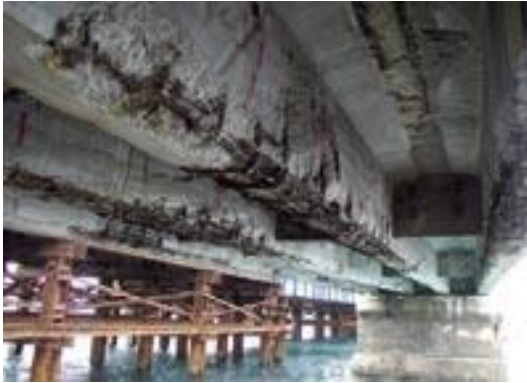
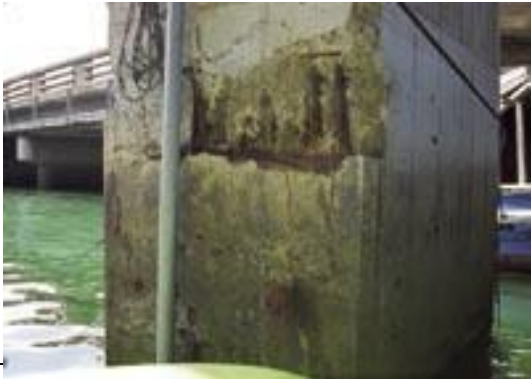
Element	Defect	Defect rating	Element	Defect	Defect rating
Girder	Chemical (Salt) attack	C/(D)	Pier column	Chemical (Salt) attack	C/(C)
Large area of spalling caused by expansion of rebar diameter due to serious corrosion by salt attack to girders above sea water. (Rating of Chemical attack is “C”, and rating of Rebar exposure/Spalling concrete is “D”)			Spalling of pier column concrete caused by expansion of rebar diameter due to serious corrosion by salt attack. (Rating of Chemical attack is “C”, and rating of Rebar exposure/Spalling concrete is “C”)

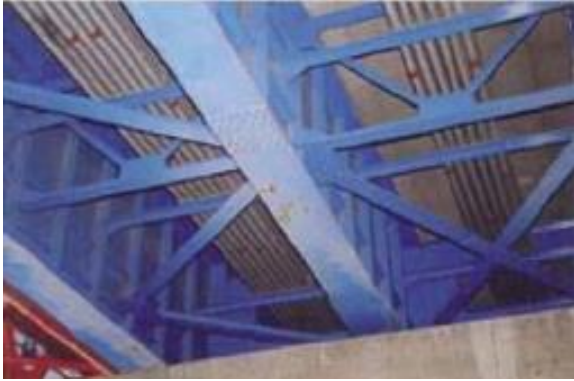
Element	Defect	Defect rating	Element	Defect	Defect rating
Girder	Deterioration of paint	B	Girder	Deterioration of paint	B
Partial rust appear due to over aged paint.

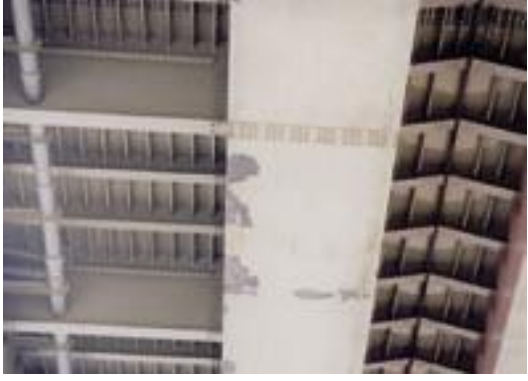
Partial paint peeling at bottom of a lower flange.

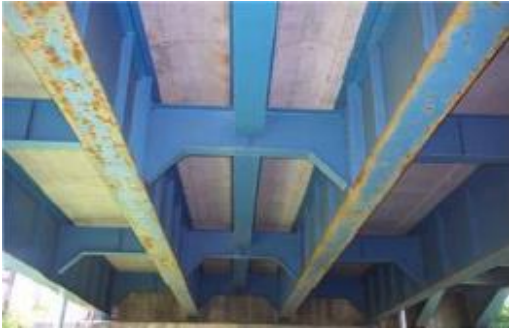
8.5.1.3 Girder

Element	Defect	Defect rating	Element	Defect	Defect rating
Girder	Deterioration of paint	C	Girder	Deterioration of paint	C
Rust is spreading whole area of the lower flange of girder.

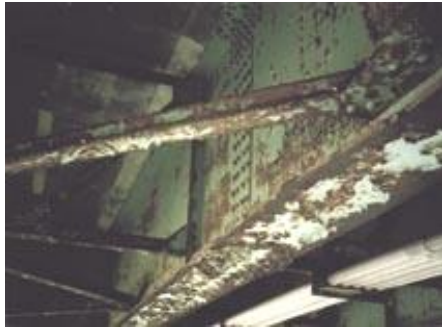
Rusting widely spreading due to deterioration of paint.

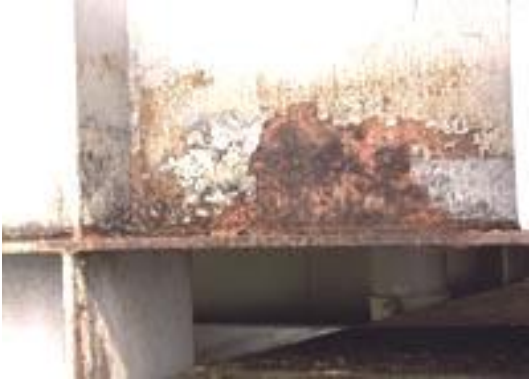
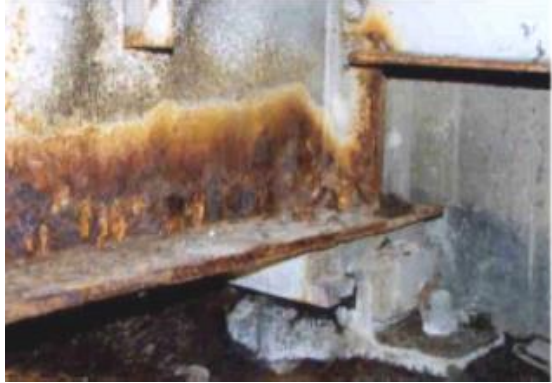
Element	Defect	Defect rating	Element	Defect	Defect rating
Girder	Corrosion	B	Girder	Corrosion	C
Reduction of thickness of the lower flange and web plate partially due to severe corrosion.			Reduction of thickness of the lower flange and web plate widely due to severe corrosion.

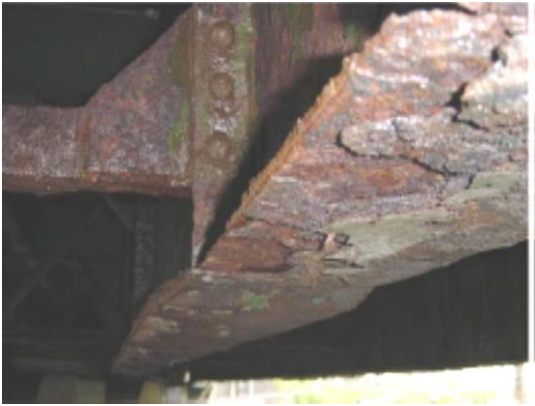
8.5.2.3 Steel girder, Truss member, Arch member and Steel pier

Element	Defect	Defect rating	Element	Defect	Defect rating
Girder	Corrosion	D			
The lower flange and other member lost section seriously due to heavy corrosion.

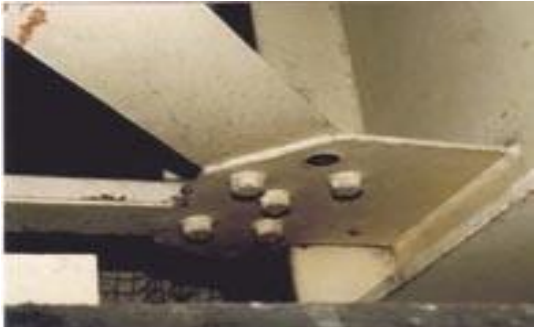
Element	Defect	Defect rating	Element	Defect	Defect rating
Bracing	Loosen and fallen of bolt	B			
One missing bolt-nut at a connection point.

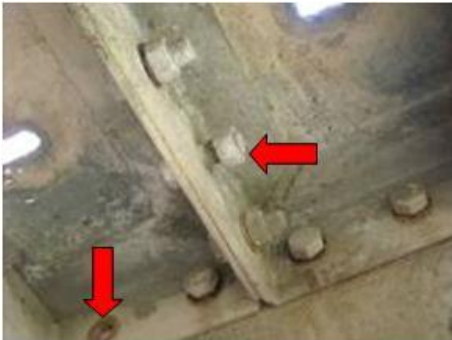
8.5.3.3 Steel girder, Truss member, Arch member and Steel pier, Steel cross beam, Stringer, Diaphragm

Element	Defect	Defect rating	Element	Defect	Defect rating
Girder	Loosen and fallen of bolt	C	Girder	Loosen and fallen of bolt	C
1 nut losing and 1 bolt-nut missing.

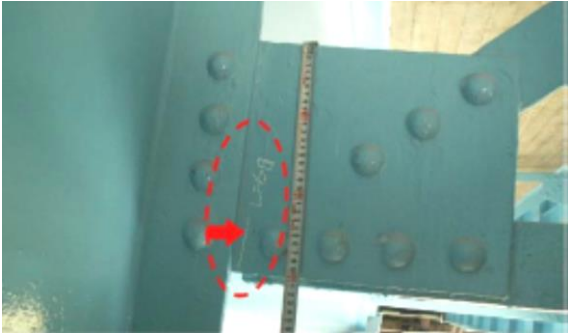
Element	Defect	Defect rating	Element	Defect	Defect rating
Gusset plate for bracing	Crack	C	Pier head beam	Crack	C
Crack at the welding portion with gusset plate for bracing.			Progressing crack at welding portion of rounding corner of steel pier head.
