THE PROJECT FOR CAPACITY ENHANCEMENT IN ROAD MAINTENANCE PHASE-II

Final Report

VOLUME 3.4: PHOTO ALBUM FOR ROAD FACILITY DEFECTS

March 2018

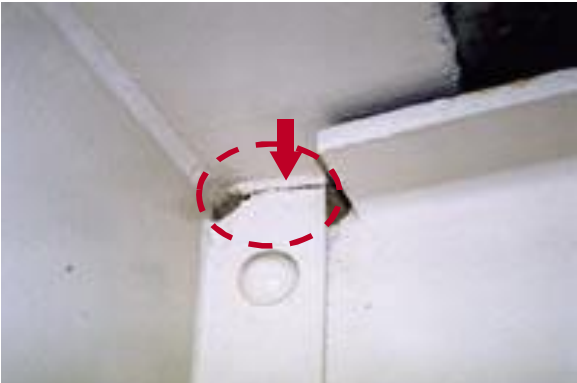
8.5.4.15 Cross beam, Stringer, Diaphragm

Element	Defect	Defect rating	Element	Defect	Defect rating
Girder	Crack	C			
Crack at the welding portion with vertical stiffener.

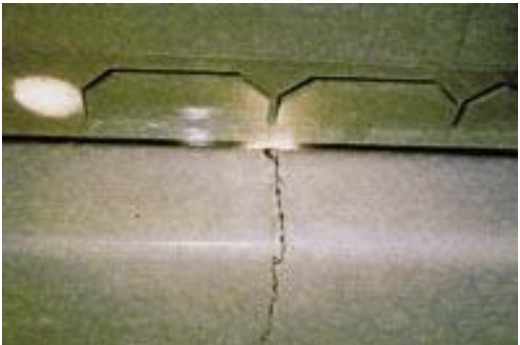
8.5.4.16 Cross beam, Stringer, Diaphragm

Element	Defect	Defect rating	Element	Defect	Defect rating
Vertical stiffener	Crack	D	U section stiffener for steel deck	Crack	D
Crack reaches to the steel deck plate from welding portion.			Full length of crack at the bud welding portion of the U section stiffener for steel deck plate.

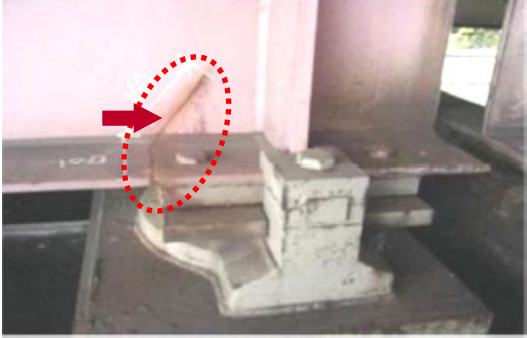
8.5.4.17 Cross beam, Stringer, Diaphragm

Element	Defect	Defect rating	Element	Defect	Defect rating
Girder	Crack	D			
Crack at the lower flange above the sole plate reaches to the web plate.

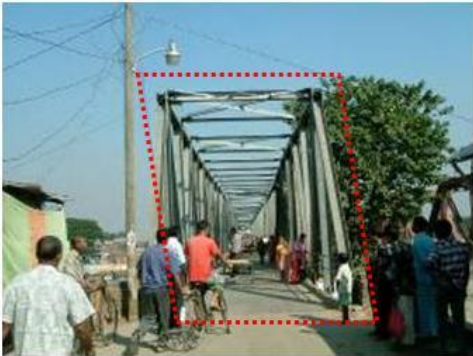
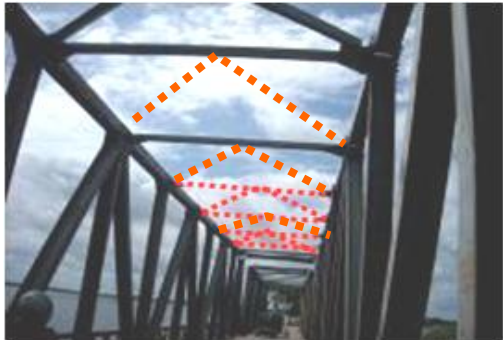
8.5.5.3 All steel structures

Element	Defect	Defect rating	Element	Defect	Defect rating
Truss frame	Deformation and buckling	C	Upper lateral bracing	Deformation and buckling	C
Truss frame tilting significantly due to settlement of substructure.			Missing of upper lateral bracing members by collision of tall vehicle.

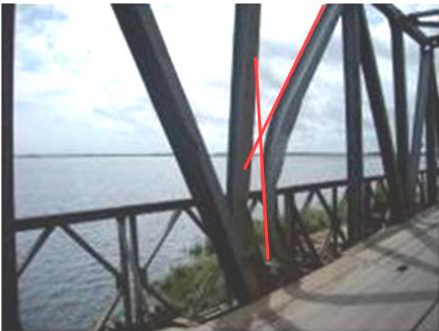
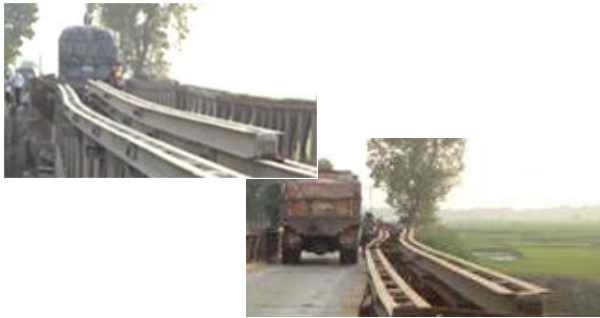
8.5.5.4 All steel structures

Element	Defect	Defect rating	Element	Defect	Defect rating
Diagonal member of truss	Deformation and buckling	C	Bailey bridge	Deformation and buckling	C
Deformation of a diagonal member due to vehicle collision.			Horizontal deformation due to over load. Vehicle weight shall be controlled.

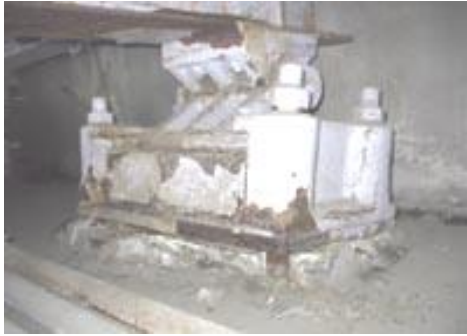
8.6.1.2 Breakage, Crack of bearing shoe body

Element	Defect	Defect rating	Element	Defect	Defect rating
Bearing shoe body	Breakage, Crack of bearing shoe body	B	Bearing shoe body	Breakage, Crack of bearing shoe body	C
Movement or rotation function slight malfunction			Breakage of a bearing shoe which will no longer support load.

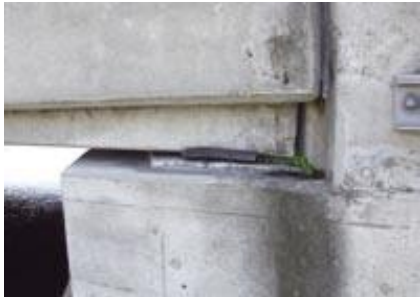
8.6.1.4 Deterioration of rubber (Loose of elastic, deformation, spalling, blister)

Element	Defect	Defect rating	Element	Defect	Defect rating
Bearing shoe body	Deterioration of rubber (Loose of elastic, deformation, spalling, blister)	B	Bearing shoe body	Deterioration of rubber (Loose of elastic, deformation, spalling, blister)	C
No cracking, some deformed			Rubber bearing shoe with losing load bearing and movement function

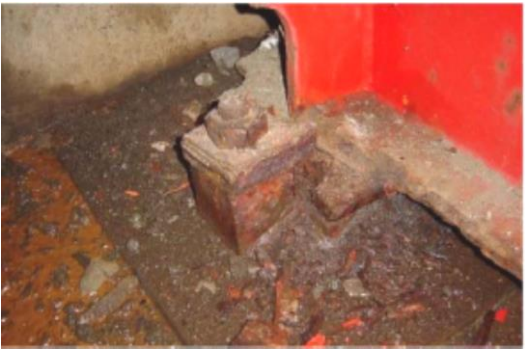
8.6.1.7 Corrosion

Element	Defect	Defect rating	Element	Defect	Defect rating
Bearing shoe body	Corrosion	D			
Steel bearing shoe which lost load supporting and movement function due to serious corrosion.

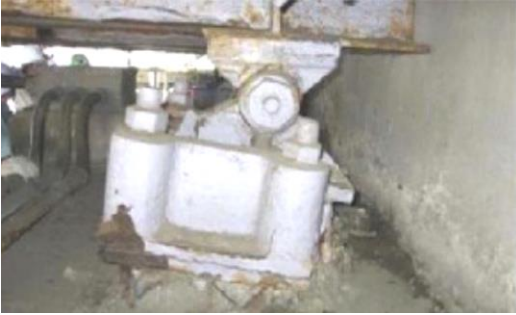
8.6.1.9 Displacement

Element	Defect	Defect rating	Element	Defect	Defect rating
Bearing shoe body	Displacement	D			
Tilting of bearing shoe roller and lost supporting function of virtual load and movement.

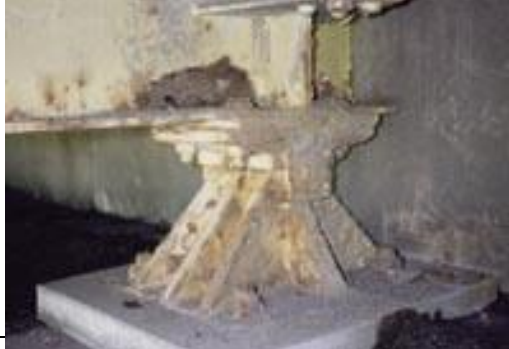
8.6.1.10 Damages to attachments, anchor bolt-nuts

Element	Defect	Defect rating	Element	Defect	Defect rating
Bearing shoe attachments, anchor bolt-nuts	Damages to attachments, anchor bolt-nuts	B	Bearing shoe attachments, anchor bolt-nuts	Damages to attachments, anchor bolt-nuts	C
Looseness of set bolts, side block and anchor bolt nuts.			Corrosion of anchor bolt nuts of the bearing shoe.

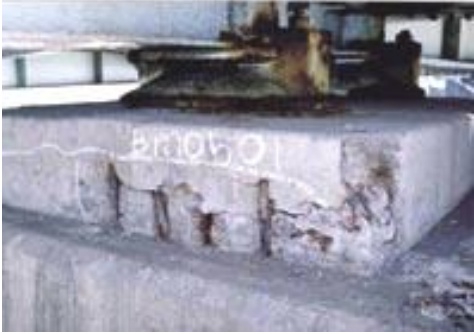
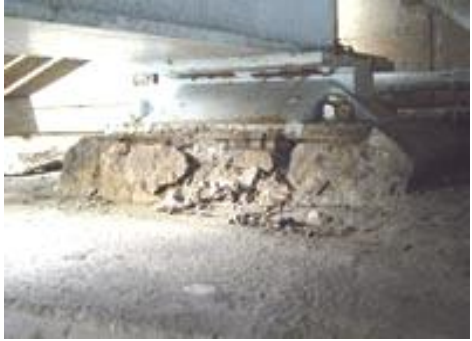
8.6.1.11 Damages to grout concrete or mortar

Element	Defect	Defect rating	Element	Defect	Defect rating
Bearing shoe grout concrete or mortar	Damages to grout concrete or mortar	C	Bearing shoe grout concrete or mortar	Damages to grout concrete or mortar	D
Spalling concrete and exposed rebars of the bearing shoe bed			Fully crashed base mortar of the bearing shoe bed.

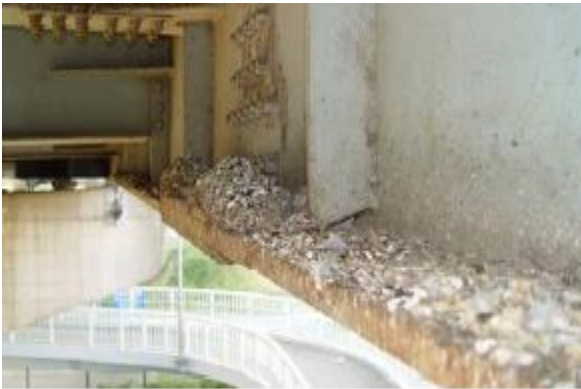
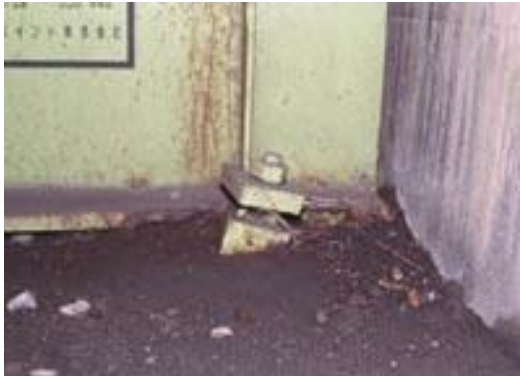
8.6.1.13 Piling of dust and sand

Element	Defect	Defect rating	Element	Defect	Defect rating
Bearing shoe bed	Piling of dust and sand	C	Bearing shoe bed	Piling of dust and sand	D
Mounted bird waste near shoe bed.			Buried and displaced bearing shoe by piling soil and dust.

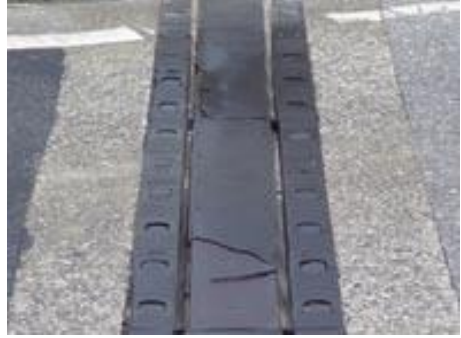
8.7.2 Crack, Torn, Splitting:

Element	Defect	Defect rating	Element	Defect	Defect rating
Rubber expansion joint	Crack, Torn, Splitting:	B	Rubber expansion joint	Crack, Torn, Splitting:	C
Torn around, no crack, not splitting			Crack of rubber expansion joint due to deterioration by over aging.

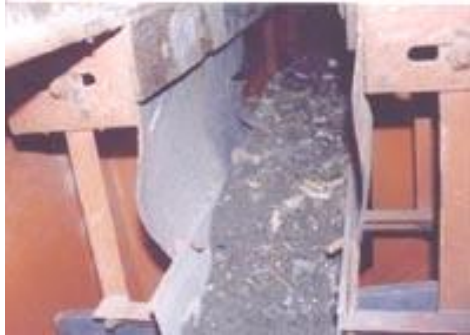
8.7.7 Drainage damage

Element	Defect	Defect rating	Element	Defect	Defect rating
Expansion joint	Drainage damage	B	Expansion joint	Drainage damage	C
Drain gutter is broken partially			Pilling of debris in the ditch below the expansion joint.

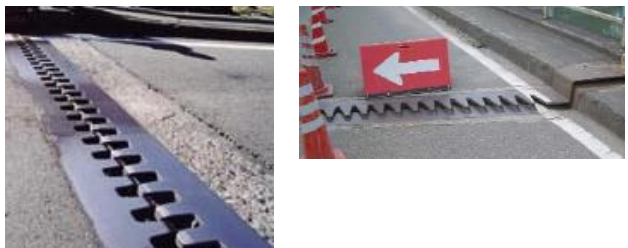
8.7.8 Leveling gap

Element	Defect	Defect rating	Element	Defect	Defect rating
Expansion joint	Leveling gap	B	Expansion joint	Leveling gap	C
Tilt appeared			Dangerous elevation gap due to pier sank.

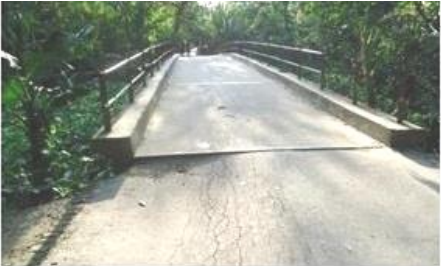
9.1.2 Settlement, movement or deformation

Element	Defect	Defect rating	Element	Defect	Defect rating
Embankment	Settlement, movement or deformation	B	Embankment	Settlement, movement or deformation	C
Settlement, movement - no signs of new movements			Spillage out of backfill soil of the abutment causes settlement of approach road. The settlement will develop if any counter measure taken immediately due to spillage is still continuing.

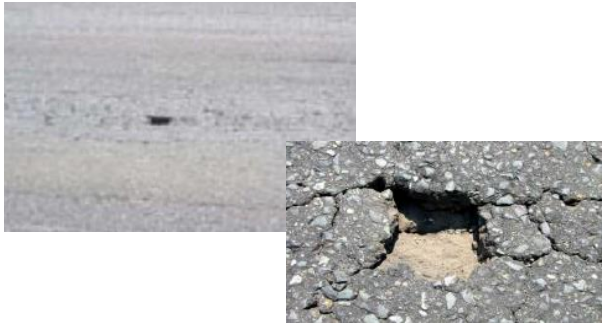
9.1.4 Spalling/ Pothole on pavement

Element	Defect	Defect rating	Element	Defect	Defect rating
Pavement	Spalling/ Pothole on pavement	B	Pavement	Spalling/ Pothole on pavement	C
Some spalling, no potholes			Some spalling and potholes

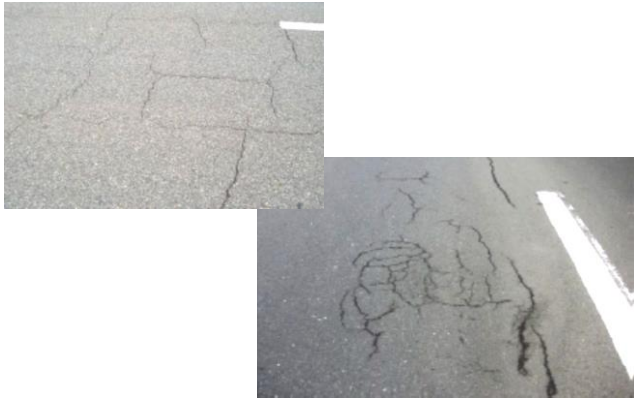
9.1.6 Crack on pavement

Element	Defect	Defect rating	Element	Defect	Defect rating
Pavement	Crack on pavement	B	Pavement	Crack on pavement	C
Some cracking			Severe localized cracking

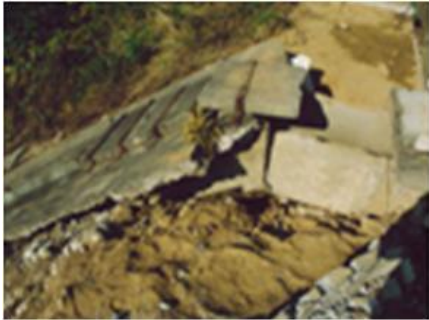
9.2.3 Joint damages

Element	Defect	Defect rating	Element	Defect	Defect rating
Joint of drainage	Joint damages	B	Joint of drainage	Joint damages	C
Leakage of water, but no degradation of drain functions.			Vertical drainage facility was scored at surrounding area.

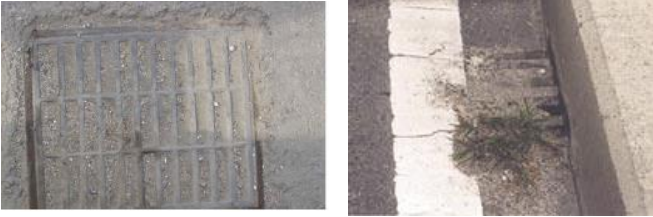
9.2.5 Piling of debris

Element	Defect	Defect rating	Element	Defect	Defect rating
Drainage	Piling of debris	B	Drainage	Piling of debris	C
Slight surface water flow due to the degradation of drain functions.			Serious surface water flow caused by the degradation of drain functions
