**AGRICULTURE INCOME IMPROVEMENT PROJECT**  
 SHWE BO, MYANMAR  
 SANVU CONSULTANTS INC.  
 Longitudinal Section of Kindat OMC  
 DWN :  
 CHK :  
 APPR :  
 DRAWING NO. LS - RD - OMC - 01  
 DATE/MAR 2017  
 FORMAT : A3

## Verification of the safety of Thapanzeik dam against flood

# Rehabilitation of Kabo Weir

### V.9.3 Rehabilitation Plan of Kabo Weir (Bed Protection Works)

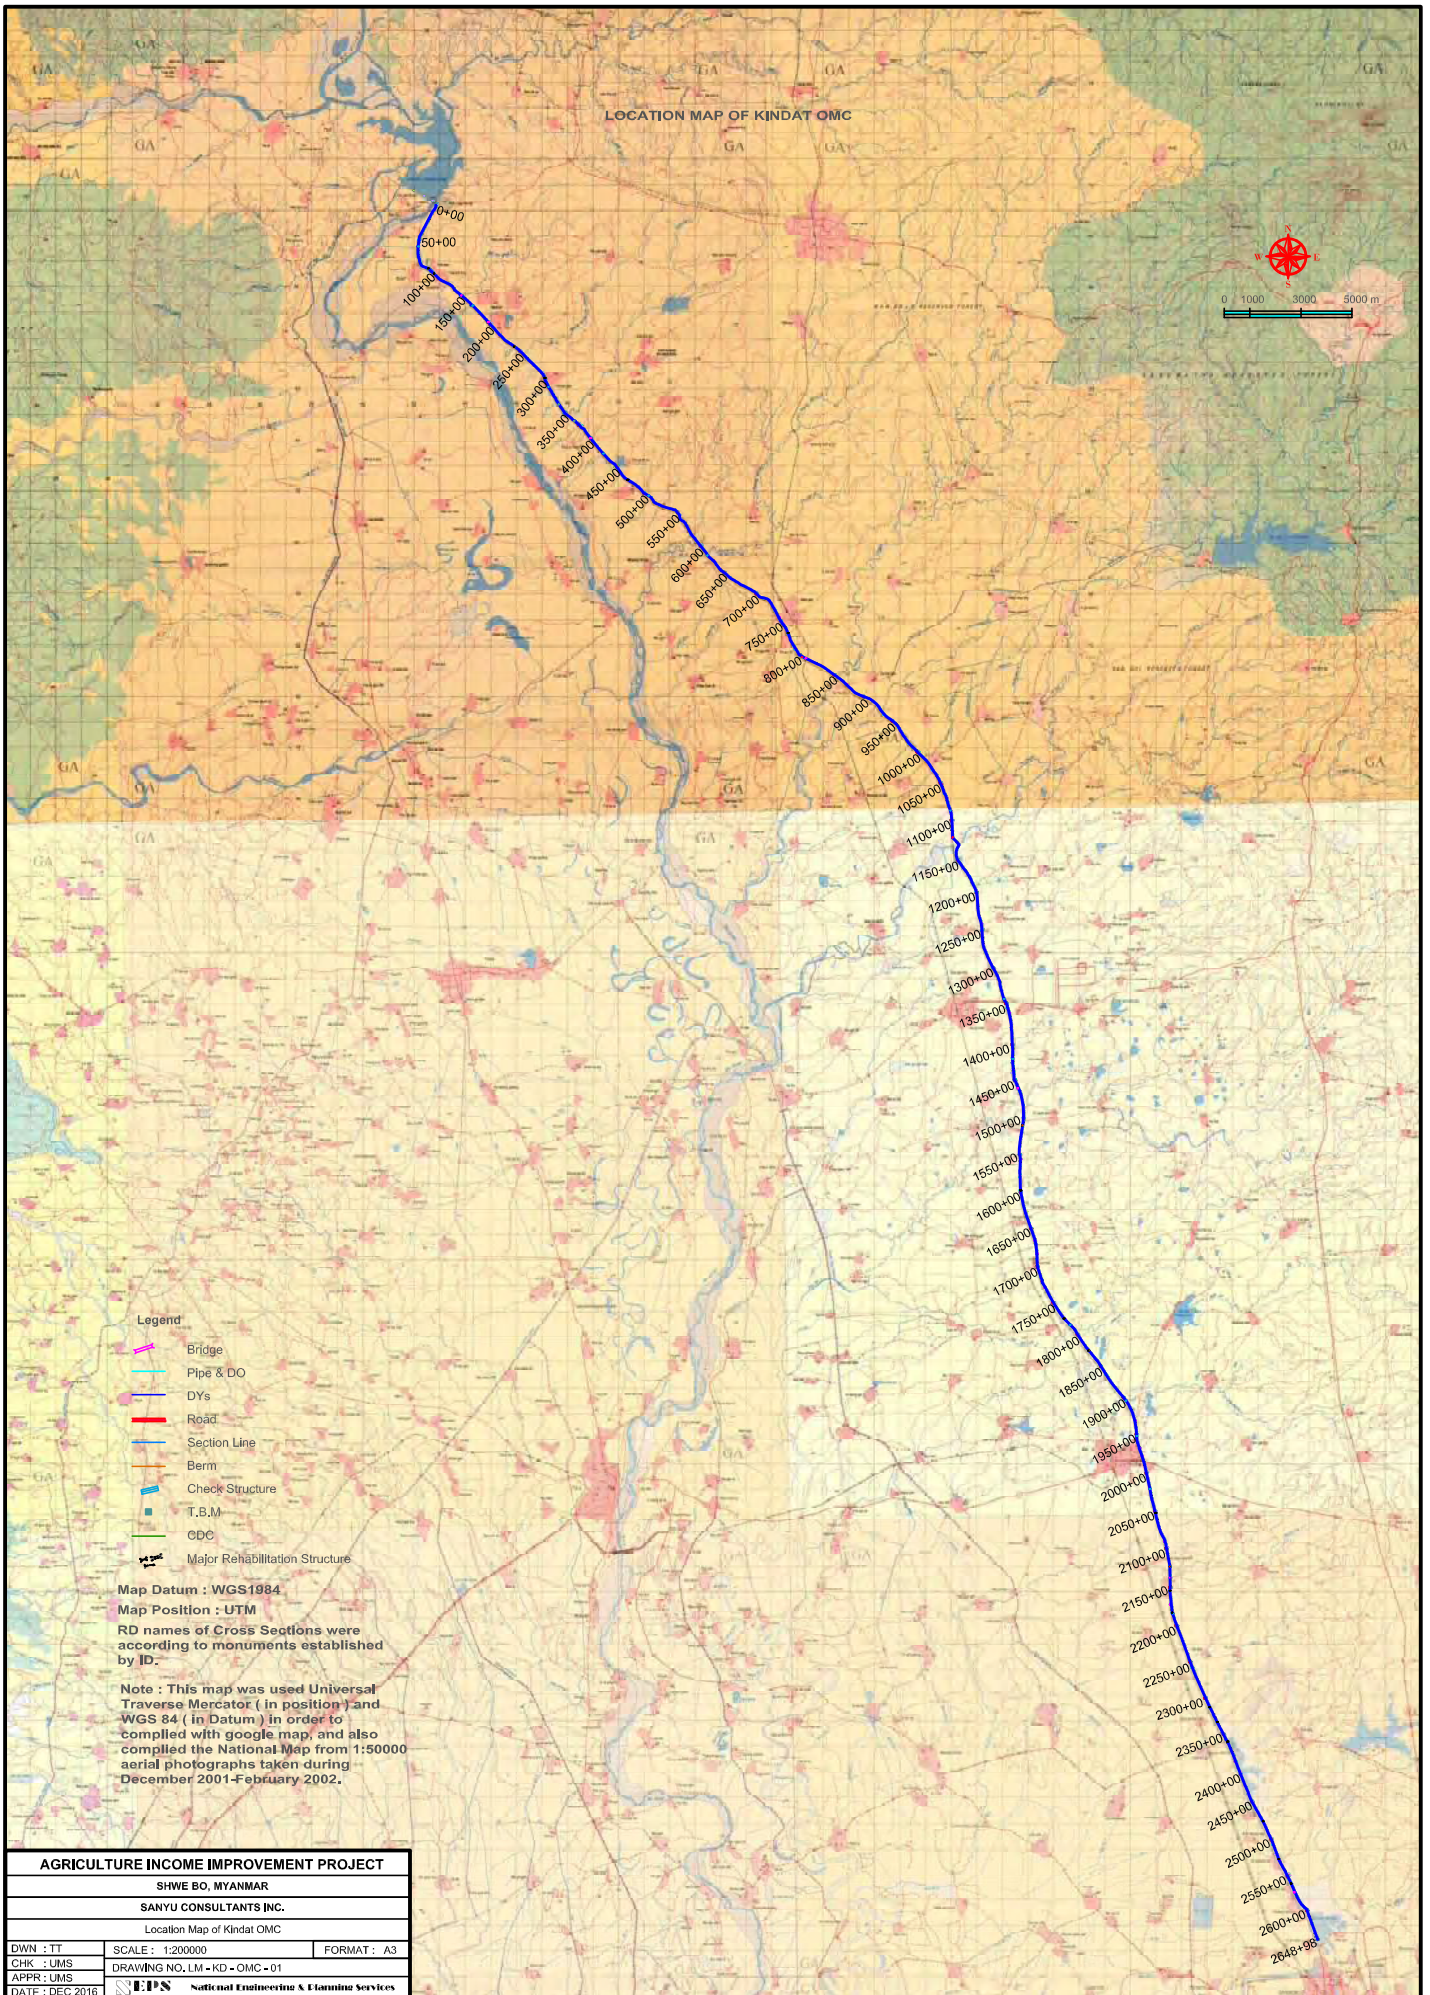
**LONGITUDINAL SECTION OF KINDAT OMC RD (0+000 TO 80+741)**

REDUCED DISTANCE (m)	REDUCED LEVEL (m)	REMARK (RD OF ID) Feet
0+000	138.053	
1+000	136.043	
2+000	133.562	
3+000	133.509	
4+000	133.734	
5+000	134.460	
6+000	132.177	
7+000	132.419	
8+000	132.419	
9+000	132.733	
10+000	132.658	
11+000	131.110	
12+000	133.004	
13+000	132.730	
14+000	133.204	
15+000	132.254	
16+000	131.064	
17+000	131.108	
18+000	131.254	
19+000	130.665	
20+000	130.658	
21+000	130.448	
22+000	130.491	
23+000	131.001	
24+000	130.317	
25+000	130.216	
26+000	129.548	
27+000	129.257	
28+000	128.633	
29+000	128.384	
30+000	128.459	
31+000	128.626	
32+000	128.737	
33+000	128.485	
34+000	128.203	
35+000	127.309	
36+000	126.652	
37+000	126.613	
38+000	126.317	
39+000	126.103	
40+000	126.805	
41+000	126.880	
42+000	122.798	
43+000	123.081	
44+000	122.672	
45+000	122.103	
46+000	121.608	
47+000	121.622	
48+000	121.228	
49+000	120.837	
50+000	120.882	
51+000	120.787	
52+000	120.554	
53+000	120.347	
54+000	120.890	
55+000	120.739	
56+000	120.736

57+000	120.326	
58+000	120.326	
59+000	119.910	
60+000	119.059	
61+000	118.888	
62+000	118.005	
63+000	116.639	
64+000	115.956	
65+000	115.121	
66+000	114.881	
67+000	113.698	
68+000	113.648	
69+000	113.149	
70+000	112.889	
71+000	112.251	
72+000	111.930	
73+000	111.979	
74+000	112.105	
75+000	111.296	
76+000	111.178	
77+000	111.202	
78+000	112.413	
79+000	110.943	
80+000	111.070	
80+741	111.096

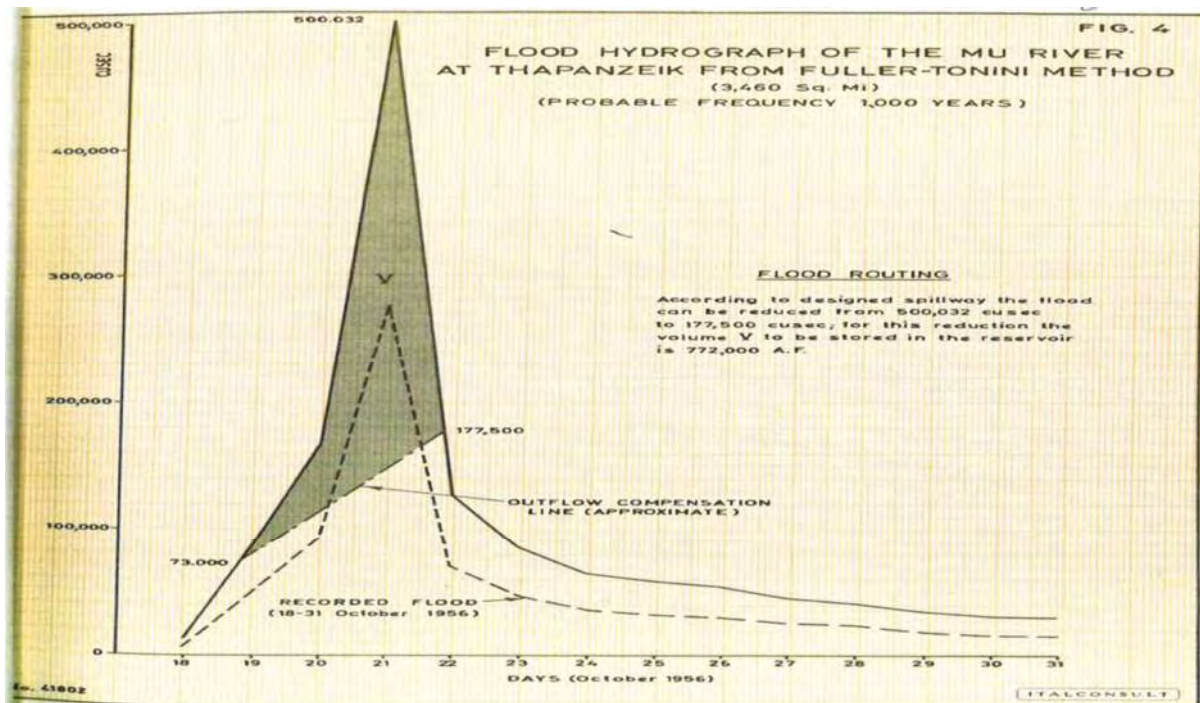
**Figure-1 Flood hydrograph of the Mu river at Thapanzeik from fuller-Tonini method**

The spillway design flood at Thapanzeik dam was assumed to be 500,032 cusecs (14,159 m<sup>3</sup>/s), which is for 1,000 year flood. The hydrograph for this flood is given in Figure 1. The routing capacity of the reservoir between the full tank level of reservoir and maximum water level is such as to reduce the flood peak to 177,500 cusecs (5,026 m<sup>3</sup>/s), which is 35.5 % of the spillway design flood at Thapanzeik dam.

Finally the maximum flood flow at Thapanzeik dam was estimated to be 500,032 cusecs (14,159 m<sup>3</sup>/s) with 1,000-year frequency. Then, when designing the spillway structure, accounting has been taken of the routing effect of the reservoir. The spillways had been proportioned for the maximum overall discharge of 177,500 cusecs (5,026 m<sup>3</sup>/s) at an elevation of 552' (168.25 m). Taking account of the routing effect of the reservoir, this is equivalent to the 1,000-yr flood discharge of 500,032 cusecs (14,159 m<sup>3</sup>/s).

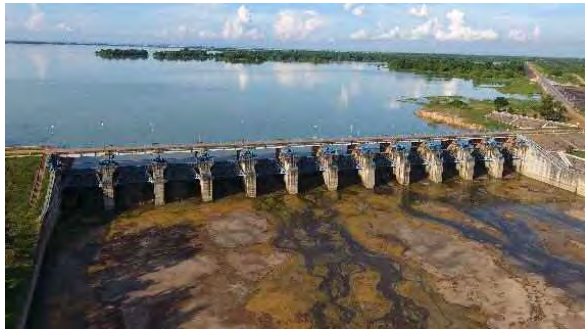
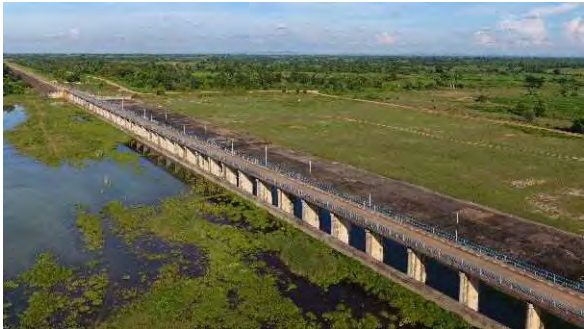
**Table-3 Spillway discharge which is taken account of the routing effect of the reservoir.**

Water level of reservoir	Available maximum discharge from spillway					
	Service spillway		Auxiliary Spillway		Total	
	(cusecs)	(m <sup>3</sup> /s)	(cusecs)	(m <sup>3</sup> /s)	(cusecs)	(m <sup>3</sup> /s)
~ RL 530 ft (RL 161.54 m)	0	0	0	0	0	0
~ RL 545 ft (RL 166.12 m)	~ 73,000	2,067	0	0	~ 73,000	2,067
~ RL 547 ft (RL 166.73 m)	~ 88,000	2,492	0	0	~ 88,000	~ 2,492
~ RL 552 ft (RL 168.25 m)	~ 130,000	3,681	~ 47,500	1,345	~ 177,500	~ 5,026

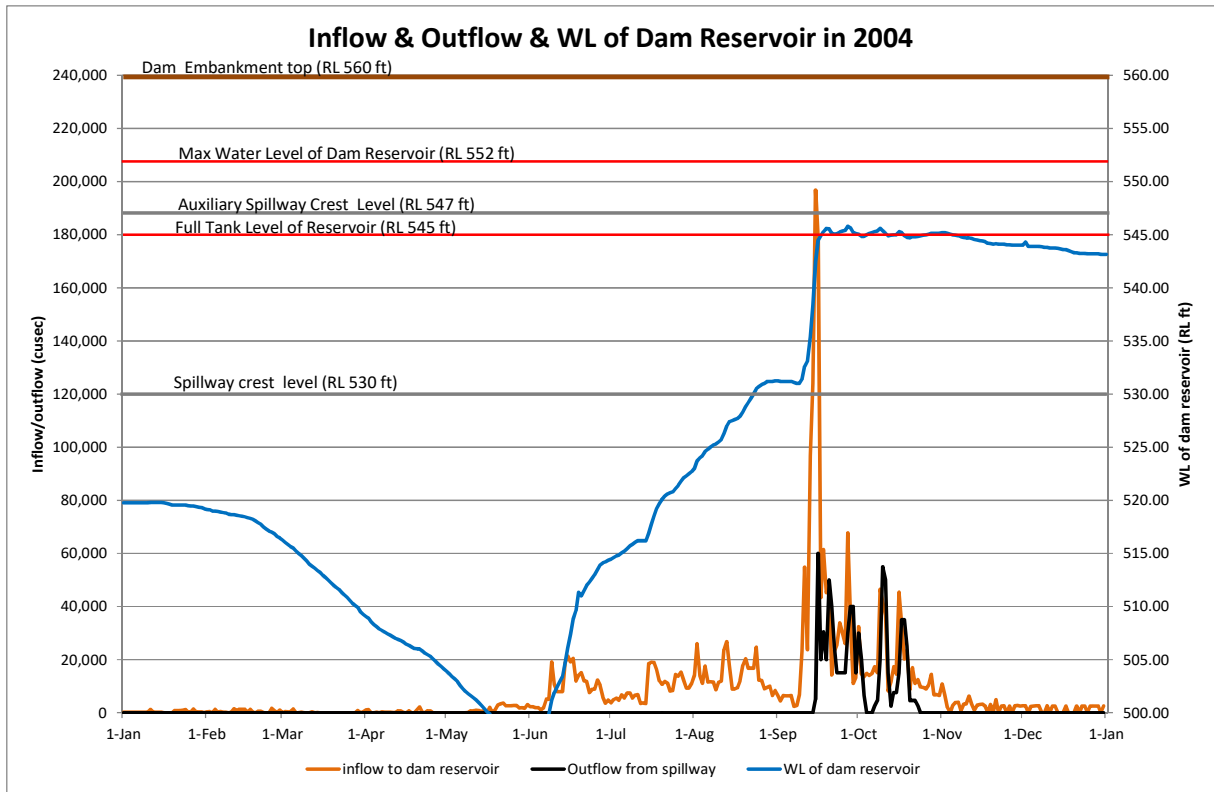
**Figure-3 Inflow (runoff to dam reservoir) and outflow (spillway discharge) and water level of dam reservoir in 2004**

Although the highest flood discharge was 196,843 cusecs (5,574 m<sup>3</sup>/s) on September 14, 2004, the flood discharge on October 12, 1956 was higher; it is 243,103 cusecs (6,884 m<sup>3</sup>/s). However, since water level of dam reservoir was nearly full tank level, water level reached the maximum RL 548.10' on October 11, 2015. This water level of dam reservoir is highest for the 15 years operation since 2001. In this day, discharge from spillway also reached 64,538 cusecs (1,828 m<sup>3</sup>/s), the biggest for 15 years.

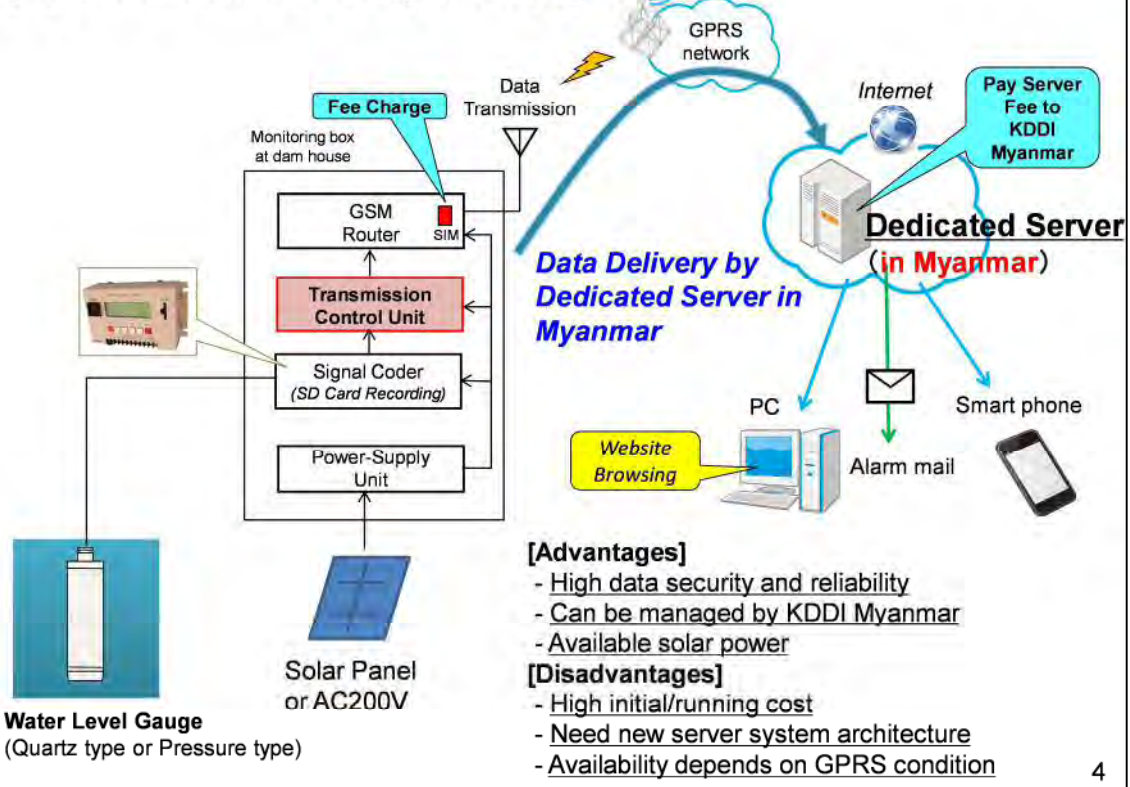
### [C] Dedicated Sever System (Myanmar)

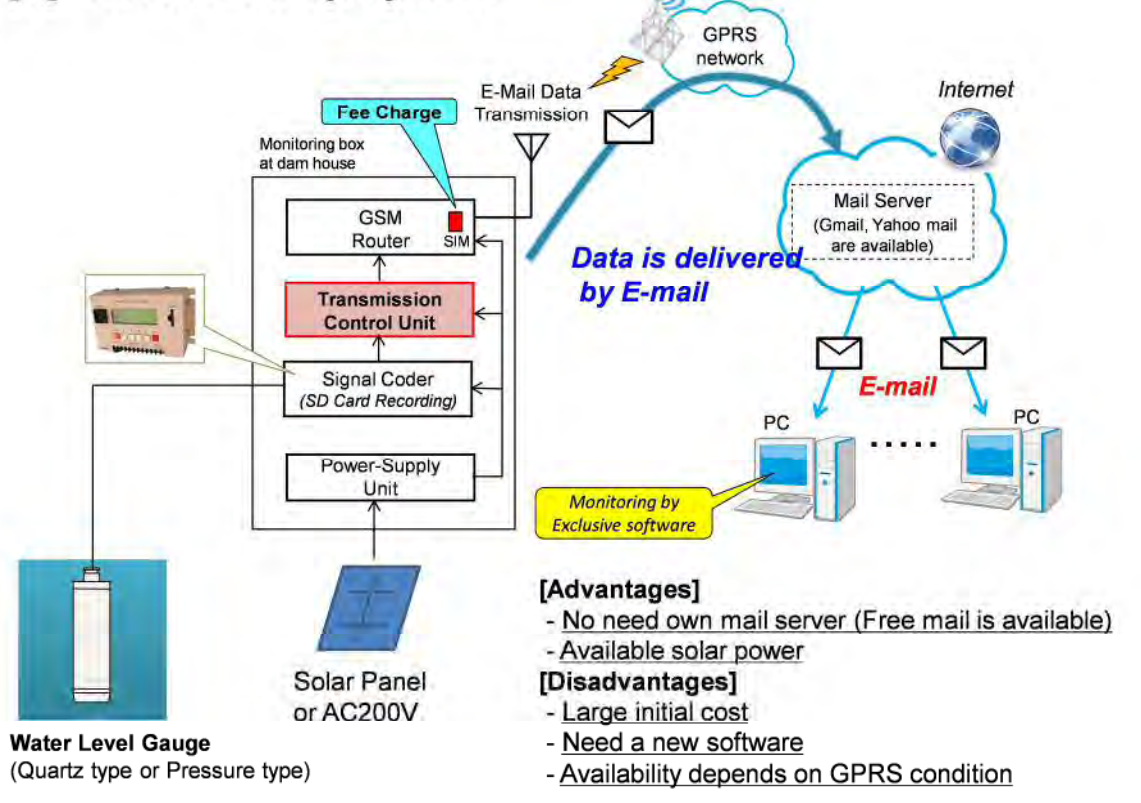
### [D] E-mail Delivery System

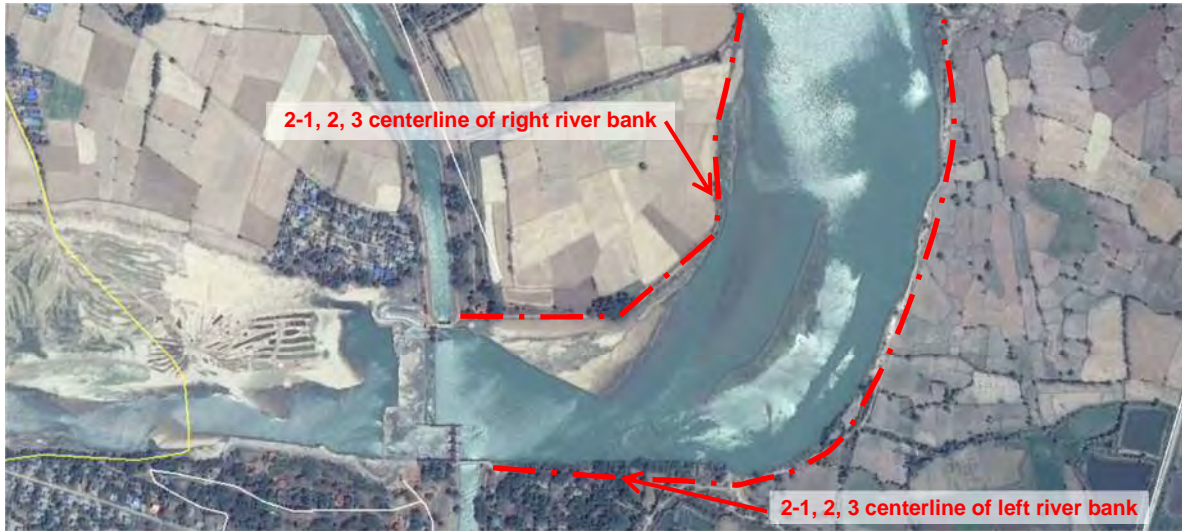
**Figure 2-2: Location of Center line profile survey & longitudinal cross section survey along the river dike**
