付 録

ALTERNATIVES FOR BYPASS-1, CHIATLANG BYPASS

1.1.2 Bypass No2 (Serchhip Area)

2. GEOLOGICAL SURVEY RESULT

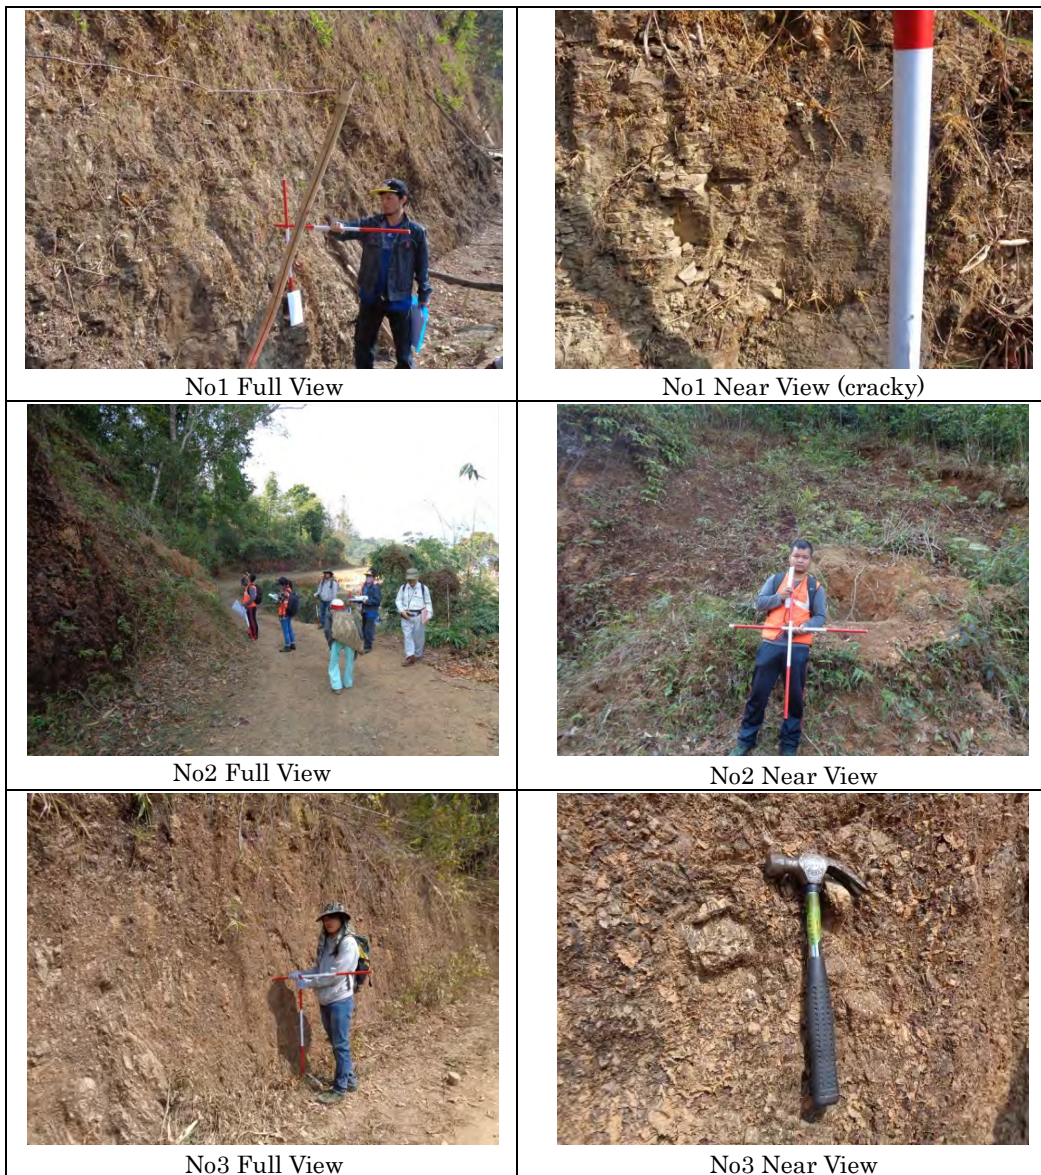
Figure 1-2 Outcrop conditions

Siltstone and sandstone are mainly distributed as bedrock in this area. Weathered condition of bedrock is strong to middle, so cracked rocks are observed along the cutting slope. Color of the rock is brownish color by weathering. As a whole, self-standing of the cutting slope is good. Therefore the slope failure is hardly seen along the road. But if the height of cutting is high, there is a possibility of slope failure. On the other hand, a hard rock of sandstone was observed characteristically at the No8 site.

Table 1-1 and Figure 1-1 show the survey sites location and Table 1-2 shows the outcrop conditions. Each outcrop condition is shown in Figure 1-2.

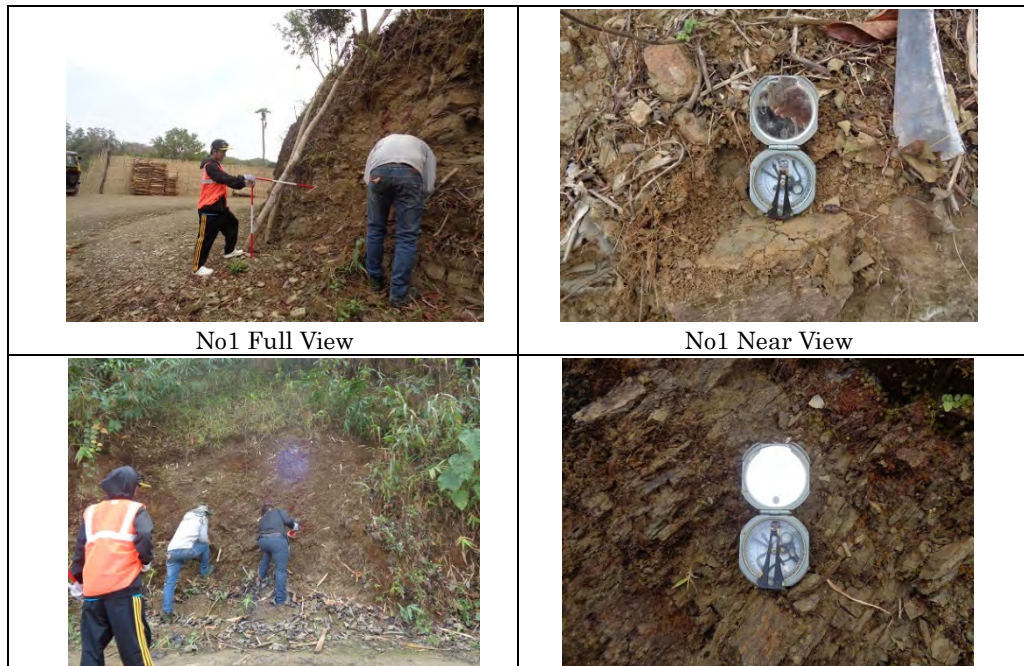
Figure 1-4 Outcrop conditions

Siltstone and sandstone are mainly distributed as bedrock in this area. Weathered condition of bedrock is mainly strong to middle, so cracked rocks are observed along the cutting slope. Also the sediment with rock is observed in places. This sediment is judged from weathered rock at present location as mentioned below (refer to chapter 2). Color of the rock is brownish color by weathering.

As a whole, self-standing of the cutting slope is good. But small slope failures are observed locally. On the other hand, the middle weathered rocks are observed around the ridge as shown in No6 to No10. Probably, the strong weathered rocks on the middle weathered rocks, which look like the sediment, are thought to have almost flowed out in the past. A part of the strong weathered rocks can be seen on the middle weathered rocks in No7 site. If the height of cutting is high, the weathered rocks have a possibility of slope failure.

Table 1-3 and Figure 1-3 show the survey sites location and Table 1-4 shows the outcrop conditions. Each outcrop condition is shown in Figure 1-4.

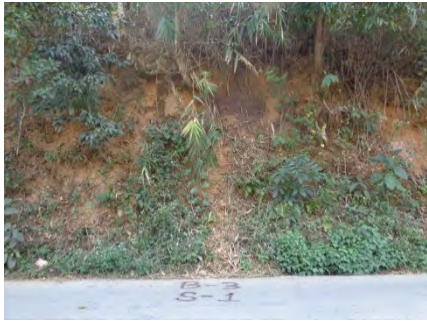
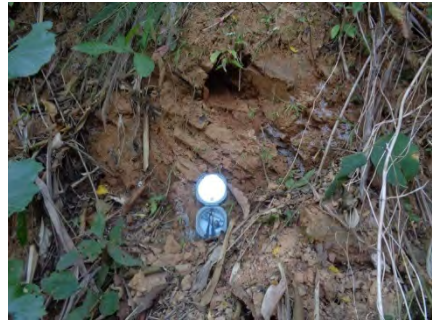
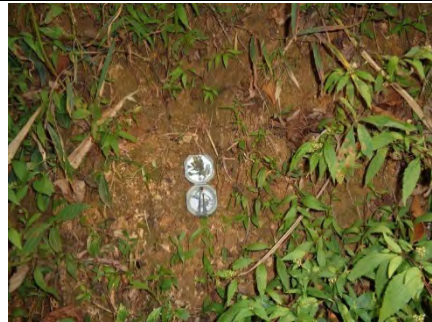
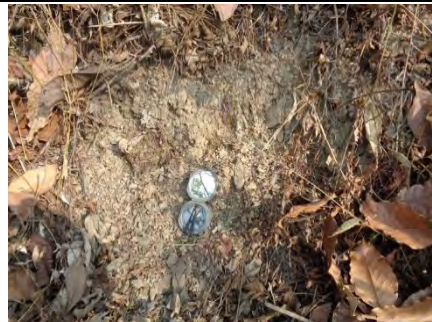
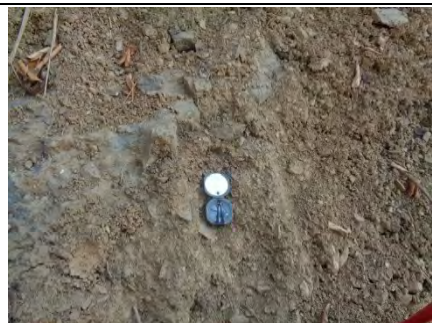
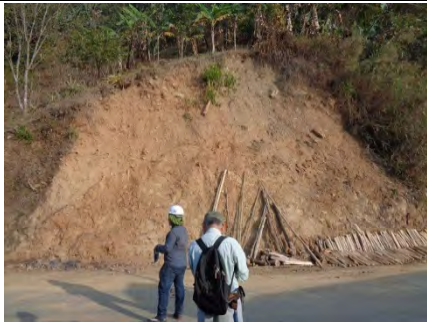
Figure 1-6 Outcrop conditions

Siltstone and sandstone are mainly distributed as bedrock in this area. Weathered condition of bedrock is strong to middle, so cracked rocks are observed along the cutting slope. Also the sediment with rock is observed in places. This sediment is judged from weathered rock at present location as mentioned below (refer to chapter 2). Color of the rock is brownish color by weathering. As a whole, self-standing of the cutting slope is good. But as seen in No4, No5, No8, No9, No13, No16 and No20, along the road, small slope failures are observed locally. Therefore, if the height of cutting is high, these weathered rocks have a possibility of slope failure.

Table 1-5 and Figure 1-5 show the survey sites location and Table 1-6 shows the outcrop conditions. Each outcrop condition is shown in Figure 1-6.

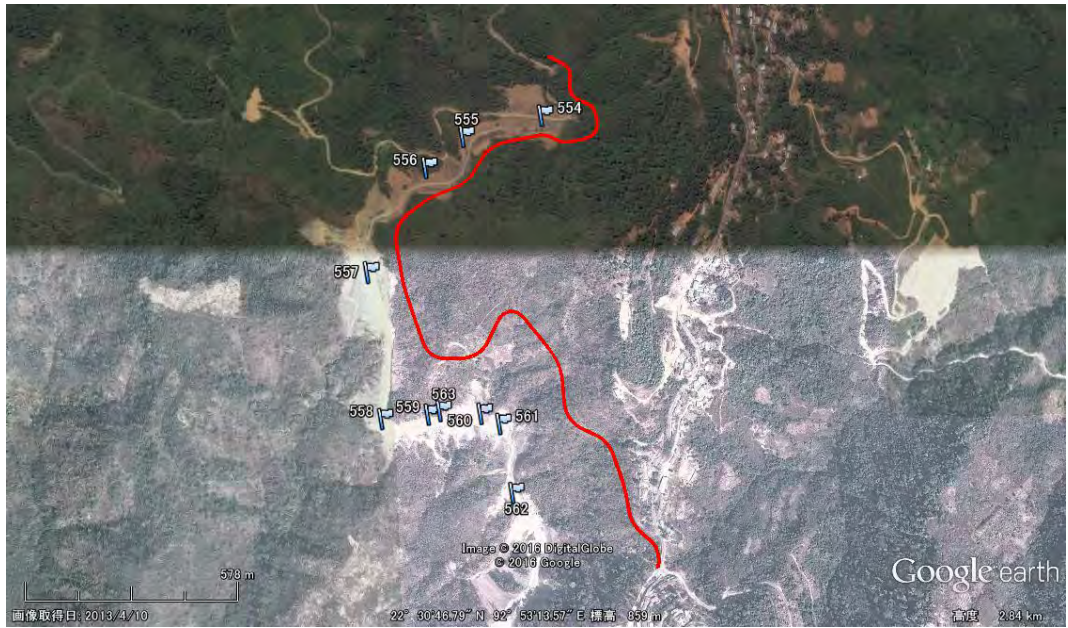
Figure 1-7 Survey sites location

Red line is the planned bypass line

Table 1-7 and Figure 1-7 show the survey sites location and Table 1-8 shows the outcrop conditions. Each outcrop condition is shown in Figure 1-8.

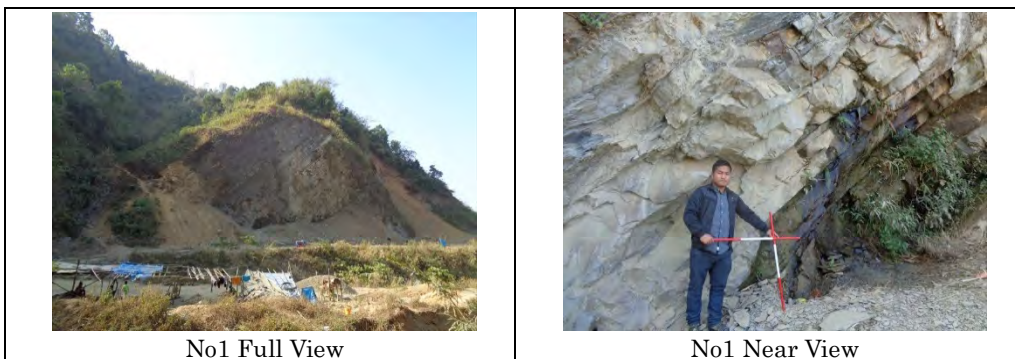
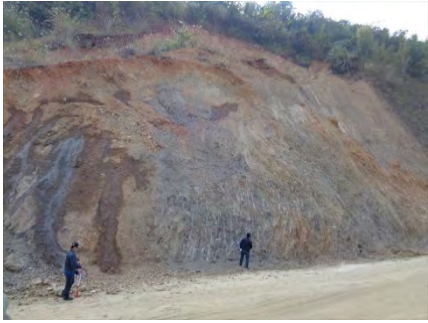
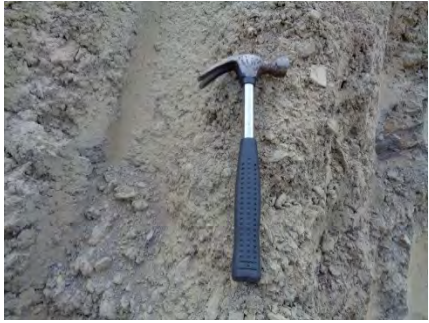
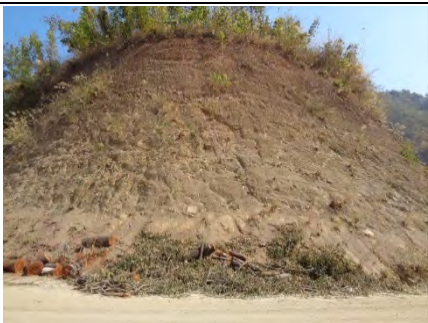
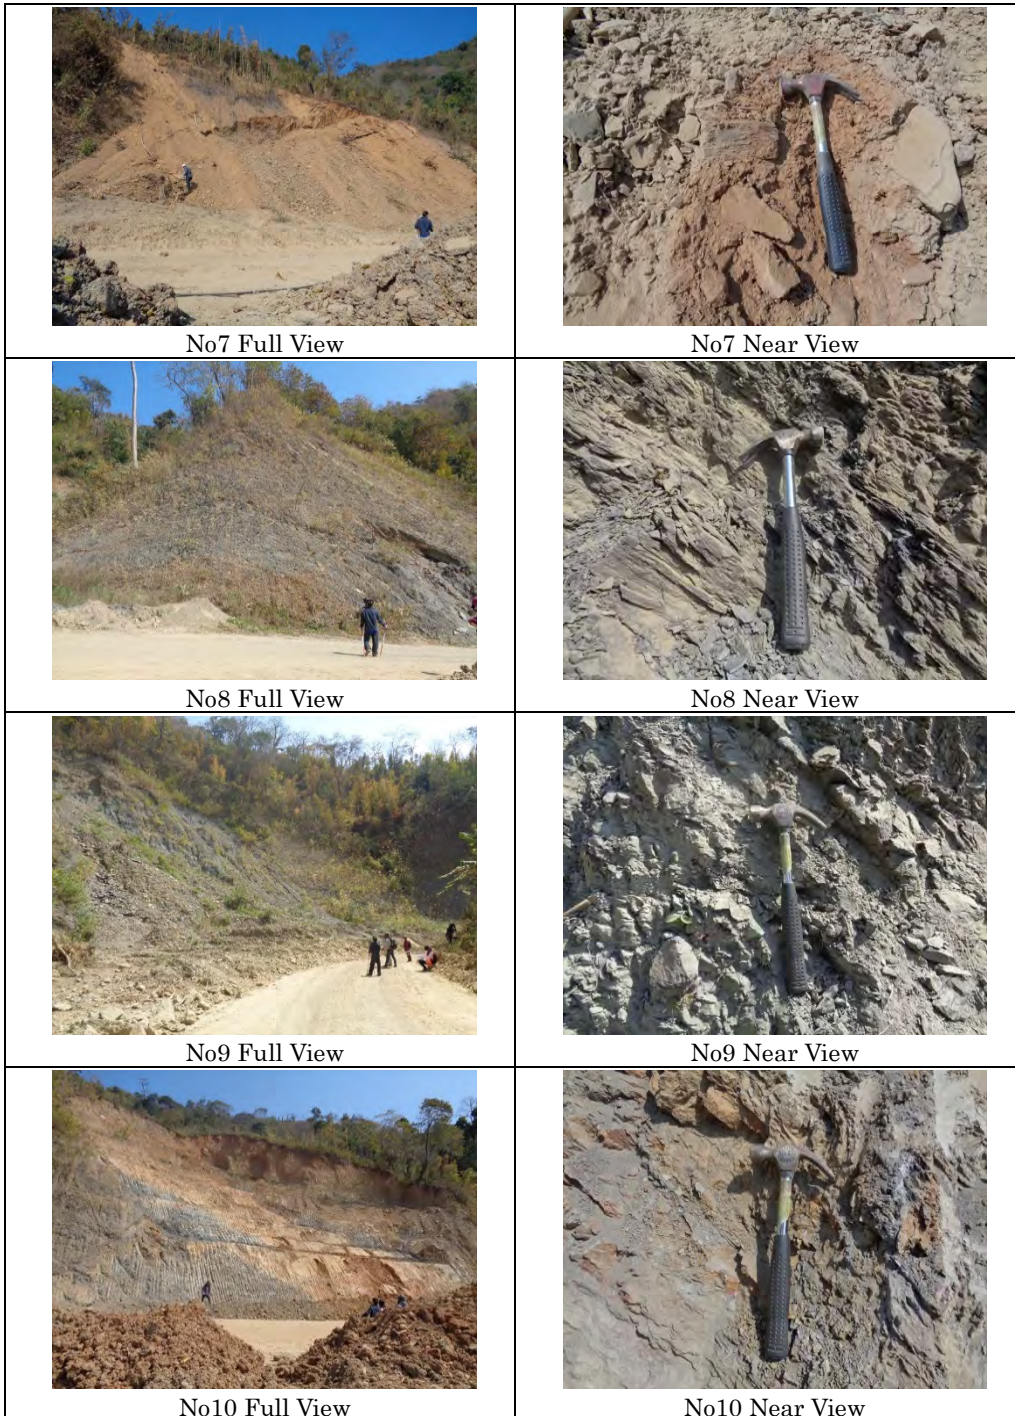
Figure 1-8 Outcrop conditions

- Weathering condition of bedrock which had got a lot of stress is significant compared to other bypass areas. Therefore this area has a condition which the slope failure and the landslide are easy to occur.
- The active landslide which occurred by cutting has observed along the road (No7). And this landslide has been moving at present.
- The brownish sediment which was formed by the slope failure in the past is distributed on the slope (No10).

Actually, the sediment deposition which has a variation history is distributed on the slope along the bypass No4. This condition is obviously different from the other three areas (No1-No3).

Probably, the landslide of No7 is thought to be the old one. Because, the disturbed outcrop is observed at the sliding cliff (refer to chapter 3).

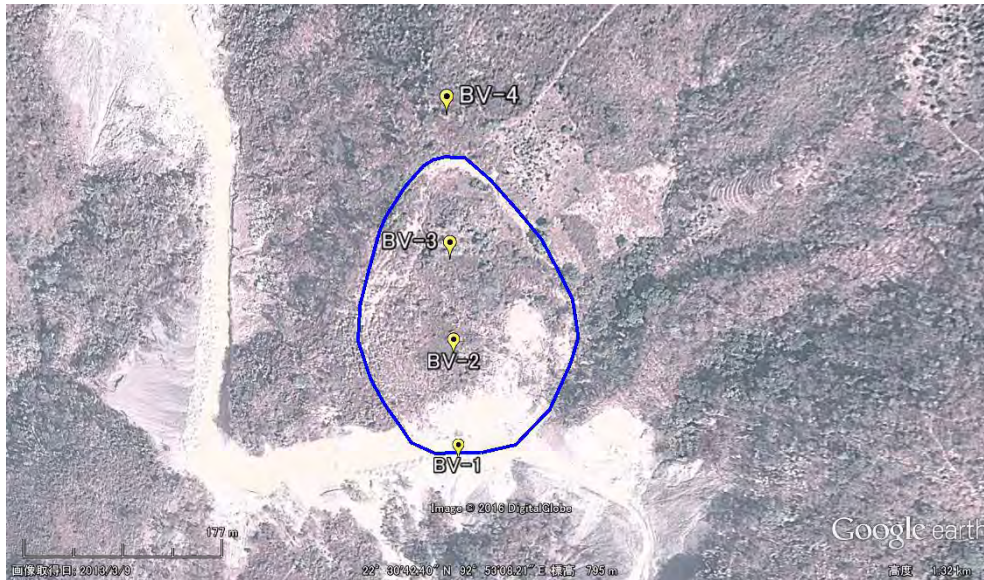
Figure 2-1 Location of Boring Survey

Figure 2-1 shows the location of boring survey.

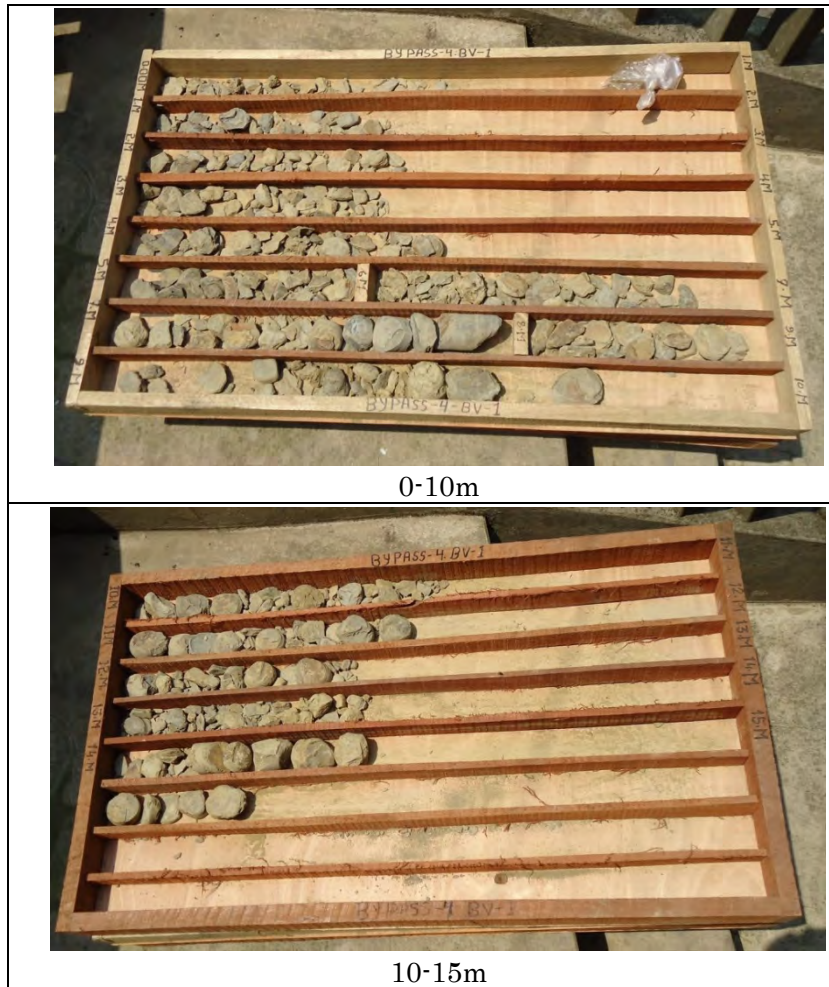
Figure 2-2 Core Photos (BV-1)

Geological condition is presumed as follows based on boring core. Probably, banking material is assumed to be distributed from 0.0m to about 6.0m. Natural ground is presumed to be distributed at about 6m, because grayish core was collected at the depth between 6m and 8m (Table 2-2, Figure 2-2).

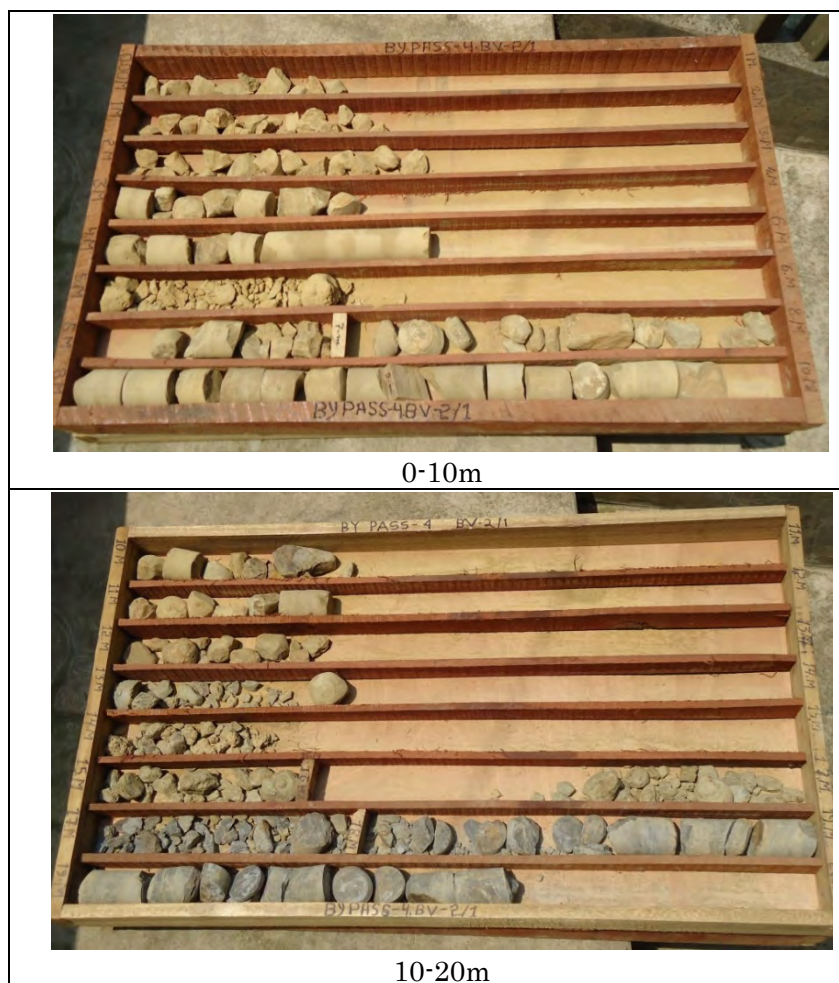
Figure 2-3 Core Photos (BV-2)

Geological condition is presumed as follows based on boring core. Brownish sandstone was collected between 0.0m and 12.0m. Almost boring core is pebble shape but locally short stick shape. Natural ground is presumed to be distributed at about 17.0m, because grayish core was collected at the depth between 17.0m and 20.0m. Slip surface is presumed to be about 10m in depth considering landslide scale (Table 2-3, Figure 2-3).

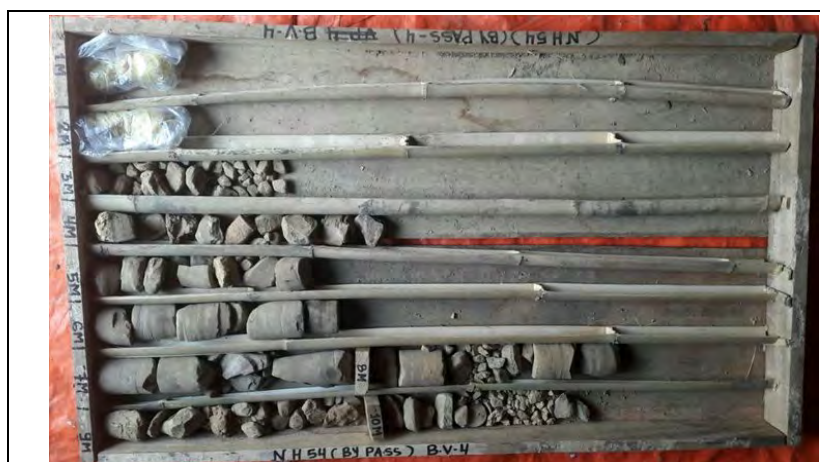
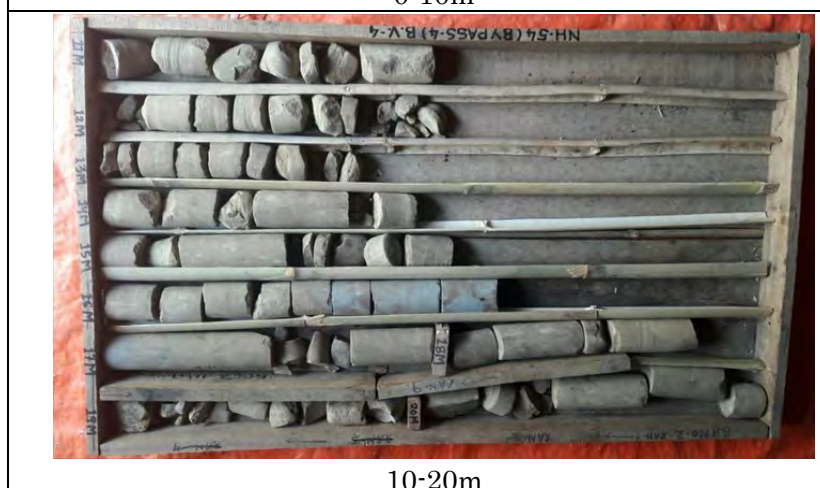
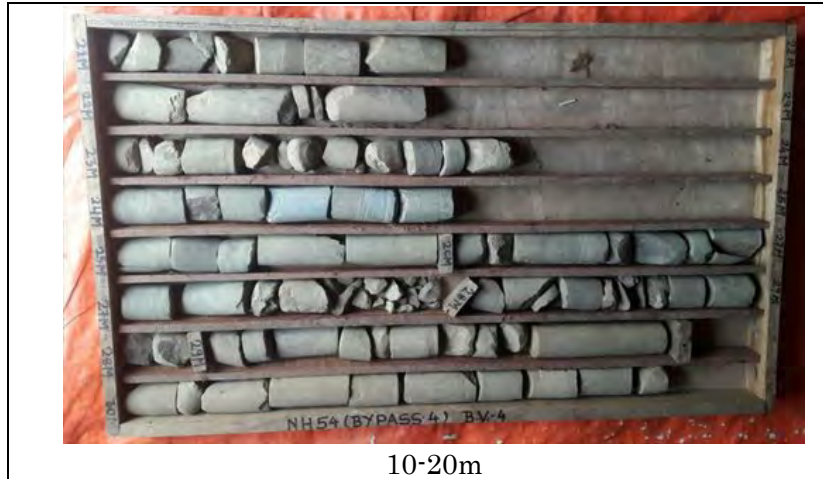
Figure 2-6 Core Photos (BV-4)

Geological condition is presumed as follows based on boring core. Grayish shale was collected between 2.0m and 30.0m excluding surface soil (0.0-2.0m). Boring core between 2.0 and 11.0m is a bit crushed. Probably, this interval is presumed to be a looseness zone. Fresh rock core is collected blow 11.0m. Weathered condition is almost fresh rock. And the direction of crack is almost horizontal (Table 2-6Table 2-5, Figure 2-6).

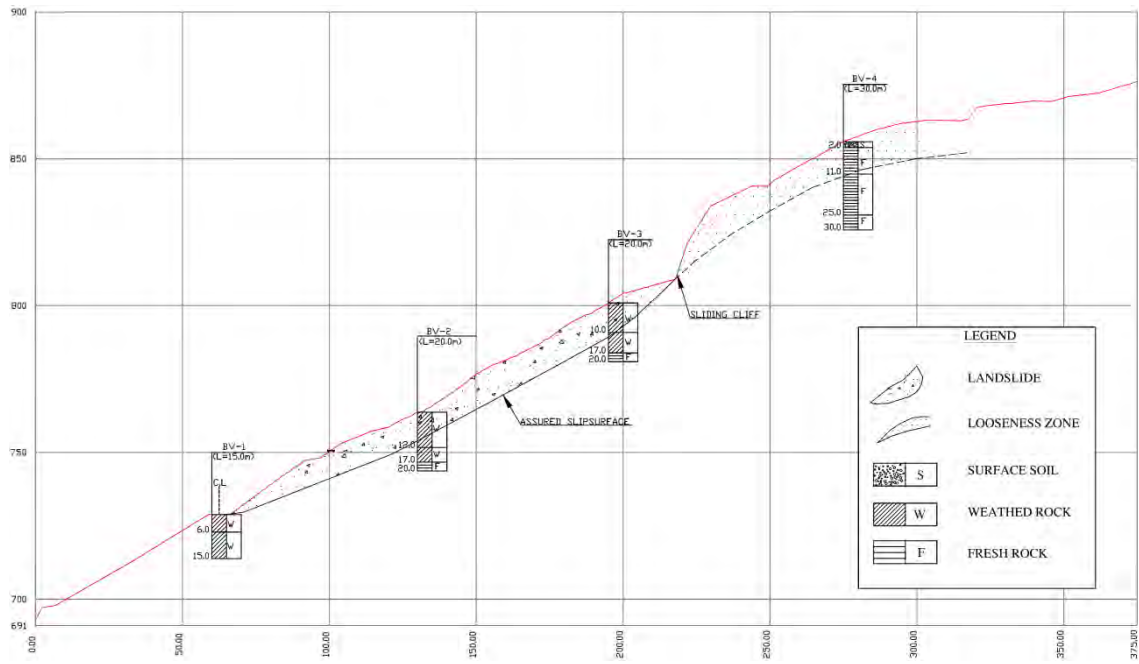
Figure 2-8 Assumed landslide Profile

Obvious sliding cliff is observed. So, the location of the head of landslide is judged to be located at the lower end of the sliding cliff.

Figure 2-8 shows an assumed landslide profile studied based on the survey result above.
