**PREPARATORY STUDY  
FOR  
ROAD NETWORK IMPROVEMENT  
IN  
NORTH-EAST STATES OF INDIA**

**FINAL REPORT**

**(Volume 3: Supplementary Technical Assistance for Additional  
Engineering Surveys and Design Modification / Application of  
Contract Mode and Preparation of Technical Specifications)**

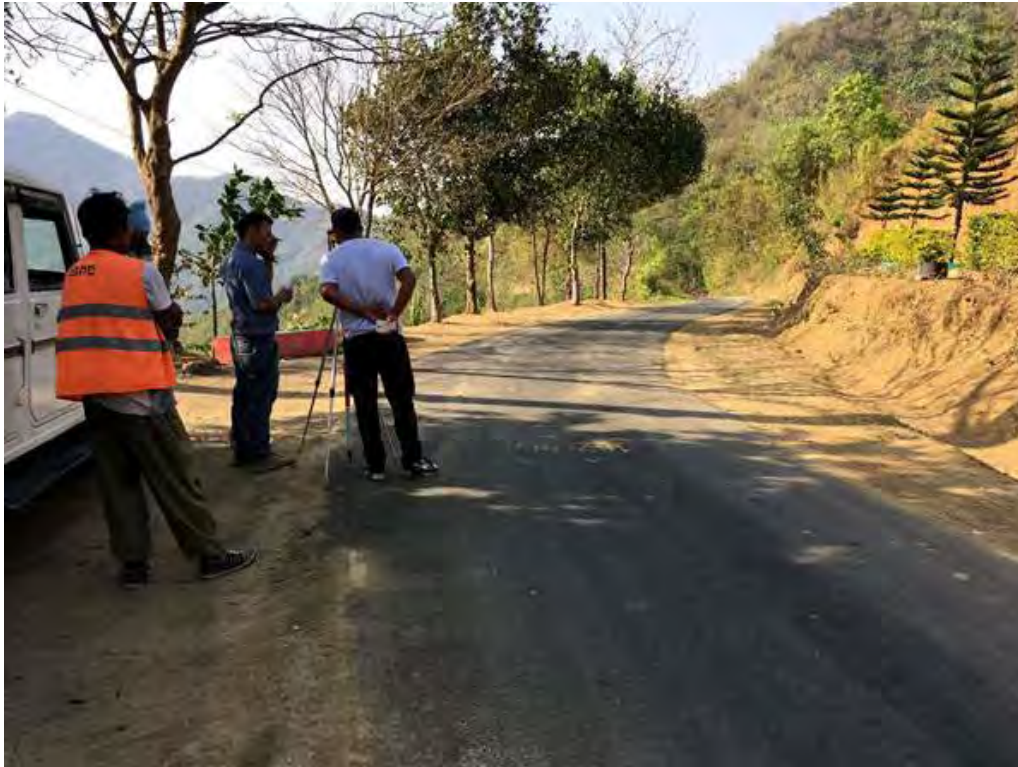
**Figure 3.2-1 View of Topographical Survey (Traverse Survey)**

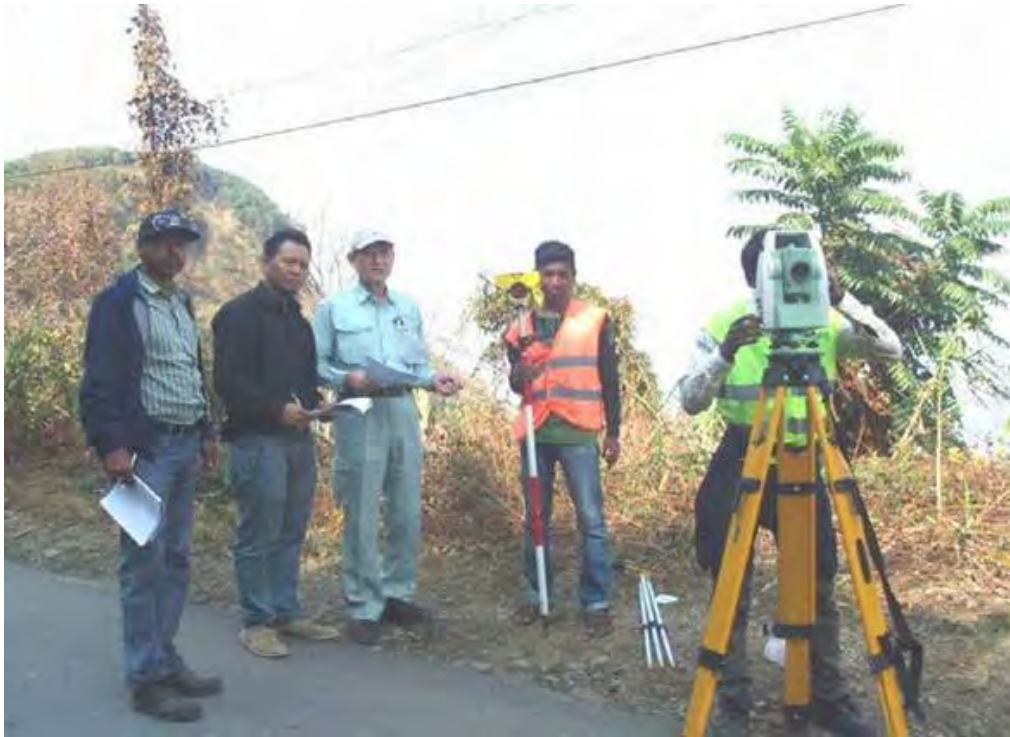
**Figure 3.2-3 View of Technical Guidance for Topographical Survey (At Site)**

The additional survey consultant planned to divide the topographic information by tendering package and to provide topographic drawing to the JICA Study Team in the order of the priority package. During the discussion, the JICA Study Team found a mismatch between the boundary plotted by the consultant and one of the package defined for tender. The distance of the gap of each boundary position is around 6 km at the maximum. To settle this issue, the JICA Study Team instructed that every topographic drawing shall include proper road stretch for each package.

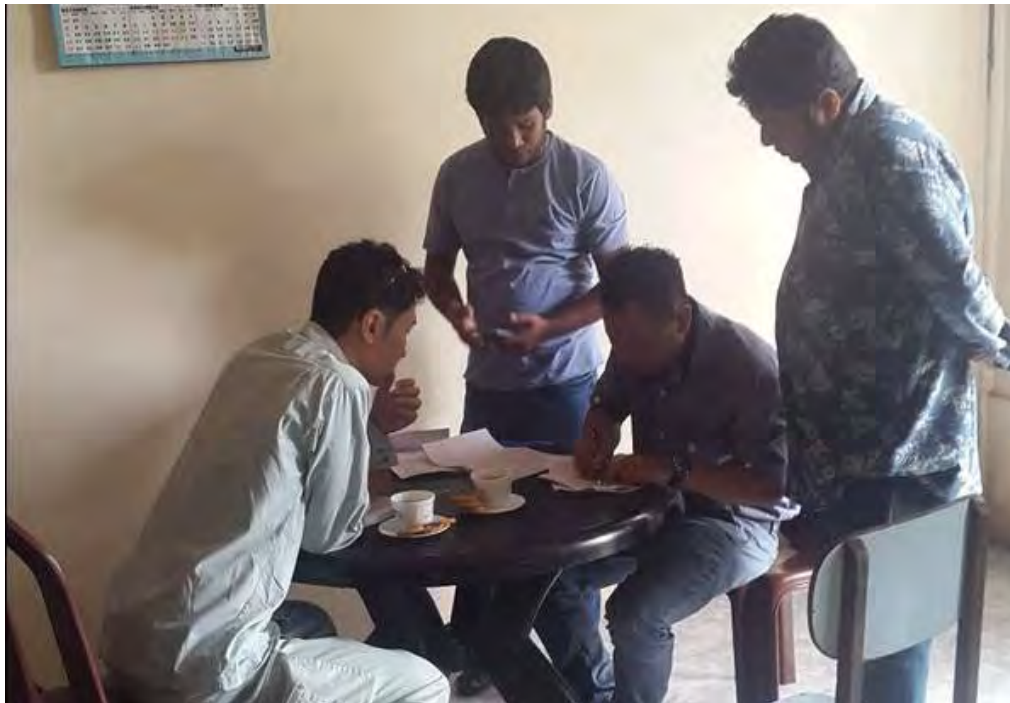
**Figure 3.2-4 View of Technical Guidance for Topographical Survey (In Meeting)**

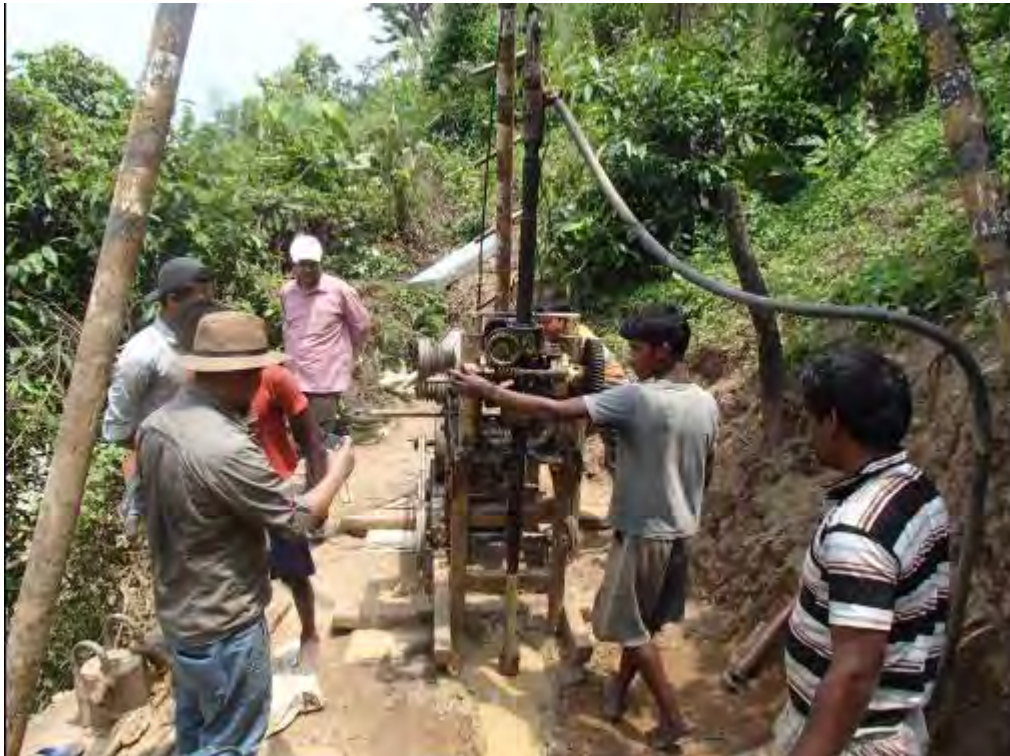
**Figure 3.3-2 View of Borehole Survey (Drilling Work)**

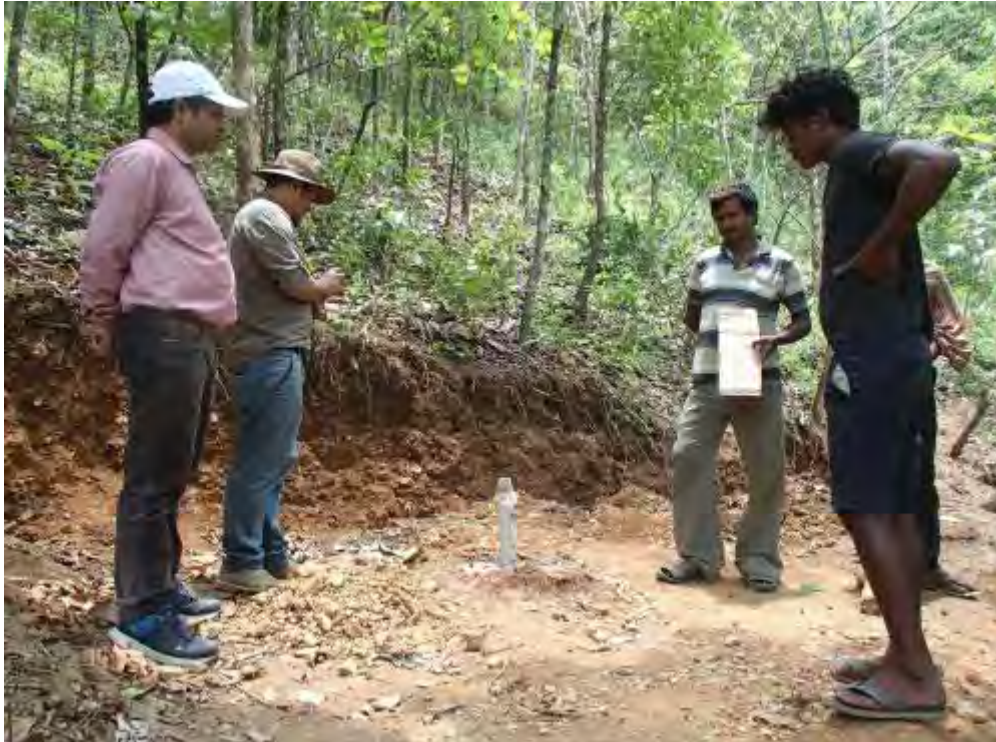
**Figure 3.3-3 View of Borehole Survey (Installation of PVC Pipe)**

- Conservation of Groundwater Monitoring Borehole: Since some PVC pipes inserted to the boreholes for groundwater monitoring were broken or clogged by local people, the team requested BPC to explain to the local people and add lockable instruments.

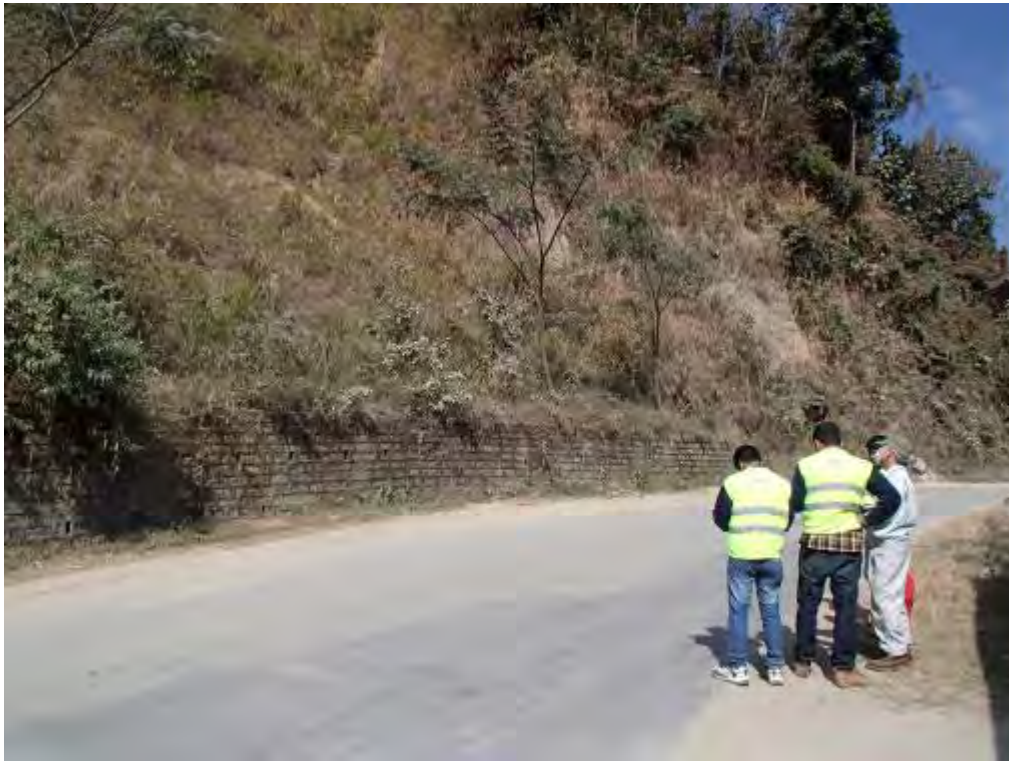
**Figure 3.3-4 View of Technical Guidance on Slope Inventory Survey**

The JICA Study Team reviewed the slope inventory survey results received from BPC and sent comments in writing on June 1 (Appendix-IV.2). The comments are (1) a clear mismatch between the survey points and the site condition, (2) imprecise description about dip slope, and the team requested to correct these two points.

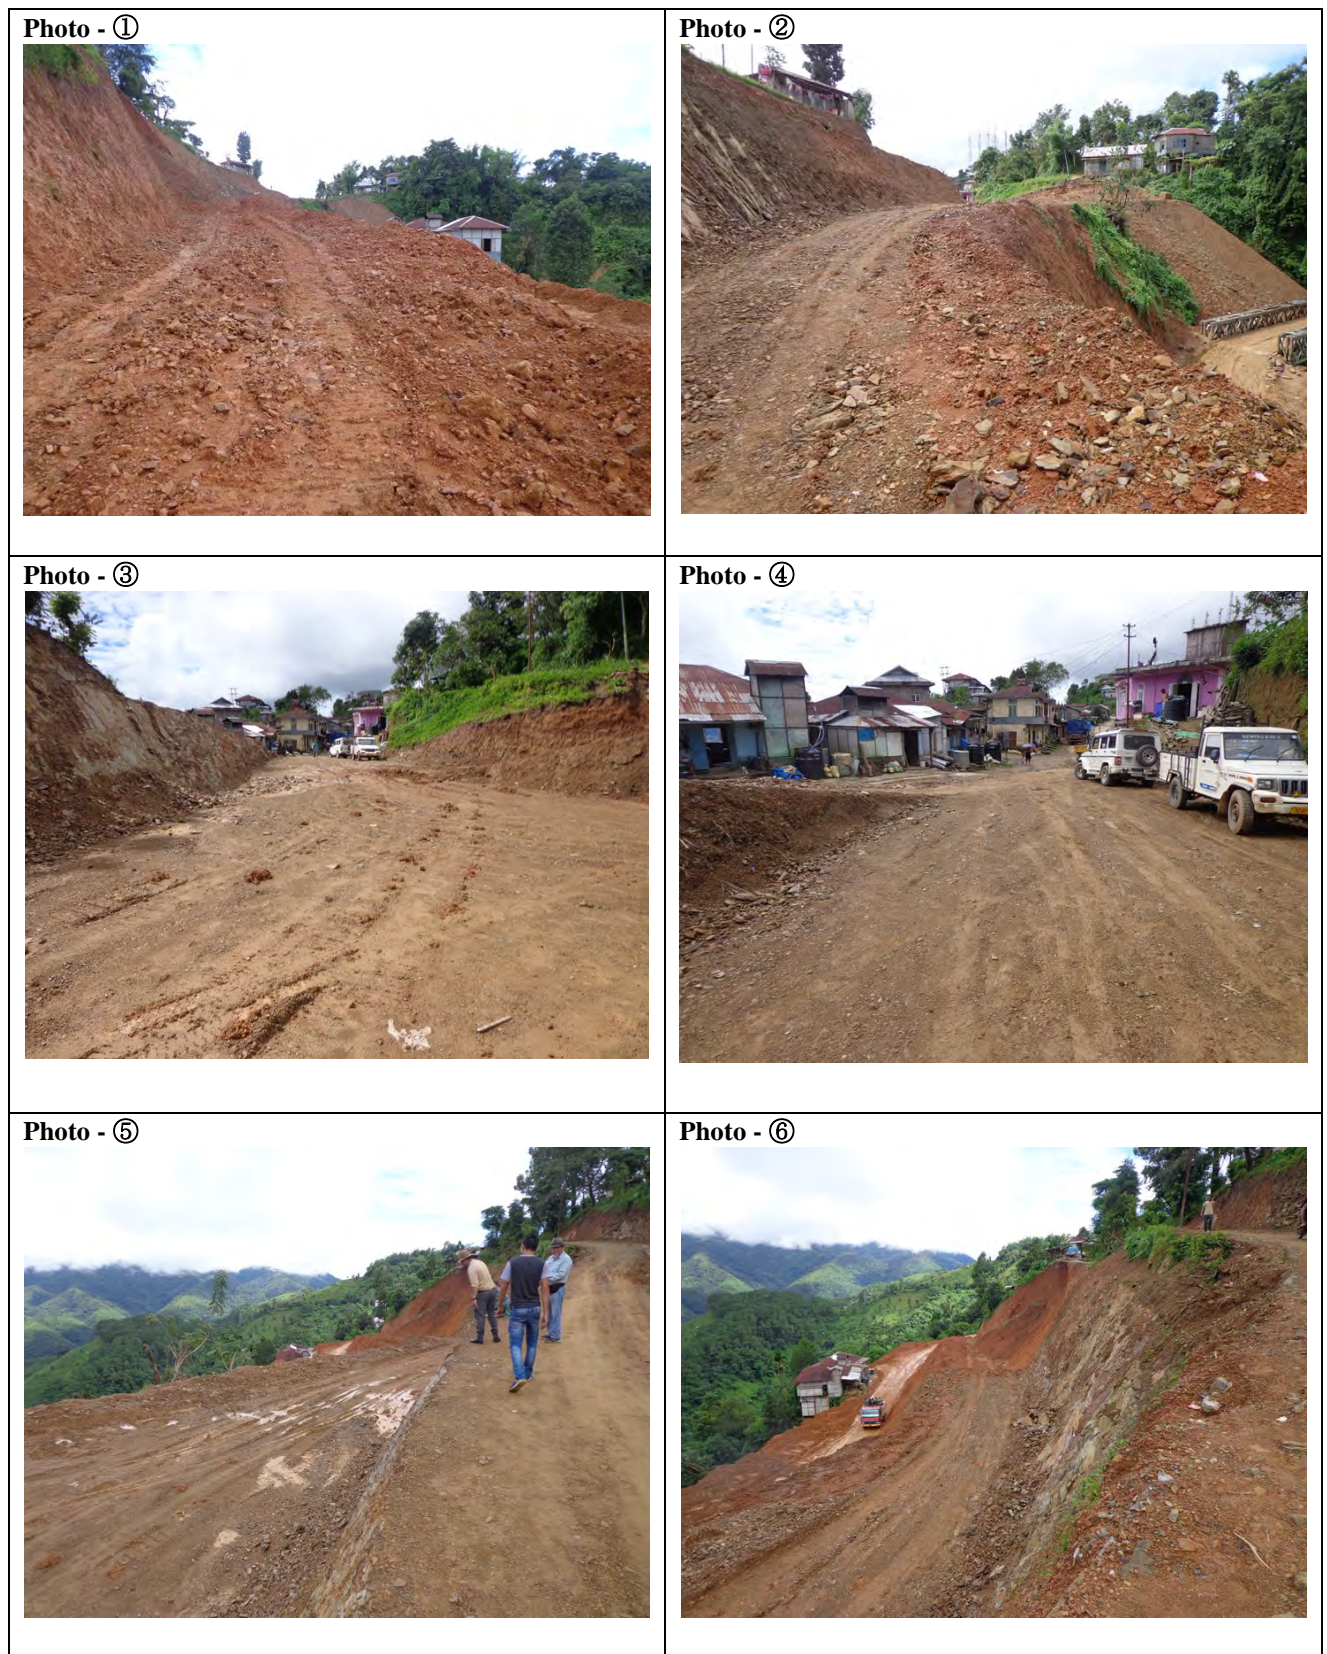
In the middle of August 2017, a new fact was found that the construction of shortcut road in Chhingchhip, located near the existing bailey bridge of NH54 was newly commenced by PWD (Refer to Figure 3.4-1, Figure 3.4-2). By a construction of shortcut road, NH54 can be connected without passing over the curved gully section where bailey bridge is placed at present. Hence, it is required for the design modification that route plan is revised by taking account of the existence of the shortcut road.

**Figure 3.4-2 Short-cut Road in Chhingchhip**

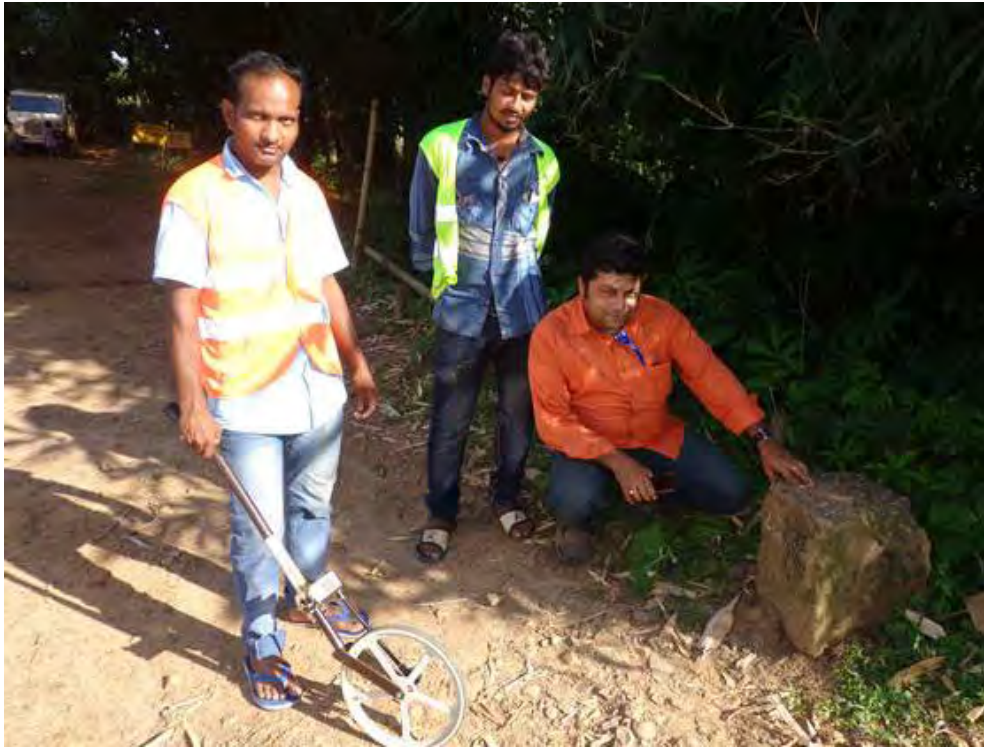
**Figure 4.2-1 View of Topographical Survey (Datum Level Check)**

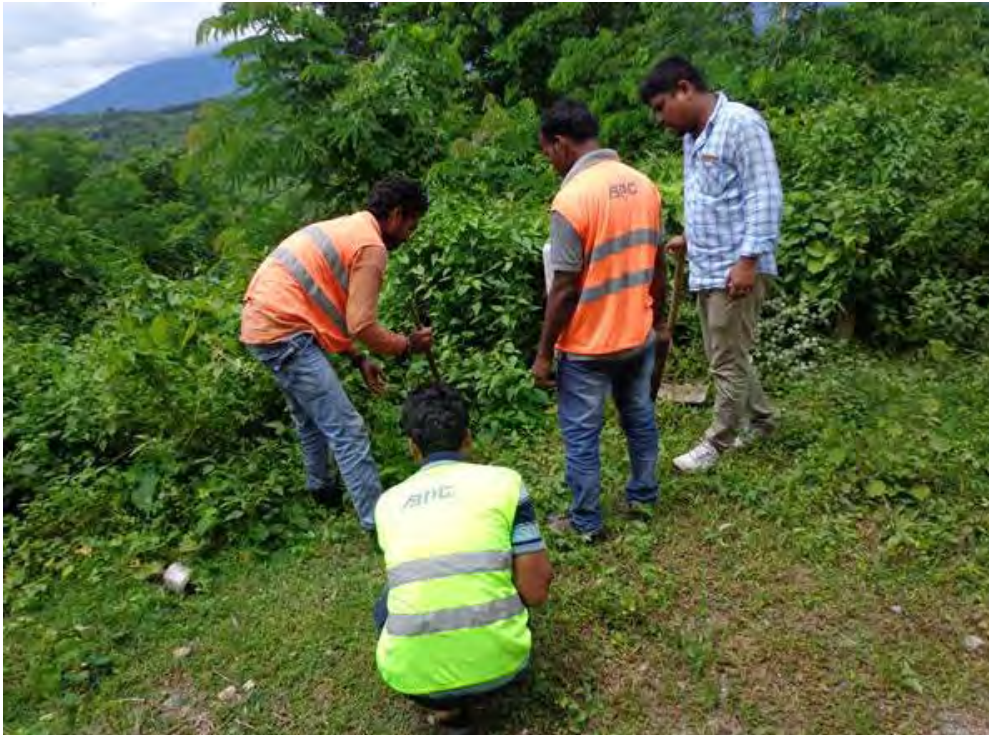
**Figure 4.3-1 View of Geological/ Geotechnical Survey (Wooden Peg Installation)**

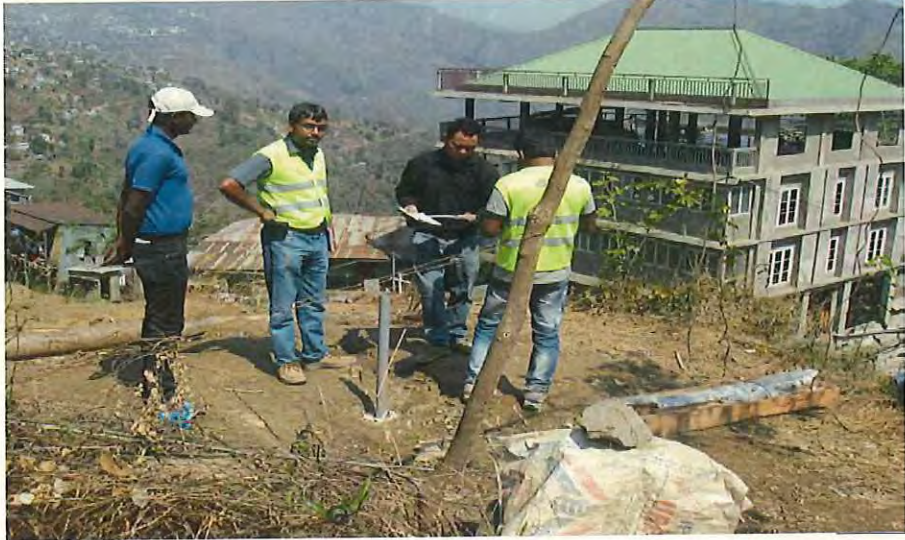
<p align="center"><b>Photo No. 1</b></p> <p><b>DATE:</b> 9-March-2017</p> <p><b>DESCRIPTION:</b></p> <p><b>Borehole Works</b>                      LS No. : A03                      B No. : BH-1                      General View                      with Geo-technical Engineers                      Completed on 28th Feb.                      Depth=20m</p> <p><b>LOCATION:</b> Sta. 8+430~8+490</p>

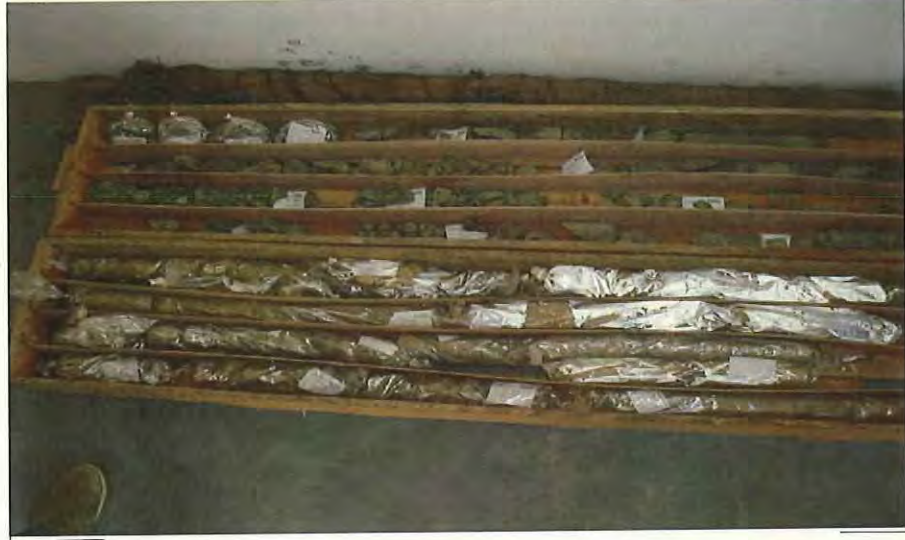
<p align="center"><b>Photo No. 2</b></p> <p><b>DATE:</b> 9-March-2017</p> <p><b>DESCRIPTION:</b></p> <p><b>Borehole Works</b>                      LS No. : A03                      B No. : BH-1                      Core Box</p> <p>Completed on 28th Feb. Depth=20m</p> <p><b>LOCATION:</b> Sta. 8+430~8+490</p>

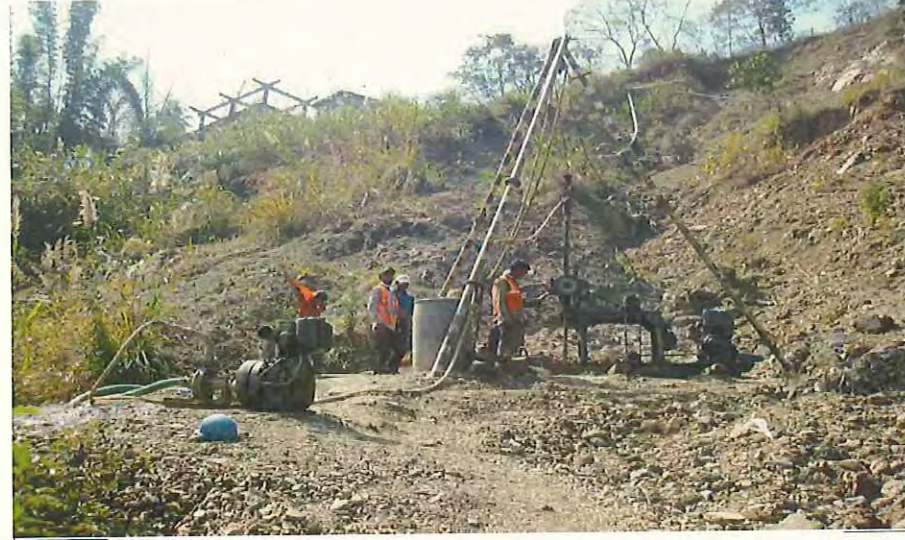
<p align="center"><b>Photo No. 3</b></p> <p><b>DATE:</b> 9-March-2017</p> <p><b>DESCRIPTION:</b></p> <p><b>Borehole Works</b>                      LS No. : A03                      B No. : BH-2                      General View                      Started on 2nd March</p> <p><b>LOCATION:</b> Sta. 8+430~8+490</p>

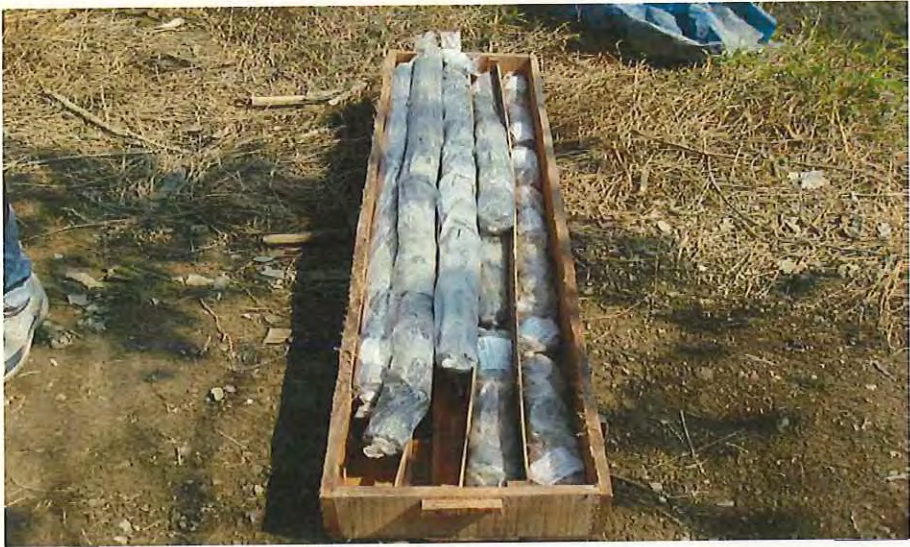
<p align="center"><b>Photo No. 4</b></p> <p><b>DATE:</b> 9-March-2017</p> <p><b>DESCRIPTION:</b></p> <p><b>Borehole Works</b>                      LS No. : A03                      B No. : BH-2                      Core Box                      Progress : As of 9th March                      Depth=22m</p> <p><b>LOCATION:</b> Sta. 8+430~8+490</p>

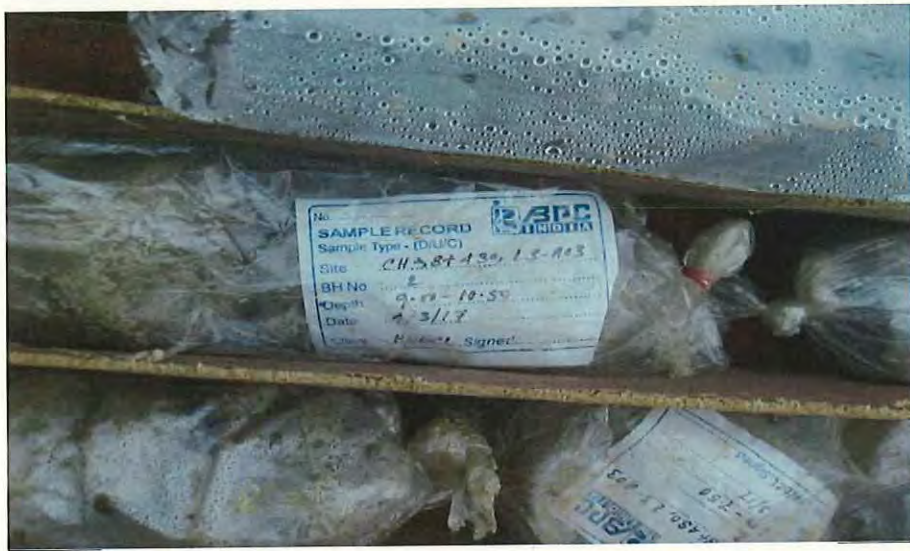
<p align="center"><b>Photo No. 5</b></p> <p><b>DATE:</b> 9-March-2017</p> <p><b>DESCRIPTION:</b></p> <p><b>Borehole Works</b>                      LS No. : A03                      B No. : BH-2                      Core Box                      Label of Sample Record</p> <p><b>LOCATION:</b> Sta. 8+430~8+490</p>

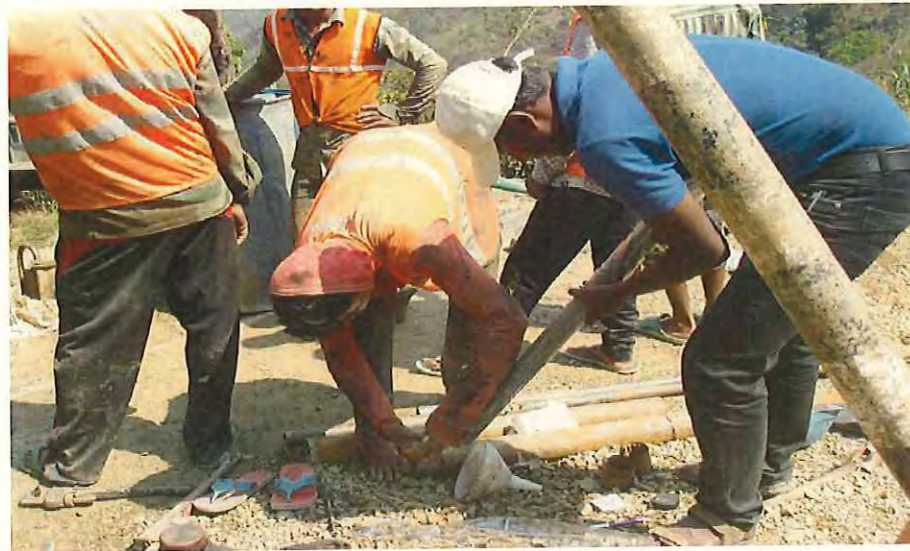
<p align="center"><b>Photo No. 6</b></p> <p><b>DATE:</b> 9-March-2017</p> <p><b>DESCRIPTION:</b></p> <p><b>Borehole Works</b>                      LS No. : A03                      B No. : BH-2                      Core Extraction</p> <p><b>LOCATION:</b> Sta. 8+430~8+490</p>

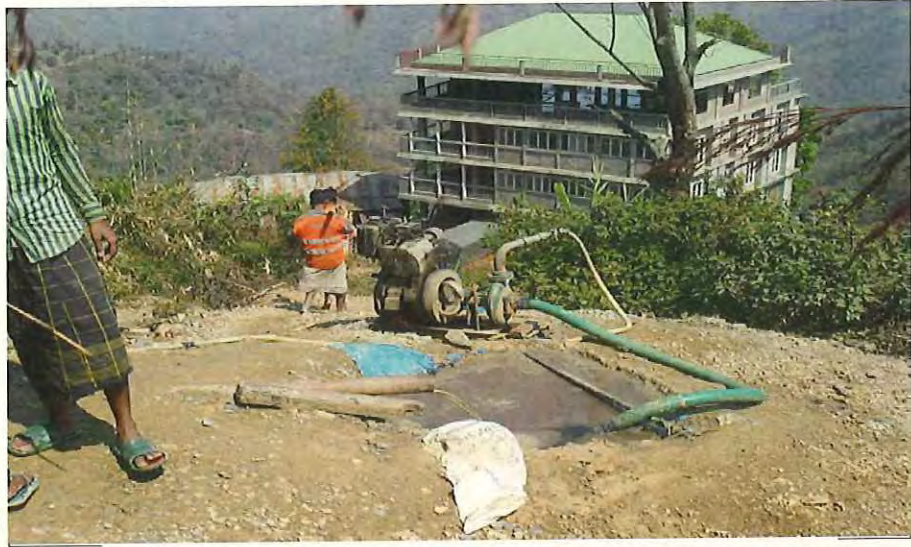
<p align="center"><b>Photo No. 7</b></p> <p><b>DATE:</b> 9-March-2017</p> <p><b>DESCRIPTION:</b></p> <p><b>Borehole Works</b> LS No. : A03 B No. : BH-2 Drilling Mud Treatment</p> <p><b>LOCATION:</b> Sta. 8+430~8+490</p>

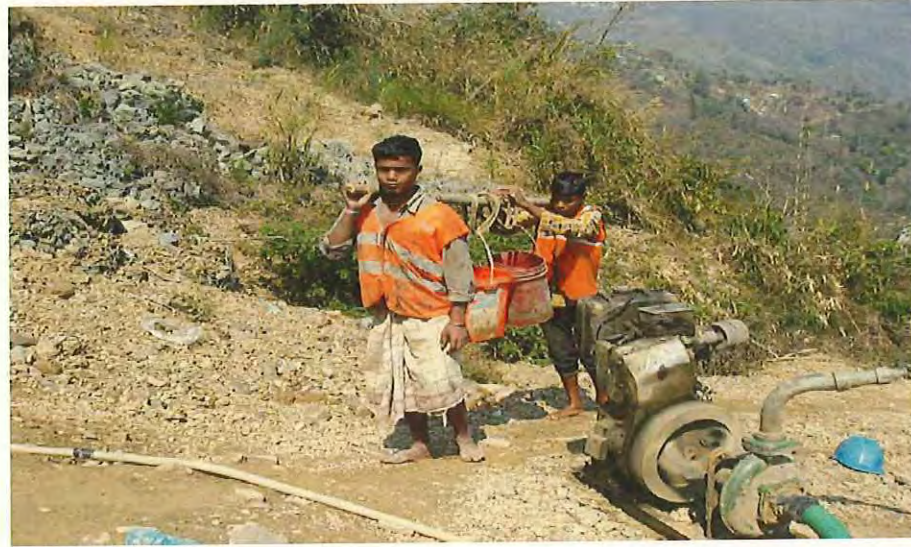
<p align="center"><b>Photo No. 8</b></p> <p><b>DATE:</b> 9-March-2017</p> <p><b>DESCRIPTION:</b></p> <p><b>Borehole Works</b> LS No. : A03 B No. : BH-2 Water Supply</p> <p><b>LOCATION:</b> Sta. 8+430~8+490</p>

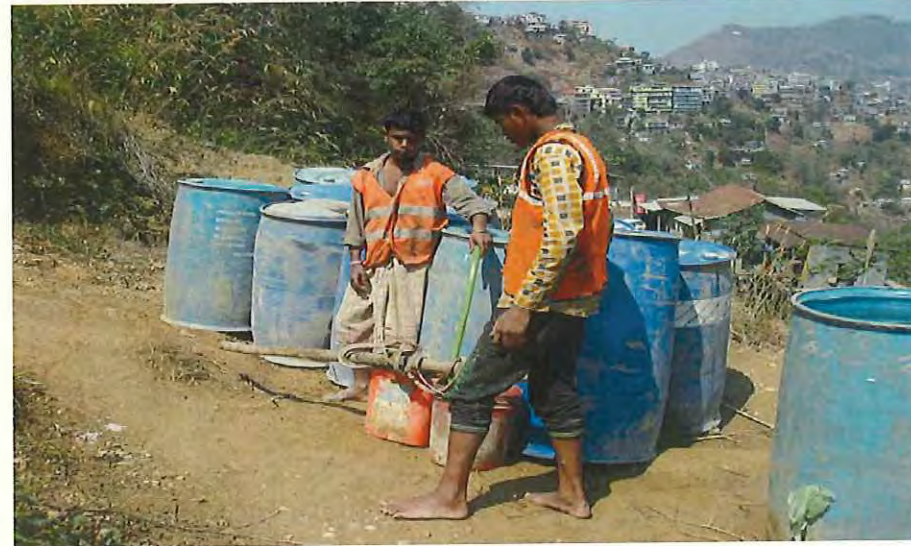
<p align="center"><b>Photo No. 9</b></p> <p><b>DATE:</b> 9-March-2017</p> <p><b>DESCRIPTION:</b></p> <p><b>Borehole Works</b> LS No. : A03 B No. : BH-2 Water Stock Tanks</p> <p><b>LOCATION:</b> Sta. 8+430~8+490</p>

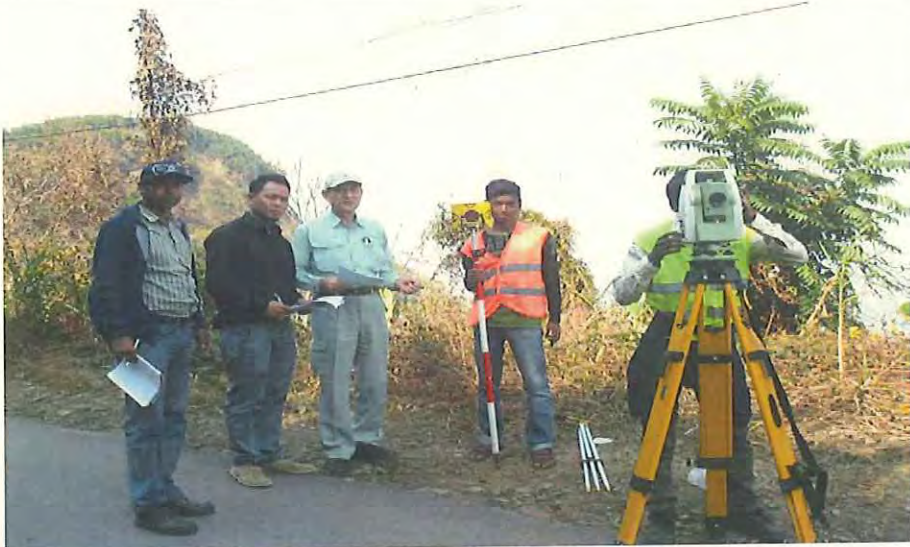
<p align="center"><b>Photo No. 10</b></p> <p><b>DATE:</b> 9-March-2017</p> <p><b>DESCRIPTION:</b>  Secondary Control Point Survey (TBM) Works  Total Station Survey Team-B Observation</p> <p><b>LOCATION:</b> Sta. 59+250</p>

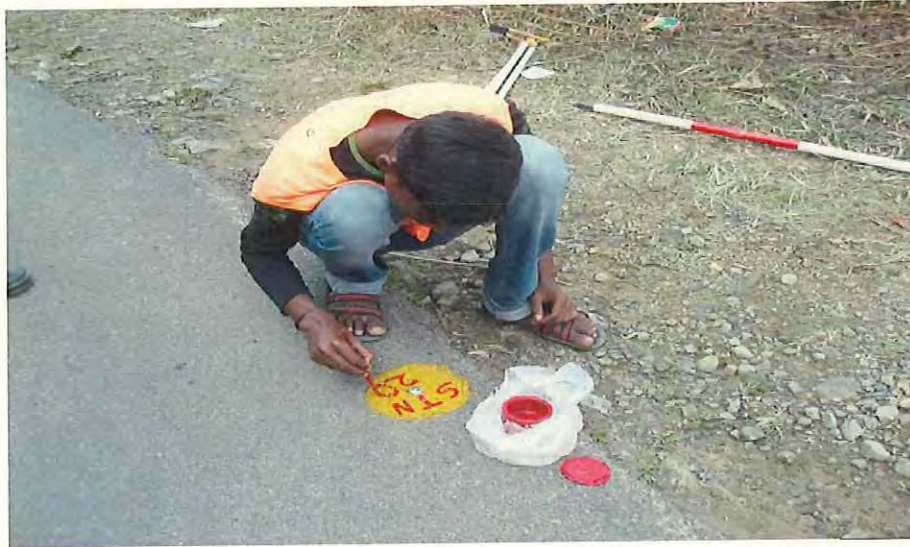
<p align="center"><b>Photo No. 11</b></p> <p><b>DATE:</b> 9-March-2017</p> <p><b>DESCRIPTION:</b>  Secondary Control Point Survey (TBM) Works  Total Station Survey Team-B Painting of Traverse Point</p> <p><b>LOCATION:</b> Sta. 59+300</p>

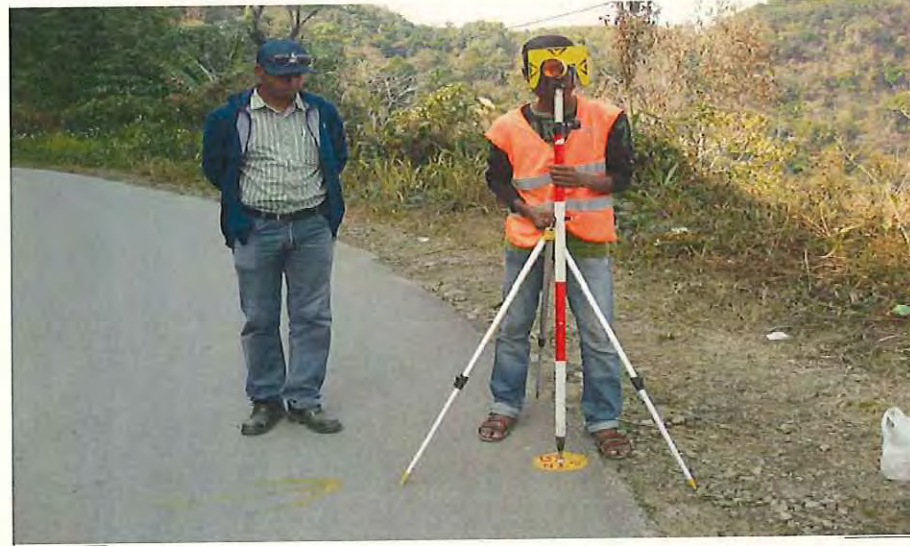
<p align="center"><b>Photo No. 12</b></p> <p><b>DATE:</b> 9-March-2017</p> <p><b>DESCRIPTION:</b>  Secondary Control Point Survey (TBM) Works  Total Station Survey Team-B Setting of Mirror with Team Leader</p> <p><b>LOCATION:</b> Sta. 59+300</p>

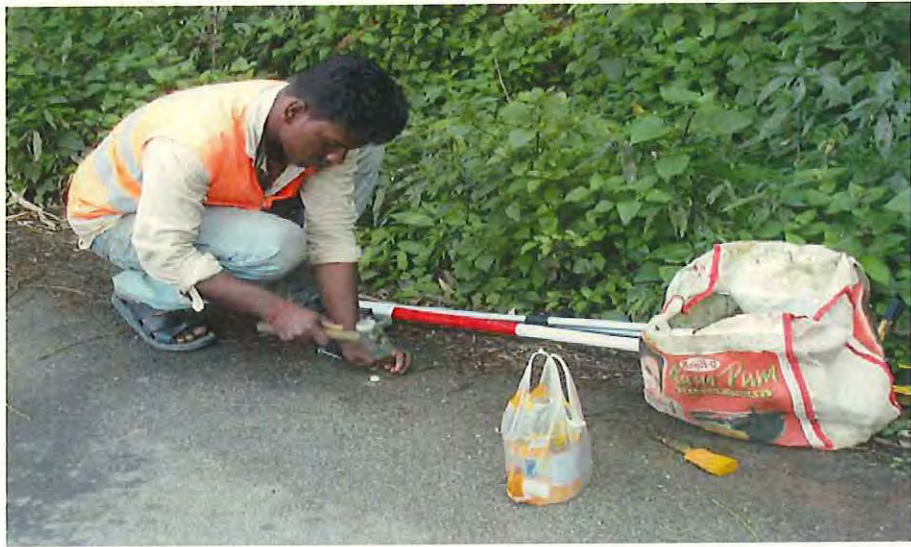
<p align="center"><b>Photo No. 13</b></p> <p><b>DATE:</b> 9-March-2017</p> <p><b>DESCRIPTION:</b>  Secondary Control Point Survey (TBM) Works  Total Station Survey Team-B Nail hitting of Traverse Point</p> <p><b>LOCATION:</b> Sta. 59+350</p>

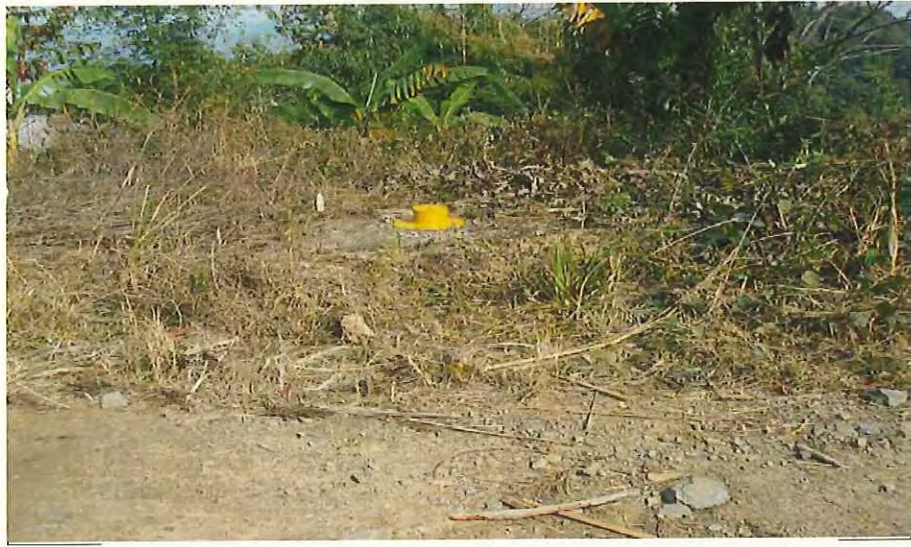
<p align="center"><b>Photo No. 14</b></p> <p><b>DATE:</b> 9-March-2017</p> <p><b>DESCRIPTION:</b>  Secondary Control Point Survey (TBM) Works  Concrete Pillar of intermediate DGPS</p> <p><b>LOCATION:</b> Sta. 59+500</p>

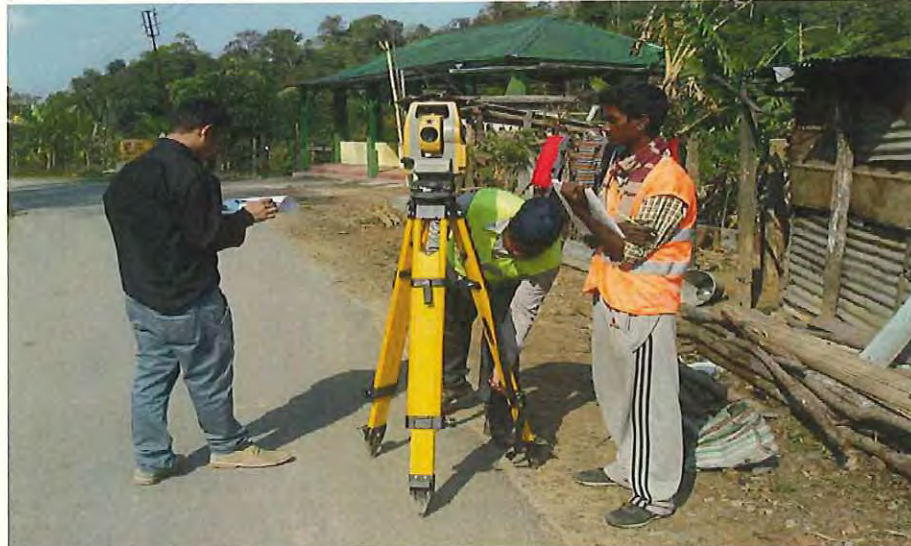
<p align="center"><b>Photo No. 15</b></p> <p><b>DATE:</b> 9-March-2017</p> <p><b>DESCRIPTION:</b>  Secondary Control Point Survey (TBM) Works  Total Station Survey Team-A Setting of Equipment</p> <p><b>LOCATION:</b> Sta. 61+700</p>

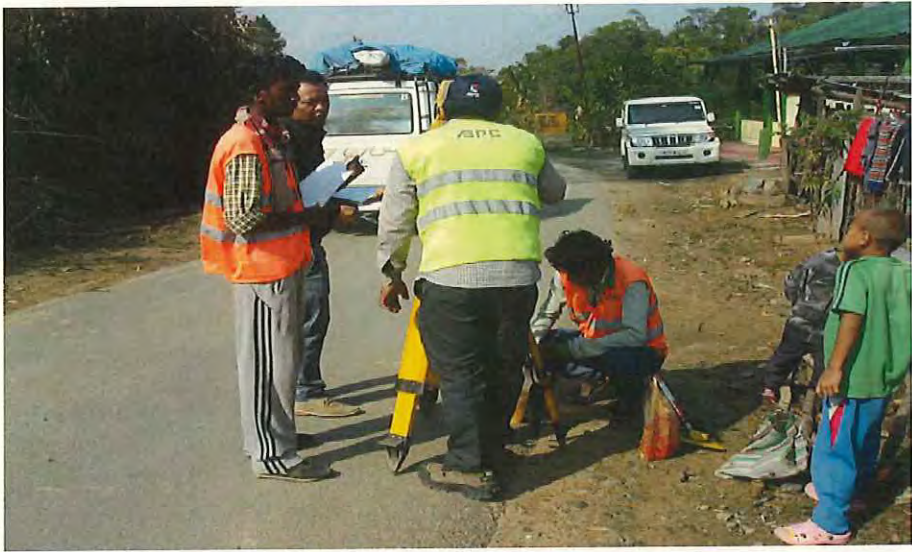
<p align="center"><b>Photo No. 16</b></p> <p><b>DATE:</b> 9-March-2017</p> <p><b>DESCRIPTION:</b>  Secondary Control Point Survey (TBM) Works  Total Station Survey Team-A Observation toward the Backsight</p> <p><b>LOCATION:</b> Sta. 61+700</p>

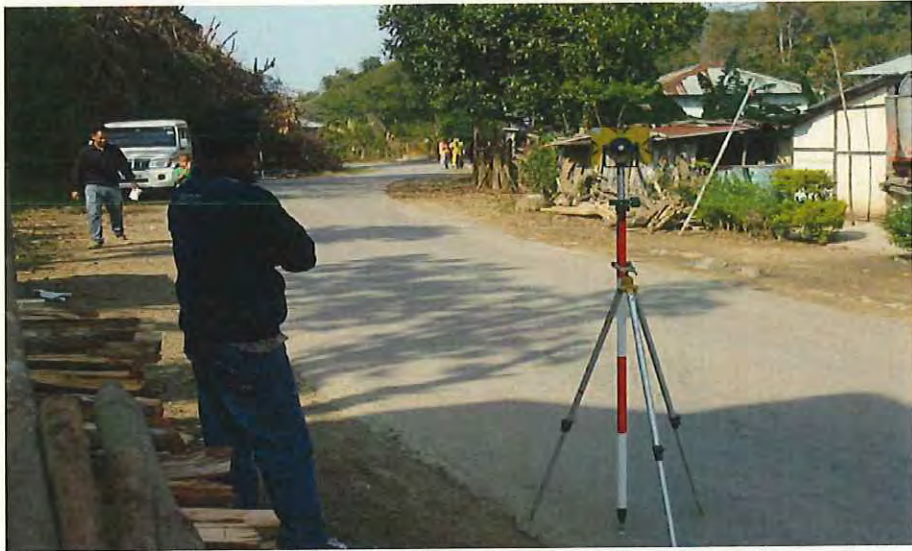
<p align="center"><b>Photo No. 17</b></p> <p><b>DATE:</b> 9-March-2017</p> <p><b>DESCRIPTION:</b>  Secondary Control Point Survey (TBM) Works  Total Station Survey Team-A Observation toward the Foresight</p> <p><b>LOCATION:</b> Sta. 61+700</p>

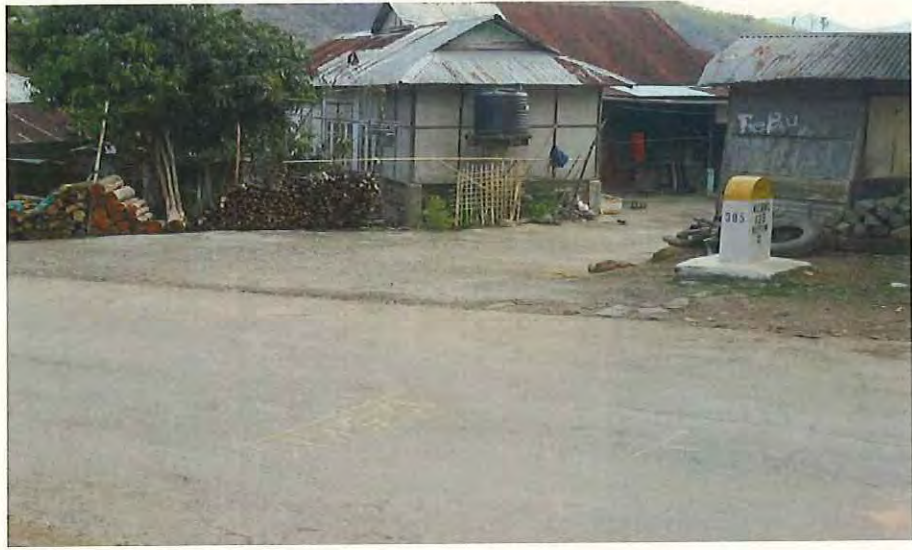
<p align="center"><b>Photo No. 18</b></p> <p><b>DATE:</b> 9-March-2017</p> <p><b>DESCRIPTION:</b>  Kilo Post at Keitum Border between Section 1 &amp; 2 End Point of Section-1 CH=122+023 Beginnig Point of Section-2 CH=125+000</p> <p><b>LOCATION:</b> Sta. 125+000</p>

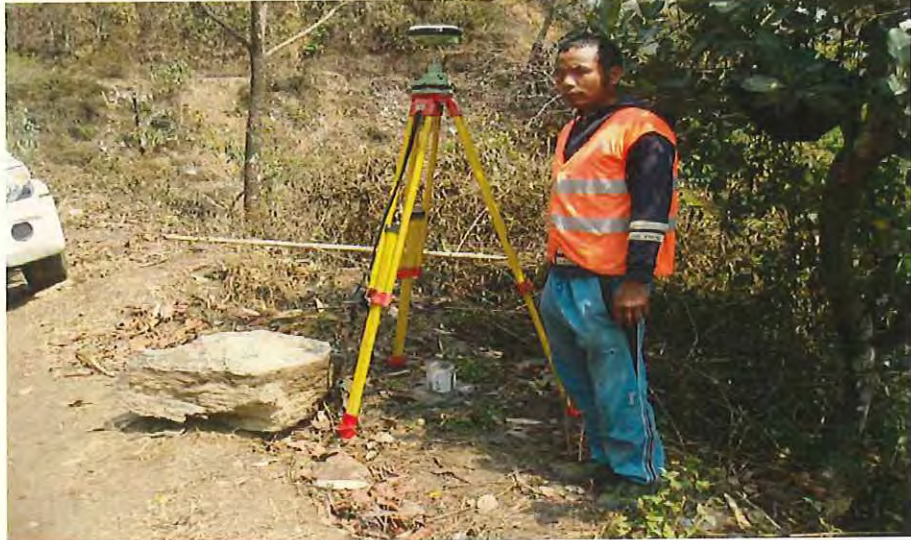
<p align="center"><b>Photo No. 19</b></p> <p><b>DATE:</b> 10-March-2017</p> <p><b>DESCRIPTION:</b>   <b>DGPS Survey Works</b>                      on Reference Point Pillar                      (GCP62A)                      Receiving the Satellite Data</p> <p><b>LOCATION:</b> Sta. 162+500</p>

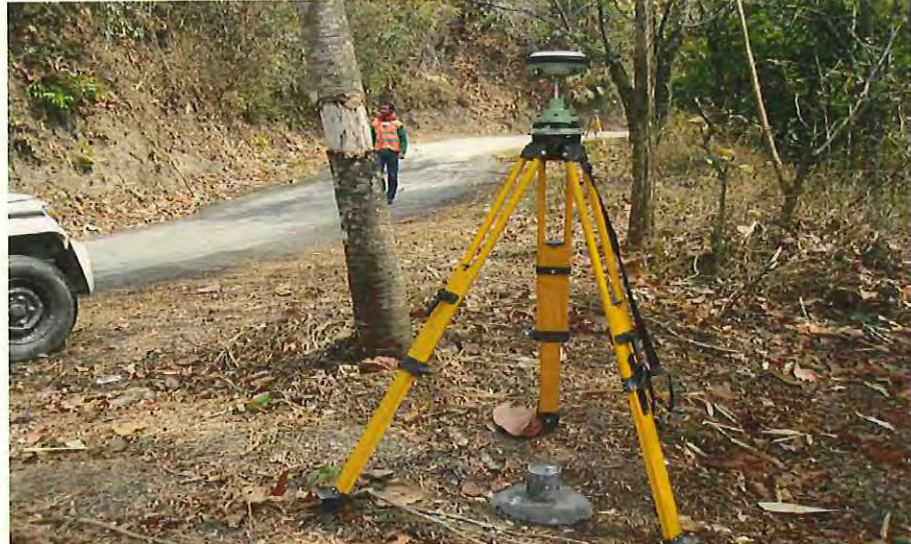
<p align="center"><b>Photo No. 20</b></p> <p><b>DATE:</b> 10-March-2017</p> <p><b>DESCRIPTION:</b>   <b>DGPS Survey Works</b>                      on Reference Point Pillar                      (GCP63B)                      Receiving the Satellite Data</p> <p><b>LOCATION:</b> Sta. 165+000</p>

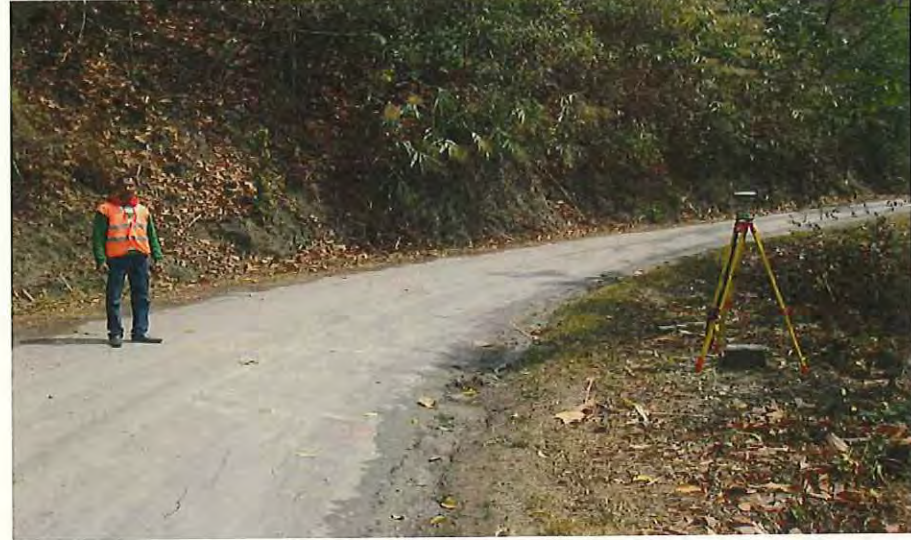
<p align="center"><b>Photo No. 21</b></p> <p><b>DATE:</b> 10-March-2017</p> <p><b>DESCRIPTION:</b>   <b>DGPS Survey Works</b>                      on Main Point Pillar                      (GCP63A)                      Receiving the Satellite Data</p> <p><b>LOCATION:</b> Sta. 165+000</p>

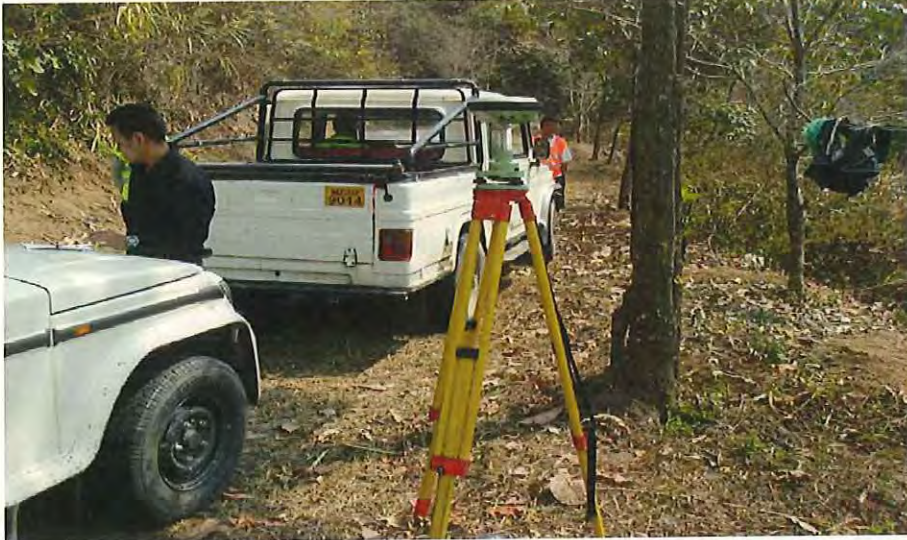
<p align="center"><b>Photo No. 22</b></p> <p><b>DATE:</b> 10-March-2017</p> <p><b>DESCRIPTION:</b>  DGPS Survey Works on Reference Point Pillar (GCP64B) Receiving the Satellite Data</p> <p><b>LOCATION:</b> Sta. 167+500</p>

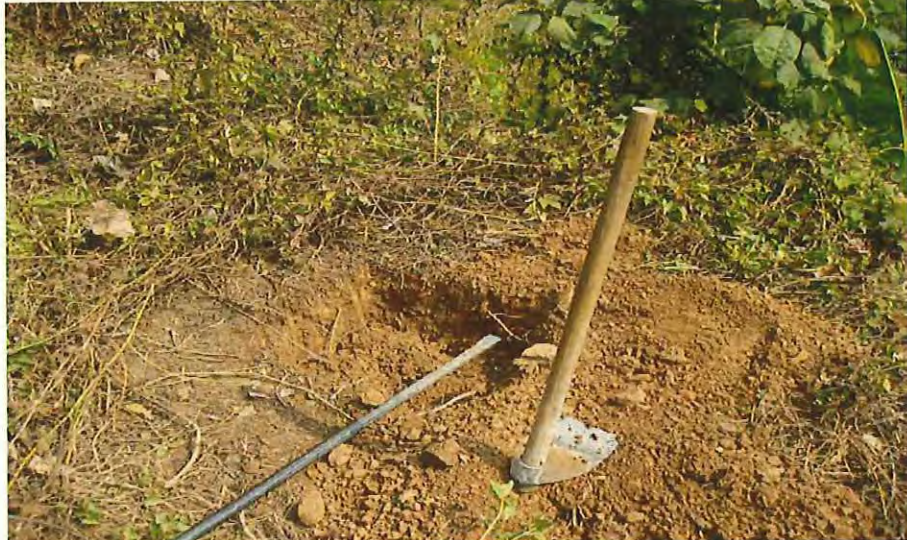
<p align="center"><b>Photo No. 23</b></p> <p><b>DATE:</b> 10-March-2017</p> <p><b>DESCRIPTION:</b>  Pillar Fixation Works (Main DGPS) Excavation of Pillar</p> <p><b>LOCATION:</b> Sta. 195+100</p>

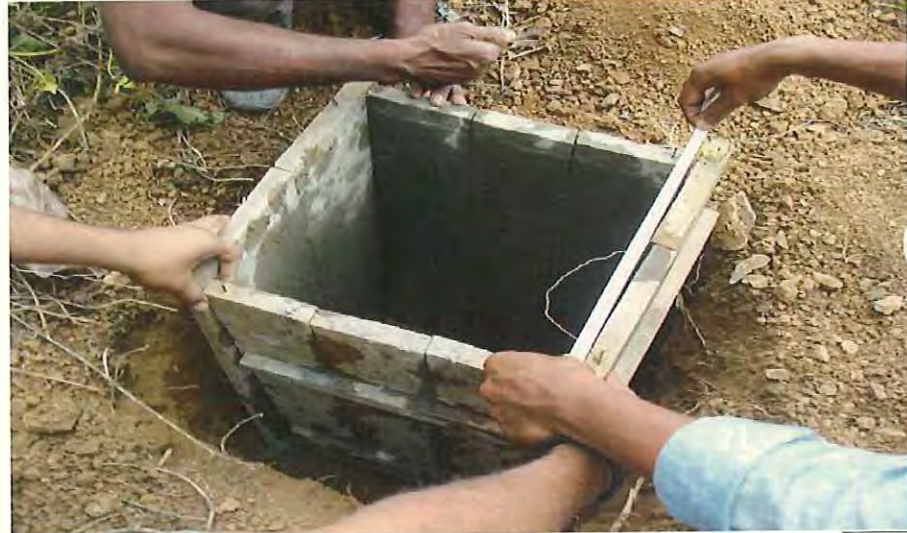
<p align="center"><b>Photo No. 24</b></p> <p><b>DATE:</b> 10-March-2017</p> <p><b>DESCRIPTION:</b>  Pillar Fixation Works (Main DGPS) Setting of Form (30cm x 30cm)</p> <p><b>LOCATION:</b> Sta. 195+100</p>

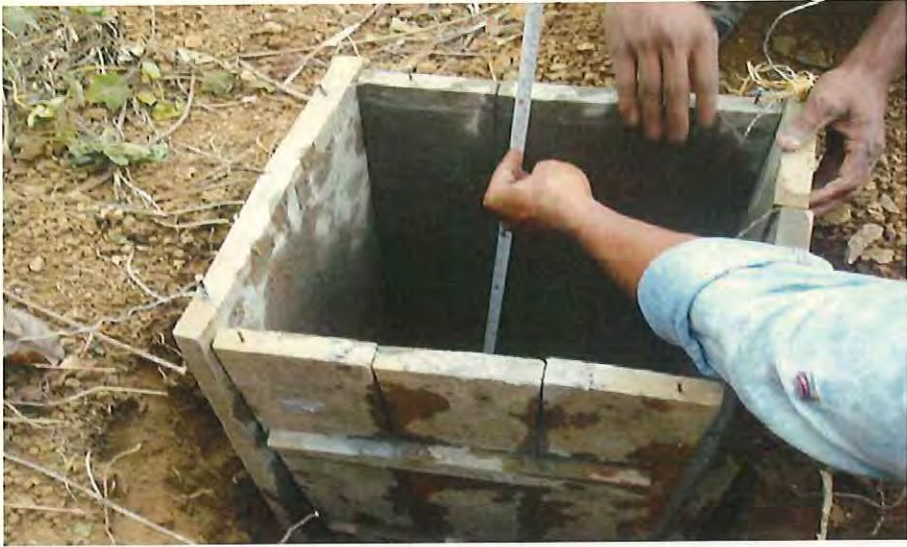
<p><b>Photo No. 25</b></p> <p><b>DATE:</b> 10-March-2017</p> <p><b>DESCRIPTION:</b>  <b>Pillar Fixation Works</b> (Main DGPS) Setting of Form (30cm × 30cm × 60cm)</p> <p><b>LOCATION:</b> Sta. 195+100</p>
