**PREPARATORY STUDY  
FOR  
ROAD NETWORK IMPROVEMENT  
IN  
NORTH-EAST STATES OF INDIA**

**FINAL REPORT**

**(Volume 3: Supplementary Technical Assistance for Additional  
Engineering Surveys and Design Modification / Application of  
Contract Mode and Preparation of Technical Specifications)**

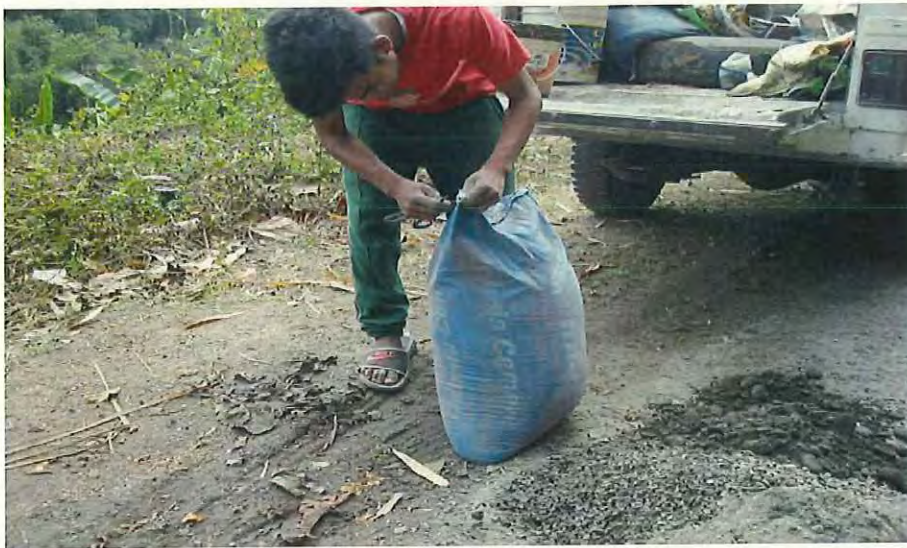
<p><b>Photo No. 26</b></p> <p><b>DATE:</b> 10-March-2017</p> <p><b>DESCRIPTION:</b>  <b>Pillar Fixation Works</b> (Main DGPS) Cement (Indian Cement)</p> <p><b>LOCATION:</b> Sta. 195+100</p>

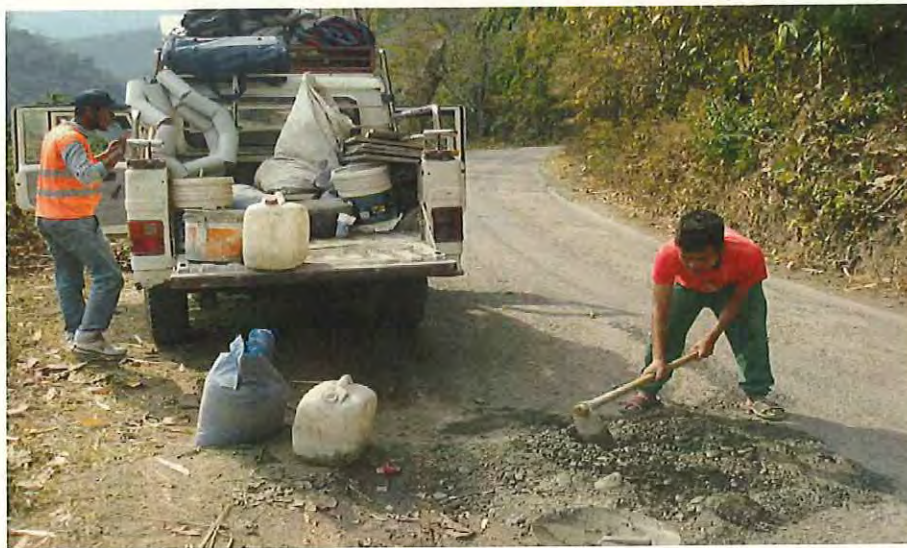
<p><b>Photo No. 27</b></p> <p><b>DATE:</b> 10-March-2017</p> <p><b>DESCRIPTION:</b>  <b>Pillar Fixation Works</b> (Main DGPS) Mixing by Manual</p> <p><b>LOCATION:</b> Sta. 195+100</p>

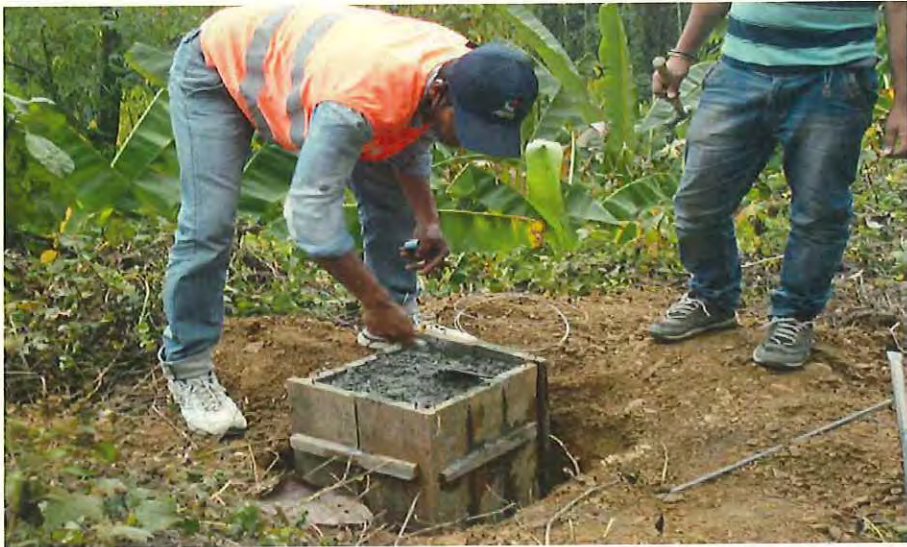
<p align="center"><b>Photo No. 28</b></p> <p><b>DATE:</b> 10-March-2017</p> <p><b>DESCRIPTION:</b>  Pillar Fixation Works (Main DGPS) Concrete Casting</p> <p><b>LOCATION:</b> Sta. 195+100</p>

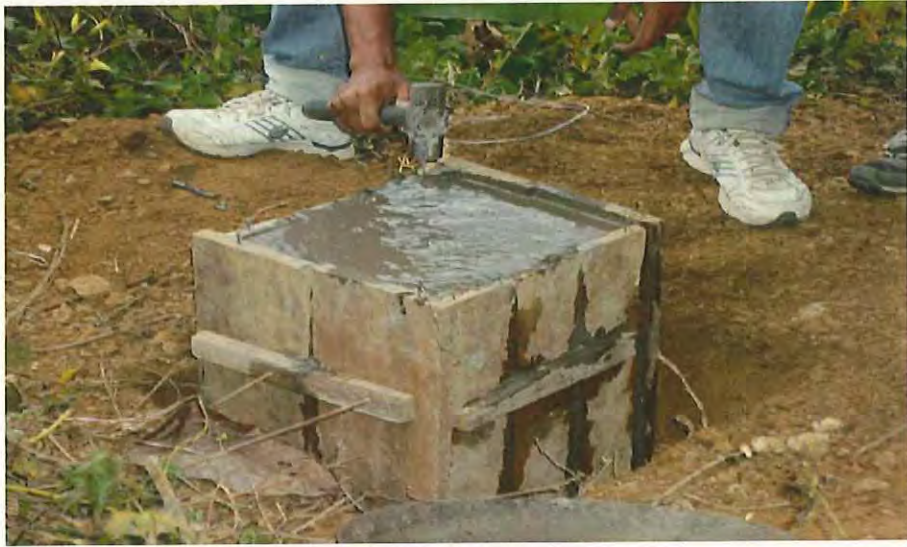
<p align="center"><b>Photo No. 29</b></p> <p><b>DATE:</b> 10-March-2017</p> <p><b>DESCRIPTION:</b>  Pillar Fixation Works (Main DGPS) Concrete Finishing</p> <p><b>LOCATION:</b> Sta. 195+100</p>

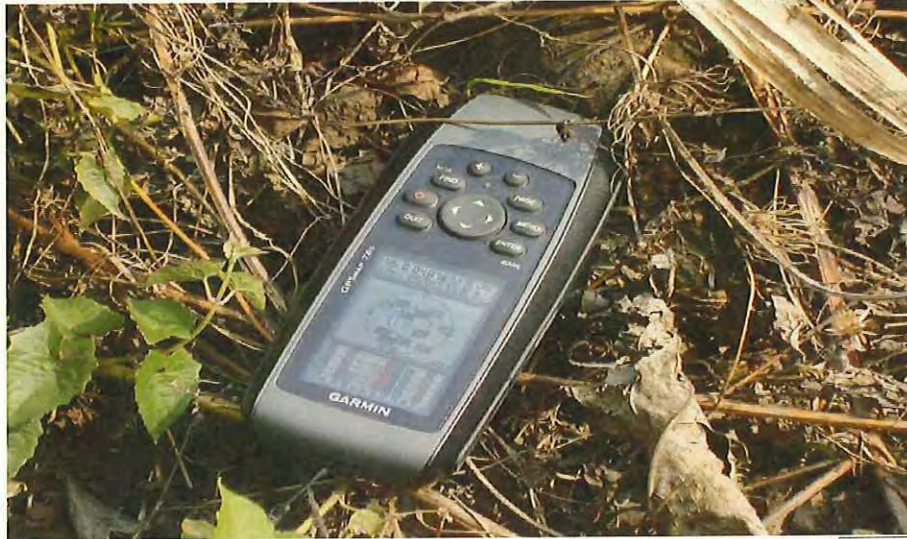
<p align="center"><b>Photo No. 30</b></p> <p><b>DATE:</b> 10-March-2017</p> <p><b>DESCRIPTION:</b>  Pillar Fixation Works  Portable GPS Receiver (GPS map 78s)</p> <p><b>LOCATION:</b> Sta. 195+100</p>

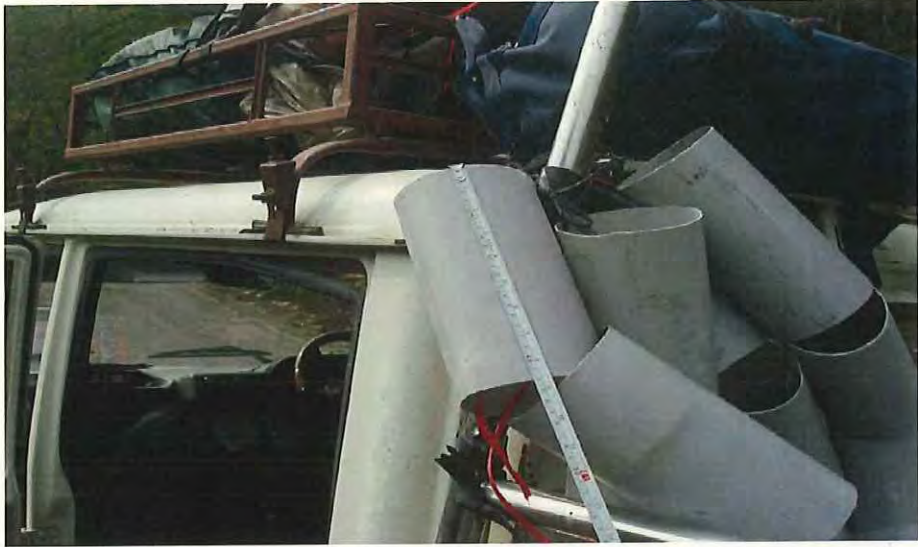
<p align="center"><b>Photo No. 31</b></p> <p><b>DATE:</b> 10-March-2017</p> <p><b>DESCRIPTION:</b>  Pillar Fixation Works  Form for Reference Piont Pillar (Polyvinyl Chloride Pipe)</p> <p><b>LOCATION:</b> Sta. 195+100</p>

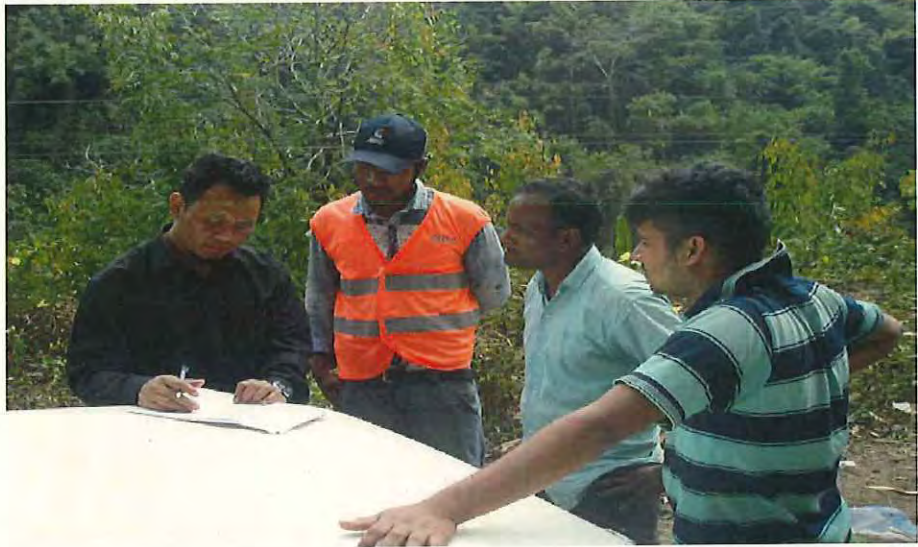
<p align="center"><b>Photo No. 32</b></p> <p><b>DATE:</b> 10-March-2017</p> <p><b>DESCRIPTION:</b>  Site Works Monitoring  Query the Pillar Fixation &amp; Chainage Marking Works to their Team Leaders by JICA Team's Assitant,</p> <p><b>LOCATION:</b> Sta. 195+100</p>

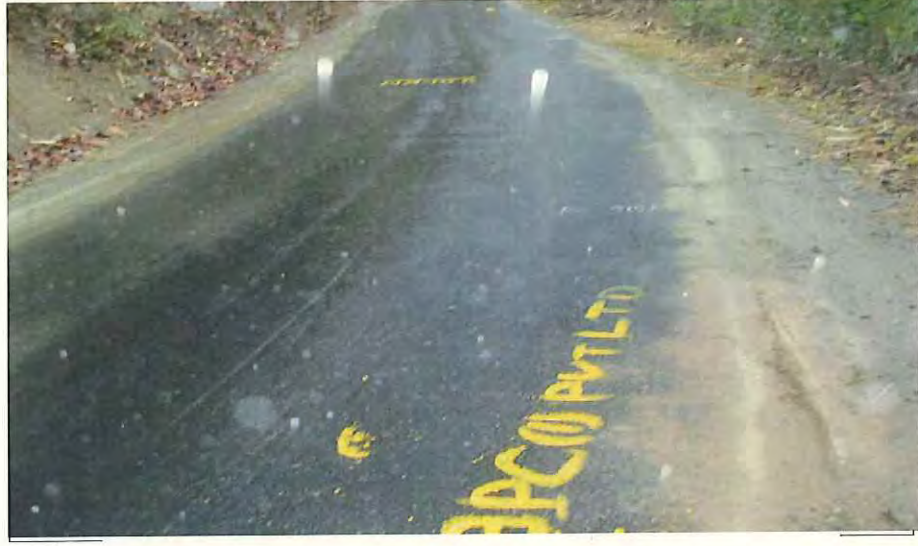
<p align="center"><b>Photo No. 33</b></p> <p><b>DATE:</b> 10-March-2017</p> <p><b>DESCRIPTION:</b>  Chainage Marking Works  Progress : up to 201km No work, due to rainy day</p> <p><b>LOCATION:</b> Sta. 201+000</p>

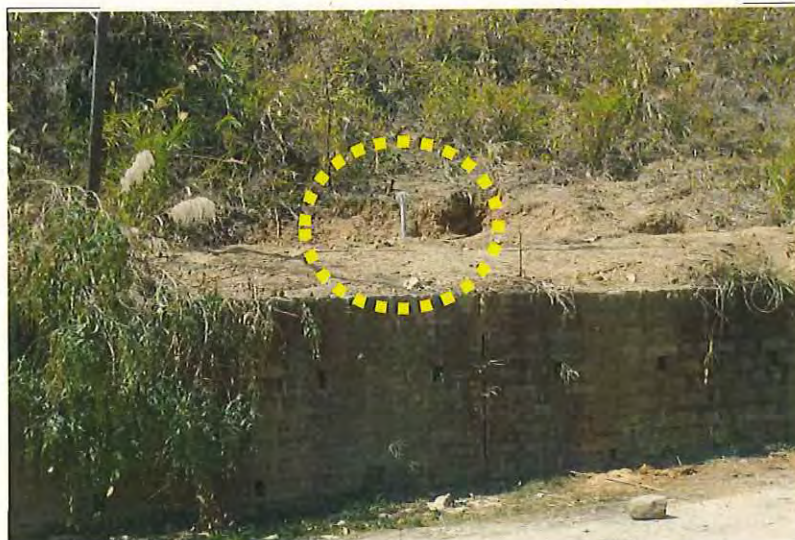
<p style="text-align: center;"><b>Photo No. 2</b></p> <p><b>DATE:</b> 15-March-2017</p> <p><b>DESCRIPTION:</b>  Borehole Works LS No. : A05 B No. : BH-1 Completed on 7th March Depth=30m</p> <p><b>LOCATION:</b> CH 10+450</p>

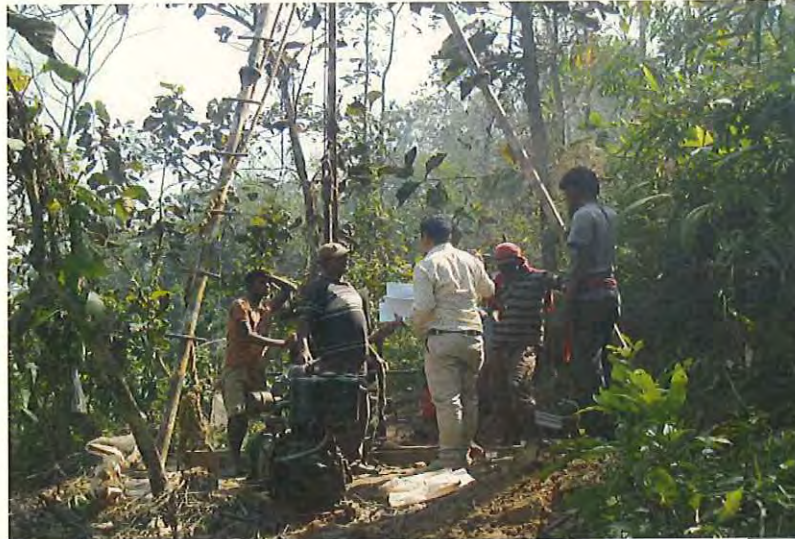
<p style="text-align: center;"><b>Photo No. 3</b></p> <p><b>DATE:</b> 15-March-2017</p> <p><b>DESCRIPTION:</b>  Borehole Works LS No. : A11 B No. : BH-1 General View Started on 15th March</p> <p><b>LOCATION:</b> CH 18+680</p>

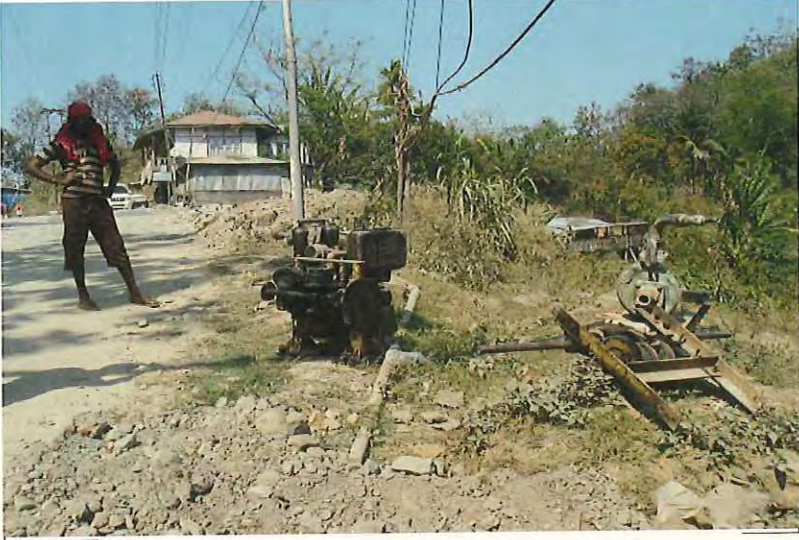
<p align="center"><b>Photo No. 4</b></p> <p><b>DATE:</b> 15-March-2017</p> <p><b>DESCRIPTION:</b>  Borehole Works LS No. : A12  Movement Work for assemble only</p> <p><b>LOCATION:</b> CH 18+850</p>

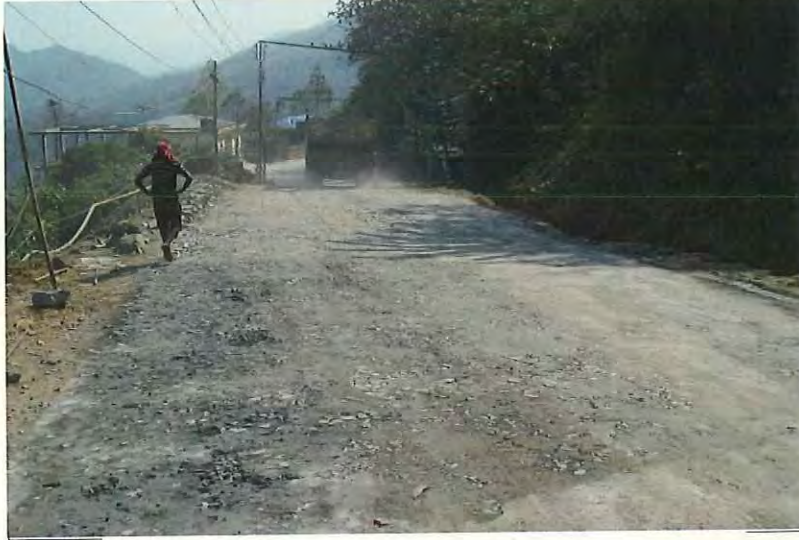
<p align="center"><b>Photo No. 5</b></p> <p><b>DATE:</b> 15-March-2017</p> <p><b>DESCRIPTION:</b>  Landslide Site No. A12  Road has been repaired by PWD (Covered by Sand &amp; Gravel)</p> <p><b>LOCATION:</b> CH 18+850</p>

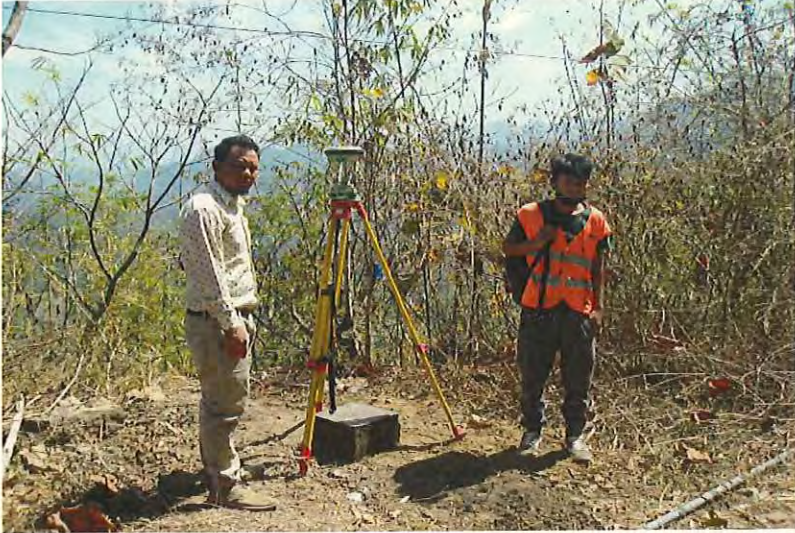
<p align="center"><b>Photo No. 8</b></p> <p><b>DATE:</b> 16-March-2017</p> <p><b>DESCRIPTION:</b>  DGPS Works (GCP81A)  Receiving the Satellite Data</p> <p><b>LOCATION:</b> CH 210+000</p>

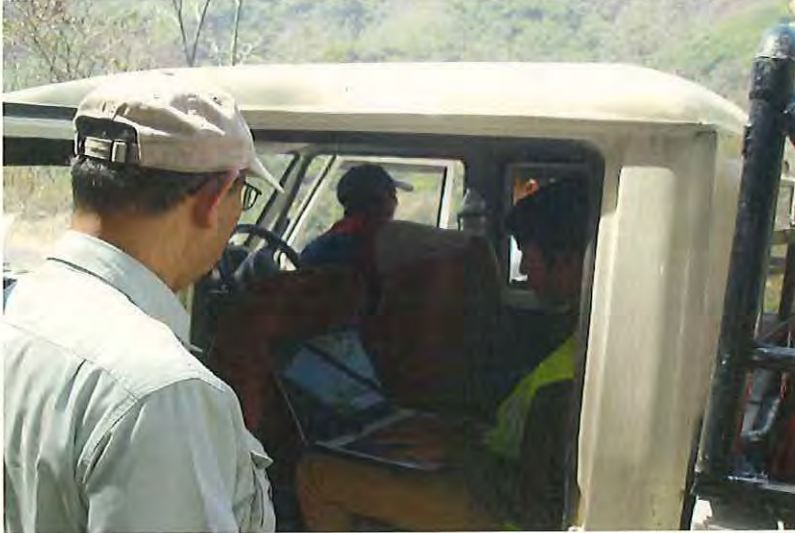
<p align="center"><b>Photo No. 9</b></p> <p><b>DATE:</b> 16-March-2017</p> <p><b>DESCRIPTION:</b>  DGPS Works  DGPS's Data collection from BPC's Surveyor</p> <p><b>LOCATION:</b> CH 208+300</p>

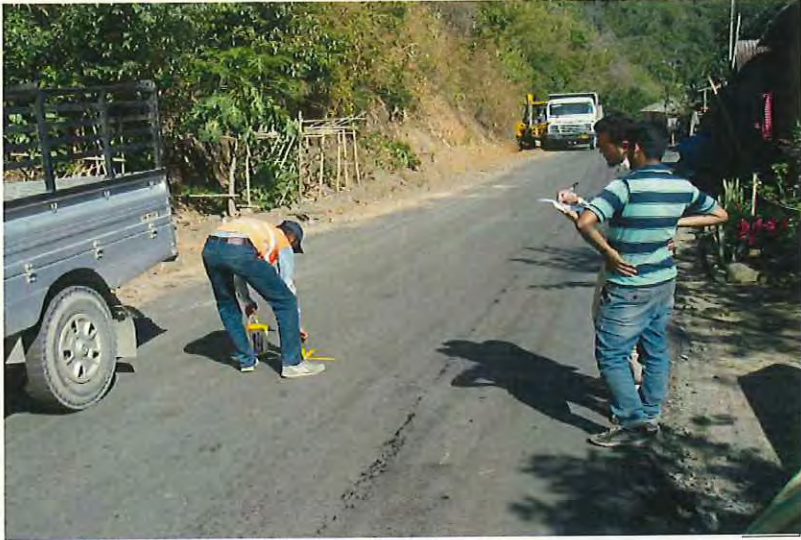
<p align="center"><b>Photo No. 10</b></p> <p><b>DATE:</b> 16-March-2017</p> <p><b>DESCRIPTION:</b>  Chainage Marking Works on Existing Alignment  Hearing to Team-A</p> <p><b>LOCATION:</b> CH 232+625</p>

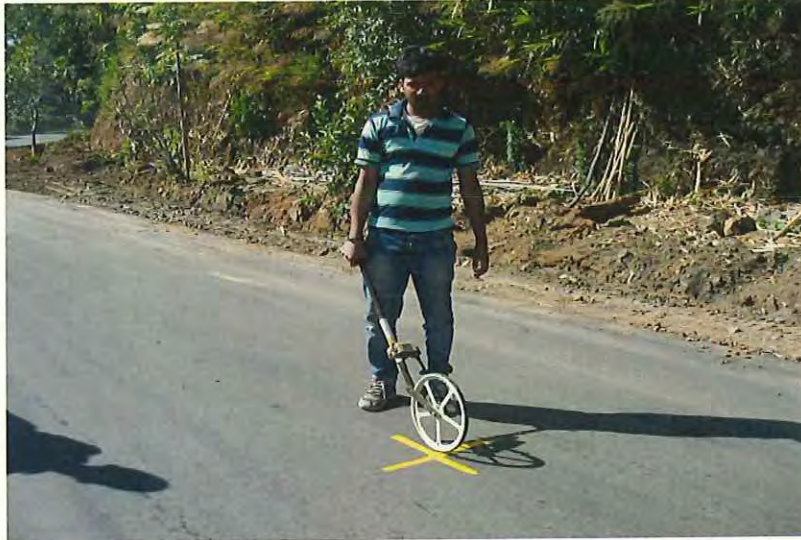
<p align="center"><b>Photo No. 11</b></p> <p><b>DATE:</b> 16-March-2017</p> <p><b>DESCRIPTION:</b>  Chainage Marking Works on Existing Alignment  Distance Measuring Wheeler (Team-A)</p> <p><b>LOCATION:</b> CH 232+625</p>

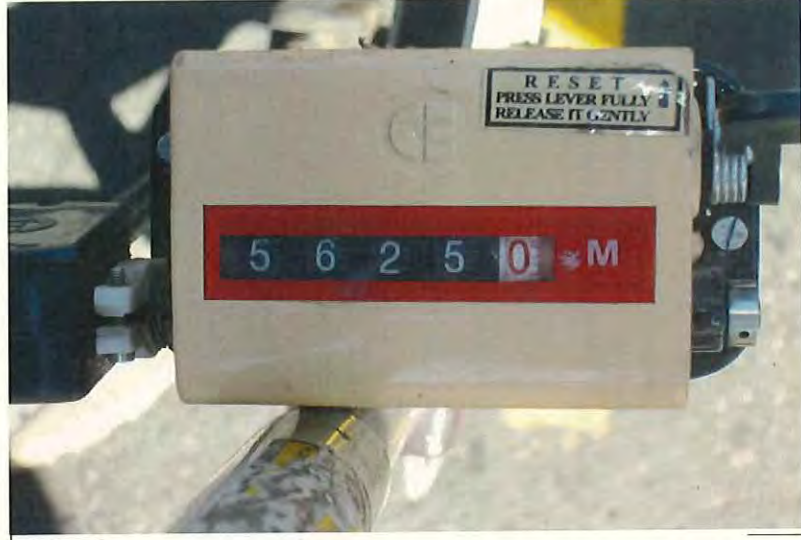
<p align="center"><b>Photo No. 12</b></p> <p><b>DATE:</b> 16-March-2017</p> <p><b>DESCRIPTION:</b>  Chainage Marking Works on Existing Alignment  Distance Meter (Team-A) 5km+625m from CH 227+000</p> <p><b>LOCATION:</b> CH 232+625</p>

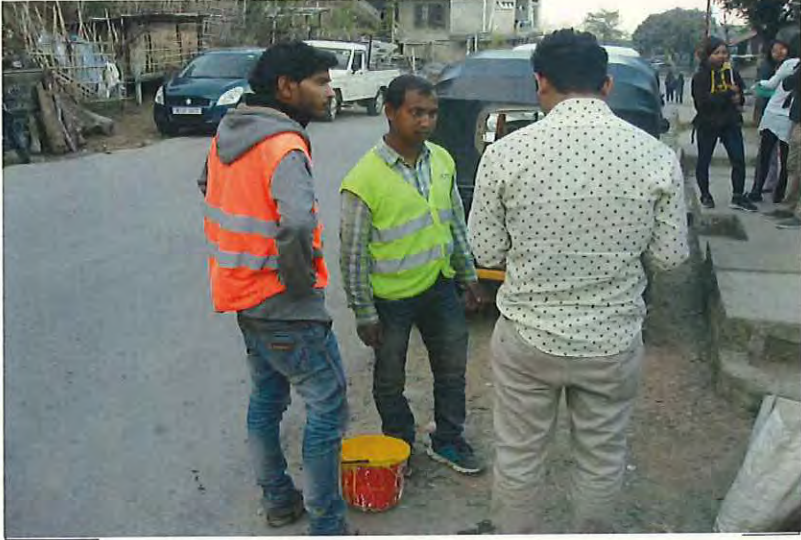
<p align="center"><b>Photo No. 13</b></p> <p><b>DATE:</b> 16-March-2017</p> <p><b>DESCRIPTION:</b> Chainage Marking Works on Existing Alignment  Hearing to Team-B</p> <p><b>LOCATION:</b> CH 296+229</p>

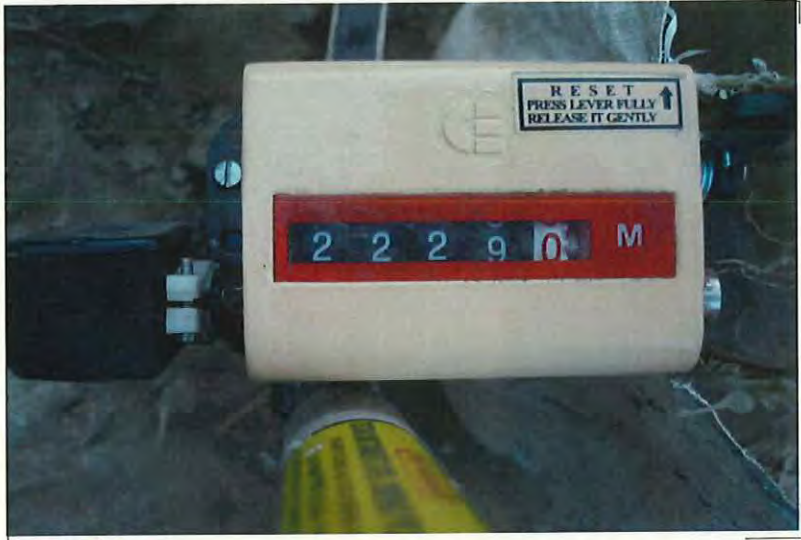
<p align="center"><b>Photo No. 14</b></p> <p><b>DATE:</b> 16-March-2017</p> <p><b>DESCRIPTION:</b> Chainage Marking Works on Existing Alignment  Distance Meter (Team-B) 2km+229m from CH 294+000</p> <p><b>LOCATION:</b> CH 296+229</p>

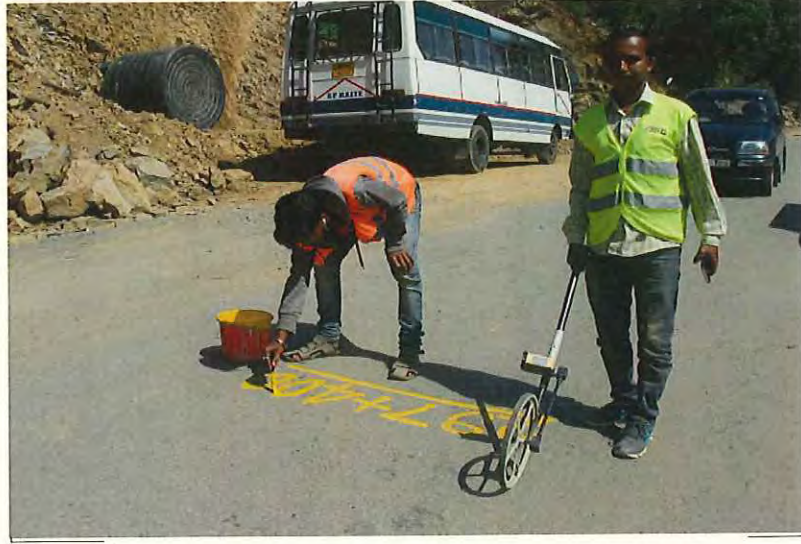
<p align="center"><b>Photo No. 15</b></p> <p><b>DATE:</b> 16-March-2017</p> <p><b>DESCRIPTION:</b> Chainage Marking Works on Existing Alignment  Painting &amp; Distance Measuring (Team-B)</p> <p><b>LOCATION:</b> CH 297+400</p>

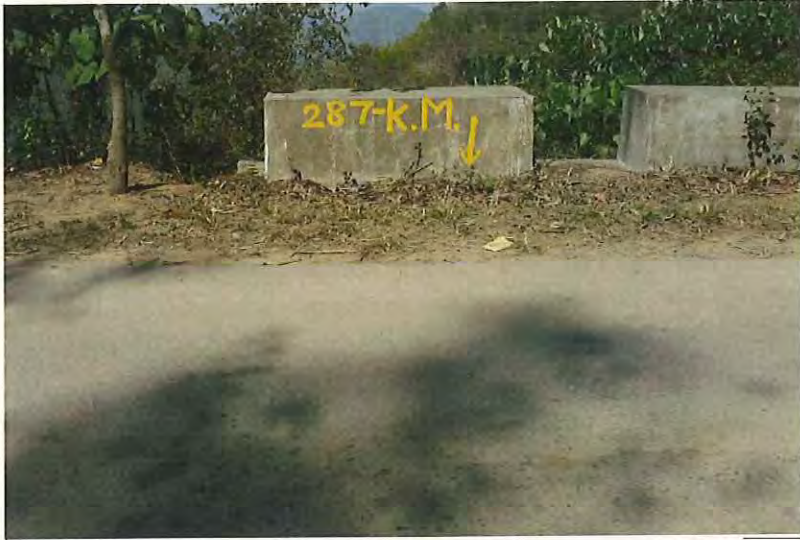
<p align="center"><b>Photo No. 16</b></p> <p><b>DATE:</b> 16-March-2017</p> <p><b>DESCRIPTION:</b>  Chainage Marking Works  Marking on the Guard Block in case of rough surface road</p> <p><b>LOCATION:</b> CH 287+000</p>

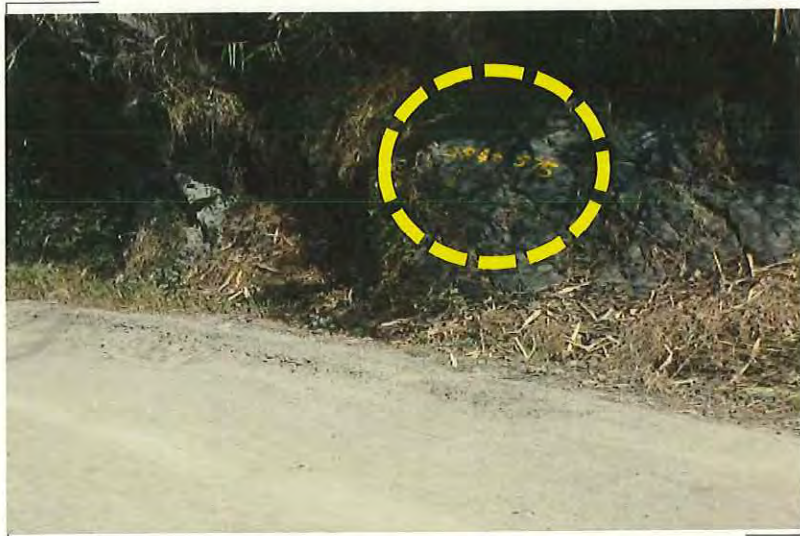
<p align="center"><b>Photo No. 17</b></p> <p><b>DATE:</b> 16-March-2017</p> <p><b>DESCRIPTION:</b>  Chainage Marking Works  Marking on the Rock in case of rough surface road</p> <p><b>LOCATION:</b> CH 284+575</p>

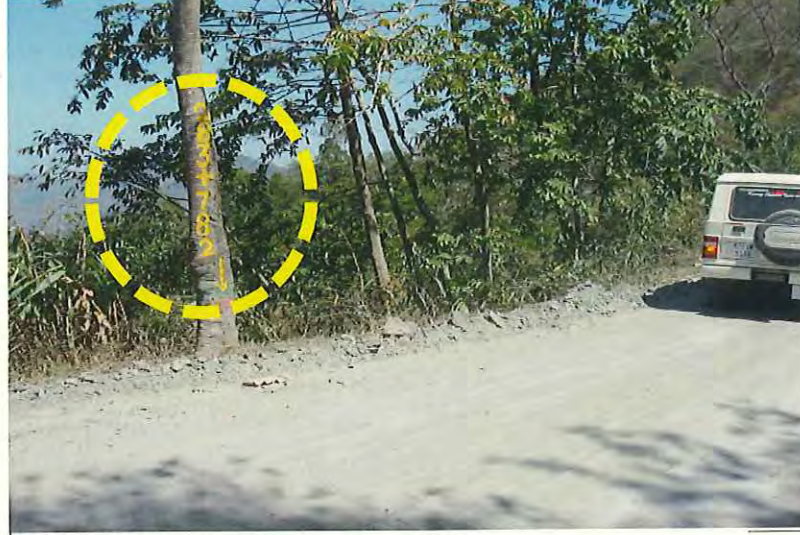
<p align="center"><b>Photo No. 18</b></p> <p><b>DATE:</b> 16-March-2017</p> <p><b>DESCRIPTION:</b>  Chainage Marking Works  Marking on a Tree in case of rough surface road</p> <p><b>LOCATION:</b> CH 283+782</p>

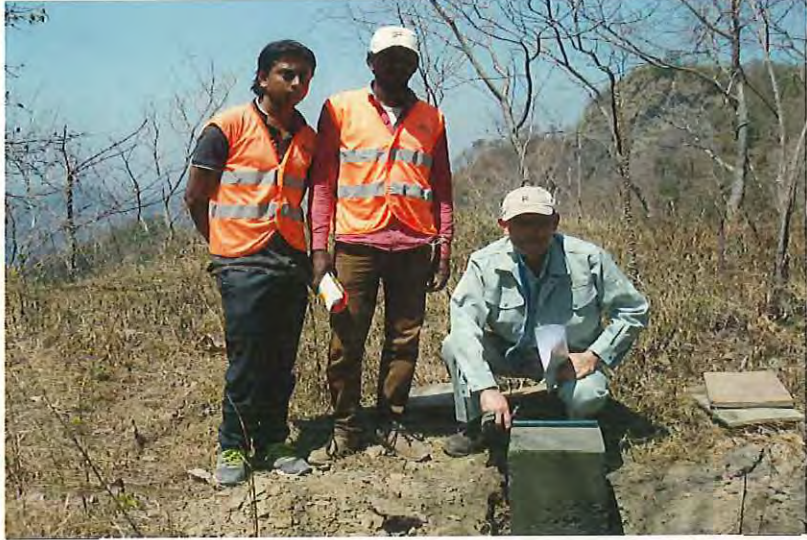
<p align="center"><b>Photo No. 19</b></p> <p><b>DATE:</b> 17-March-2017</p> <p><b>DESCRIPTION:</b>  Pillar Fixition Works (Team-B)  Main Concrete Pillar (30cm×30cm×60cm)</p> <p><b>LOCATION:</b> CH 285+000</p>

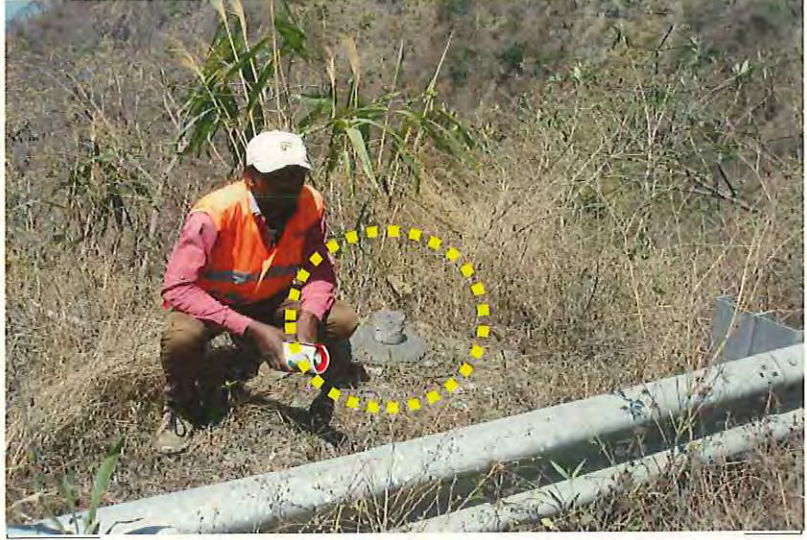
<p align="center"><b>Photo No. 20</b></p> <p><b>DATE:</b> 17-March-2017</p> <p><b>DESCRIPTION:</b>  Pillar Fixition Works (Team-B)  Reference Concrete Pillar (φ15cm)</p> <p><b>LOCATION:</b> CH 284+980</p>

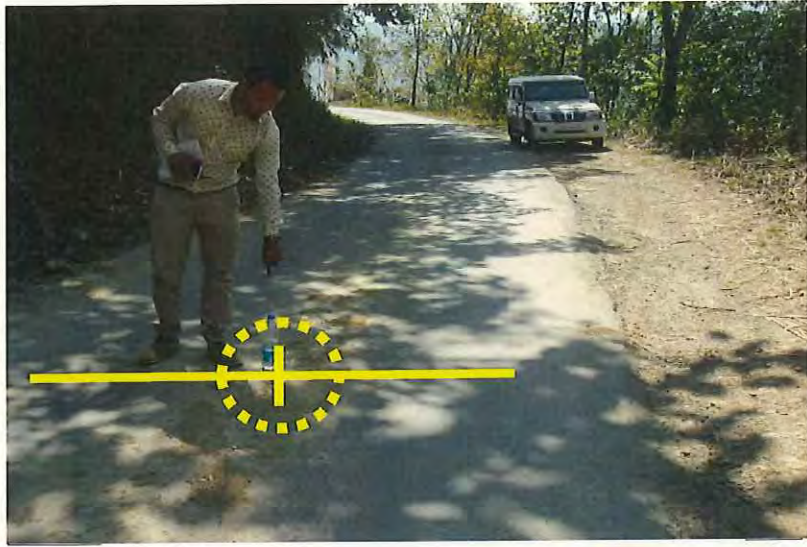
<p align="center"><b>Photo No. 22</b></p> <p><b>DATE:</b> 17-March-2017</p> <p><b>DESCRIPTION:</b>  Chainage Marking Works (Team-B)  Starting Point 250km of Section-3 toward Section-3 (instructed by NHIDCL)</p> <p><b>LOCATION:</b> CH 250+000</p>

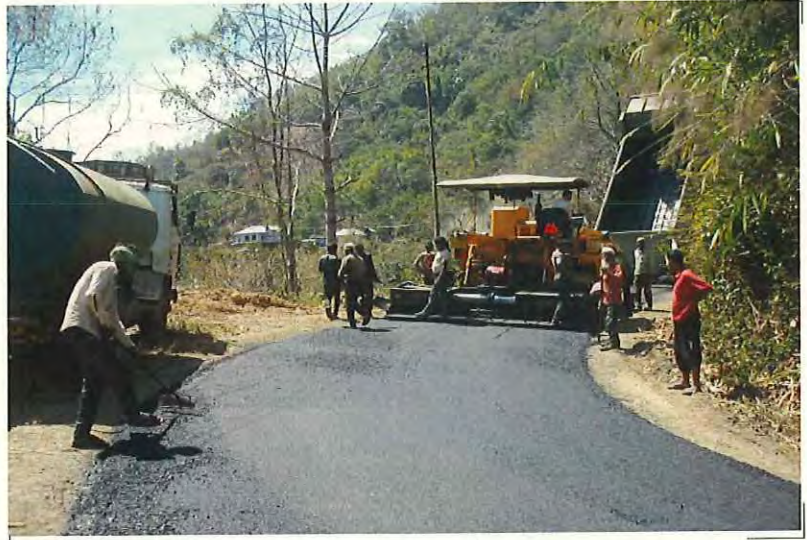
<p align="center"><b>Photo No. 23</b></p> <p><b>DATE:</b> 17-March-2017</p> <p><b>DESCRIPTION:</b>  Road Repairing Works by PWD  Asphalt Pavement Works by Asphalt Finisher</p> <p><b>LOCATION:</b> CH 150+000</p>

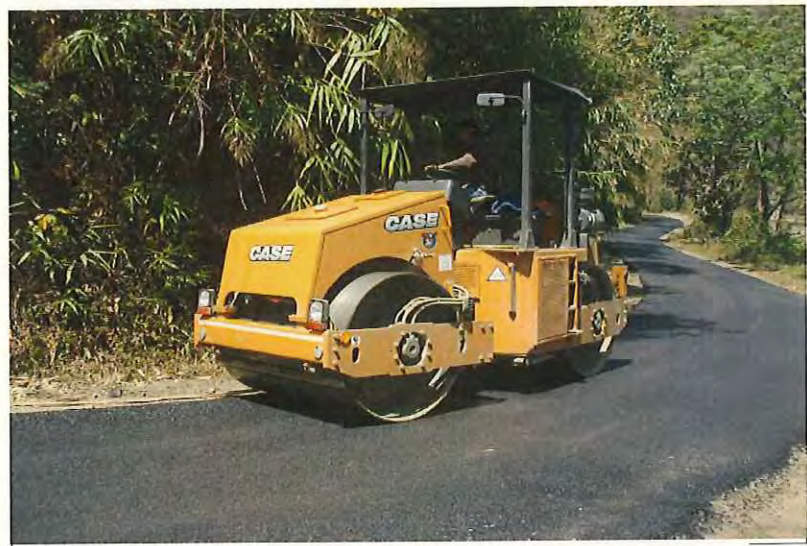
<p align="center"><b>Photo No. 24</b></p> <p><b>DATE:</b> 17-March-2017</p> <p><b>DESCRIPTION:</b>  Road Repairing Works by PWD  Asphalt Pavement Works by Tandem Loller</p> <p><b>LOCATION:</b> CH 150+000</p>

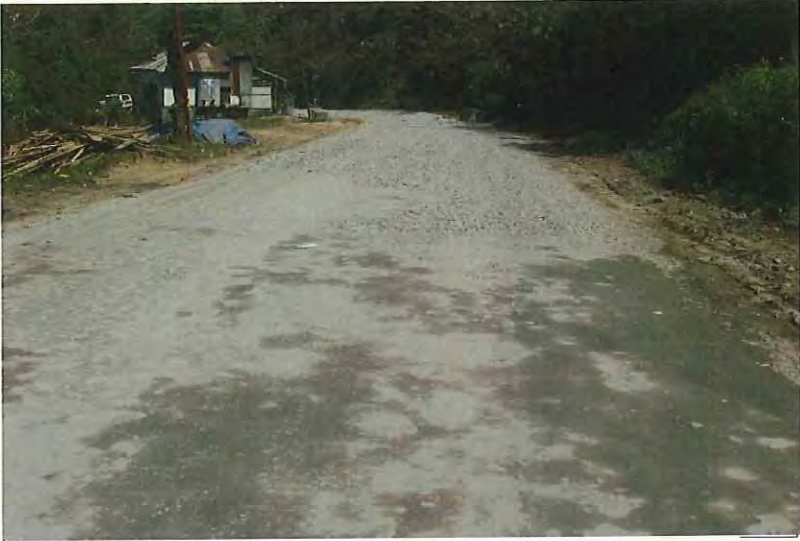
<p align="center"><b>Photo No. 25</b></p>
	<p><b>DATE:</b> 17-March-2017</p>
	<p><b>DESCRIPTION:</b>  Road Repairing Works by PWD  Base Course Works</p>
<p><b>LOCATION:</b> CH 200+000</p>

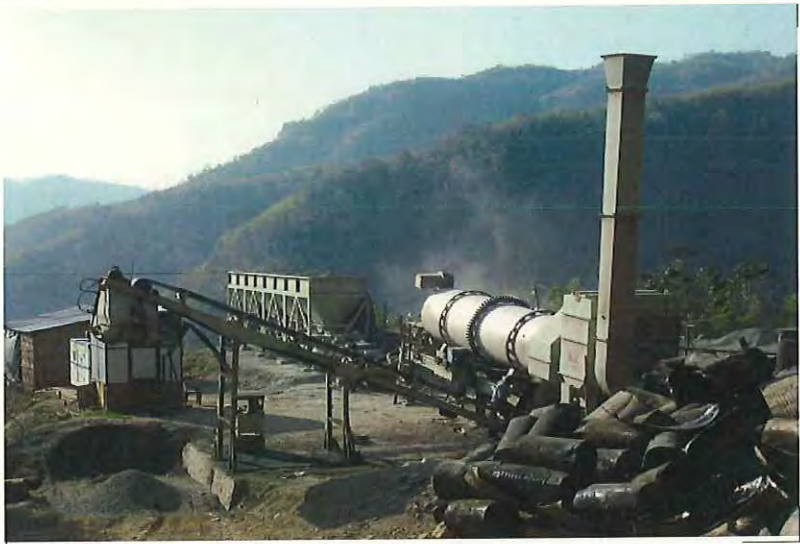
<p align="center"><b>Photo No. 26</b></p>
	<p><b>DATE:</b> 17-March-2017</p>
	<p><b>DESCRIPTION:</b>  Road Repairing Works by PWD  Portable Asphalt Mixing Plant</p>
<p><b>LOCATION:</b> CH 193+000</p>
