中波アンテナシステム更新に関する MEIDECC からの書簡

Subject: JICA NEWS Project: Dismantle of Existing Antenna at Popua Transmitting Station

Project: Preparatory Survey by JICA on the Project for Nationwide Early Warning System and Strengthening Disaster Communications in the Kingdom of Tonga under Japan's Grant Aid

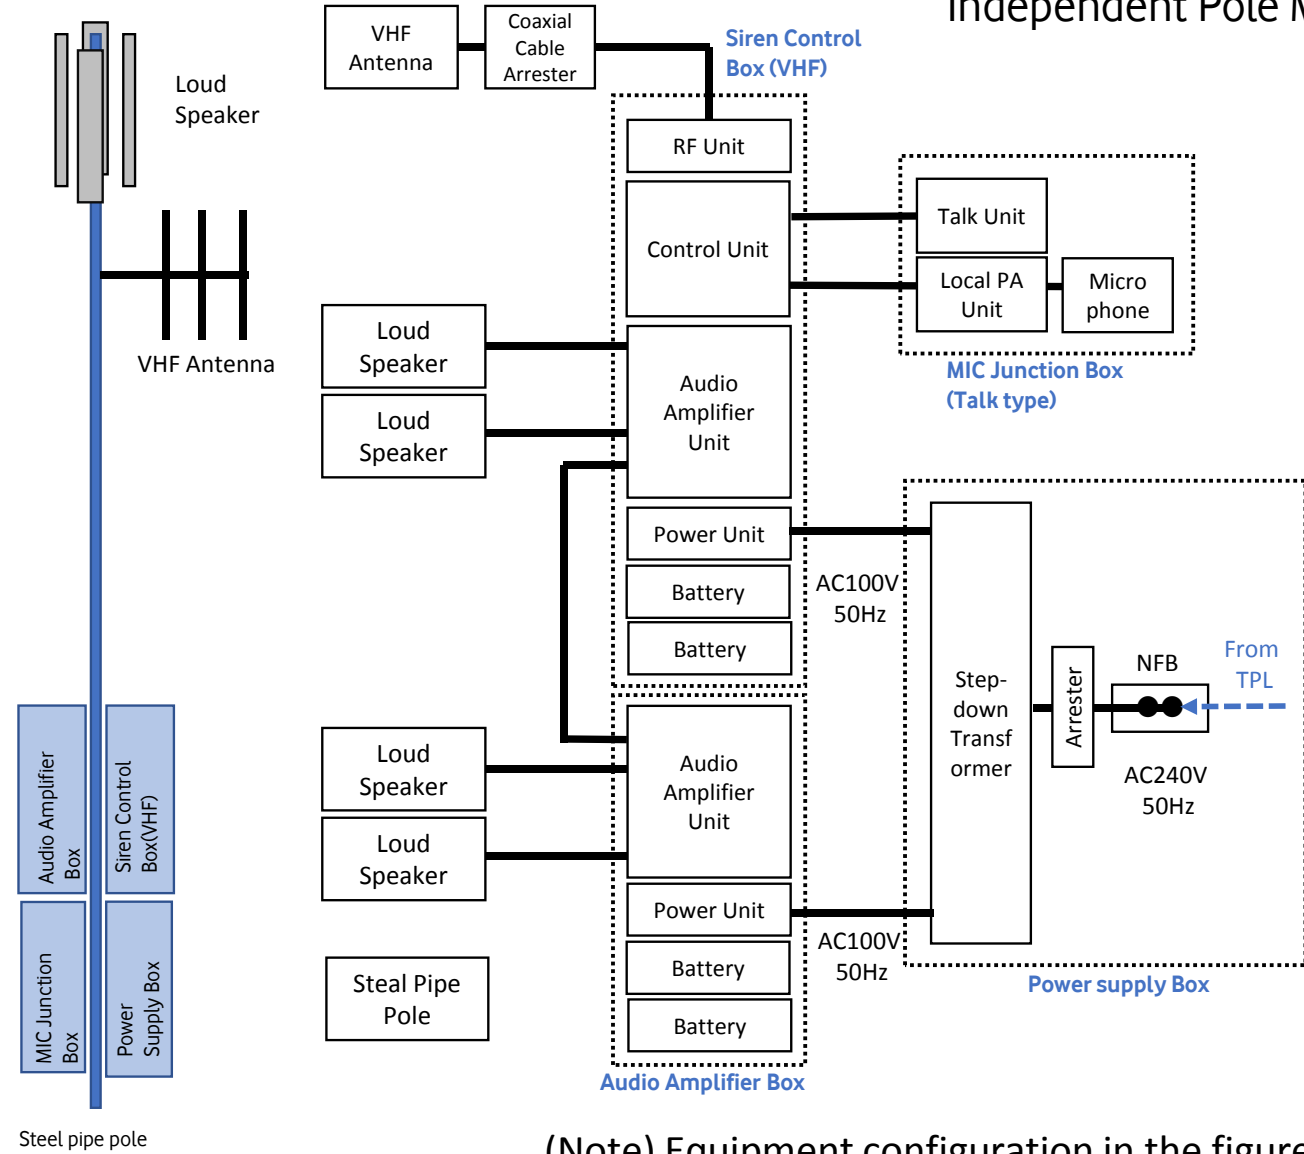
Independent Pole Mount/VHF Control/Electrified Area

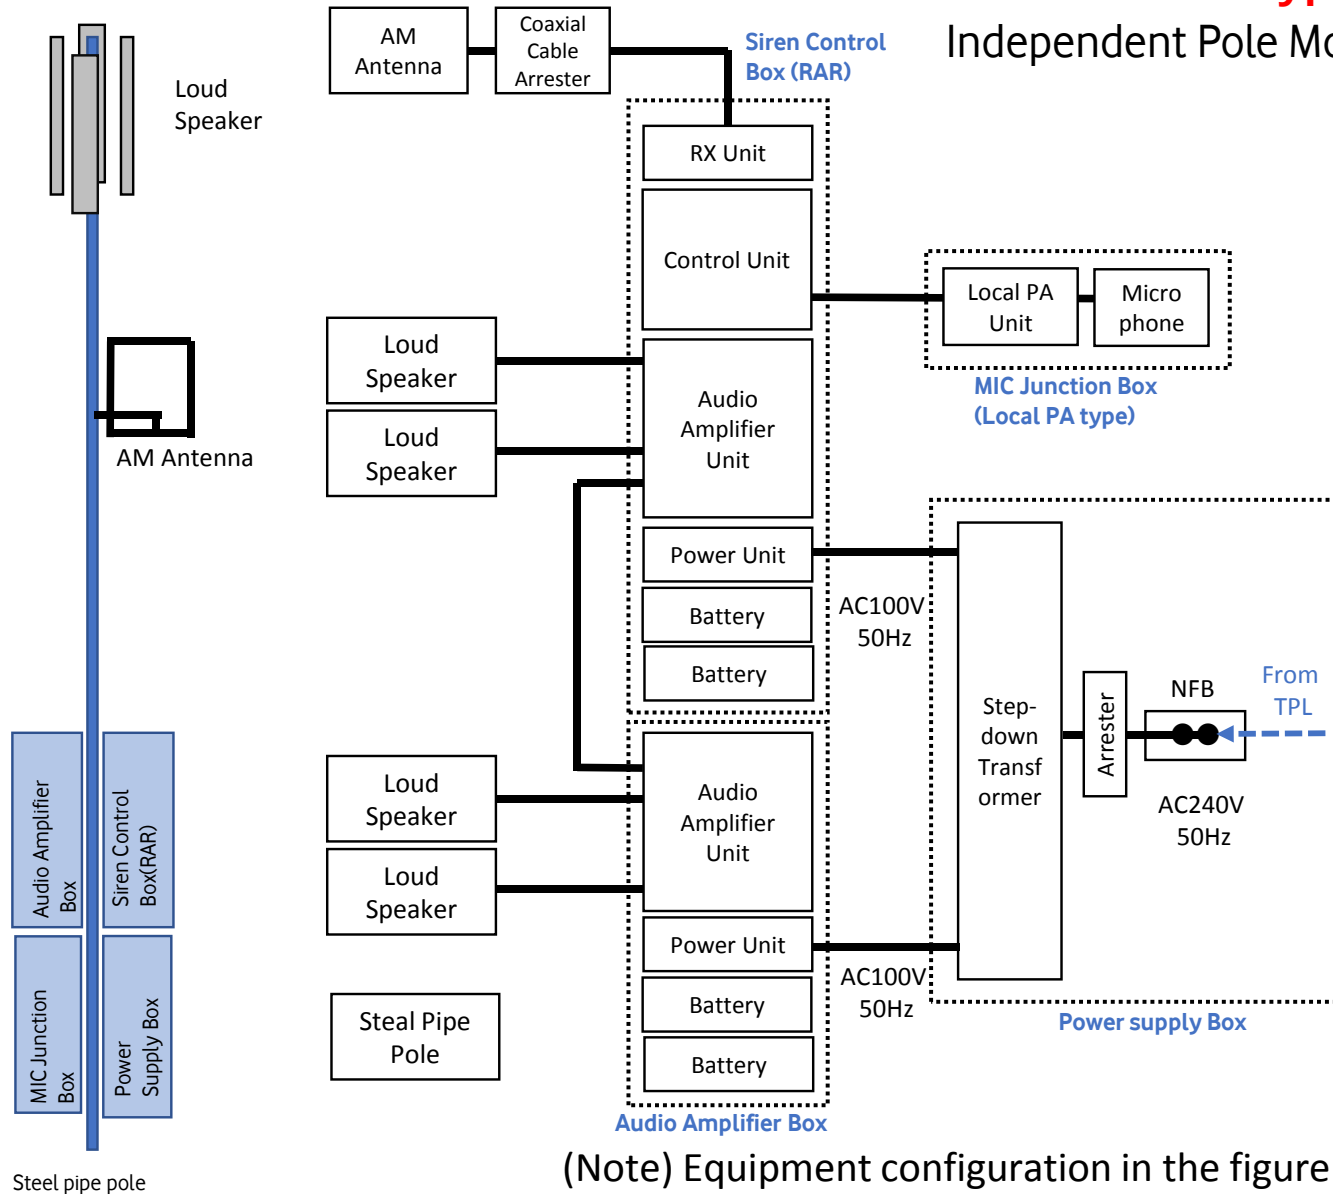
Independent Pole Mount/RAR Control/Electrified Area

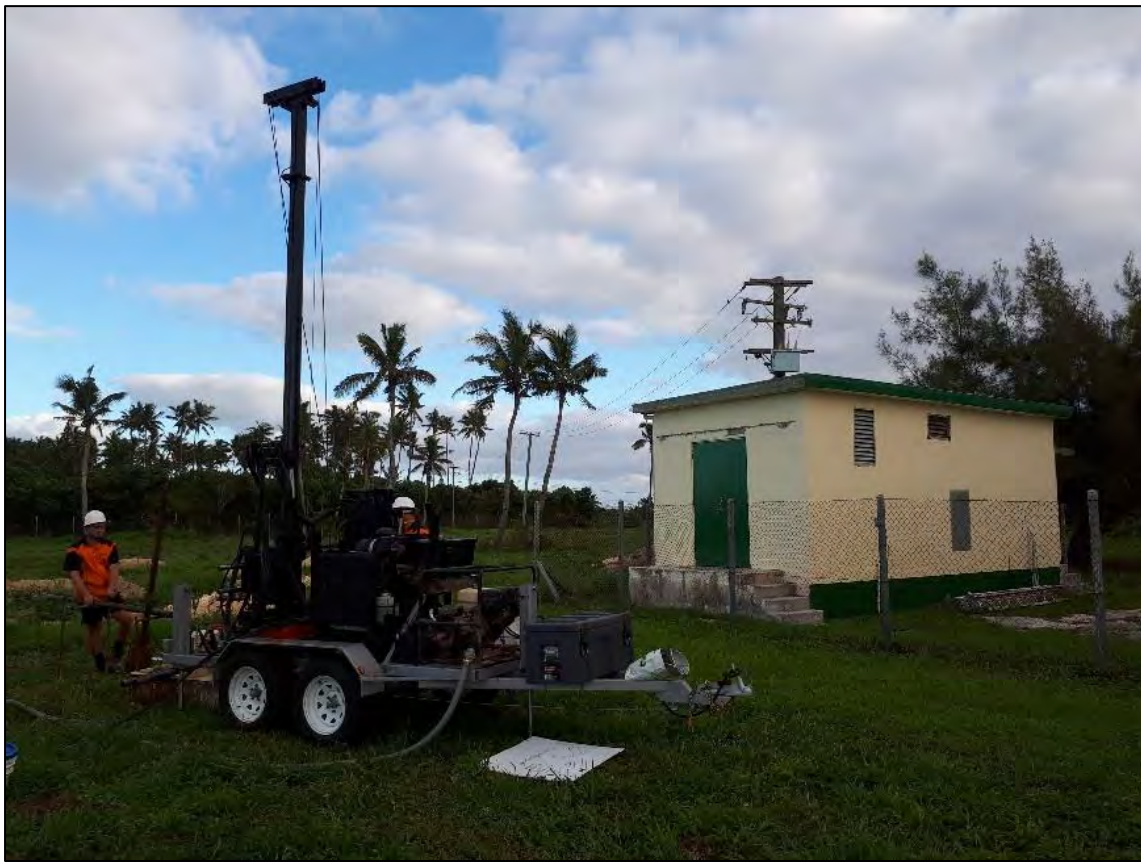
Figure 3.1: Photo of the GDI drill rig used during the investigations, at the TBC MW TX site.
