**CAPACITY DEVELOPMENT
ON
CONSTRUCTION OF LAGUNBYIN WATER
TREATMENT PLANT
UNDER
GREATER YANGON WATER SUPPLY IMPROVEMENT
PROJECT**

FINAL REPORT

MAY 2018

JAPAN INTERNATIONAL COOPERATION AGENCY

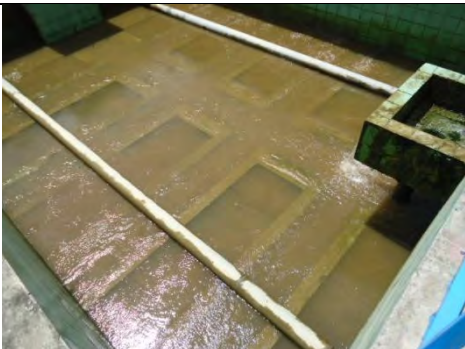
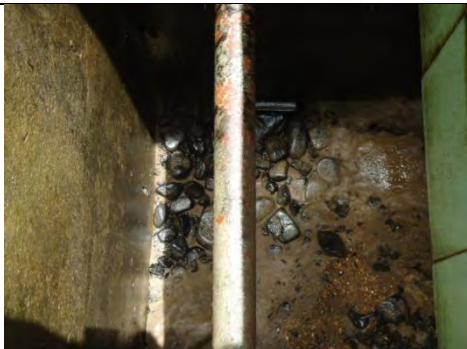
- ✓ Understanding problems in the existing WTP is very important for Lagunbyin WTP, thus Advisers and YCDC engineers inspected the filtration facilities of Nyaunghnapin WTP.
- ✓ After a comprehensive assessment it was confirmed that it was not functioning well due to outflow of filter media and could stop functioning if corrective measures were not taken.
- ✓ The causes of malfunctioning of these filters may be: 1) imbalance between composition of anthracite/sand filter media and pressure of backwashing water, 2) relatively high volume of backwashing water, and 3) the troughs for backwashing and drainage gates are comparatively small for the volume of water to be drained, etc.
- ✓ Since a large amount of anthracite filter media already drained out of filter quality control of the anthracite was assumed to be difficult.

<p>Existing filter tank situation under backwashing (28 May 2014) Only 1.5 minutes after opening of the backwashing valve, water stagnates in the filter tank. For that reason, operators interrupted backwashing process temporarily. It reflects inefficient operation.</p>	<p>The surface of sand filter media after backwashing (28 May 2014) Support gravel was visible on surface of sand filter media. Much of Anthracite filter media/sand filter media were drained out.</p>

- ✓ Quality control of anthracite filter media was observed to be difficult, and advisers proposed the use of monolayer sand filter to improve the system, in June 2014.
- ✓ Strainer type of under drain system as same as the existing WTP Phase 2 was applied for the filter tanks.
- ✓ The imported products of lift pump/backwash pump and Valves equivalent to Nyaunghnapin WTP Phase 2 were decided.
- ✓ It was the first case in YCDC to install blower for filter washing. Therefore, to procure quality

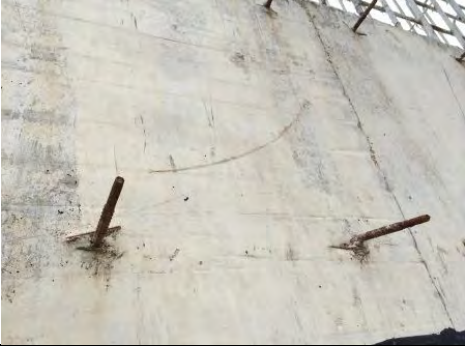
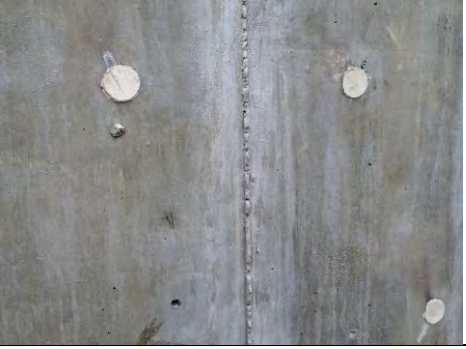
<p>Introduction of 9 mm weir plate of shuttering (10 July 2014)</p>	<p>Introduction of handmade corns (31 Oct 2014)</p>

<p>Concrete finishing before introduction of corns (03 Sep 2014)</p>	<p>Concrete finishing after introduction of corns (31 Oct 2014)</p>

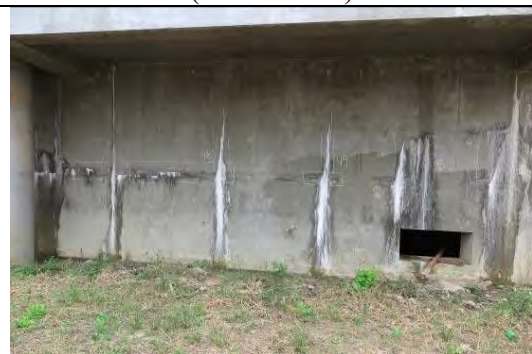
Thus, investigations for the location, conditions and the volume of leakages were carried out. Leakages observed in the construction joints were suspected to be caused by poor workmanship during construction works; such as fixing of reinforcement bars, erection of formworks, installation of water bars, and forms of construction joints and concreting. However, it was assumed that the reinforcement bars are not affected by corrosion due to leaking water nor submergence of an internal space was of any concern. To control the leakages, YCDC, under the recommendation of Adviser, sought help of an experienced specialist(s) who was selected solely based on the capability.

Leakage Condition of Sedimentation Tank
(07 Dec 2016)

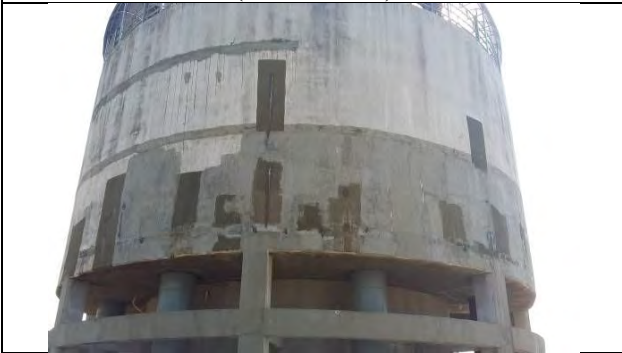
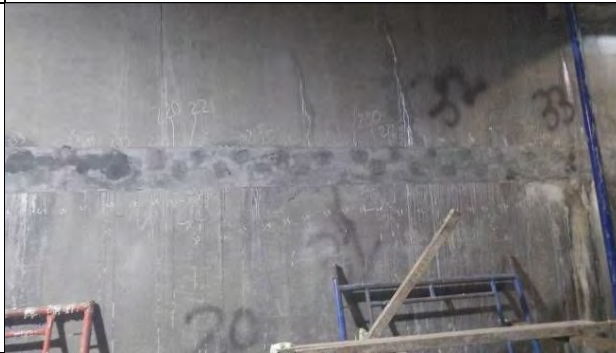
<p>Leakage Repair of Dividing Well (31 Mar 2017)</p>	<p>Leakage Repair of Filter Tank (14 Mat 2017)</p>

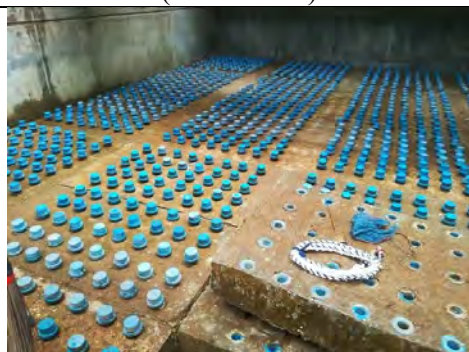
Strainers which were installed in the Filter tank by YCDC were not functioning well at the time of air backwash. Upon investigation, it was found that the height of beam which supported drain plates was modified from the design drawing which was the main reason for the shortage of the length of strainers. Thus, improvement measures were studied with EDWS, and extension of the length of strainers was decided. Thereafter, the improvement work was carried out.

Strainers Condition (29 Aug 2017)

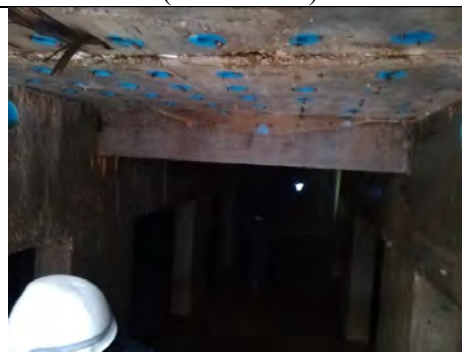
- ✓ August 2017: The space under the bottom slab in Filter tank was inspected jointly with YCDC. It was identified that the height of beam which supports drain plates was higher than design drawing.
- ✓ August 2017: Advisers prepared a test tank. Some improvement measures of strainers were evaluated using the test tank. And then, the proper length of strainers was proposed.
- ✓ September 2017: YCDC carried out trial construction of Filter tank which took in improvement measure. After the strainers were repaired, it was confirmed that air was distributed by the whole filter tank during air washing.
- ✓ November 2017: Strainers improvement work was completed.

Joint Inspection under Filter Tank
(29 Aug 2017)

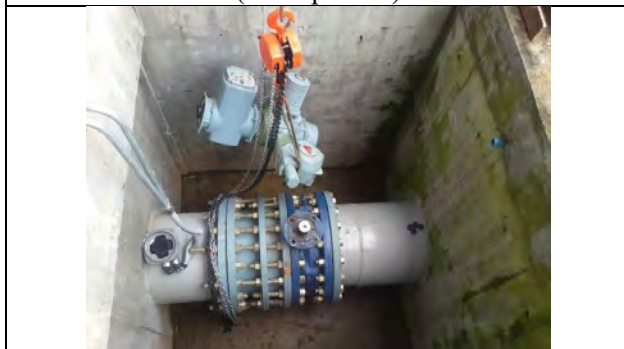
Repair Work of Inlet Valve
(28 Jul 2017)

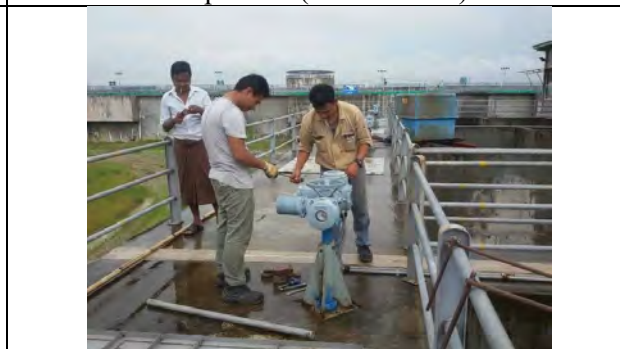
Malfunction of Discharge Valve on Filter Tank
(28 Jul 2017)

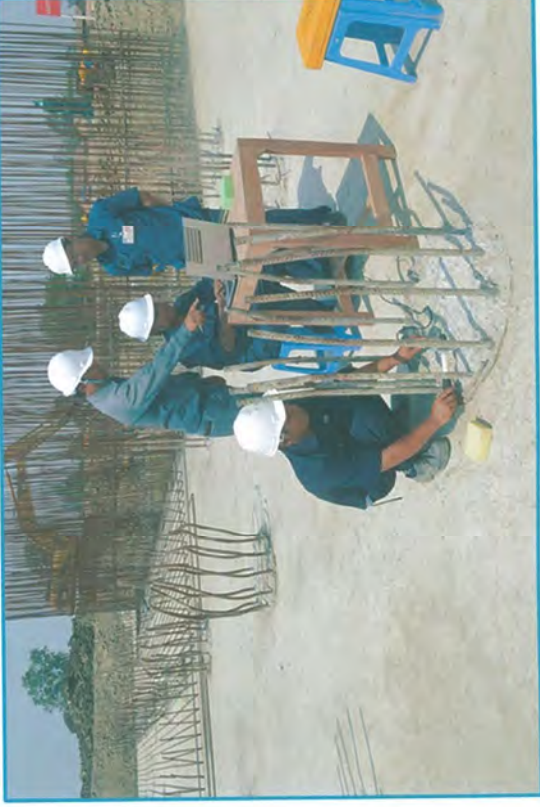
Bored Pile စီမံအစဉ်သွေးအား Piles Eco Test (PET) စမ်းသပ်နေပုံ

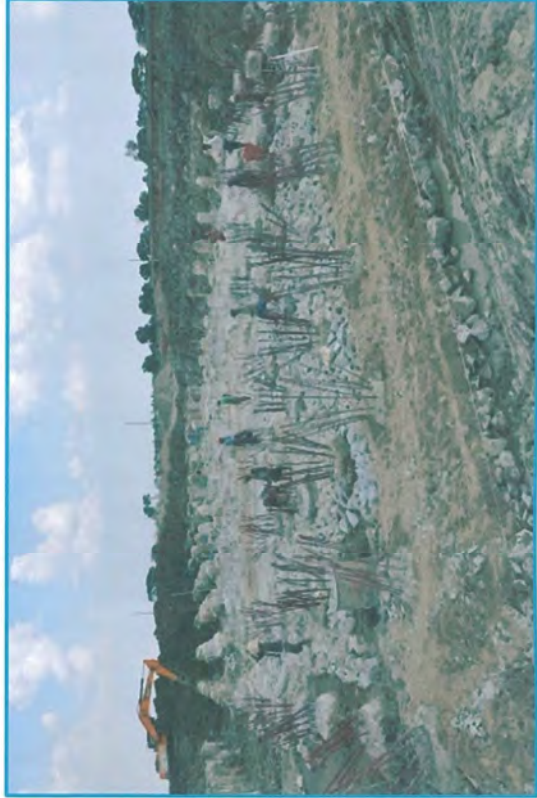
Sedimentation Basin တွင် ၃၂"Ø Bored Pile အား Pile ခေါင်းခွဲခြင်းလုပ်ငန်း
ဆောင်ရွက်နေပုံ
