4-4 テクニカルノート(現地調査 I)

The Preparatory Survey for the Project
for the Upgrading and the Construction of Secondary Schools
aimed at promoting Inclusive Education in Lesotho

Technical Notes

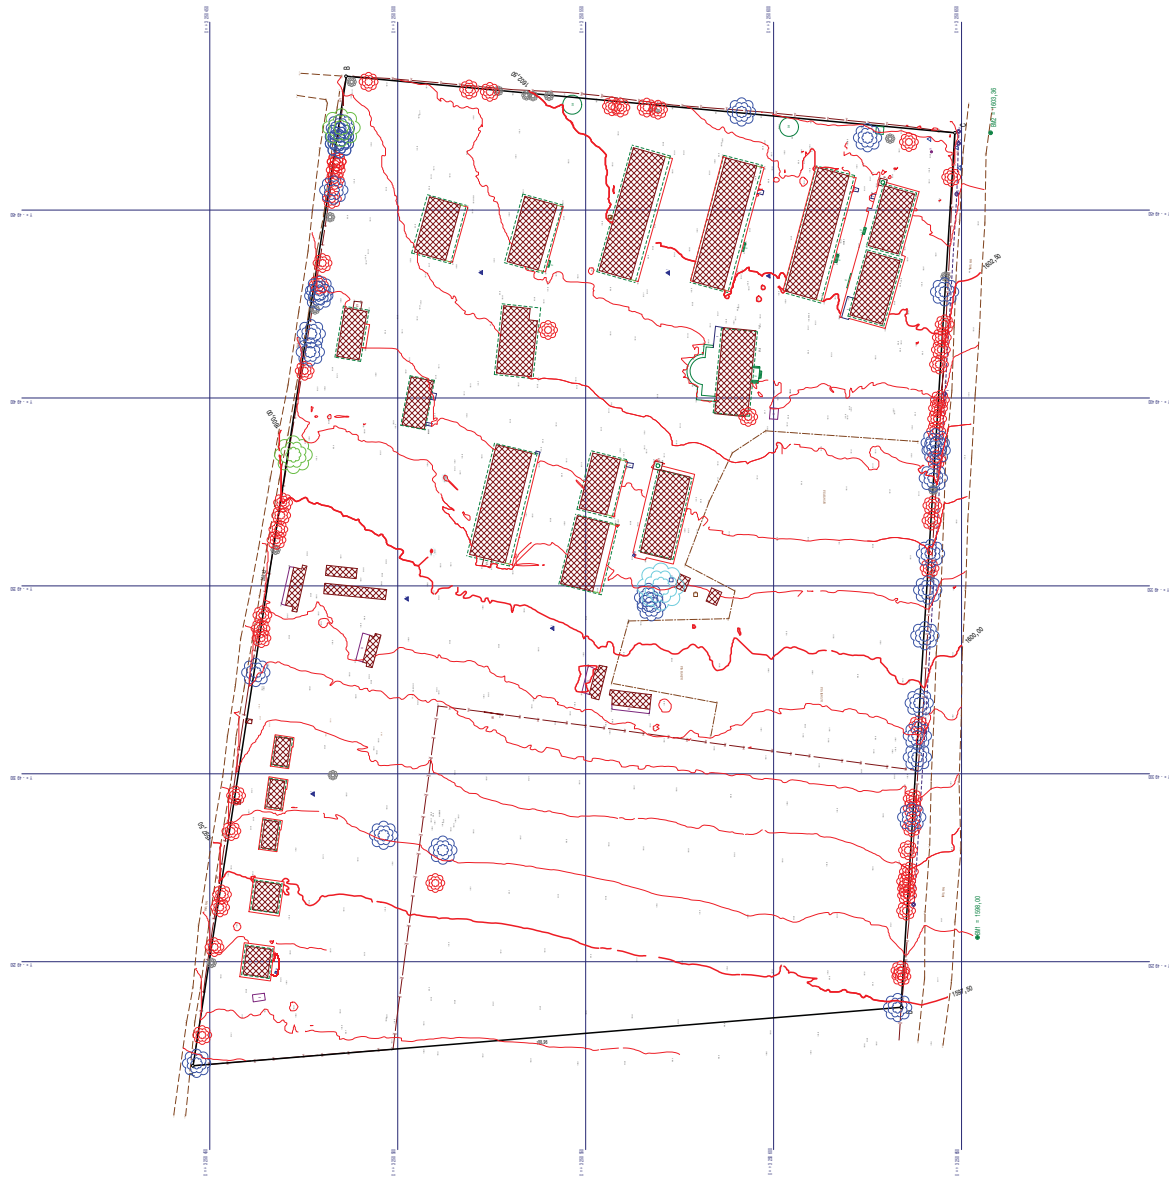
E1-Abia

REF: E1-ABIA-1 DETAIL SURVEY ABIA HIGH SCHOOL MASERU	
LEGEND BH = BOUNDARY CP = CONCRETE PAVEMENT CS = CLUSTERS DM = DRIVEWAY EM = ELECTRICAL METER FM = FENCE IM = IRON FENCE SM = SURVEY MARK TM = TOWER UM = UTILITY MARK VM = VALVE WM = WASTE WATER MAIN XM = WATER MAIN YM = YARD MARK ZM = ZONE MARK	REF: E1-ABIA-1 DETAIL SURVEY ABIA HIGH SCHOOL MASERU
COORDINATE SYSTEM: APPROPRIATE - LOZ (M384)	REF: E1-ABIA-1 DETAIL SURVEY ABIA HIGH SCHOOL MASERU
NOTE: THE FIGURE ABOVE REPRESENTS ABIA HIGH SCHOOL, BEING APPROXIMATE 4.3415 HECTARES IN EXTENT	REF: E1-ABIA-1 DETAIL SURVEY ABIA HIGH SCHOOL MASERU
BRANCH MARK DESCRIPTIONS: BH 12mm ROUND IRON PEG IN CONCRETE	REF: E1-ABIA-1 DETAIL SURVEY ABIA HIGH SCHOOL MASERU

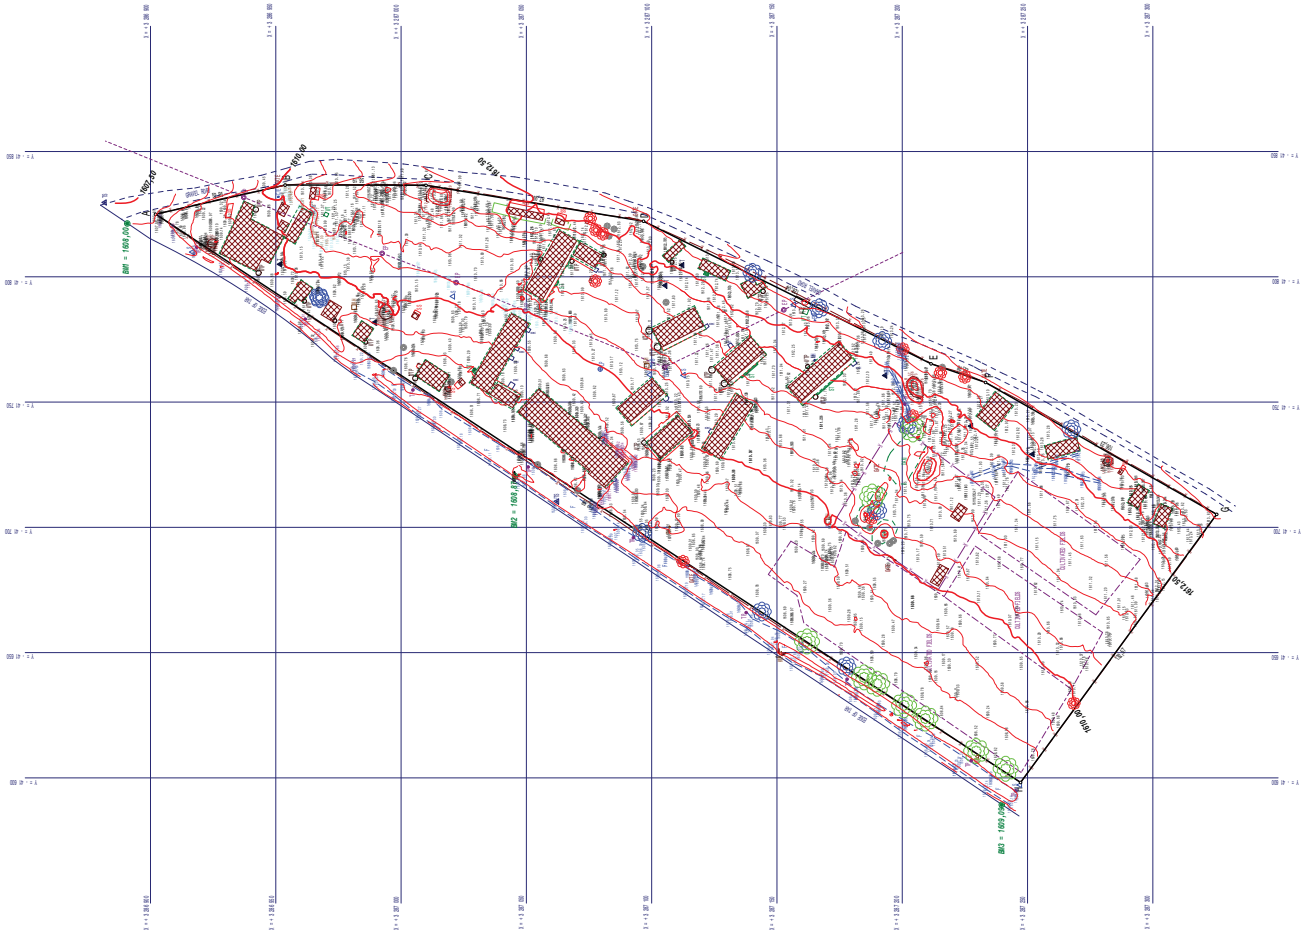
REF: E2-MOTSEKUOA

DETAIL SURVEY MOTSEKUOA HIGH SCHOOL MAFETENG	
LEGEND	B = BOUNDARY C = CULVERT D = DRAIN ED = ELECTRIC DISTRIBUTION BOX EP = EROSION POLE MP = KULUMEBI POLE UP = UMBILO POLE P = PUMP B = BOUNDARY D = DRAIN ED = ELECTRIC DISTRIBUTION BOX EP = EROSION POLE MP = KULUMEBI POLE UP = UMBILO POLE P = PUMP B = BOUNDARY D = DRAIN ED = ELECTRIC DISTRIBUTION BOX EP = EROSION POLE MP = KULUMEBI POLE UP = UMBILO POLE P = PUMP
CO-ORDINATE SYSTEM:	APPROXIMATE - UTM (MSR4)
NOTE:	THE FIGURE ABOVEFIGURA REPRESENTS MOTSEKUOA HIGH SCHOOL, BEING APPROXIMATE 4.0442 HECTARES IN EXTENT. BOUNDARY DESCRIPTIONS: BDC PALE IN CONCRETE (BOUNDARY) BDC PALE IN CONCRETE (BOUNDARY) BDC 120mm ROUND IRON PIPE IN T/R
BRUNN VIJVEREN AND PARTNERS	BRUNN VIJVEREN AND PARTNERS P.O. BOX 505, KENYA TEL: (001 254) 471 810 (01) 241 420 FAX: (001 254) 471 811 E-MAIL: BRUNNVIJVEREN@KICDZ.KI
DRAWN BY: G.S. MARE AN RENNEN, BS 112 10/08/09 2011

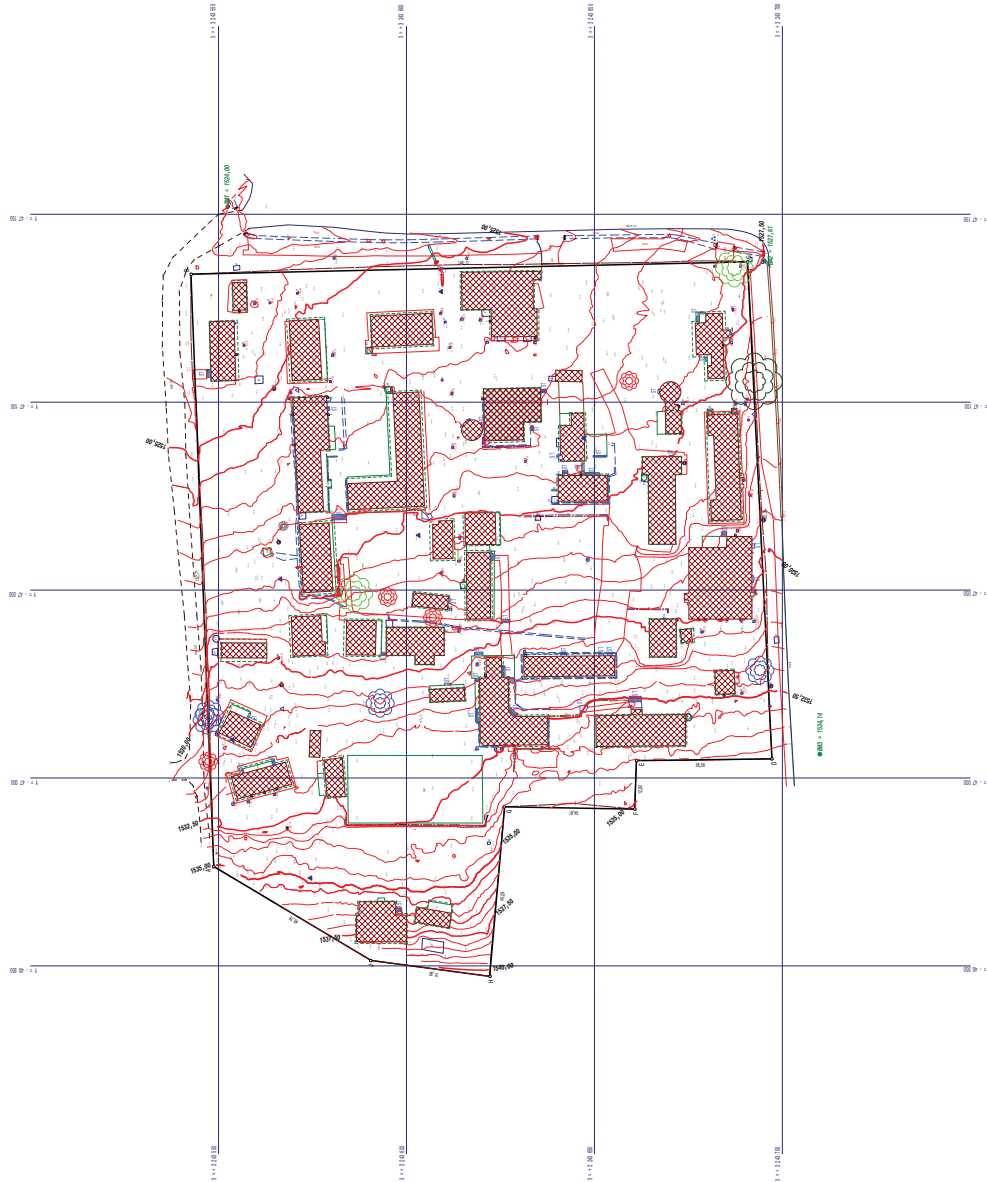
REF. E4- ST CATHERINE	
DETAIL SURVEY	ST CATHERINE HIGH SCHOOL
MASERU	
LEGEND	M = MANHOLE COVER D = GATE PIT S = DRIVE B = ELECTRICAL CABLE E = TELEPHONE CABLE F = FURNACE T = TANK H = HOLE IN MARBLE RITH L = LIGHT POLE UP = WATER TANK PLANT ROOM
COORDINATE SYSTEM:	UZ2 (MS84)
NOTE:	THE FIGURE ABOVE/BELOW REPRESENTS ST CATHERINE HIGH SCHOOL, BEING APPROXIMATE 2,3550 HECTARES IN EXTENT APPROXIMATE
BENCH MARK DESCRIPTIONS:	BH HOLE IN MARBLE RITH BUC/500 HOLE IN CONCRETE
BRAIN YILUEN AND PARTNERS CIVIL ENGINEERS P.O. BOX 523, MASERU, BUTHA BUTHE 5400 TEL: (011) 2944771 FAX: (011) 234 428 E-MAIL: BRYAN@BRAIN.YILUEN.CO.ZA WWW.BRAIN.YILUEN.CO.ZA	
DRAWN BY: G.S. MASE AN RESERV. NO. 172 08/09/2013

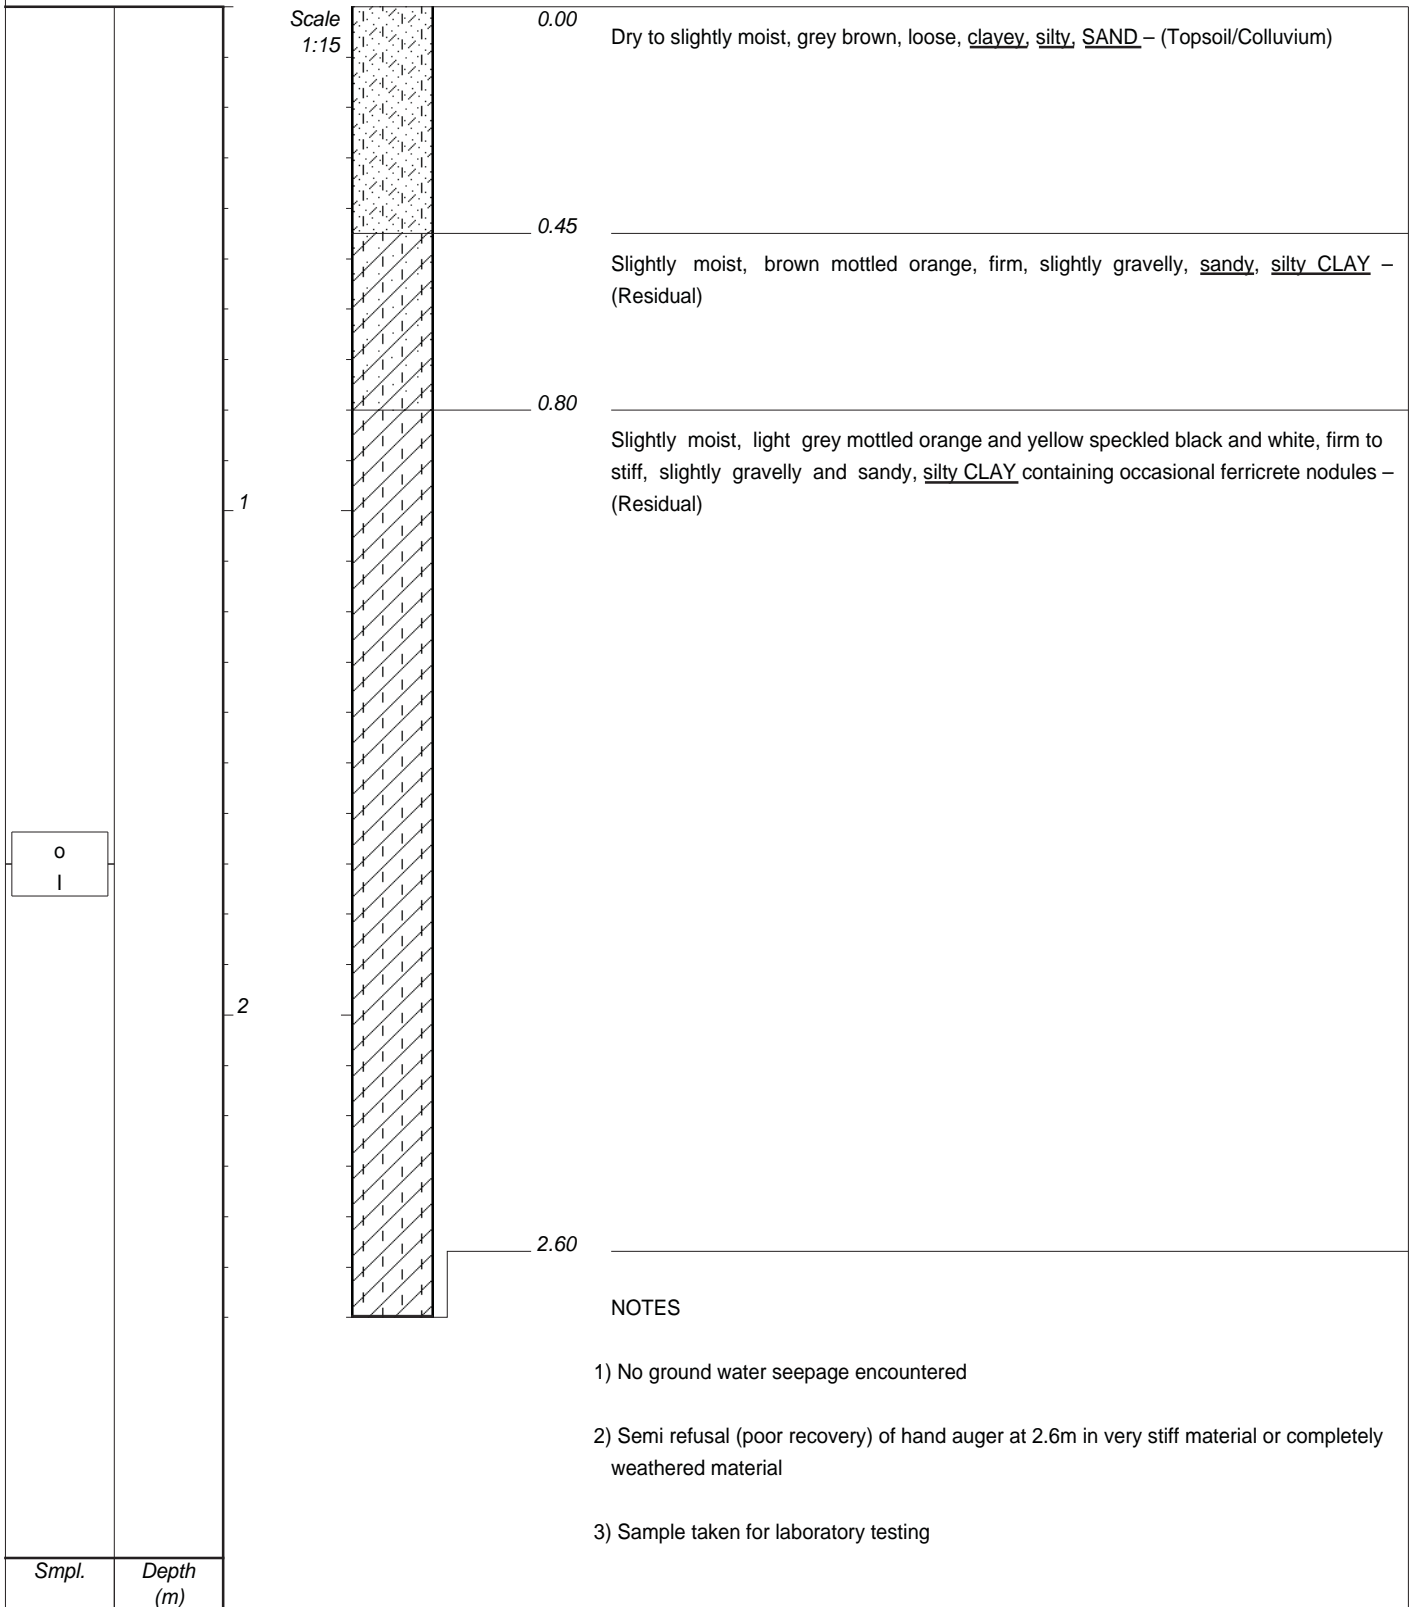
- 1) No ground water seepage encountered
- 2) Semi refusal (poor recovery) of hand auger at 2.6m in very stiff material or completely weathered material
- 3) Sample taken for laboratory testing

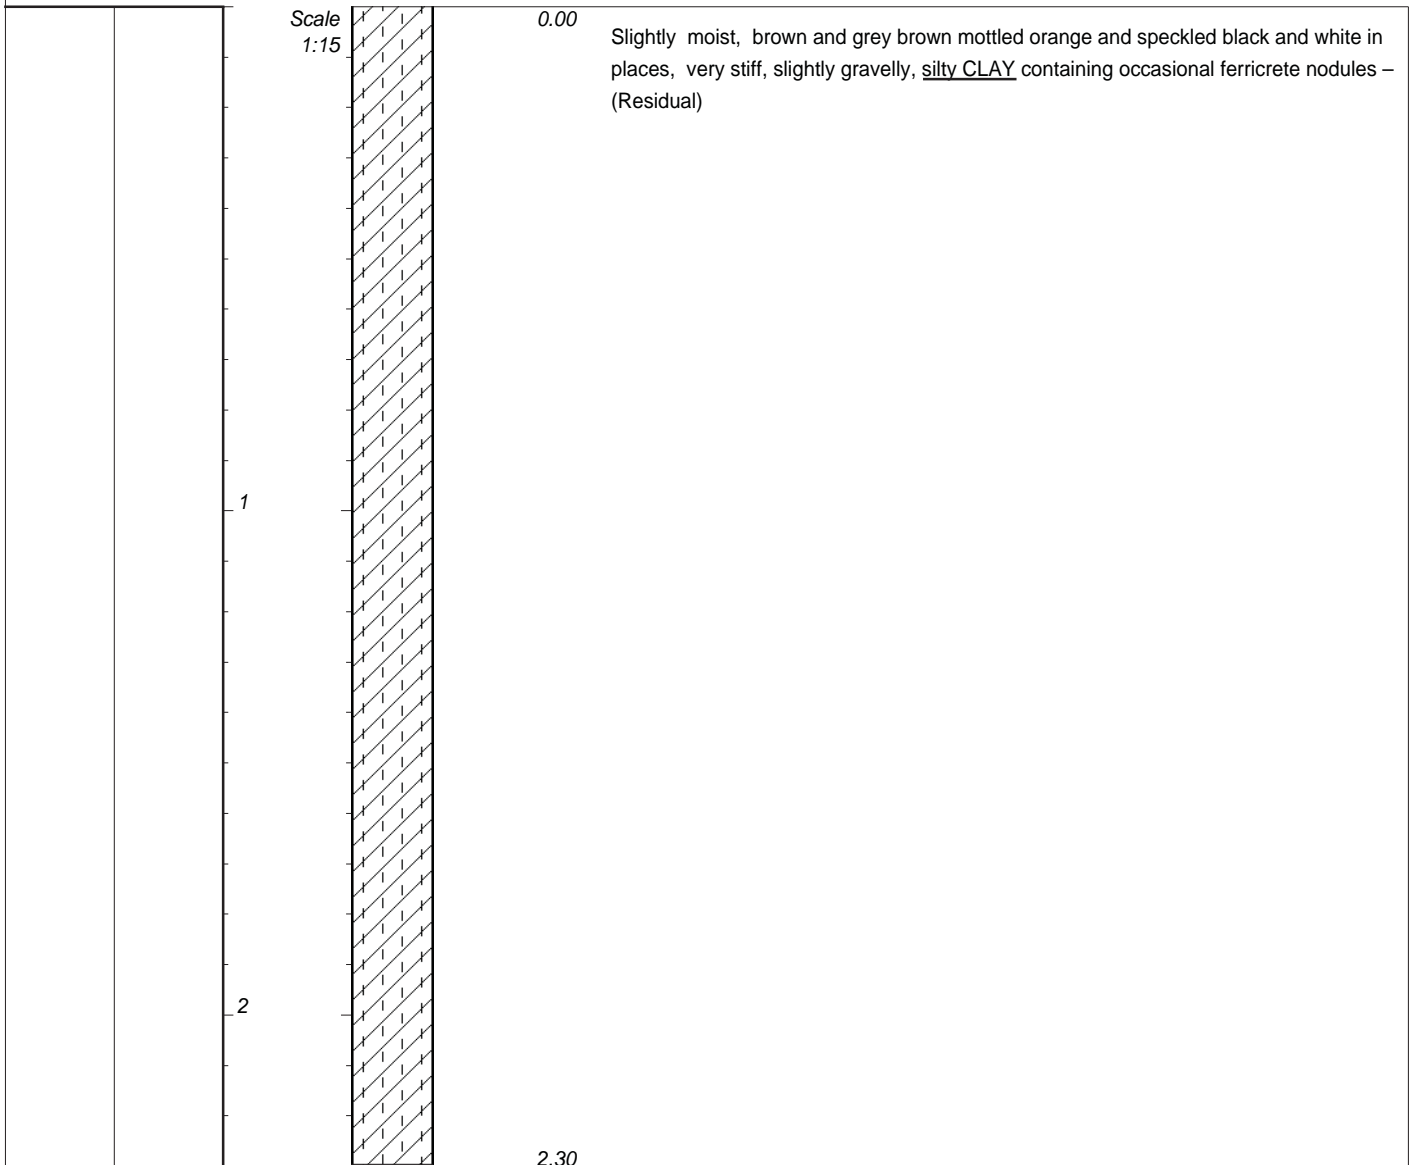
- 1) No ground water seepage encountered
- 2) No hand auger refusal encountered although hard excavation was encountered in the stiff material with depth

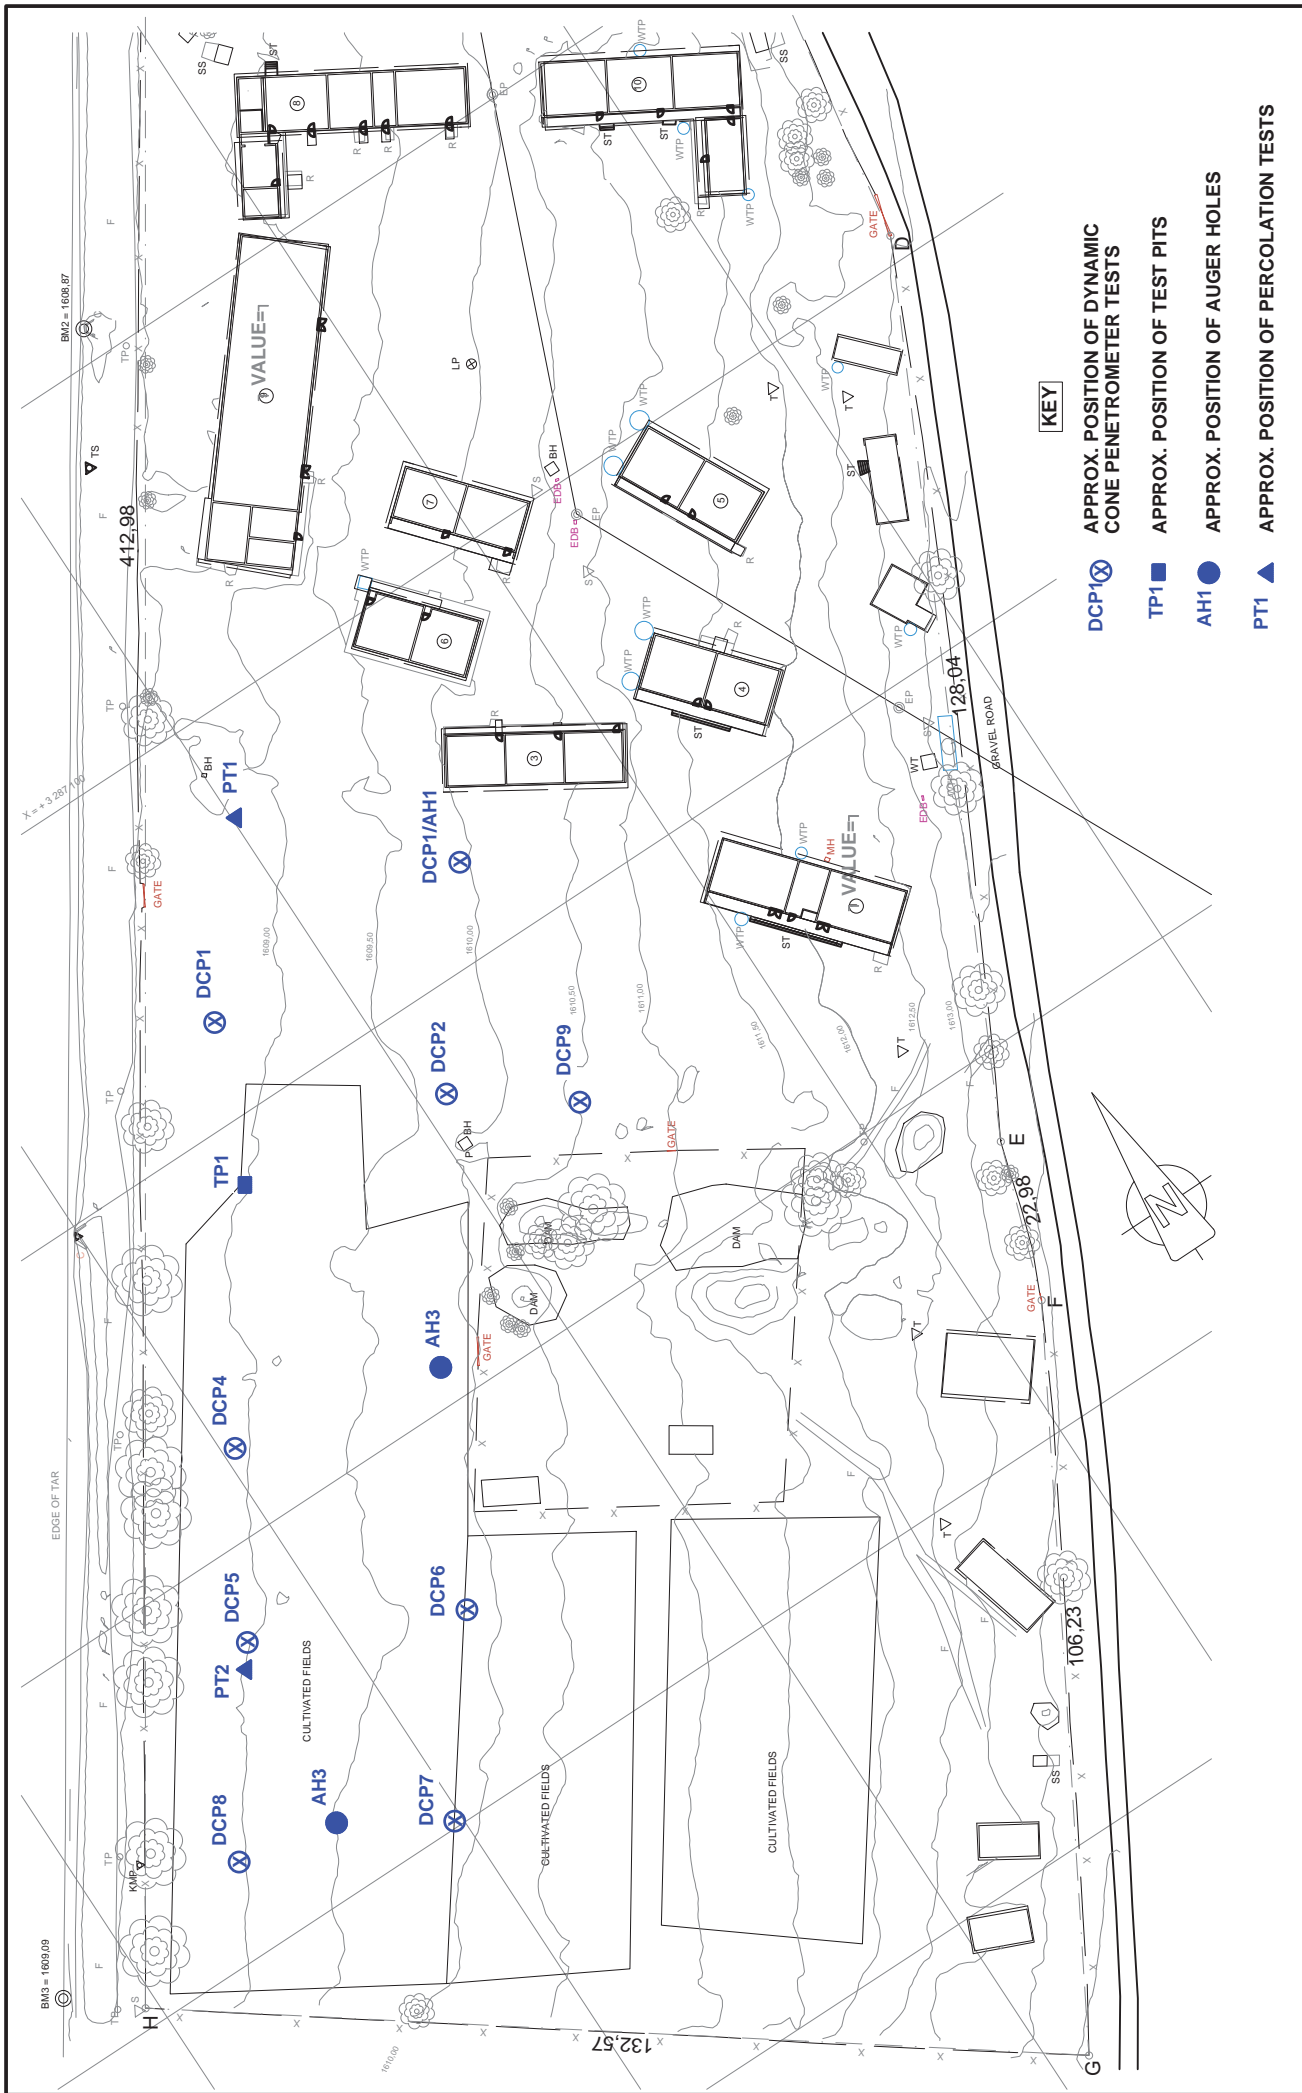
FIGURE 1
Site Plan

- KEY**
- DCP1 ⊗ APPROX. POSITION OF DYNAMIC CONE PENETROMETER TESTS
 - TP1 ■ APPROX. POSITION OF TEST PITS
 - AH1 ● APPROX. POSITION OF AUGER HOLES
 - PT1 ▲ APPROX. POSITION OF PERCOLATION TESTS

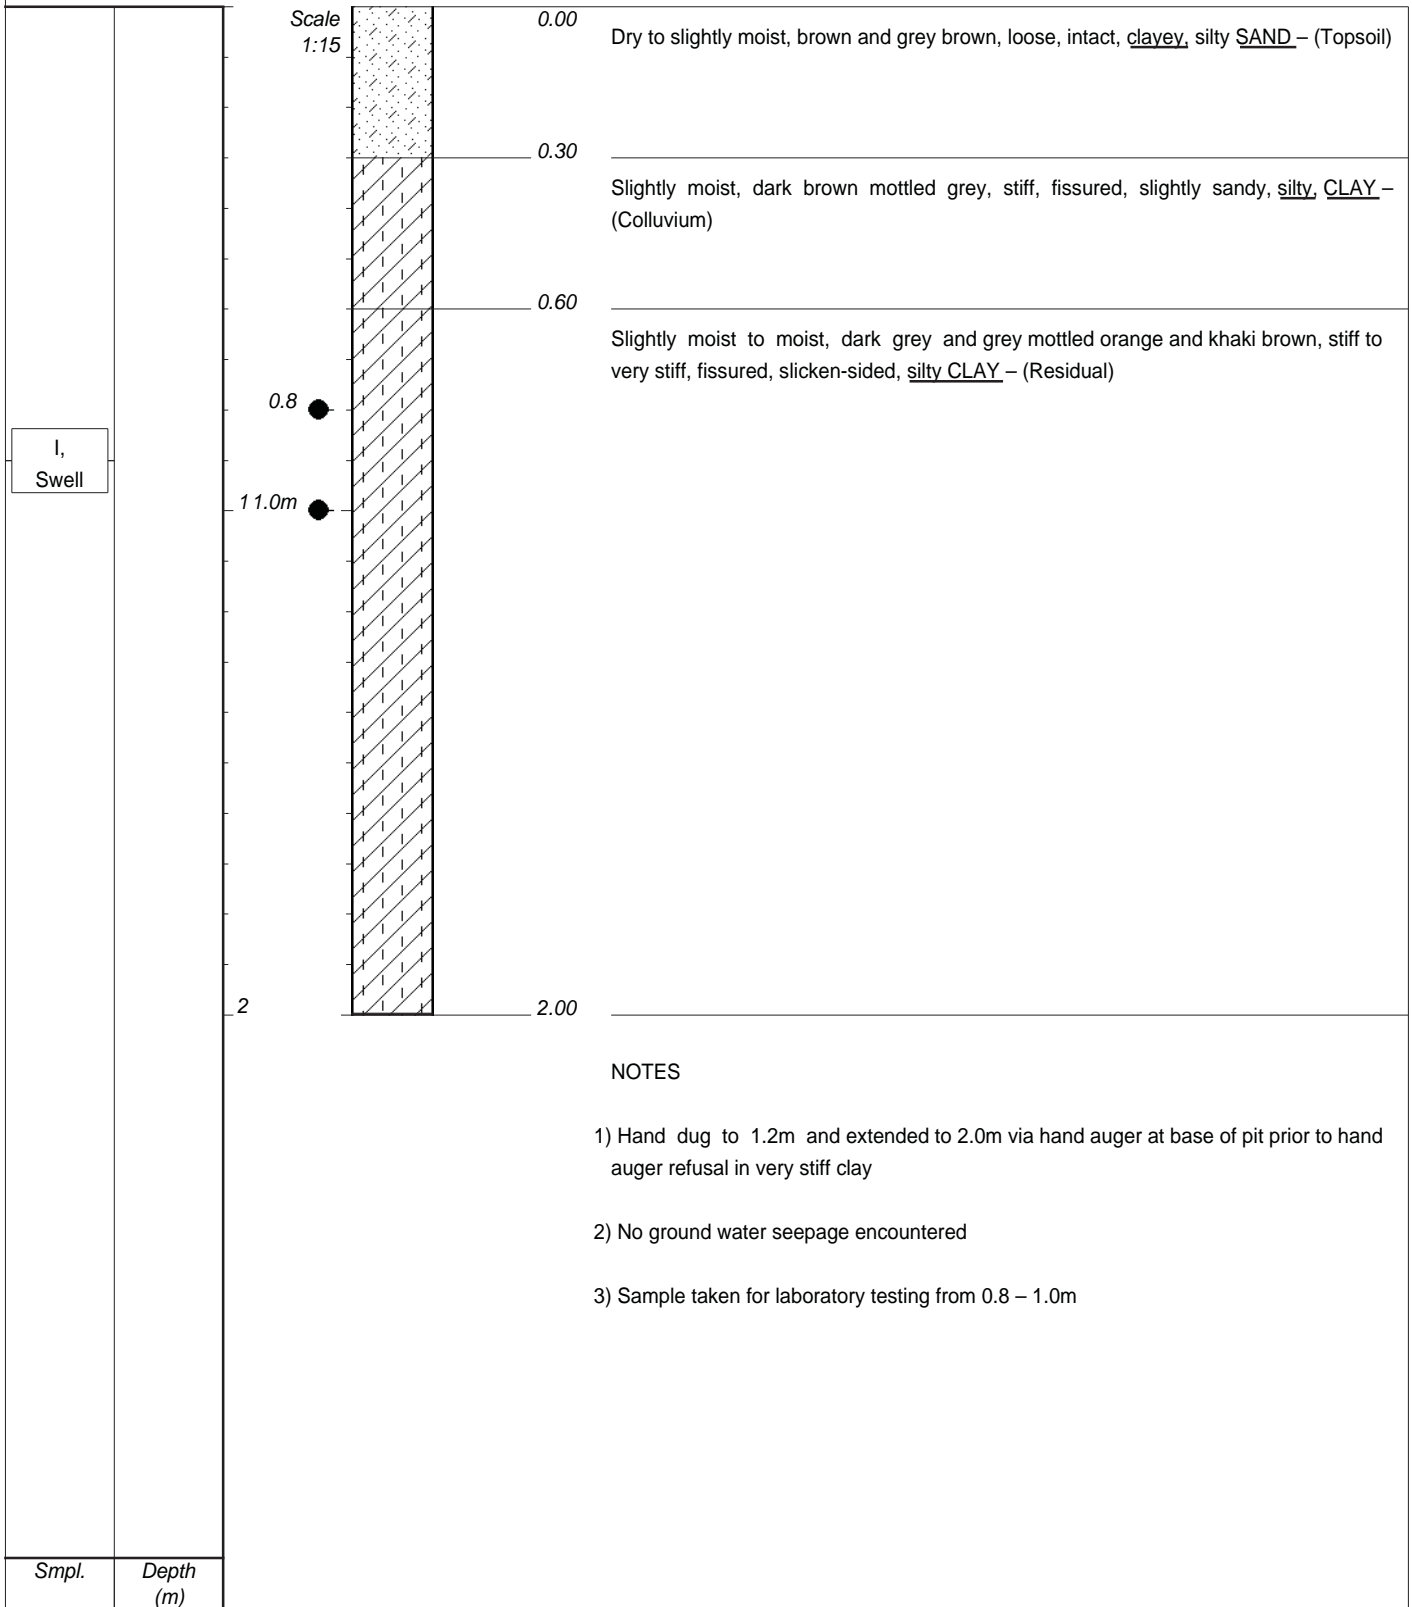
- 1) Hand dug to 1.2m and extended to 2.0m via hand auger at base of pit prior to hand auger refusal in very stiff clay
- 2) No ground water seepage encountered
- 3) Sample taken for laboratory testing from 0.8 – 1.0m

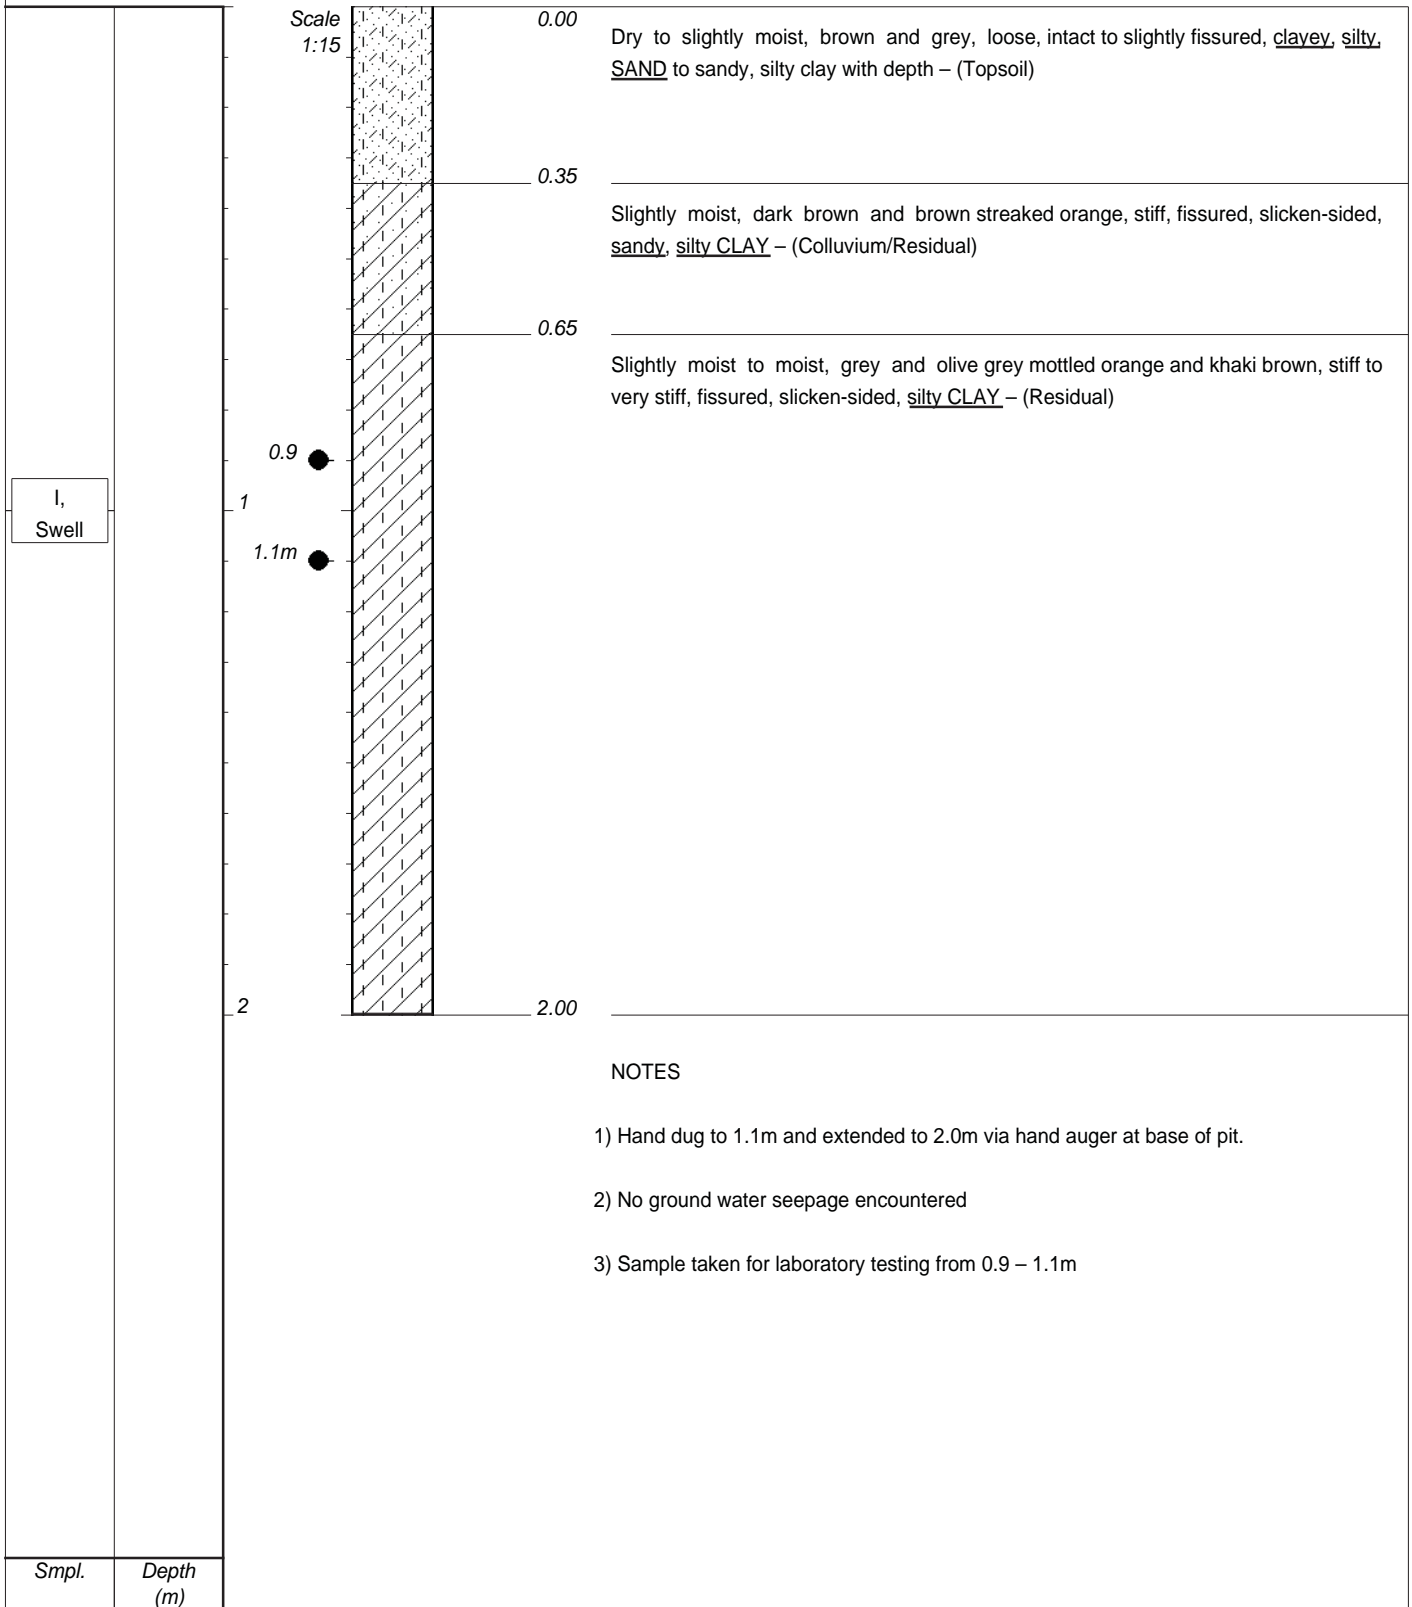
- 1) Hand dug to 1.1m and extended to 2.0m via hand auger at base of pit.
- 2) No ground water seepage encountered
- 3) Sample taken for laboratory testing from 0.9 – 1.1m

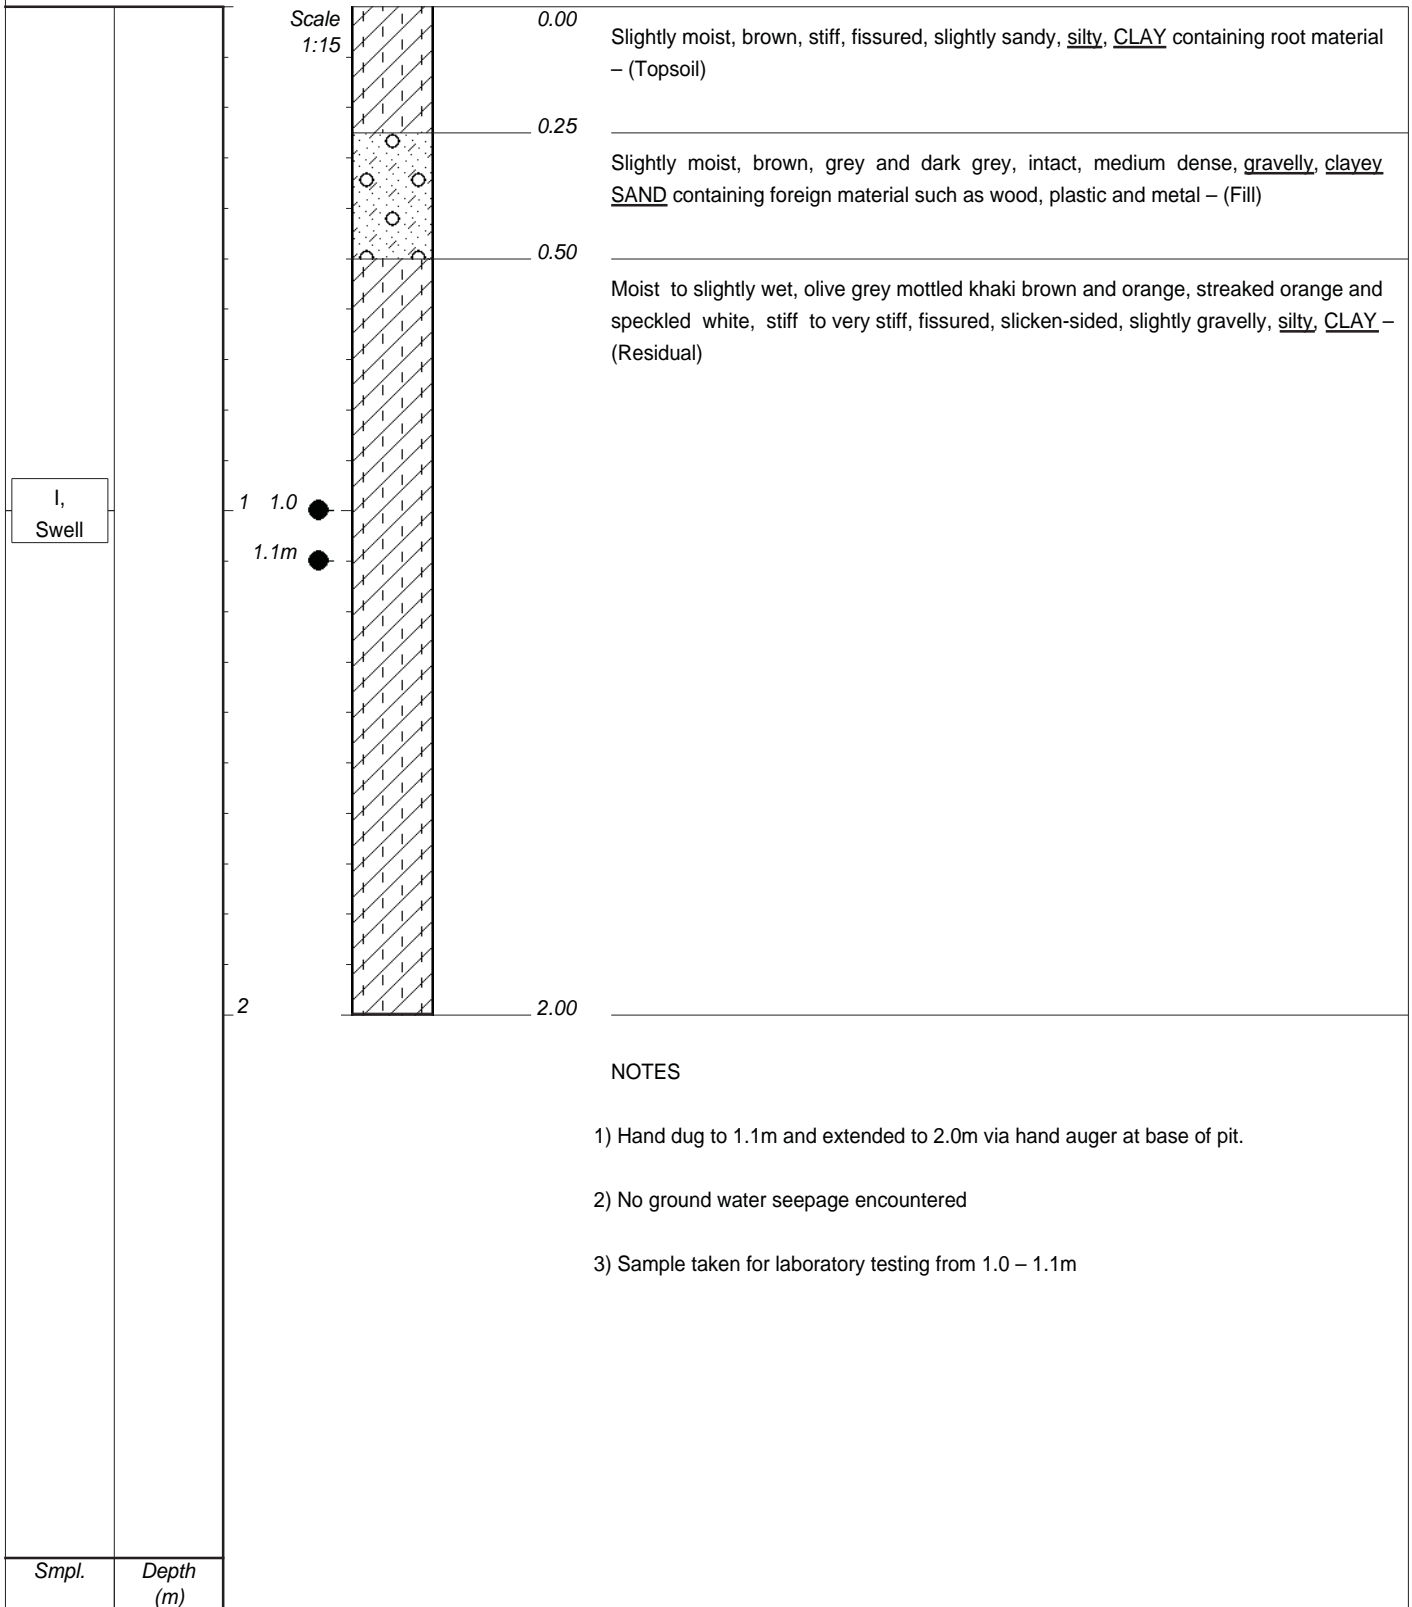
- 1) Hand dug to 1.1m and extended to 2.0m via hand auger at base of pit.
- 2) No ground water seepage encountered
- 3) Sample taken for laboratory testing from 1.0 – 1.1m
