## 4-4 TECHNICAL NOTES (Field Survey I)

The Preparatory Survey for the Project  
for the Upgrading and the Construction of Secondary Schools  
aimed at promoting Inclusive Education in Lesotho

### Technical Notes

**GEOTECHNICAL INVESTIGATION**  
**LESOTHO SCHOOLS UPGRADE PROJECT**  
**ABIA HIGH SCHOOL - E1**

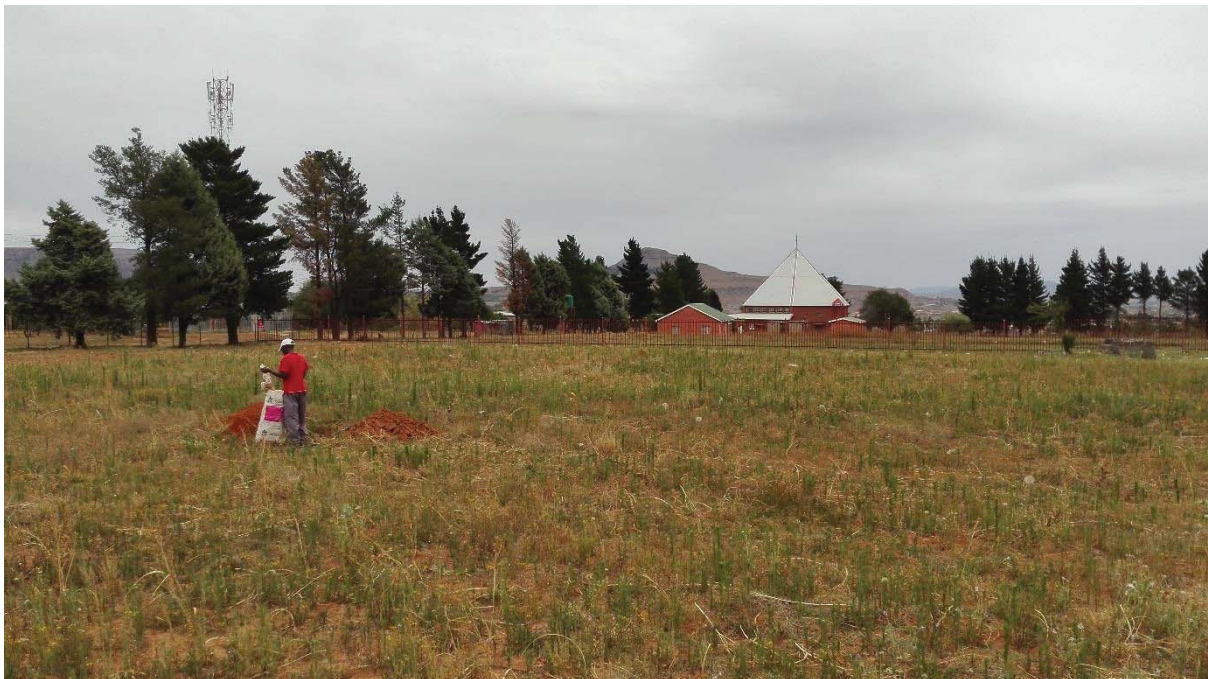
The proposed development areas are located towards the central southern and western portions of the site and comprise currently vacant, previously ploughed/cultivated areas (Plate 2).

**Plate 2 :** Observer looking downslope from eastern development area in a westerly direction across gently sloping site. TP 1 excavation in midground.

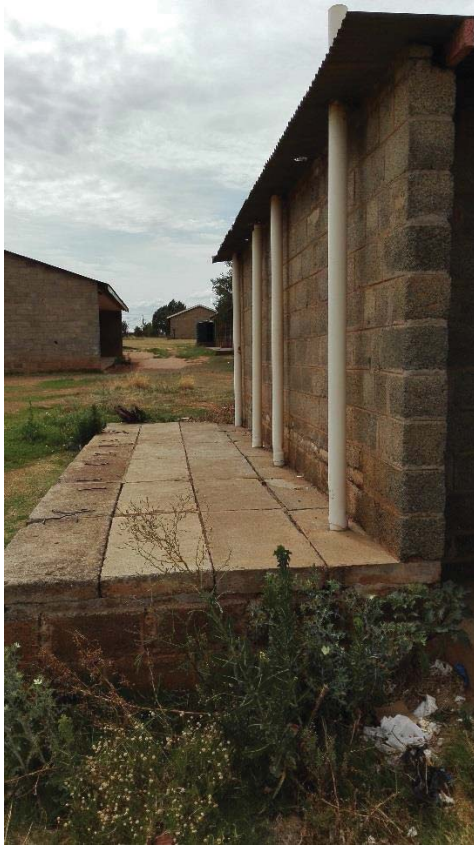
The existing school structures comprise single storey brick structures with several existing ventilated pit latrine facilities located across the site (Plate 3).

**Plate 3** : Example of existing permanent pit latrines on site with single storey school structures located in background.

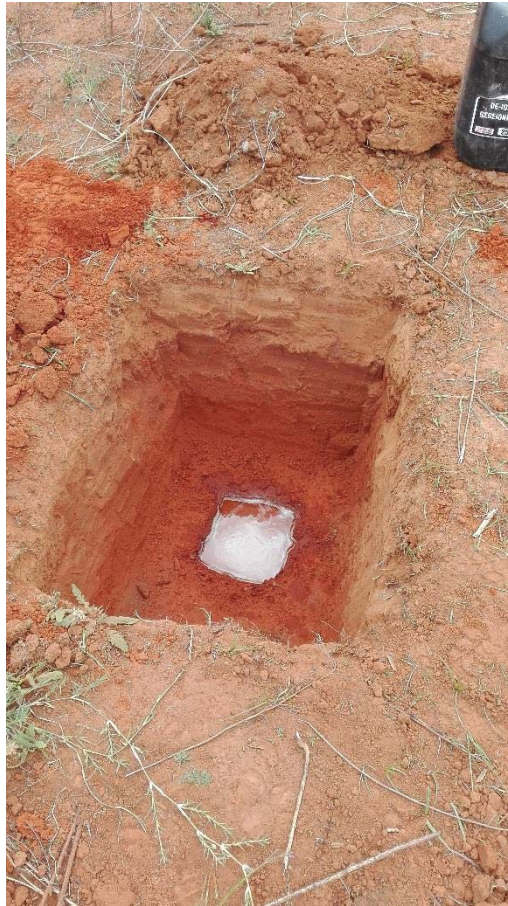
The residual material is overlain by approximately 1 - 1.5m thick horizon of medium dense to dense colluvial material described as orange brown, intact, slightly gravelly, silty sand to clayey silty sand . The colluvium was consistently intersected at a depth of 0.3 depth and overlain by a thin mantle of brown silty sand topsoil material (Plate 4 and 5).

**Plate 5** : Percolation testing and subsoils exposed in PT2 pit.

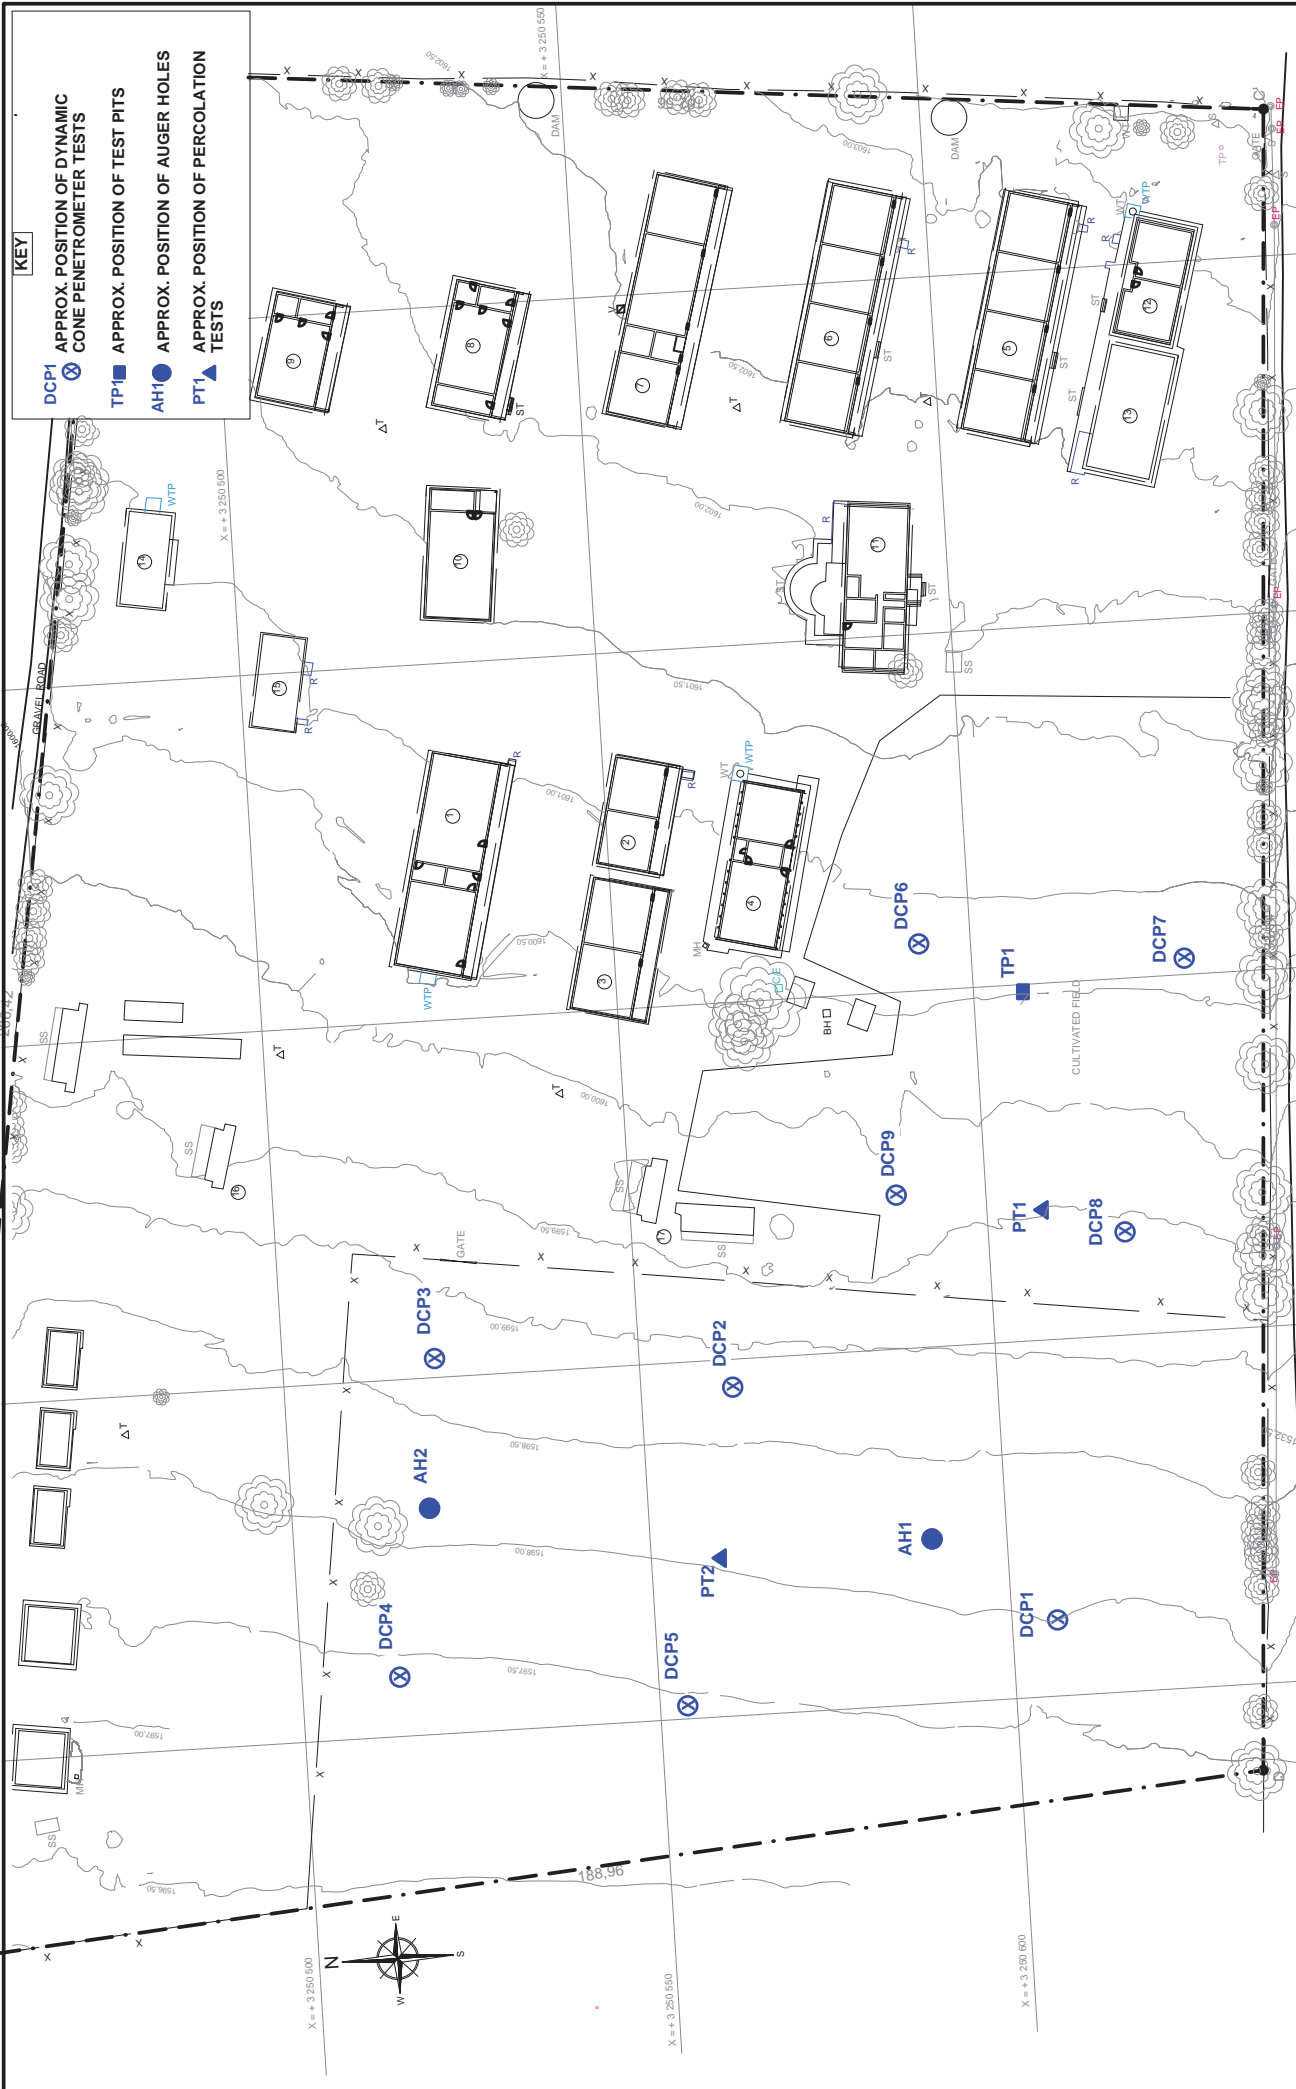
REF. NO. **31181-2**  
 FIG. NO. **1**

**FIGURE 1**  
**Site Plan**

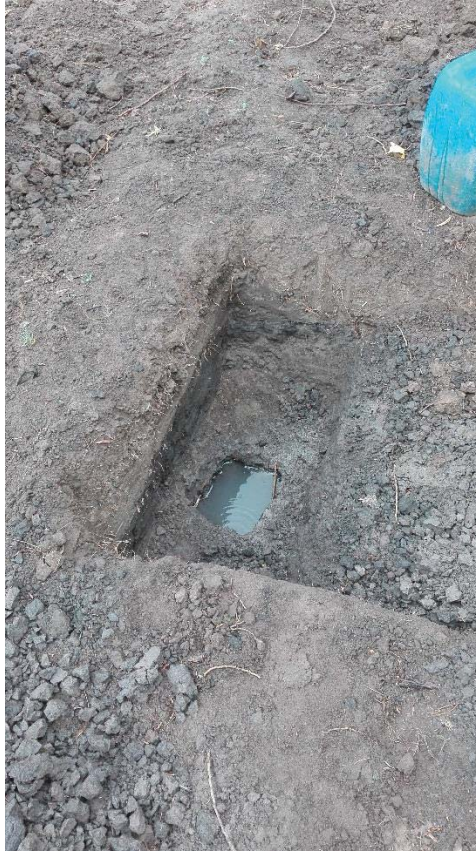
**Plate 3** : Typical dark grey clayey subsoils exposed in PT2 pit in which percolation test carried out.

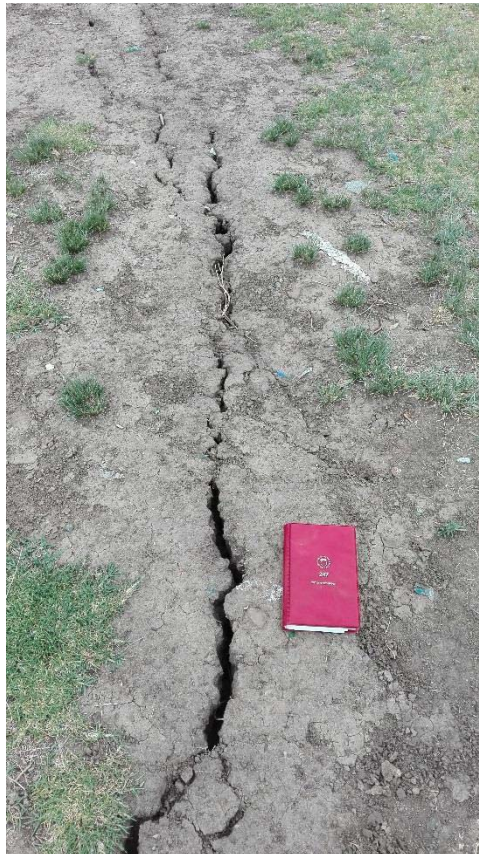
**Plate 4** : Very widely open desiccation cracks at ground level within the active clayey subsoils.

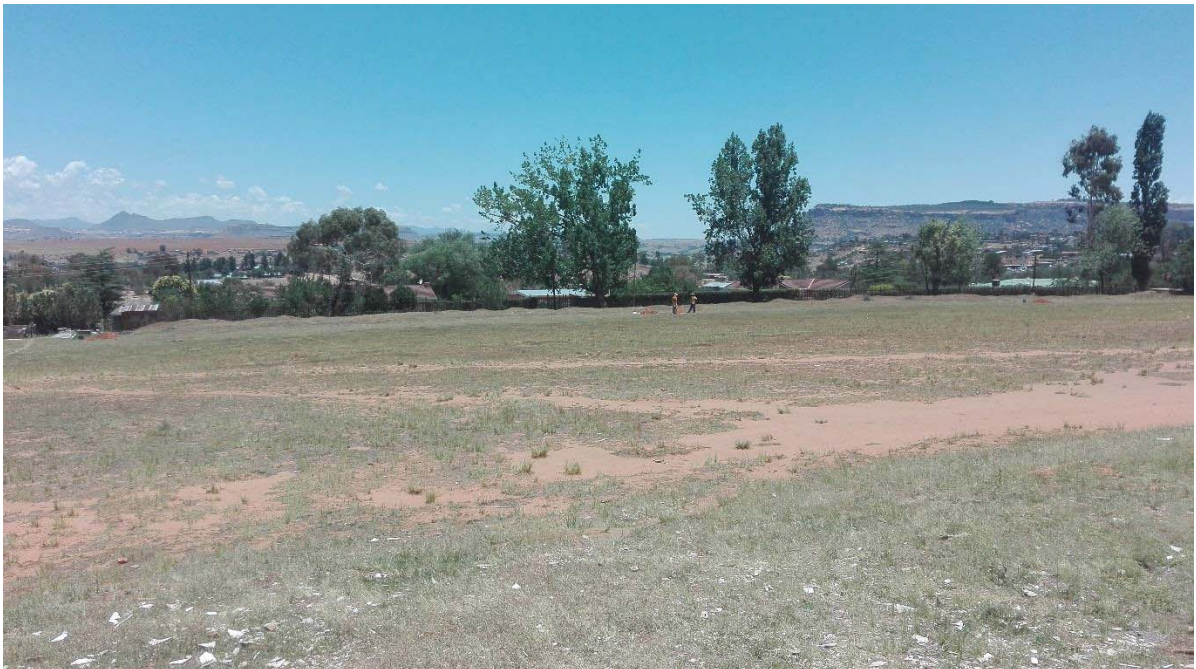
The development area and site in general slopes gently in a south easterly direction at approximately 4° with a planar to slightly convex slope conformation (Plates 2 -3).

**Plate 2 : Development area looking in a south westerly direction**

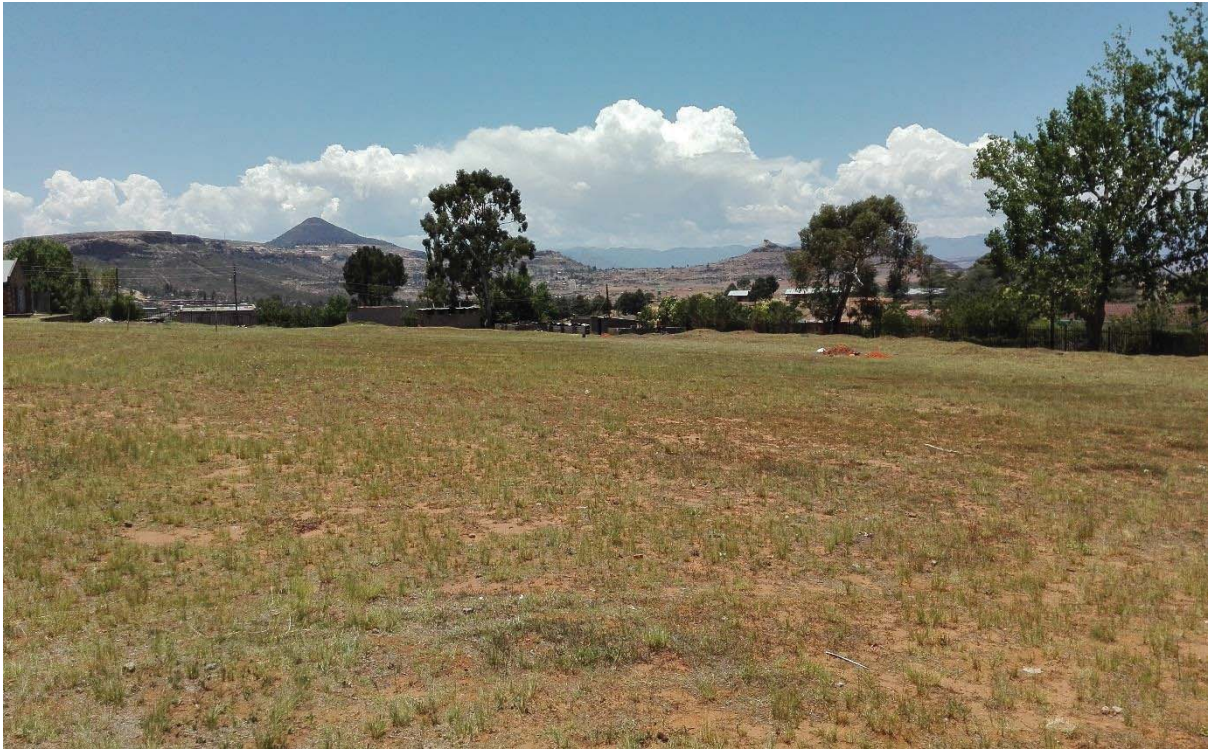
**Plate 3 : Gently sloping site: Observer located along western boundary looking in south easterly direction.**

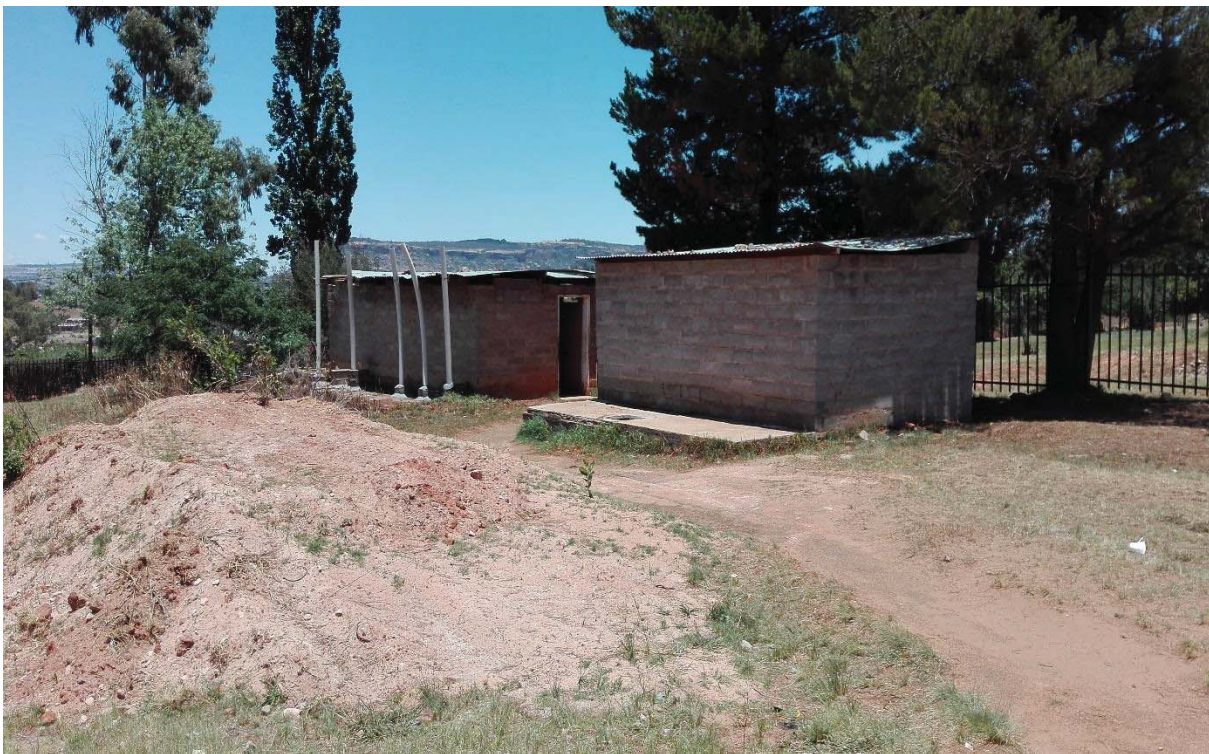
The area is largely vacant with the exception of goal posts, existing ablution facilities towards the south western corner (Plate 4) and groundsman dwelling towards the lower south eastern corner of the school property.

**Plate 4 : Existing Pit latrine ablution facilities located at south western corner of the site.**

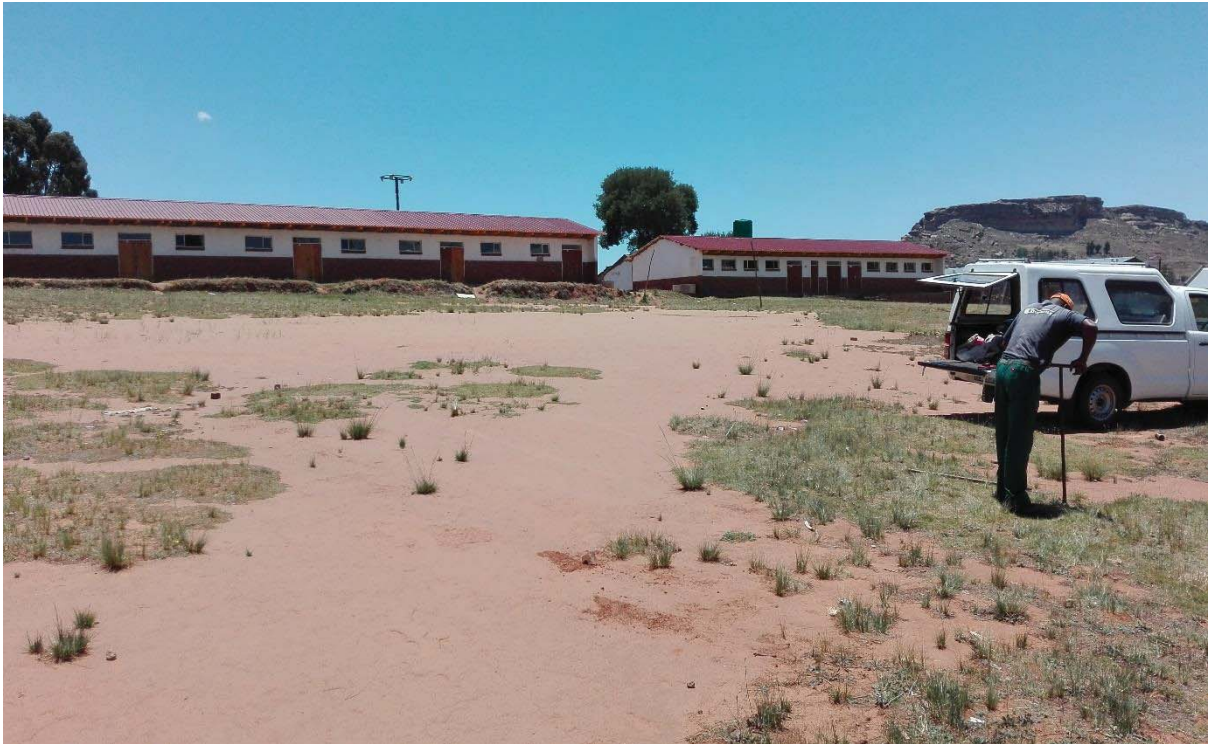
Portions of the investigated area were denuded of grass with hard, well compacted ground exposed at the surface (Plate 5).

**Plate 5: Denuded, hardened ground surface. Observer positioned centrally on site looking in north easterly direction towards existing single storey structures.**

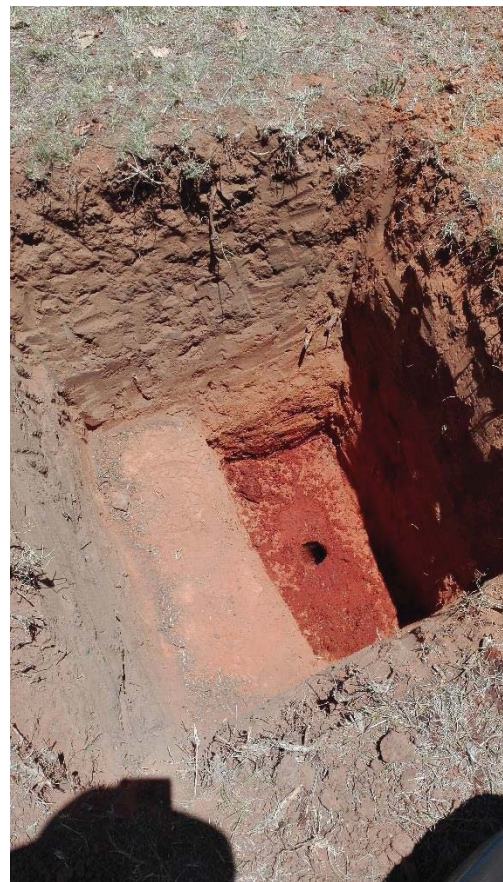
The colluvial/residual material is encountered to depths in excess of 1.3m below existing ground level and is capped by a mantle of topsoil/colluvium comprising brown, dense to very dense, slightly clayey silty sand ranging from 0.2 - 0.8m thick in places (Plate 6 and 7).

**Plate 6 and 7 : Subsoils exposed in PT2 and TP 1.**

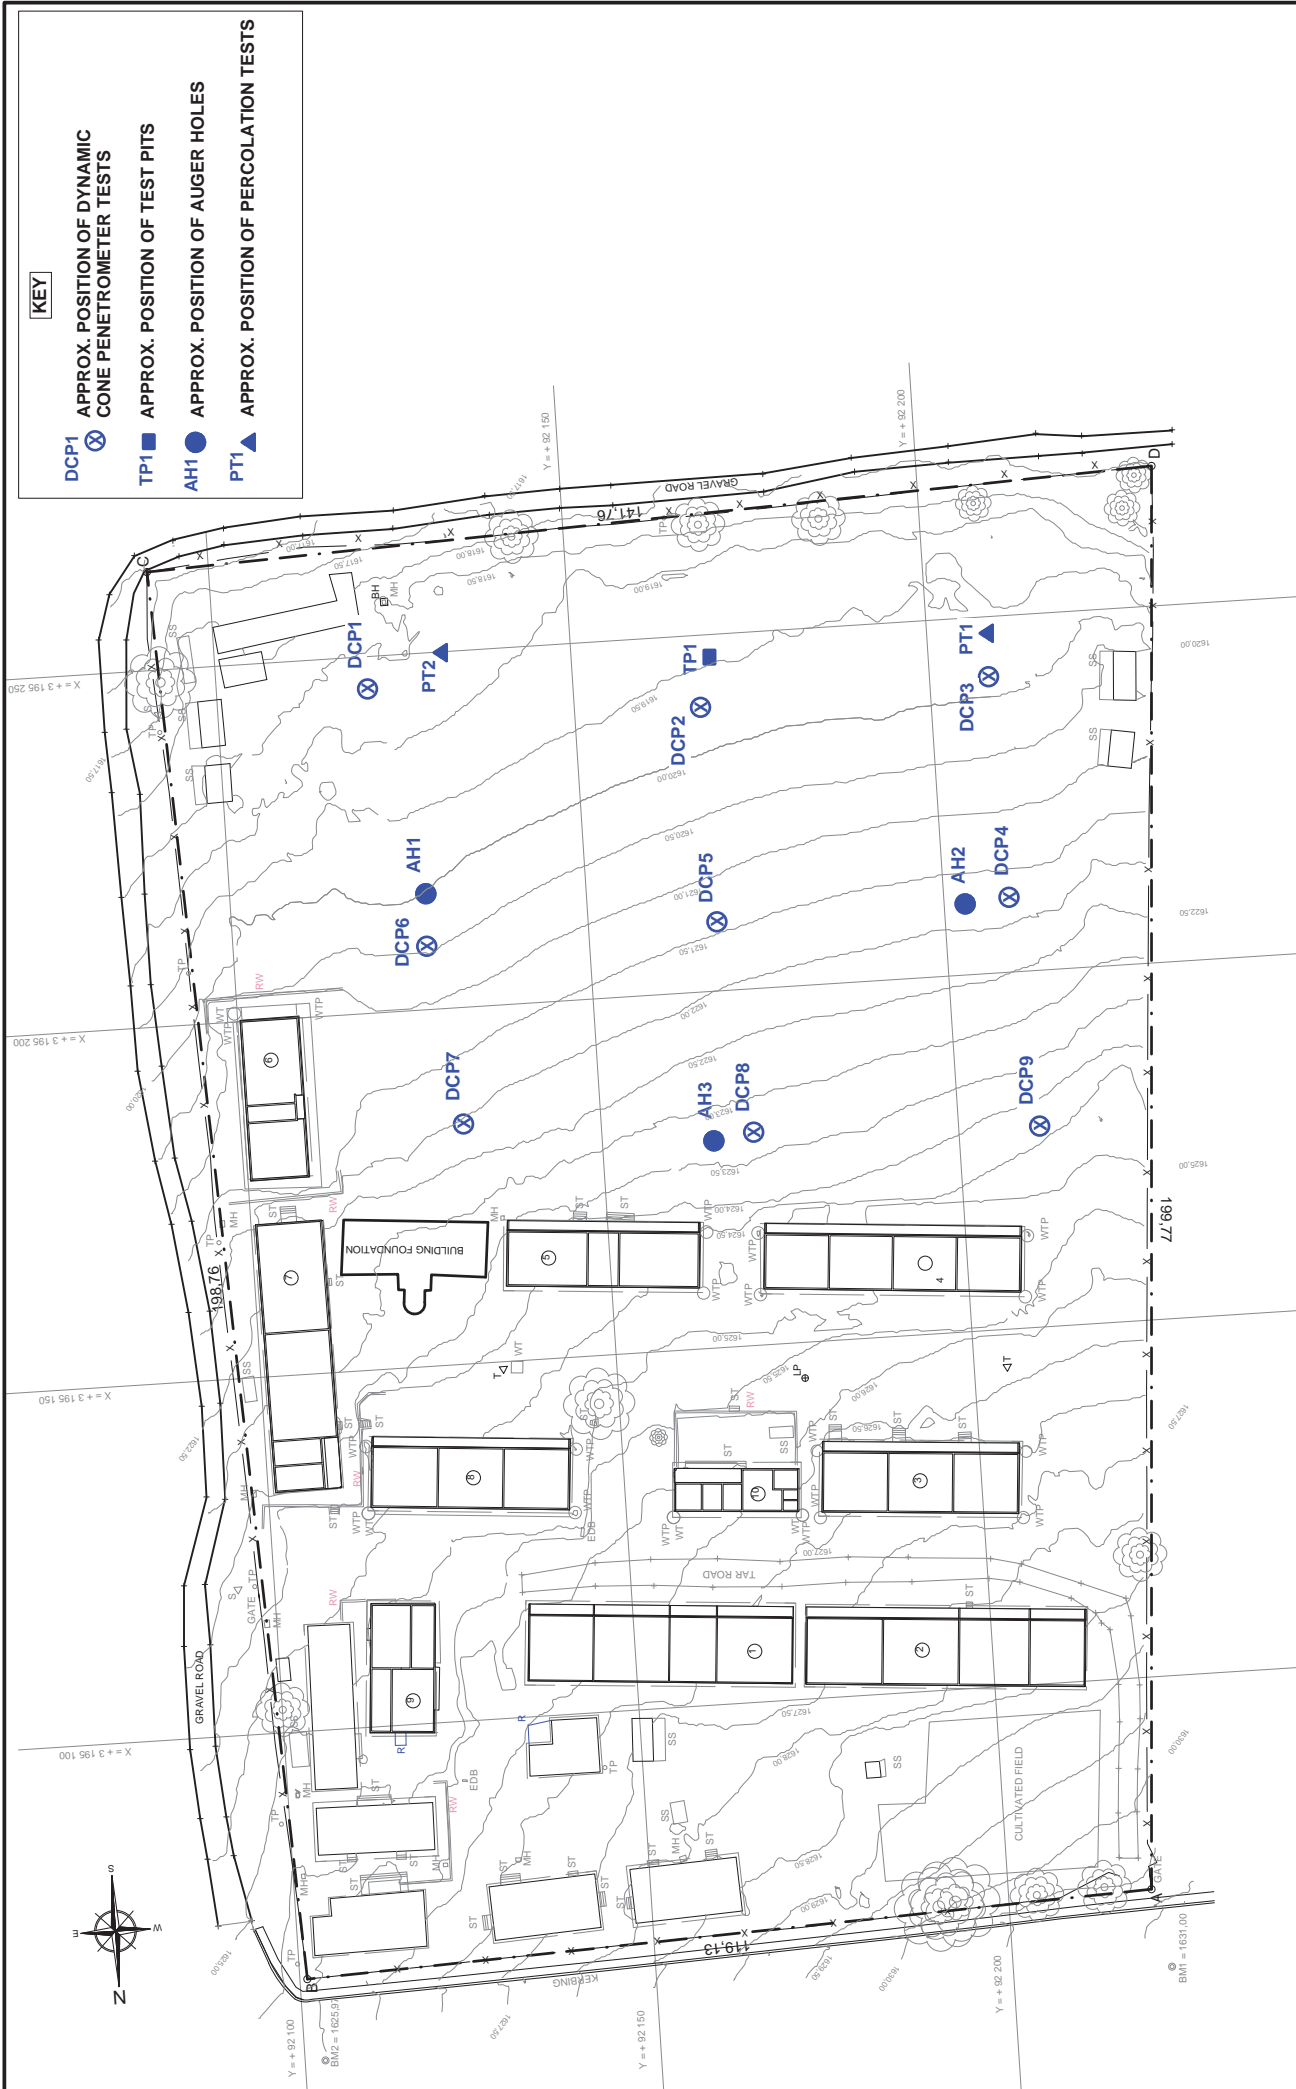
**FIGURE 1**  
**Site Plan**

KEY	
DCP1	APPROX. POSITION OF DYNAMIC CONE PENETROMETER TESTS
PT1	APPROX. POSITION OF TEST PITS
AH1	APPROX. POSITION OF AUGER HOLES
PT1	APPROX. POSITION OF PERCOLATION TESTS

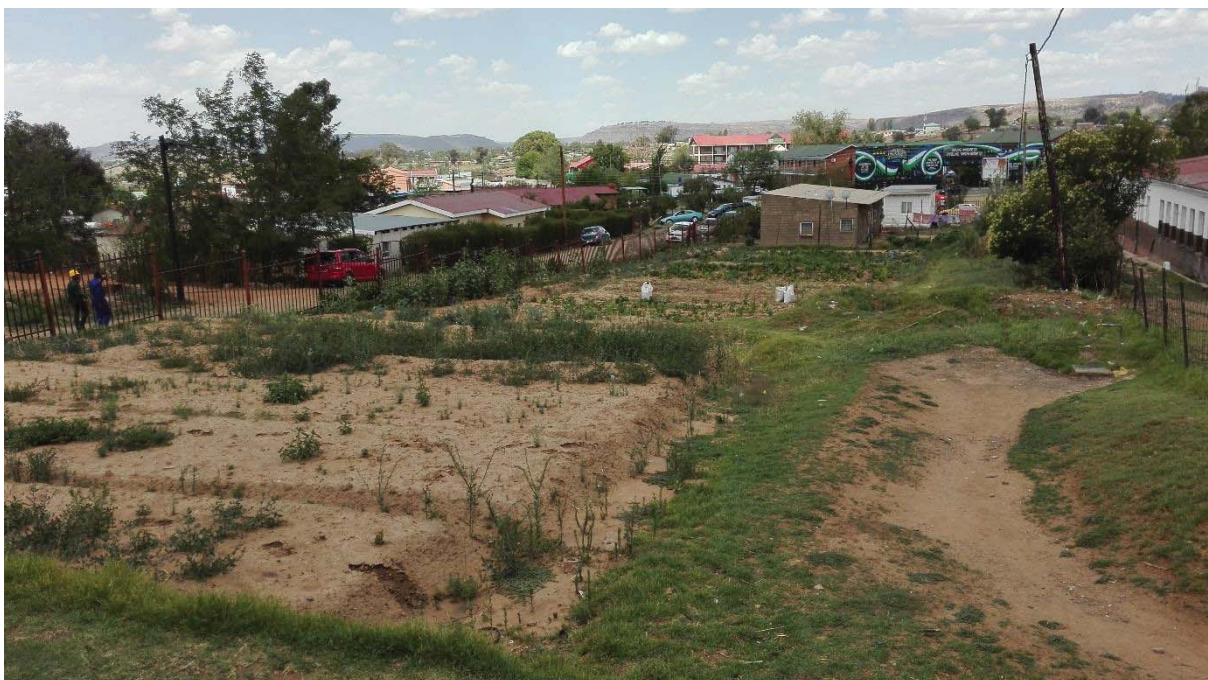
The proposed development area along the northern boundary comprises an existing small cultivated area that slopes gently (4°) in an easterly direction with a planar slope conformation (Plate 2). The area adjacent to the tennis courts is roughly level to gently sloping in an easterly direction and is currently unoccupied.

Plate 2 : Observer looking in a easterly direction across gently sloping northern most development area currently used as cultivated land.

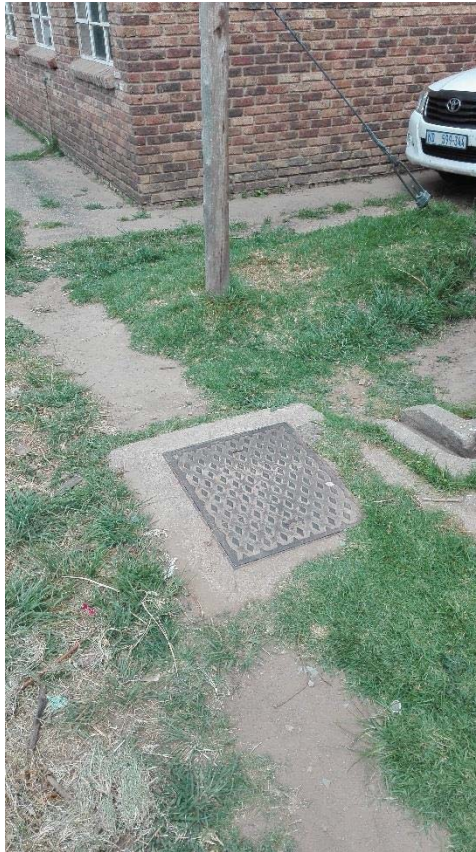
During the course of the site assessment several man hole covers for possible existing storm water and/or sewerage disposal systems were noted across the school premises (Plate 3). However, the functionality of the system could not be ascertained at the time. Given the sites position in the centre of Maseru, it is most probable that there exists a municipal sewerage and/or storm water system in the area. Furthermore, running water is also available on site.

Plate 3 : Example of manhole for possible sewerage / storm water disposal system existing on site.

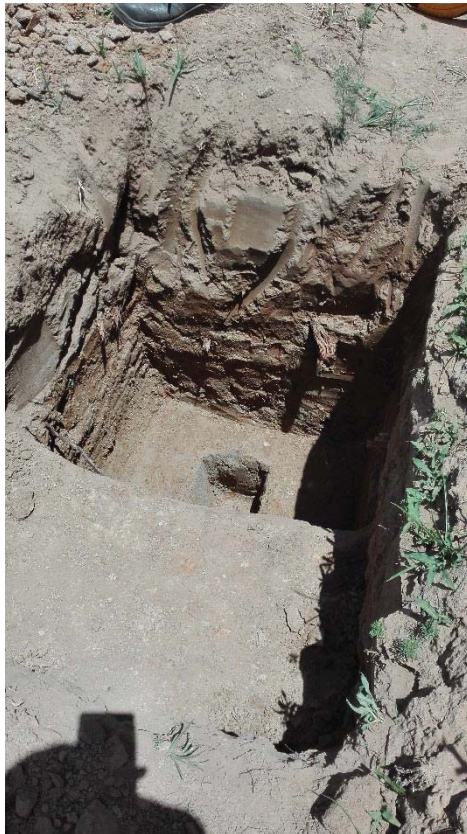
The general subsoil conditions prevailing across the site are depicted in Plate 4 -6 included in Appendix D herewith.

Plate 4 : Soil profiles exposed in TP 1 excavated to 1.5m depth and extended to 2.35m via auger.

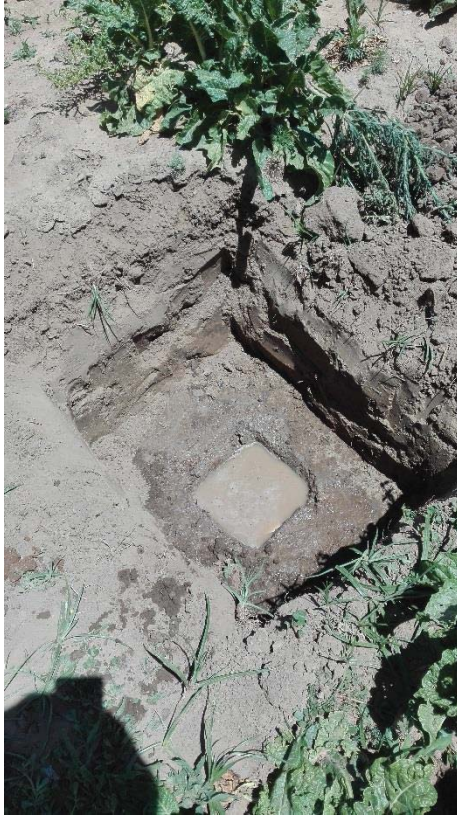
Plate 5 : Soil profile exposed PT1 pit in which percolation test was carried out.

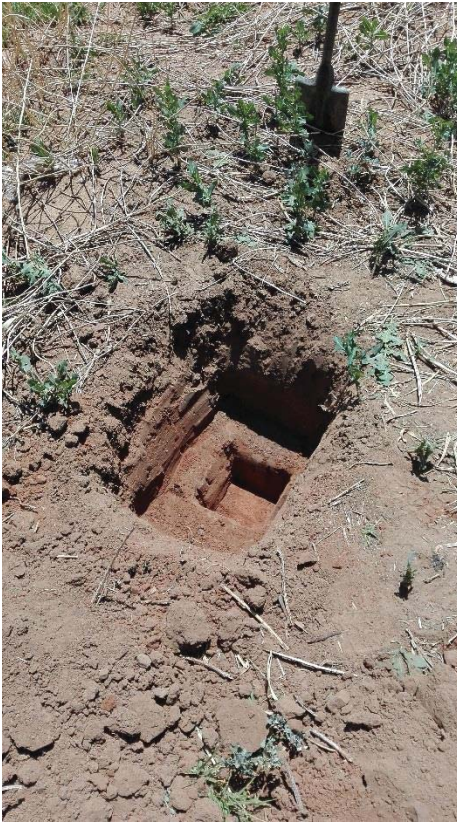
Plate 6 : Soil profile exposed PT2 pit in which percolation test was carried out.

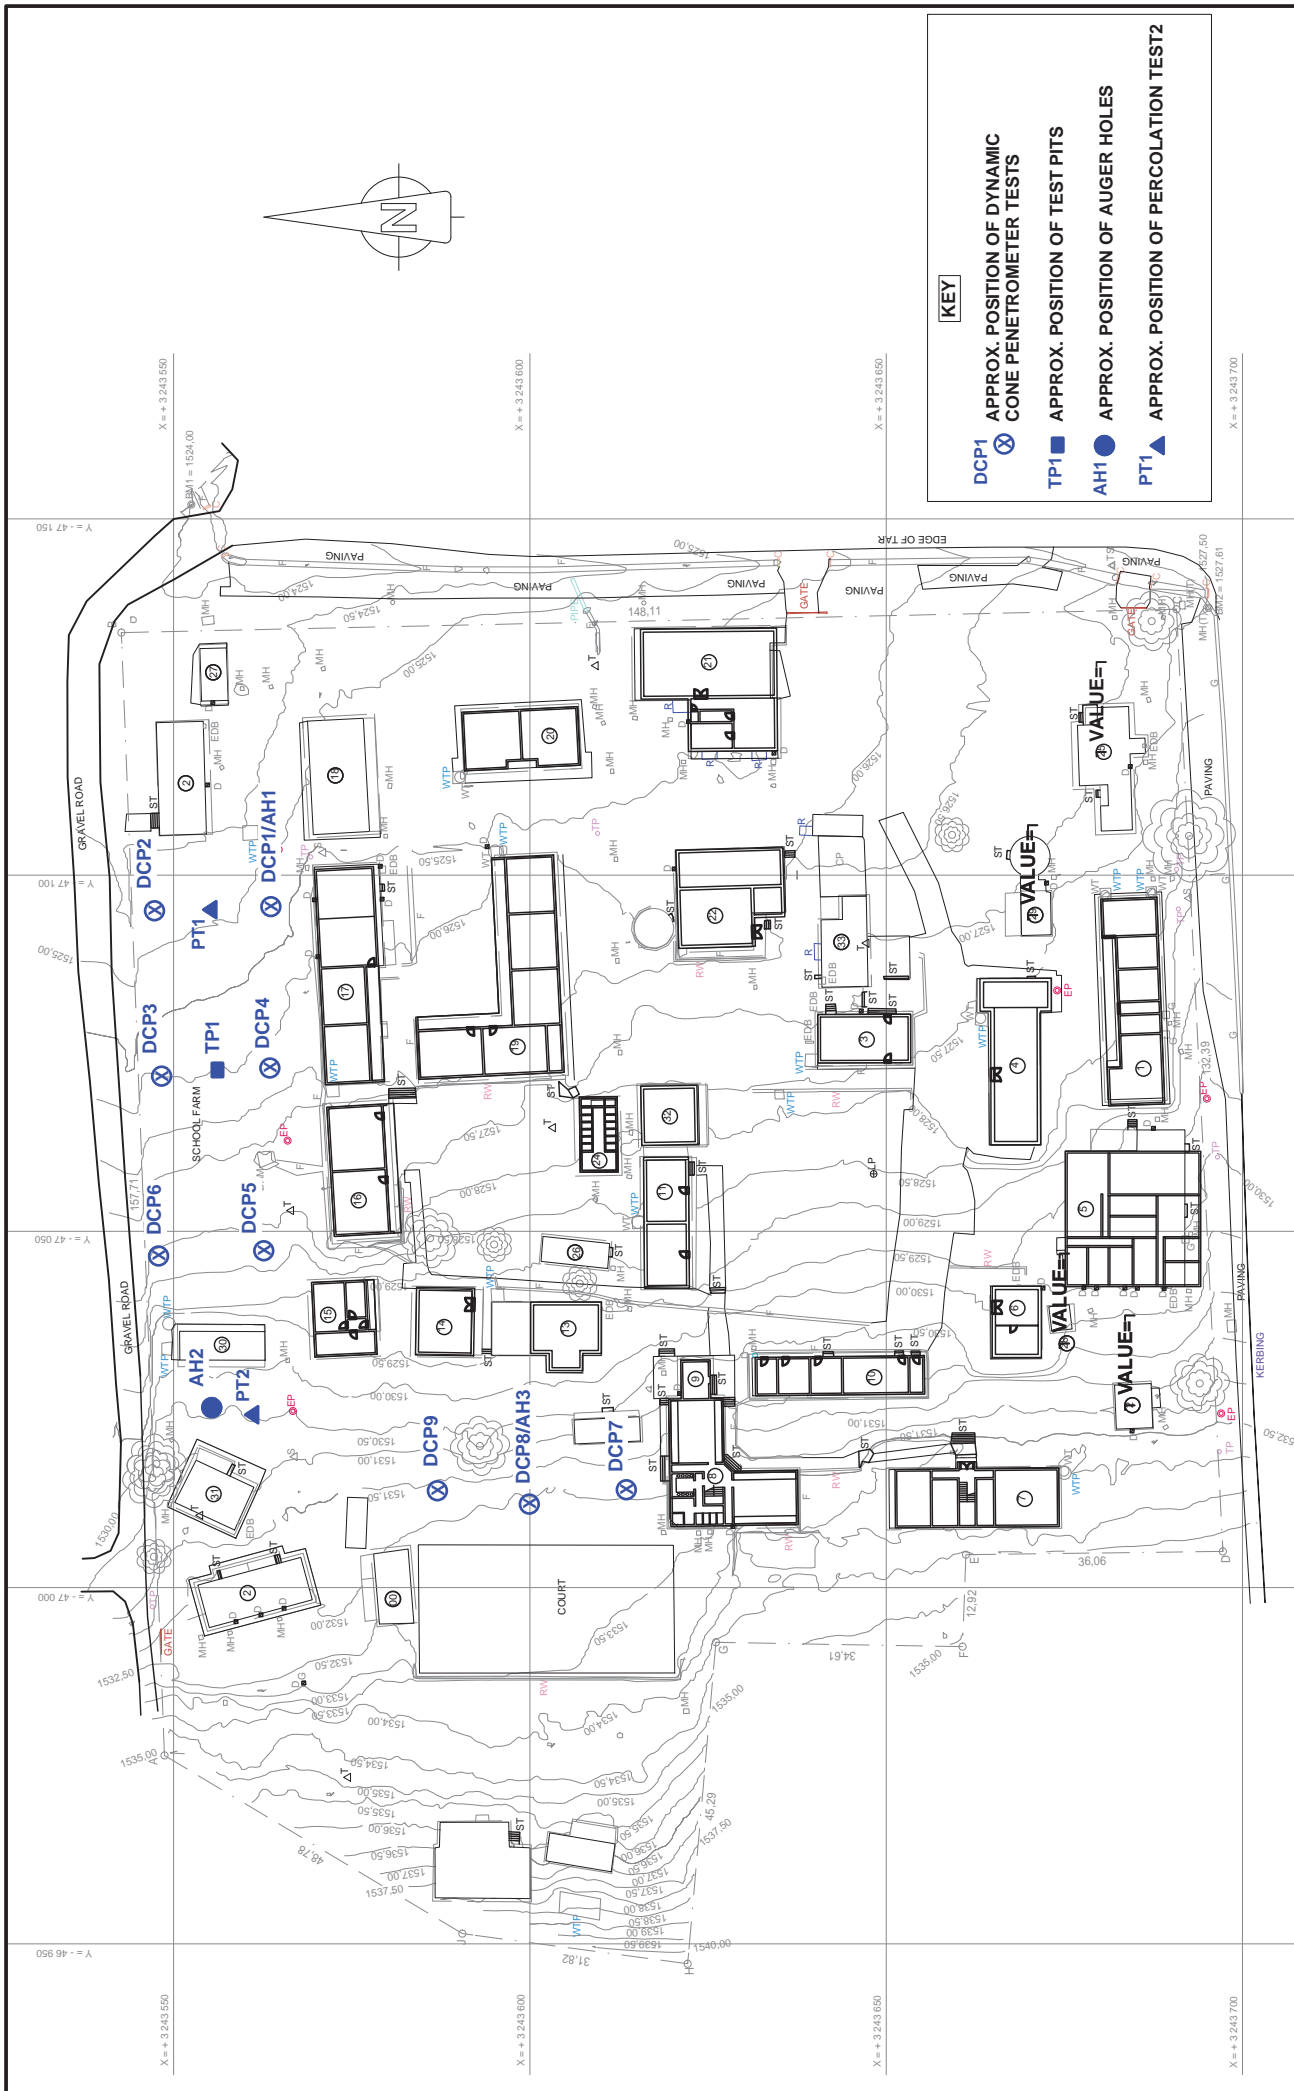
**FIGURE 1**  
**Site Plan**
