ЗАКЛЮЧЕНИЕ

ГОСУДАРСТВЕННОЙ ЭКОЛОГИЧЕСКОЙ ЭКСПЕРТИЗЫ

на Отчет «Предварительная оценка воздействия на окружающую среду»
проекта реконструкции моста через реку Урмарал на автодороге Тараз-Талас

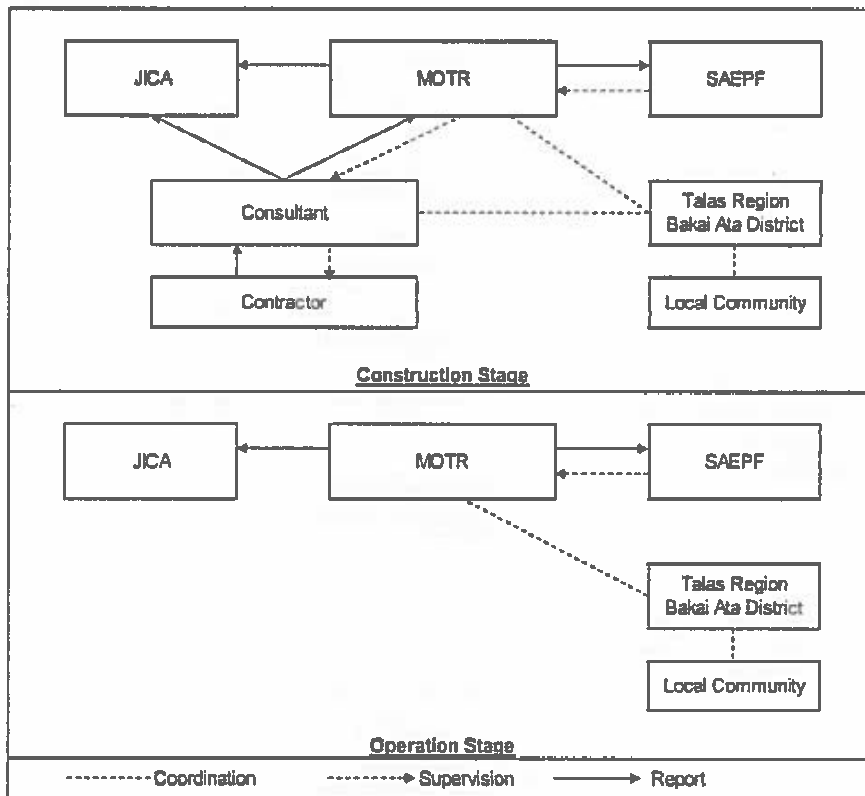
Figure1-4-8 Implementation Structure of EMP and EMoP

The implementation structure of EMP and EMoP during construction and operation stage are shown in Figure 1-4-8.

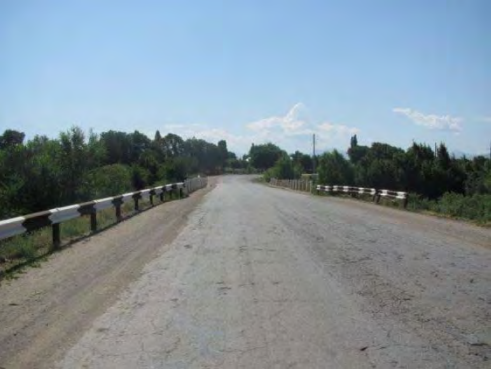
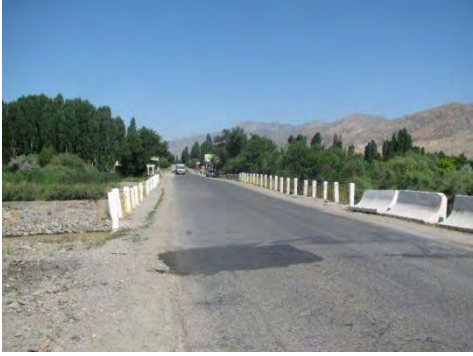
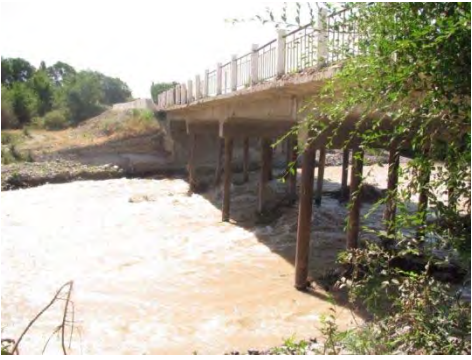
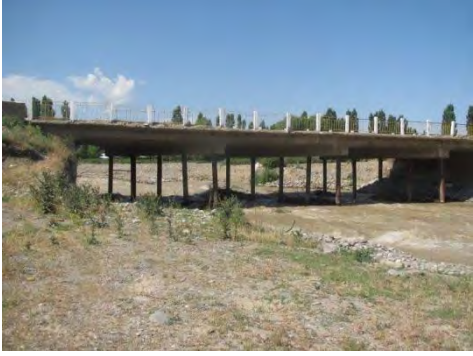
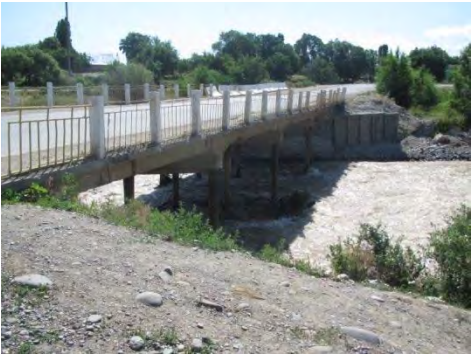
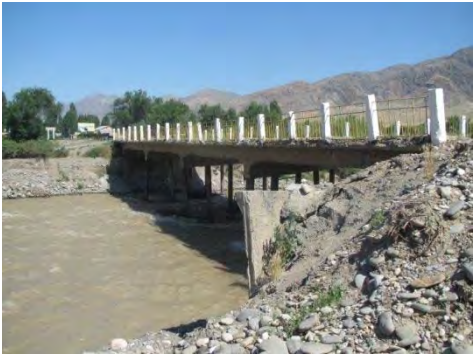
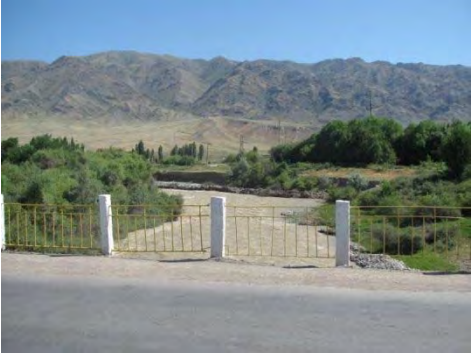
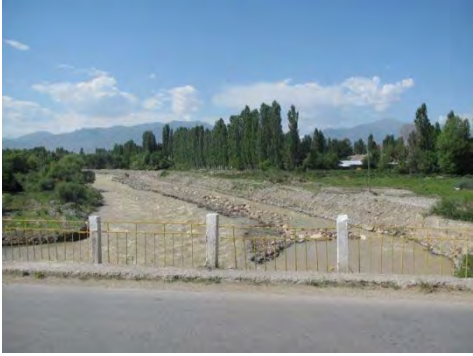
Название моста		Мост через реку Урмарал		Название дороги		Автодорога Талас-Тараз	
Состояние проектного участка	Вид	Со стороны Тараза		Вид	Со стороны Таласа

Вид	Со стороны Тараза вверх по течению		Вид	Со стороны Таласа вверх по течению

Вид	Со стороны Тараза вниз по течению		Вид	Со стороны Таласа вниз по течению

Вид	Направление вниз по течению		Вид	Направление вверх по течению

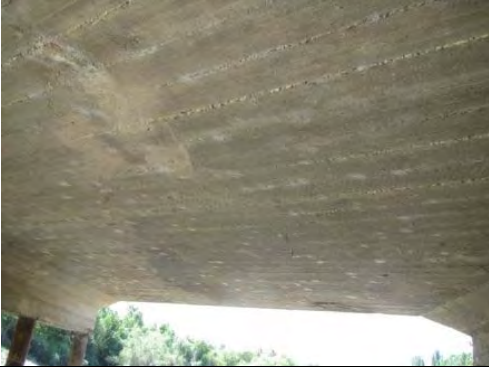
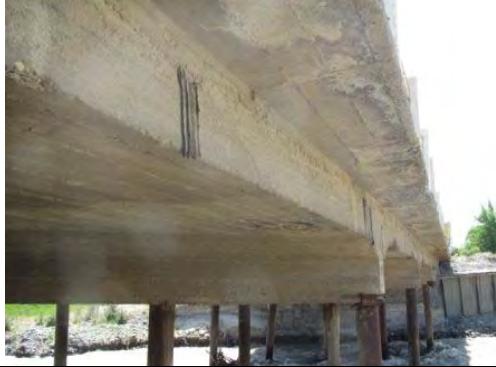
Название моста	Мост через реку Урмарал			Название дороги	Автодорога Талас-Тараз		
Элемент	Плита (снизу)			Элемент	Плита (сбоку)		
Повреждение	Целостность	Уровень	a	Повреждение	Протечка воды	Уровень	c
Состояние	Присутствуют несколько трещин, но они не оказывают влияния на уровень безопасности.			Состояние	Протечка воды с частицами асфальта по краю плиты

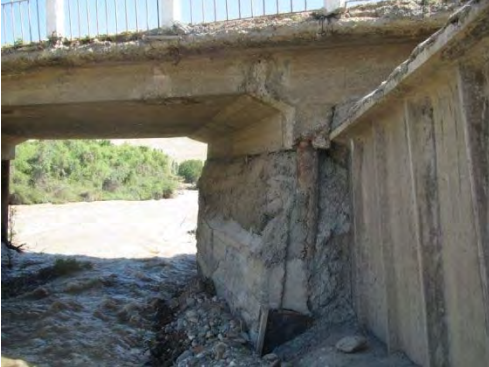
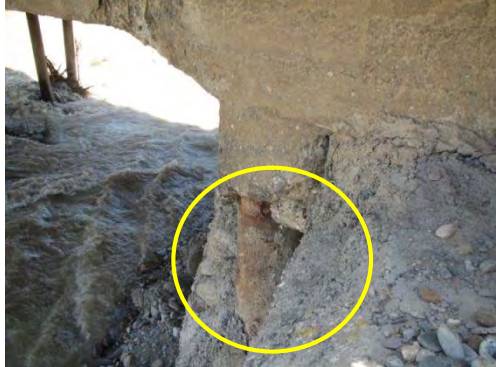
Элемент	Тело (основание)			Элемент	То же, что и с левой стороны		
Повреждение	Откалывание бетона	Уровень	c	Повреждение	То же самое с левой стороны	Уровень	-
Состояние	Отколота часть бетона с лицевой стороны фундамента основания			Состояние	Жёлтым выделена часть сваи внутри фундамента основания

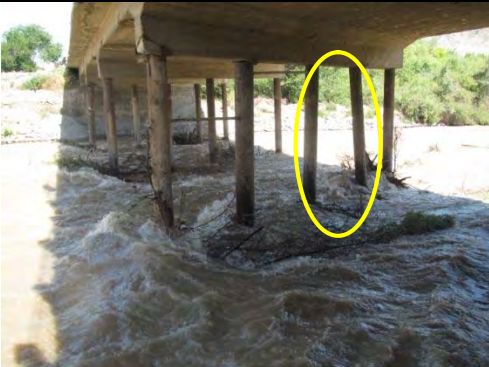
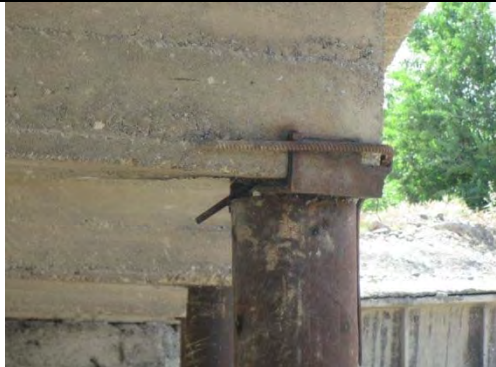
Элемент	Тело (свая)			Элемент	То же, что и с левой стороны		
Повреждение	Деформация	Уровень	c	Повреждение	-	Уровень	-
Состояние	Со стороны вниз по течению видны деформации			Состояние	Свая и плита не соединены между собой

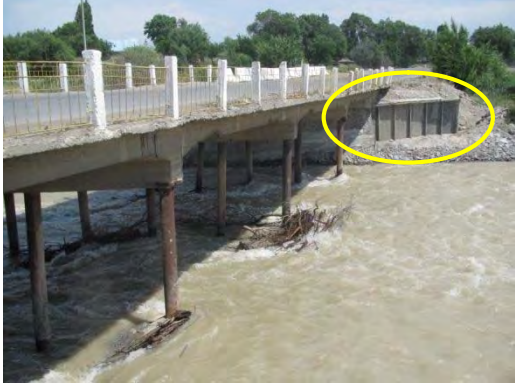
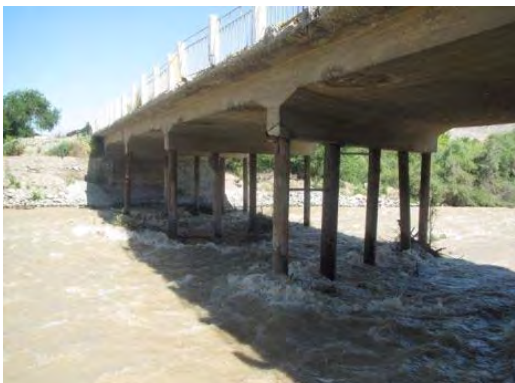
Фото повреждений	Название моста			Мост через реку Урмарал			Название дороги			Автодорога Талас-Тараз		
	Элемент			Каменная кладка			Элемент			Опорный башмак		
	Повреждение			-			Уровень			-		
	Состояние			Жёлтым выделена отремонтированная часть после обрушения в результате половодья в прошлом году			Состояние			У данного типа моста нет опорных элементов

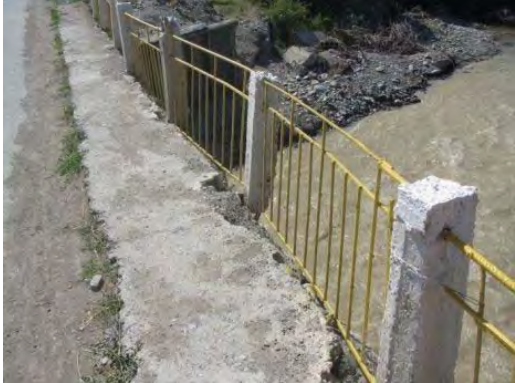
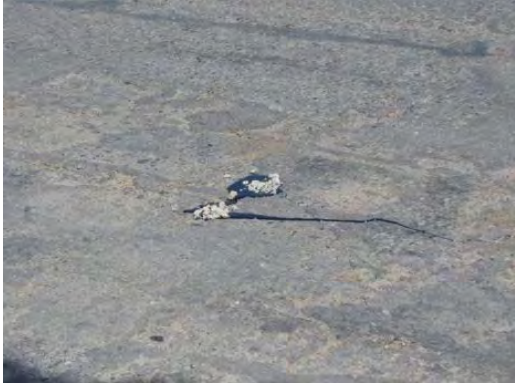
Элемент			Перильные ограждения			Элемент			Поверхность плиты		
	Повреждение			Деформации / Отсутствие			Уровень			с		
	Состояние			Перильные ограждения частично отсутствуют			Состояние			Присутствуют яма и трещина

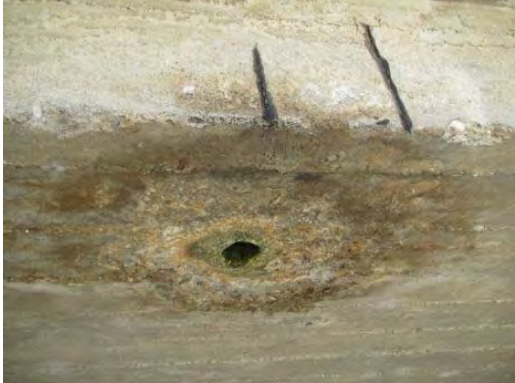
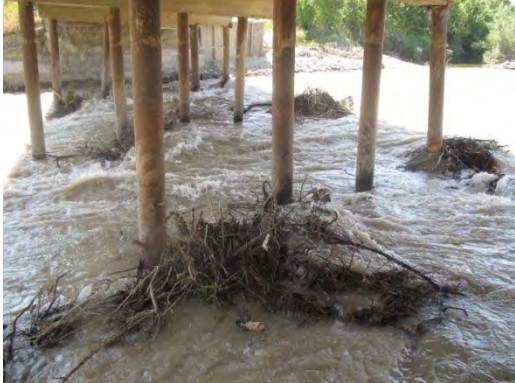
Конструкция	Элемент	Повреждения	Оценка повреждения	Примечание
Опорный башмак	Башмак	Функциональные повреждения	—	У данного типа моста нет опорных элементов
		Несвойственные звуки	—	
	Раствор	Забит грунтом	—	
		Деформации / Отсутствие	—	
Вспомогательные элементы	Перильные ограждения	Деформации / Отсутствие	c	Ограждение частично отсутствует
Поверхность плиты	Дорожная одежда	Нарушения структуры покрытия	e	Присутствуют яма и трещина
		Неровности на поверхности дороги	a	
	Температурные швы	Неровности на поверхности дороги	Не видны	Из-за уложенного поверх асфальта
		Повреждения на местах соединений	Не видны	
Дренаж		Забит грунтом	Отсутствует	
		Протечка воды / Накапливание воды	Отсутствует	
Мост в целом		Отклонение от нормального состояния	a	
		Просадки / сдвиги, наклоны	a	
		Эрозия	a	
		Прочее	—	Данная конструкция опор способствует застреванию и накапливанию плавающего мусора. Из-за этого явления существует вероятность обрушения моста.

Элемент			Дренаж			Элемент			Мост в целом		
Повреждение			Протечка воды			Уровень			е			
Состояние			Дренажная труба отсутствует			Состояние			Данная конструкция опор способствует застреванию и накоплению плавающего мусора. Из-за этого явления существует вероятность обрушения моста.

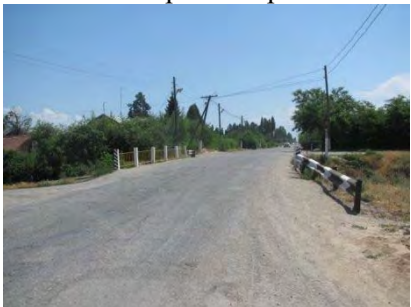
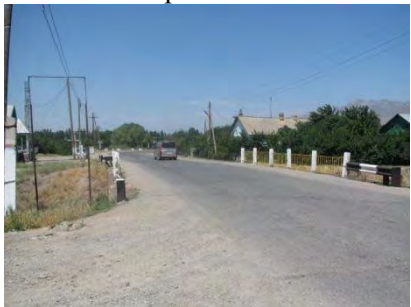
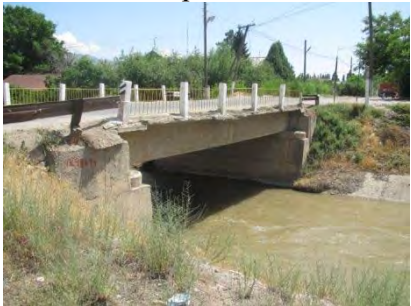
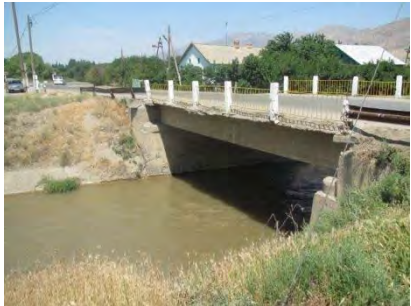
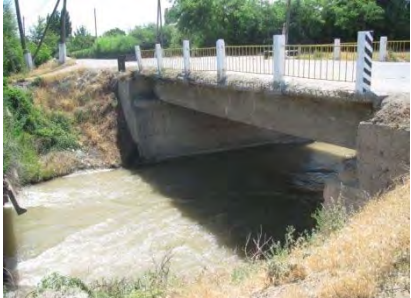
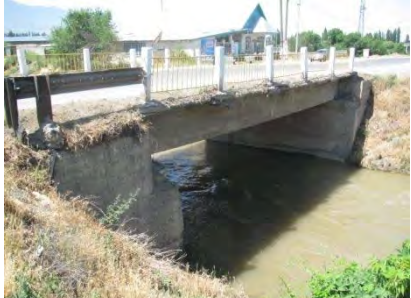
Таблица -1 Характеристики моста № 1

Год постройки	1963	Расположение	В.Д.:71.9430556 С.Ш.:42.5472222
Высота над у.м.	1064м	Расстояние от города Талас	в 20км к западу
Полезная ширина дороги	8.0м (дорожное полотно)		
Грузоподъёмность	НГ-60		
Пролетное строение	Тип : Ж/б мост с Т-образной балкой, Длина моста: 13.5м		
Опорная часть	Основание гравитационного типа (бетон/каменная кладка)		
Фото	【 со стороны Тараза】		【 со стороны Таласа】

【 вверх по течению со стороны Тараза】		【вверх по течению со стороны Таласа】

【вниз по течению со стороны Тараза】		вниз по течению со стороны Таласа】

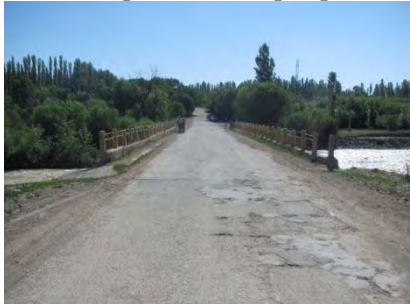
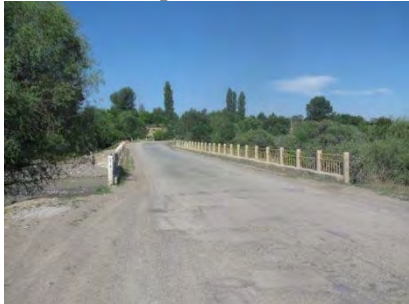
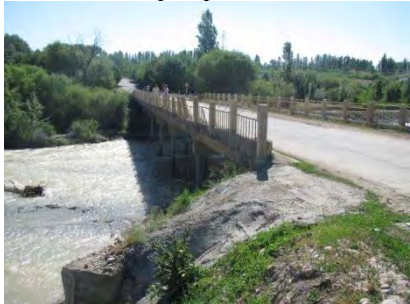
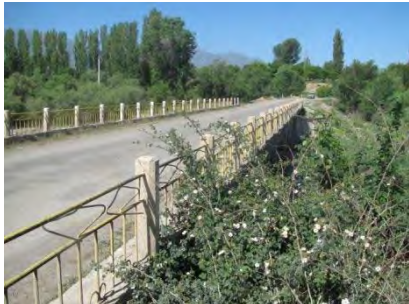
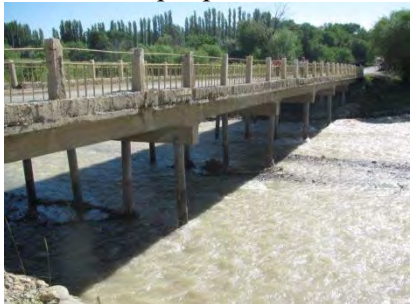
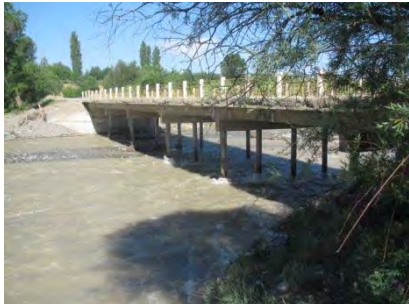
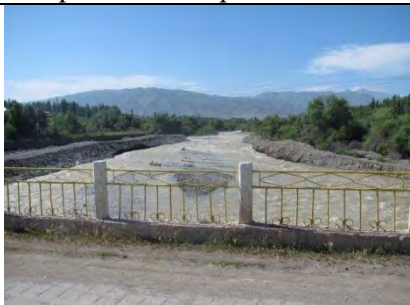
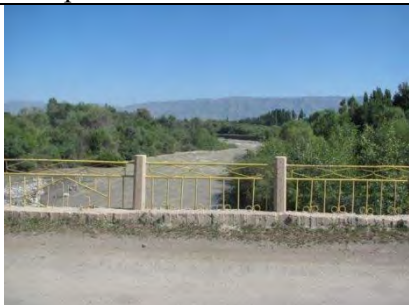
Таблица -3 Характеристики моста № 3

Год постройки	1961	Расположение	В.Д.:71.968647 С.Ш.:42.462967
Высота над у.м.	1195м	Расстояние от города Талас	в 20 км к западу
Полезная ширина дороги	8.0м (Дорожное полотно) *Измерено исследовательской группой		
Пролетное строение	Тип : Ж/б 5-пролетный плитный мост		
	Длина моста : 45м *Измерено исследовательской группой		
Опорная часть	Стальная труба		
Фото	【 со стороны села Урмарал】		【 со стороны г. Талас】

【 вверх по течению со стороны с. Урмарал】		【 вверх по течению со стороны г. Талас】

Фото	【 вниз по течению со стороны с. Урмарал】		【 вниз по течению со стороны г. Талас】

【 направление вверх по течению】		【 направление вниз по течению】

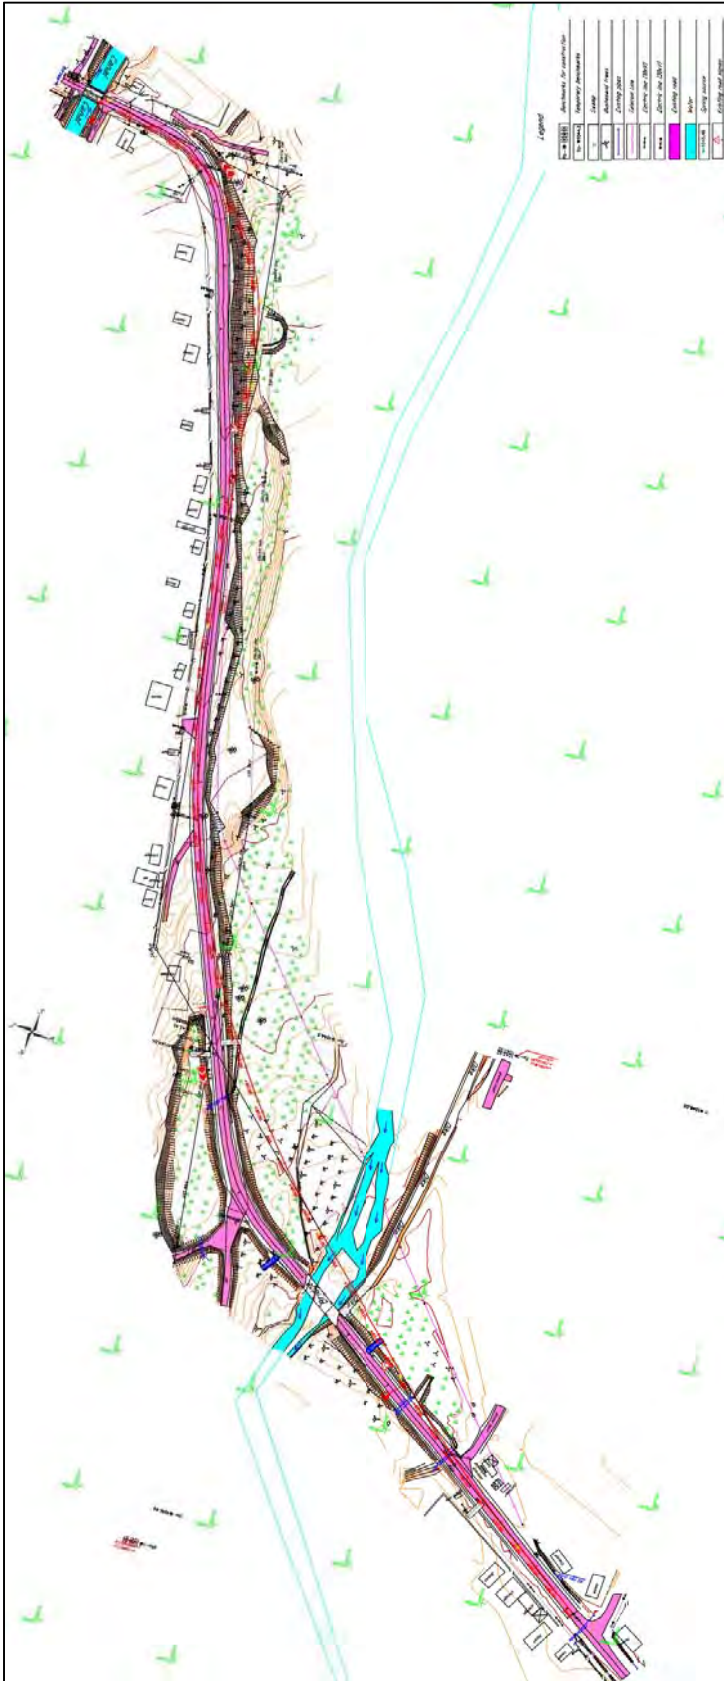
Plan

(3) Результаты топографической съёмки
