## 資料編

**REPORT  
ON  
SOIL INVESTIGATION  
FOR  
EINME RAIL-WAY PROJECT  
EINME TOWNSHIP, AYEYARWADDY REGION**

**REPORT  
ON  
SOIL INVESTIGATION  
FOR  
EINME RAIL-WAY PROJECT**

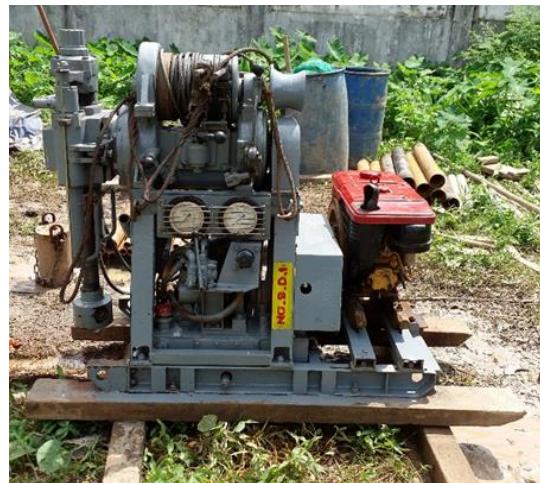
The boring equipment, TOHO-D1 was applied in the soil investigation work of project area, to study general condition of soil layers under planned area for future construction. The specification and the types of boring equipment were presented in Table-1.2.

Photo - 1.7 TOHO-D1 Drilling Machine

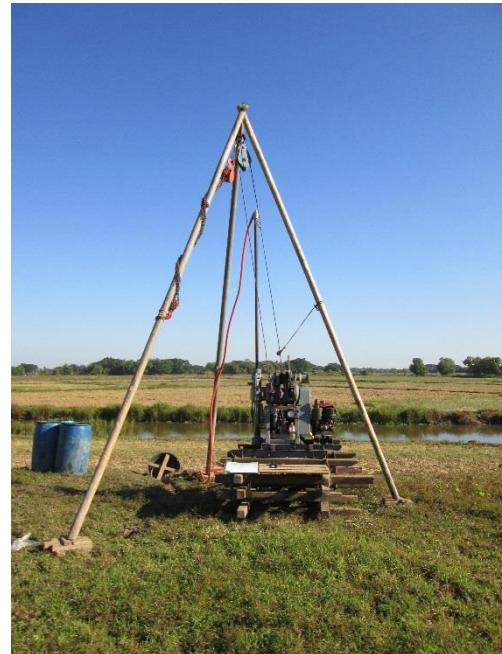
In boring, rotary direct circulation method is appropriately applied using metal crown bits attached to casings of Ø112mm and metal crown bits of Ø64mm in diameter setting with single core tube are properly applied depending on soil condition to drilling process. The drilling machines are operated by setting on the stage with maintaining horizontal level of drilling machine and vertical position of drilling direction while drilling on field investigation works. Boring and SPT testing in all the points are operated from drilling stage maintaining the stability of boring machine. In the way of direct circulation of drilling fluid, water and bentonite slurry was inevitably utilized to control the circulation of the sludge. The schematic diagram of boring equipment is shown in following Figure - 3.2.

Figure - 3.3 Schematic View of Drilling Machine setting

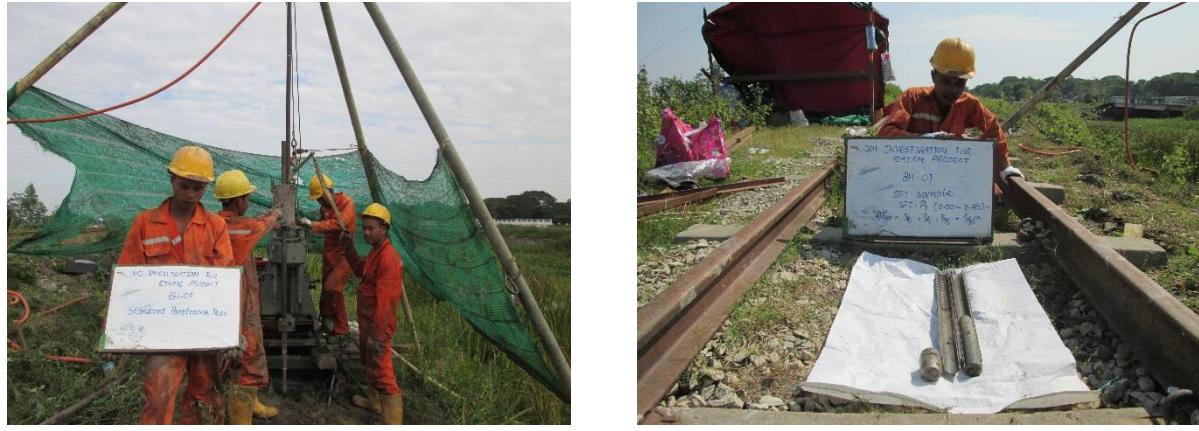
Photo - 3.7 View of Standard Penetration Test and SPT Sample
