Appendix-6: Types of Defects and Rating

1. Types of Defects and Rating

Table 1 Summary of Types of Defects and Rating

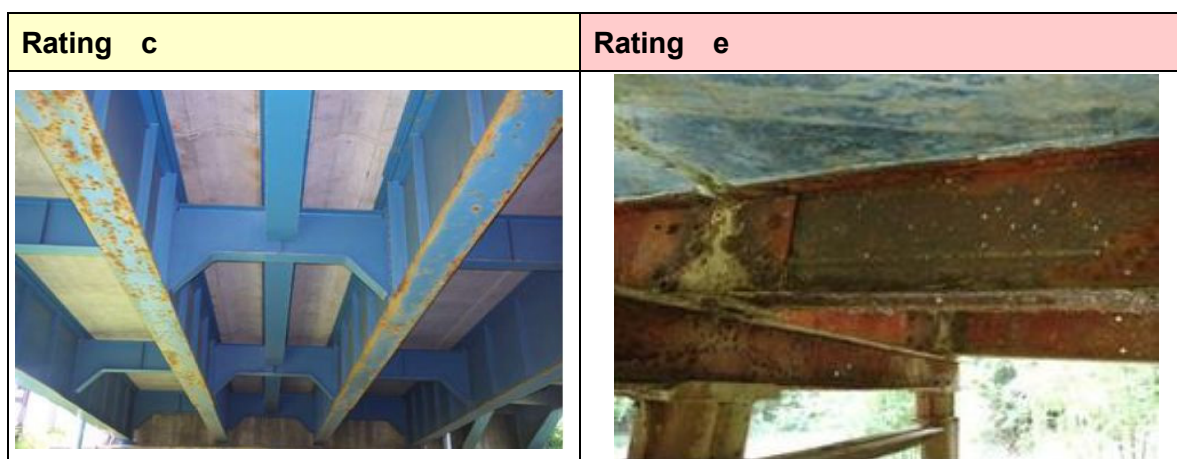
(3) Sample Photographs

Extent	Rating Criteria
large	Significant expansion in thickness on steel plate surface is found or significant plate thickness reduction is found
small	Corrosion is superficial and no significant plate thickness reduction is found.

Extent	Rating Criteria
large	Corroded area is widely spread or multiple corroded places
small	Corroded area is not wide and local

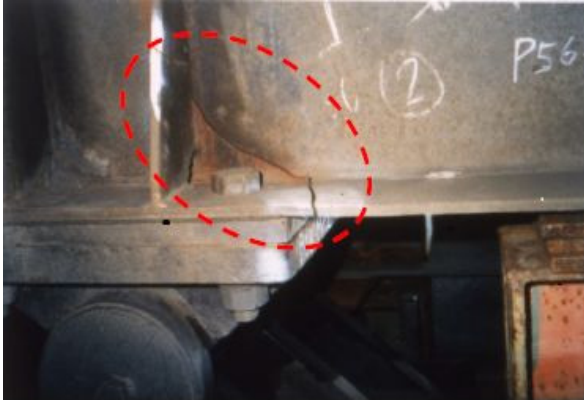
Rating e	Rating e

Rating	Rating Criteria
a	No crack in steel
c	Coating film crack at the sharply changed section and welded connection is found. Minor crack which is not linear or short length and small crack is found.
e	Linear crack is found, or coating film crack at which crack is suspected is found.

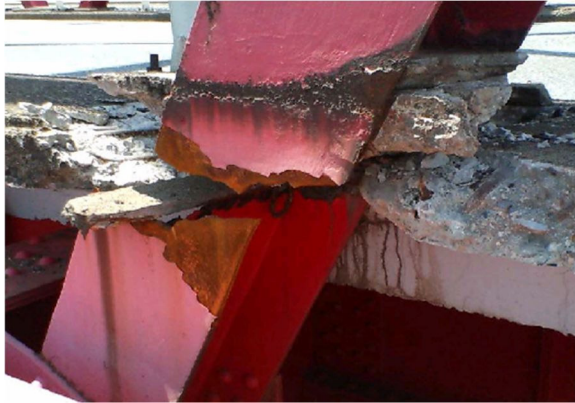
Rating e	Rating e

Rating	Rating Criteria
a	No fracture
e	Presence of fracture

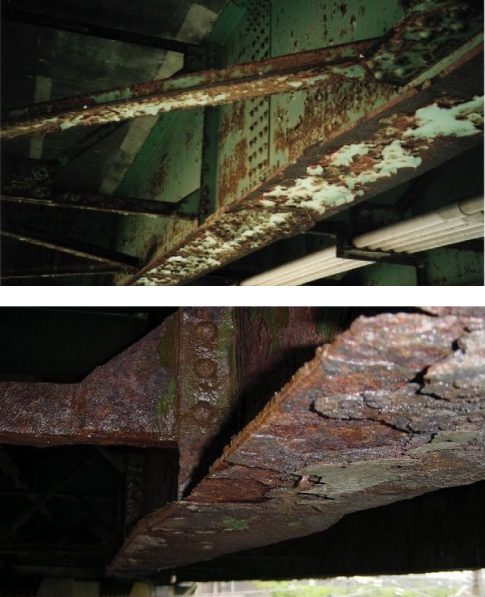
<p>Significant Expansion on steel plate surface or significant plate thickness reduction is found</p> <p>Corroded area is not wide and local (Area<50%)</p>
<p style="text-align: center;">Dt (Emergency)</p>

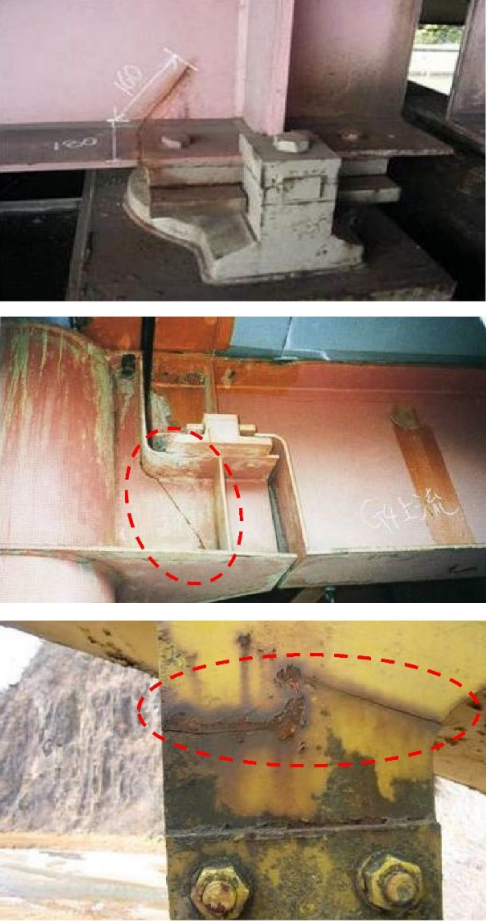
Obvious crack is occurred in except main member and there is a possibility that trouble in function of structure will occur if it progressed
<p style="text-align: center;">Dt (Emergency)</p>

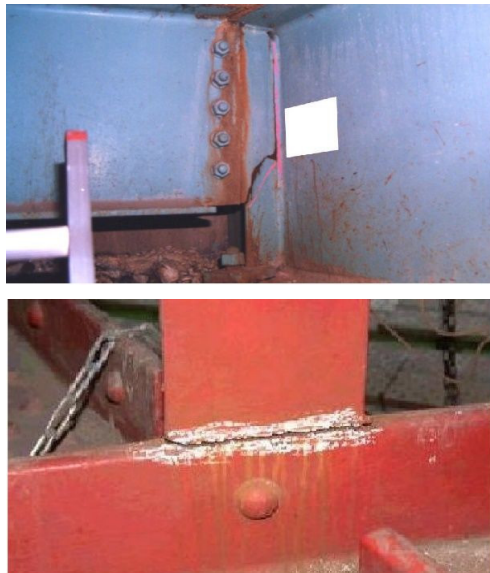
<p>Fracture of Sway Bracing (Secondary member)</p> <p>Fracture of Railing</p> <p>Fracture of Expansion Joint</p>
Dt (Emergency)

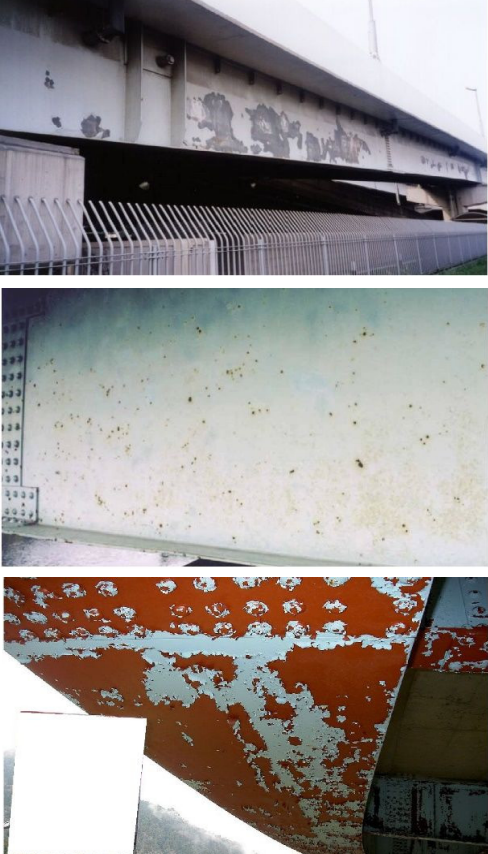
<p>Protective paint layer is peeled and undercoat is exposed</p>
<p style="text-align: center;">Ct (Major Repair)</p>

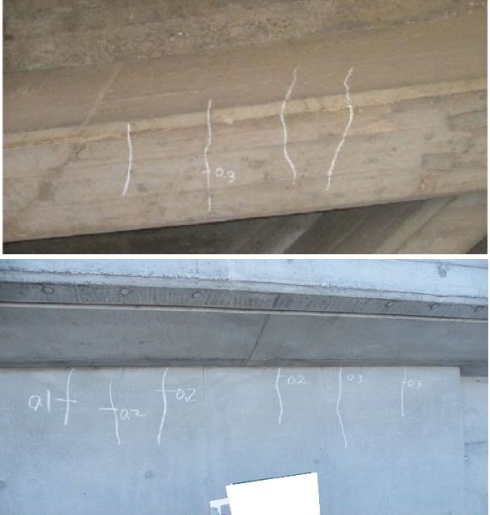
<p>Span center: Pattern 2) Crack width is small Crack spacing is large</p>
<p style="text-align: center;">Bt (Minor Repair)</p>

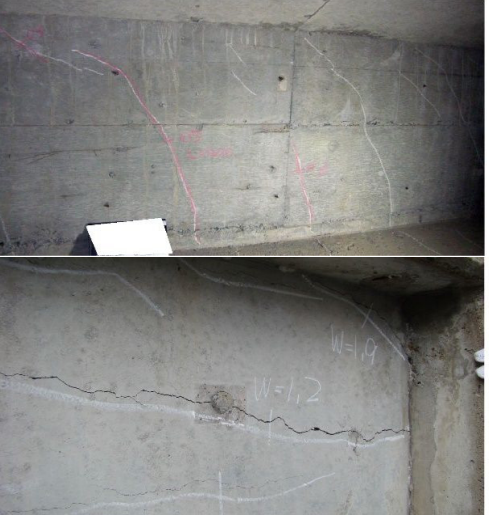
<p>Span center: Pattern 1) Crack width is medium Crack spacing is large</p> <p>Support point: Pattern 8) Crack width is medium Crack spacing is large</p>
<p style="text-align: center;">Ct (Major Repair)</p>

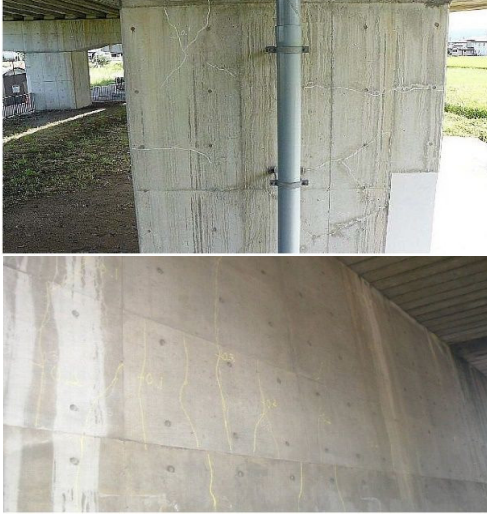
<p>T-shaped pier: Pattern 7) Crack width is small Crack spacing is large</p>
<p style="text-align: center;">Bt (Minor Repair)</p>

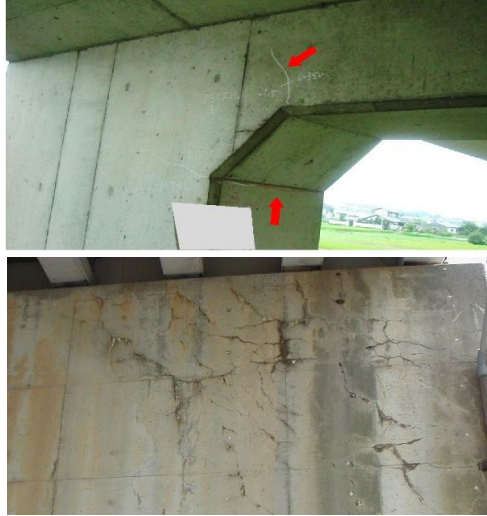
<p>T-shaped pier: Pattern 4) Crack width is large Crack spacing is large</p> <p>Overall abutment: pattern 2) Crack width is large Crack spacing is large</p>
<p style="text-align: center;">Ct (Major Repair)</p>

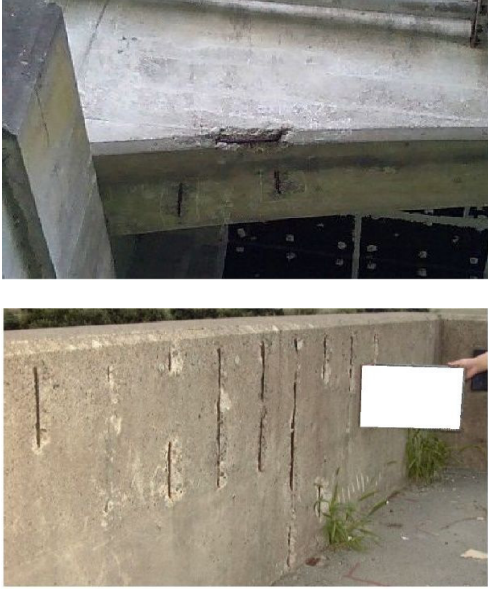
<p>Spalling is small area and no exposed rebar</p>
<p style="text-align: center;">Bt (Minor Repair)</p>

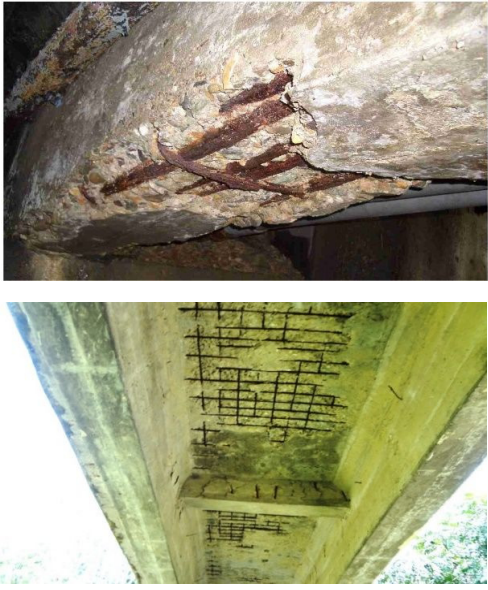
<p>Spalling is small area, and minor corrosion of rebar</p>
<p style="text-align: center;">Ct (Major Repair)</p>

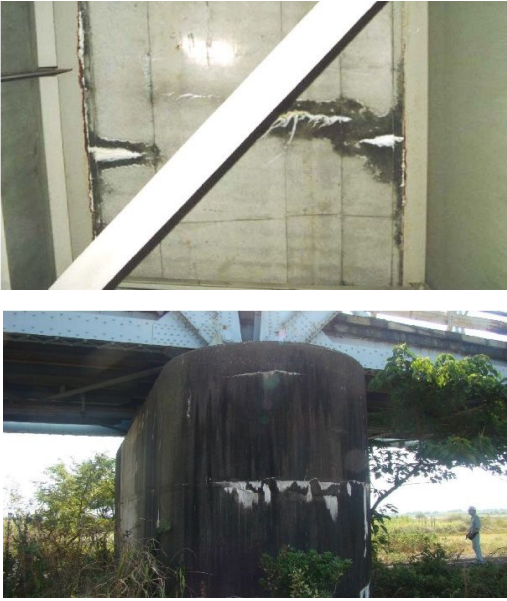
<p>Presence of water leakage from concrete crack Little rust stain or efflorescence is found (Small area)</p>
<p style="text-align: center;">Bt (Minor Repair)</p>

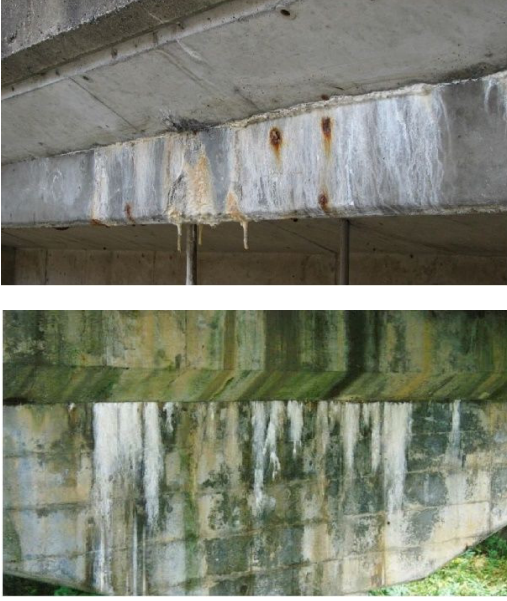
<p>Presence of water leakage from concrete crack Little rust stain or efflorescence is found (Large area)</p>
<p style="text-align: center;">Ct (Major Repair)</p>

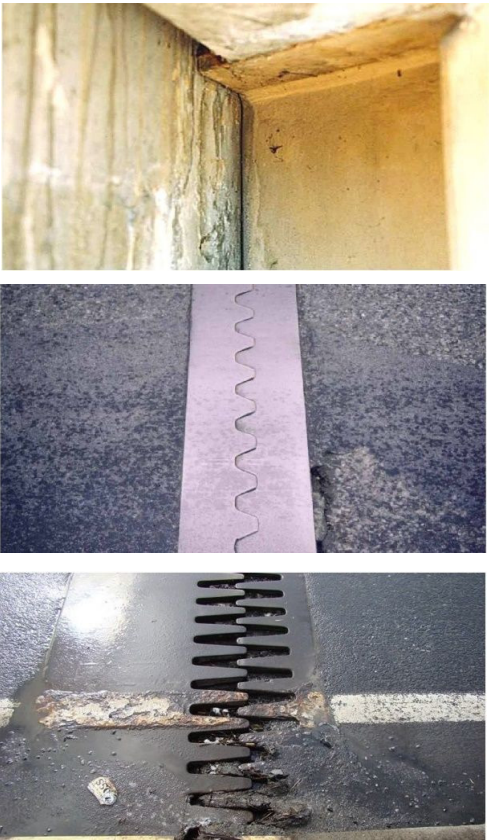
Abnormal spacing including no adequate transverse spacing
<p style="text-align: center;">Ct (Major Repair)</p>

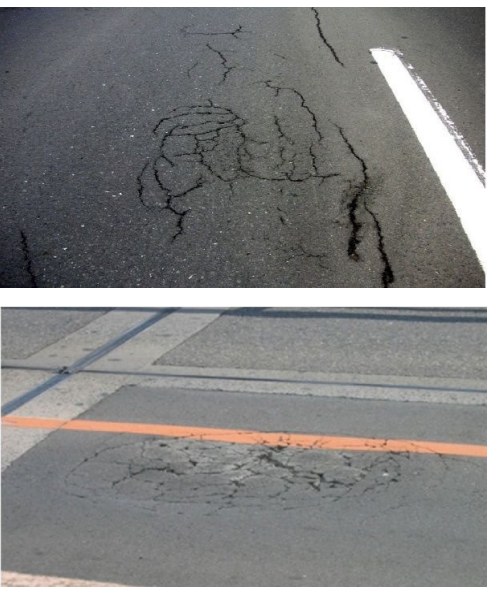
<p>Pothole Depth 30 - 50mm, and dent with a diameter of less than 20cm</p>
<p style="text-align: center;">Ct (Major Repair)</p>

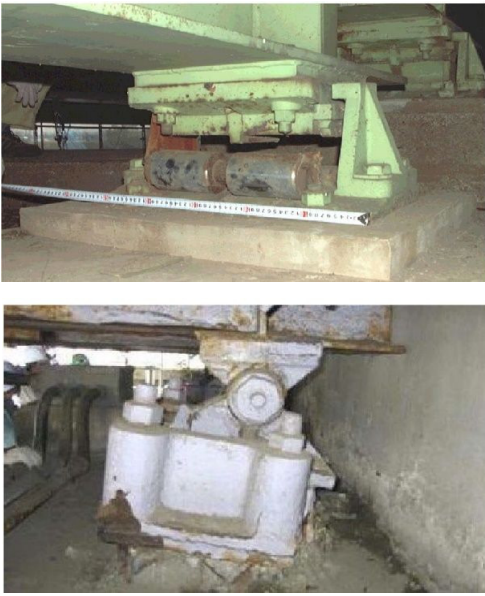
<p>Bearing function has remarkably decreased</p> <p>Significant corrosion</p> <p>Crack in rubber bearing</p>
<p style="text-align: center;">Dt (Emergency)</p>

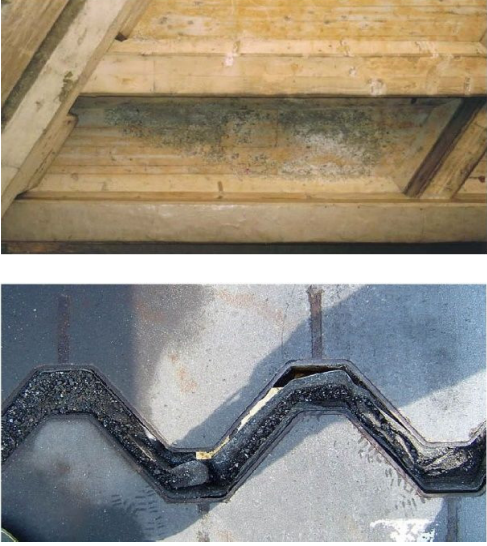
<p>Discoloration / Deterioration is locally (Area<50%)</p> <p>Discoloration of Steel Deck</p> <p>Deterioration of sealing of Exp joint</p>
<p style="text-align: center;">Bt (Minor Repair)</p>

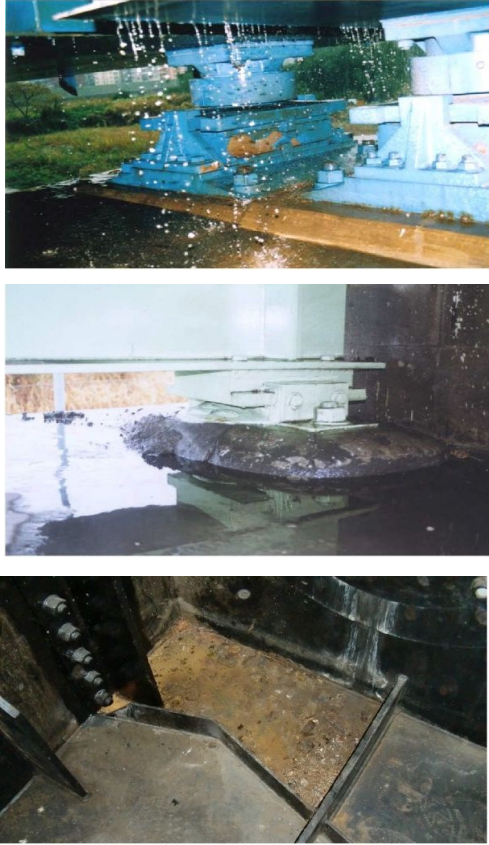
<p>Water leakage from drainage</p> <p>Puddle on pavement</p>
<p style="text-align: center;">Ct (Major Repair)</p>

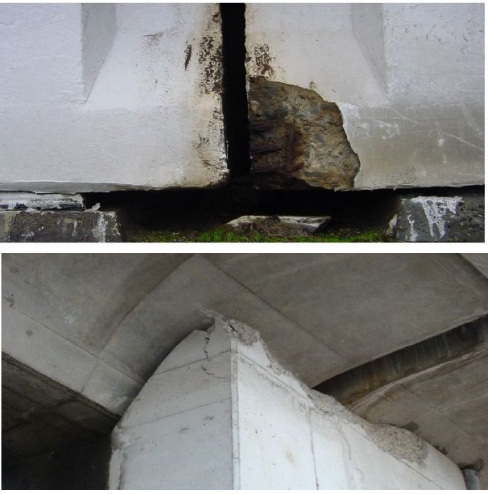
Local deformation / break is identified or partial missing of member
<p style="text-align: center;">Ct (Major Repair)</p>

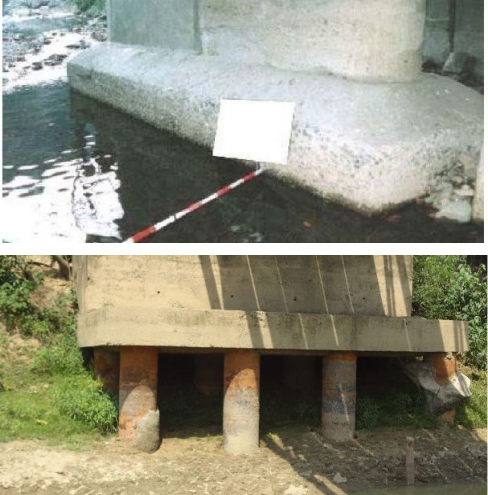
<p>Significant scouring</p> <p>Exposure of the upper surface of footing (Spread foundation)</p> <p>Exposure of top of caisson foundation</p> <p>Exposure of the footing underside (Pile foundation)</p>
<p style="text-align: center;">Dt (Emergency)</p>
