Appendix-8: Detailed Investigation

Appendix 8.1 Repair case study by Degradation prediction of Carbonation

Appendix 8.2 Repair case study by Degradation prediction of Chloride attack

Appendix 8.3 Non-destructive tests for concrete structure

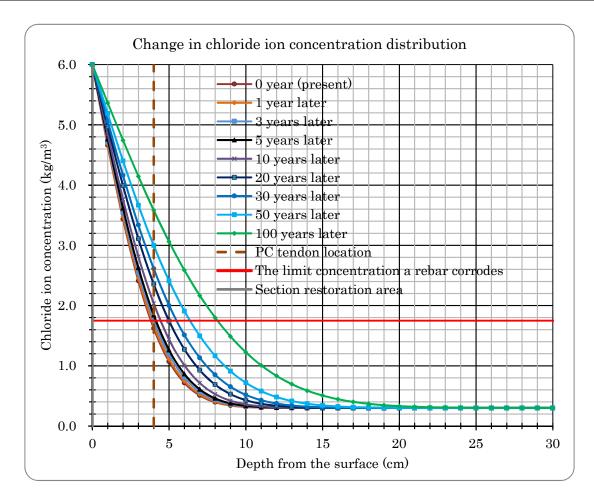
Table 4 Spread of predicted chloride ion concentration (without surface protection)

The spread of chloride ion concentration in future is predicted in according to Fick's formula with C_o and diffusivity constant. If no surface protection is applied to the structure, the spread of predicted chloride ion concentration is shown in Table 4. If chloride ion concentration in the PC tendon location exceeds the concentration limit, PC tendon corrodes. In this case, PC Tendon will be corroded in 1 or 3 years later (Tendon is located at 4 cm depth from the surface).

Repair is required to save PC tendon from chloride damage.

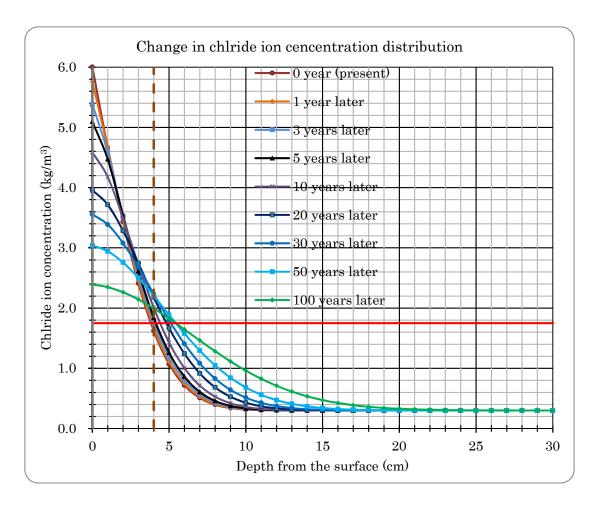
Table 5 Prediction of Infiltration of Chloride ion Concentration (with surface protection)

Even if surface protection is applied, chloride ion infiltrates through; Chloride ion concentration prediction of infiltration through the surface protection is shown in Table 5. Chloride ion concentration at the PC tendon location won't be less than the concentration limit at which PC tendon corrodes regardless of surface protection; is shown in Table 5.

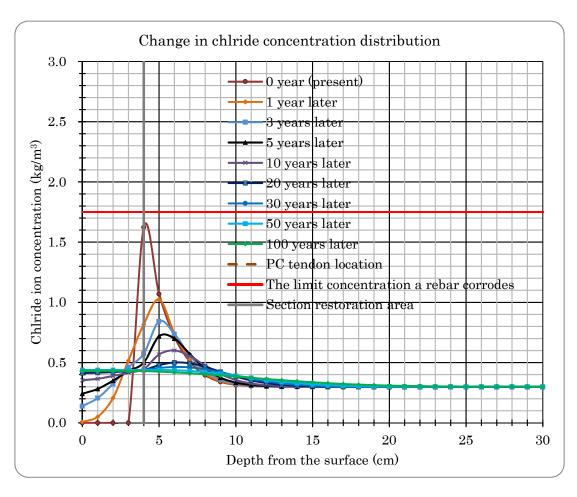
Table 6 Prediction of Infiltration of Chloride ion Concentration (taken out 40mm and refill + surface protection)

Assumed method of repair for chloride ion concentration is Taken out the concrete of the structure up to 40 mm depth from the surface and then refilling and applying surface protection (hereinafter called "taken out and refill 40 mm + surface protection"). Chloride ion concentration prediction of infiltration of "taken out and refill 40mm + surface protection" is shown in Table 6. In this method, even after 100 years chloride ion concentration at PC tendon location will be below the concentration limit at which PC Tendon corrodes; is shown in Table 6.

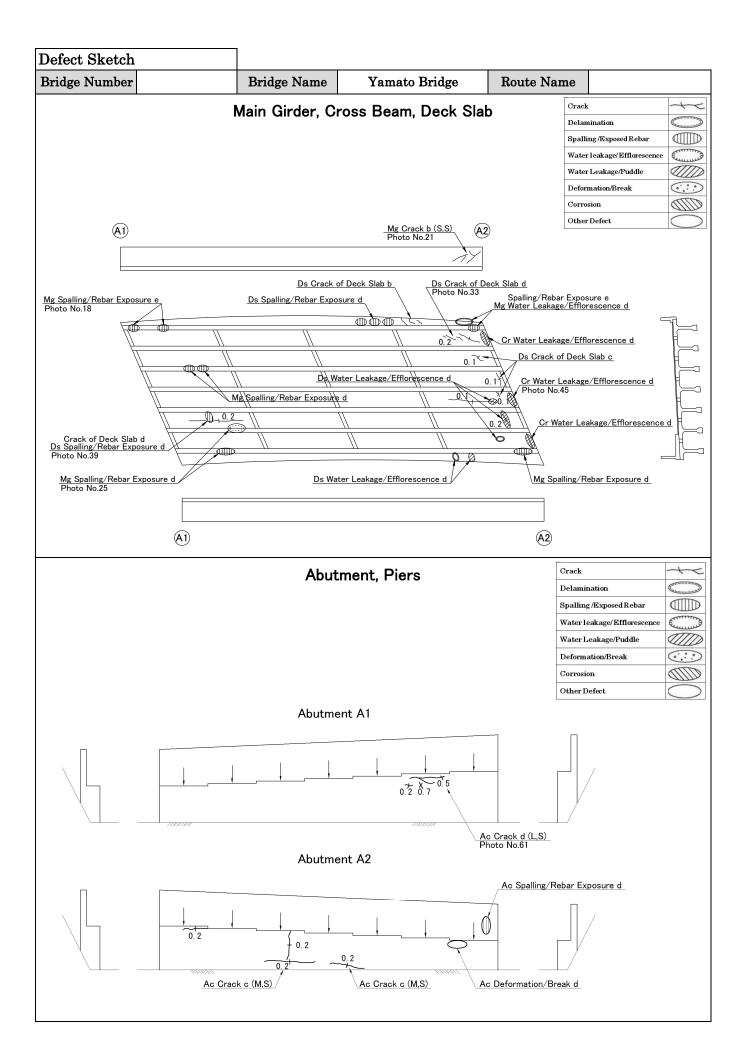
Defect P								
Bridge Nu		T		Yama	ato Bridge		Route Na	
Span No.	1	Photo No.	18		Span No.	1	Photo No.	21
Element	Main Girder	Defect	Spalling/Rebar Expos	sure	Element	Main Girder	Defect	Crack
		Rating	е				Rating	Ъ
Span No.	1	Photo No.	25		Span No.	1	Photo No.	45
Element	Main Girder	Defect	Spalling/Rebar Expos	sure	Element	Cross Beam	Defect	Leakage/Efflorescence
		Rating	d				Rating	d
/)	1		80x20) x 0
Span No.	1	Photo No.	33		Span No.	1	Photo No.	39
Element	Deck Slab	Defect	Crack of Deck Slab	b	Element	Deck Slab	Defect	Spalling/Rebar Exposure
		Rating	d				Rating	d

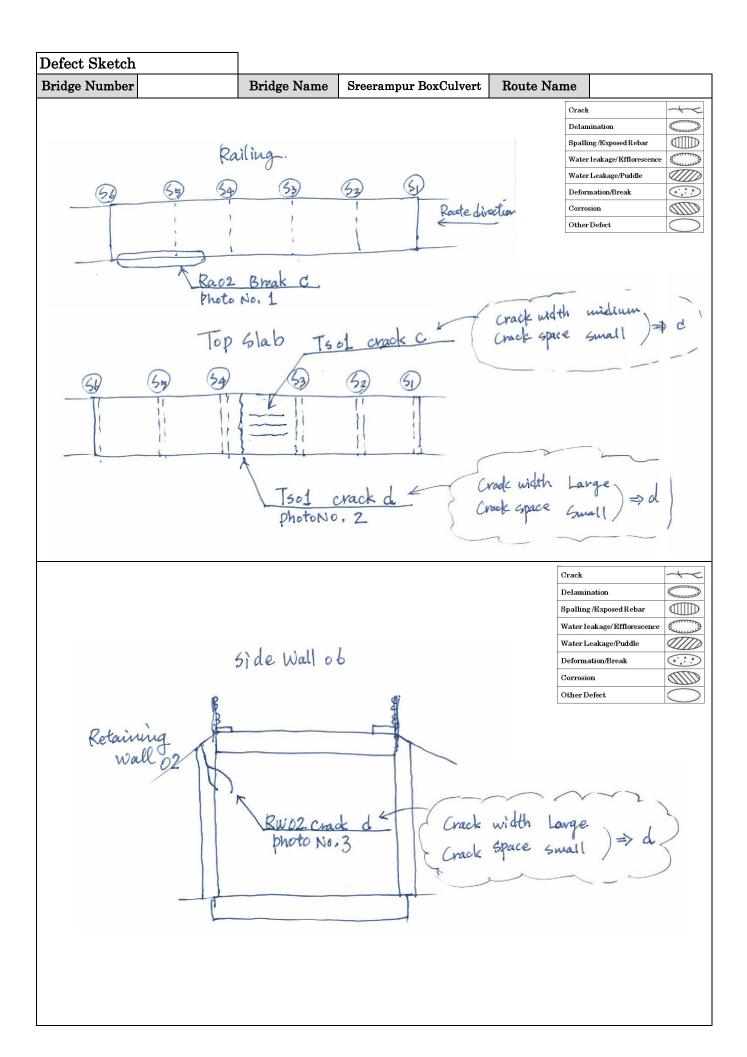
Defects 3	Photos							
Bridge Nu	mber		Bridge Name	Sreera	mpur Box	Culvert	Route Na	ame
Span No.	6	Photo No.	1		Span No.		Photo No.	
Element	Railing	Defect	Break		Element		Defect	
		Rating	c				Rating

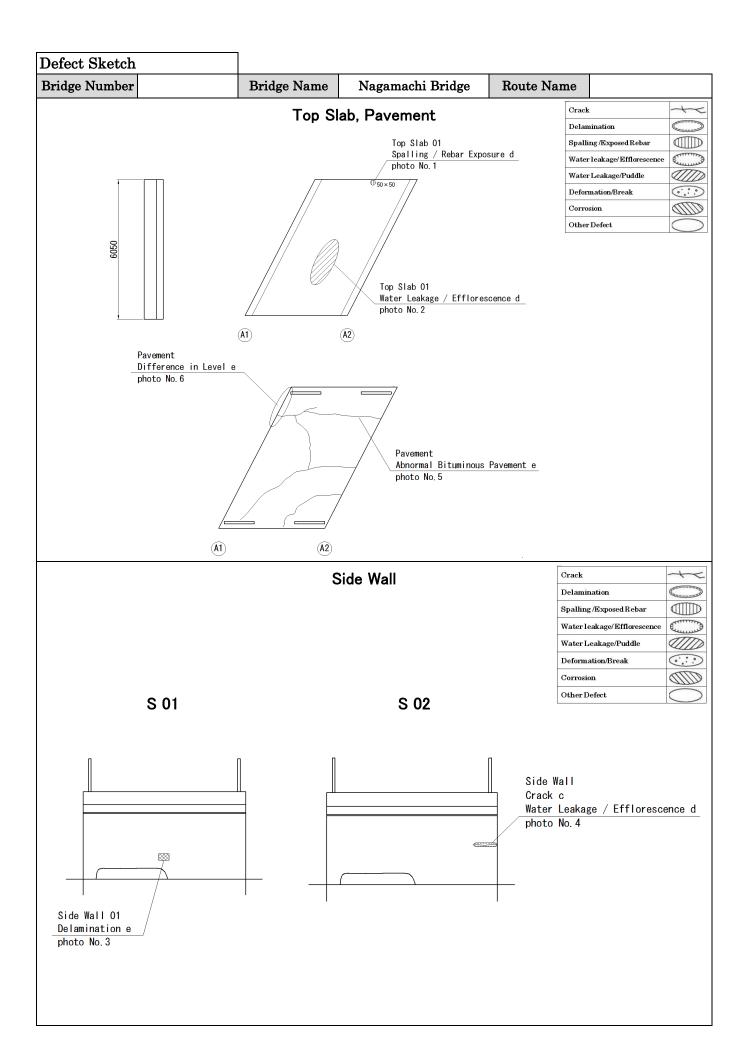
Defect P	Photos							
Bridge Nu	mber		Bridge Name	Naga	machi Brid		Route Na	ame
Span No.	1	Photo No.	1		Span No.	1	Photo No.	2
Element	Top Slab	Defect	Spalling/Rebar Expo	sure	Element	Top Slab	Defect	Water Leakage / Puddle
	Rating		d				Rating	е
