## Appendix 1 Review of Related Policies, Plans, Laws and Organizations

## Appendix 2 Damage of Gorkha Earthquake

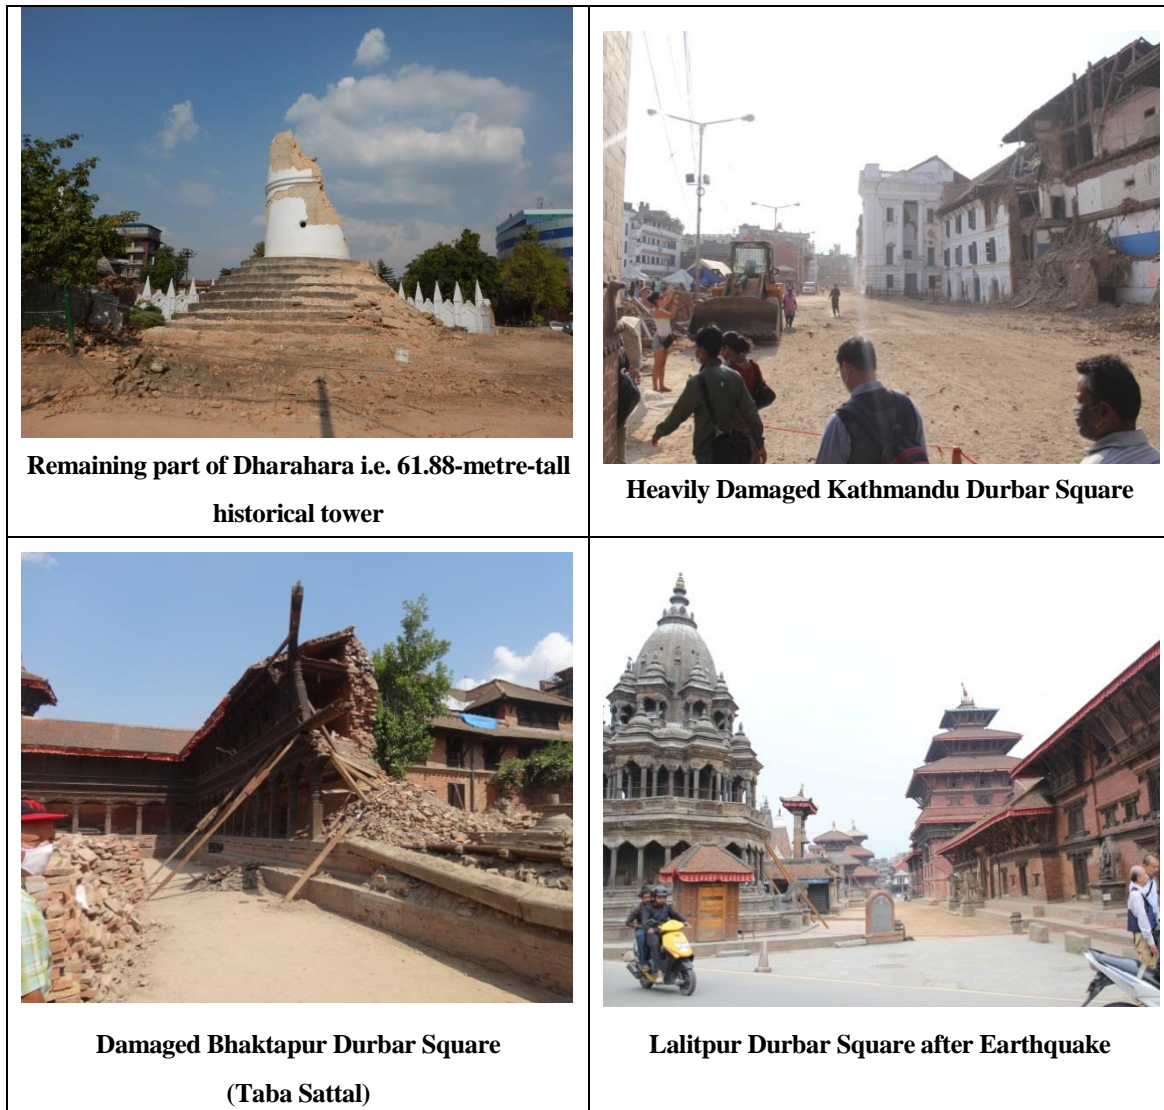
**Figure 2.2.2 Damage to Historical Monuments**

seismic load larger, which might be one of the reasons of the heavy damage. Figure 2.2.2 shows the Dharahara, Kathmandu Durbar Square, Bhaktapur Durbar Square and Lalitpur Durbar Square after the earthquake.

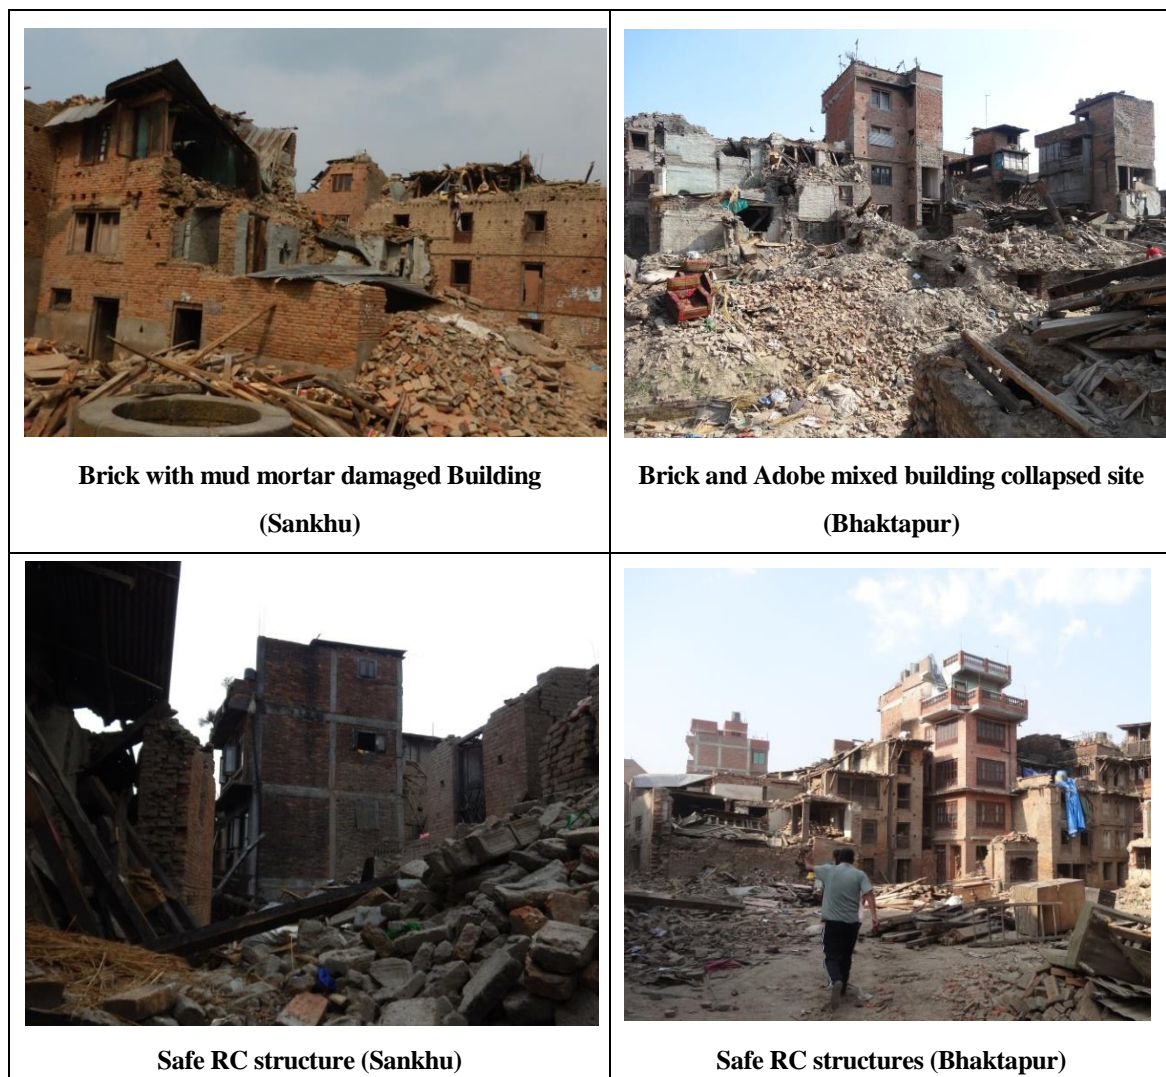
**Figure 2.2.4 Damage of Residential Buildings at Sankhu and Bhaktapur**

A detailed damage survey on residential buildings was carried out in Sankhu and Bhaktapur. The survey items were: structure type, number of stories, the year of construction, use, and the damage level. The results are summarized in Table 2.2.1 and Table 2.2.2. Few damages to the RC frame buildings and large damages to the bricks and adobe with mud mortar buildings were found in both the cities as also shown in Figure 2.2.4. The building with bricks and cement mortar were observed to have suffered less damage as compared to the buildings with bricks and mud mortar. From the above result, it is observed that the joint of mud mortar is the main issue for the weakness of the buildings in those two areas.

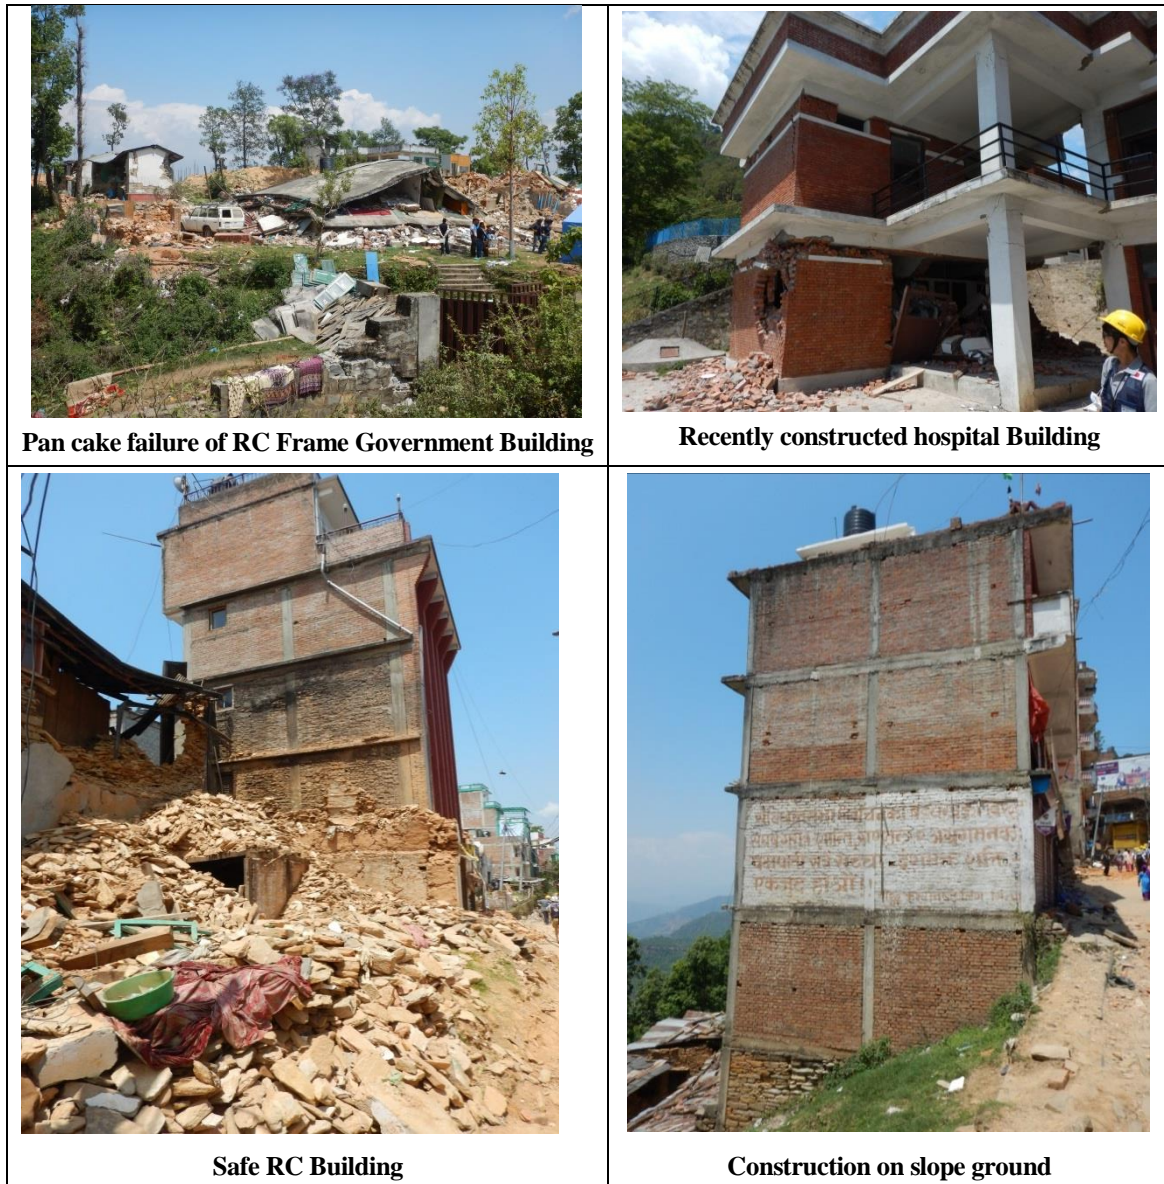
A damage survey was carried out in Chautara, headquarters of the Sindhupalchowk District, for taking into consideration the damages in rural areas. Chautara is located on the ridge of the mountain, and many buildings have been constructed on the slopes. It was observed that, mainly stone masonry buildings with mud mortar were heavily damaged. Also, for the buildings constructed on the slopes, the collapse of columns on the ground floor resulted in collapse of the whole building. A recently constructed two story hospital was also observed to have suffered heavy structural damage. The major damages were found on the structures of stone masonry with joints of mud mortar and/or constructed on the slope of the ridge of the mountain. Figure 2.2.5 shows the damage situation at Sindhupalchowk.

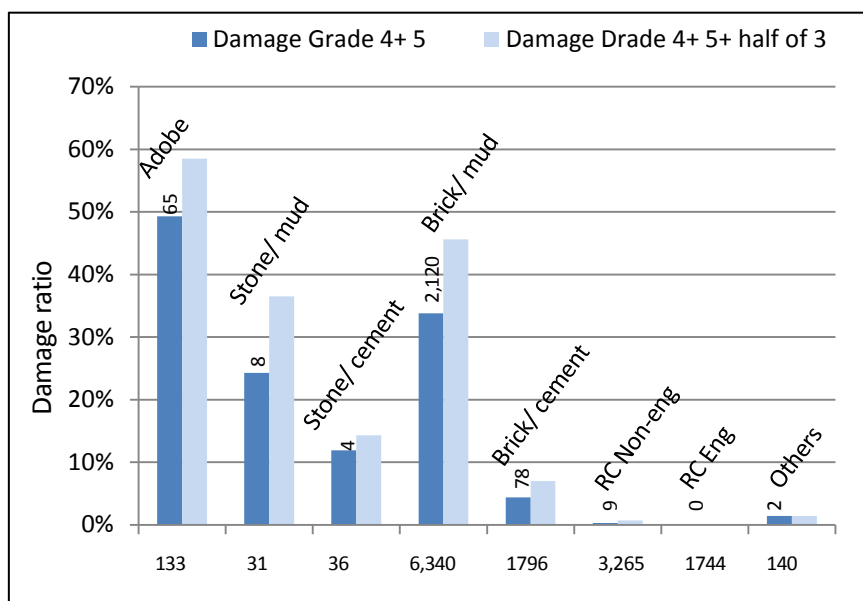
Damage ratio (Grade 4+ 5) of EMS98 is 33.4 % for “Brick masonry with mud mortar joints”, 4.4% for “Brick masonry with cement mortar joints” and 0.3 % for “RC non-engineered”.

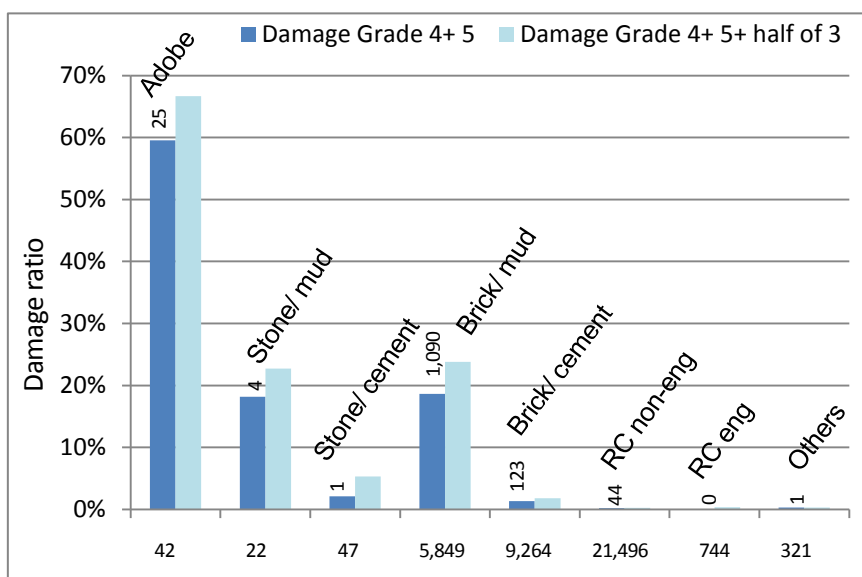
Damage ratio (Grade 4+ 5) of EMS 98 is 18.7 % for “Brick masonry with mud mortar joints”, 1.3 % for “Brick masonry with cement mortar joints” and 0.2 % for “RC non-engineered”.

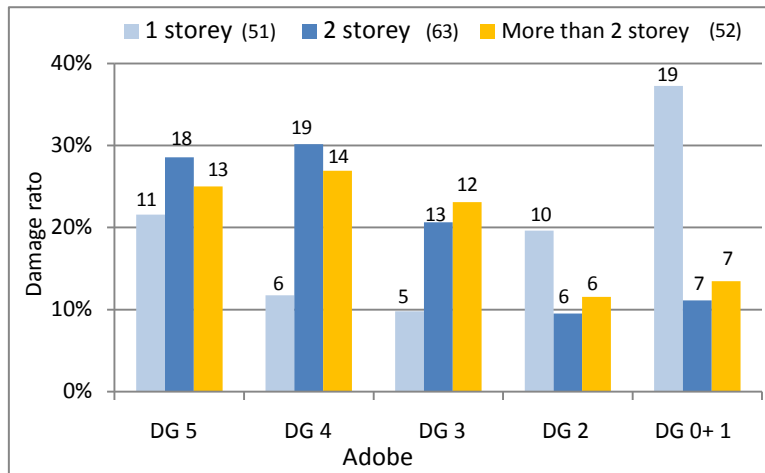
a. Adobe Bhaktapur Municipality + Lalitpur sub-metropolitan city (LSMC) (Ward 1~22)

The damage ratio of masonry by type and number of stories were studied for the 2015 Gorkha earthquake. For “Adobe”, the damage ratio was estimated for 1-storey, 2-storeys, 3-storeys and more, for “Brick masonry with mud mortar joint” it was estimated for 1- to 3-storey, 4-storey, and more, and for “Brick masonry with cement mortar joint” 1- to 3-storey, 4-storey and more. The result is shown in Figure 2.3.8. There is a clear difference of damage ratio by the type of masonry. In case of “Adobe”, damage ratio differs by the number of stories.

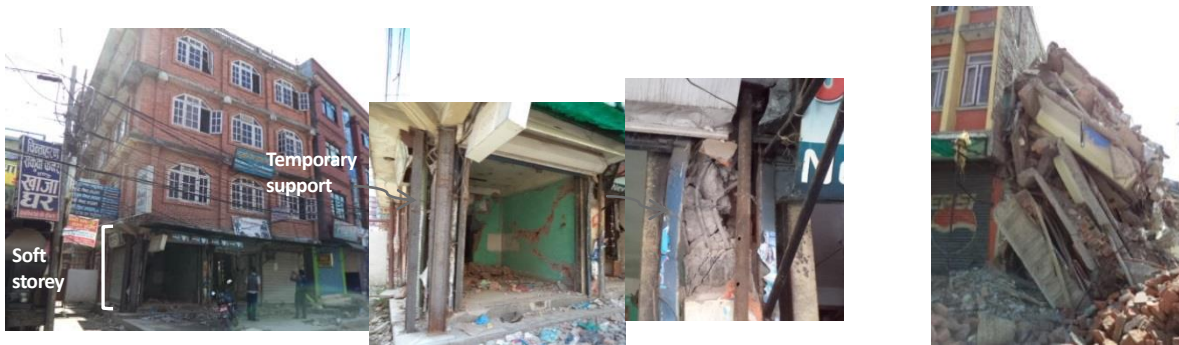
Figure 2.3.9, Building damage was observed due to a soft storey at GFL, where no brick wall was provided for one direction. Damage by shear failure of RC column was observed, where diagonal cracks penetrated the brick wall in transverse direction. (Right), a collapsed building with pan-cake crash is shown.

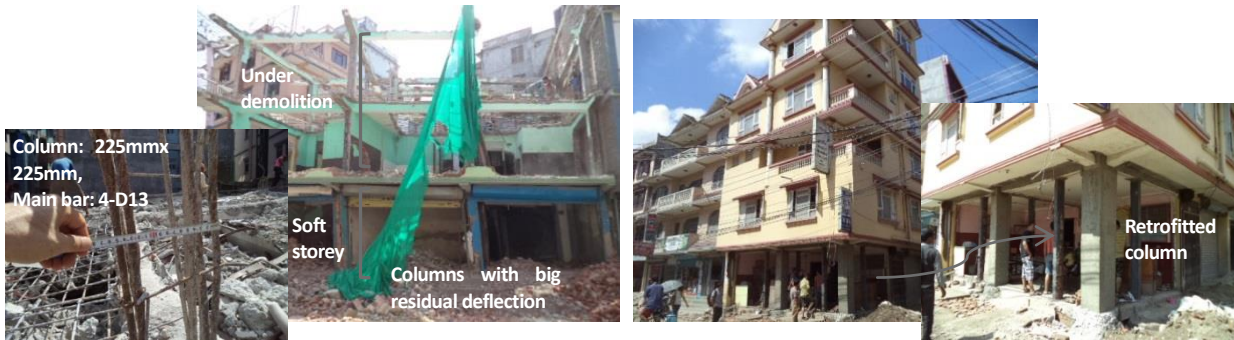
Figure 2.3.10, building under demolition was surveyed. Column span is 3.5m to 4.0m, column section size is 225mmx 225mm, column main bar is 4-13 $\phi$ , tie is 6mm diameter and at an interval of 150mm, and supposed concrete strength 15MPa (cube). Figure shows the lap joint portion. (Centre), another 3-storey building under demolition was observed. GFL is a soft storey and columns are inclined to North direction with big residual deflection. (Right), 5-storey RC building with column retrofit at GFL after the earthquake was observed. Size of retrofitted column is 400mmx 400mm.

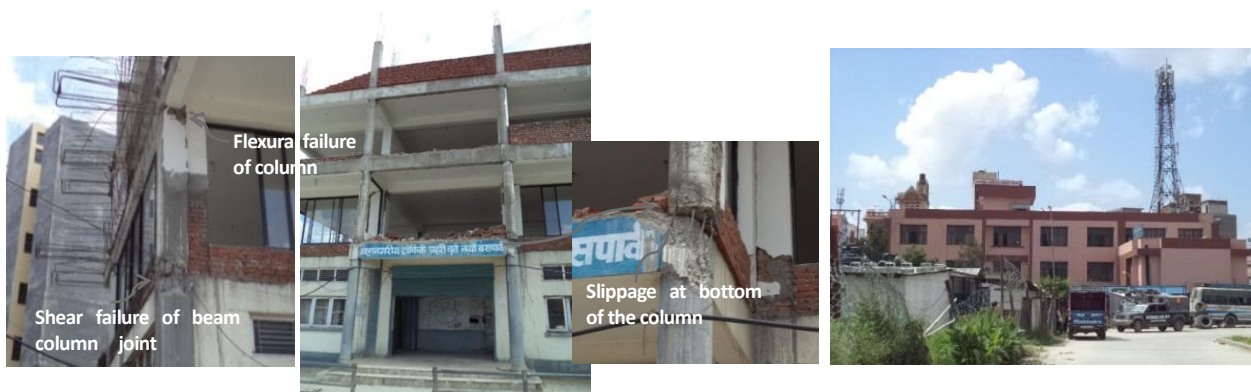
Figure 2.3.11, “RC engineered” building damaged in the Gongabu area. Possible reason of damage might be the lack of a structural plan as well as the lack of construction quality control. Columns on the first storey of this building have been inclined and shear failure at the beam-column joint was observed. There is a low height brick wall (thickness 225mm) on the first storey, hence a soft storey. (Right), there is almost no structural damage for this telecommunication building where the steel tower is located on the roof.

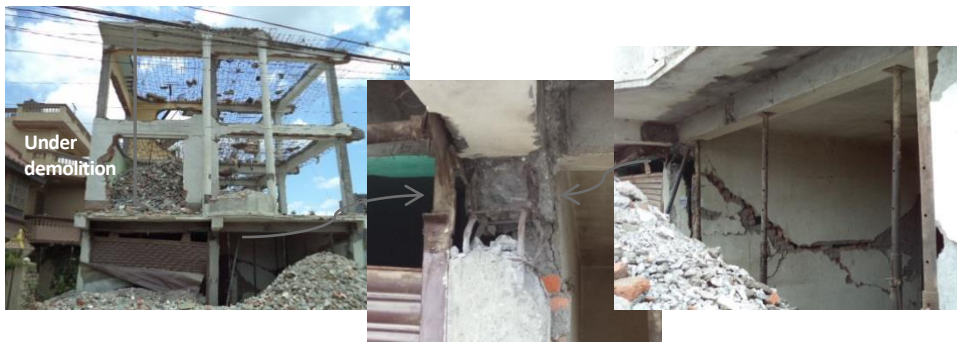
Figure 2.3.12, 3-storey RC building under demolition and there is no brick wall at front side. Column size is 230mmx 230mm and main-bar is 4-D13. Shear failure of RC column was observed, along with severe cracks on the brick walls in transverse direction. The brick walls at the other side were damaged similarly.

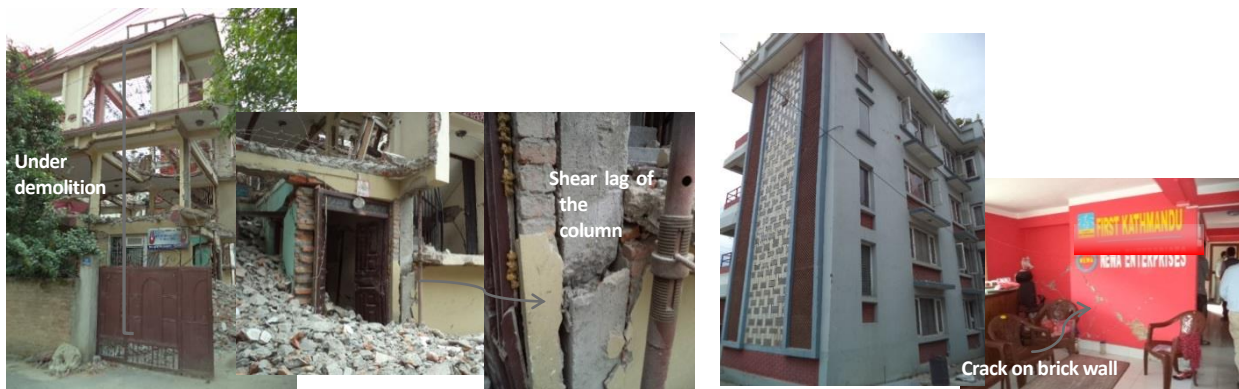
Balkhu is located at West South of the Ring road. Figure 2.3.13, 3-storey RC building under demolition, shear lag of a column was observed. (Right), 4-storey RC building, no damage was observed from the outside, but non-structural brick wall was damaged with diagonal cracks. The water tank on the roof toppled to the ground because of the earthquake.

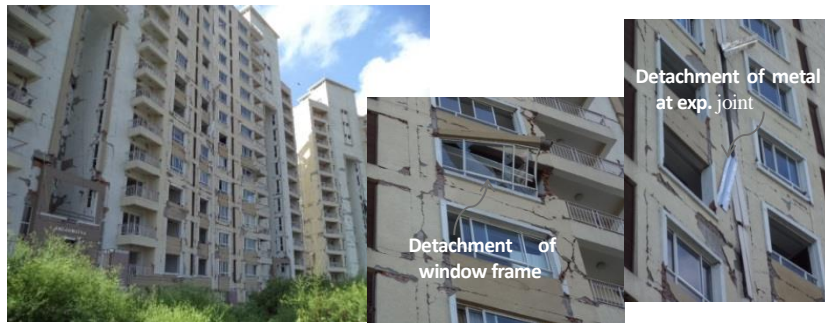
Figure 2.3.14, 16-storey residential building is shown. RC frame is damaged partially but there is no serious damage in the structure. Non-structural brick walls that couldn't follow the deflection of ductile RC frame were damaged, and dropped to the ground. Some window frames, as well as some covers at expansion joints, were detached. The thickness of the external brick wall is 9" (225mm). Brick size is 9"x4"x2". This is an example of damage of non-structural elements.

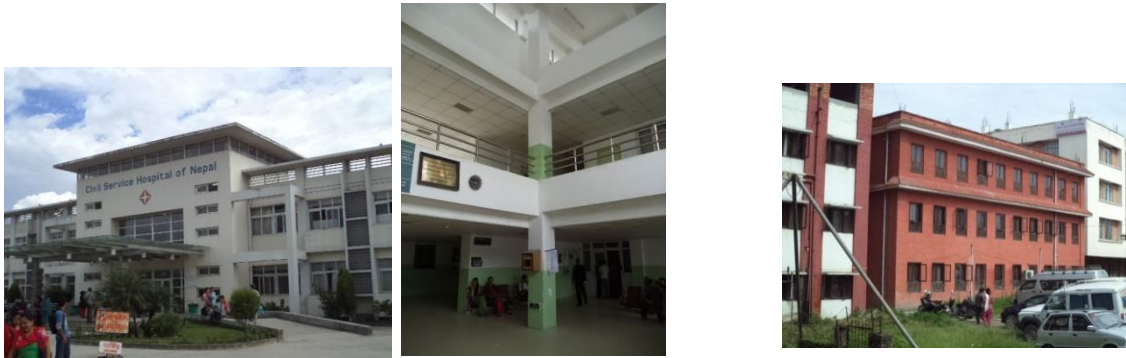
No damaged hospital buildings were observed in the surveyed area. Figure 2.3.21, Civil Service Hospital of Nepal located in Kathmandu Metropolitan City (KMC), which has a 2-storey RC building and a 3-storey RC building, has no damage. Column span is approximately 6m x 8m and column size is 500mm x 500mm for the 2-storey and 600mm x 600mm for the 3-storey including finish material. (Right), a hospital building in Bhaktapur.

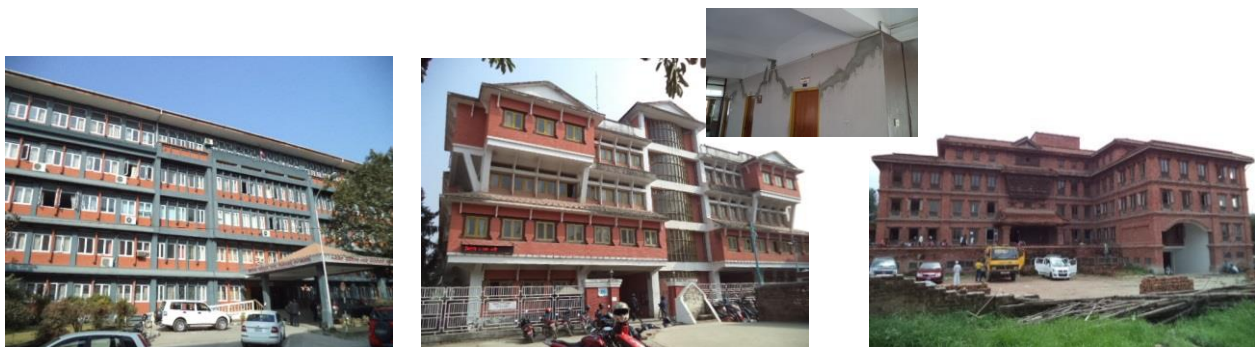
Three governmental buildings are shown in Figure 2.3.22, 5-storey RC building was not damaged. (Centre), 5-storey RC building was not damaged except some damage to non-structural brick walls located in the area just below the RC floor slab. (Right), 5-storey RC building was not damaged.

a) Governmental building b) Lalitpur Sub-metropolitan City building c) Bhaktapur Municipality building  
Source: JICA Project Team

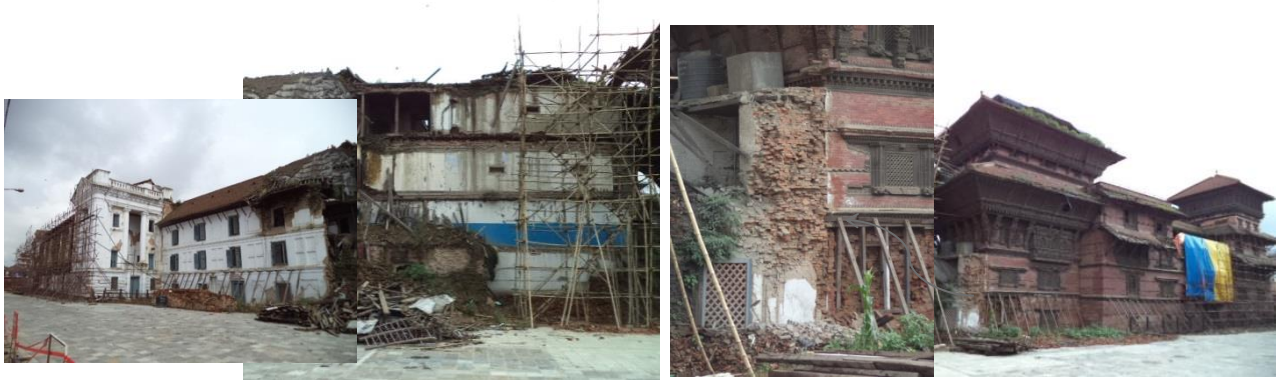
North side of Basantapur square, (left), heavy damage of Gaddhi Bhaitak (hall). (Right), heavy damage of Basantapur tower

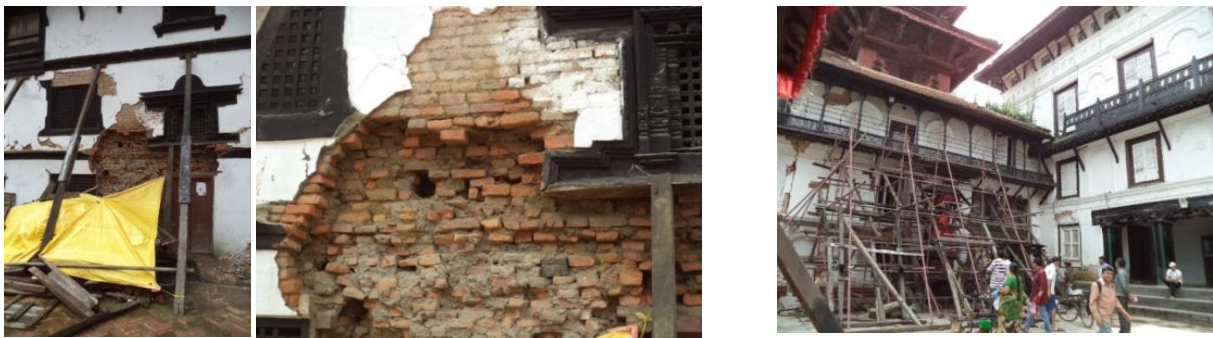
**Figure 2.3.25 Kathmandu Durbar Square (August 2015)**

(Left), brick wall of an office and school at South side of Basantapur square (right), Mohan Chowk supported by temporary support beams.

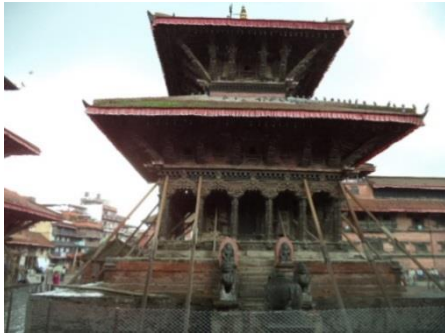
(Left), Vishvanath Temple supported by temporary support beams (Centre), two completely collapsed temples. (Right), partially collapsed school located at the north side of Keshar Narayan Chowk.

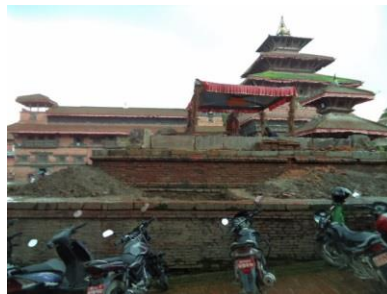
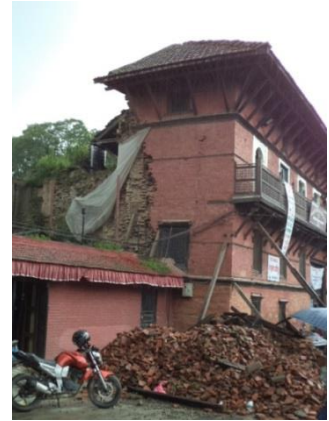
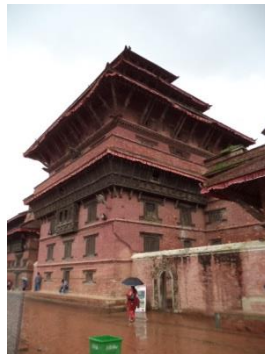
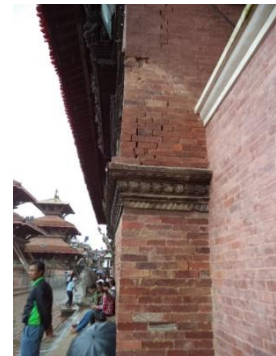
**Figure 2.3.26 Lalitpur Durbar Square (August 2015)**

(Left), Top of Taleju Temple was damaged (the other side), (centre) (right) 3 storey Sundari Chowk and swelled brick wall.

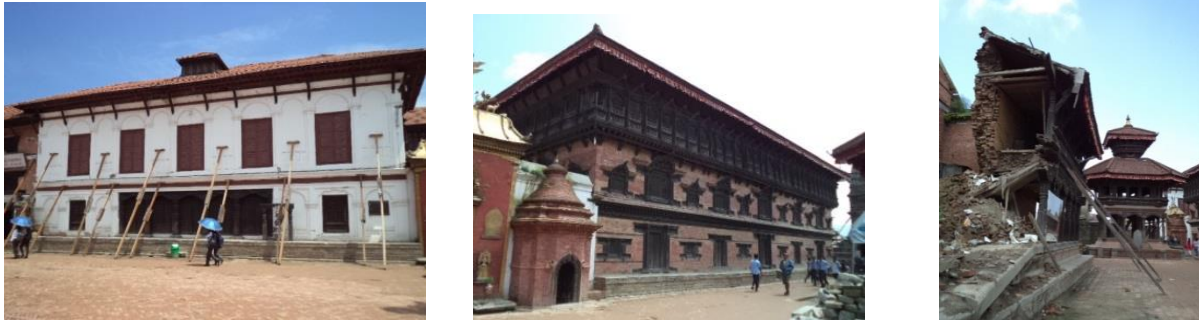
(Left), former royal palace. (Centre), palace wing with 55 windows, no damage was observed, as retrofit work had been recently carried out using horizontal timber member and others. (Right), heavily damaged building (corridor portion, brick wall at one side, the other side is wooden frame).

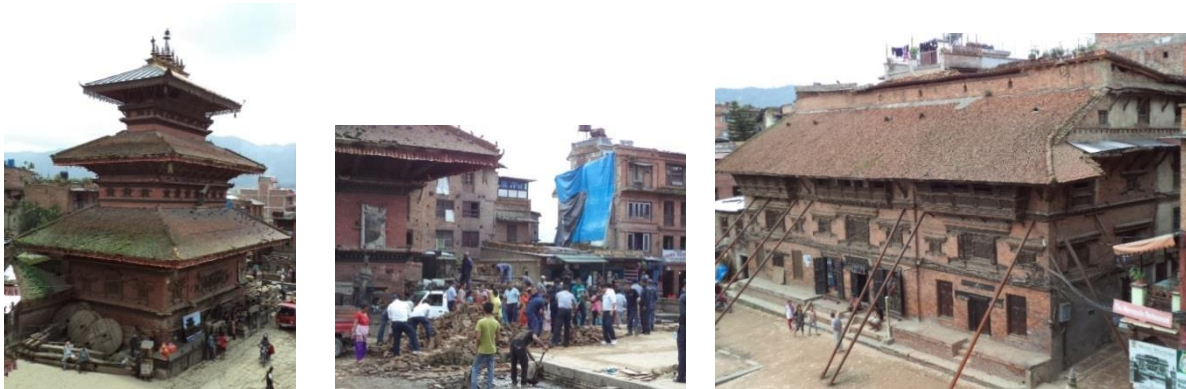
**Figure 2.3.27 Bhaktapur Durbar Square (August 2015)**

(Left), (centre), (right), Condition of Tachupal square

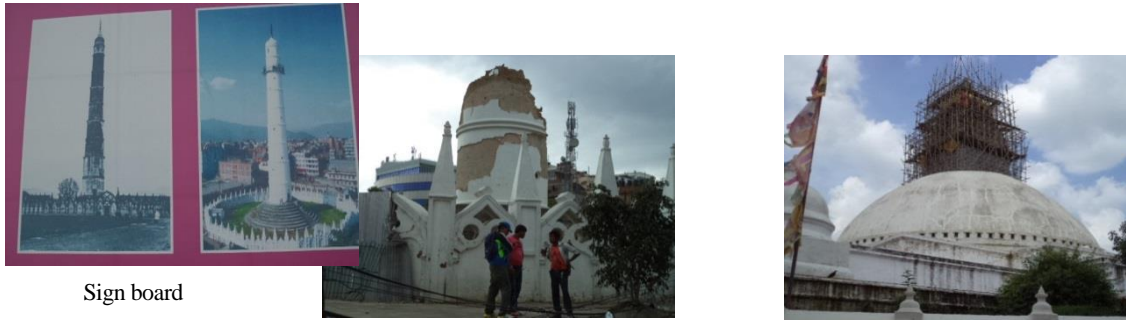
Figure 2.3.28, Height of Dharahara Tower, which collapsed due to the Gorkha earthquake, was approximately 62m. It was first constructed in 1832 and was reconstructed after the earthquake in 1934, which collapsed again due to the earthquake in 2015. Brick masonry and Lime Surkhi mortar (mix of mud, lime and brick dust) have been used at its joint. (Right), Boudhanath has hemispherical dome with the diameter of approximately 36m. The top portion was damaged and is under reconstruction.

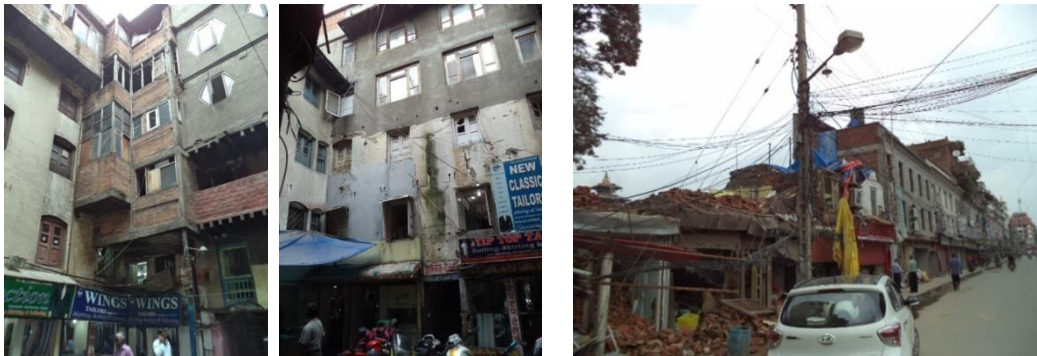
As following the figure, inside spaces of residential buildings with some floors used for commercial purposes. The building is brick masonry of 5- to 6-stories. Joint mortar at the GFL is mud mortar and upper floor is cement mortar. No damage is observed by visual observation. (Right), collapsed building of “Brick masonry with mud mortar joint” (front side).

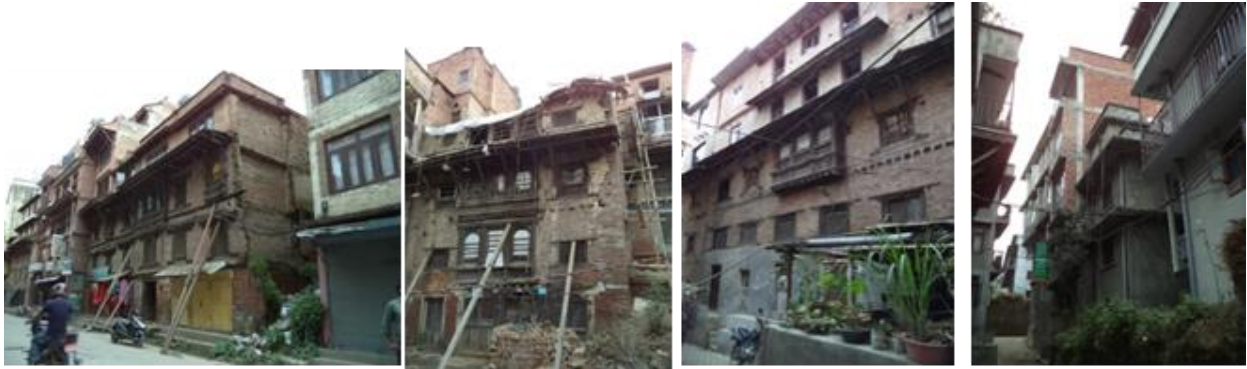
(Right), 5-storey “RC non-engineered”, and no damage is seen by the visual observation.

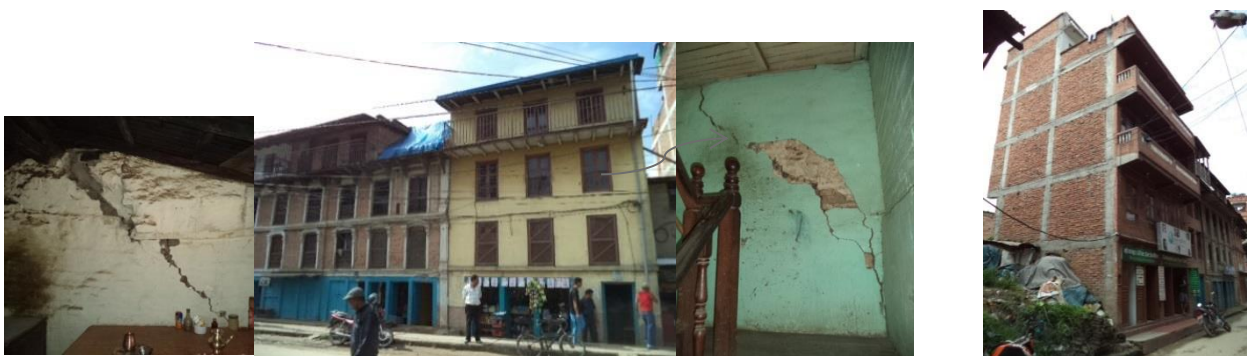
(Right), “RC non-engineered”, and, from the appearance it seems to have no damage.

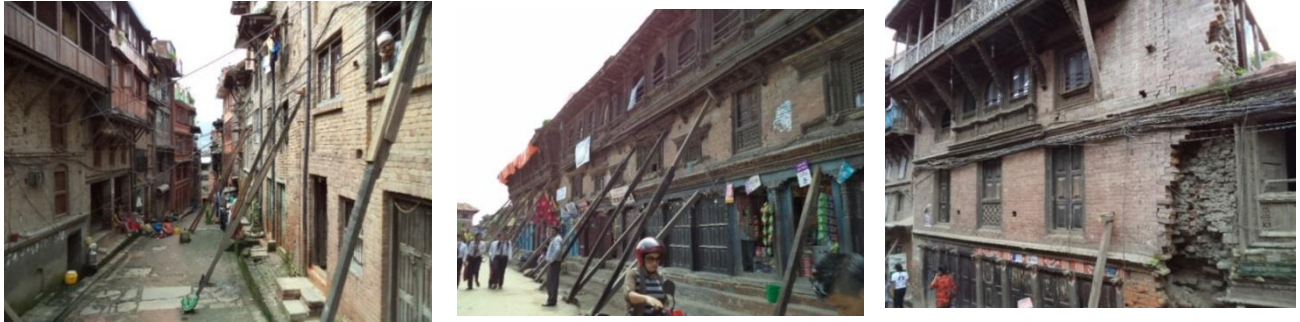
(Left), “Brick masonry with mud mortar joint” supported by temporary members. Building on the left side was constructed 50 years ago and the one on the right side was constructed 25 years ago.

(Right), “Brick masonry with mud mortar joint”, heavy damage was observed on the inside.

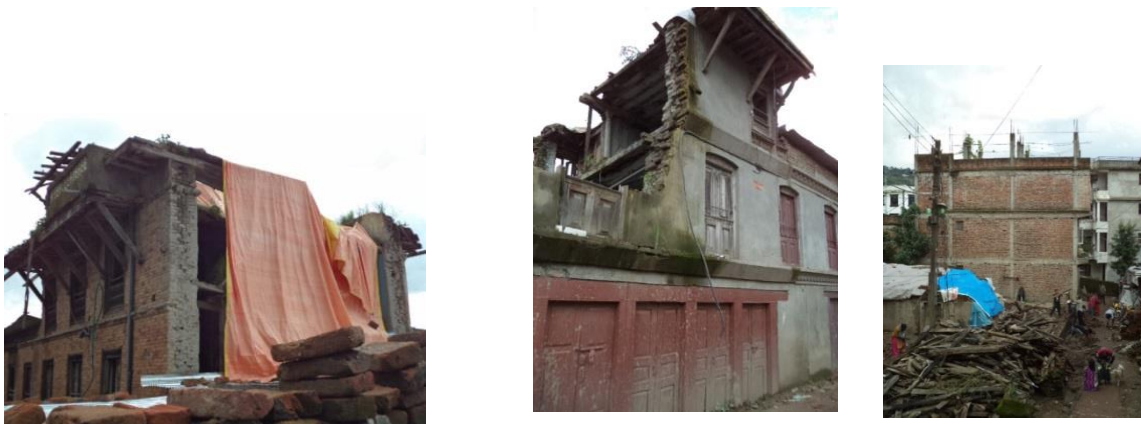
(Right), 4-storey “RC non-engineered”, there seems to be no damage as observed from the outside.

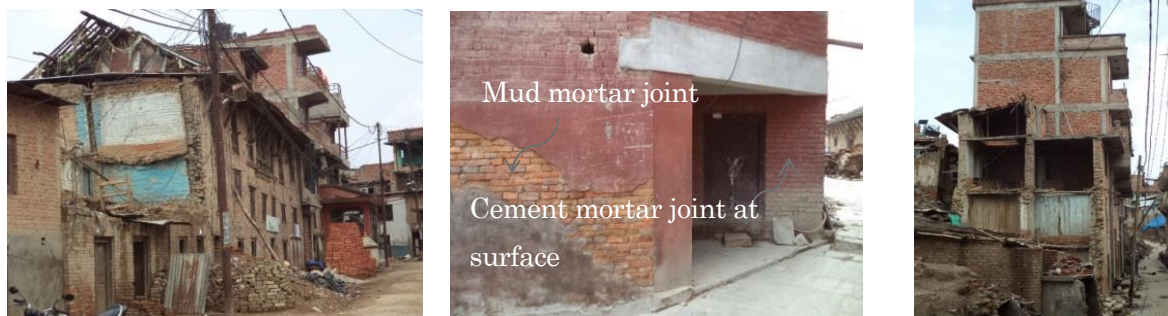
(Right), “RC non-engineered”, there seems to be no damage as observed from the outside (the other side)

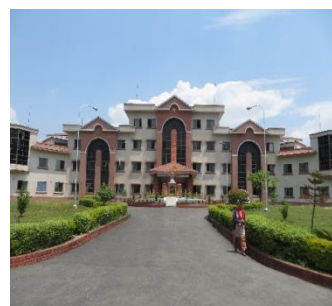
**Figure 6.2.3 Building detail survey (school and hospital)**

b) Hospital: RC engineered

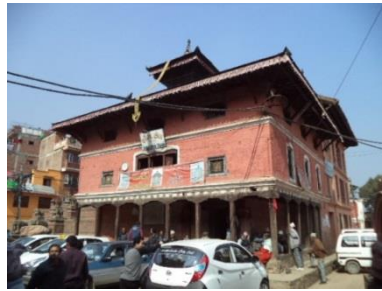
**Figure 6.2.4 Building detail survey (historical building)**

“Dyochhen” which is a Newari house as well as a temple, and is called as “Residence of God or Guard of God“, was selected in Bhaktapur. This building was damaged in the Nepal-Bihar earthquake in 1934, and had been reconstructed.

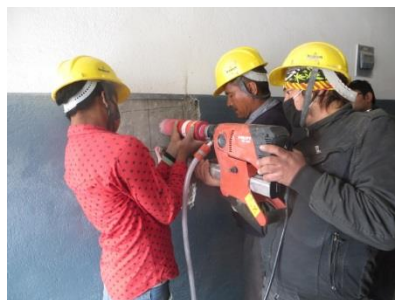
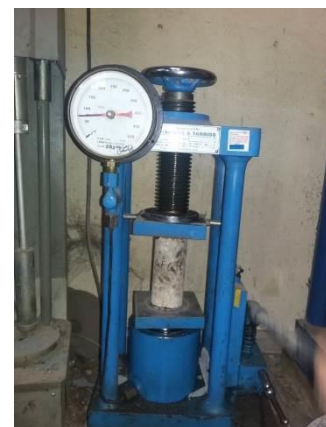
**Figure 6.2.6 Concrete core sampling and strength test (governmental building)**

“Dyochhen” of item 3, and governmental buildings and municipality buildings of item 4 were selected by the suggestion and support of MOUD. As far as a governmental buildings, re-bar detail of column and concrete core strength survey were done at the site, since there was a lack of as-built drawings (Figure 6.2.6).

left) Marking the exact location of the re-bar with a re-bar detector  
centre) Fixing the core cutter in the exactly marked location where it doesn't touch the re-bar  
right) Testing of the concrete core taken from the ground floor column (D18)  
Source: ESS

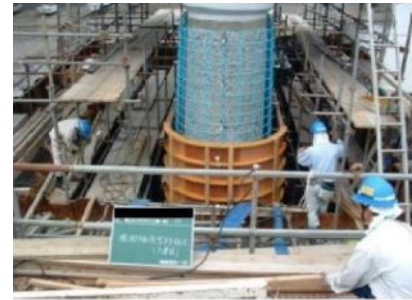
**Figure 8.2.1 RC Jacketing**

It is a construction method to reinforce existing bridge pier with insufficient strength. This method gives bridge pier additional bending capacity by axial reinforcing bars and prevents sticking out of axial reinforcing bars by adding hoop bar to improve ductility of bridge pier. As a disadvantage, since the mass of the bridge pier body increases, the inertia force in the horizontal direction during the earthquake also increases, which gives an overload to the foundation.

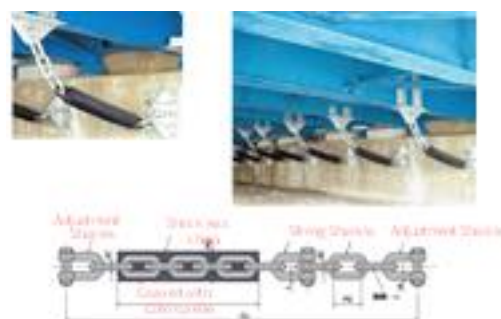
**Figure 8.2.4 Movement Limiting Device for Girder Fall Prevention**

Hold relative displacement between the girders and the bridge piers due to the earthquake to prevent a girder from moving beyond girder seating length. This also assumes the behavior mainly in the longitudinal direction of the girder.
