4. Etude des conditions naturelles Package B (Amendement-1)

NATURAL CONDITIONS SURVEY PACKAGE-B

PREPARATORY SURVEY ON REINFORCEMENT OF MARITIME TRANSPORT AT GOLF OF TADJOURAH

DJIBOUTI AND TADJOURAH PORTS REPUBLIC OF DJIBOUTI

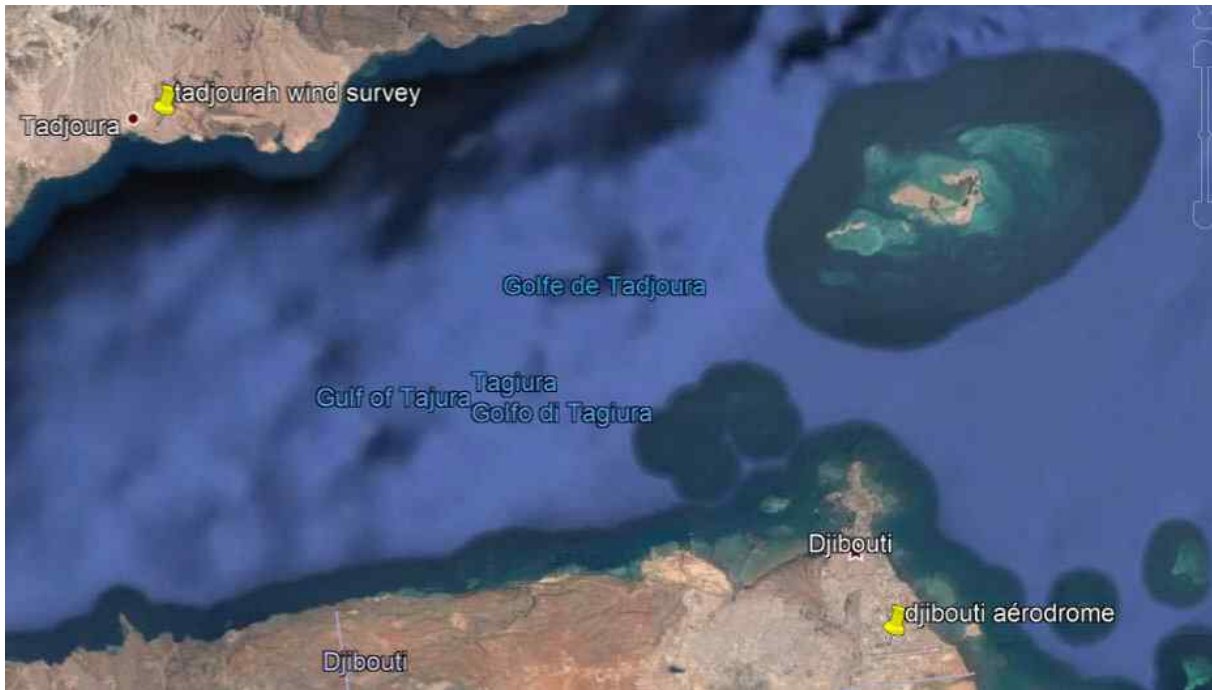
Figure 2 Djibouti airport (Utm Z 38298645- 1277513) Tadjourah (270020- 1303970)

- 2 years of daily observation of the station of Tadjourah installed on an hill above 28 meters above the sea. The wind measurement was 10 meters and the direction was in degree rose of 360°.
- More 10 years of daily observation of the station of Djibouti airport.

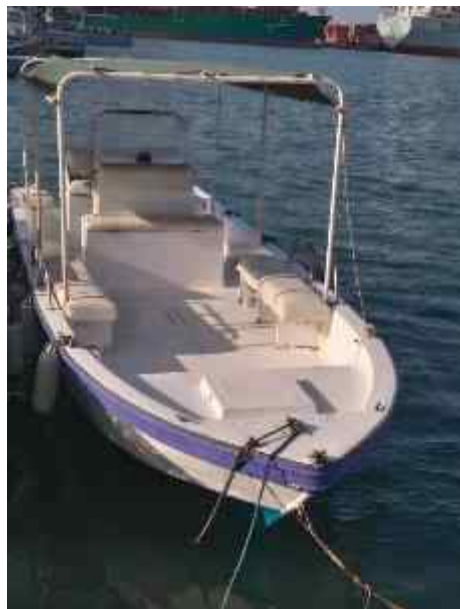
Figure 6 : Vessel used

The production of electrical energy to power the various on-board equipment (computers, echosounder, display, ...) is achieved through solar panels coupled to two 12 V batteries. One 12-200 V converter complete the device power supply.

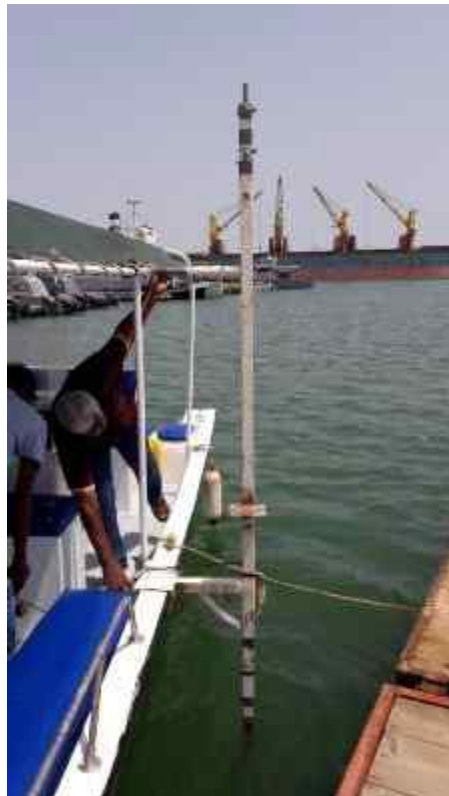
Figure 7 : Assembly of the Pole

Hydroterra Engineering has built and adapted a multi-support pole so that various equipment can be installed along the edge of the boat (figure 3).

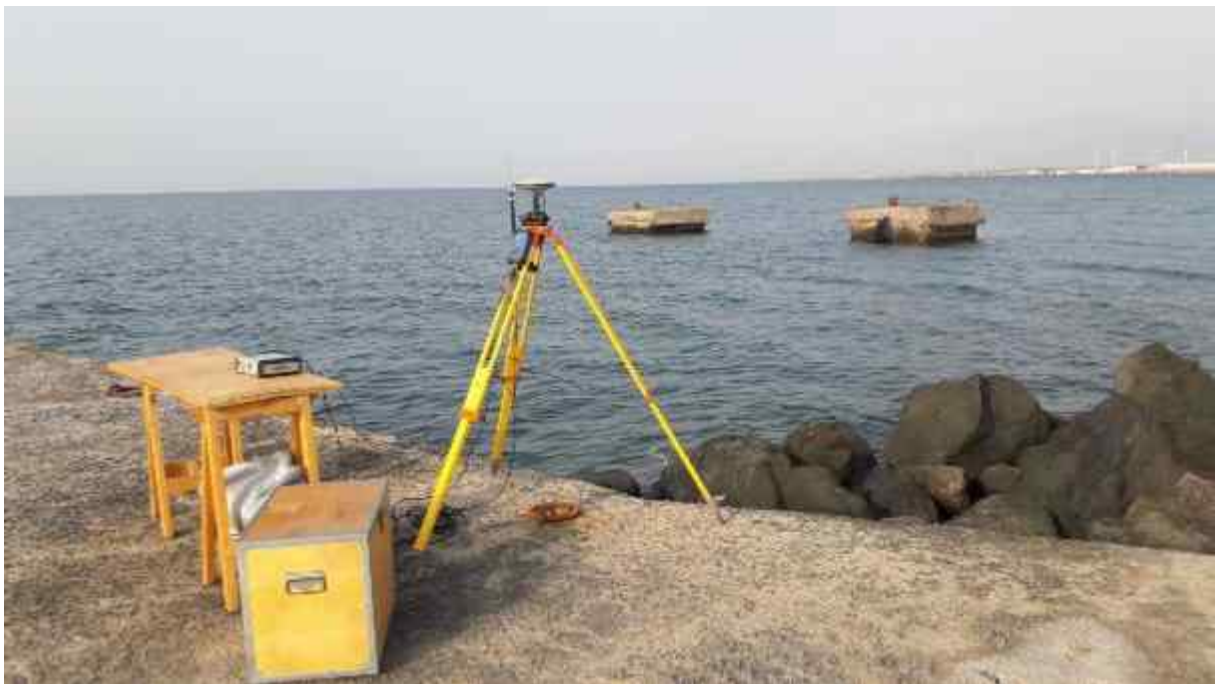
Figure 9 : GNSS Base station

The positioning equipment used is composed by two Proflex 800 GNSS system developed by the company Ashtec. Each system consists of a receiver, an antenna and all associated cables and connectors. The receiver used are adapted to receive signals from US (GPS) and Russian (GLONASS) constellations. The GNSS base station is installed on a well-know geodetic point (figure 5) and the mobile is installed on board the vessel (figure 6).

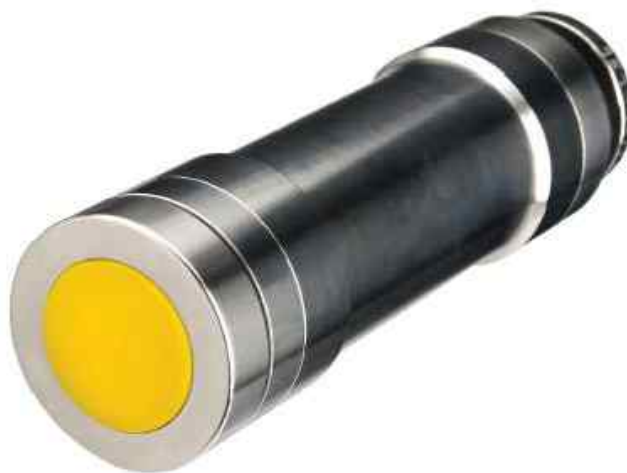
Figure 12 : Tritech PA500 echosounder

The single beam echosounder used during surveys is a Tritech PA500 fixed on the pole to the vertical of GNSS antenna (figure 8). This equipment operates at a 500 kHz frequency and with a 6° conical beamwidth.

The echosounder was checked in August 2018 (see Product test Record in appendix A).

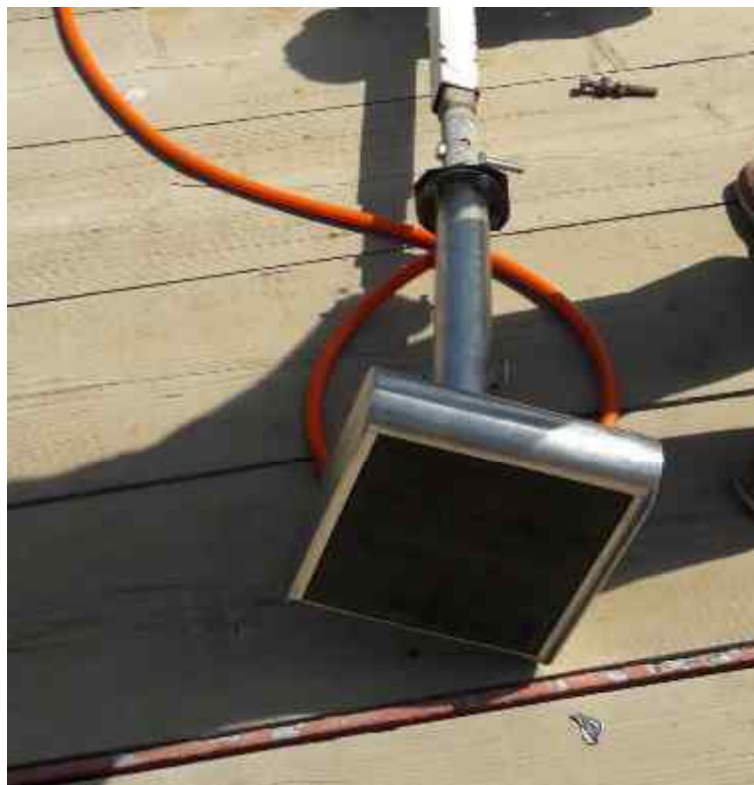
Figure 15 : SBP transducer fixed on pole

Transducer array used to transmit and receive the signals (figure 9).

The system is a parametric sediment sounder. This technology is based on a physical phenomenon generating low frequency waves from two high intensity acoustic signals sent simultaneously at two slightly different frequencies (primary frequency: 85-110 kHz and secondary frequencies between 4 and 15 kHz). These two frequencies interact during the propagation of the signal and generate low frequency waves. This signal is very narrow and does not have a secondary diffusion lobe, which improves the signal-to-noise ratio.

The theoretical vertical resolution is 5 cm and the horizontal resolution is less than 7% of the water depth.

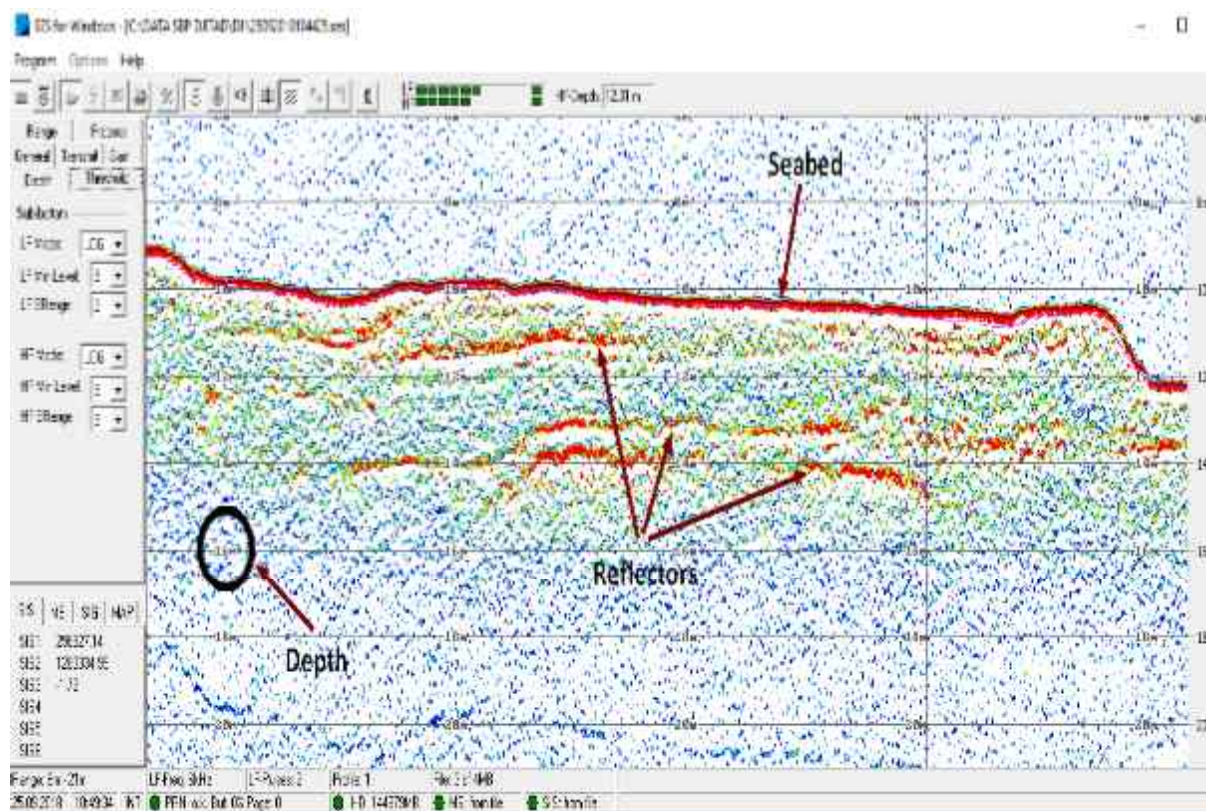
Figure 1 : Typical raw SBP image in Seswin software

On the echogram, the vertical scale corresponds to the depth below the waterline and the horizontal scale depends of the vessel speed. The first red echo is the seabed. Several reflectors can be observed below the seabed.

The recording of data on a laptop is done with the SESwin software developed by Innomar (figure 10). During acquisition, various parameters can be adjusted to obtain the best possible image of the marine basement (range, frequency, gain, rate of shots, ...).

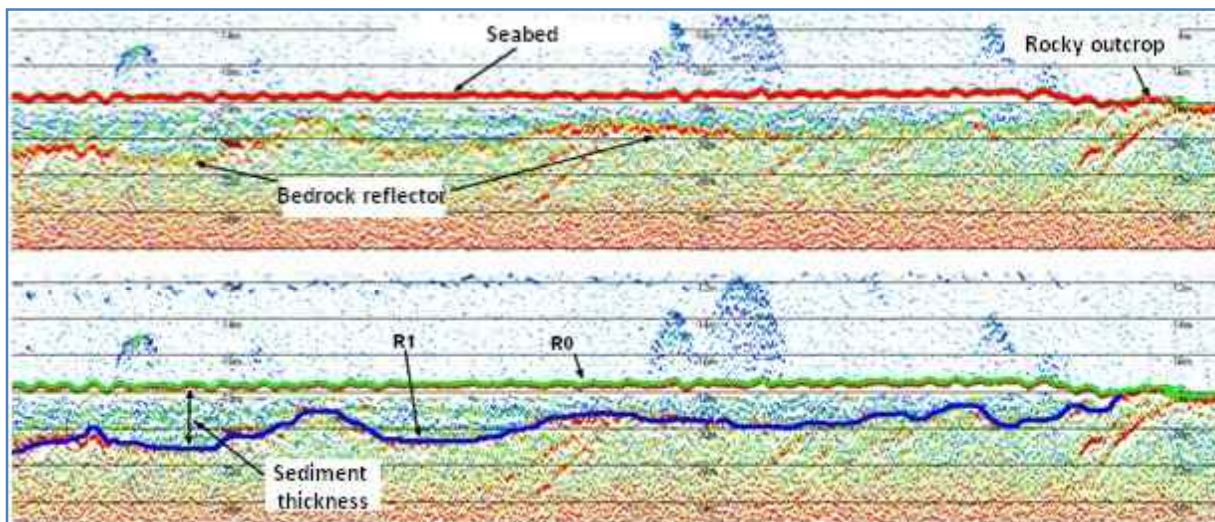
Figure 17 : Typical processed SBP line (up) and interpreted image in ISE2 software

We can distinguish the water-sediment interface (seabed) noted R0 and a reflector R1 more or less well marked and irregular depth that corresponds to a change in nature background. The reflector R1 has been interpreted as the top of the substratum.

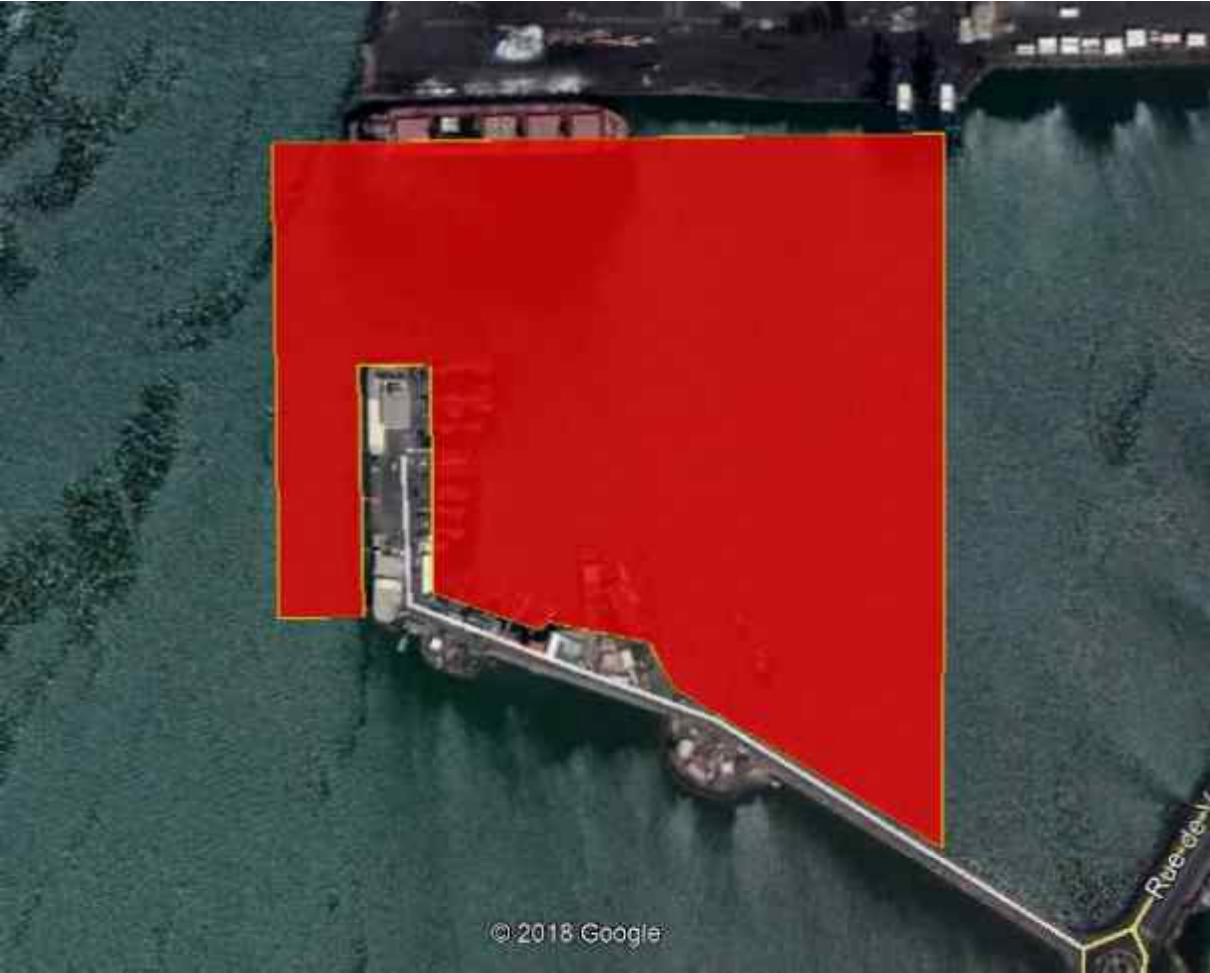
Figure 2 : Survey area in Djibouti port

The sector survey consists of an 184 800 m² area located in one of the oldest part of Djibouti port (figure 11).

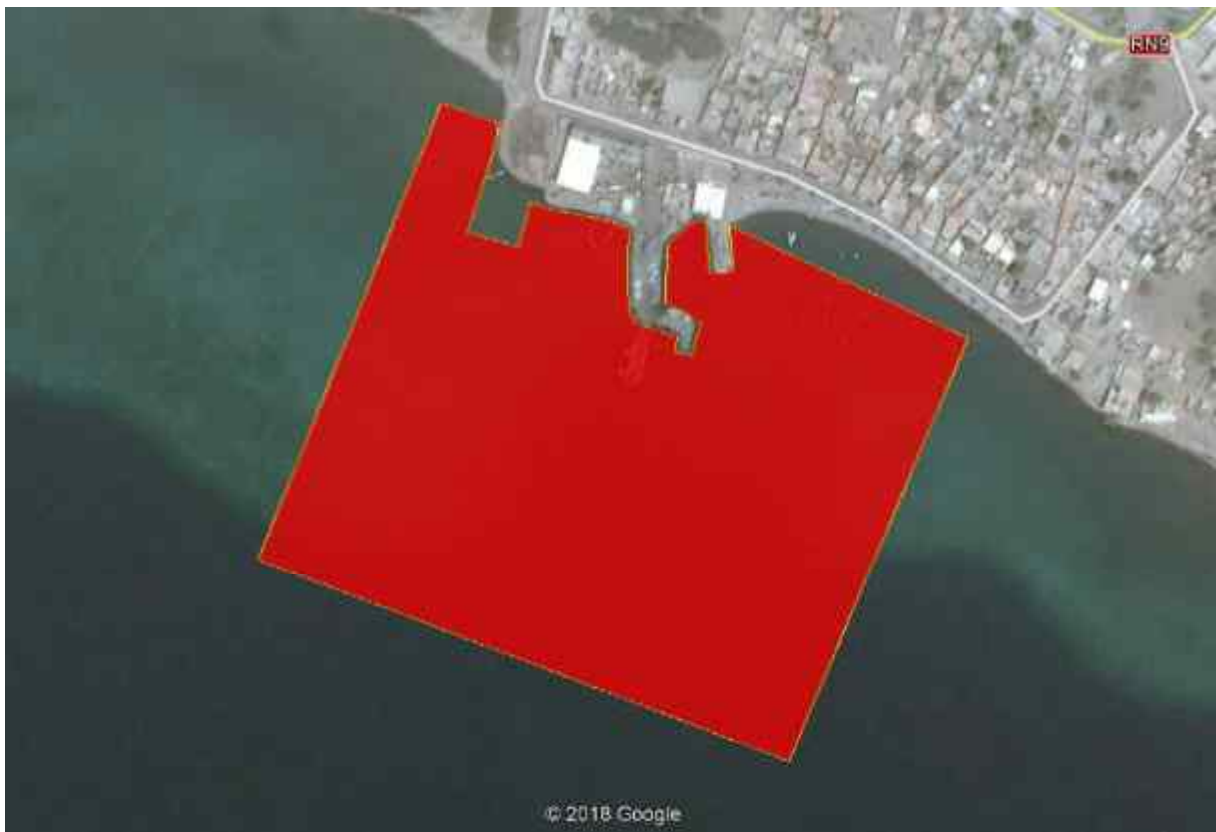
Figure 3 : Survey area in Tadjourah port

The sector survey consists of an 125 200 m² area located around Tadjourah port (figure 12).

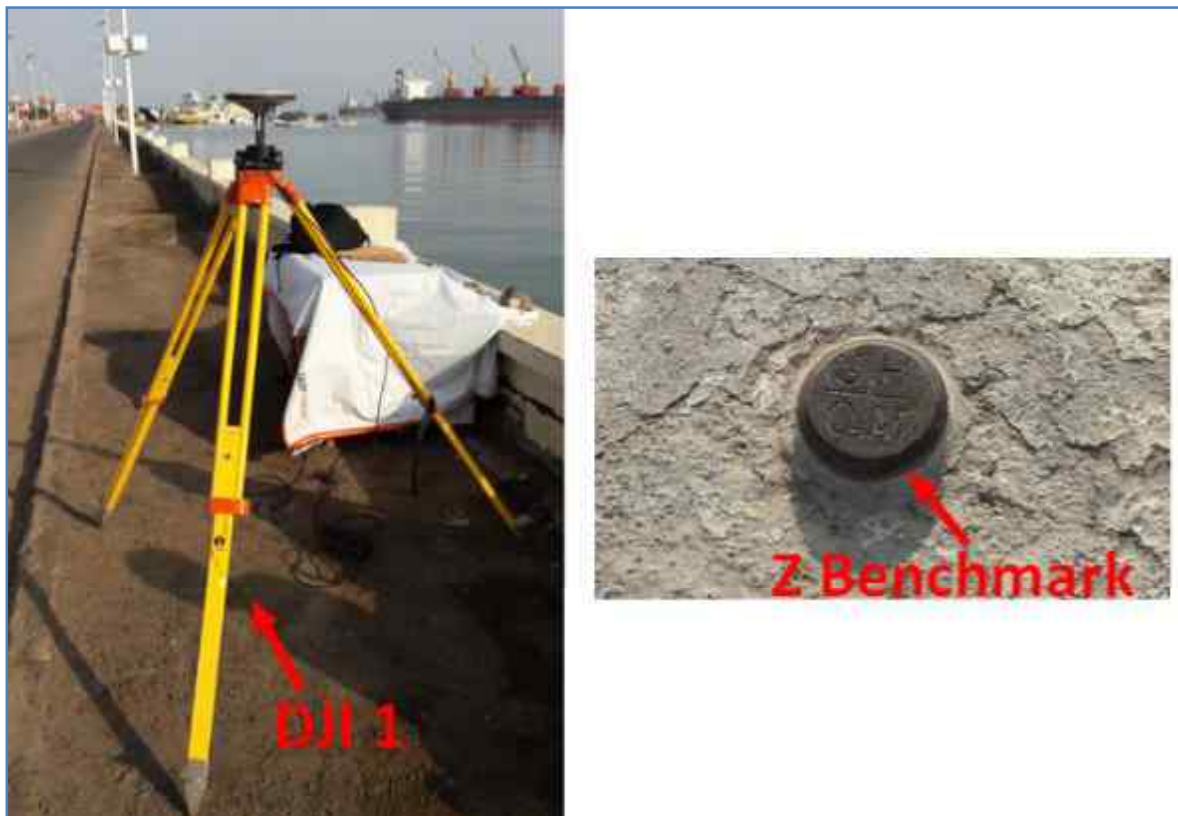
Figure 6 : Geodetic references in Djibouti area

The geodetic base point of Djibouti (DJI 1) is issued from GNSS raw data recording during 6 hours and attached to a SHOM benchmark (Z) located nearby (figure 15).

The UTM coordinates and Z/CD of DJ1 and Z points are given in table 6.

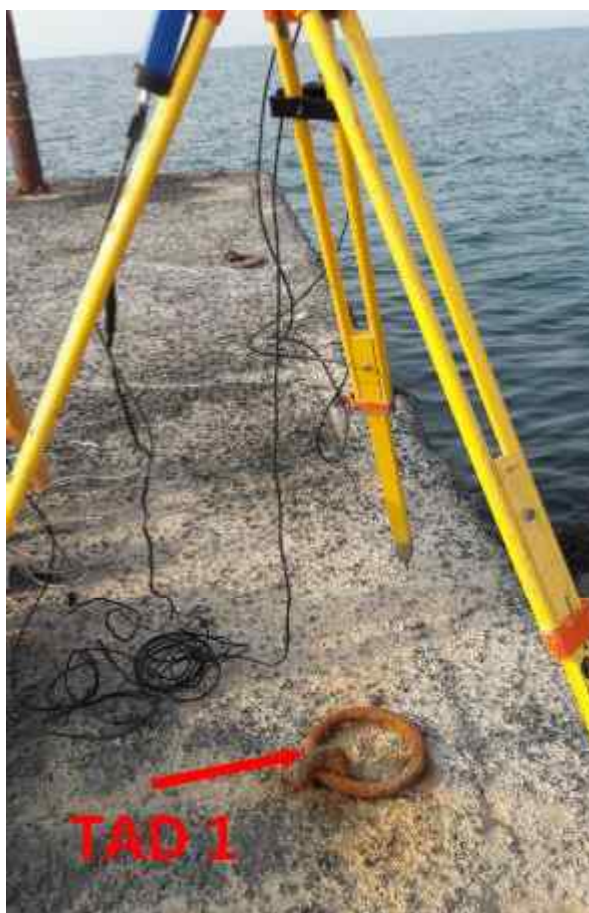
Figure 7 : Geodetic references in Tadjourah area

The geodetic base point of Tadjourah (TAD1) is issued from SHOM GNSS raw data recording (figure 16).

The UTM coordinates and Z/CD of TAD 1 are given in table 7.

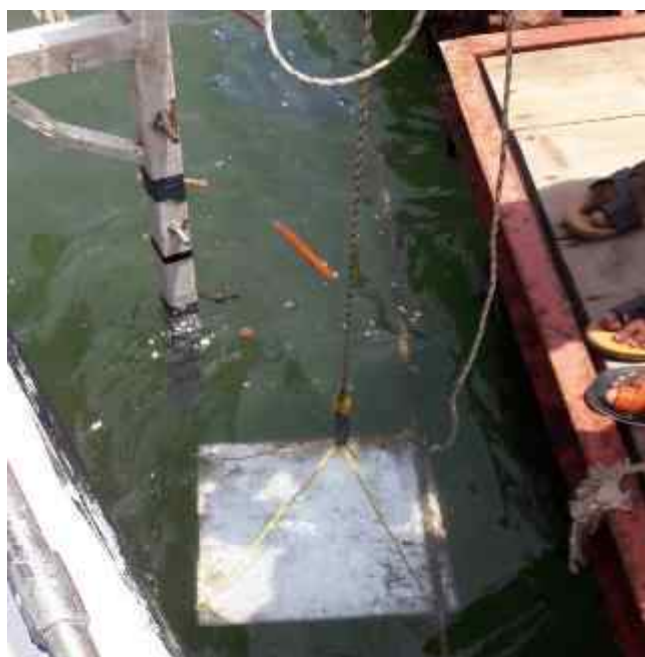
Figure 8 : Metal plate used for PA500 calibration

A metal plate was used to calibrate the PA500. It was positioned directly below the sounder at the respective depths of 1m, 2m, 3m and 4m. This operation consists to check the accuracy of the values indicated by the sounder and determinate the speed of sound in the water. A velocity of 1545 m/s was calculated for the two areas

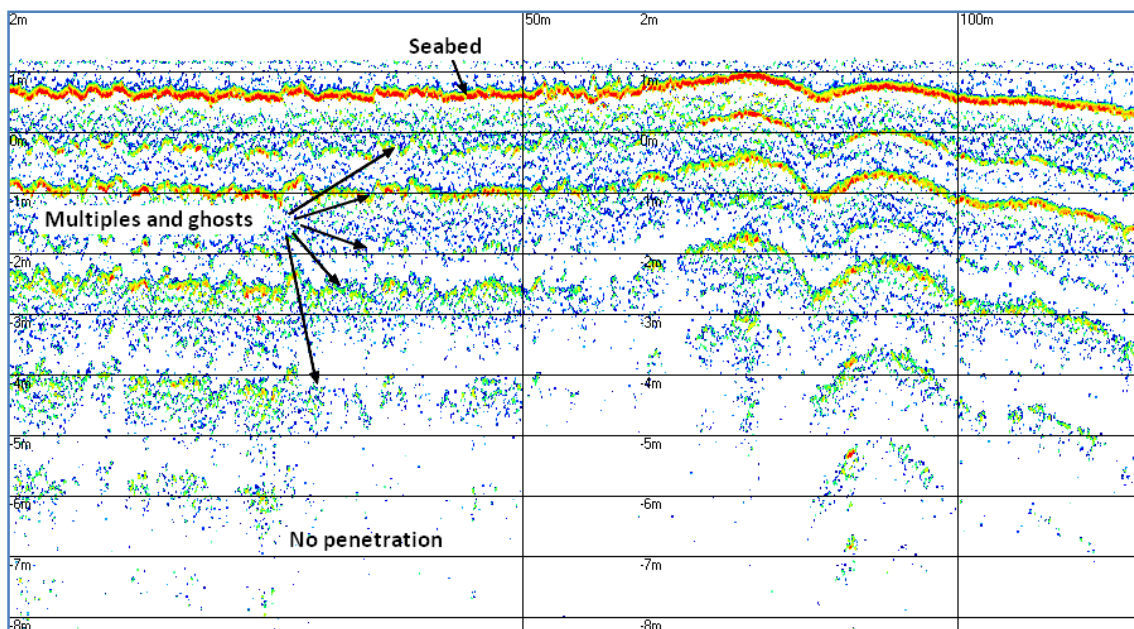
Figure 37 : Example of SBP record in very shallow water area (D1)

In the very shallow part, no reflector can be observed into the sediment (figure 23).

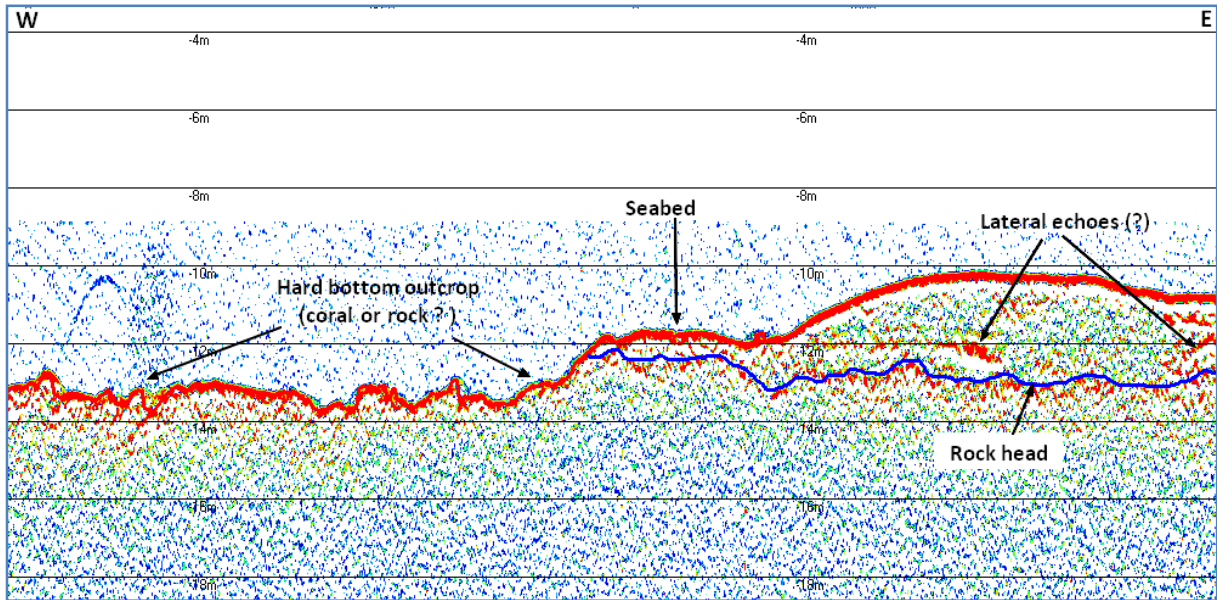
Figure 39 : Example of SBP record in the central part of the dredged area (D3)

In the West and central parts of the dredged area, the hard bottom is outcropping. The hard bottom could be probably coral or volcanic rocks. On the figure 25, it is possible to observe the rock head under 2m of sediment.

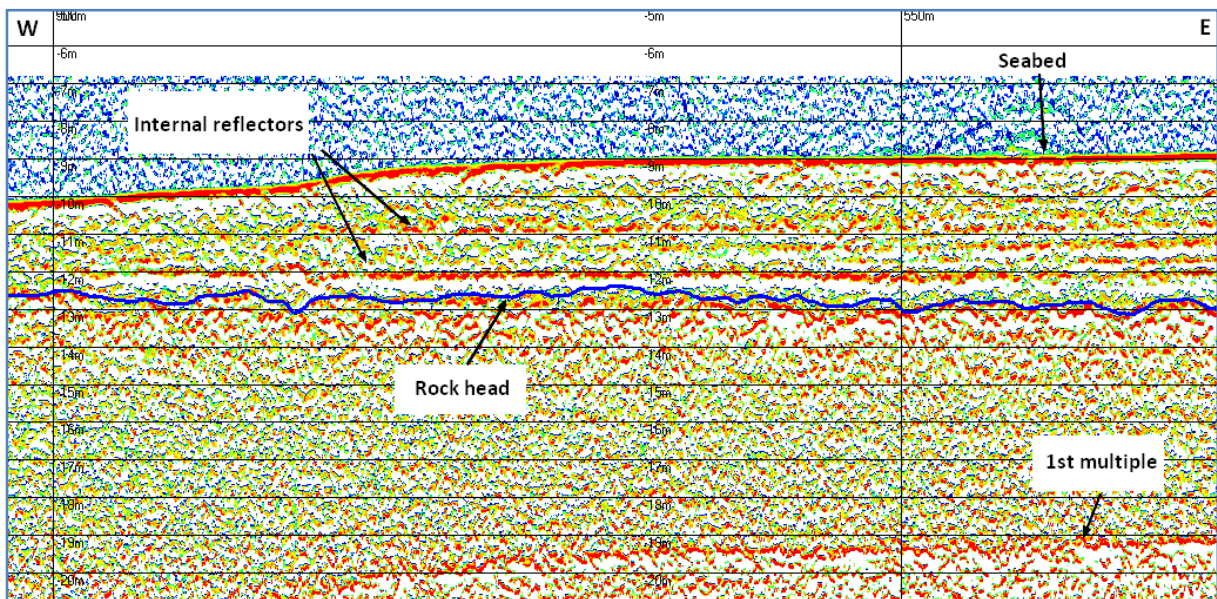
Figure 40 : Example of SBP record in the East part of the dredged area (D4)

In the East part of the dredged area, the hard bottom is under 5 to 6 m of sediment (figure 26). Some horizontal internal reflectors can be observed in the sediment.

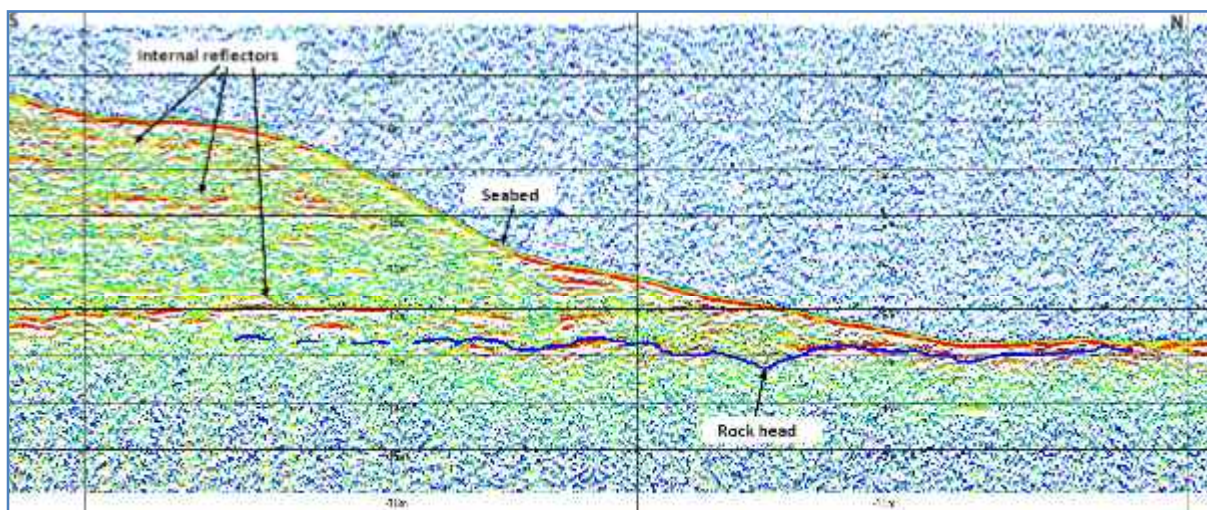
Figure 41 : Example of SBP record on the bottom slope (D5)

The figure 27 shows a typical recording of sedimentation at the bottom slope (between 7 and 13m CD). The maximum sediment thickness observed is about 5 to 6m. The internal reflectors are usually discontinuous and slightly marked.

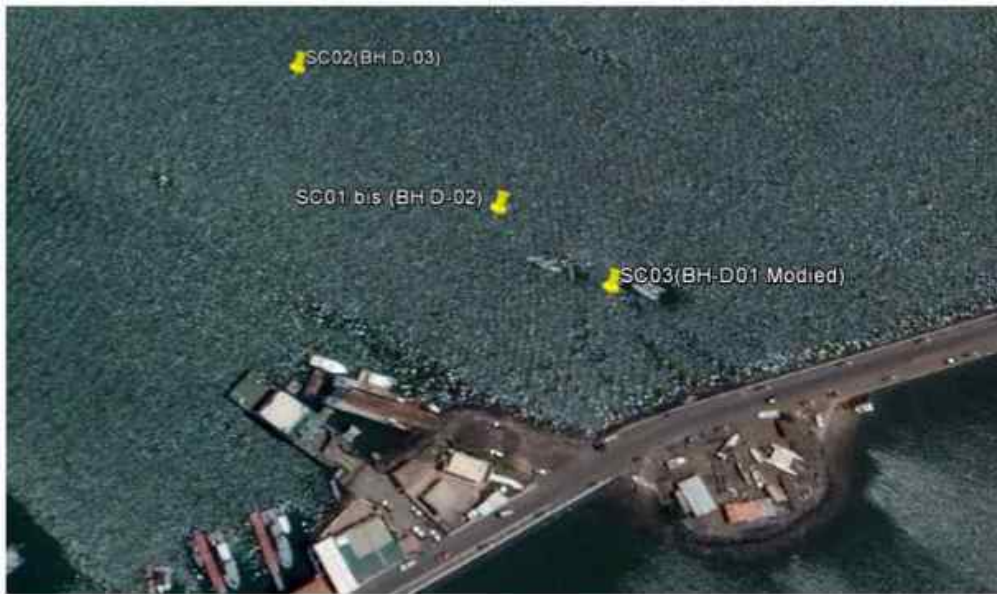
Location of surveys, Djibouti site

- Site of Djibouti
 - o An SPT survey (SC01bis) 33m deep,
 - o A 10m deep SPT (SC02) survey,
 - o An SPT (SC03) survey 21m deep,

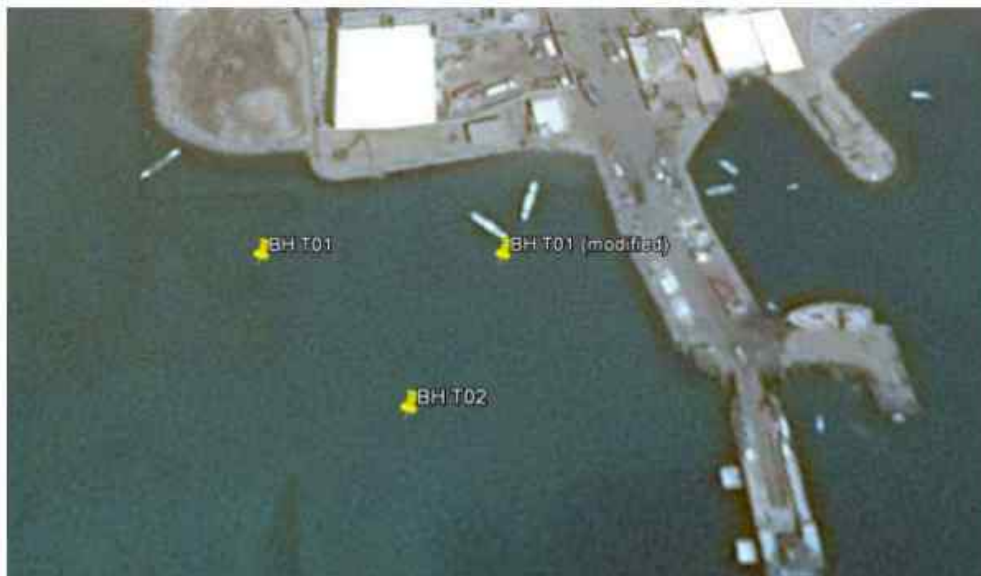
Location of boreholes, Tadjourah site

- o An SPT survey (BHT01) 21m deep,
- o An SPT survey (BHT01_modified) 12m deep,
- o An SPT survey (BHT02) 22.5m deep,

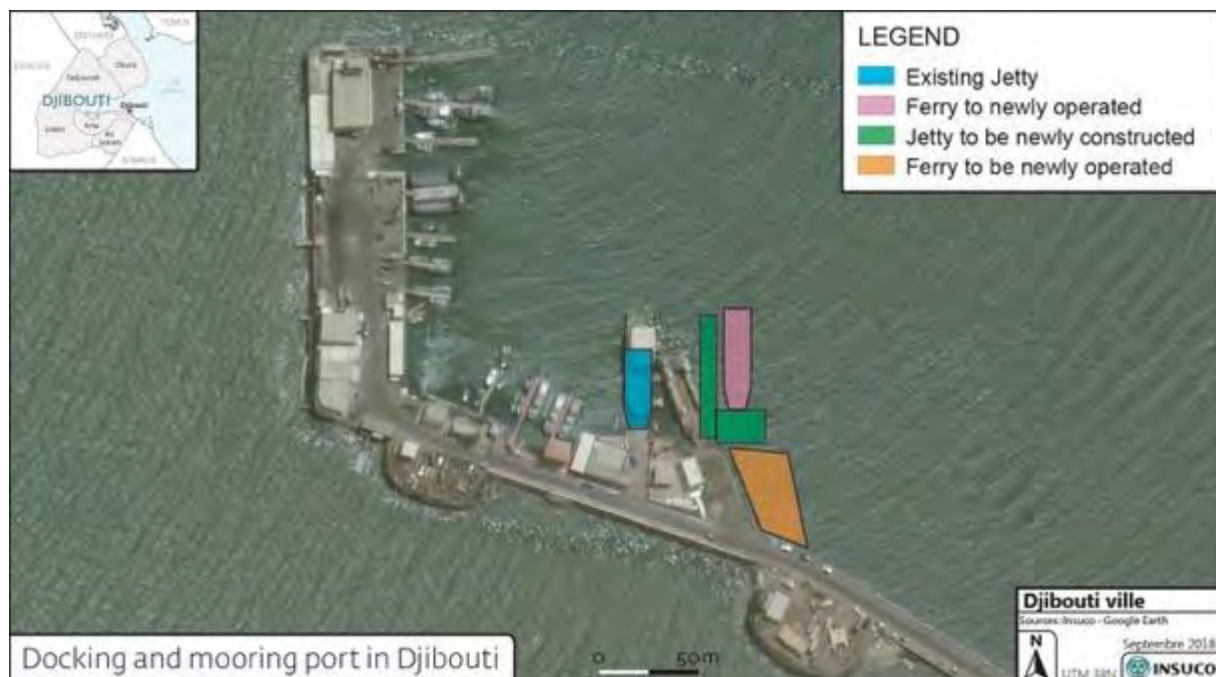
Figure 1: Existing and new infrastructures to be built in Djibouti Port

The work envisioned in the framework of the project are located in the port of Djibouti and in the port of Tadjourah, the figures 1 and 2, below, present the existing infrastructures as well as the new one to be built.

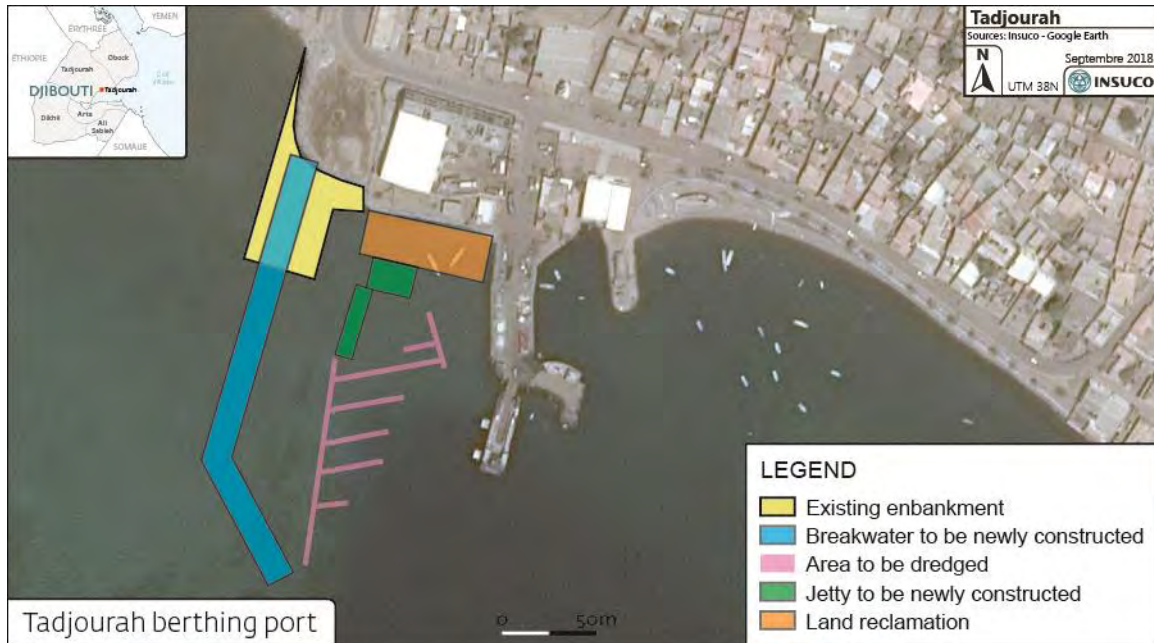
Figure 2: Existing and new infrastructures to be built in the port of Tadjourah

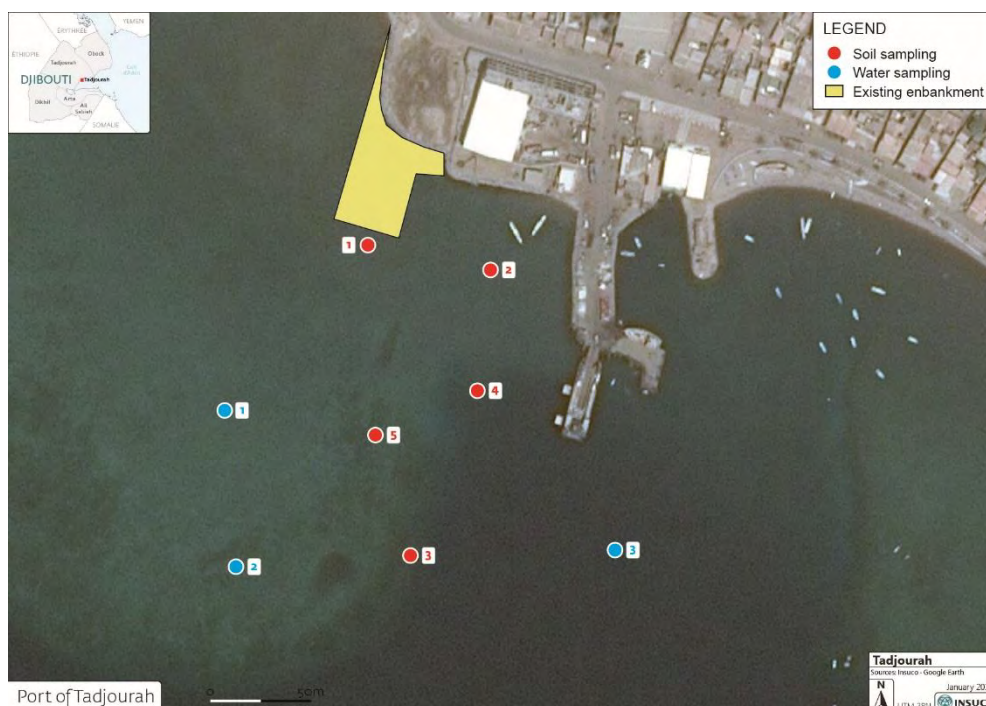
Figure 4: Sampling sites in Tadjourah

The sampling points are precisely located using a GPS. At each point, sampling date, weather conditions and environmental parameters of seawater (temperature and salinity) were registered.

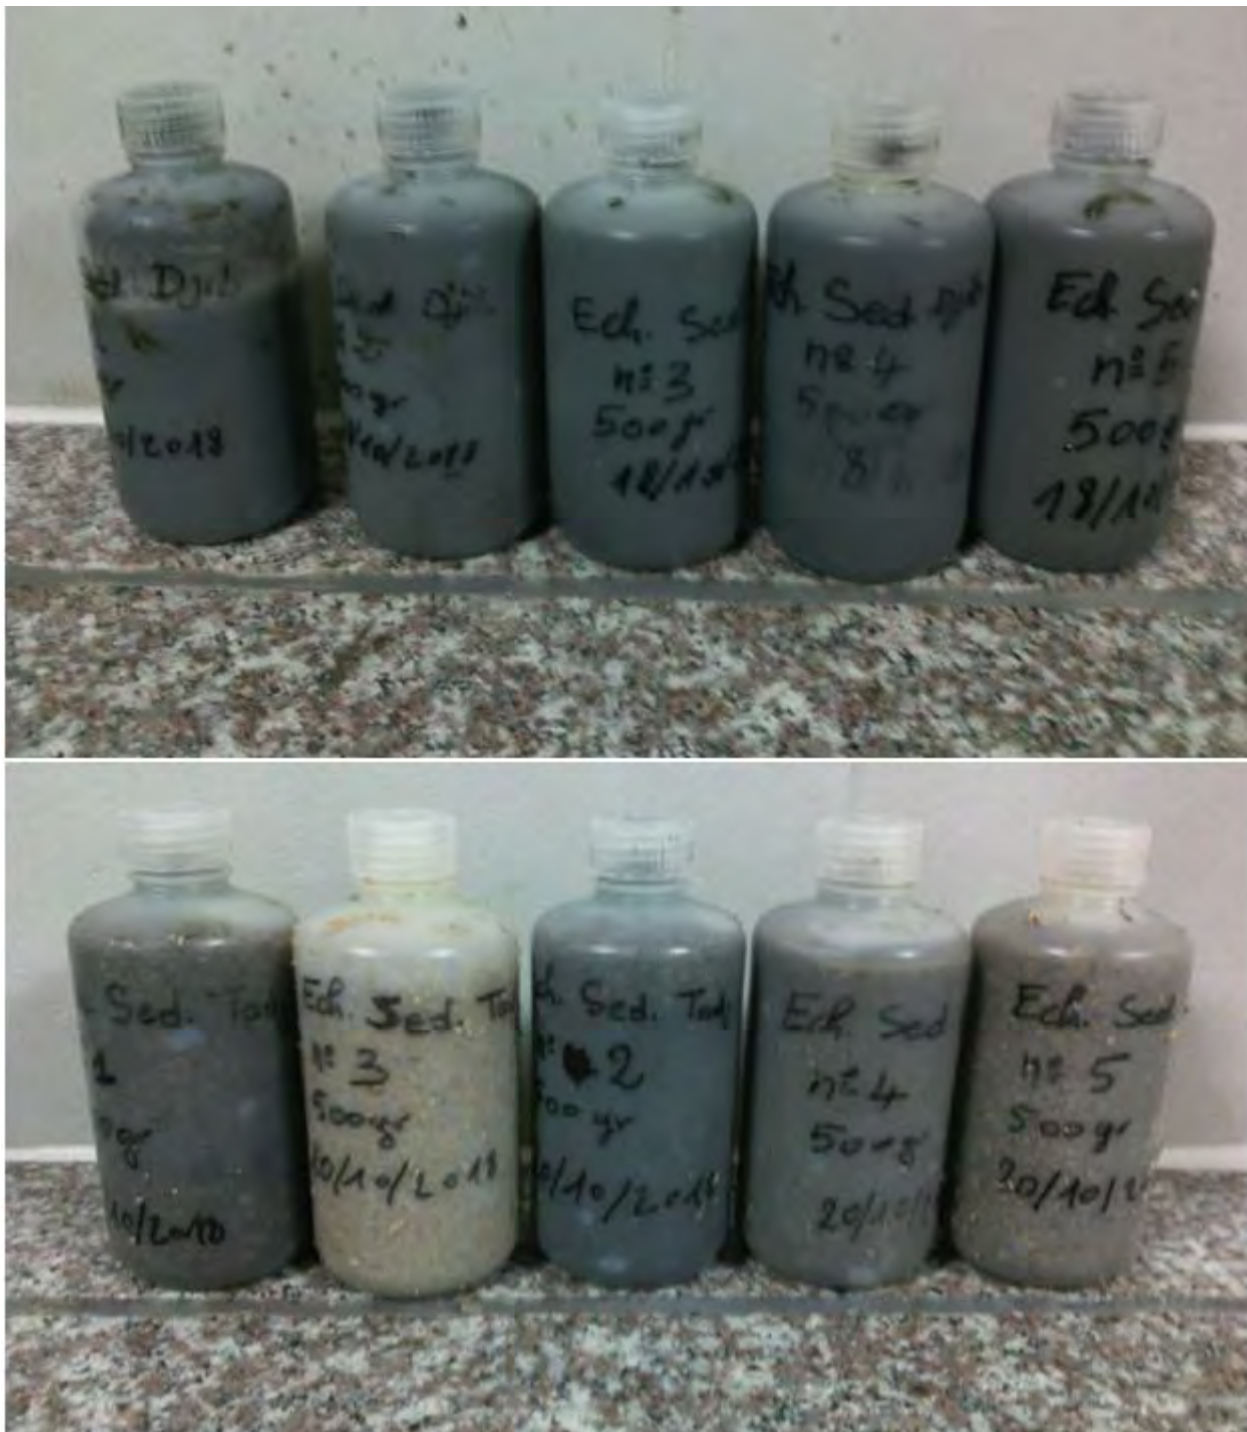
Photo 1: Seabed sediment: Top 5: samples (Djibouti Site) Down: 5 samples (Tadjourah Site)

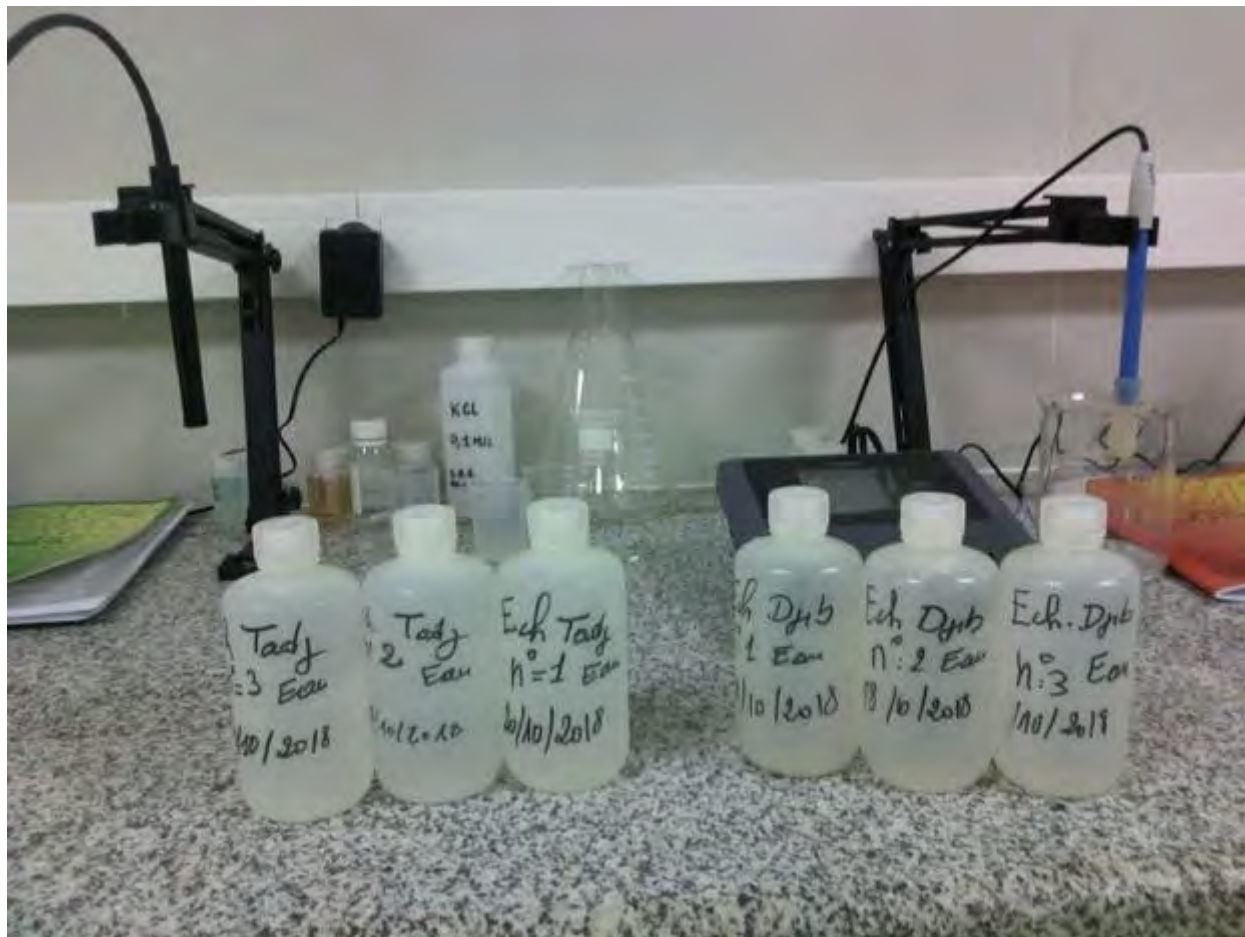
The sample of seawater were taken at the surface, approximatively 50 cm from the seasurface. The closed container (bottle of 1 L) is immersed in water. At about 50 cm below the surface, the bottle is open, filled and brought to the surface. Then the sample is kept in a cooler box until analyzed in the lab.

Photo 2: Seawater samples: 3 samples from Tadjourah Site & 3 samples from Djibouti Site

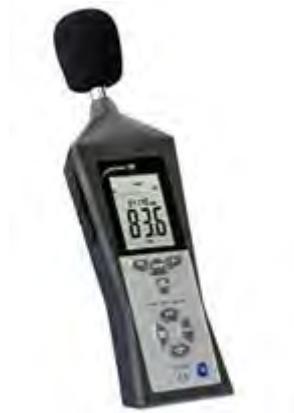
A decibelmeter was used to perform the noise study.

Figure 6: Sound level meter Instrument

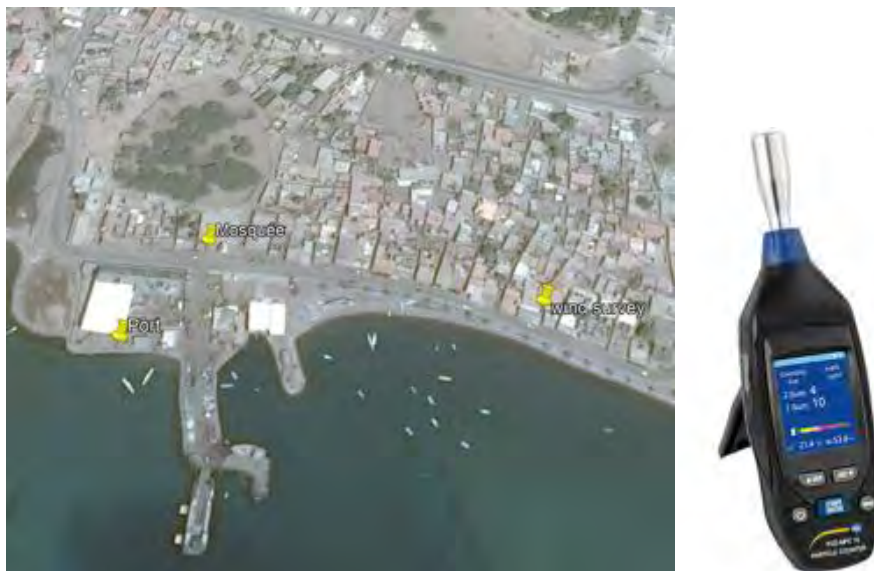
A DT particle counter was used to measure the mass concentrations of PM 2.5 and 10. For wind and temperature measurements we relied on the automatic station installed during the Adcp measurements located about 200 meters from the test sites. measures. (Annex3).

Figure 8 : Location of 2 points of noise and Air measurement (Harbor/port and Mosque/mosquee) with the particle counter

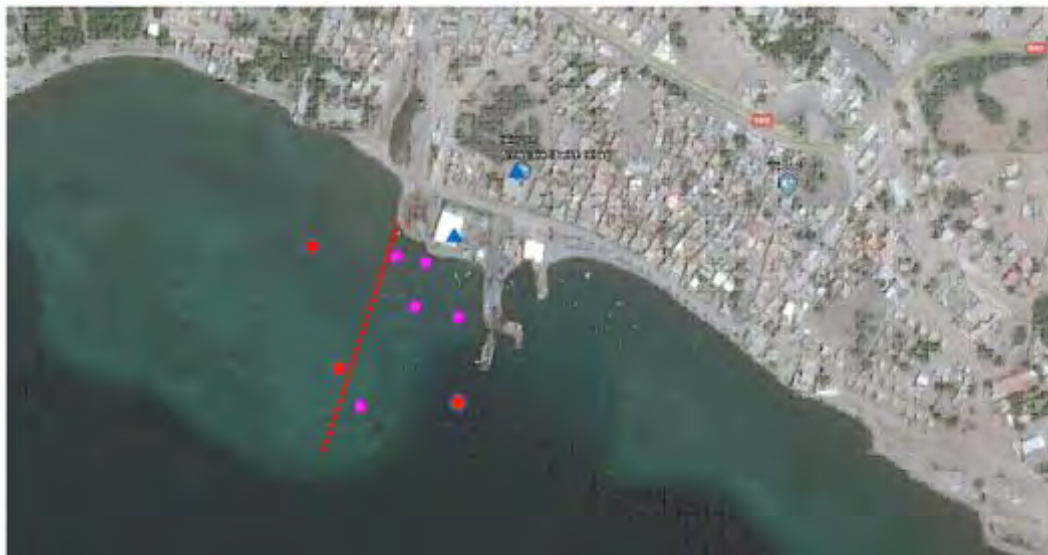
The prospective coral survey has been done along the path of the future breakwater.

Figure 9: Indication (line) for the prospective survey

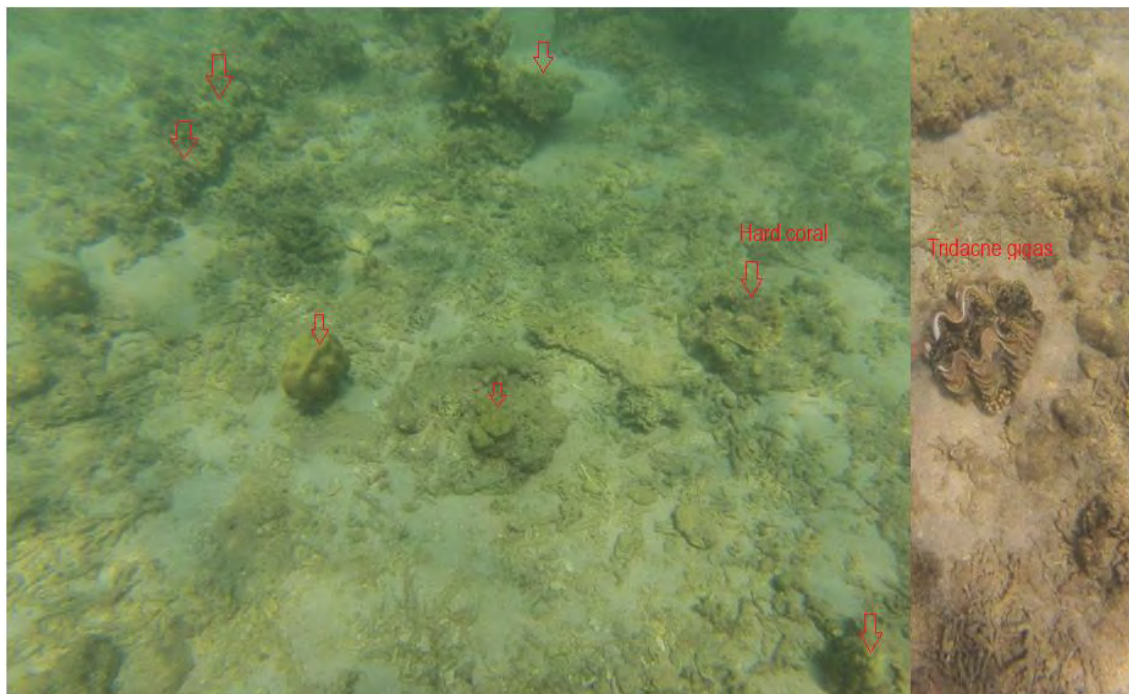
The first type of substrates encountered near the coastline consists of mainly of coral rubble, sand and stone blocks. Live corals are sparse and represented by massive isolated forms and branching shapes hanging on the stone blocks (Photo 1). Some species of small fish (*Lutjanus sp.*) and giant clams (*Tridacne gigas*) were observed during the survey.

• Photo 3: Seabed covered by coral bioclats and some live corals (indicated by red arrows). On the left the giant tridances

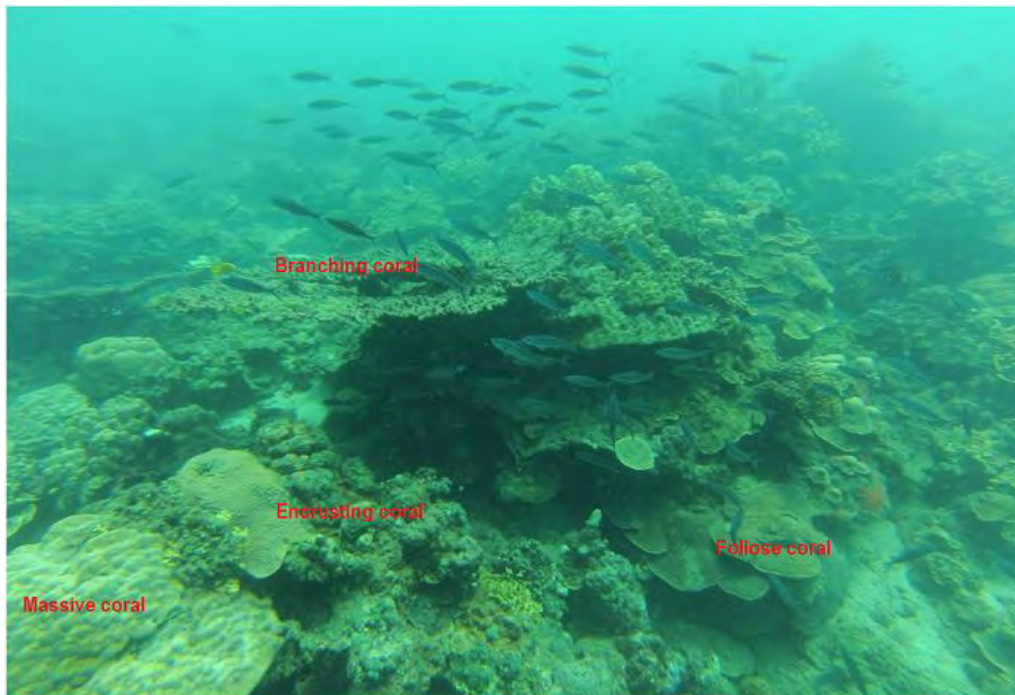
The reef ridge is distinguished from the massive coral zone by the diversity of coral forms and species (Photo 3).

Photo 5: The reef crest covered by massive corals, encrusting, covering and branched
