4. Etude des conditions naturelles Package B (Amendement-1)

NATURAL CONDITIONS SURVEY PACKAGE-B

PREPARATORY SURVEY ON REINFORCEMENT OF MARITIME TRANSPORT AT GOLF OF TADJOURAH

DJIBOUTI AND TADJOURAH PORTS REPUBLIC OF DJIBOUTI

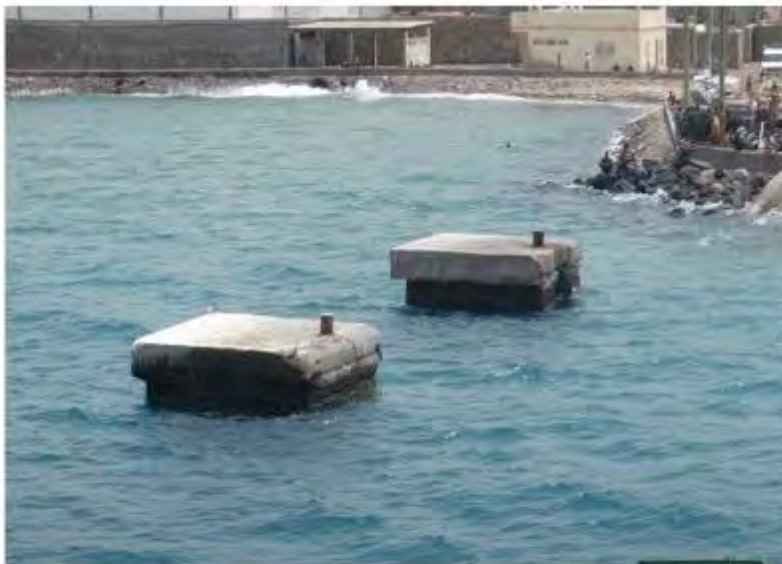
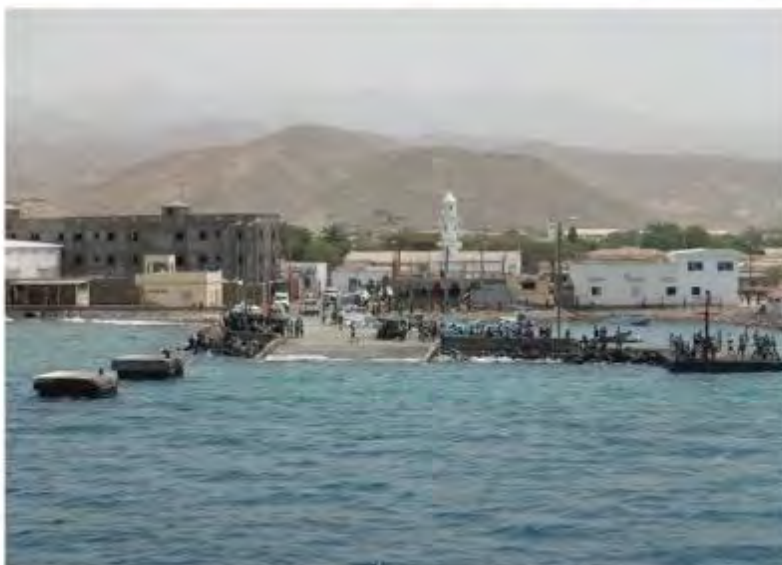
Photo 6: Two dolphins in Tadjourah (above water photos)

It was asked to seize the opportunity of the diving, to get some photos of the two dolphins in Tadjourah Port (photos hereunder provided by JPC). The diving team went around them and collected some photographs in order to identify their current state.

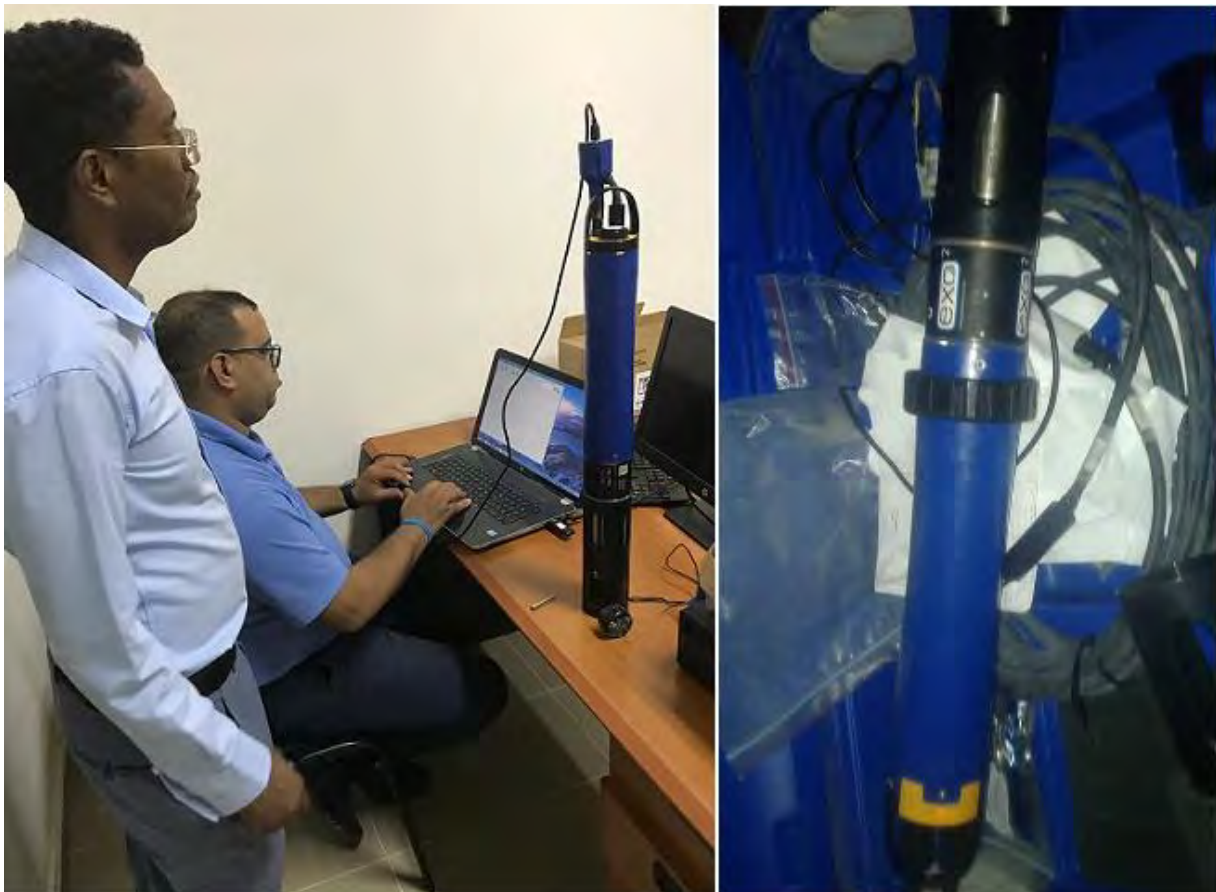
Figure 2 : Calibration of the EXO multiparameter

At each station, the probes were launched using an EXO Handheld. The frequency of recording was set up at 30 minutes for physic-chemical parameters (fig. 2) and every 10 min for the currentmeter.

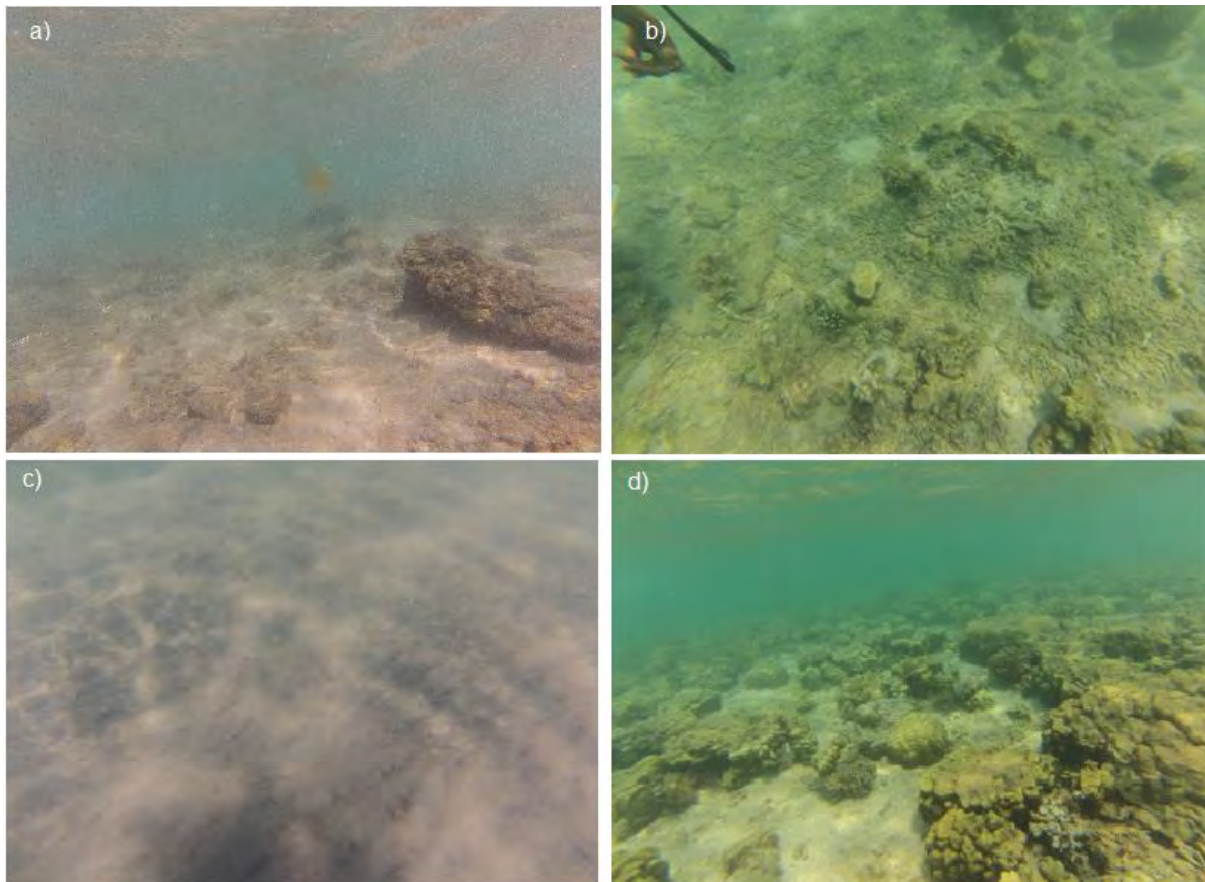
- **The intertidal zone** exposed to tidal variations and characterized by the absence of living substrates. The seabed is covered by sands and rocks.
- **The reef flat area** dominated by rubbles with a few rare living corals. Rubbles occupies large areas and seems resulting from a destroyed reef
- **The back reef area** dominated by massive corals (genus porites) and rocks. In the east and in the middle, this area is particularly affected by the algae.
- **The almost deserts sandy area** located between the existing jetty and coral reef. This zone ends in a drop off near the two dolphins.

Photography 2: Different types of seabed found in ZONE 1, a) intertidal zone, b) reef flat with a high proportion of rubbles c) sandy area (d) the back reef dominated by massive corals (porites).

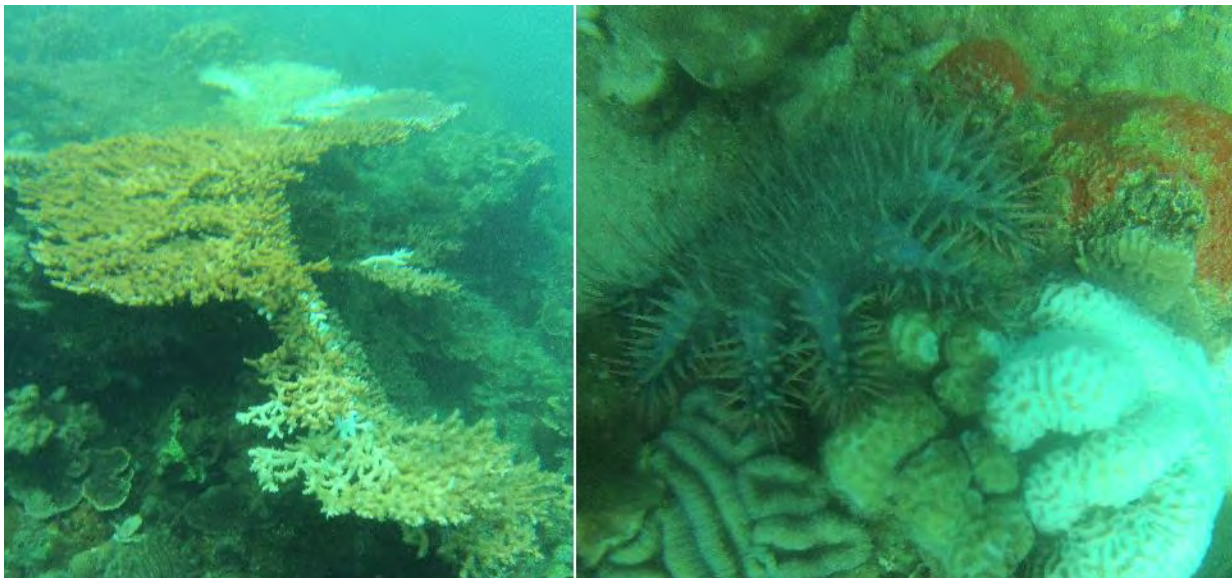
Photography 3 : Bleached coral (Left), *Acanthaster planci* (Right)

Throughout the study area including ZONE 1 and ZONE 2 the coral cover is variable. The lowest percentages of coral cover were observed in the near-coastal area and in the east (Z 1 ER). The coral reef also contains particularly damaged areas dominated by coral rubbles (indicating the widespread mortality), recently dead corals and algae (photography3). These impacts are likely due to possible increase of temperature and low water quality due to proximity to the town of Tadjourah and past port activities. The presence of coral disease is also indicative of the latter. All these impacts are localized ZONE 1 and along the eastern wall in ZONE 2.

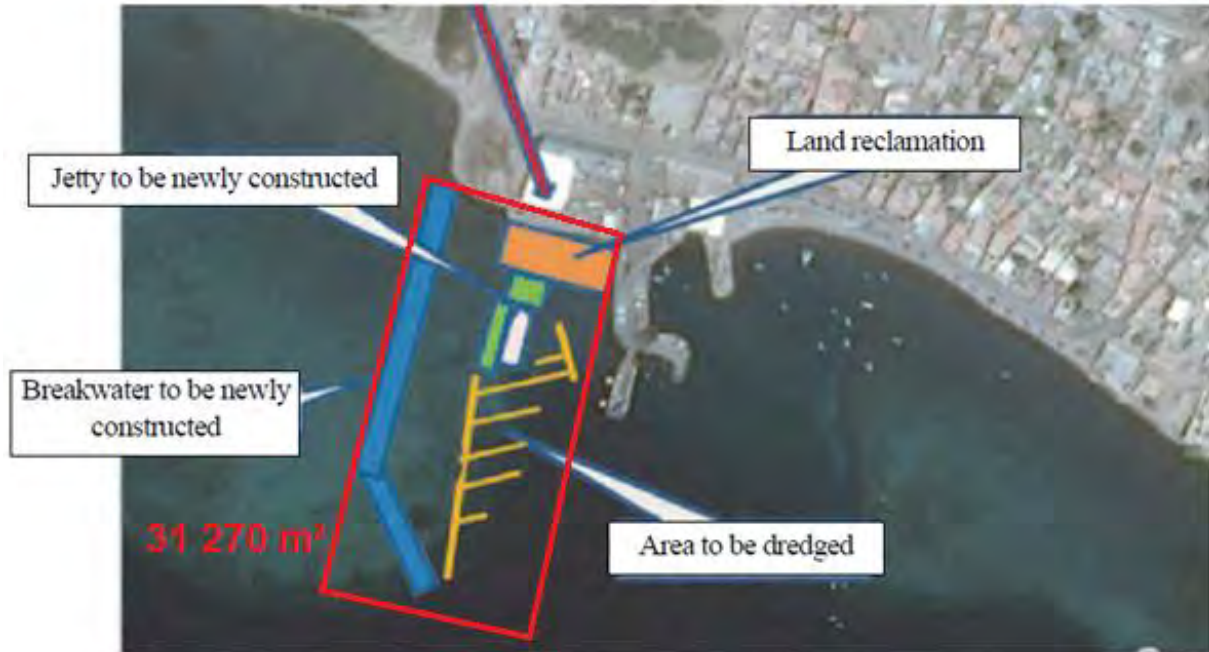
The project plans to rehabilitate the former port of Tadjourah and build berthing infrastructures for the new ferry. These facilities include land reclamation, new jetty and breakwater. The planned area is located west of the former port and covers an area of 31 270 m² (figure 13, red rectangle).

Figure 13 : Map showing Project area (red rectangle), planned area for breakwater (blue thick line), Land reclamation (orange rectangle), Jetty (green) and dredging area (yellow)

According to the overall planning, the breakwater will be constructed in the west part of the project site, the land reclamation and new jetty in the northern part. The area that will be dredged is located in the south and east of the new jetty (figure 13).

The project plans to dredge an important area around the new jetty (see figures 13 & 15). Dredging/Excavation will cause disturbance of the marine bottom sediment. The excavation will also modify bathymetric feature and consequently the current system. Both dredging and excavation will increase the suspended solid (SS) concentrations in the water column which could spread over long distances.

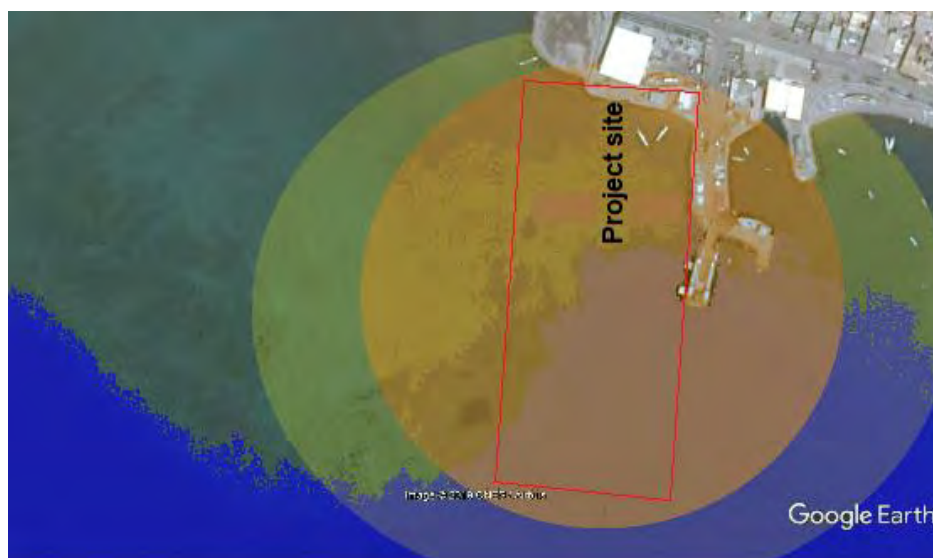
Figure 15 : Project site and project area of influence

Depending on the weather conditions (current velocity) and the spread of suspended particles, the area of influence was delineated at about 500 m around the project site (Figure 15).

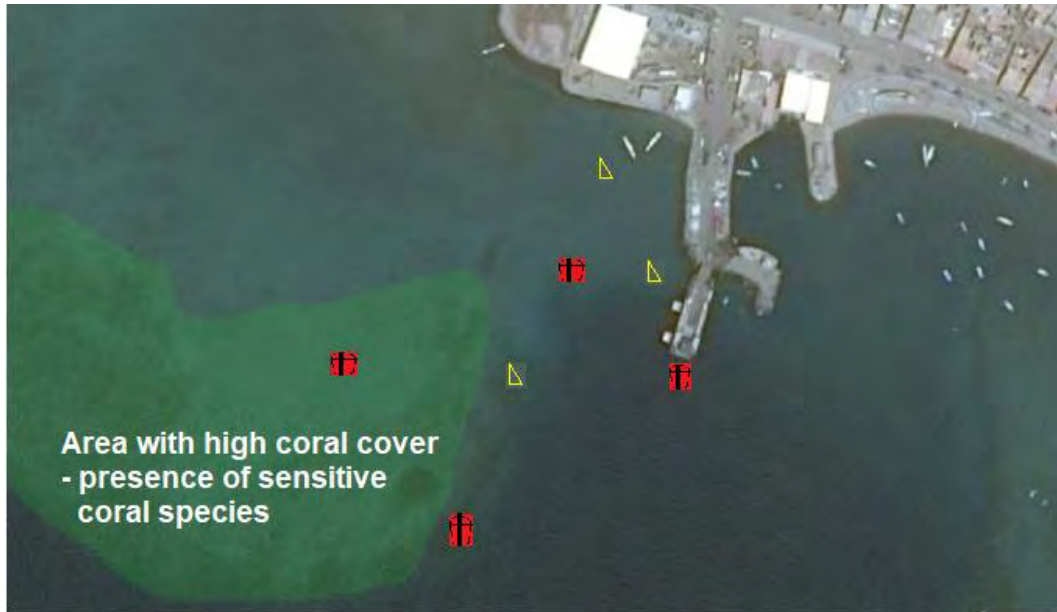
Figure 16 : Proposed location for water measurements

- Current velocity and direction (red),
- Turbidity, salt content, temperature and dissolved oxygen (yellow)
