Work Plan for Kuta Road,
Western Highlands Province

The Pilot Project for Capacity Development on Road Maintenance in the Independent State of Papua New Guinea

Work Plan for Introduction for Civil Staff

07 June 2017

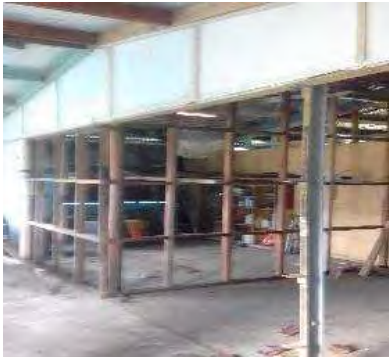
Office construction

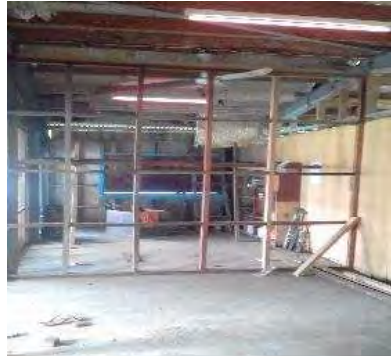
Office construction

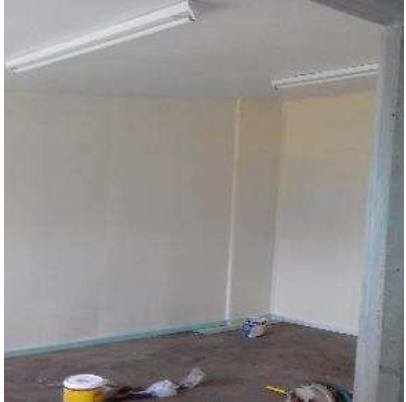
Office completed and painting in progress

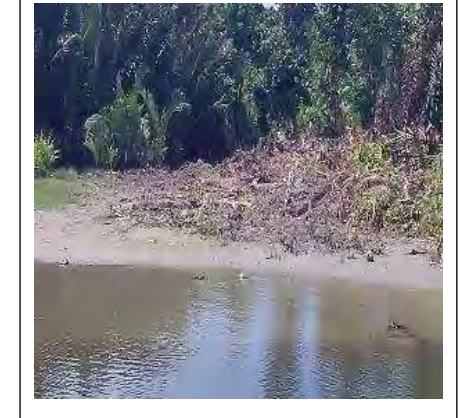
Outlet at Pukpuk Bridge

The river diversion works commence on the 17th August 2017. The plant used was an excavator only which was used to do the clearing and grubbing from the CIS area to the sea at Boram, The clearing and grubbing works has been completed in which the total length was 870m and the average width was 20m. The current clearing begins in front of the CIS Institution and ends at the Pukpuk Bridge near the Boram Beach.

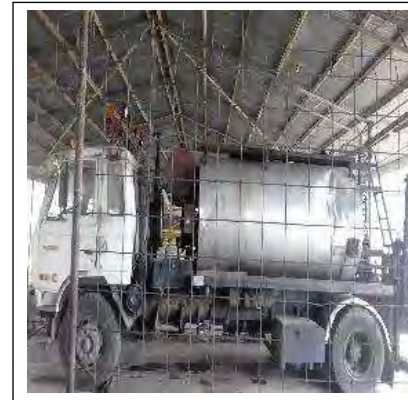
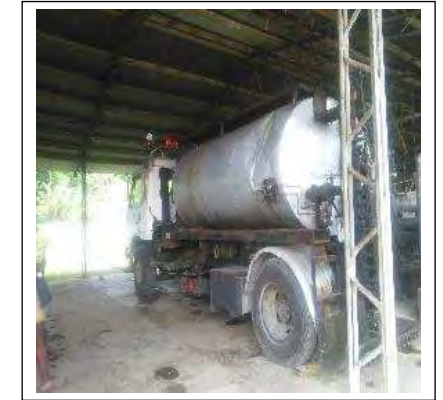
3.30) Sealing Spray Truck

The spray truck is undergoing minor maintenance works. A new engine was purchased and placed in the truck – overall the truck is ready for any sealing works

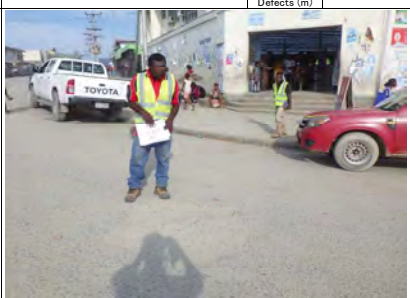
Existing Road Surface Condition on the Road				No	Station	Height of Embankment (m)	Total Carriage Width (m)	Remarks
Date: July 2017				D17-4	4 + 100	0.0	7.00	Post Office Road

4.10 km from DoW Office				
Right hand side towards East (Ocean)	Existing Lane width (m)	3.50	Right hand side towards East (Ocean)	Existing Lane width (m)	3.50			
	Type of Defects	Pot-hole		Type of Defects	Pot-hole			
	The width of Defects (m)	0.3		The length of Defects (m)	0.3			
Existing Road Surface Condition on the Road				No	Station	Height of Embankment (m)	Total Carriage Width (m)	Remarks
Date: July 2017				D17-3	4 + 100	0.0	7.00	Post Office Road

4.10 km from DoW Office				
Right hand side towards East (Ocean)	Existing Lane width (m)	3.50	Right hand side towards East (Ocean)	Existing Lane width (m)	3.50			
	Type of Defects	Major pot-hole		Type of Defects	Major pot-hole			
	The width of Defects (m)	1.0		The length of Defects (m)	1.0

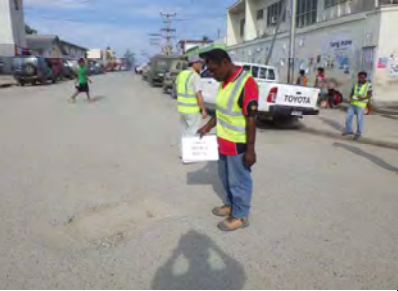
Existing Road Surface Condition on the Road				No	Station	Height of Embankment (m)	Total Carriage Width (m)	Remarks
Date: July 2017				D17-1	4 + 100	0.0	8.00	Post Office Road -Refer to other photos (Drainage)

4.10 km from DoW Office				0.5 km from Post Office
Towards West (Ocean)	Existing Lane width (m)	4.00	Towards West (Ocean)	Existing Lane width (m)	4.00			
	Type of Defects	Major pot-hole		Type of Defects	Major pot-hole			
	The width of Defects (m)	0.5		The length of Defects (m)	0.5

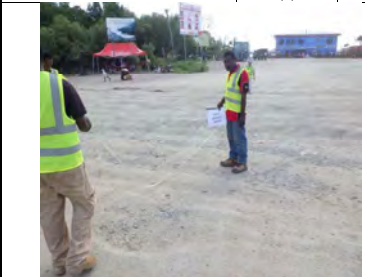
Existing Road Surface Condition on the Road				No	Station	Height of Embankment (m)	Total Carriage Width (m)	Remarks
Date: July 2017				D16	4 + 100	0.0	13.00	Post Office Road -Refer to other photos (Drainage)

4.10 km from DoW Office				0.5 km from Post Office
Towards West (Ocean)	Existing Lane width (m)	6.50	Towards West (Ocean)	Existing Lane width (m)	6.50			
	Type of Defects	Exposed base		Type of Defects	Exposed base			
	The width of Defects (m)	13.0		The length of Defects (m)	40.0

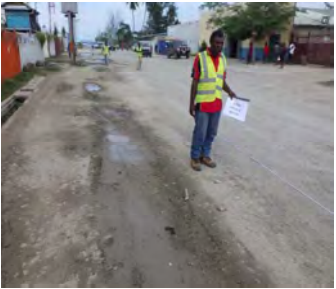
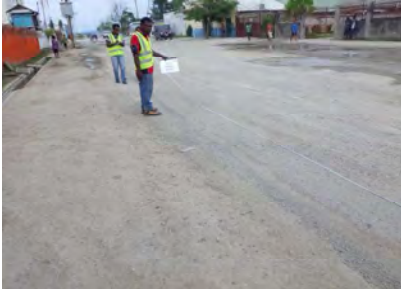
Existing Road Surface Condition on the Road				No	Station	Height of Embankment (m)	Total Carriage Width (m)	Remarks
Date: July 2017				D15-3	4 + 0	0.0	8.30	Post Office Road

4.00 km from DoW Office				0.4 km from Post Office
Left hand side towards East (Ocean)	Existing Lane width (m)	4.15	Left hand side towards East (Ocean)	Existing Lane width (m)	4.15			
	Type of Defects	Exposed base		Type of Defects	Exposed base			
	The width of Defects (m)	8.3		The length of Defects (m)	63.0

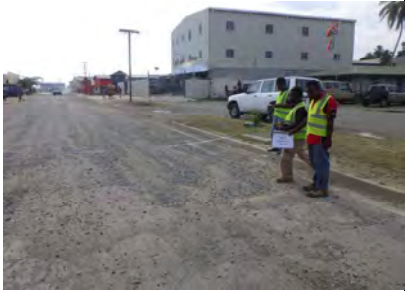
3.88 km from DoW Office		0.2 km from Post Office			
Left hand side towards West (Ocean)	Existing Lane width (m)	3.50		Right hand side towards West (Ocean)	Existing Lane width (m)	3.50			
	Type of Defects	Major pot-hole			Type of Defects	Major pot-hole			
	The width of Defects (m)	8.3			The length of Defects (m)	9.0

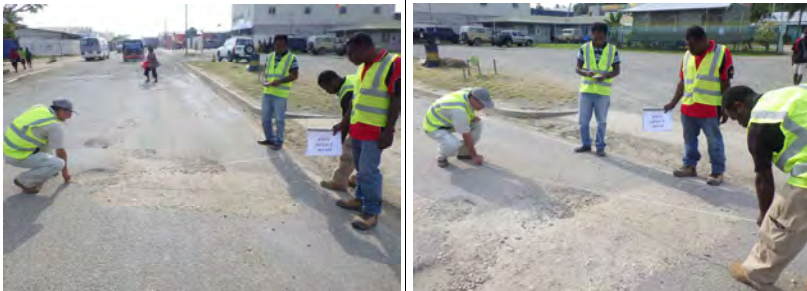
Existing Road Surface Condition on the Road				No	Station	Height of Embankment (m)	Total Carriage Width (m)	Remarks	
Date: July 2017				D14	3 + 750	0.0	7.00	Post Office Road

3.75 km from DoW Office		0.15 km from Post Office			
Left hand side towards West (Ocean)	Existing Lane width (m)	3.50		Right hand side towards West (Ocean)	Existing Lane width (m)	3.50			
	Type of Defects	Major pot-hole			Type of Defects	Major pot-hole			
	The width of Defects (m)	2.0			The length of Defects (m)	2.0

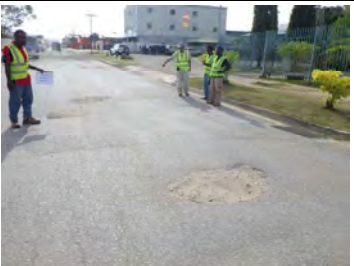
Existing Road Surface Condition on the Road				No	Station	Height of Embankment (m)	Total Carriage Width (m)	Remarks	
Date: July 2017				D13-4	3 + 700	0.0	7.00	Post Office Road

3.70 km from DoW Office		0.1 km from Post Office			
Left hand side towards West (Ocean)	Existing Lane width (m)	3.50		Right hand side towards West (Ocean)	Existing Lane width (m)	3.50			
	Type of Defects	Major pot-hole			Type of Defects	Major pot-hole			
	The width of Defects (m)	2 @4			The length of Defects (m)	2.0

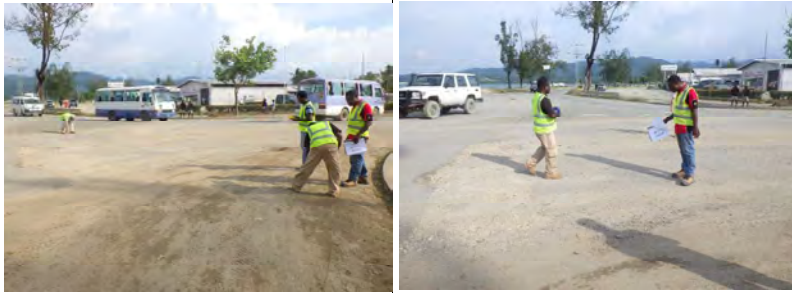
Existing Road Surface Condition on the Road				No	Station	Height of Embankment (m)	Total Carriage Width (m)	Remarks
Date: July 2017				D12-16	3 + 700	0.0	7.00	Post Office Road

3.70 km from DoW Office				
Right hand side towards South	Existing Lane width (m)	3.50		Right hand side towards South	Existing Lane width (m)	3.50		
	Type of Defects	Exposed base			Type of Defects	Exposed base		
	The width of Defects (m)	6.0			The length of Defects (m)	11.5

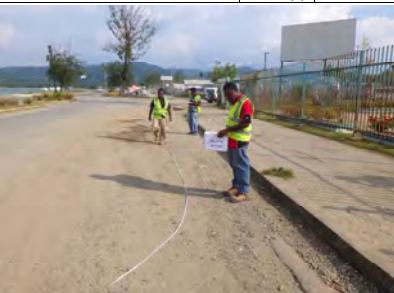
Existing Road Surface Condition on the Road				No	Station	Height of Embankment (m)	Total Carriage Width (m)	Remarks
Date: July 2017				D12-15	3 + 700	0.0	7.00	Beach Road

3.70 km from DoW Office				
Left hand side towards South	Existing Lane width (m)	3.50		Right hand side towards South	Existing Lane width (m)	3.50		
	Type of Defects	Major pot-hole			Type of Defects	Major pot-hole		
	The width of Defects (m)	6.0			The length of Defects (m)	23.0

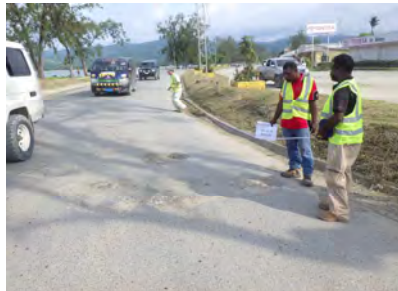
Existing Road Surface Condition on the Road				No	Station	Height of Embankment (m)	Total Carriage Width (m)	Remarks				
Date: July 2017				D12-10	3 + 600	0.0	7.00	Beach Road

3.60 km from DoW Office								
Left hand side towards South	Existing Lane width (m)	3.50	Right hand side towards South	Existing Lane width (m)	3.50							
	Type of Defects	Major pot-hole		Type of Defects	Major pot-hole							
	The width of Defects (m)	3.5		The length of Defects (m)	16.0

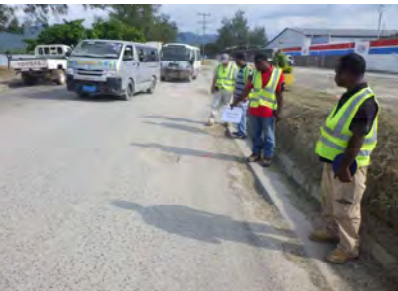
Existing Road Surface Condition on the Road				No	Station	Height of Embankment (m)	Total Carriage Width (m)	Remarks
				Date: July 2017				D12-9	3 + 550	0.0	7.00	Beach Road

3.55 km from DoW Office								
Left hand side towards South	Existing Lane width (m)	3.50	Right hand side towards South	Existing Lane width (m)	3.50							
	Type of Defects	Major pot-hole		Type of Defects	Major pot-hole							
	The width of Defects (m)	2.5		The length of Defects (m)	2.8

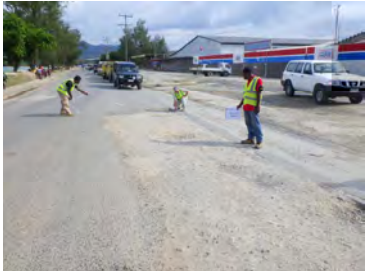
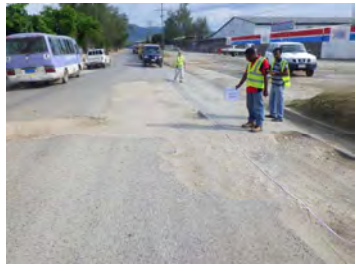
Existing Road Surface Condition on the Road				No	Station	Height of Embankment (m)	Total Carriage Width (m)	Remarks
				Date: July 2017				D12-8	3 + 500	0.0	7.00	Beach Road

3.50 km from DoW Office								
Left hand side towards South	Existing Lane width (m)	3.50	Right hand side towards South	Existing Lane width (m)	3.50							
	Type of Defects	Exposed base		Type of Defects	Exposed base							
	The width of Defects (m)	3.5		The length of Defects (m)	16.0

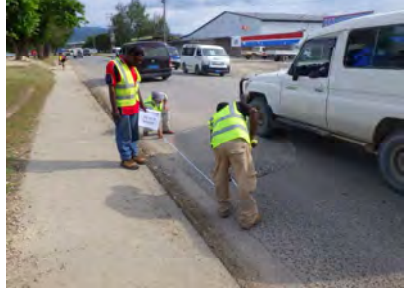
Existing Road Surface Condition on the Road				No	Station	Height of Embankment (m)	Total Carriage Width (m)	Remarks				
Date: July 2017				D12-7	3 + 500	0.0	7.00	Beach Road

3.50 km from DoW Office								
Left hand side towards South	Existing Lane width (m)	3.50	Right hand side towards South	Existing Lane width (m)	3.50							
	Type of Defects	Major pot-hole		Type of Defects	Major pot-hole							
	The width of Defects (m)	3.0		The length of Defects (m)	3.5

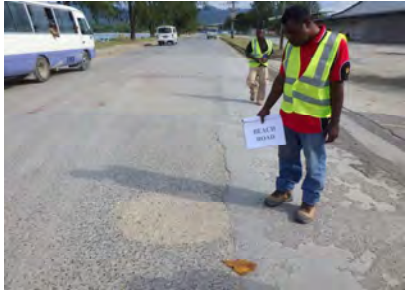
Existing Road Surface Condition on the Road				No	Station	Height of Embankment (m)	Total Carriage Width (m)	Remarks
				Date: July 2017				D12-6	3 + 400	0.0	7.00	Beach Road

3.40 km from DoW Office								
Left hand side towards South	Existing Lane width (m)	3.50	Right hand side towards South	Existing Lane width (m)	3.50							
	Type of Defects	Major pot-hole		Type of Defects	Major pot-hole							
	The width of Defects (m)	1.0		The length of Defects (m)	1.0

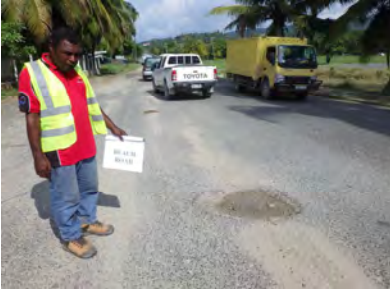
Existing Road Surface Condition on the Road				No	Station	Height of Embankment (m)	Total Carriage Width (m)	Remarks
Date: July 2017				D11-11	1 + 600	0.0	7.00	Beach Road

1.60 km from DoW Office				
Left hand side towards East	Existing Lane width (m)	3.50	Right hand side towards East	Existing Lane width (m)	3.50			
	Type of Defects	Major pot-hole		Type of Defects	Major pot-hole			
	The width of Defects (m)	1.0		The length of Defects (m)	1.0

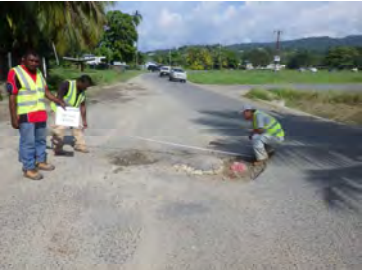
Existing Road Surface Condition on the Road				No	Station	Height of Embankment (m)	Total Carriage Width (m)	Remarks
Date: July 2017				D11-9	1 + 550	0.0	7.00	Beach Road

1.55 km from DoW Office				
Left hand side towards East	Existing Lane width (m)	3.50	Right hand side towards East	Existing Lane width (m)	3.50			
	Type of Defects	Major pot-hole		Type of Defects	Major pot-hole			
	The width of Defects (m)	2.0		The length of Defects (m)	3.0

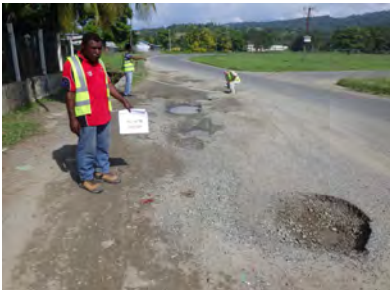
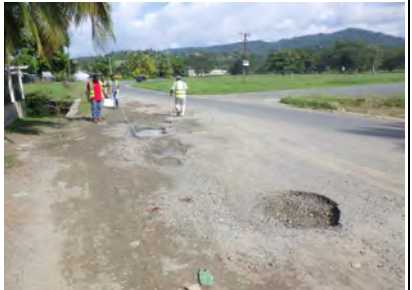
Existing Road Surface Condition on the Road				No	Station	Height of Embankment (m)	Total Carriage Width (m)	Remarks
Date: July 2017				D11-8	1 + 530	0.0	7.00	Beach Road

1.53 km from DoW Office				
Left hand side towards East	Existing Lane width (m)	3.50	Left hand side towards East	Existing Lane width (m)	3.50			
	Type of Defects	Deposited base		Type of Defects	Deposited base			
	The width of Defects (m)	4.0		The length of Defects (m)	26.0

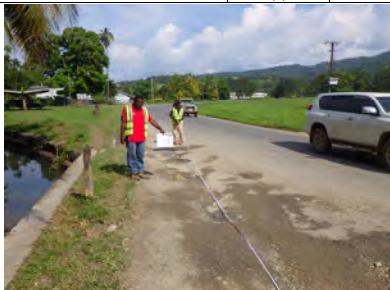
Existing Road Surface Condition on the Road				No	Station	Height of Embankment (m)	Total Carriage Width (m)	Remarks
Date: July 2017				D11-8	1 + 520	0.0	7.00	Beach Road

1.52 km from DoW Office				
Left hand side towards East	Existing Lane width (m)	3.50	Right hand side towards East	Existing Lane width (m)	3.50			
	Type of Defects	Deposited base		Type of Defects	Deposited base			
	The width of Defects (m)	4.0		The length of Defects (m)	26.0

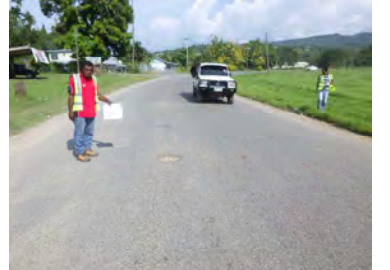
Existing Road Surface Condition on the Road				No	Station	Height of Embankment (m)	Total Carriage Width (m)	Remarks
Date: July 2017				D11-7	1 + 500	0.0	7.00	Beach Road

1.50 km from DoW Office				
Left hand side towards East	Existing Lane width (m)	3.50	Right hand side towards East	Existing Lane width (m)	3.50			
	Type of Defects	Major pot-hole		Type of Defects	Major pot-hole			
	The width of Defects (m)	0.3		The length of Defects (m)	0.3

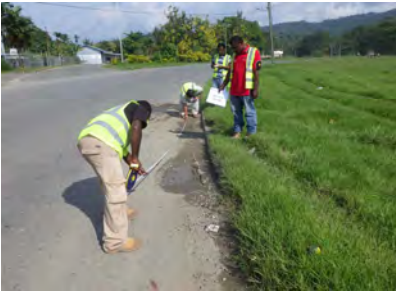
1.50 km from DoW Office				
Left hand side towards East	Existing Lane width (m)	3.50		Right hand side towards East	Existing Lane width (m)	3.50		2.3 km from Post Office
	Type of Defects	Major pot-hole			Type of Defects	Major pot-hole		
	The width of Defects (m)	0.5			The length of Defects (m)	0.5		
Existing Road Surface Condition on the Road				No	Station	Height of Embankment (m)	Total Carriage Width (m)	Remarks
Date: July 2017				D11-5	1 + 480	0.0	7.00	Beach Road

1.48 km from DoW Office				
Left hand side towards East	Existing Lane width (m)	3.50		Right hand side towards East	Existing Lane width (m)	3.50		2.32 km from Post Office
	Type of Defects	Major pot-hole			Type of Defects	Major pot-hole		
	The width of Defects (m)	0.7			The length of Defects (m)	5.0

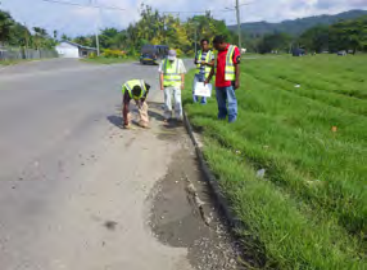
Existing Road Surface Condition on the Road				No	Station	Height of Embankment (m)	Total Carriage Width (m)	Remarks
Date: July 2017				D11-4	1 + 470	0.0	7.00	Beach Road

1.47 km from DoW Office				
Left hand side towards East	Existing Lane width (m)	3.50		Right hand side towards East	Existing Lane width (m)	3.50		2.33 km from Post Office
	Type of Defects	Major pot-hole			Type of Defects	Major pot-hole		
	The width of Defects (m)	1.4			The length of Defects (m)	1.6

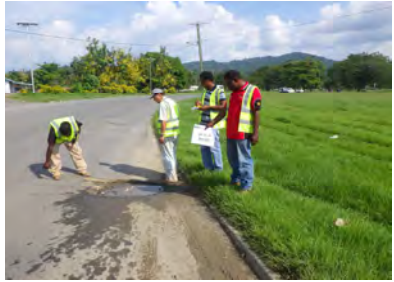
Existing Road Surface Condition on the Road				No	Station	Height of Embankment (m)	Total Carriage Width (m)	Remarks
Date: July 2017				D11-3	1 + 450	0.0	7.00	Beach Road

1.48 km from DoW Office				
Left hand side towards East	Existing Lane width (m)	3.50		Right hand side towards East	Existing Lane width (m)	3.50		2.35 km from Post Office
	Type of Defects	Major pot-hole			Type of Defects	Major pot-hole		
	The width of Defects (m)	1.0			The length of Defects (m)	1.0

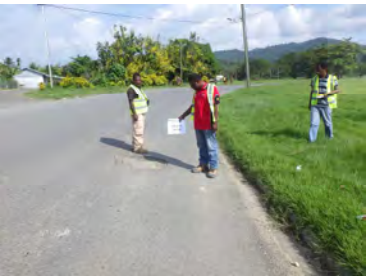
1.44 km from DoW Office				
Left hand side towards East	Existing Lane width (m)	3.50		Right hand side towards East	Existing Lane width (m)	3.50		2.38 km from Post Office
	Type of Defects	Pot-hole			Type of Defects	Pot-hole		
	The width of Defects (m)	0.3			The length of Defects (m)	0.3		
Existing Road Surface Condition on the Road				No	Station	Height of Embankment (m)	Total Carriage Width (m)	Remarks
Date: July 2017				D11-1	1 + 440	0.0	7.00	Beach Road

1.44 km from DoW Office				
Left hand side towards East	Existing Lane width (m)	3.50		Right hand side towards East	Existing Lane width (m)	3.50		2.36 km from Post Office
	Type of Defects	Major pot-hole			Type of Defects	Major pot-hole		
	The width of Defects (m)	1.0			The length of Defects (m)	1.0

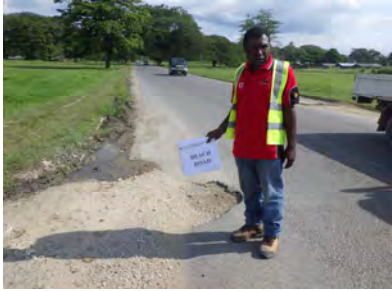
Existing Road Surface Condition on the Road				No	Station	Height of Embankment (m)	Total Carriage Width (m)	Remarks
Date: July 2017				D10	1 + 350	0.0	7.00	Beach Road

1.35 km from DoW Office		2.45 km from Post Office		
Left hand side towards South	Existing Lane width (m)	3.50	Right hand side towards South	Existing Lane width (m)	3.50			
	Type of Defects	Major pot-hole		Type of Defects	Major pot-hole			
	The width of Defects (m)	2.3		The length of Defects (m)	3.0

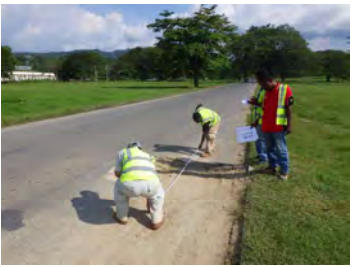
Existing Road Surface Condition on the Road				No	Station	Height of Embankment (m)	Total Carriage Width (m)	Remarks
Date: July 2017				D8	1 + 320	0.0	7.00	Beach Road

1.32 km from DoW Office		2.48 km from Post Office		
Left hand side towards South	Existing Lane width (m)	3.50	Right hand side towards South	Existing Lane width (m)	3.50			
	Type of Defects	Major pot-hole		Type of Defects	Major pot-hole			
	The width of Defects (m)	1.2		The length of Defects (m)	1.5

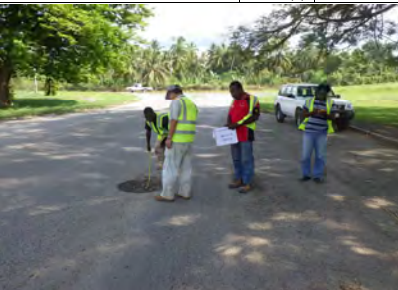
Existing Road Surface Condition on the Road				No	Station	Height of Embankment (m)	Total Carriage Width (m)	Remarks
Date: July 2017				D3	1 + 220	0.0	7.00	Beach Road

1.22 km from DoW Office				2.58 km from Post Office
Left hand side towards South	Existing Lane width (m)	3.50	Right hand side towards South	Existing Lane width (m)	3.50			
	Type of Defects	Major pot-hole		Type of Defects	Major pot-hole			
	The width of Defects (m)	1.0		The length of Defects (m)	1.2

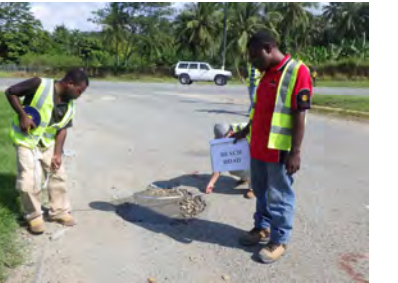
Existing Road Surface Condition on the Road				No	Station	Height of Embankment (m)	Total Carriage Width (m)	Remarks
Date: July 2017				D2-3 D2-4	1 + 200	0.0	7.00	Beach Road

1.20 km from DoW Office				2.6 km from Post Office
Left hand side towards South	Existing Lane width (m)	3.50	Right hand side towards South	Existing Lane width (m)	3.50			
	Type of Defects	Major pot-hole		Type of Defects	Major pot-hole			
	The width of Defects (m)	3.0 2.5		The length of Defects (m)	4.5 3.5

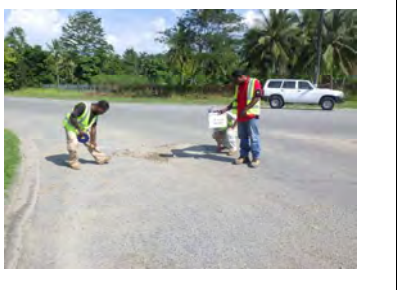
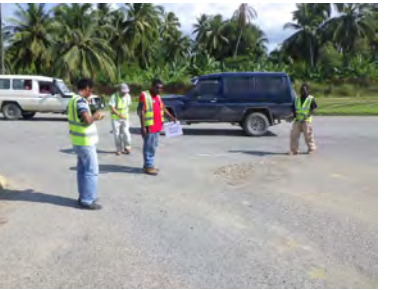
Existing Road Surface Condition on the Road				No	Station	Height of Embankment (m)	Total Carriage Width (m)	Remarks
Date: July 2017				D2-1 D2-2	1 + 200	0.0	7.00	Beach Road

1.20 km from DoW Office				2.8 km from Post Office
Left hand side towards South	Existing Lane width (m)	3.50	Right hand side towards South	Existing Lane width (m)	3.50			
	Type of Defects	Major pot-hole		Type of Defects	Major pot-hole			
	The width of Defects (m)	1.8 1.2		The length of Defects (m)	2.5 1.3

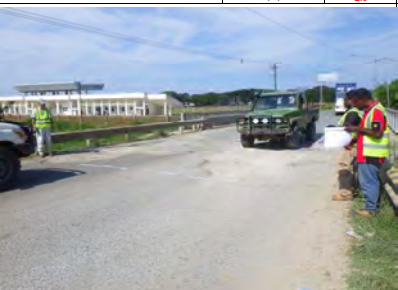
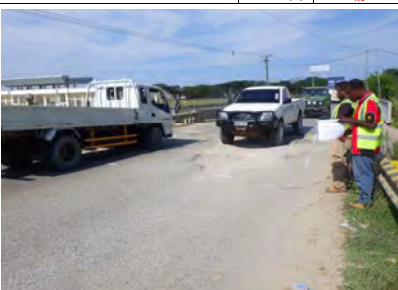
Existing Road Surface Condition on the Road				No	Station	Height of Embankment (m)	Total Carriage Width (m)	Remarks
Date: July 2017				D1-3 D1-4	1 + 140	0.0	7.00	Beach Road

1.14 km from DoW Office				2.66 km from Post Office
Left hand side towards East	Existing Lane width (m)	3.50	Right hand side towards East	Existing Lane width (m)	3.50			
	Type of Defects	Exposed base Major pot-hole		Type of Defects	Exposed base Major pot-hole			
	The width of Defects (m)	8.0 2.0		The length of Defects (m)	8.0 4.0

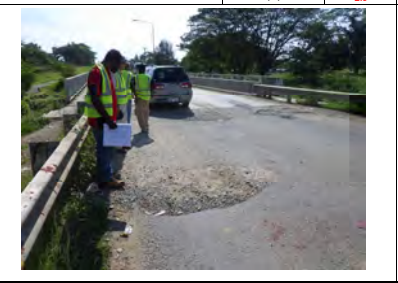
Existing Road Surface Condition on the Road				No	Station	Height of Embankment (m)	Total Carriage Width (m)	Remarks
Date: July 2017				D1-1 D1-2	1 + 120	0.0	8.00	Caritex Bridge

1.12 km from DoW Office				2.68 km from Post Office
Left hand side towards West	Existing Lane width (m)	4.00	Right hand side towards West	Existing Lane width (m)	4.00			
	Type of Defects	Major pot-hole		Type of Defects	Major pot-hole			
	The width of Defects (m)	1.5 2.5		The length of Defects (m)	2.0 7.5

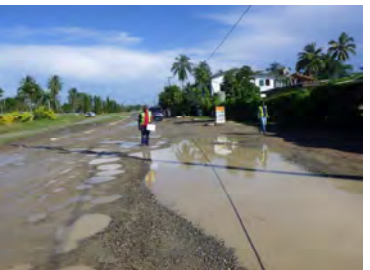
Existing Road Surface Condition on the Road				No	Station	Height of Embankment (m)	Total Carriage Width (m)	Remarks
Date: July 2017				D41-7		0.0	7.00	Boram Road
				km from DoW Office		km from Post Office		
Left hand side towards West	Existing Lane width (m)	3.50		Right hand side towards West	Existing Lane width (m)	3.50		Major pot-hole
	Type of Defects	Major pot-hole			Type of Defects	Major pot-hole		
	The width of Defects (m)	6.0			The length of Defects (m)	50.0

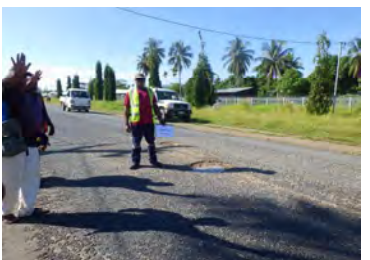
Existing Road Surface Condition on the Road				No	Station	Height of Embankment (m)	Total Carriage Width (m)	Remarks
Date: July 2017				D43-1		0.0	6.60	Boram Road
				km from DoW Office		km from Post Office		
Towards West (Ocean)	Existing Lane width (m)	3.30		Right hand side towards East	Existing Lane width (m)	3.30		Major pot-hole
	Type of Defects	Major pot-hole			Type of Defects	Major pot-hole		
	The width of Defects (m)	8.0			The length of Defects (m)	30.0

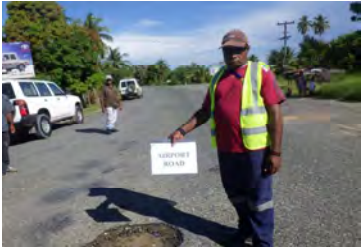
Existing Road Surface Condition on the Road				No	Station	Height of Embankment (m)	Total Carriage Width (m)	Remarks
Date: July 2017				D43-1			6.60	Boram Road

0.00 km from DoW Office		km from Post Office		
Left hand side towards West	Existing Lane width (m)	3.30	Left hand side towards West	Existing Lane width (m)	3.30			
	Type of Defects	Major pot-hole		Type of Defects	Major pot-hole			
	The width of Defects (m)	1.0		The length of Defects (m)	1.0

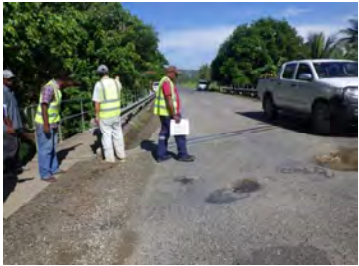
No	Station	Height of Embankment (m)	Total Carriage Width (m)	Remarks
				D44-1		0.0	7.00	Boram Road

0.00 km from DoW Office		km from Post Office		
Left hand side towards West	Existing Lane width (m)	3.50	Left hand side towards East (Ocean)	Existing Lane width (m)	3.50			
	Type of Defects	Major pot-hole		Type of Defects	Major pot-hole			
	The width of Defects (m)	1.0		The length of Defects (m)	1.0

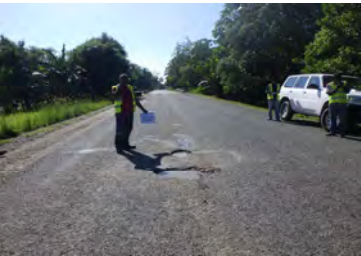
No	Station	Height of Embankment (m)	Total Carriage Width (m)	Remarks
				D44-8		0.0	7.00	Boram Road

0.00 km from DoW Office		km from Post Office		
Left hand side towards East (Ocean)	Existing Lane width (m)	3.50	Right hand side towards East	Existing Lane width (m)	3.50			
	Type of Defects	Major pot-hole		Type of Defects	Major pot-hole			
	The width of Defects (m)	1.0		The length of Defects (m)	1.0

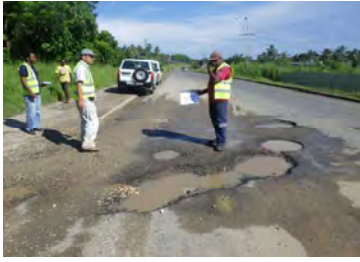
No	Station	Height of Embankment (m)	Total Carriage Width (m)	Remarks
				D45-1	+	0.0	8.00	Boram Road

0.00 km from DoW Office		km from Post Office		
Left hand side towards West	Existing Lane width (m)	4.00	Right hand side towards West	Existing Lane width (m)	4.00			
	Type of Defects	Major pot-hole		Type of Defects	Major pot-hole			
	The width of Defects (m)	3.5		The length of Defects (m)	15.0

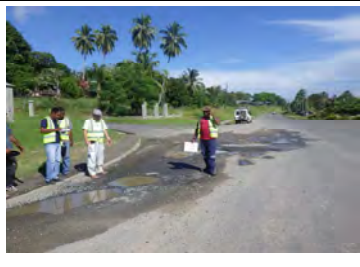
No	Station	Height of Embankment (m)	Total Carriage Width (m)	Remarks
				D15-1		0.0	8.00	Wirui Road

0.00 km from DoW Office		km from Post Office		
Left hand side towards West	Existing Lane width (m)	4.00	Right hand side towards West	Existing Lane width (m)	4.00			
	Type of Defects	Major pot-hole		Type of Defects	Major pot-hole			
	The width of Defects (m)	6.5		The length of Defects (m)	8.0

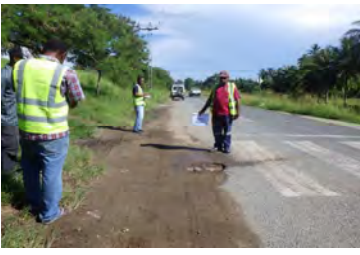
No	Station	Height of Embankment (m)	Total Carriage Width (m)	Remarks
				D50		0.0	7.00	Wirui Road

0.00 km from DoW Office		km from Post Office		
Left hand side towards West	Existing Lane width (m)	3.50	Right hand side towards West	Existing Lane width (m)	3.50			
	Type of Defects	Major pot-hole		Type of Defects	Major pot-hole			
	The width of Defects (m)	1.0		The length of Defects (m)	2.0

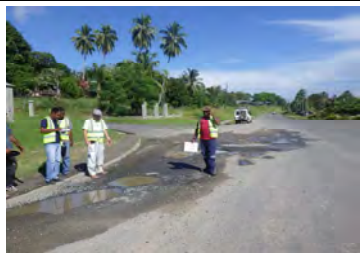
No	Station	Height of Embankment (m)	Total Carriage Width (m)	Remarks
				D15-1		0.0	8.00	Wirui Road

0.00 km from DoW Office		km from Post Office		
Left hand side towards West	Existing Lane width (m)	4.00	Right hand side towards West	Existing Lane width (m)	4.00			
	Type of Defects	Major pot-hole		Type of Defects	Major pot-hole			
	The width of Defects (m)	6.5		The length of Defects (m)	8.0

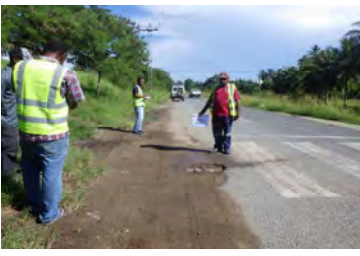
No	Station	Height of Embankment (m)	Total Carriage Width (m)	Remarks
				D50		0.0	7.00	Wirui Road

0.00 km from DoW Office		km from Post Office		
Left hand side towards West	Existing Lane width (m)	3.50	Right hand side towards West	Existing Lane width (m)	3.50			
	Type of Defects	Major pot-hole		Type of Defects	Major pot-hole			
	The width of Defects (m)	1.0		The length of Defects (m)	2.0

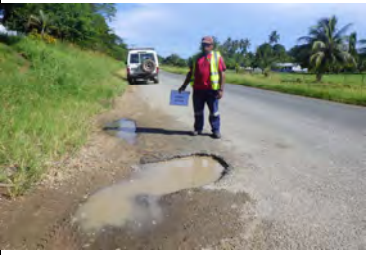
Existing Road Surface Condition on the Road				No	Station	Height of Embankment (m)	Total Carriage Width (m)	Remarks
Date: July 2017				D47		0.0	7.00	Wirui Road
				km from DoW Office		km from Post Office		
Left hand side towards West	Existing Lane width (m)	3.50	Right hand side towards West	Existing Lane width (m)	3.50			
	Type of Defects	Major pot-hole		Type of Defects	Major pot-hole			
	The width of Defects (m)	1.0		The length of Defects (m)	1.0

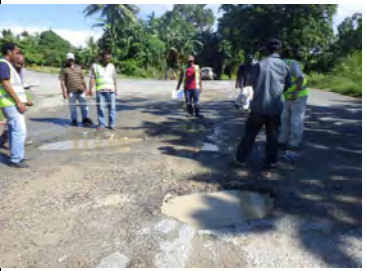
Existing Road Surface Condition on the Road				No	Station	Height of Embankment (m)	Total Carriage Width (m)	Remarks
Date: July 2017				D50		0.0	7.00	Wirui Road
				km from DoW Office		km from Post Office		
Left hand side towards West	Existing Lane width (m)	3.50	Right hand side towards West	Existing Lane width (m)	3.50			
	Type of Defects	Major pot-hole		Type of Defects	Major pot-hole			
	The width of Defects (m)	2.0		The length of Defects (m)	17.0

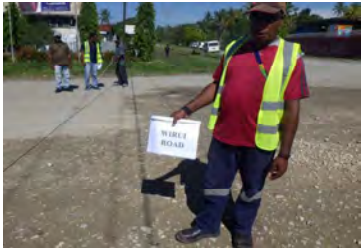
Existing Road Surface Condition on the Road				No	Station	Height of Embankment (m)	Total Carriage Width (m)	Remarks
Date: July 2017				D54-2	3 + 550	0.0	9.00	Wirui Road

3.50 km from DoW Office		0.25 km from Post Office		
Left hand side towards West	Existing Lane width (m)	4.50	Right hand side towards West	Existing Lane width (m)	4.50			
	Type of Defects	Major pot-hole		Type of Defects	Major pot-hole			
	The width of Defects (m)	8.0		The length of Defects (m)	13.0

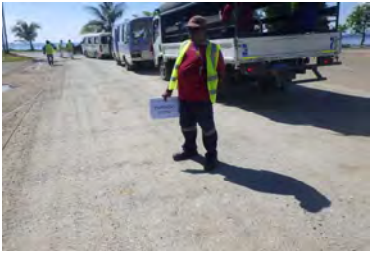
Existing Road Surface Condition on the Road			No	Station	Height of Embankment (m)	Total Carriage Width (m)	Remarks	
Date: July 2017			D155-10		0.0	7.00	Papindo Road	
			0.00 km from DoW Office		km from Post Office			
Left hand side towards East	Existing Lane width (m)	3.50	Right hand side towards East				Existing Lane width (m)	3.50
	Type of Defects	Major pot-hole					Type of Defects	Major pot-hole
	The width of Defects (m)	14.0					The length of Defects (m)	49.0

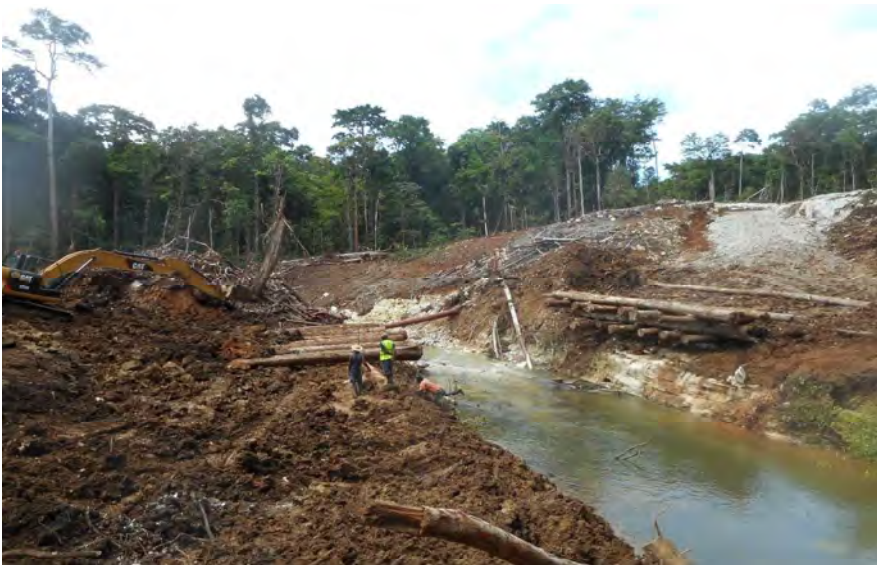
Akress River construction phase

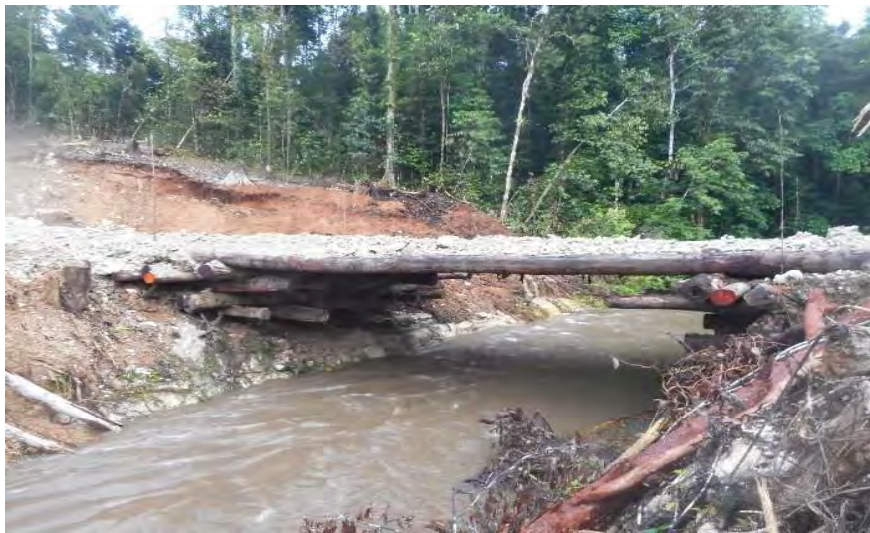
Akress River completion phase

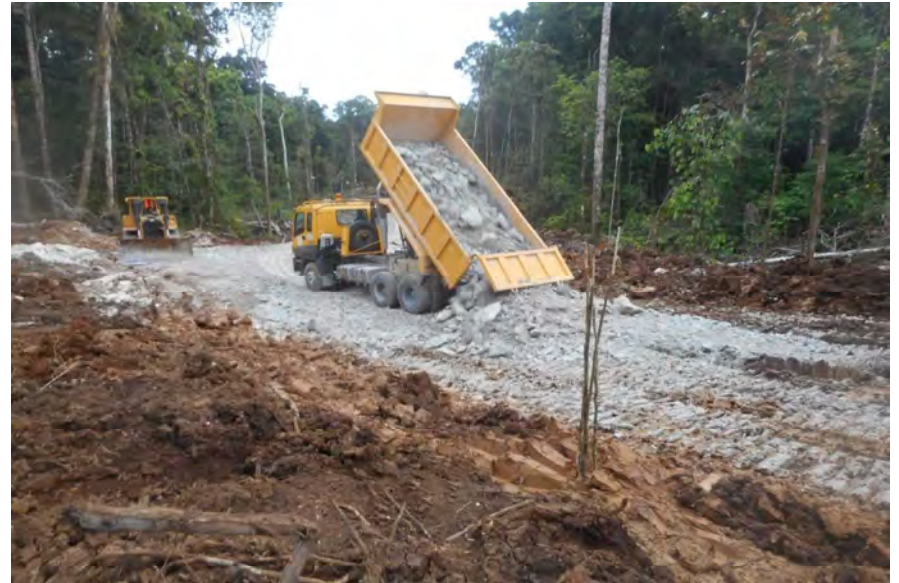
Sub Base material - Graveling Works at CH: 14.5km

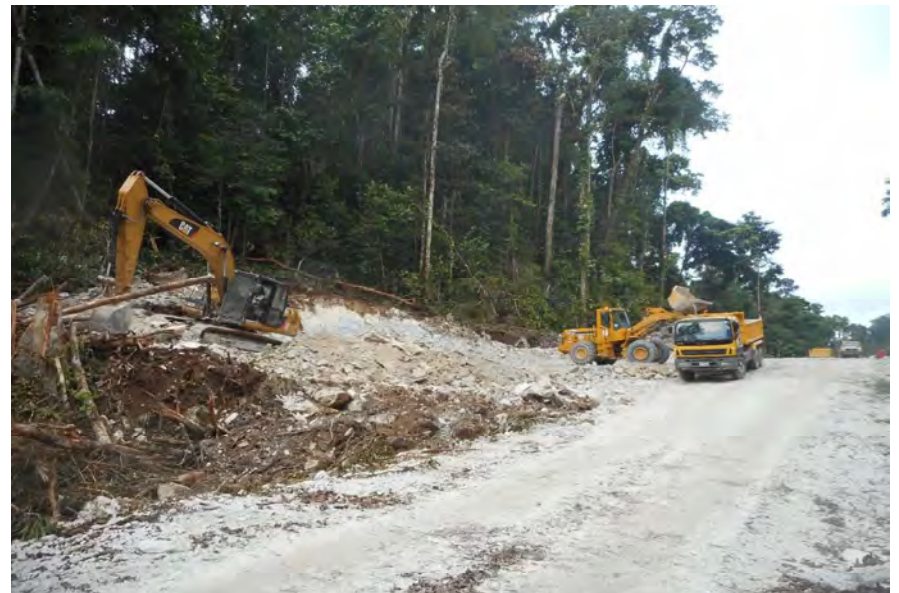
Road side pit.

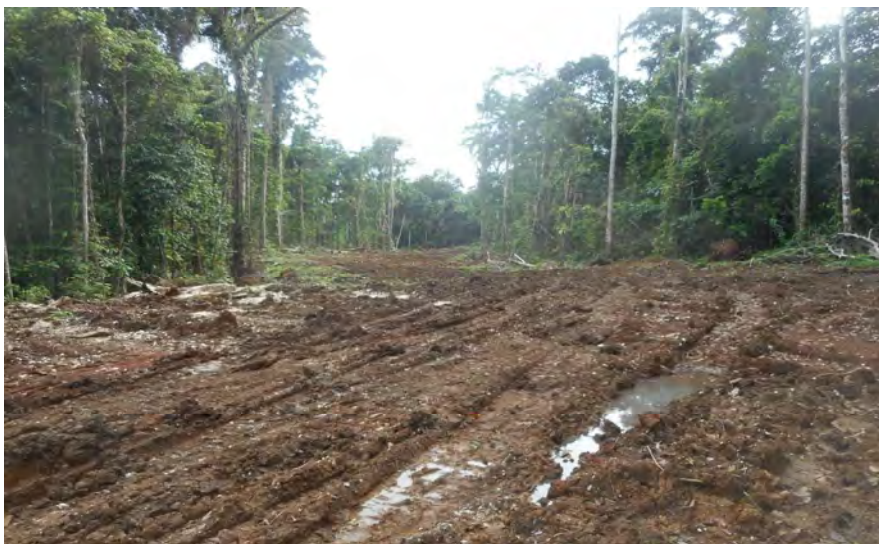
Clearing and Grubbing works CH: 14.5km to CH: 15.5km

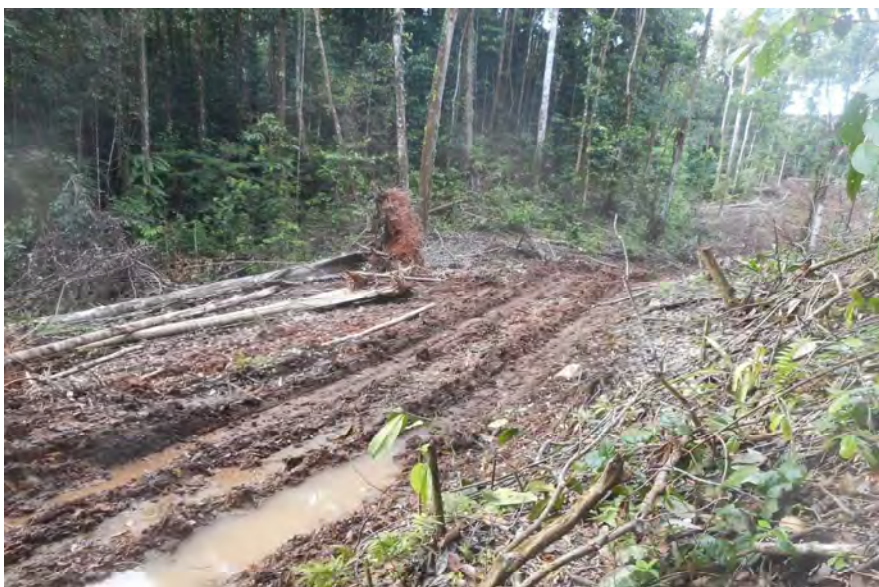
Trees felling CH: 15.5km to CH: 18.0km

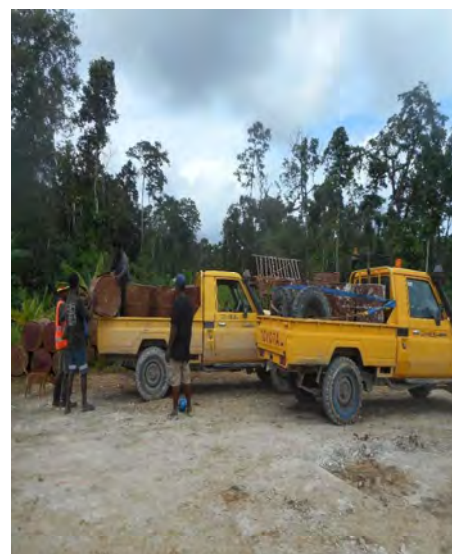
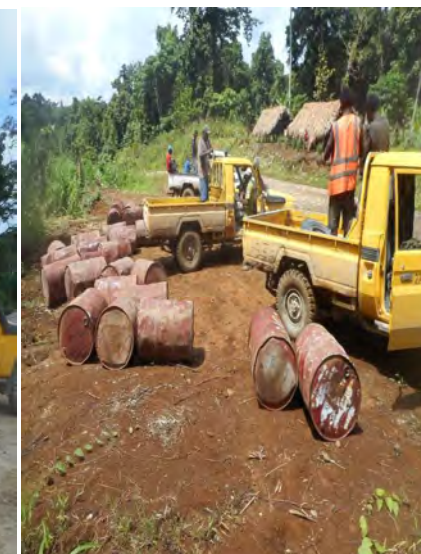
Means of fuel delivery due to bad road condition. Full Diesel drums to be transport to job site at second point of discharge from Kimbe town.

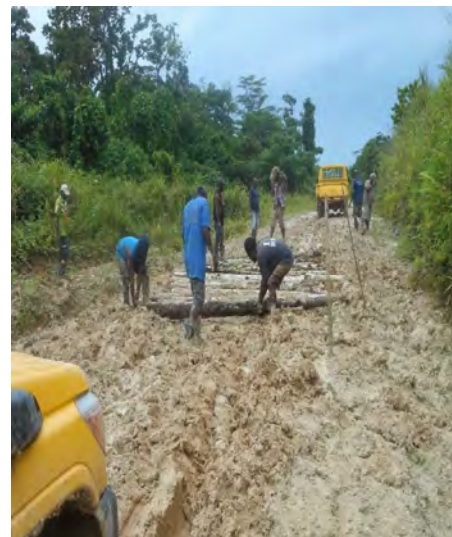
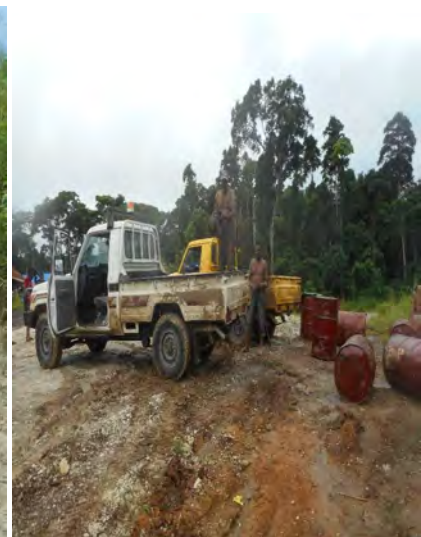
One of the bad road section between Silovuti Junction & Cape Rouges Junction that affects the project operation during rainy days.

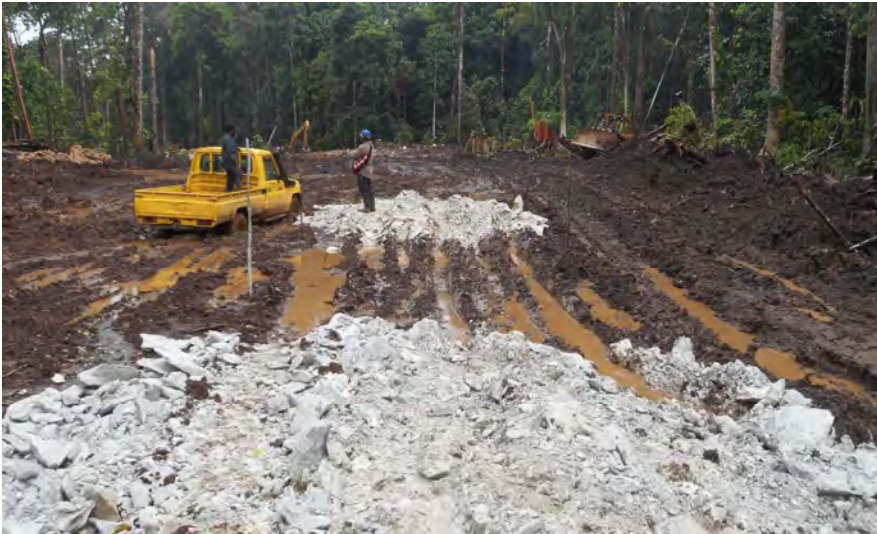
Wet days on project site

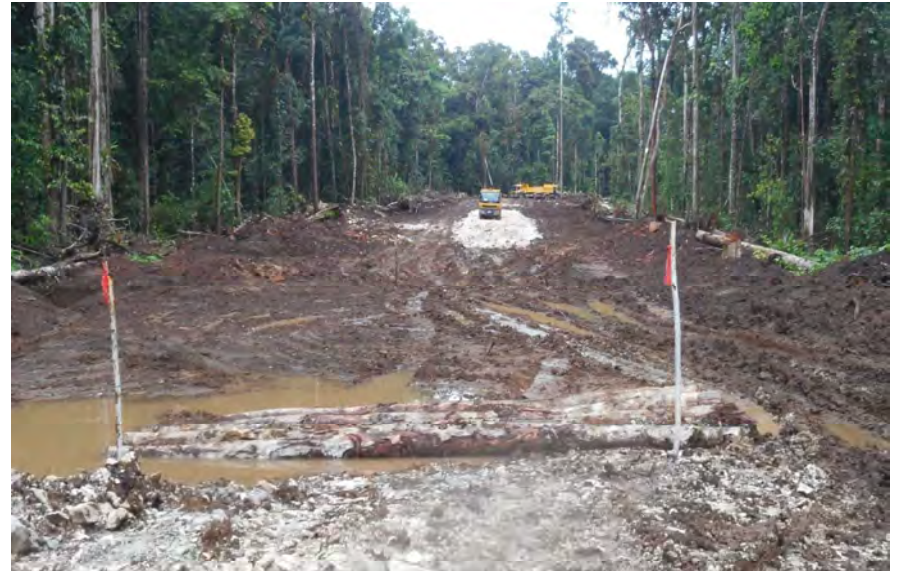
Daily activity (Gravelling) suspend due to rain

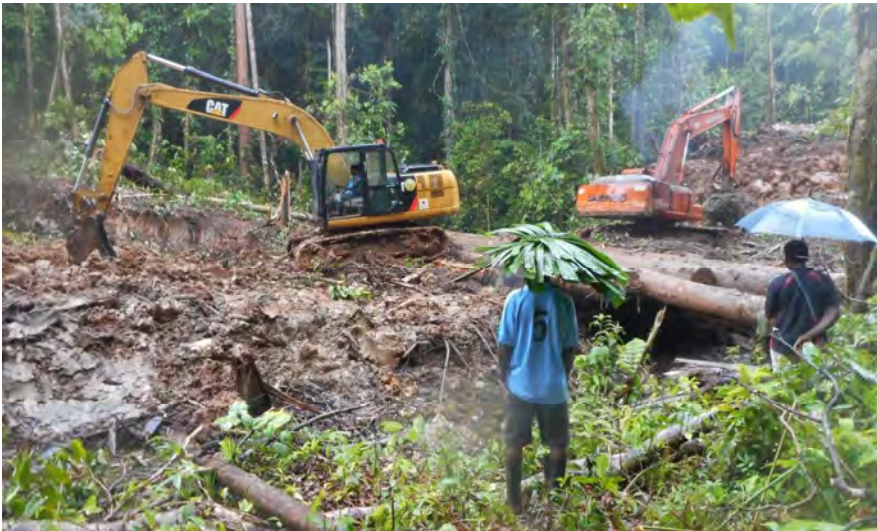
Tavurlasi Temporary log bridge construction

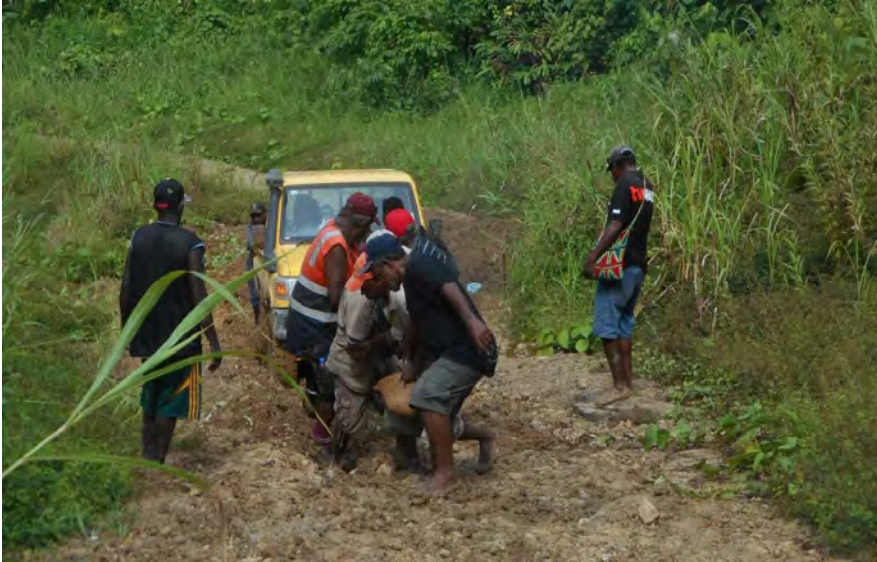
One of a muddy road section between Silovuti Junction and Ayang Bus stop

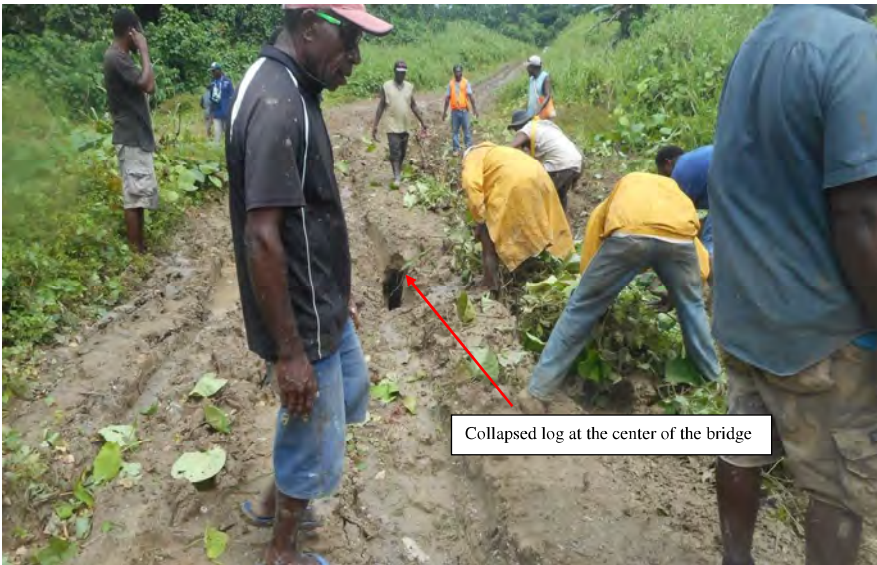
Collapsed log at the center of the bridge

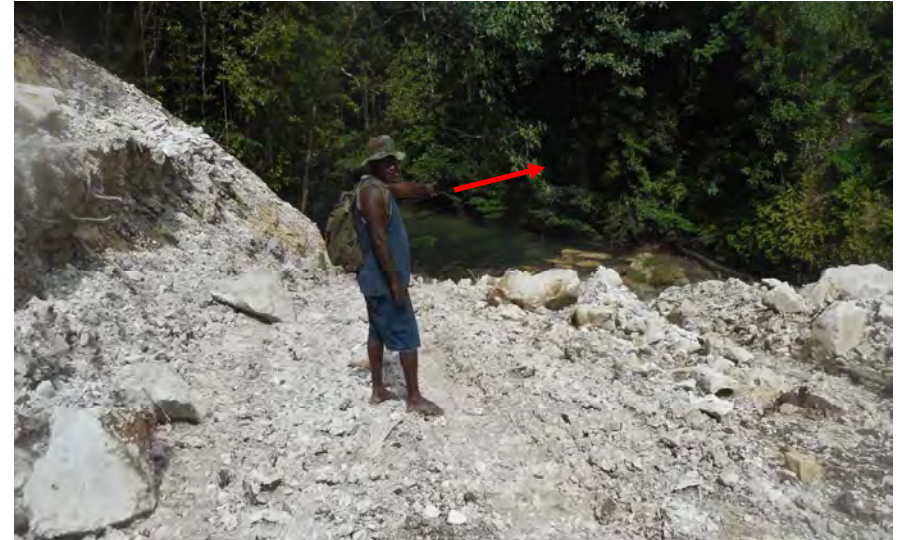
Vol River – Wet crossing (Photo before)

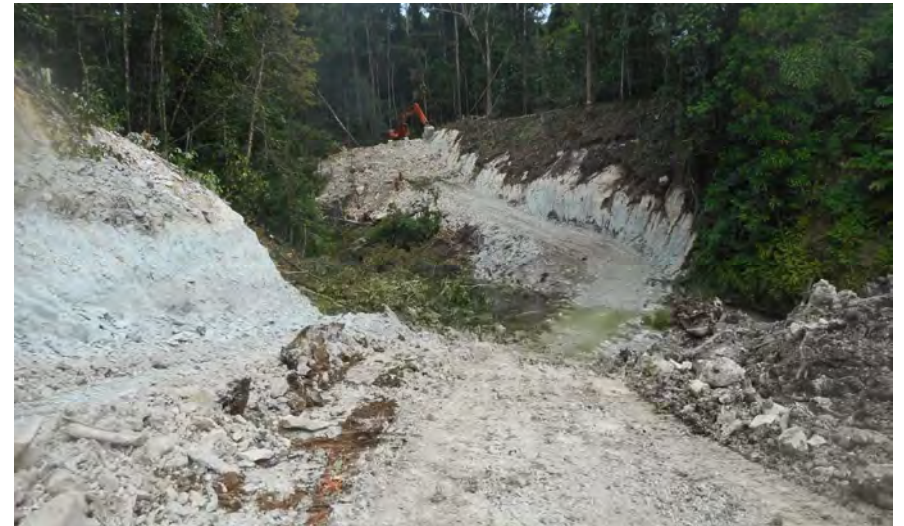
Vol River – Wet crossing (Photo after)

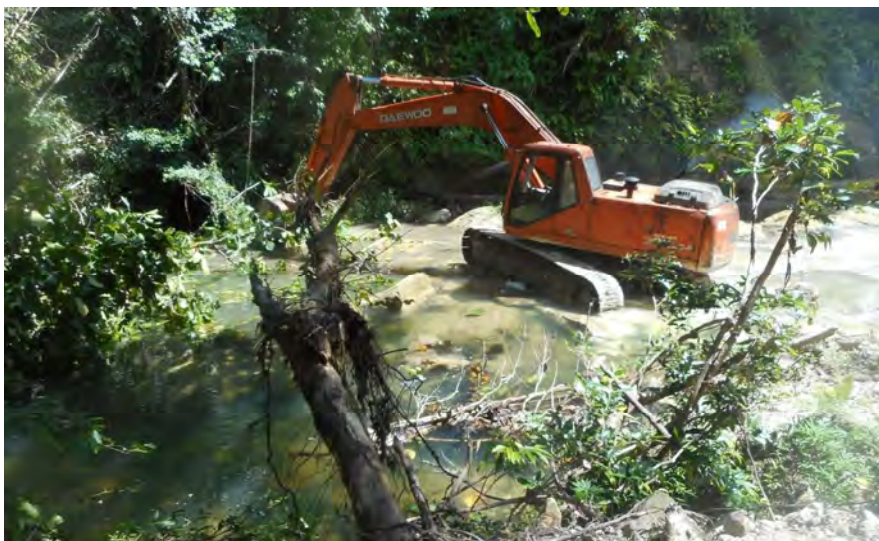
Wet crossing at Vol river – During construction

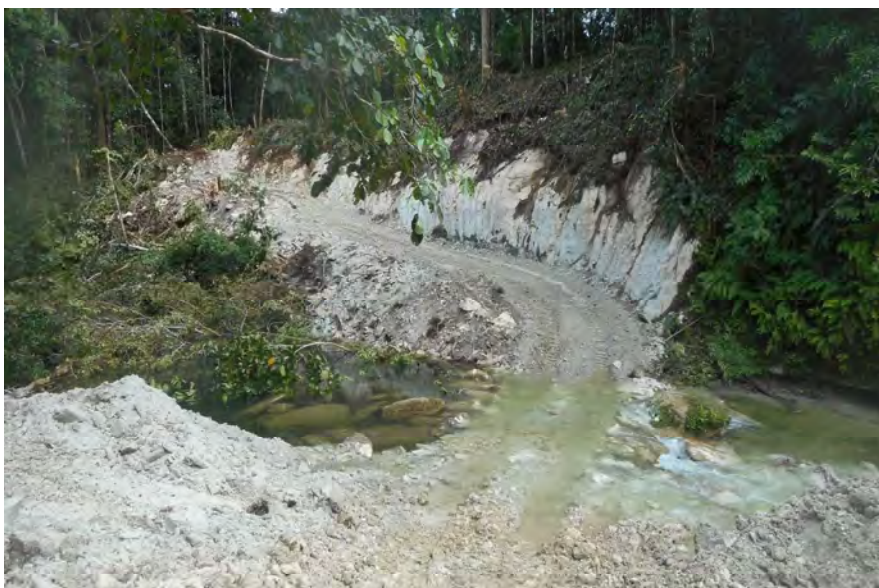
Wet crossing at Vol river after construction

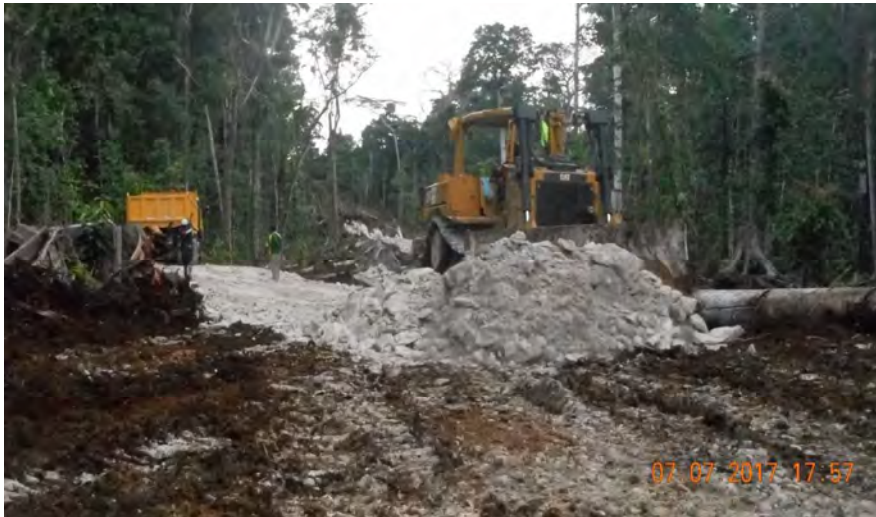
Graveling work

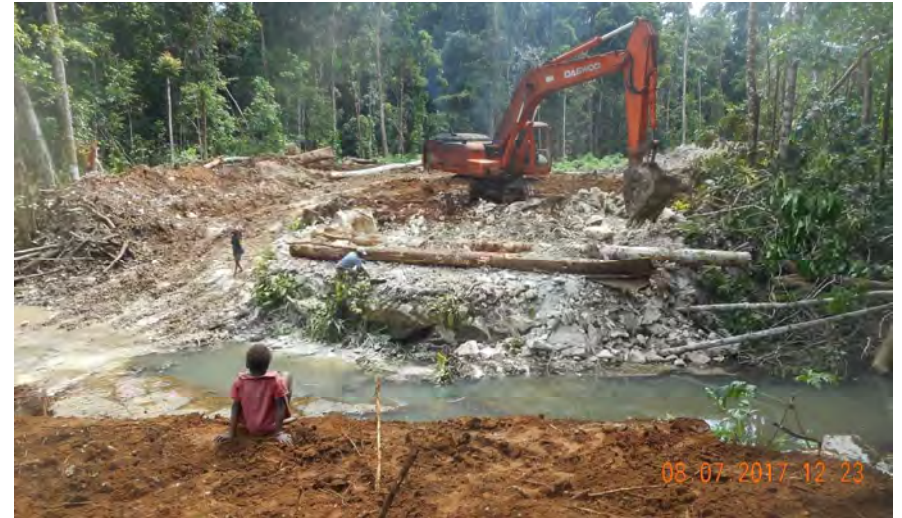
Log Bridge abutment construction – Vil Creek

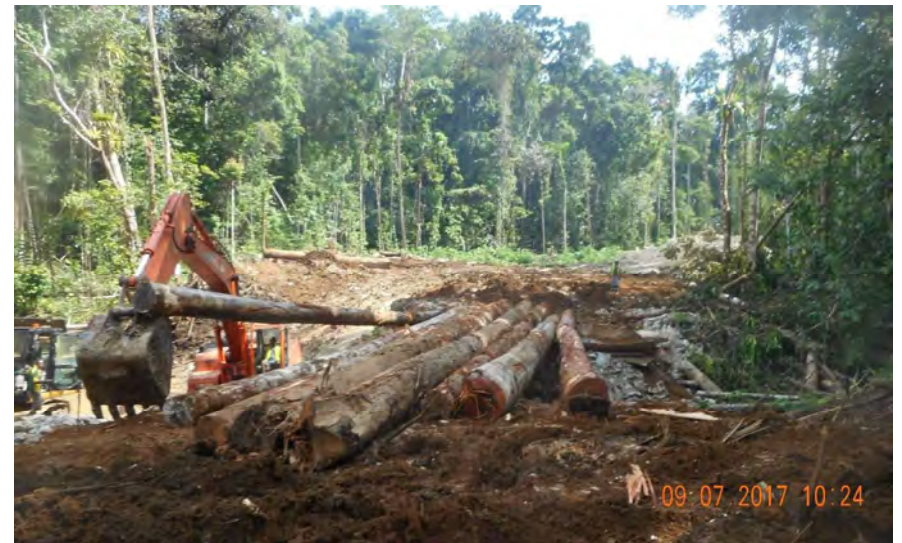
Log Bridge construction – Vil Creek
