Title: Geotechnical Investigation: Teouma Bridge, Vanuatu					
Date	Version	Description	Prepared by:	Reviewed by:	Authorised by:
09/08/2018	Draft	Draft report	M Nugent	A Pomfret	C Freer
31/08/2018	Final	Final report	M Nugent	N Hickman	C Freer

Geotechnical investigations were completed at Teouma Bridge, Efate Ring Road, located east of Port Vila, on the island of Efate, Vanuatu to support the proposed construction of a new bridge to replace the existing Teouma Bridge and associated river rehabilitation works.

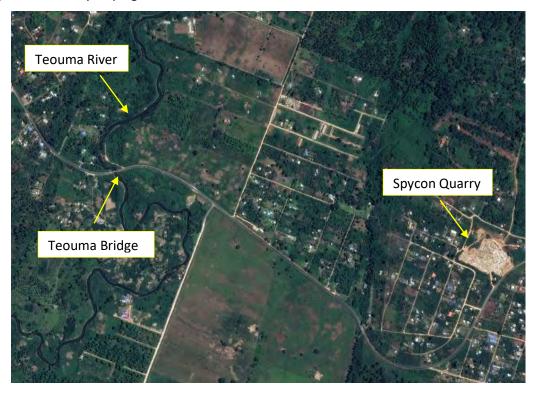
Figure 2.1: Aerial photograph of the geotechnical investigation sites, Efate Ring Road, east of Port Vila, Vanuatu.

The drill sites are situated on the banks of the Teouma River southwest and northeast of Teouma Bridge, which is located within a narrow alluvial valley, near the base of a coral bedrock escarpment approximately 7 km feast of Port Vila (shown in Figure 2.1). The sites comprise vegetated and open, gently to moderately sloping land.

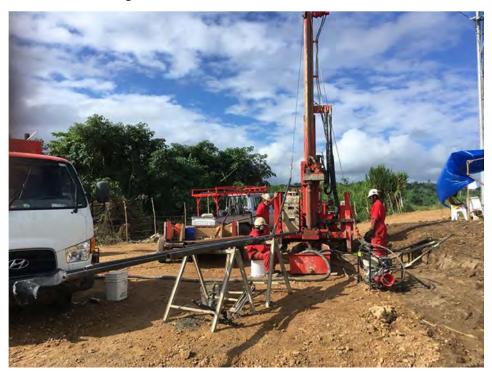
Figure 3.1: Photo of the Vanuatu Drilling Ltd drill rig used during the investigations.

The machine drilled boreholes were undertaken by Vanuatu Drilling Ltd. under the supervision of T+TI. The machine drilled (rotary cored) boreholes were performed using a trailer mounted rig using HQTT (HQ Triple Tube) wireline techniques with Standard Penetration Testing (SPT) performed at regular intervals using an unlined Raymond-type split-spoon sampler. A photo of the machine drilling equipment used is shown in Figure 3.1 below.

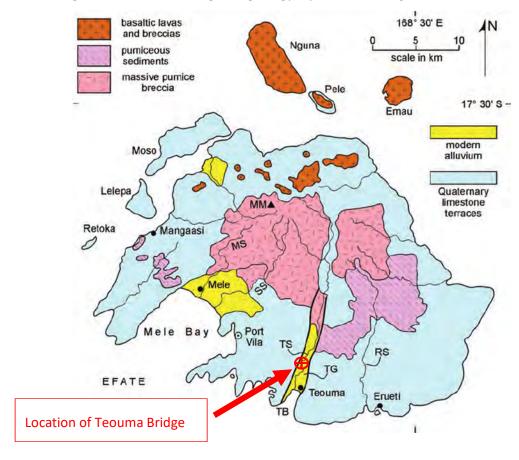
Figure 4.1: Geological map of Efate, Vanuatu (Reproduced from Ash et al. 1978)

The site is located at the base of a coral limestone escarpment to the east. The location of the sites (Teouma Bridge) in context of the regional geology is presented in Figure 4.1 below.

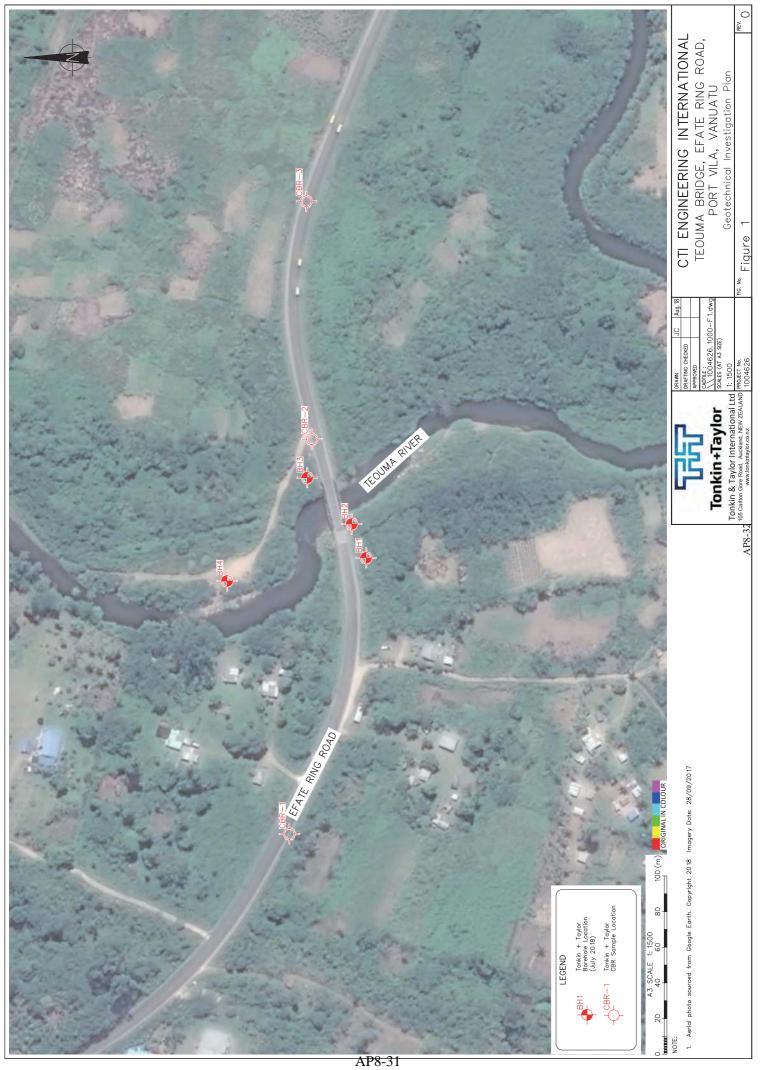
- Site plan
 - Teouma Bridge site
