BH-1 Photos – Teouma Bridge, Vanuatu

BH-2 Photos – Teouma Bridge, Vanuatu

BH-3 Photos - Teouma Bridge, Vanuatu

BH-4 Photos – Teouma Bridge, Vanuatu

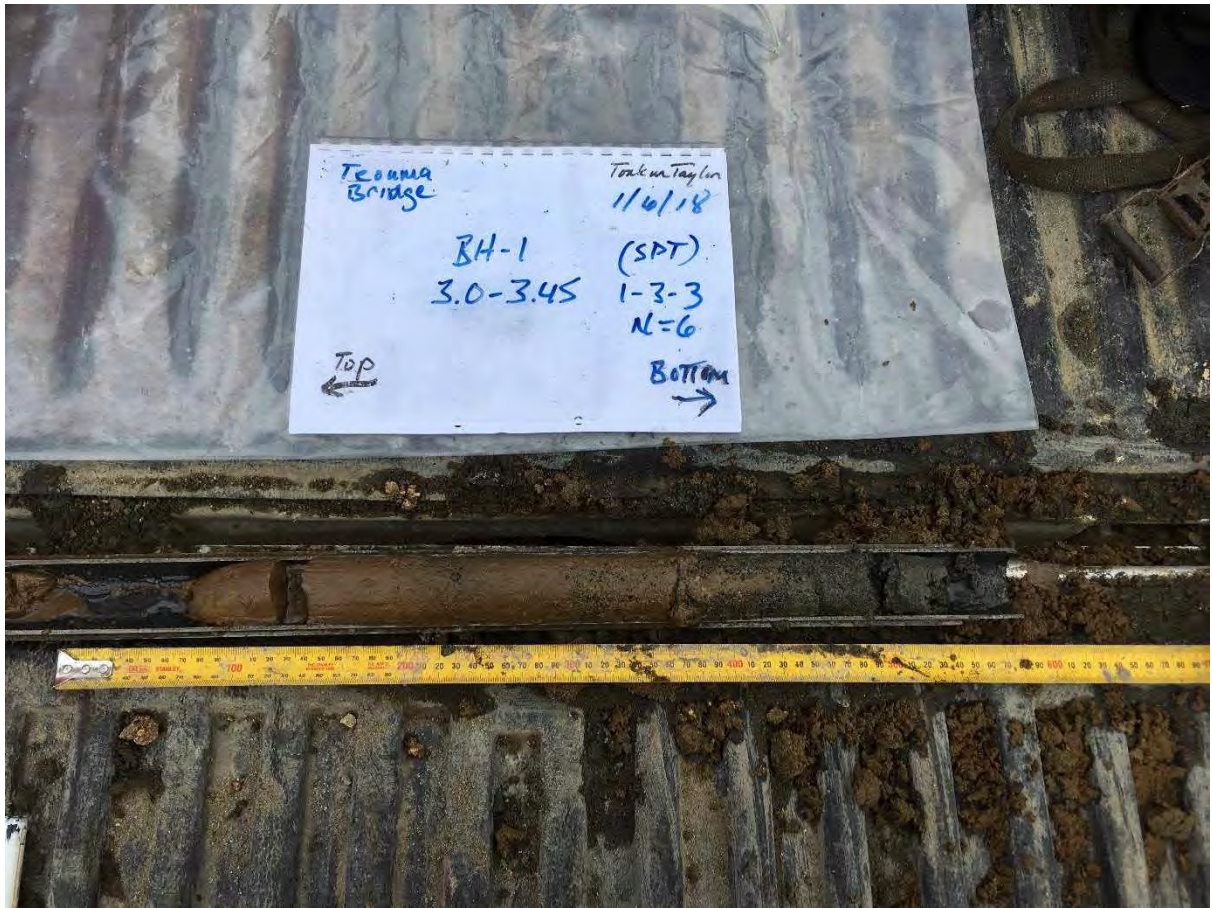
BH-1 (SPT)  
3.0-3.45 1-3-3  
N=6

Top ←

→ Bottom

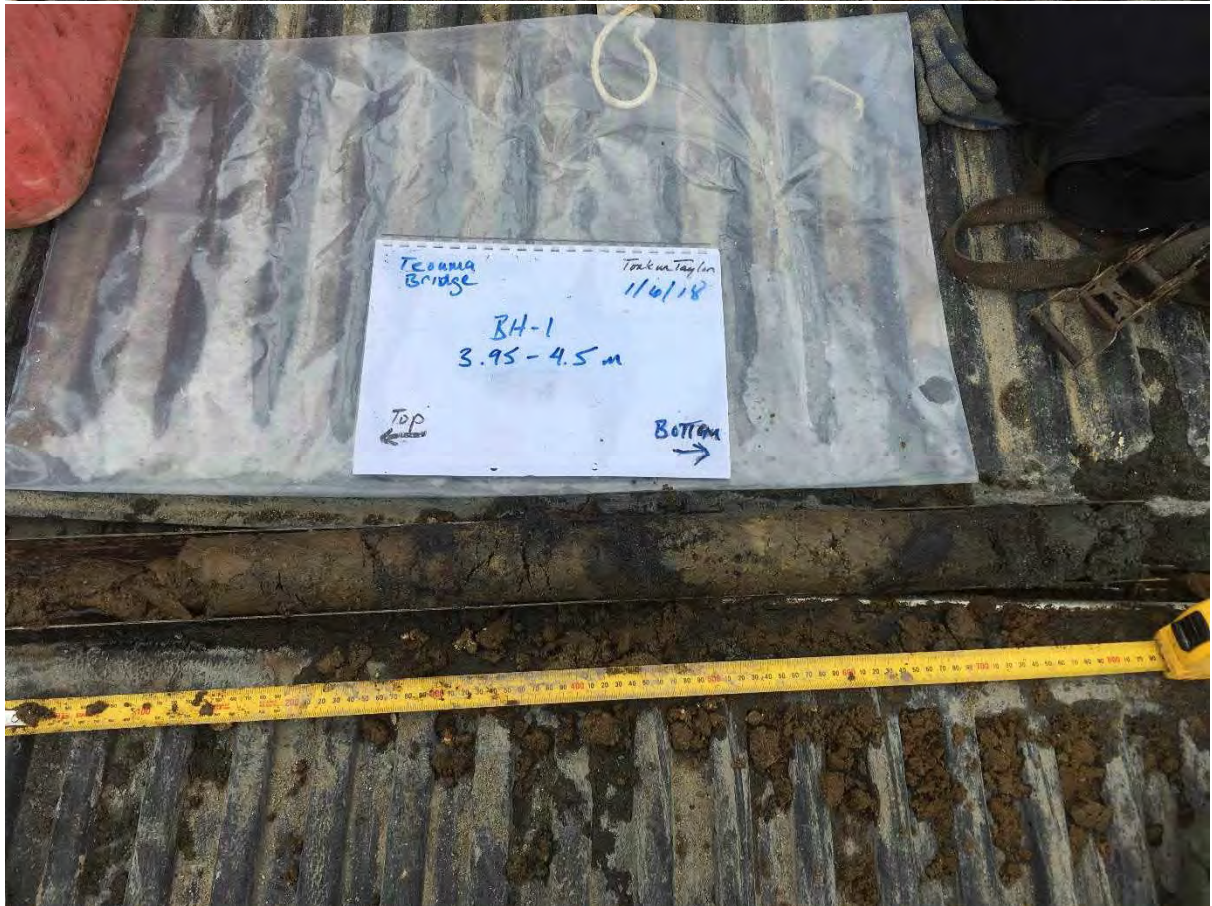
BH-1  
3.95-4.5 m

Top ←

→ Bottom
